AEI Consultants

PROPERTY CONDITION REPORT - EQUITY

1979 and 1985 Mission Street and 2950, 2960, 2970 and 2978 16th Street
San Francisco, San Francisco County, California 94132

AEI Project No. 425780
Client Reference No.
Client Reference Name:

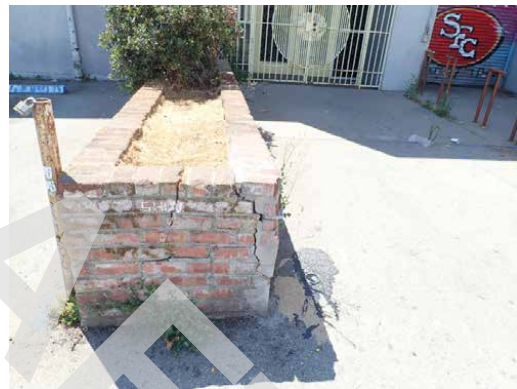
Item	Quantity	Unit	Unit Cost	Replacement Percent	Immediate Total	Short Term Total	Comments
3.1.1 Topography, Storm Water Drainage, and Retaining Walls							
Repair broken brick planter	1	Allow	\$2,000.00	100%	\$0	\$2,000	The brick planter at the north side entrance to 1985 Mission St has damaged/broken bricks

Landscape planter #2 with broken bricks

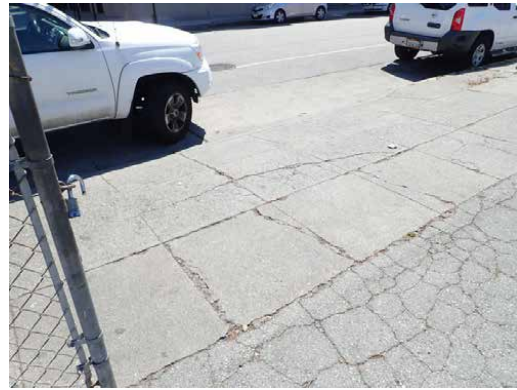
3.1.2 Site Access, Parking, Pavement							
Asphalt Pavement, Sectional Replacement/ Repairs	6,600	SF	\$3.00	100%	\$0	\$19,800	About 30% of the asphalt area is alligatored and should be replaced
Asphalt Pavement, Mill and Overlay	15,400	SF	\$1.50	100%	\$0	\$23,100	About 70% of the asphalt area needs asphalt overlay resurfacing
Concrete Pavement, Replace	1	Allow	\$1,500.00	100%	\$0	\$1,500	The parking lot entrance concrete apron surface should be repaired

Cracked concrete apron

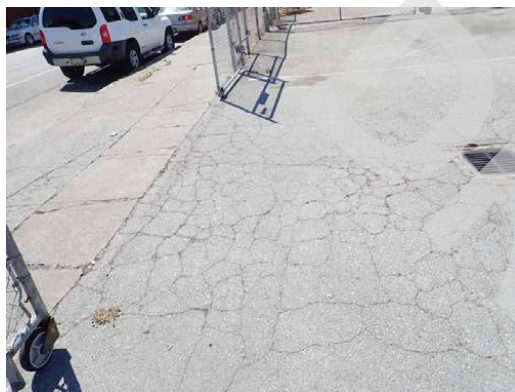
Alligatored asphalt

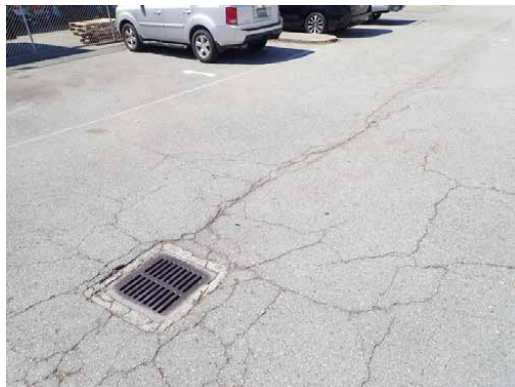
Typical asphalt cracking

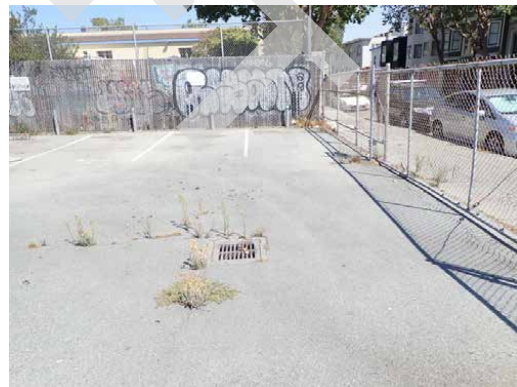
Weeds in asphalt cracks

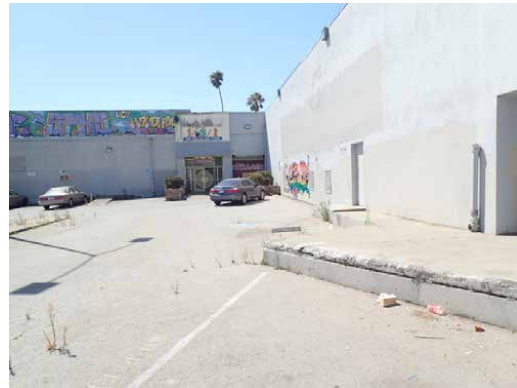
Loading dock area with damaged concrete-
1979 Mission St

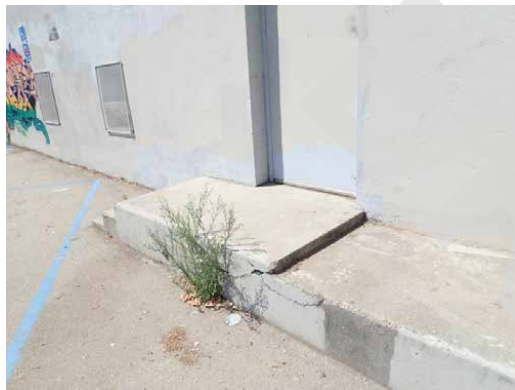
Damage concrete steps

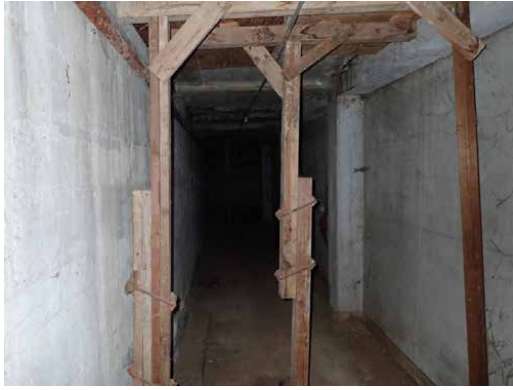
1985 Mission St / 2950-2978 16th St foundation damage to concrete ceiling area

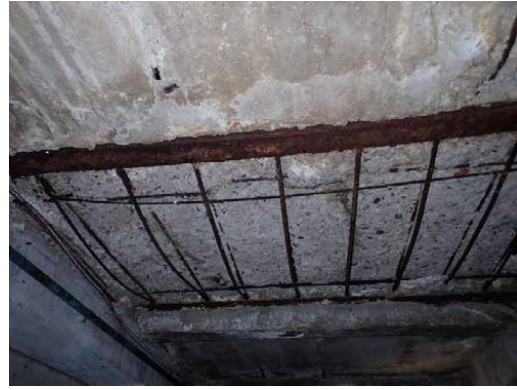
1985 Mission St / 2950-2978 16th St basement area-damaged concrete slab floor

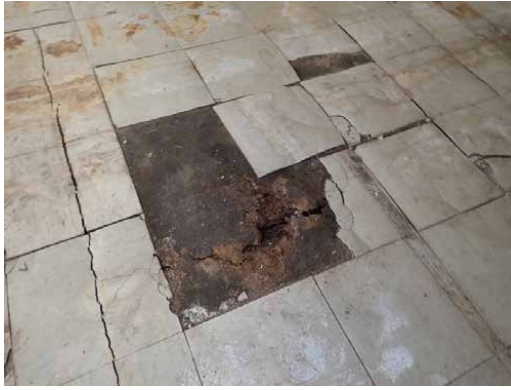
1979 Mission St- appears to be dry-rot damaged to wood flooring

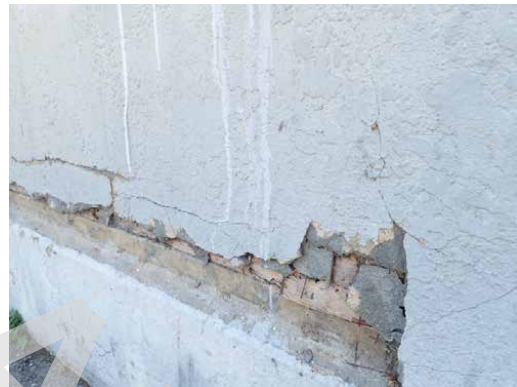
Damaged stucco over wood north side of 1985 Mission St.

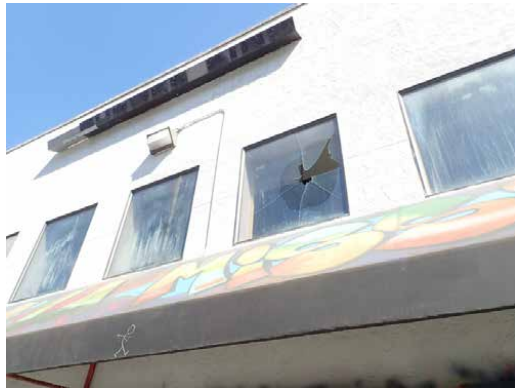
2978 16th St- broken windows

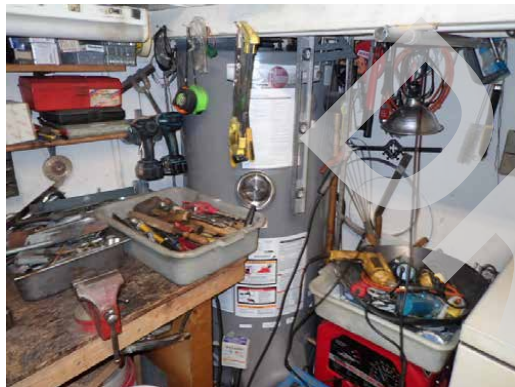
Unit 1960 water heater missing seismic straps

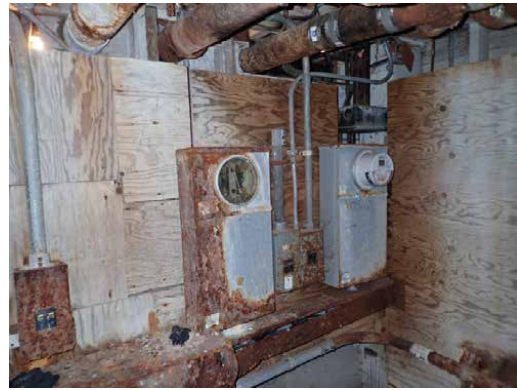
1985 Mission St / 2950-2978 16th St- rusty
electrical panel

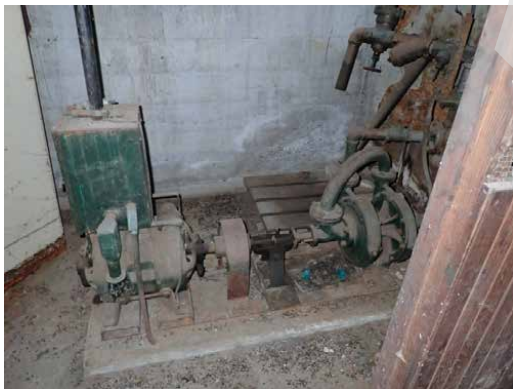
AEI observed an old non-functional hydraulic lift in the basement area of Unit 1985. It is recommended that the non-lift equipment be removed. The cost for this work is included in Section 3.3.3

Unit 1985- abandoned hydraulic lift

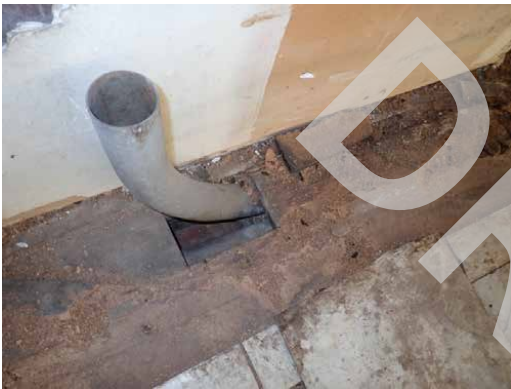
1979 Mission St- dry-rot floor area

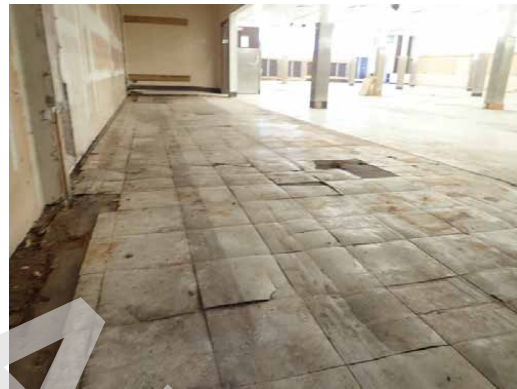
1979 Mission St- dry-rot floor area

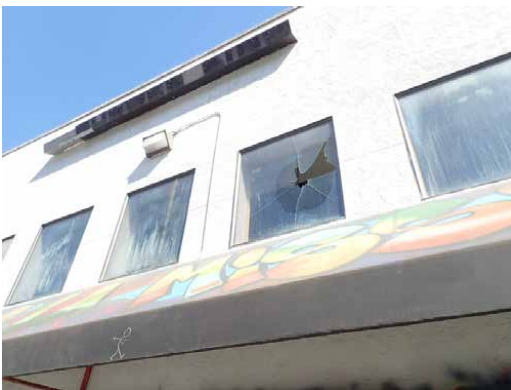
2978 16th St- broken window

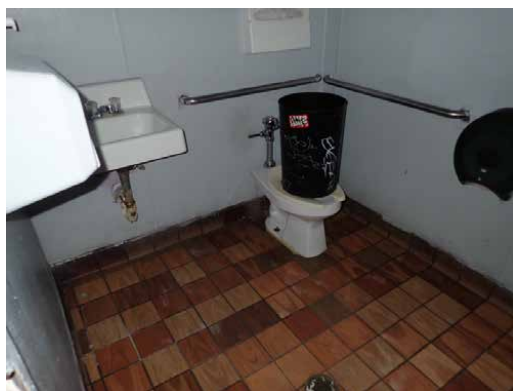
2978 16th St- area under sink not protected

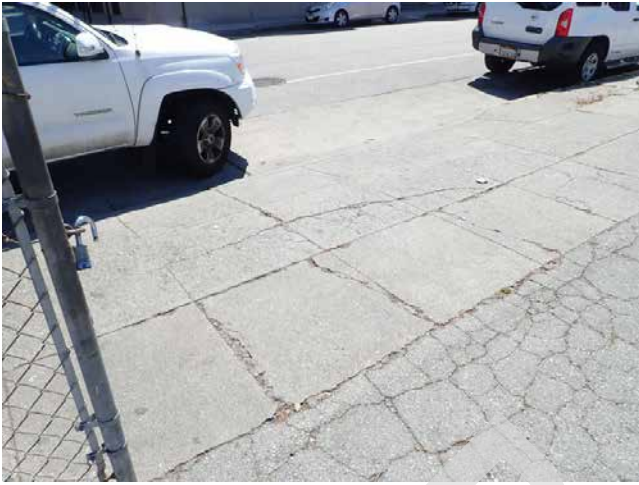
29. Cracked asphalt

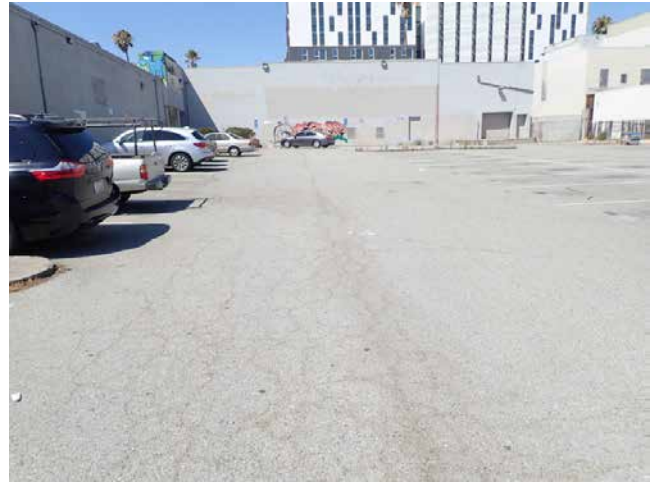
30. Alligatoring asphalt area
