San Francisco Health Network
Laguna Honda Hospital
and Rehabilitation Center

Laguna Honda Hospital Operations Updates: HVAC Presentation

John Grimes, Chief Operations Officer
August 10, 2021

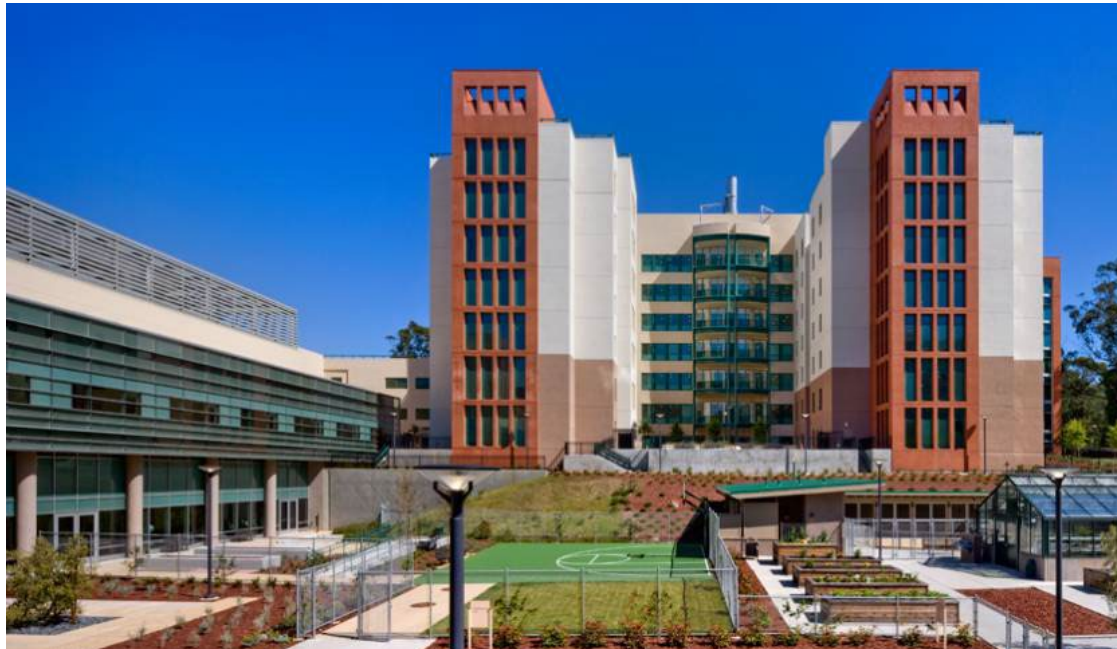
HVAC SYSTEM HISTORY

- The new hospital building included a mechanical HVAC system.
- The design was based on industry standards.
- However, there were challenges with the design. The design was not developed specifically for our location and the work was “value engineered” for budget reasons.

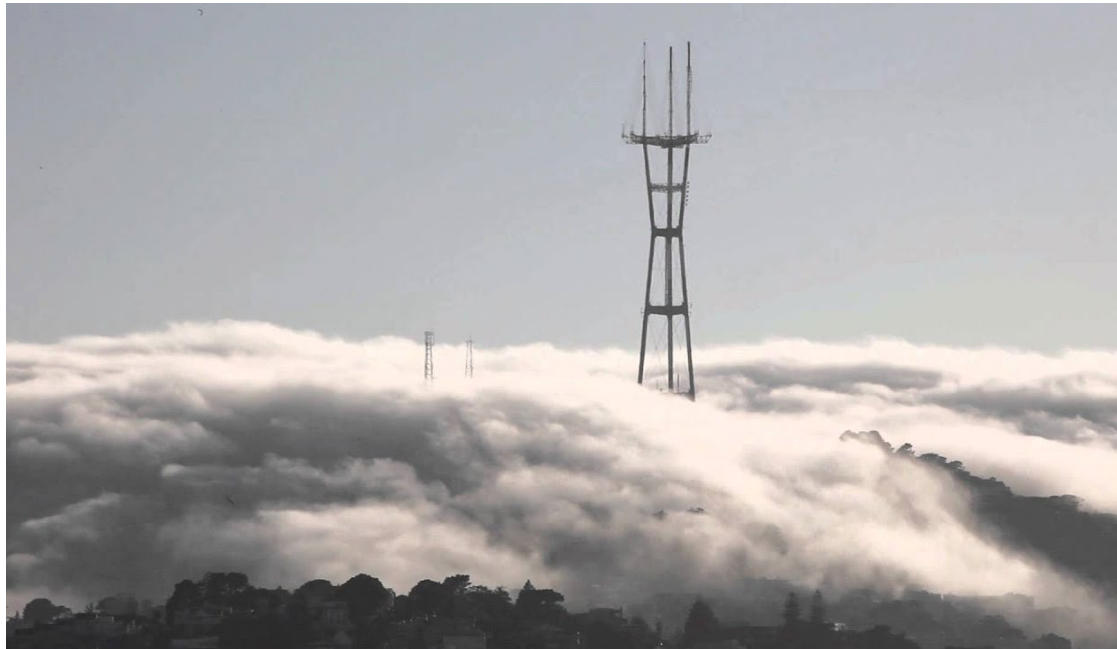
HVAC CHALLENGE #1 – OVERALL DESIGN

- The design of the HVAC system did not take into consideration the atmospheric conditions of our area (fog with high salt content) and the condition was made worse by placing non-marine grade HVAC equipment on the roof.
- The chillers and air handlers were also under sized.

- Facilities does a lot of work during heat waves to mitigate the temperatures in the different patient care areas. This includes:
 - Utilizing the Building Management System (BMS) to monitor building air temperatures even in individual resident rooms and suites.
 - Installed portable air conditioning units in the great rooms connected into the building exhaust to provide a cooling area on each of the patient floors.
 - Repeated notices to staff to keep windows and blinds closed.
- LHH also replaced roof top equipment that has pre-maturely reached its end of life. We replaced the chillers on both the North and South towers due to corrosion, and the Pavilion chiller is now at the point of needing to be replaced pre-maturely due to corrosion.
