Subject: 301 Mission Retrofit Monitoring Report 017: Results as of August 25, 2021

Millennium Tower Perimeter Pile Upgrade: Instrumentation Monitoring Data
City and County of San Francisco, California

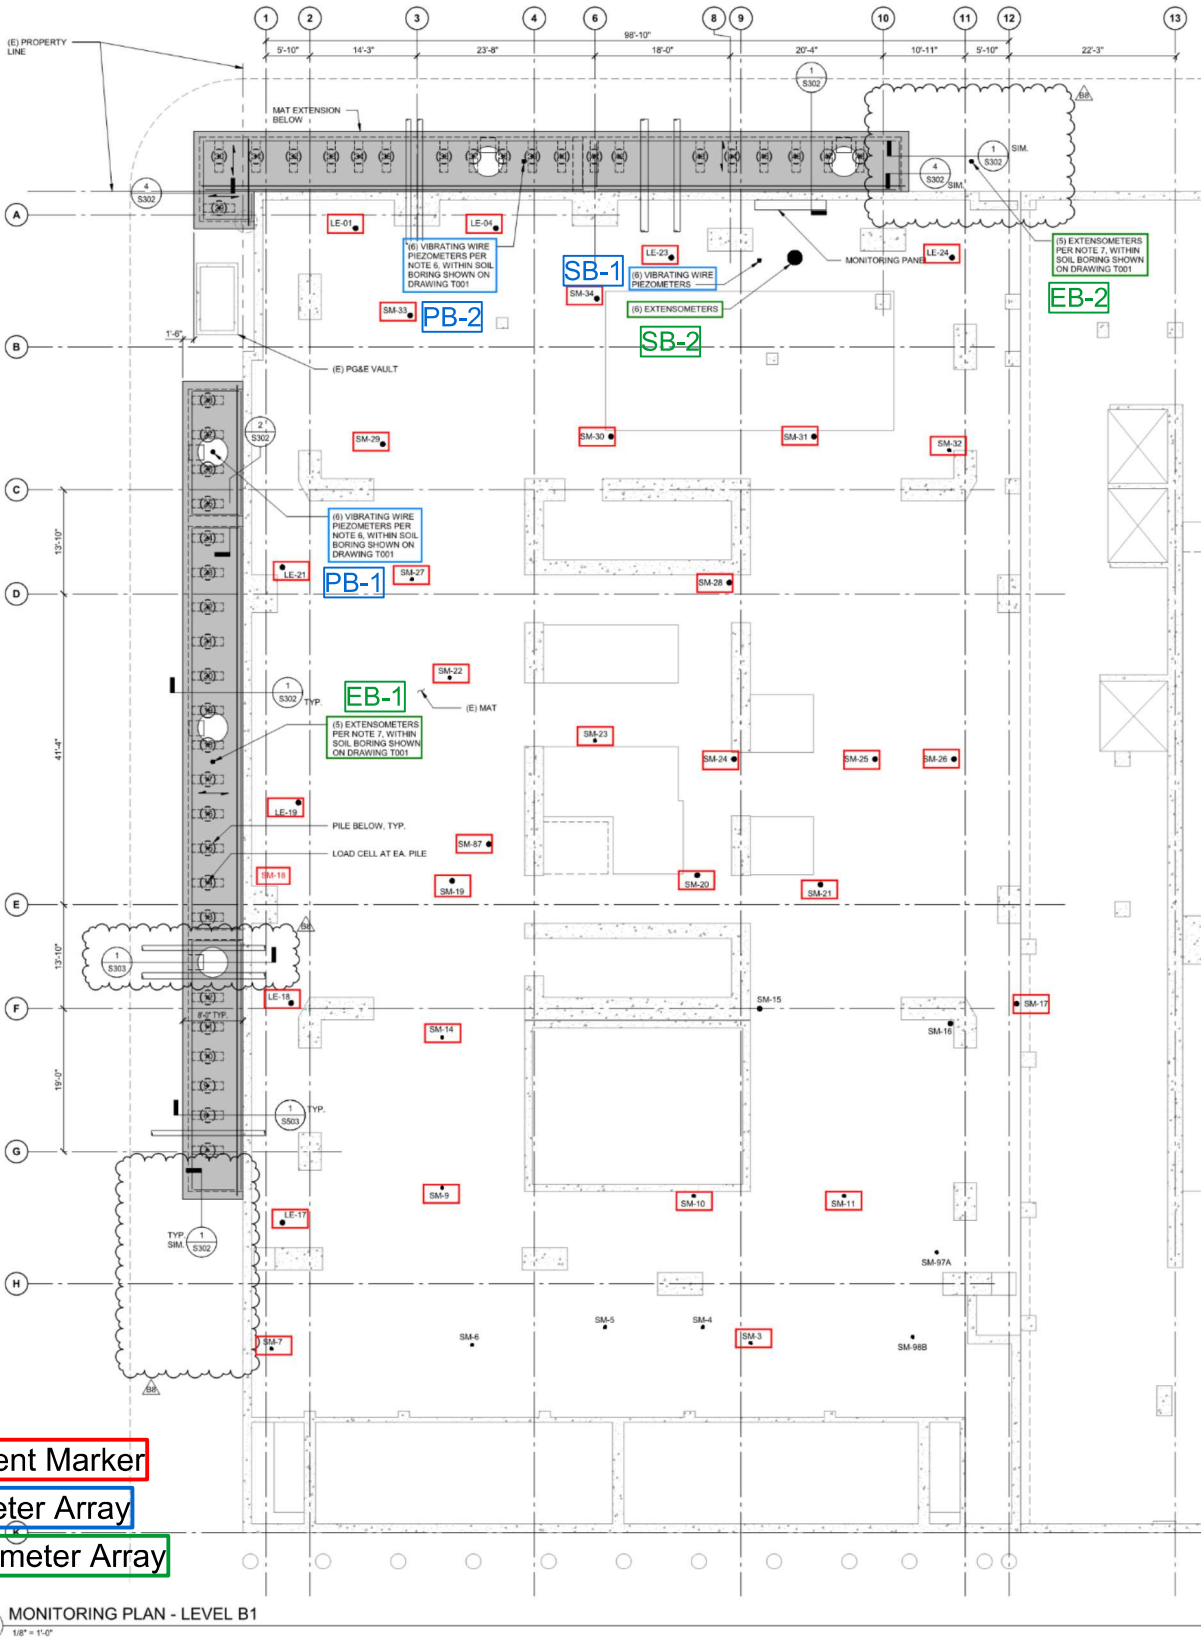
Figure No: **017-01A**

Figure 01 presents the instrument locations as referenced in later figures.

INSTRUMENT LOCATION MAP
SETTLEMENT MARKERS, PIEZOMETERS, EXTENSOMETERS

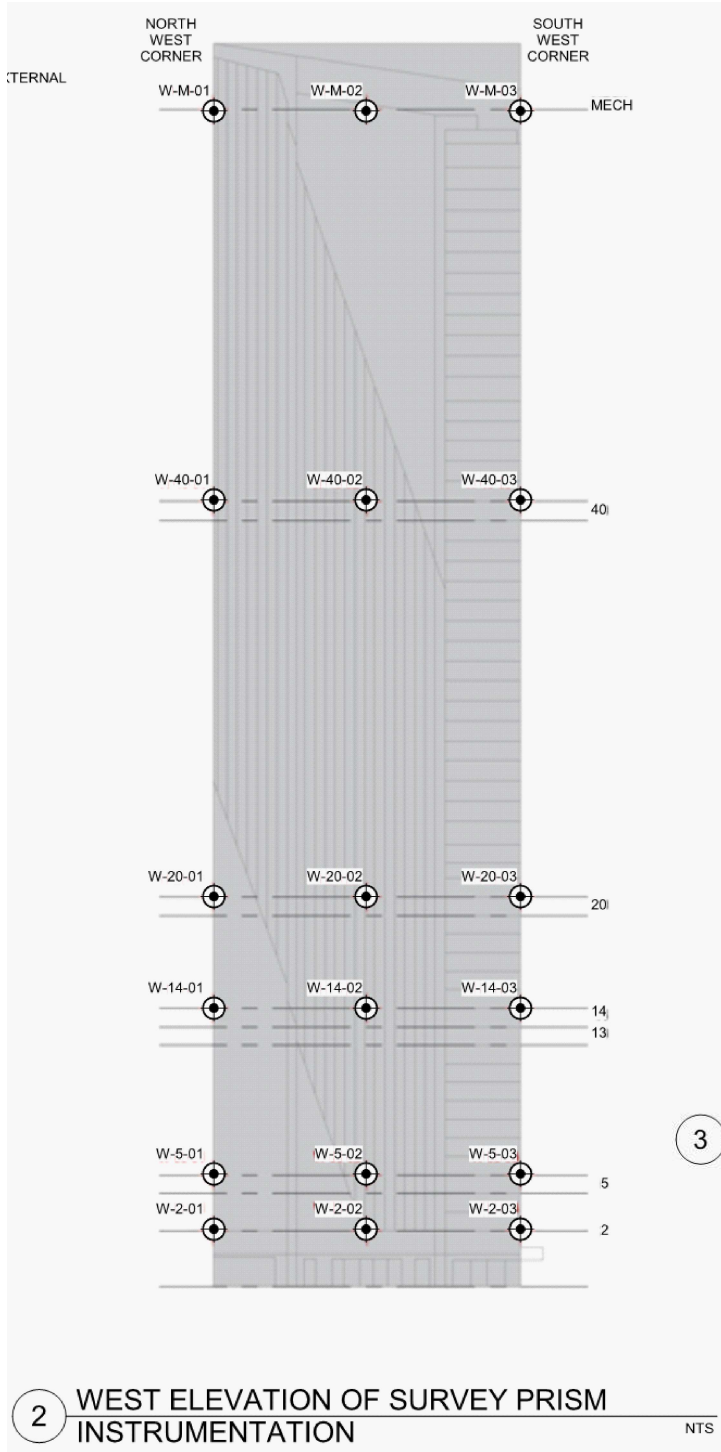
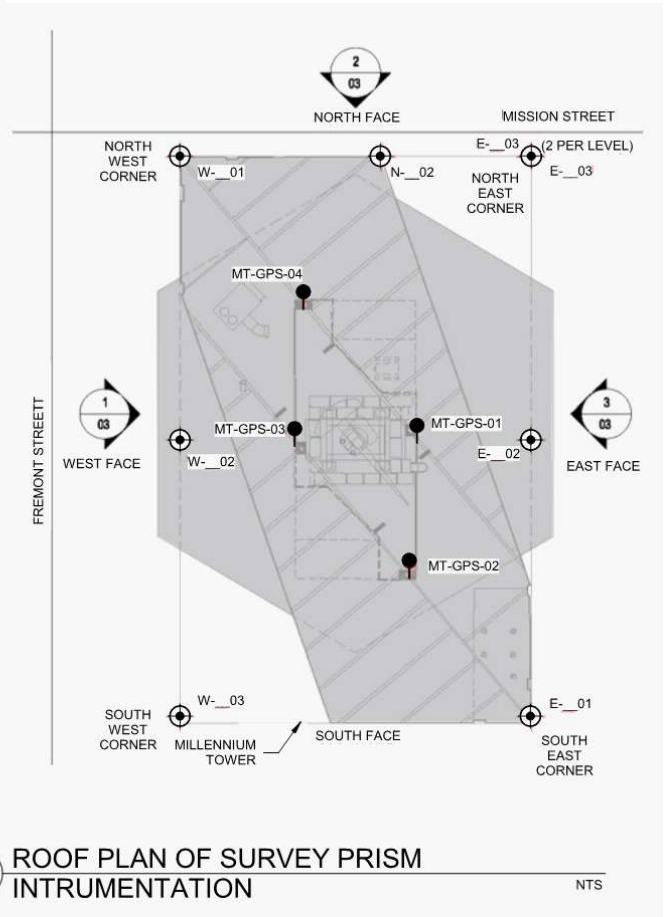
Project No: 19-009.00	Date: 7/26/2021	Created By: NBW	Checked By: DGM	Figure No: 017-01B
-----------------------	-----------------	-----------------	-----------------	---------------------------

TOWER SURVEY PRISM LOCATION SCHEMATIC

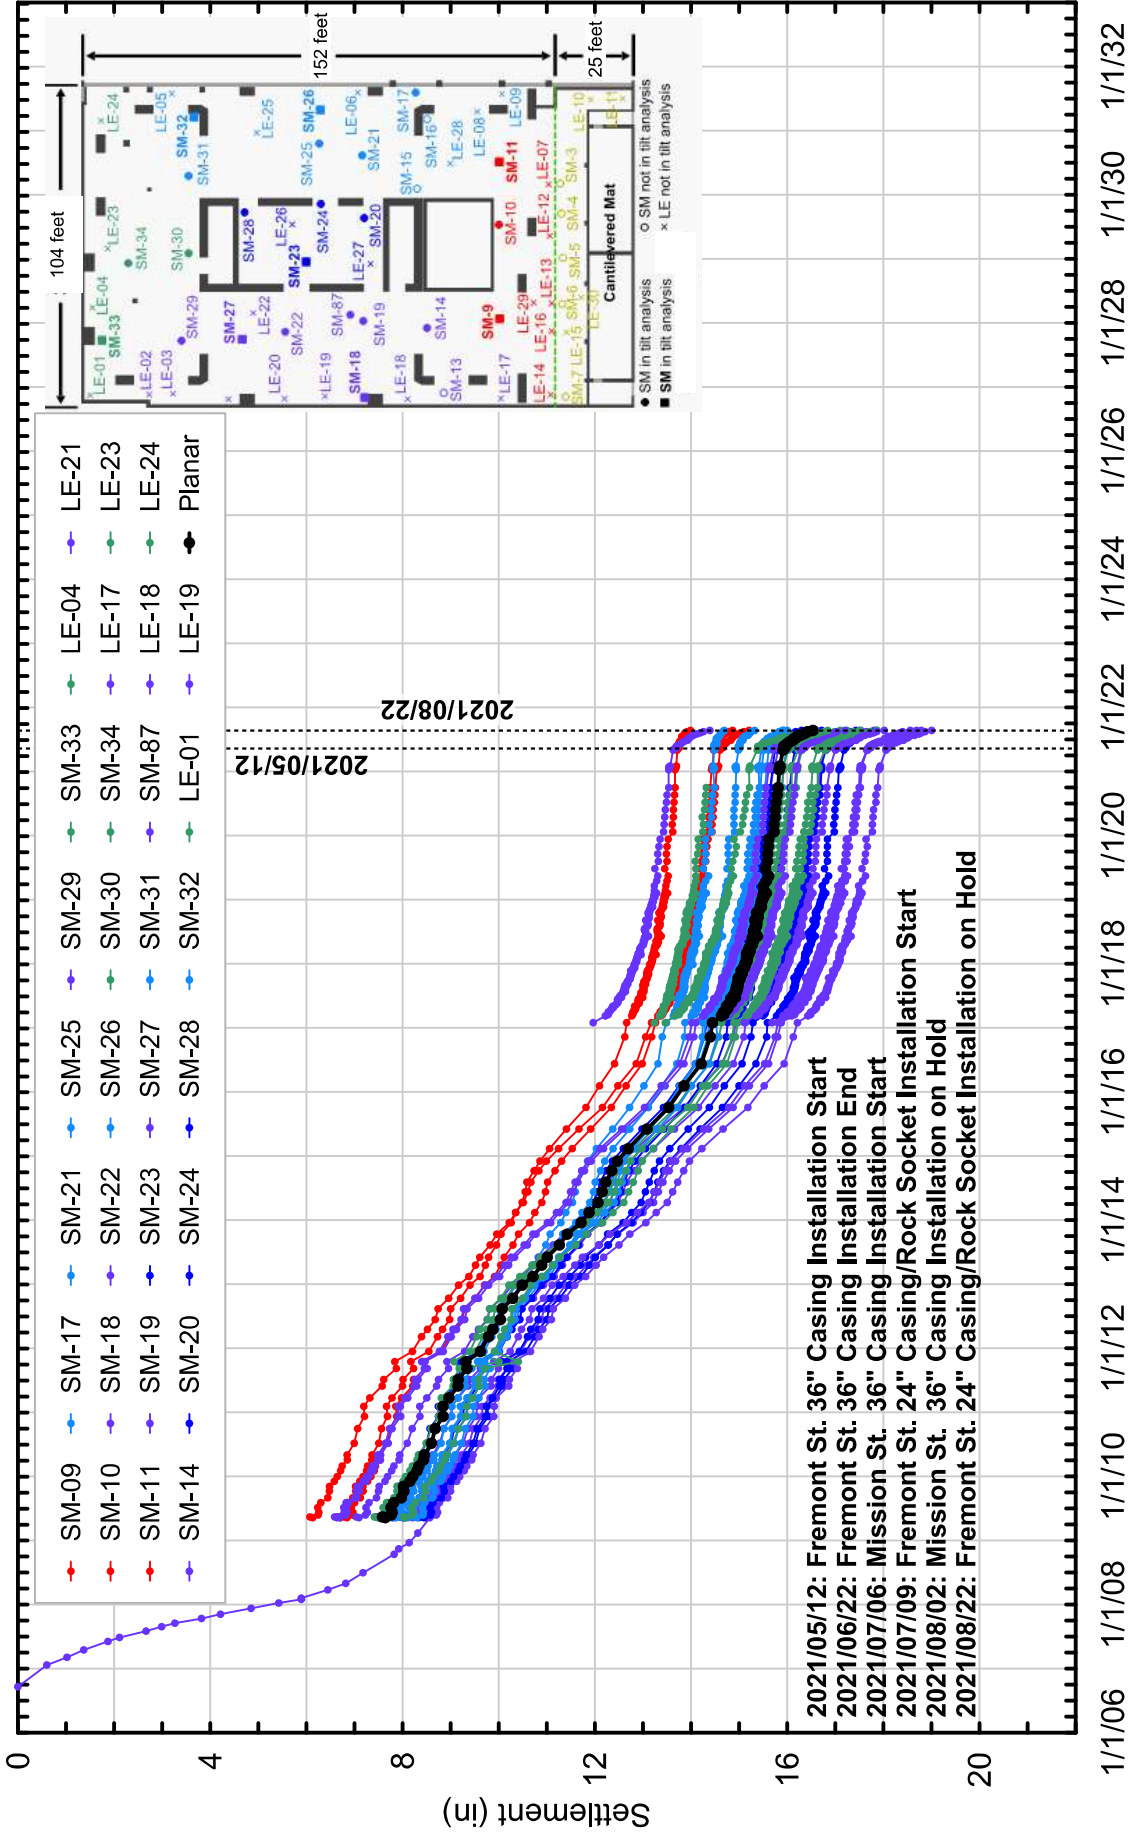
Figure 02 presents the historical settlement data interpreted from settlement markers installed on the B-1 Level of 301 Mission Tower. In addition, data from surveys performed during the retrofit are included. Figure 03A presents differential settlement data since the start of production pile installation (May 12, 2021; baseline readings on May 10, 2021) through August 23, 2021. Figure 03B presents differential settlement data since January 11, 2021, through August 23, 2021. Figure 04 presents current differential settlement contours (in inches) on August 23, 2021.

Project No: 19-009.00	Date: 8/25/2021	Created By: NBW	Checked By: DGM	Figure No: 017-02
HISTORICAL SETTLEMENT MARKER DATA Millennium Tower Perimeter Pile Upgrade: Instrumentation Monitoring Data City and County of San Francisco, California

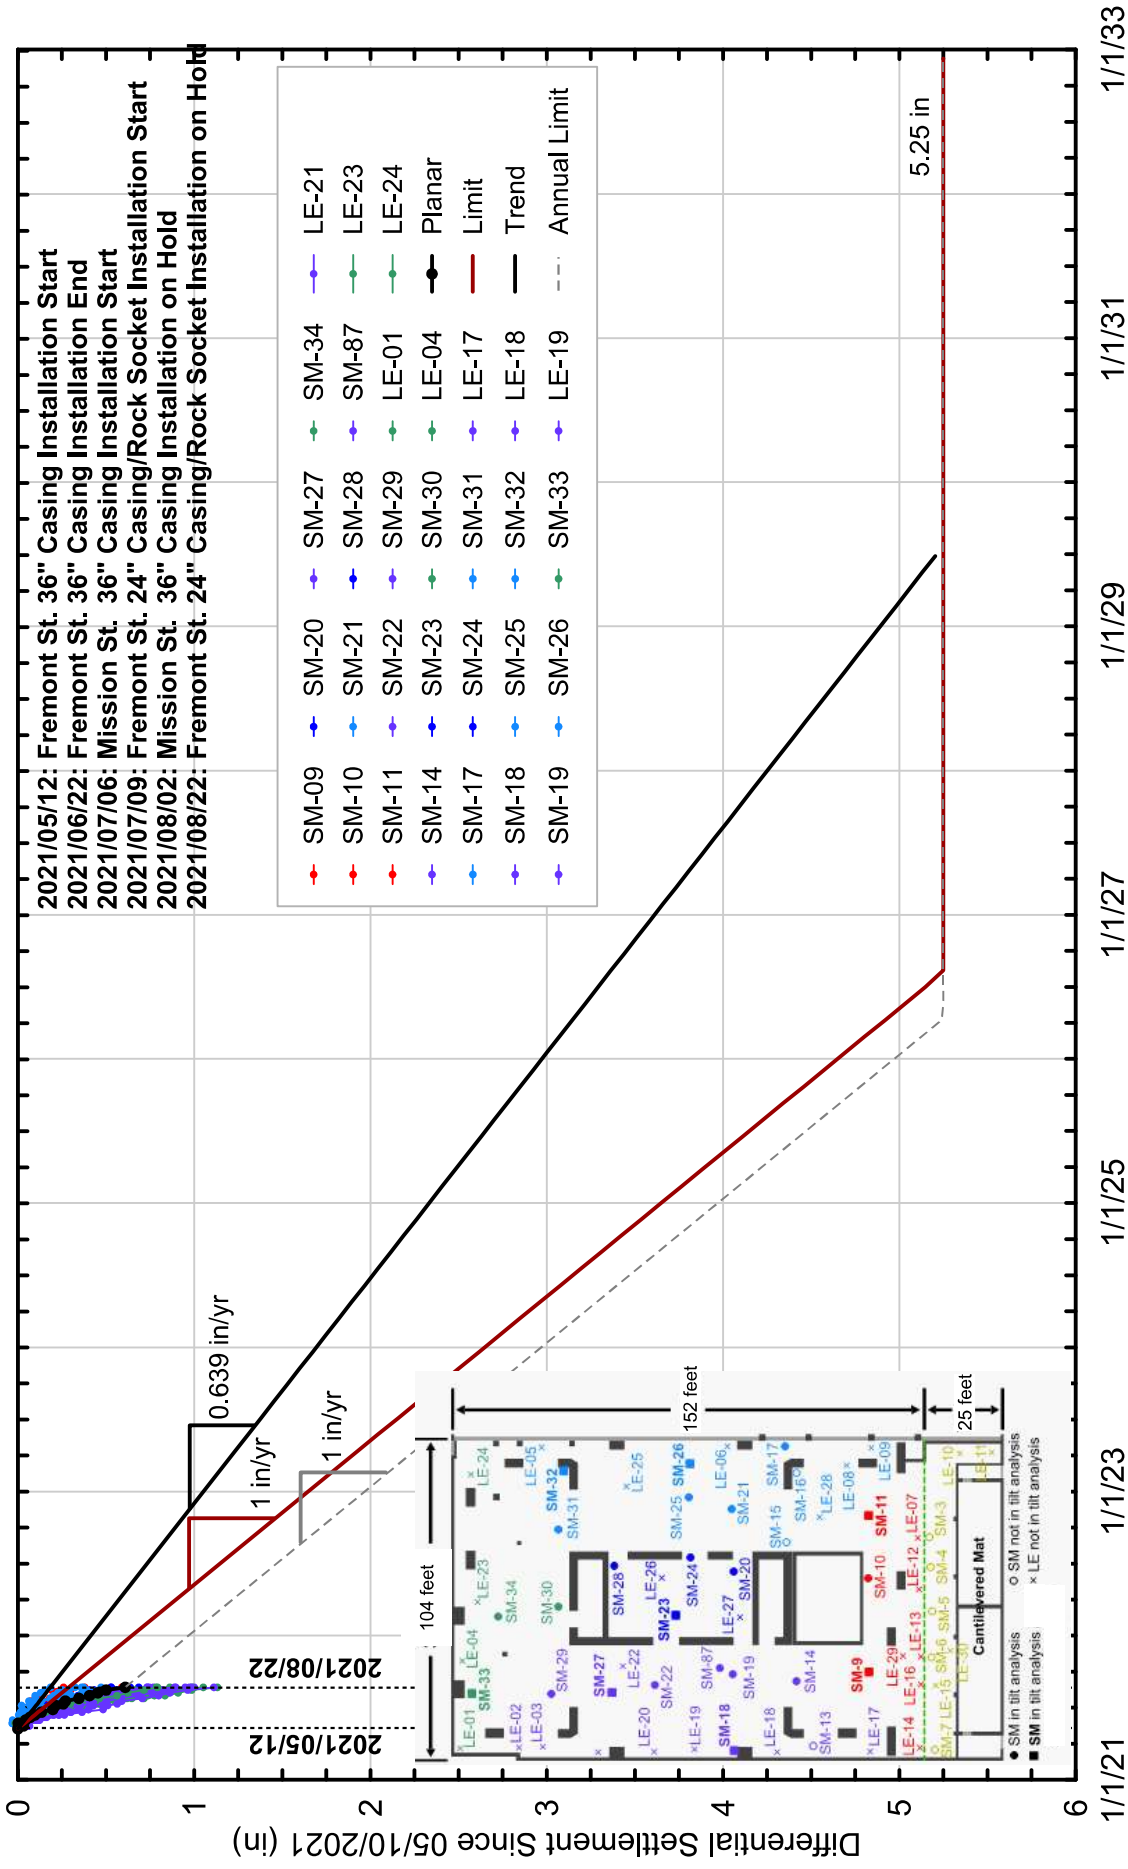
Project No: 19-009.00 Date: 8/25/2021 Created By: NBW Checked By: DGM Figure No: 017-03A

DIFFERENTIAL SETTLEMENT MARKER DATA
 SINCE 05/10/2021 THROUGH 08/23/2021

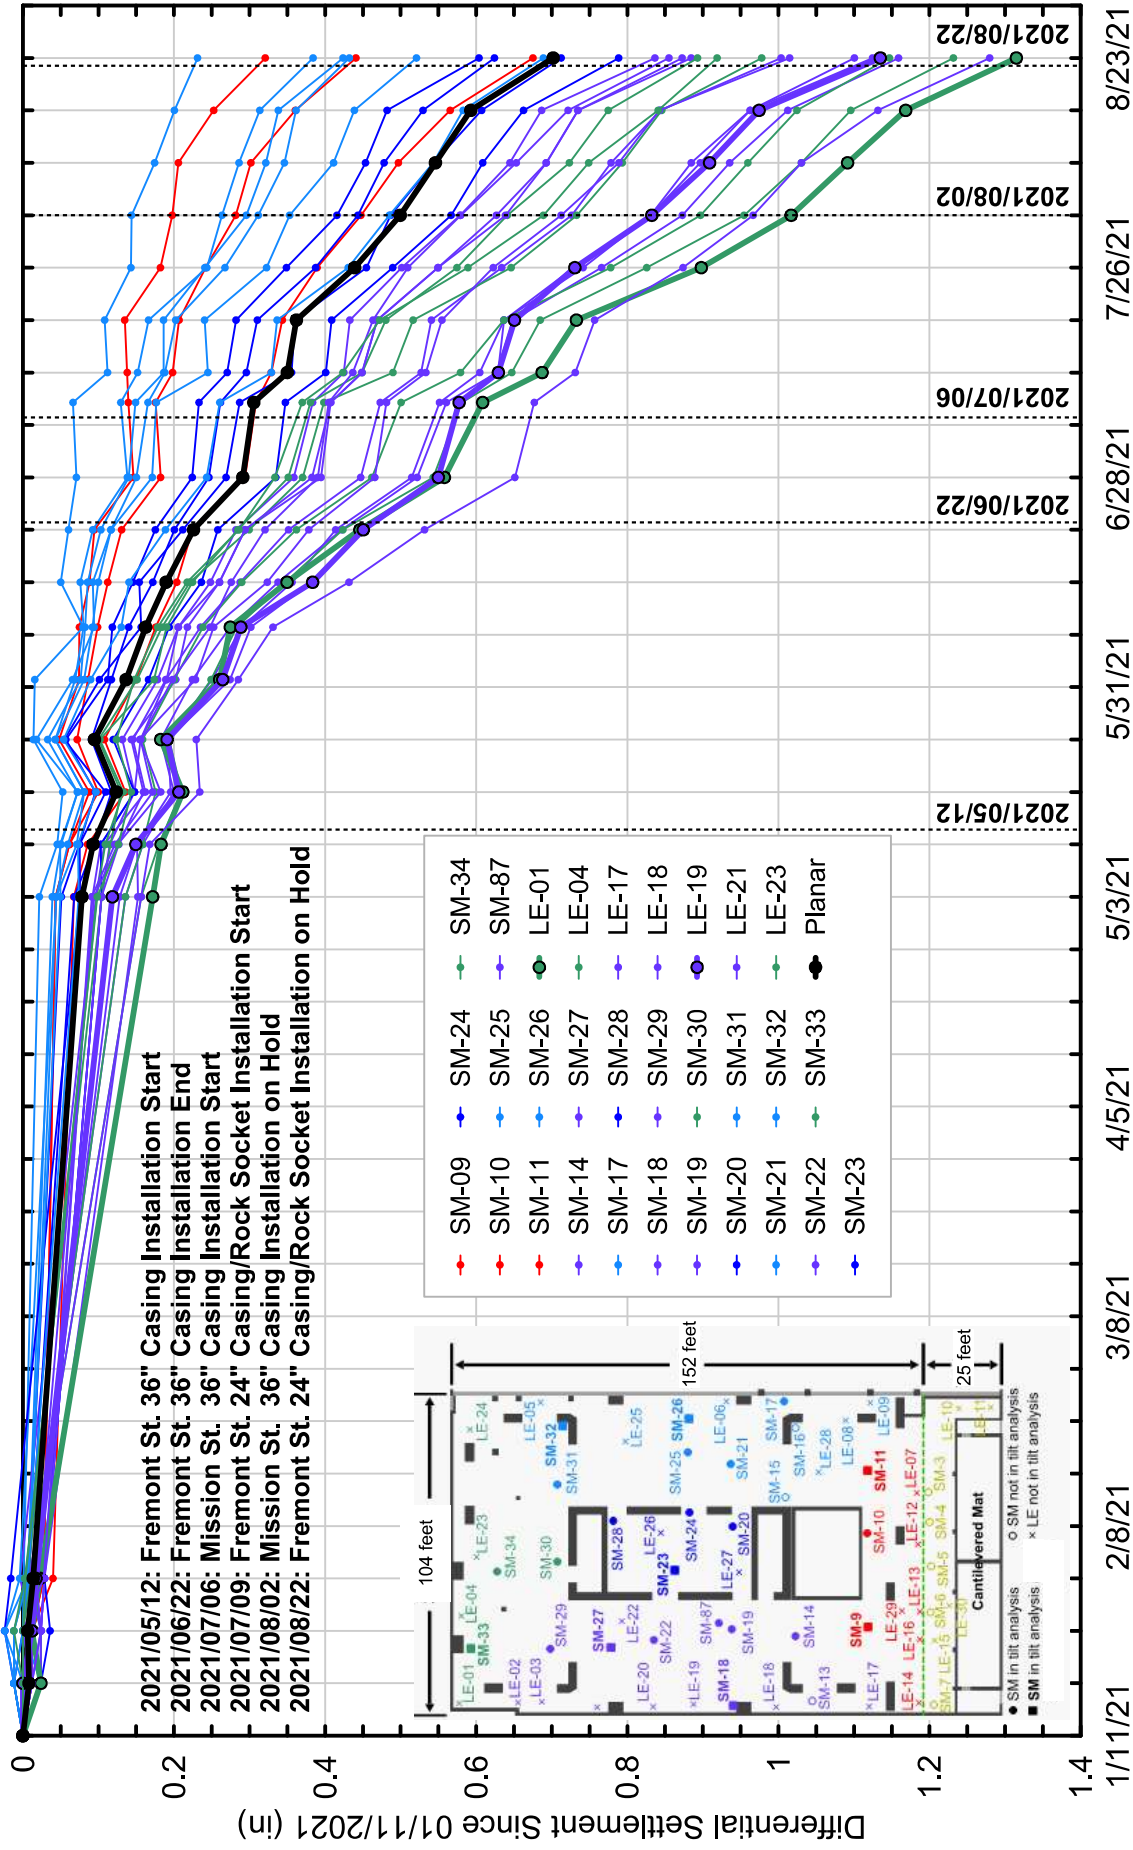
Project No: 19-009.00	Date: 8/25/2021	Created By: NBW	Checked By: DGM	Figure No: 017-03B
SLATE GEOTECHNICAL CONSULTANTS				
DIFFERENTIAL SETTLEMENT MARKER DATA SINCE 01/11/2021 THROUGH 08/23/2021 Millennium Tower Perimeter Pile Upgrade: Instrumentation Monitoring Data City and County of San Francisco, California

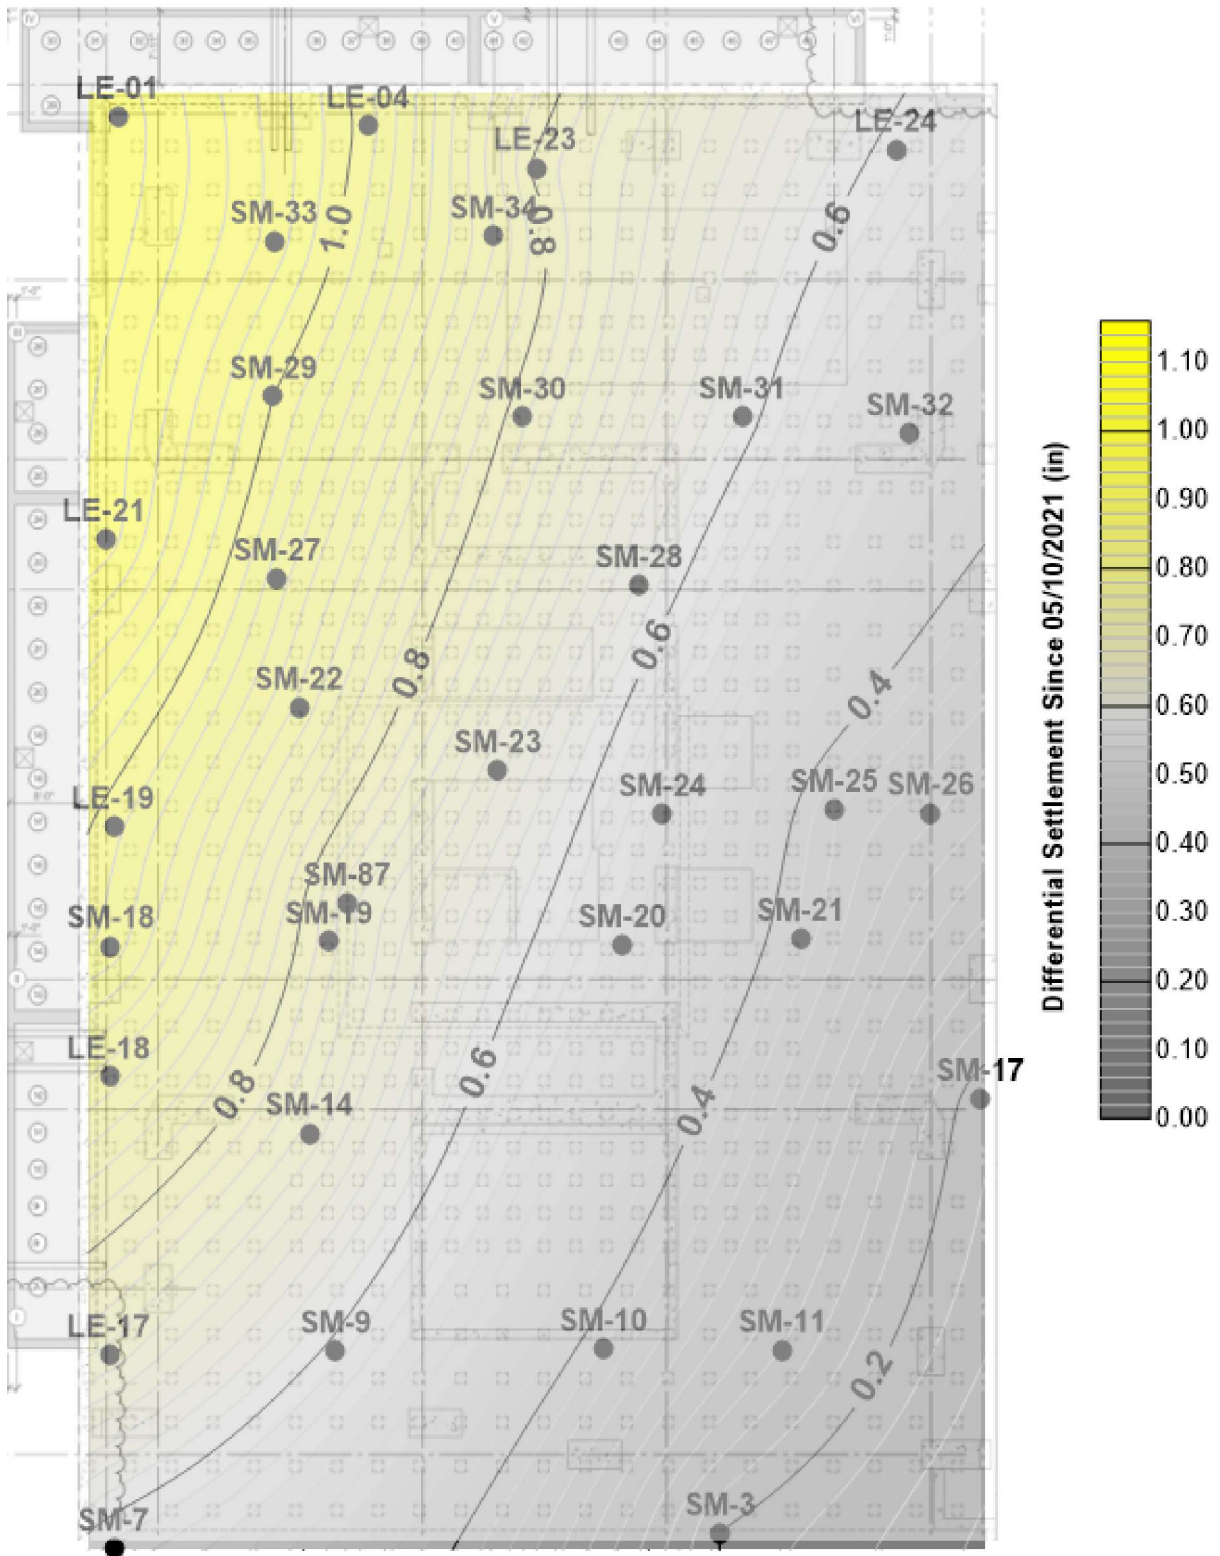
Figure No: **017-04**

DIFFERENTIAL SETTLEMENT CONTOURS
SINCE 05/10/2021 THROUGH 08/23/2021

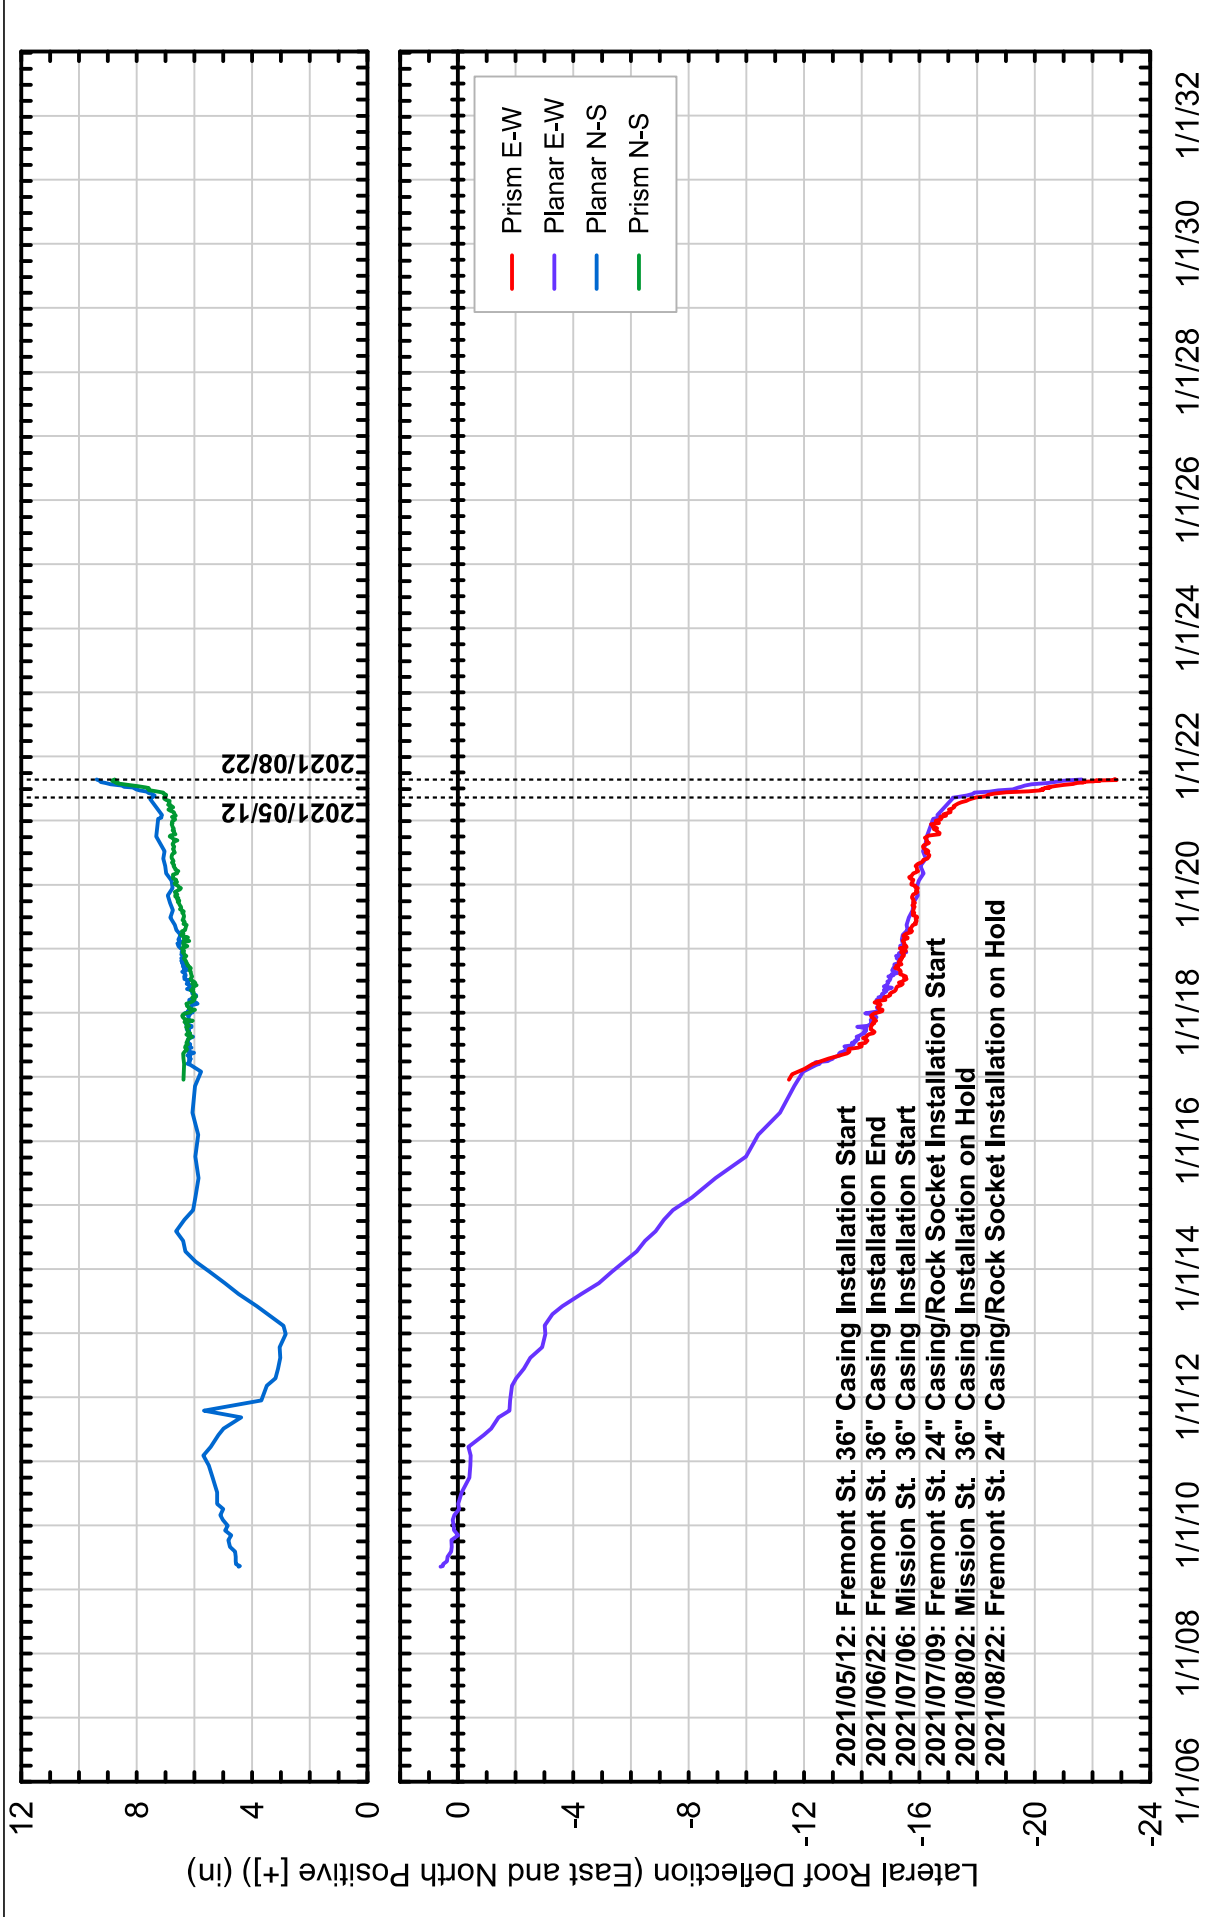
Project No: 19-009.00 Date: 8/25/2021 Created By: NBW Checked By: DGM Figure No: 017-05

Figure 05 presents historical lateral roof deflections in the project north-south and project east-west directions interpreted from survey prisms mounted on the exterior of the Tower, from InSAR data, and from a planar fit of the settlement marker data. In addition, data from survey performed during the retrofit are included. Figure 06A presents differential lateral roof deflection data from a planar fit of the settlement marker data and from survey prisms mounted on the exterior of the Tower since the start of production pile installation (May 12, 2021; baseline readings on May 10 and 13, 2021, respectively) through August 23, 2021. Figure 06B presents differential lateral roof deflection data from a planar fit of the settlement marker data and from survey prisms mounted on the exterior of the Tower since January 11, 2021, through August 23, 2021.

HISTORICAL LATERAL ROOF DEFLECTION DATA

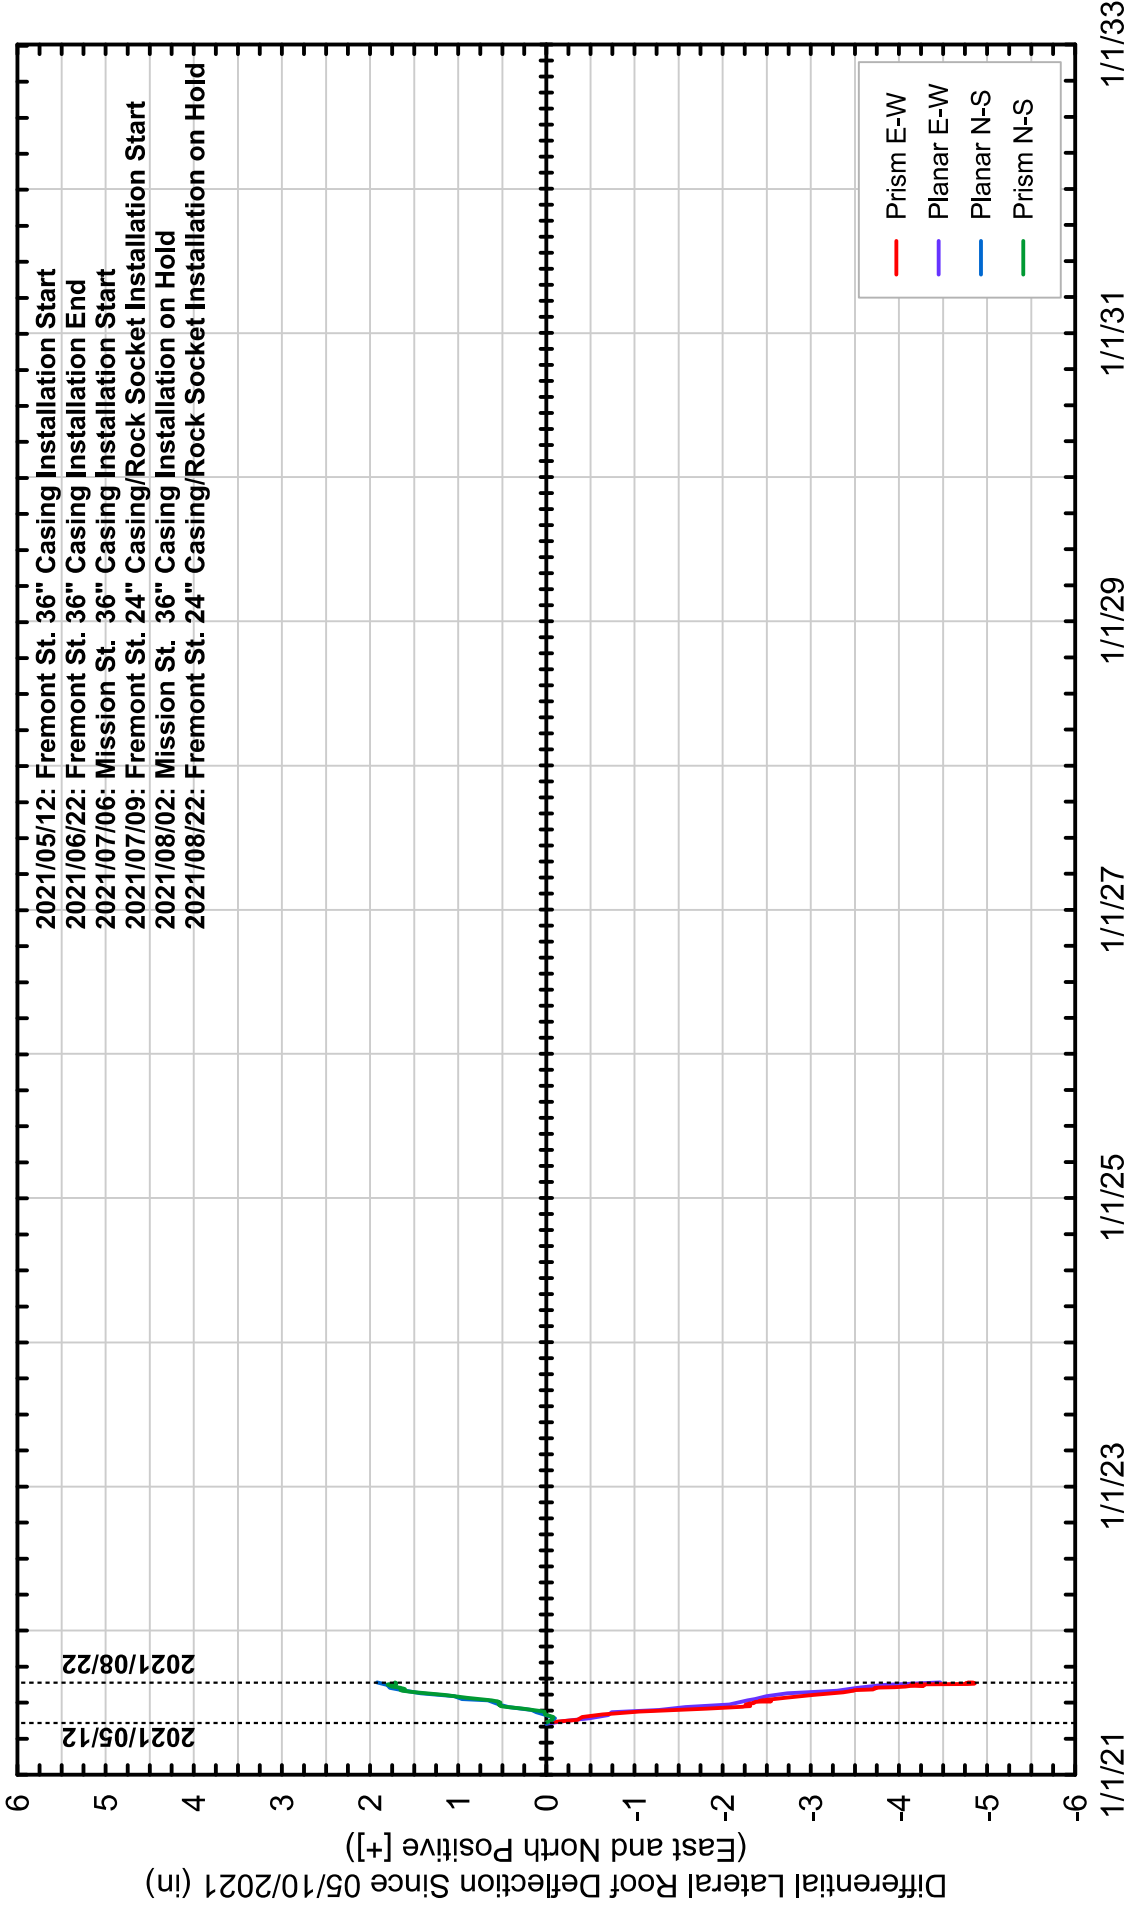
Project No: 19-009.00	Date: 8/25/2021	Created By: NBW	Checked By: DGM	Figure No: 017-06A
SLATE GEOTECHNICAL CONSULTANTS				
DIFFERENTIAL LATERAL ROOF DEFLECTION DATA SINCE 05/10/2021 THROUGH 08/23/2021				
Millennium Tower Perimeter Pile Upgrade: Instrumentation Monitoring Data City and County of San Francisco, California

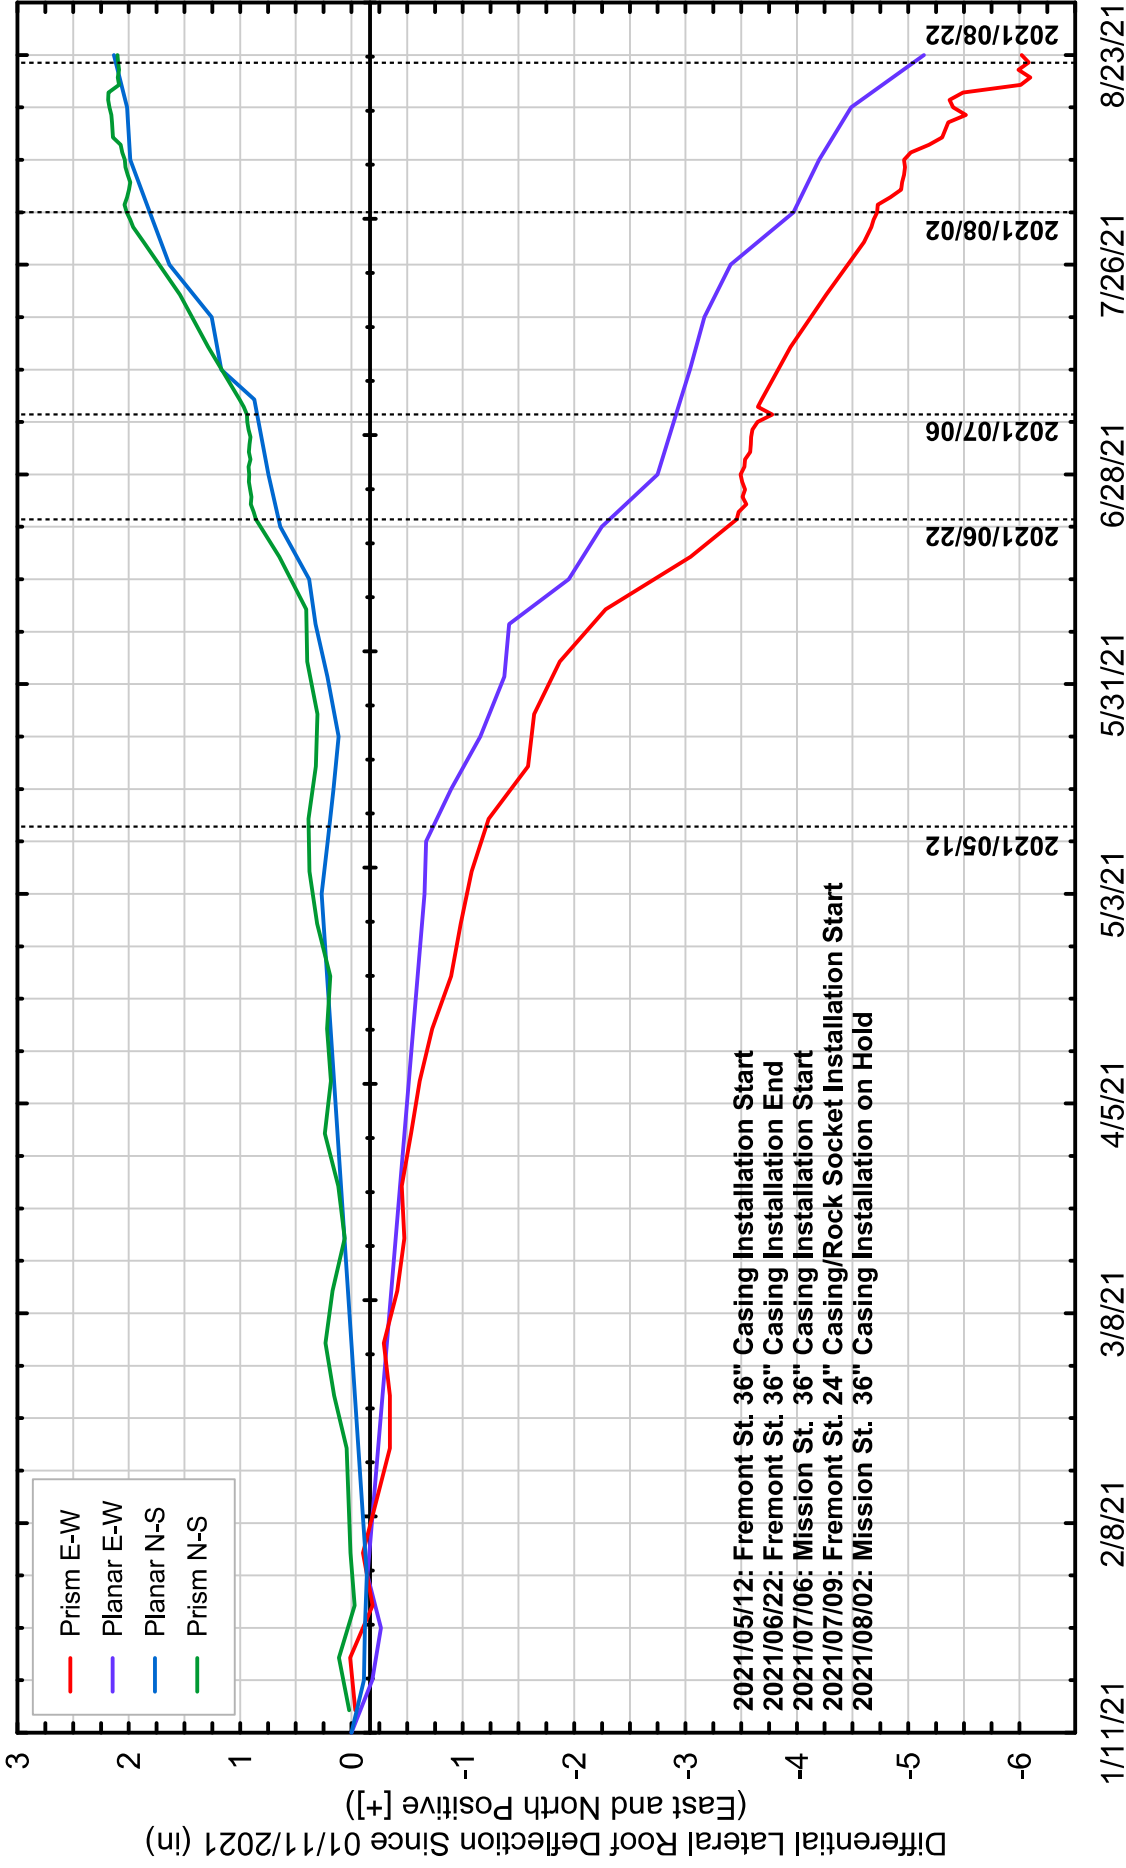
Project No: 19-009.00	Date: 8/25/2021	Created By: NBW	Checked By: DGM	Figure No: 017-06B
SLATE GEOTECHNICAL CONSULTANTS				
DIFFERENTIAL LATERAL ROOF DEFLECTION DATA SINCE 01/11/2021 THROUGH 08/23/2021				
Millennium Tower Perimeter Pile Upgrade: Instrumentation Monitoring Data City and County of San Francisco, California

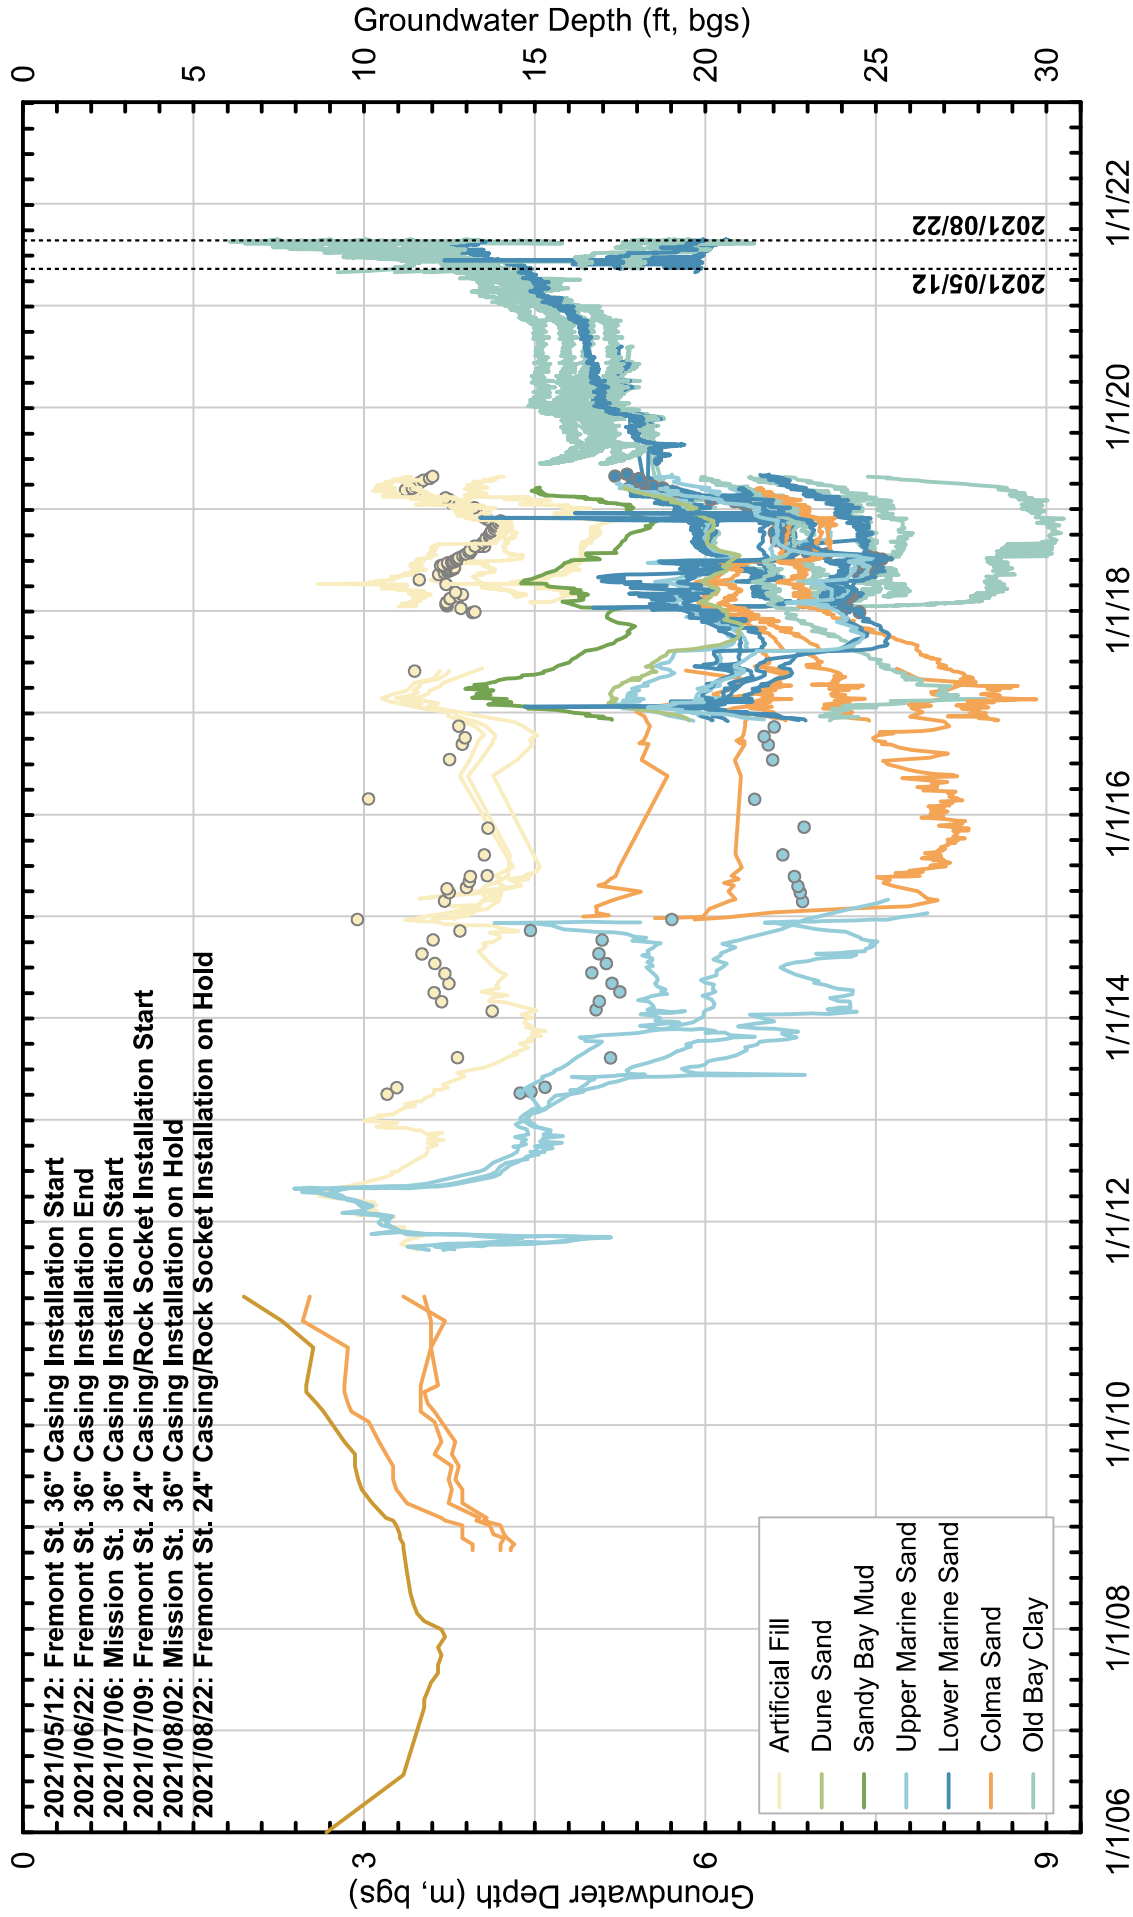
Figure No: 017-07

Figure 07 presents the historical groundwater elevation interpreted from piezometer readings at locations near 301 Mission. In addition, data from piezometers installed to monitor groundwater elevation during the retrofit are included. Figures 08 and 09 present groundwater elevation interpreted from piezometer readings in the Marine/Colma Sand and the Old Bay Clay, respectively, for the time period prior to the start of production pile installation (January 1, 2021) through August 25, 2021.

HISTORICAL GROUNDWATER ELEVATION MEASUREMENTS
AT LOCATIONS NEAR 301 MISSION
