Subject: 301 Mission Retrofit Monitoring Report 017: Results as of August 25, 2021

Millennium Tower Perimeter Pile Upgrade: Instrumentation Monitoring Data
City and County of San Francisco, California

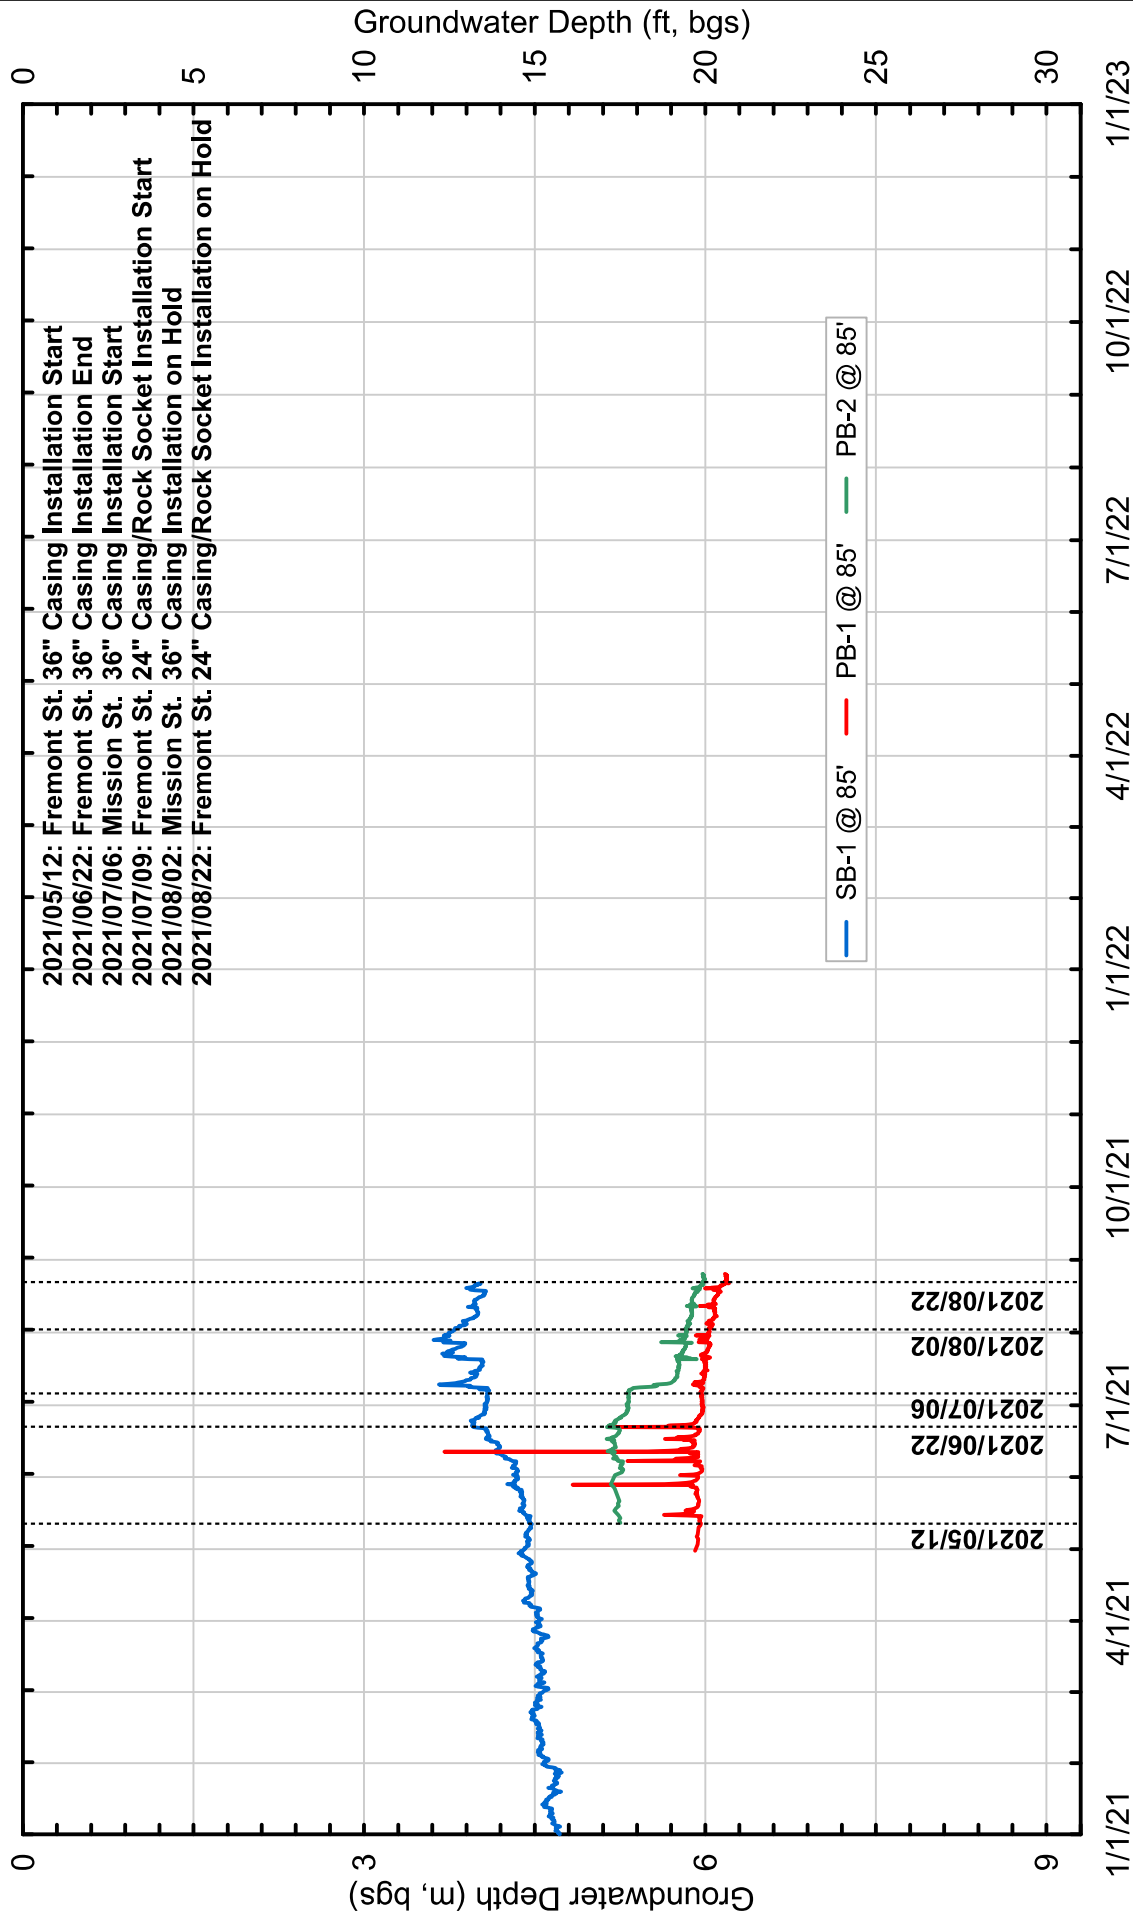
Project No: 19-009.00	Date: 8/25/2021	Created By: NBW	Checked By: DGM	Figure No: 017-08
-----------------------	-----------------	-----------------	-----------------	-------------------

GROUNDWATER ELEVATION MEASUREMENTS IN MARINE AND COLMA SAND
SINCE 01/01/2021 THROUGH 08/25/2021

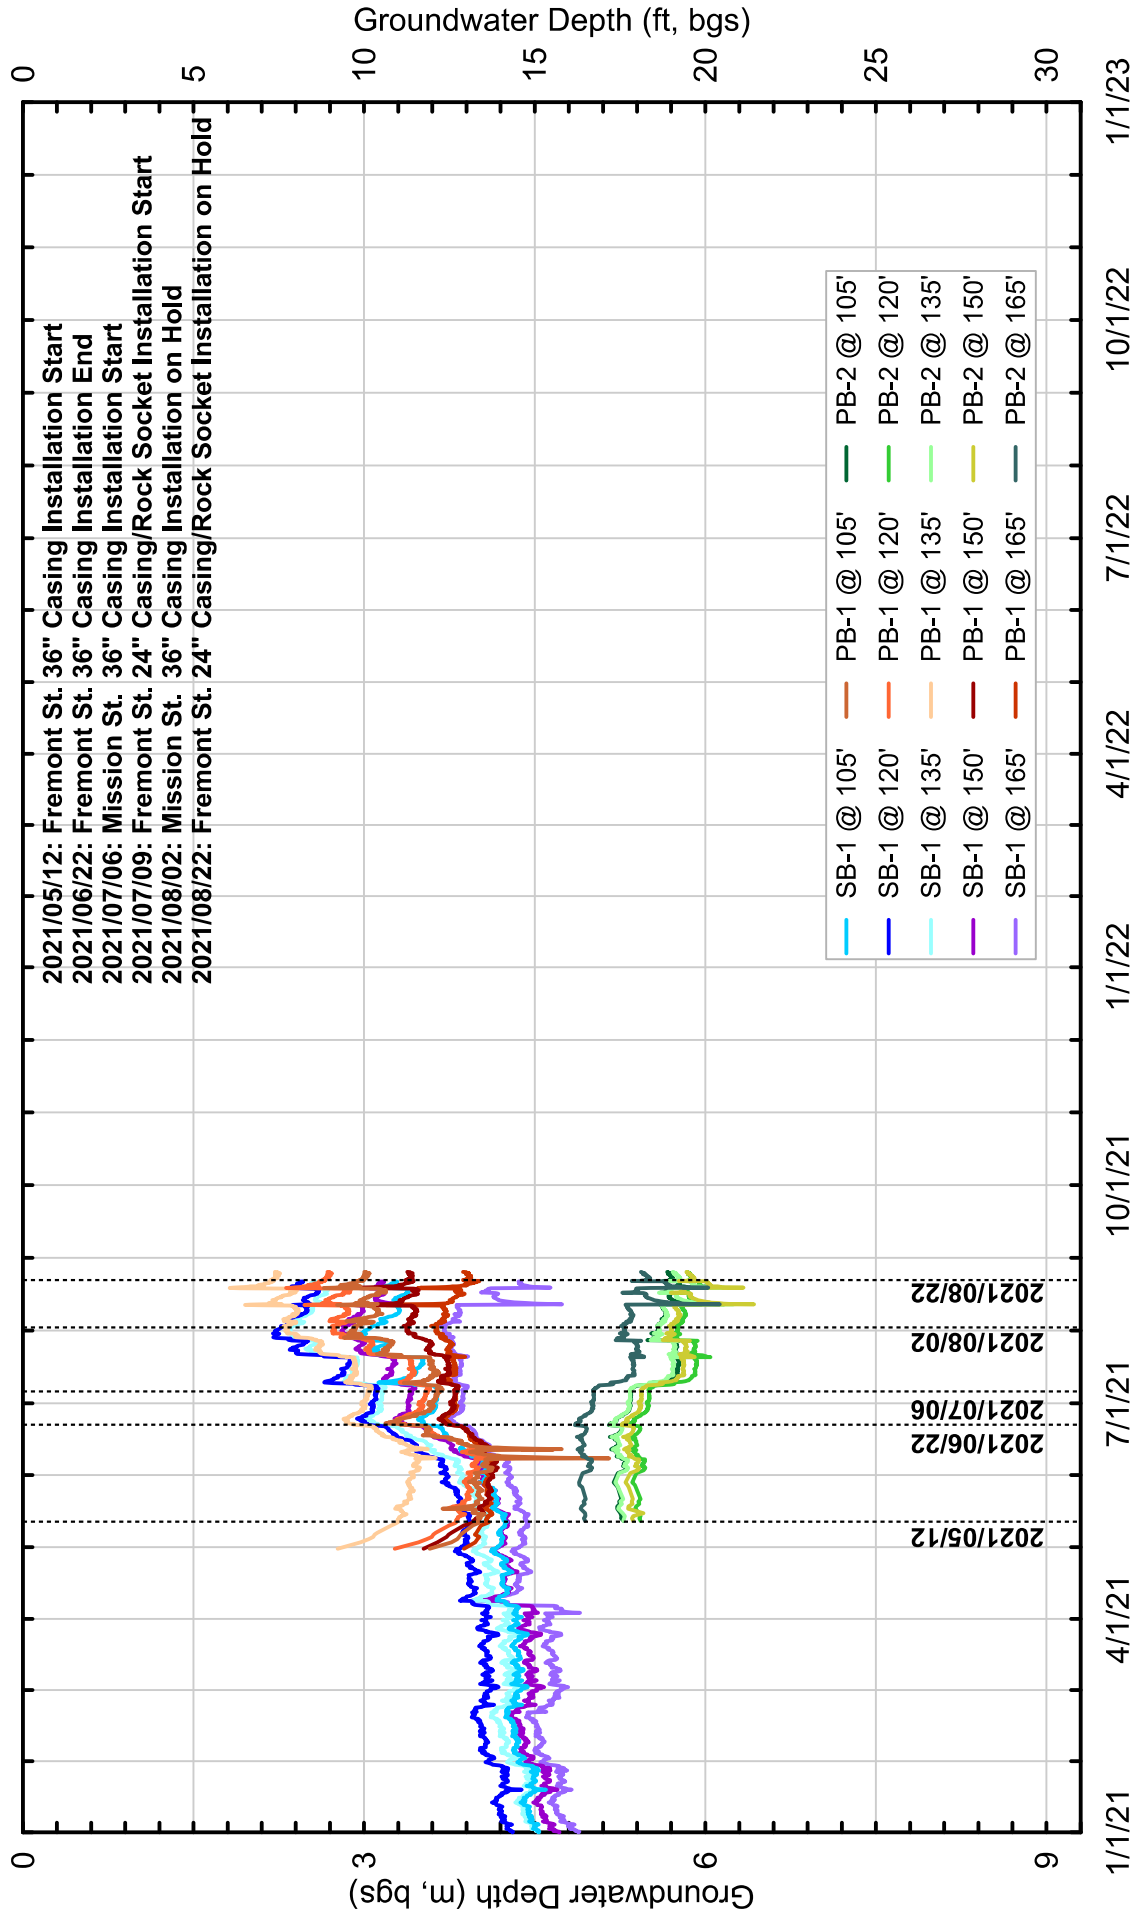
Project No: 19-009.00	Date: 8/25/2021	Created By: NBW	Checked By: DGM	Figure No: 017-09
-----------------------	-----------------	-----------------	-----------------	-------------------

GROUNDWATER ELEVATION MEASUREMENTS IN OLD BAY CLAY
SINCE 01/01/2021 THROUGH 08/25/2021

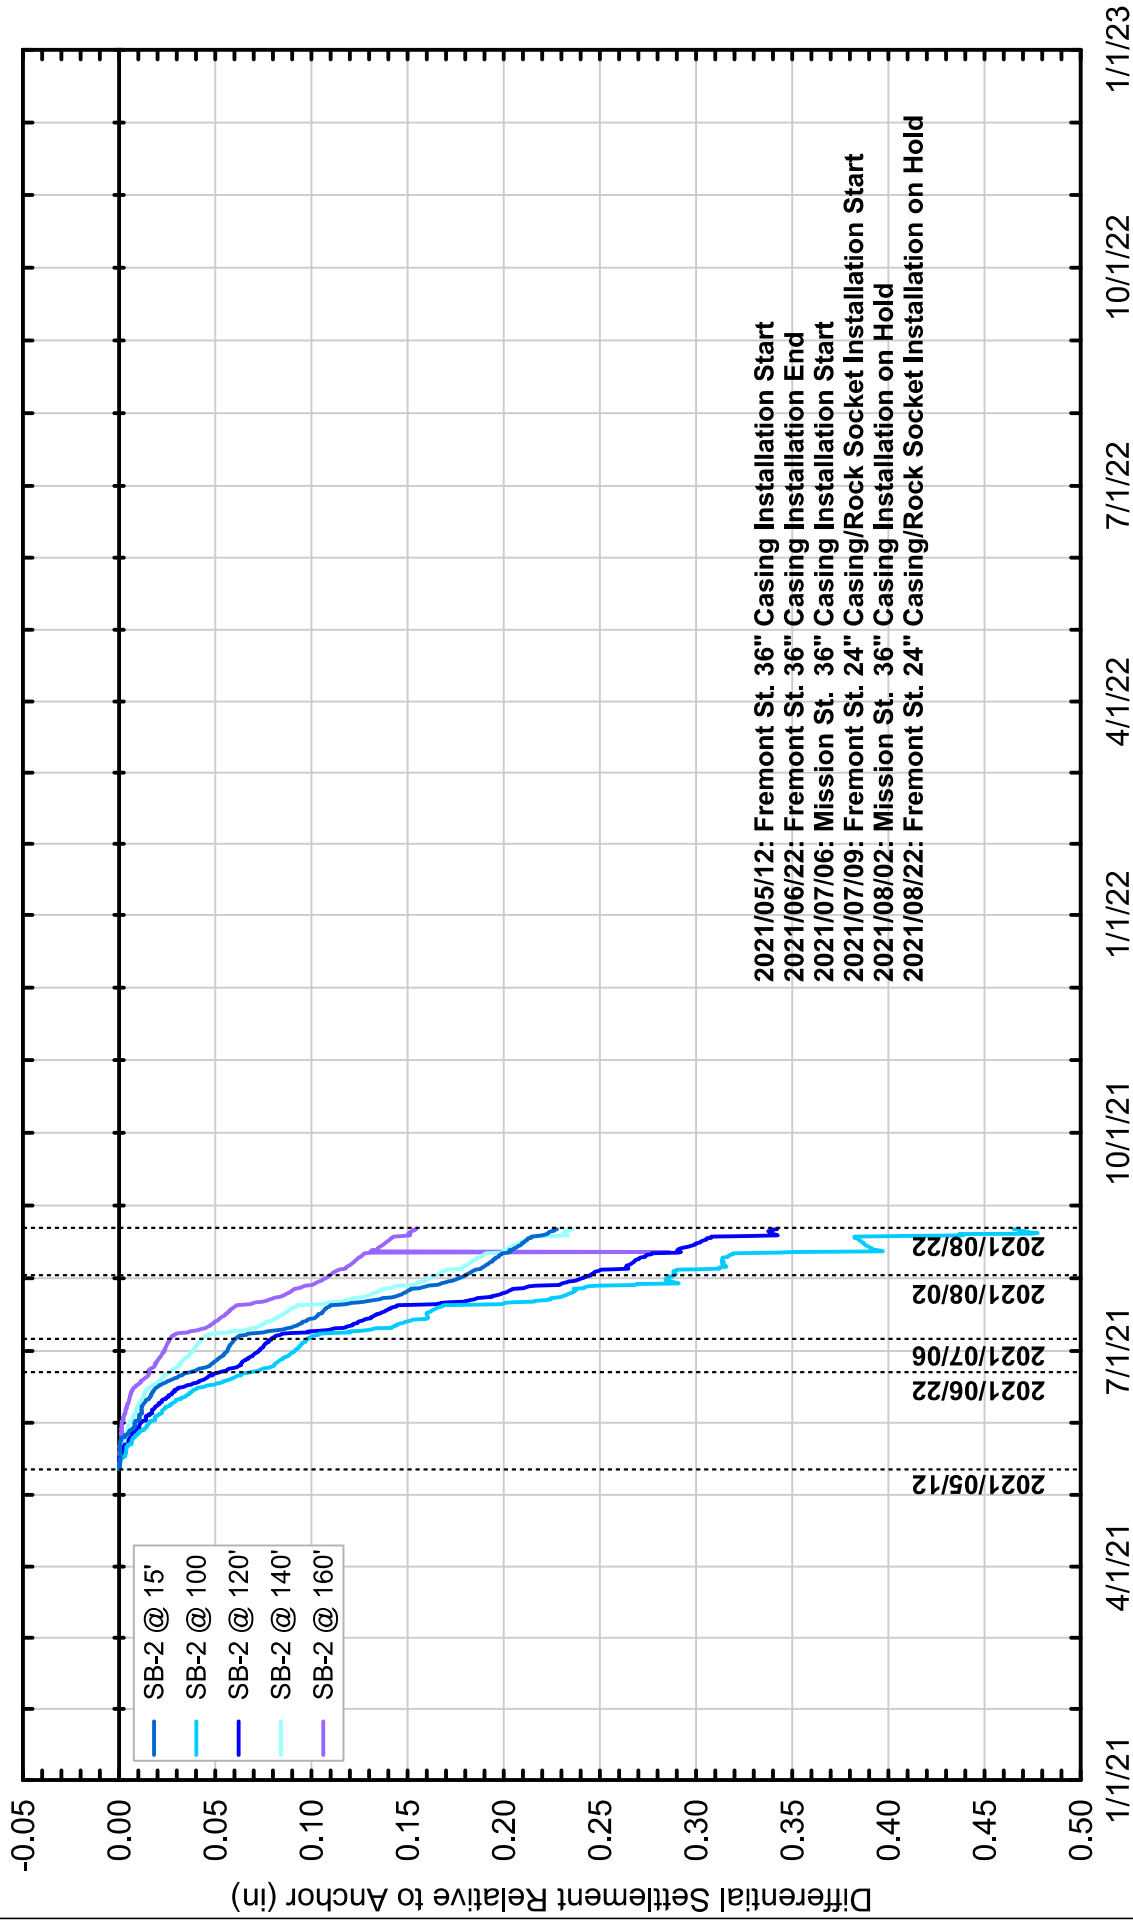
Project No: 19-009.00	Date: 8/25/2021	Created By: NBW	Checked By: DGM	Figure No: 017-10

Figure 10 presents extensometer data from within the Tower basement since the start of production pile installation (May 12, 2021) through August 21, 2021. Figure 11 presents extensometer data from Fremont

DIFFERENTIAL EXTENSOMETER DATA FROM WITHIN TOWER BASEMENT SINCE 01/01/2021 THROUGH 08/25/2021				
Millennium Tower Perimeter Pile Upgrade: Instrumentation Monitoring Data City and County of San Francisco, California

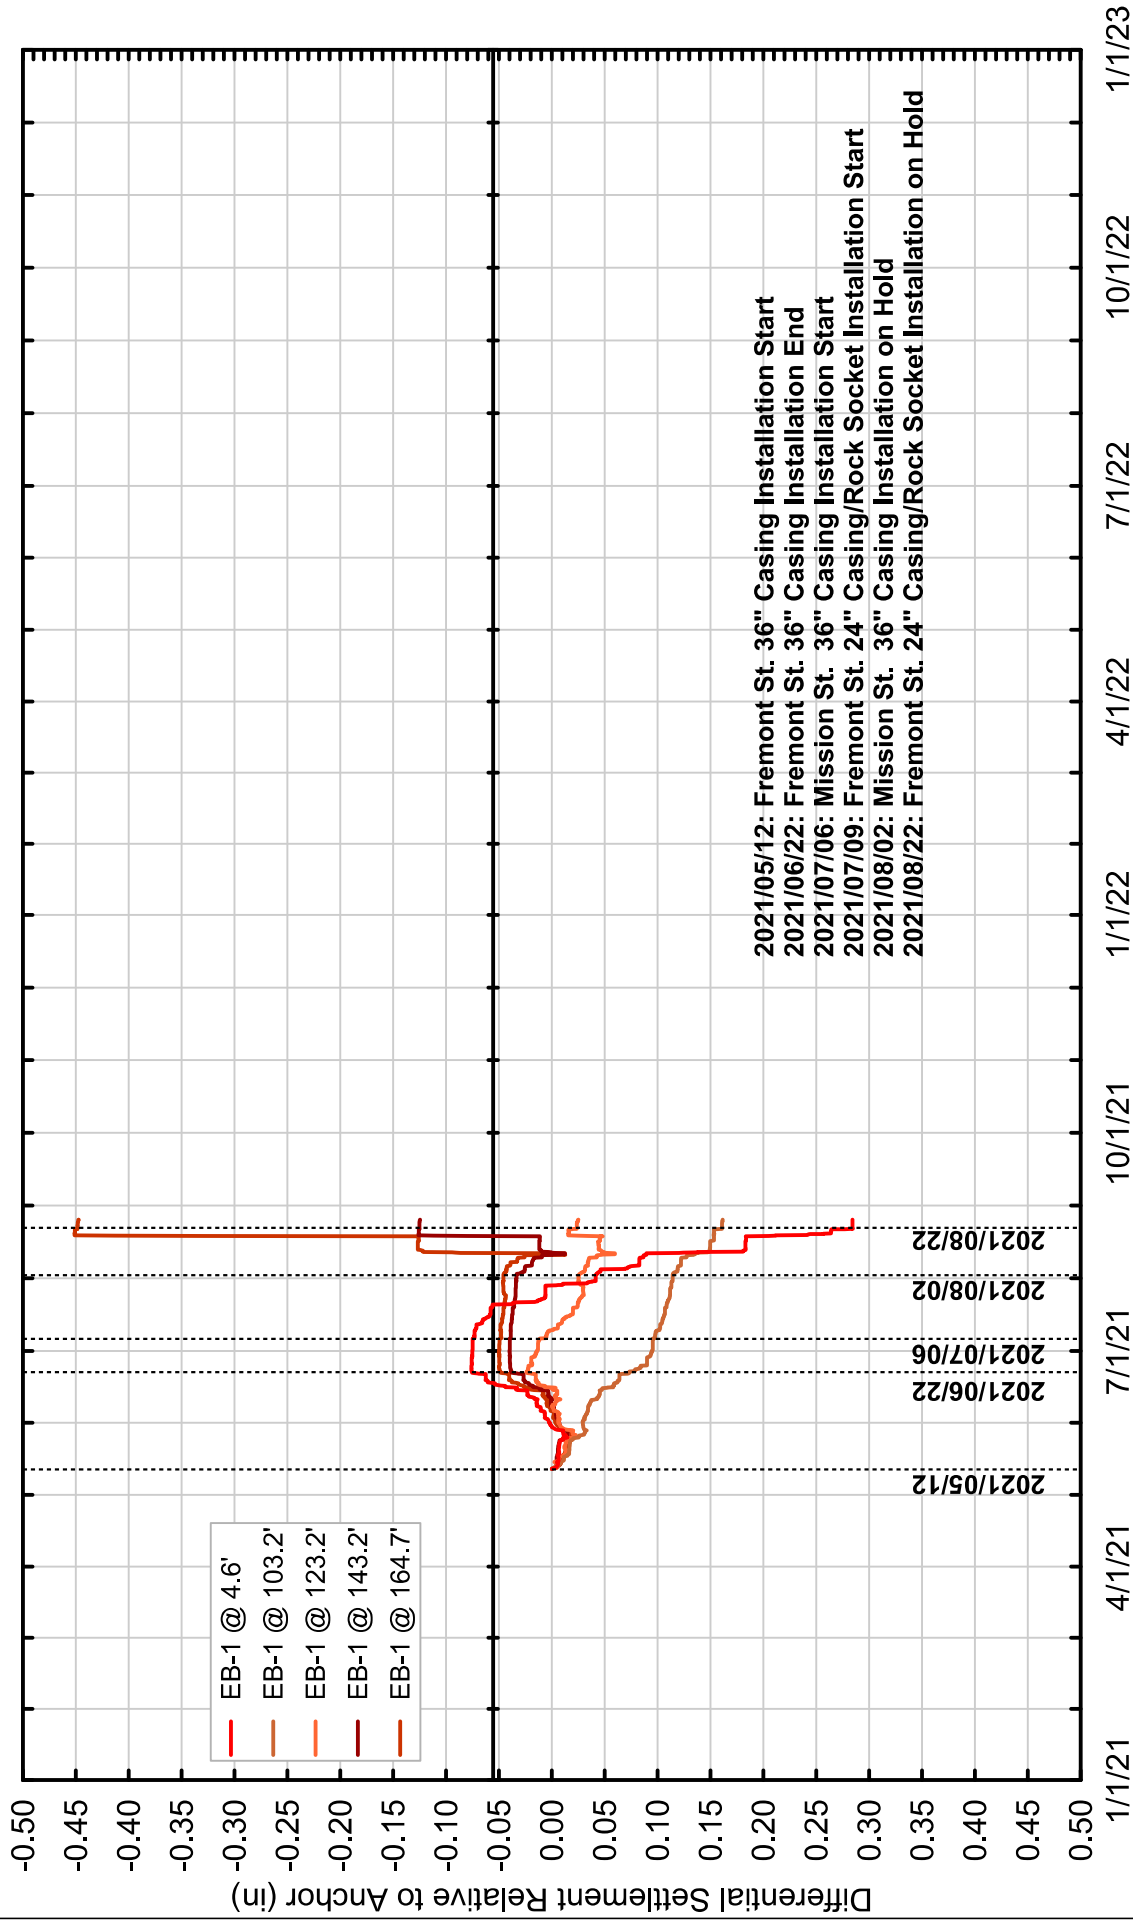
Project No: 19-009.00	Date: 8/25/2021	Created By: NBW	Checked By: DGM	Figure No: 017-11
-----------------------	-----------------	-----------------	-----------------	-------------------

DIFFERENTIAL EXTENSOMETER DATA FROM FREMONT STREET
SINCE 01/01/2021 THROUGH 08/25/2021

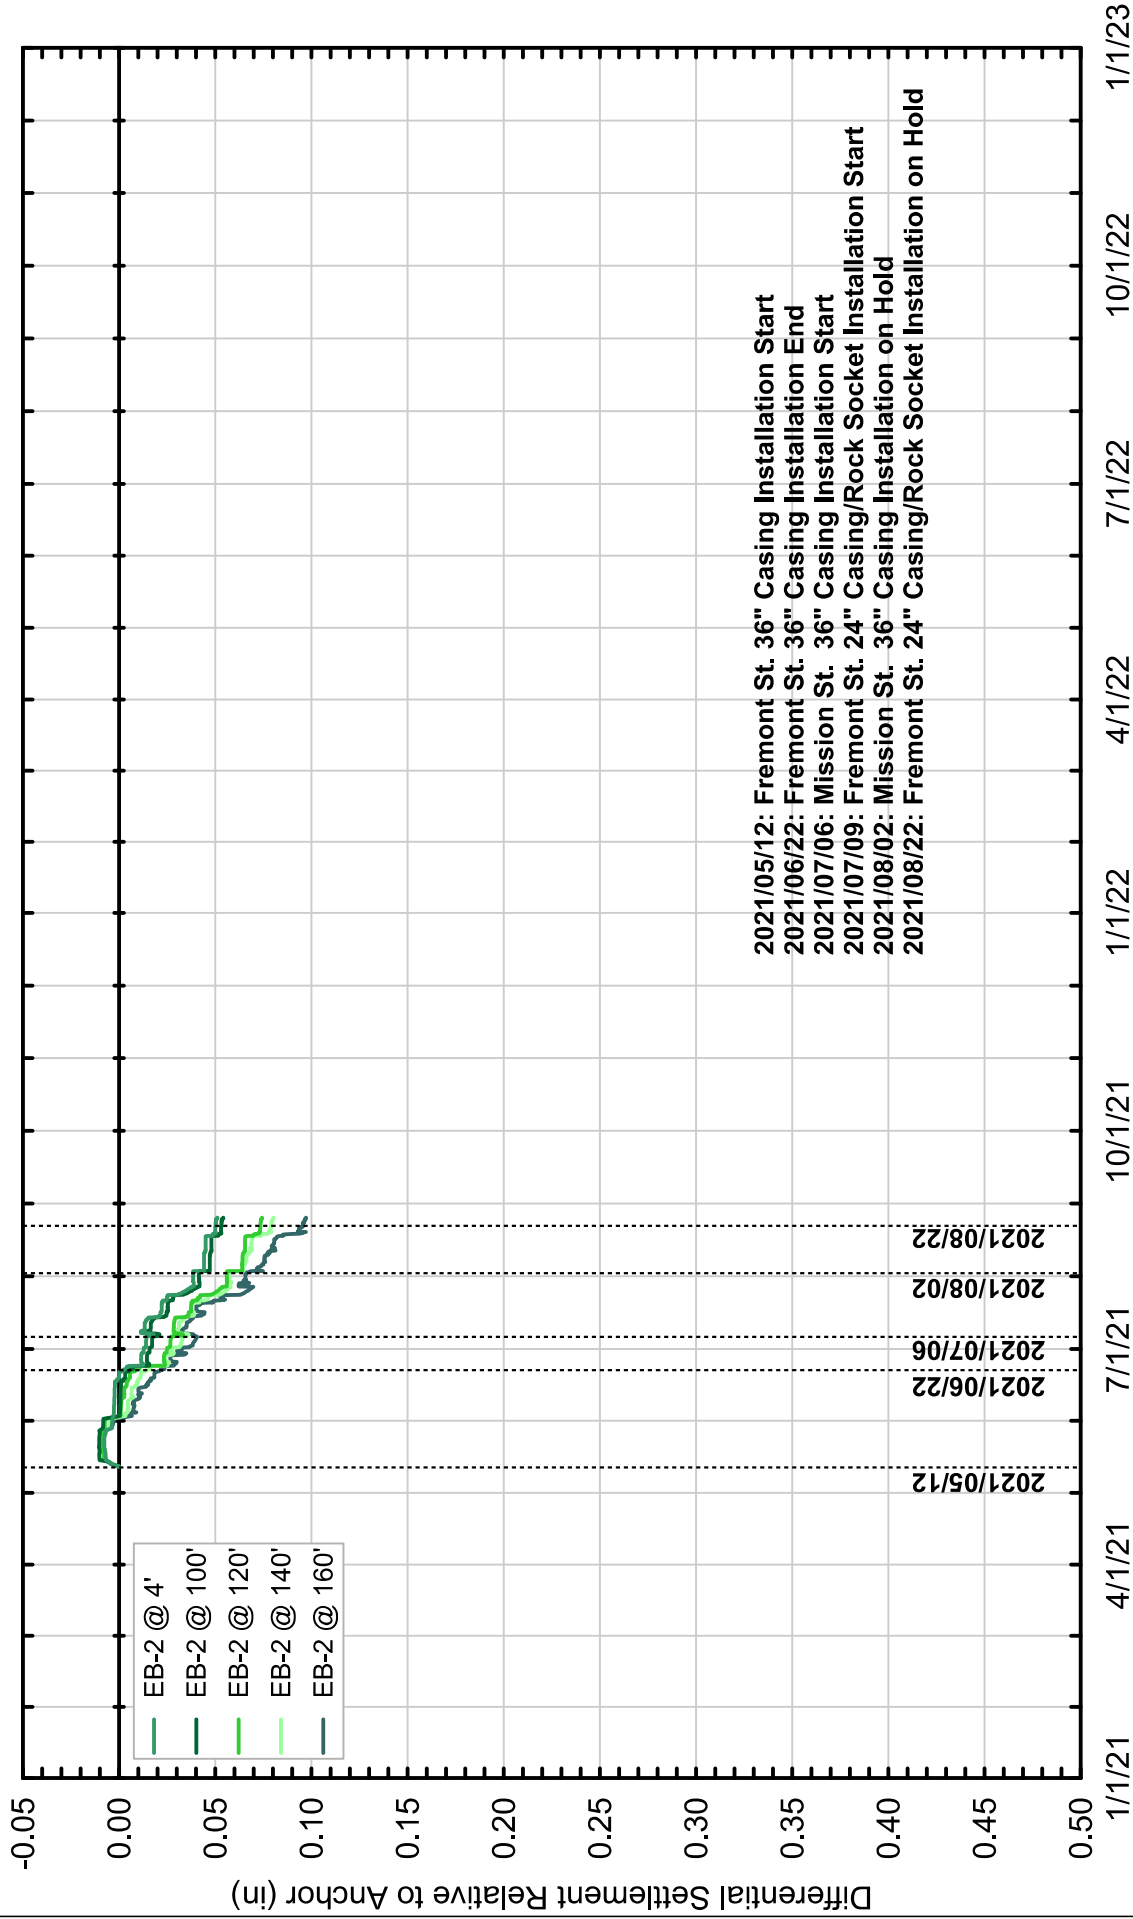
Project No: 19-009.00	Date: 8/25/2021	Created By: NBW	Checked By: DGM	Figure No: 017-12

Street since the start of production pile installation (May 12, 2021) through August 25, 2021. Figure 12 presents extensometer data from Mission Street since the start of production pile installation (May 12, 2021) through August 25, 2021.

DIFFERENTIAL EXTENSOMETER DATA FROM MISSION STREET SINCE 01/01/2021 THROUGH 08/25/2021 Millennium Tower Perimeter Pile Upgrade: Instrumentation Monitoring Data City and County of San Francisco, California
