Date: June 1, 2023 Project Number: 19-009 Subject: 301 Mission Retrofit Supplemental Monitoring Report 108: Results as of May 31, 2023

# CONTEXT

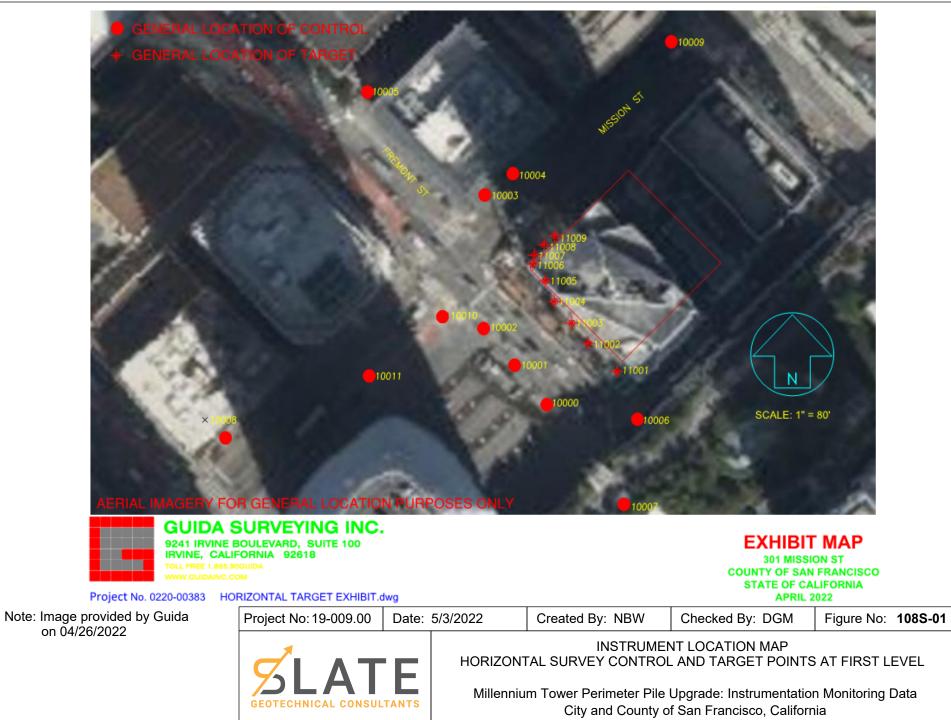
Figure S-01 presents the locations of the survey prisms (including both control and target prisms) as referenced in later figures.

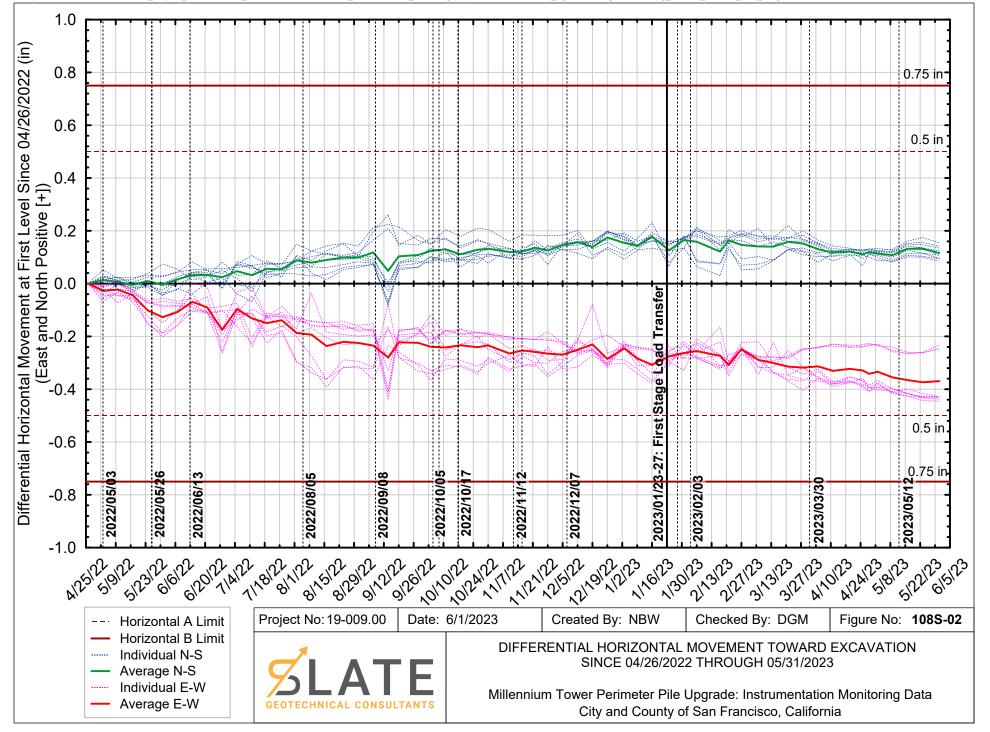
Figure S-02 presents the differential horizontal movement toward the excavation at survey prisms installed at approximately one floor level above grade on the exterior of the building, as well as the average in each of the project north-south and east-west direction, since April 26, 2022, through May 31, 2023. Limits established in the aforementioned letter are included for reference.

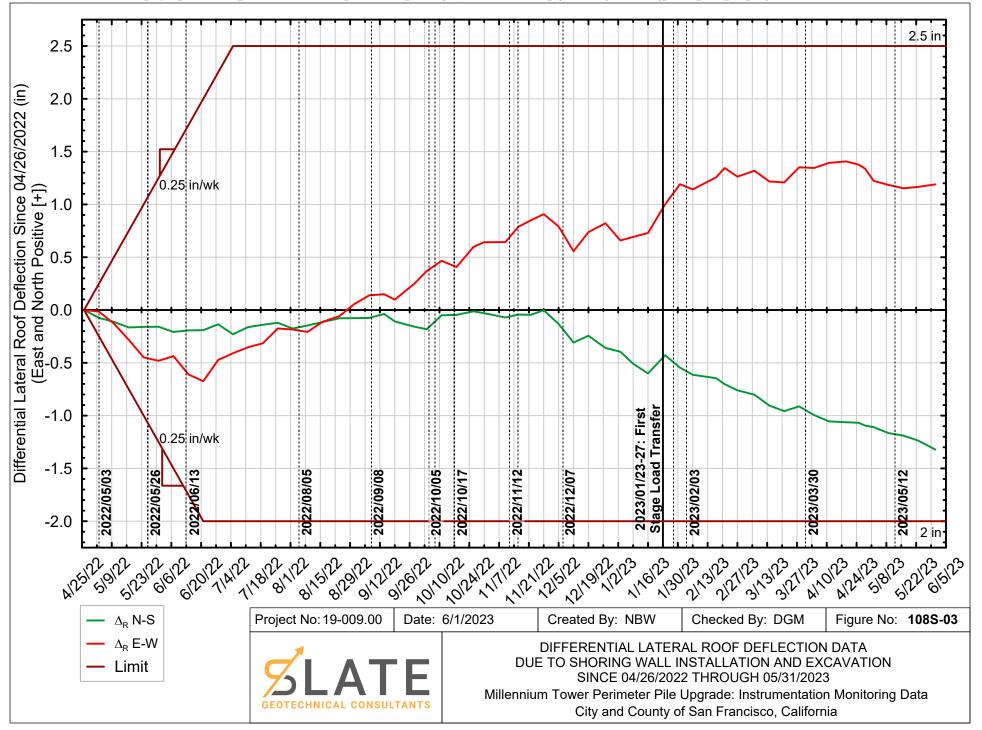
Figure S-03 – Differential Lateral Roof Deflection Data due to Shoring Wall Installation and Excavation since 04/26/2022 through 05/31/2023

Figure S-03 presents differential lateral roof deflection data due to shoring wall installation and excavation since April 26, 2022, through May 31, 2023. Limits established in the aforementioned letter are included for reference. Note that differential lateral roof deflection due to shoring wall installation and excavation is calculated following the aforementioned letter as:

- where:  $\Delta_R$  is the computed differential lateral roof deflection due to shoring wall installation and excavation during shoring wall installation (a or c) or during excavation (b or d) for the project north-south (a and b) and project east-west (c and d) directions;

- $\Delta_{R-prism}$  is the differential lateral roof deflection obtained from prism data for the project north-south (a and b) and project east-west (c and d) directions;

- $\Delta_H$  is the average differential horizontal movement "at-grade" for the project north-south (a and b) and project east-west (c and d) directions;

- $\alpha_0$  is the weekly lateral roof deflection rate from the two months of monitoring conducted immediately prior to the shoring wall installation (i.e., monitoring data from February 22, 2022, through April 26, 2022);

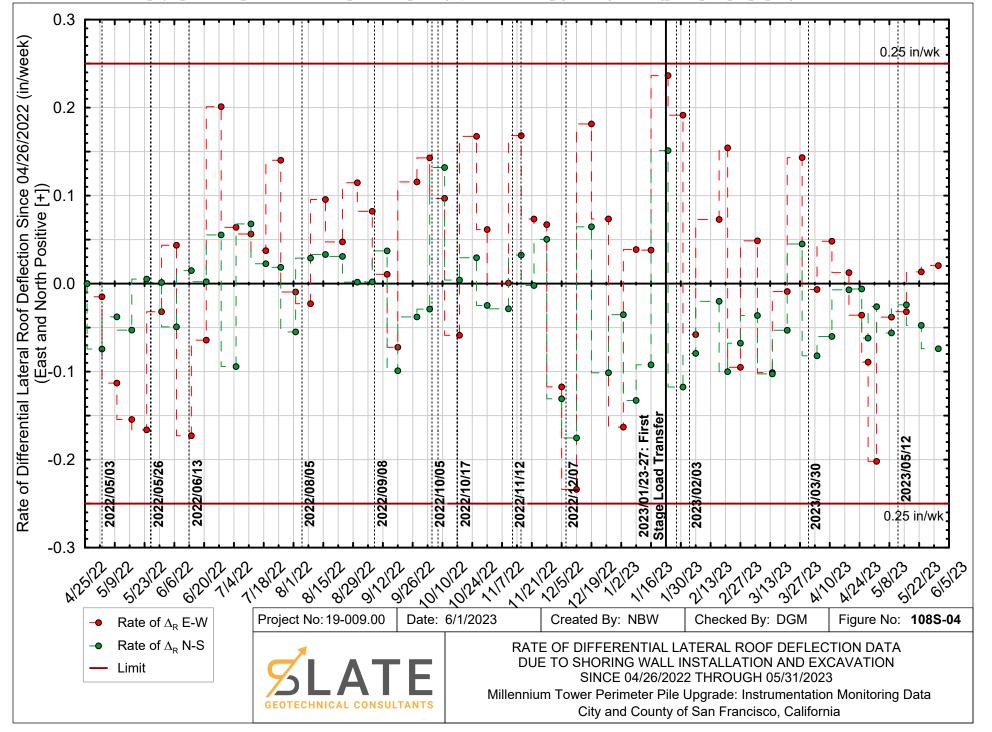
Figure S-04 – Rate of Differential Lateral Roof Deflection Data due to Shoring Wall Installation and Excavation since 04/26/2022 through 05/31/2023

Figure S-04 presents rates of differential lateral roof deflection data due to shoring wall installation and excavation since April 26, 2022, through May 31, 2023. Limits established in the aforementioned letter are included for reference. Note that the rates are calculated as:

$$\frac{d\Delta_R}{dT} \approx \frac{\Delta_{R,t} - \Delta_{R,t-1}}{T_t - T_{t-1}}$$
