Date: September 19, 2023 Project Number: 23-018-01 Subject: 301 Mission Retrofit Monitoring Report 121: Results as of September 18, 2023

301 Mission Retrofit Monitoring: Results as of September 19, 2023 Project No. 19-009 September 20, 2023

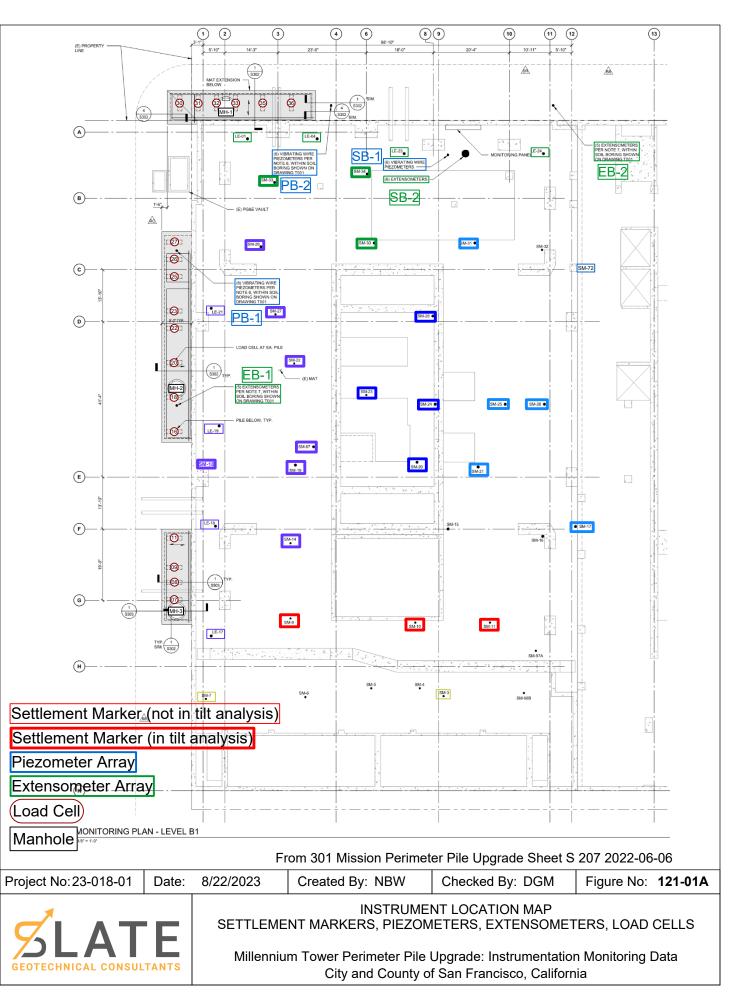
Figure 01 presents the instrument locations as referenced in later figures.

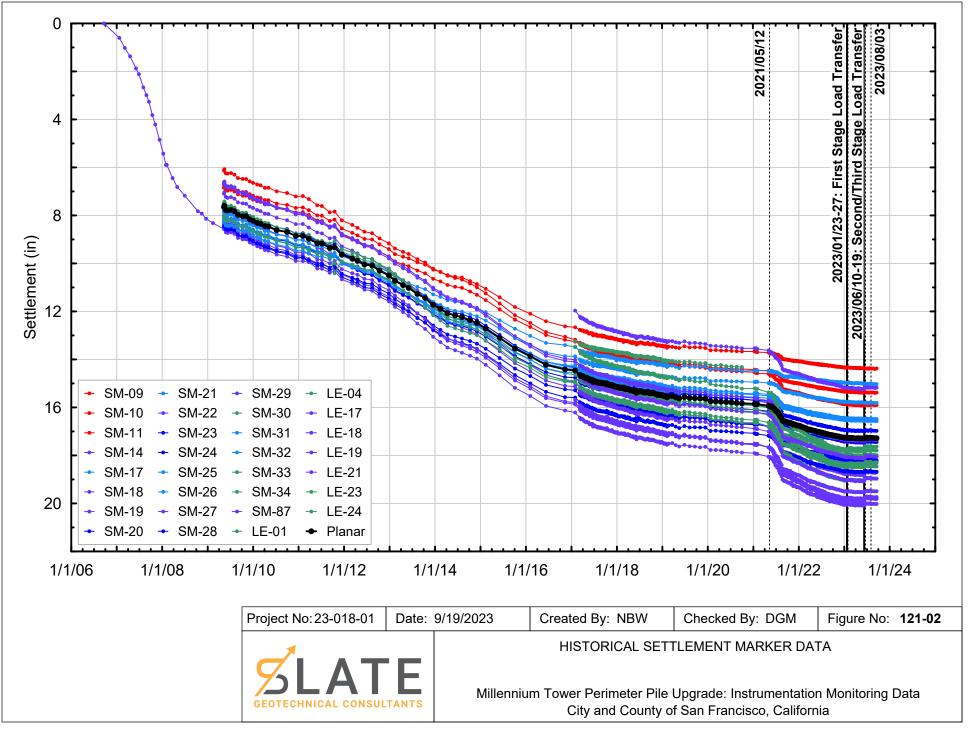
Figure 02 presents the historical settlement data interpreted from settlement markers installed on the B-1 Level of 301 Mission Tower. In addition, data from surveys performed during the retrofit are included. Figure 03 presents settlement data since the start of production pile installation (May 12, 2021; baseline readings on May 10, 2021) through September 18, 2023. Figure 04 presents current settlement contours (in inches) on September 18, 2023.

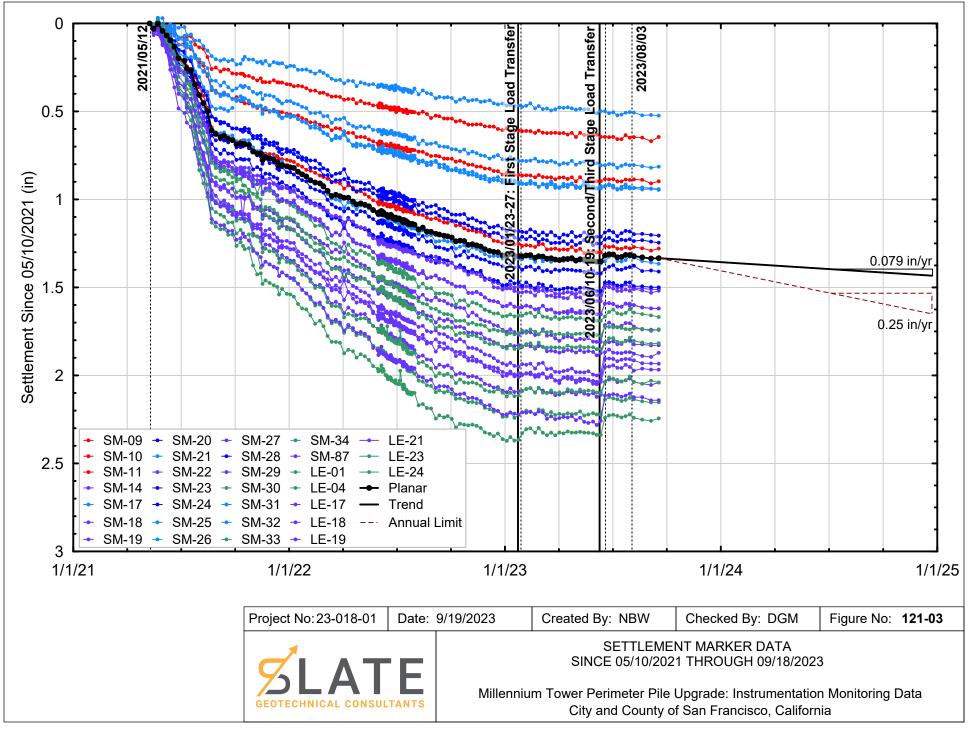
⁵ As plotted on Figure 03. The annual rate is calculated starting on the settlement monitoring date closest to one year prior to the current date or on June 19, 2023 (the settlement monitoring date corresponding to the last day of jacking load application), whichever is later, and ending on the current date.

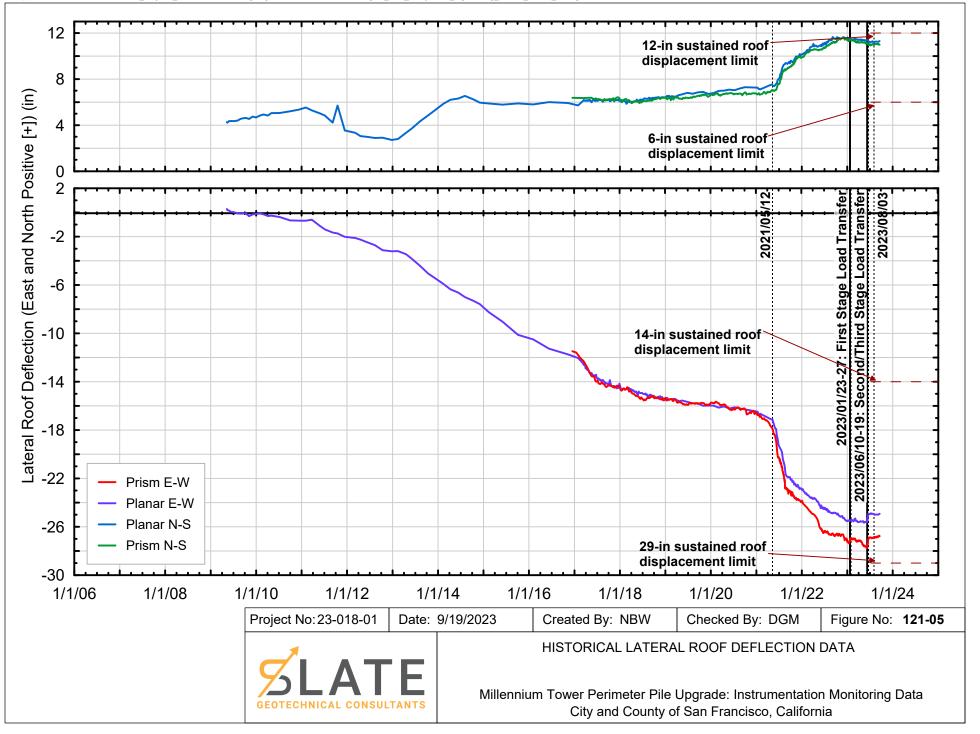
Figure 05 presents historical lateral roof deflections in the project north-south and project east-west directions interpreted from survey prisms mounted on the exterior of the Tower, from InSAR data, and from a planar fit of the settlement marker data. In addition, data from surveys performed during the retrofit are included. Figure 06A presents lateral roof deflection data from a planar fit of the settlement marker data and from survey prisms mounted on the exterior of the Tower since the start of production pile installation (May 12, 2021; baseline readings on May 10 and 13, 2021, respectively) through September 18, 2023.

⁶ As plotted on Figure 05, relative to a plumb condition.

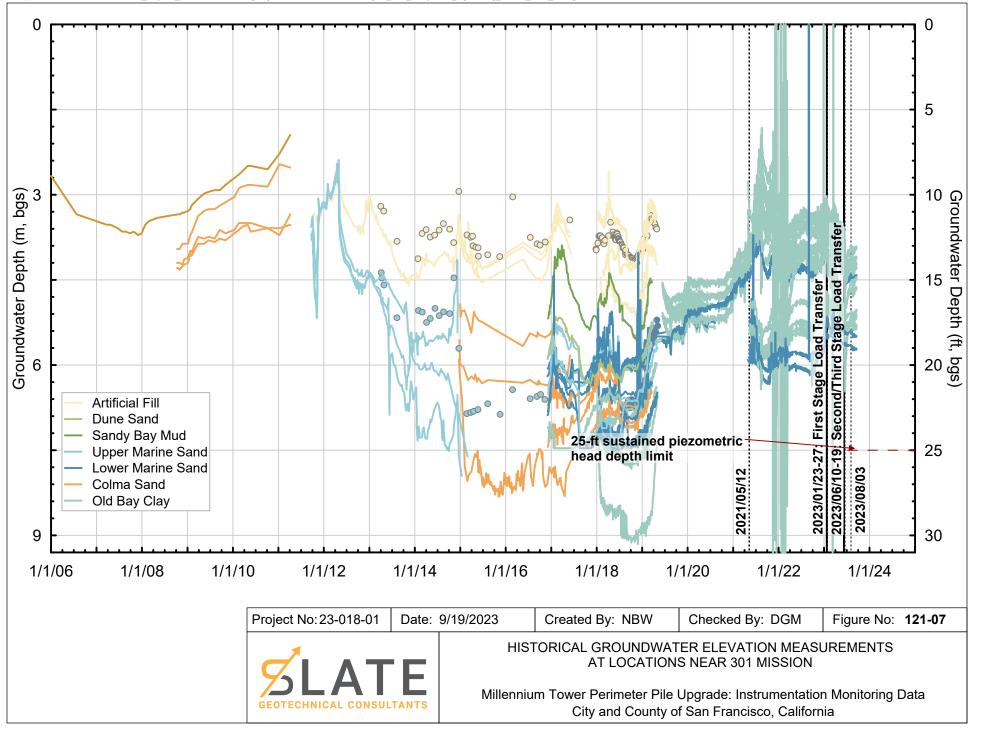
Figure 07 presents the historical groundwater elevation interpreted from piezometer readings at locations near 301 Mission. In addition, data from piezometers installed to monitor groundwater elevation during the retrofit are included. Figures 08 and 09 present groundwater elevation interpreted from piezometer readings

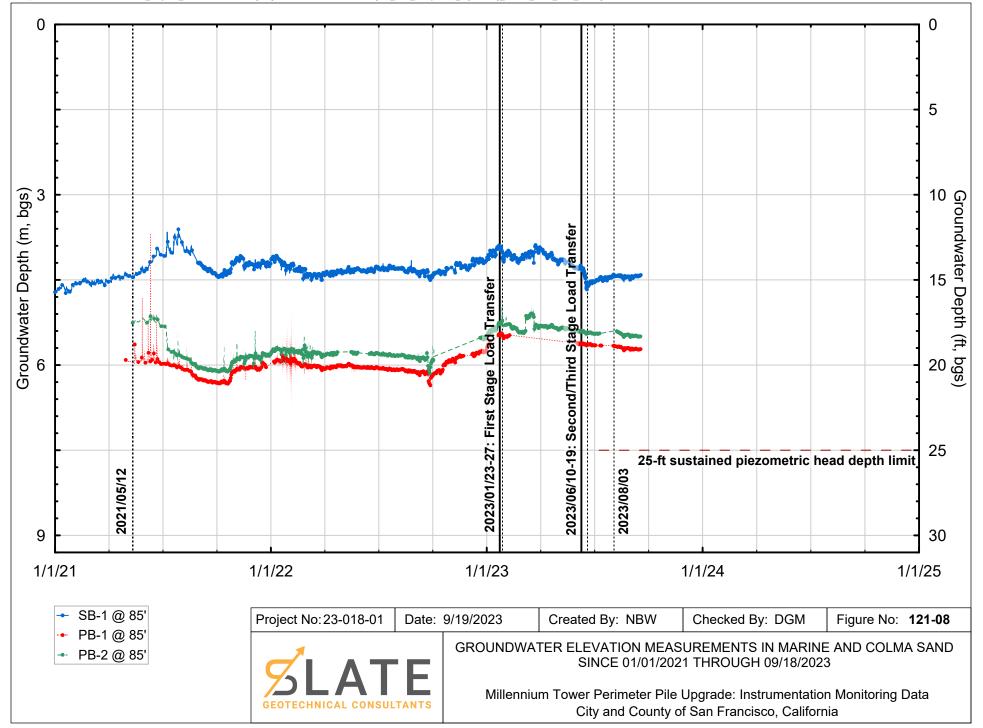
in the Marine/Colma Sand and the Old Bay Clay, respectively, for the time period prior to the start of production pile installation (January 1, 2021) through September 18, 2023.

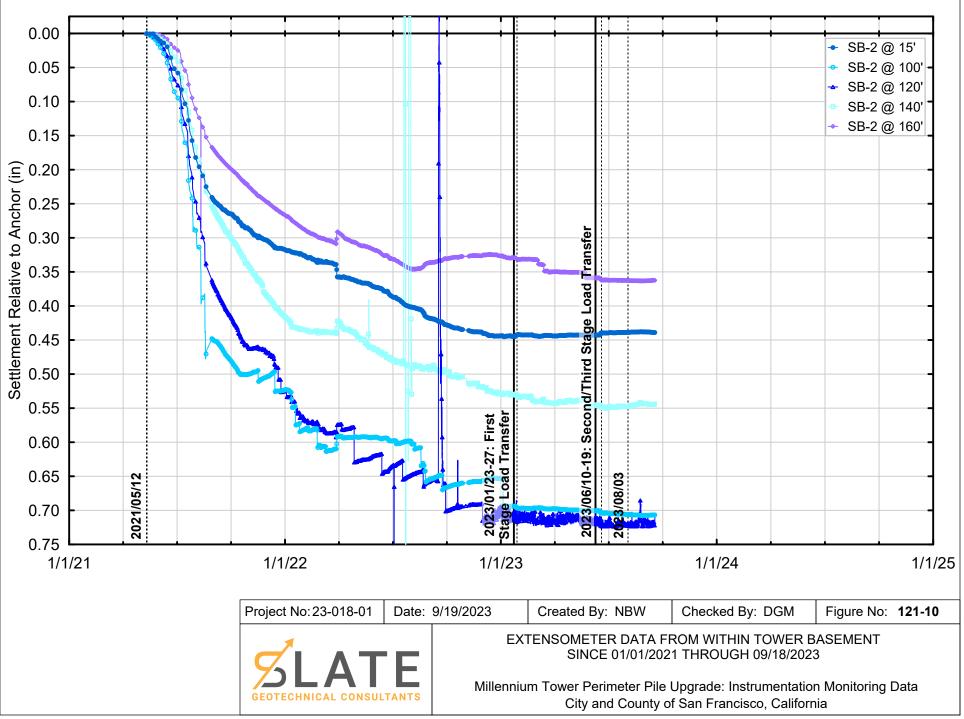
Figure 10 presents extensometer data from within the Tower basement since the start of production pile installation (May 12, 2021) through September 18, 2023. Figure 11 presents extensometer data from Fremont Street since the start of production pile installation (May 12, 2021) through May 16, 2023, and from the restart after fixing the extensometer (May 30, 2023) through September 18, 2023. Figure 12 presents extensometer data from Mission Street since the start of production pile installation (May 12, 2021) through September 18, 2023.

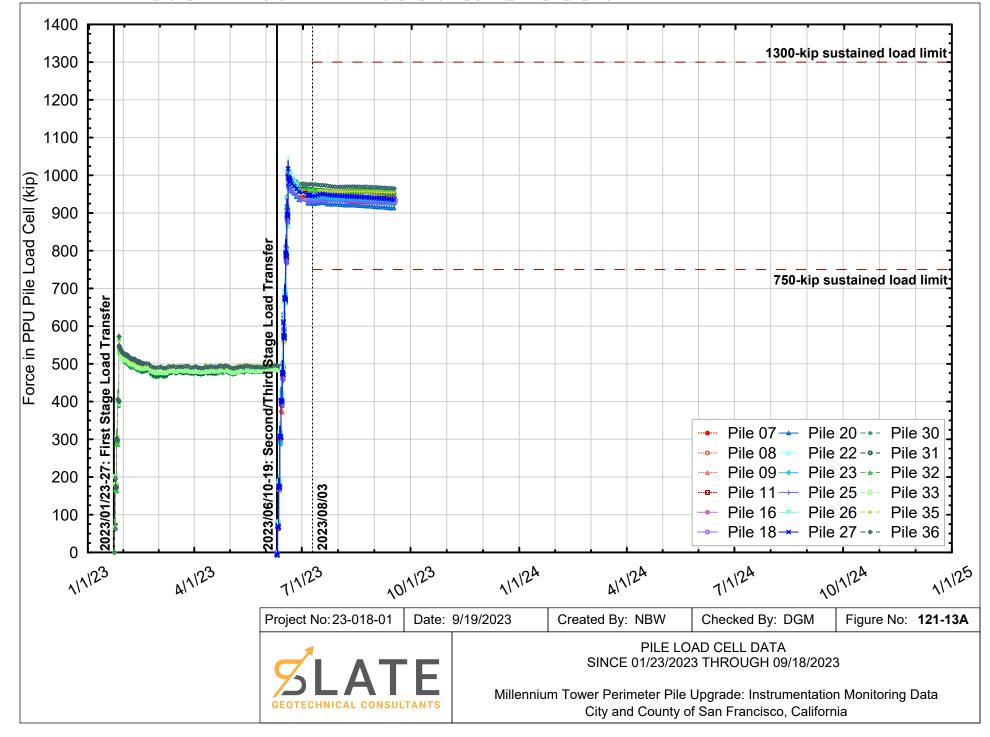
Figure 13A presents pile load cell data since the start of the First Stage Load Transfer (January 23, 2023) through September 18, 2023. Figure 13B presents the total pile load cell data since July 15, 2023, through September 18, 2023.

⁴ The load transfer rods have a maximum safe loading of 375 kips per rod, or 1,500 kips per pile. The 1,300-kip threshold is set to allow sufficient time to evaluate building behavior, should excessive load develop in one or more piles.

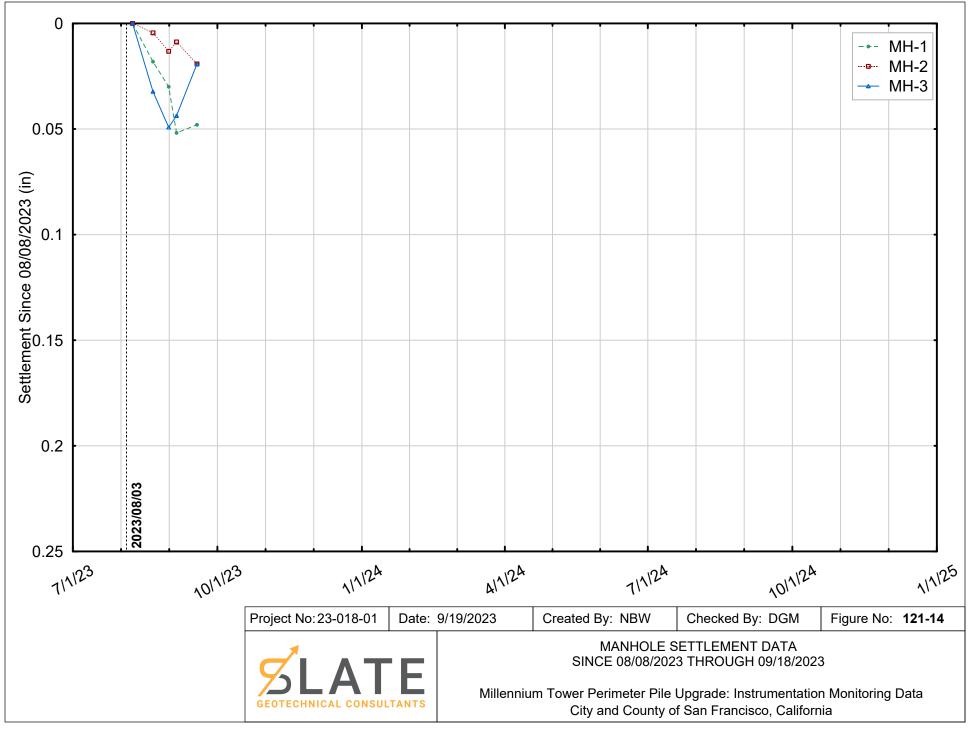
Figure 14 presents settlement data interpreted from survey points located on manholes around the Tower since August 8, 2023, through September 18, 2023.
