To: Millennium Tower Association

Date: October 18, 2023 Project Number: 23-018-01

Subject: 301 Mission Retrofit Monitoring Report 123: Results as of October 16, 2023

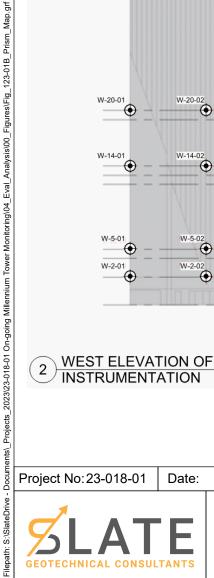
TOWER SURVEY PRISM LOCATION SCHEMATIC

Figure 01B – Tower Survey Prism Location Schematic

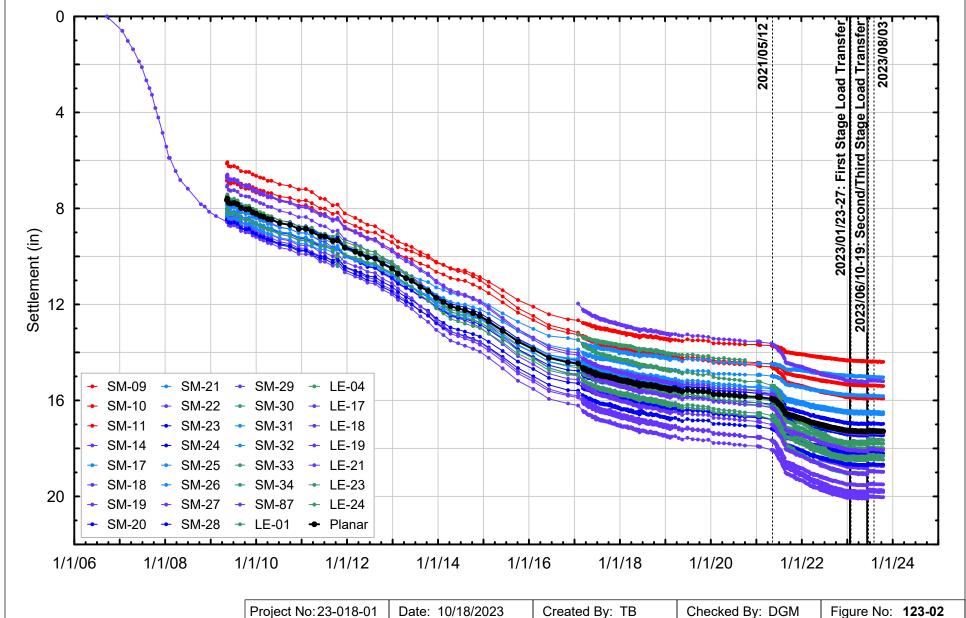
HISTORICAL SETTLEMENT MARKER DATA

Figure 02 presents the historical settlement data interpreted from settlement markers installed on the B-1 Level of 301 Mission Tower. In addition, data from surveys performed during the retrofit are included. Figure 03 presents settlement data since the start of production pile installation (May 12, 2021; baseline readings on May 10, 2021) through October 16, 2023. Figure 04 presents current settlement contours (in inches) on October 16, 2023.

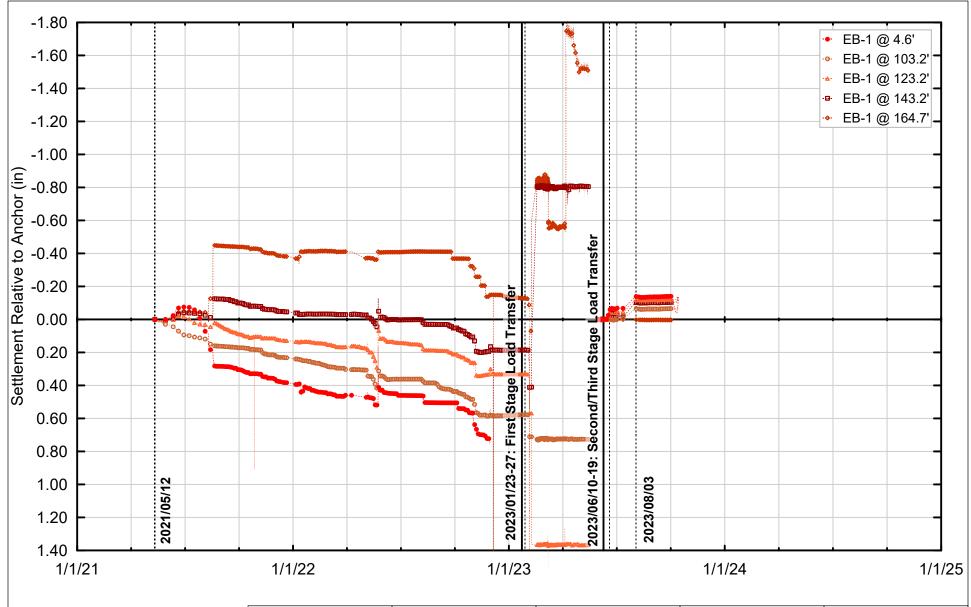
Figure No: **123-11**

The data logger for Fremont Street instruments, including piezometer PB-1 and extensometer EB-1, has been offline with intermittent data collection since October 2, 2023. Work to correct this is ongoing.

Figure 10 presents extensometer data from within the Tower basement since the start of production pile installation (May 12, 2021) through October 16, 2023. Figure 11 presents extensometer data from Fremont Street since the start of production pile installation (May 12, 2021) through May 16, 2023, and from the restart after fixing the extensometer (May 30, 2023) through October 14, 2023. Figure 12 presents extensometer data from Mission Street since the start of production pile installation (May 12, 2021) through October 16, 2023.

Note: EB-1 was repaired and reset on 2023/05/30
