To: Millennium Tower Association

Date: November 15, 2023 Project Number: 23-018-01

Subject: 301 Mission Retrofit Monitoring Report 125: Results as of November 14, 2023

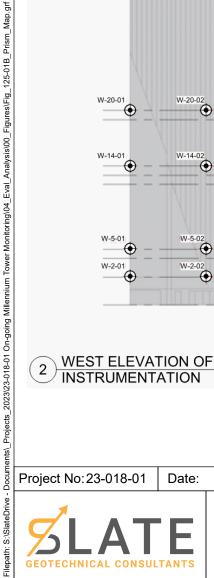
Project No: 23-018-01 7/26/2021 Checked By: DGM Date: Created By: NBW Figure No: **125-01B**

Figure 01B – Tower Survey Prism Location Schematic

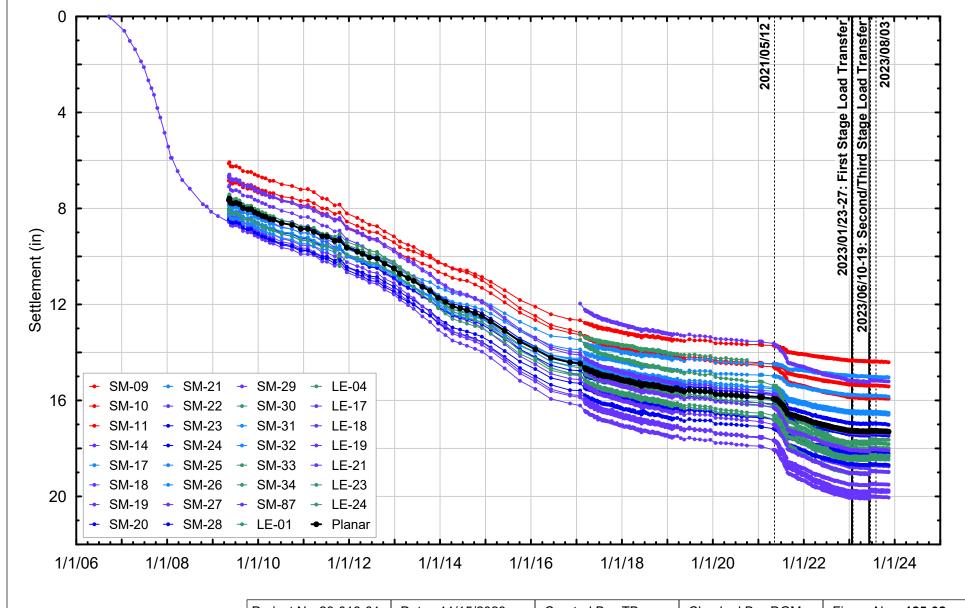
Figure No: **125-02**

Figure 02 presents the historical settlement data interpreted from settlement markers installed on the B-1 Level of 301 Mission Tower. In addition, data from surveys performed during the retrofit are included. Figure 03 presents settlement data since the start of production pile installation (May 12, 2021; baseline readings on May 10, 2021) through November 13, 2023. Figure 04 presents current settlement contours (in inches) on November 13, 2023.

Figure 02 - Historical Settlement Marker Data

TOWER SURVEY PRISM LOCATION SCHEMATIC

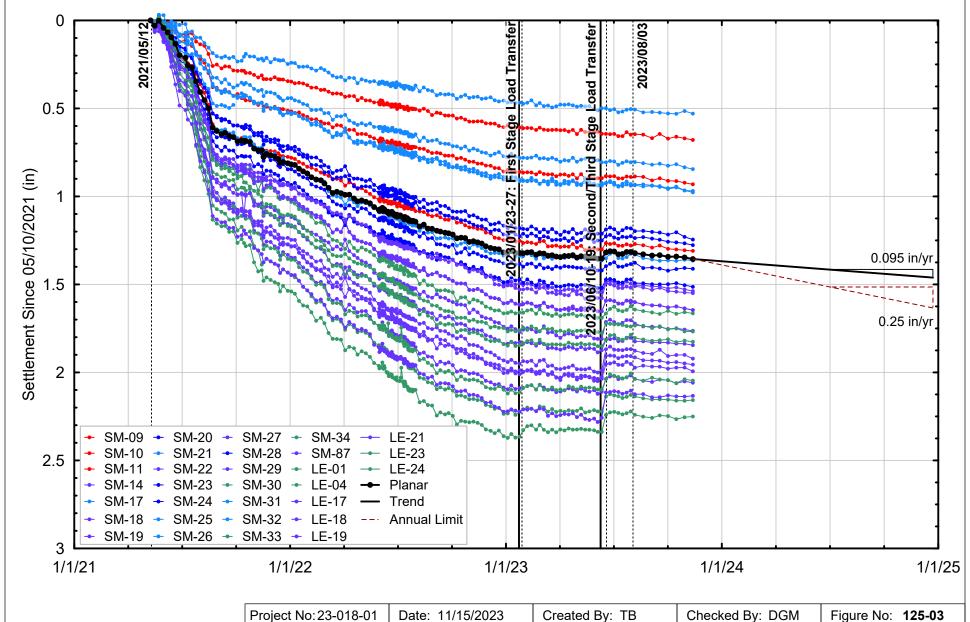
Figure 03 –Settlement Marker Data since 05/10/2021 through 11/13/2023

HISTORICAL SETTLEMENT MARKER DATA

⁵ As plotted on Figure 03. The annual rate is calculated starting on the settlement monitoring date closest to one year prior to the current date or on June 19, 2023 (the settlement monitoring date corresponding to the last day of jacking load application), whichever is later, and ending on the current date. ⁶ As plotted on Figure 05, relative to a plumb condition.

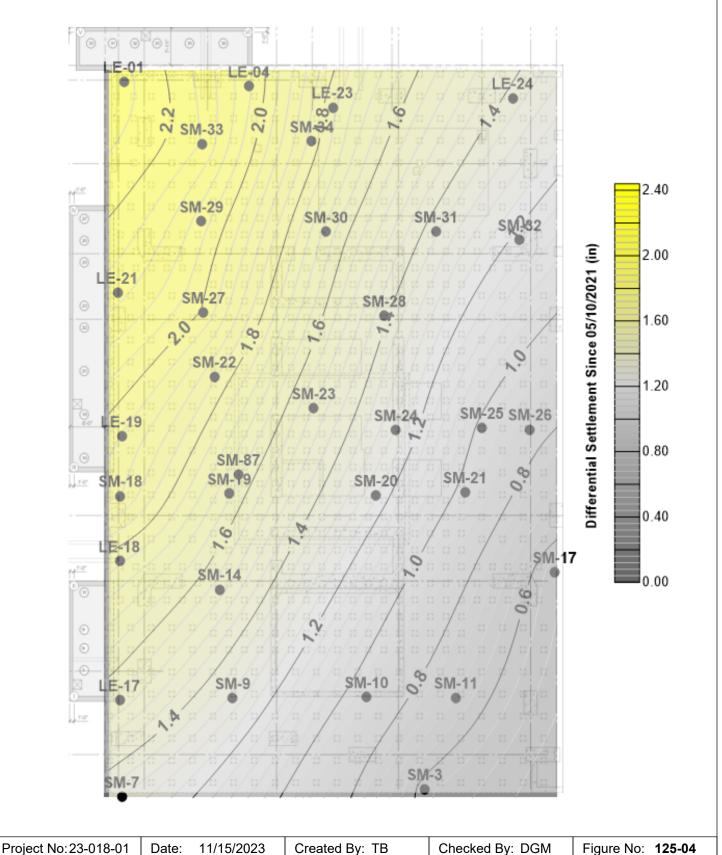
Checked By. DGM Prigure No. 125-04

Figure 04 – Settlement Contours since 05/10/2021 through 11/13/2023

SETTLEMENT MARKER DATA SINCE 05/10/2021 THROUGH 11/13/2023

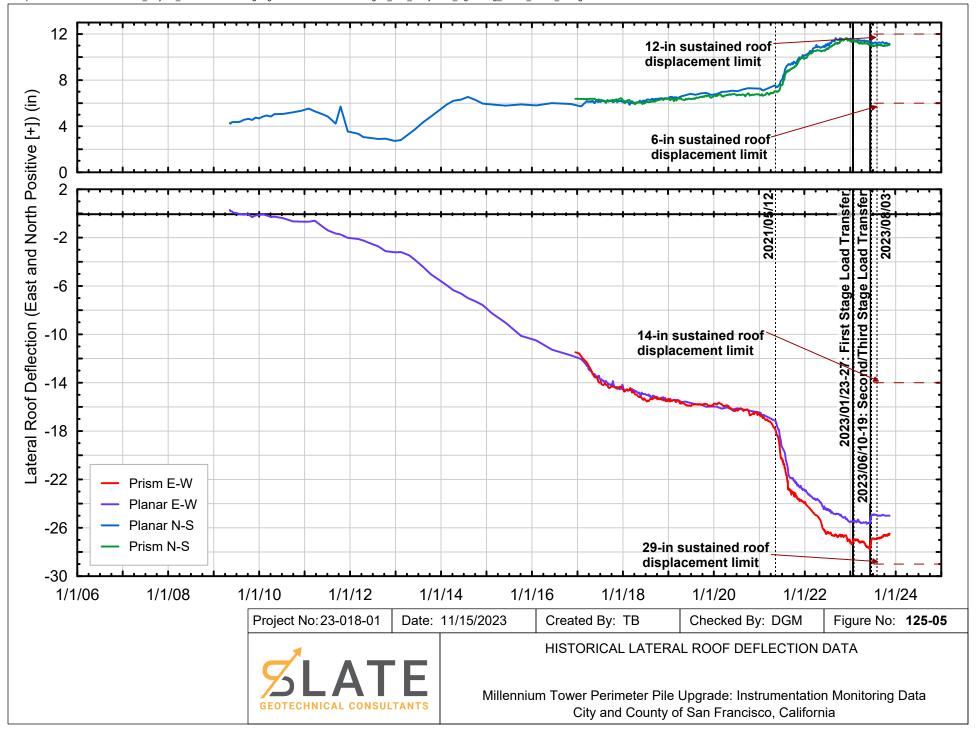
Figure 05 presents historical lateral roof deflections in the project north-south and project east-west directions interpreted from survey prisms mounted on the exterior of the Tower, from InSAR data, and from a planar fit of the settlement marker data. In addition, data from surveys performed during the retrofit are included. Figure 06A presents lateral roof deflection data from a planar fit of the settlement marker data and from survey prisms mounted on the exterior of the Tower since the start of production pile installation (May 12, 2021; baseline readings on May 10 and 13, 2021, respectively) through November 13, 2023.

Figure 05 – Historical Lateral Roof Deflection Data

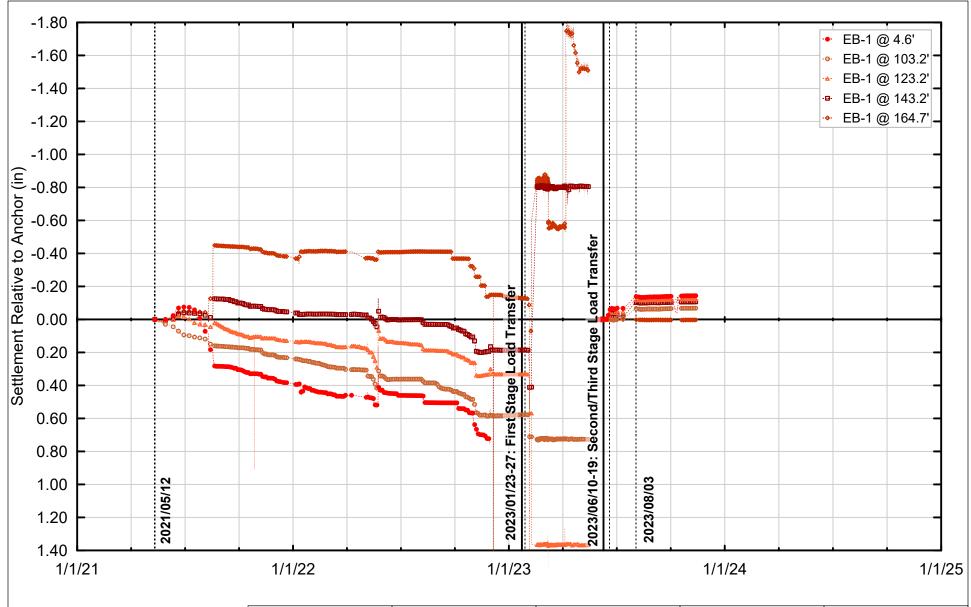
Figure No: **125-11**

Figure 10 presents extensometer data from within the Tower basement since the start of production pile installation (May 12, 2021) through November 14, 2023. Figure 11 presents extensometer data from Fremont Street since the start of production pile installation (May 12, 2021) through May 16, 2023, and from the restart after fixing the extensometer (May 30, 2023) through November 14, 2023. Figure 12 presents extensometer data from Mission Street since the start of production pile installation (May 12, 2021) through November 14, 2023.

Figure 11 – Extensometer Data from Fremont Street since 01/01/2021 through 05/16/2023, since 05/30/2023 through 11/14/2023

Note: EB-1 was repaired and reset on 2023/05/30
