To: Millennium Tower Association

Date: December 13, 2023 Project Number: 23-018-01

Subject: 301 Mission Retrofit Monitoring Report 127: Results as of December 11, 2023

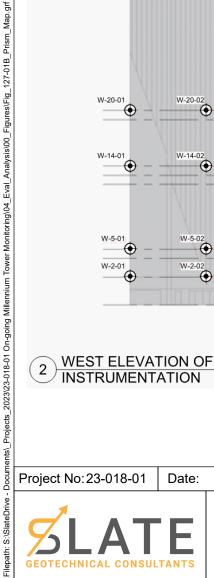
Project No: 23-018-01 7/26/2021 Checked By: DGM Date: Created By: NBW Figure No: **127-01B**

TOWER SURVEY PRISM LOCATION SCHEMATIC

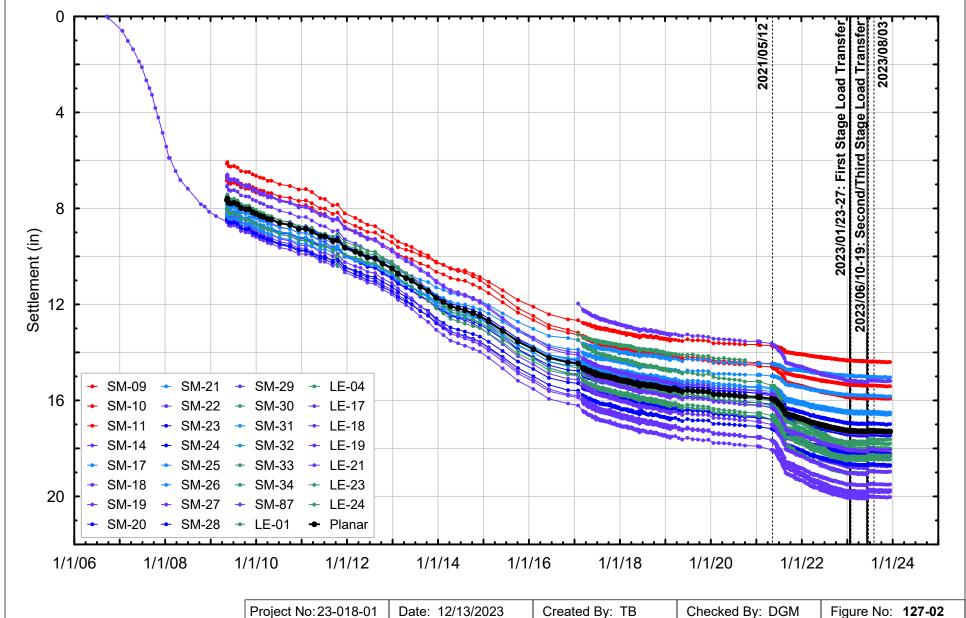
Figure 02 presents the historical settlement data interpreted from settlement markers installed on the B-1 Level of 301 Mission Tower. In addition, data from surveys performed during the retrofit are included. Figure 03 presents settlement data since the start of production pile installation (May 12, 2021; baseline readings on May 10, 2021) through December 11, 2023. Figure 04 presents current settlement contours (in inches) on December 11, 2023.

HISTORICAL SETTLEMENT MARKER DATA

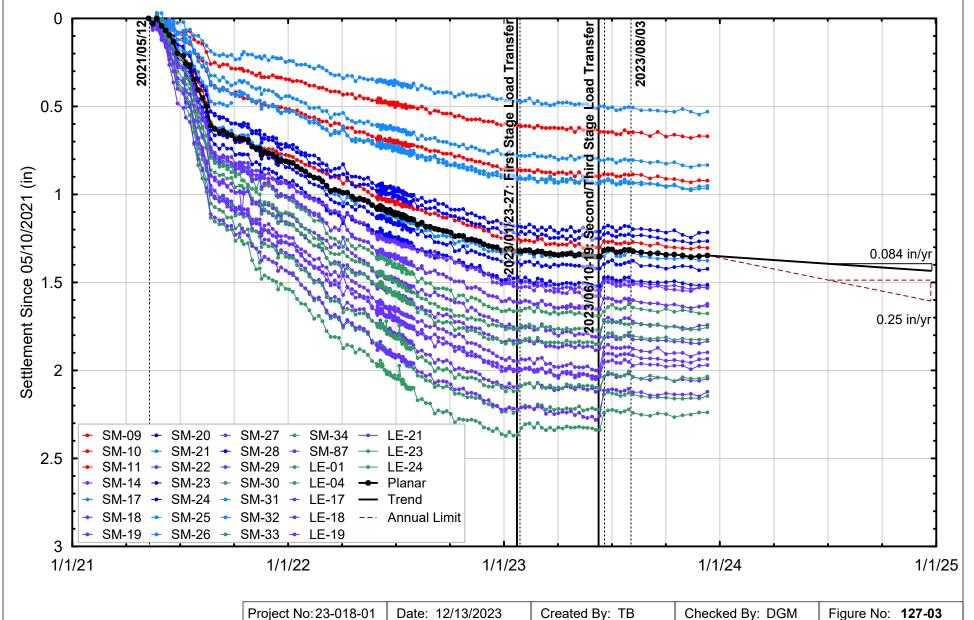
SETTLEMENT MARKER DATA SINCE 05/10/2021 THROUGH 12/11/2023

<sup>&</sup>lt;sup>5</sup> As plotted on Figure 03. The annual rate is calculated starting on the settlement monitoring date closest to one year prior to the current date or on June 19, 2023 (the settlement monitoring date corresponding to the last day of jacking load application), whichever is later, and ending on the current date.
<sup>6</sup> As plotted on Figure 05, relative to a plumb condition.

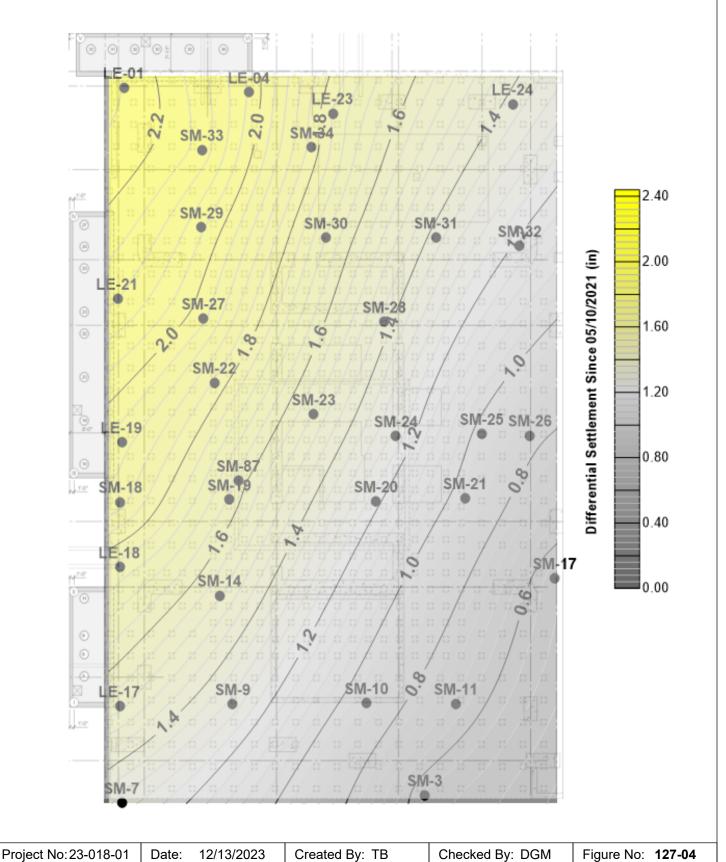
SETTLEMENT CONTOURS

SINCE 05/10/2021 THROUGH 12/11/2023

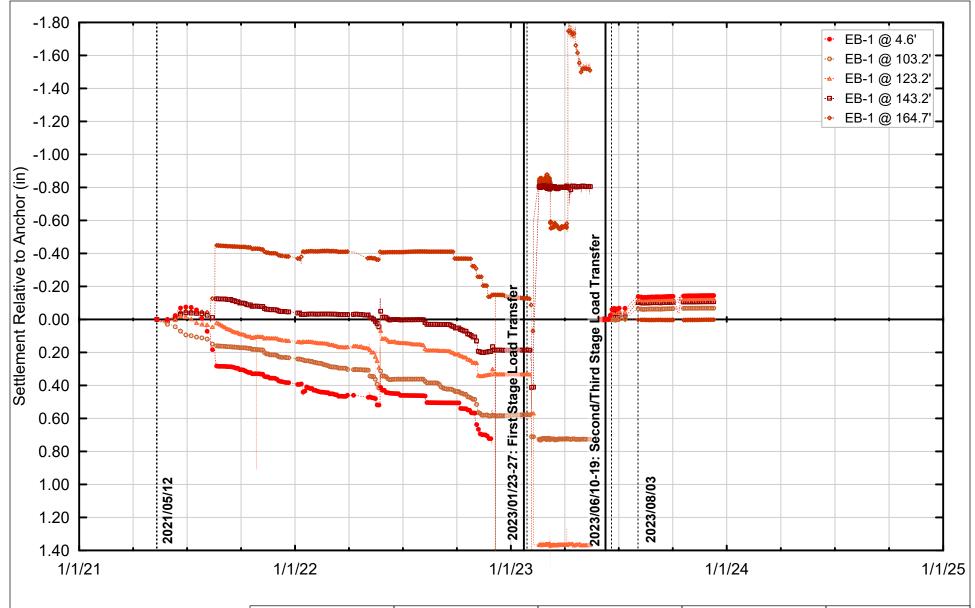
Figure No: **127-11**

Figure 10 presents extensometer data from within the Tower basement since the start of production pile installation (May 12, 2021) through December 11, 2023. Figure 11 presents extensometer data from Fremont Street since the start of production pile installation (May 12, 2021) through May 16, 2023, and from the restart after fixing the extensometer (May 30, 2023) through December 11, 2023. Figure 12 presents extensometer data from Mission Street since the start of production pile installation (May 12, 2021) through December 11, 2023.

Note: EB-1 was repaired and reset on 2023/05/30

EXTENSOMETER DATA FROM FREMONT STREET SINCE 05/10/2021 THROUGH 05/16/2023 SINCE 05/30/2023 THROUGH 12/11/2023
