To: Millennium Tower Association

Date: January 11, 2024 Project Number: 23-018-01

Subject: 301 Mission Retrofit Monitoring Report 129: Results as of January 11, 2024

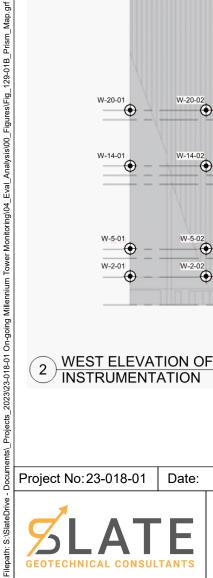
TOWER SURVEY PRISM LOCATION SCHEMATIC

Figure 01B – Tower Survey Prism Location Schematic

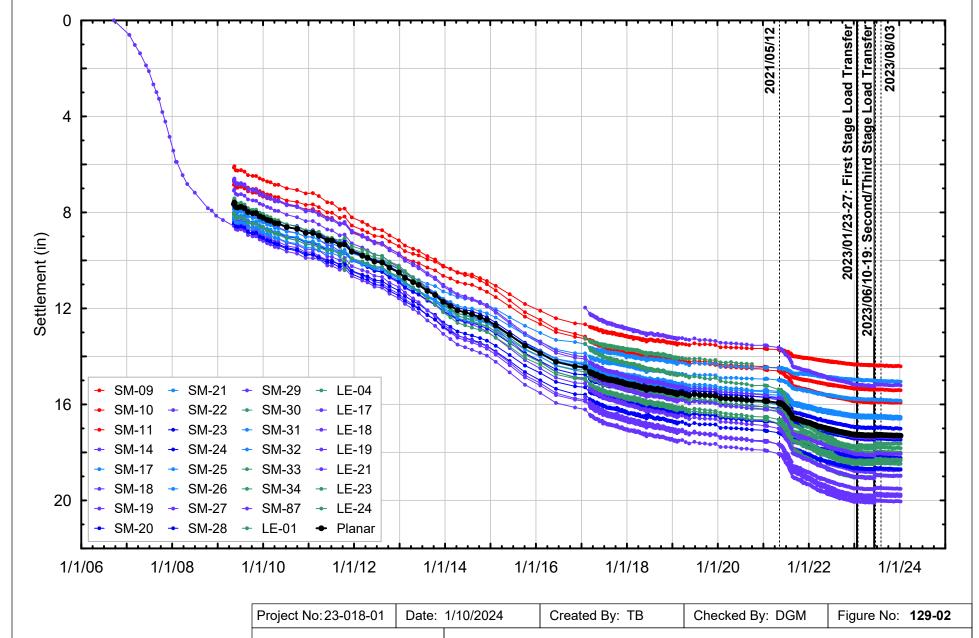
HISTORICAL SETTLEMENT MARKER DATA

Figure 02 presents the historical settlement data interpreted from settlement markers installed on the B-1 Level of 301 Mission Tower. In addition, data from surveys performed during the retrofit are included. Figure 03 presents settlement data since the start of production pile installation (May 12, 2021; baseline readings on May 10, 2021) through January 8, 2024. Figure 04 presents current settlement contours (in inches) on January 8, 2024.

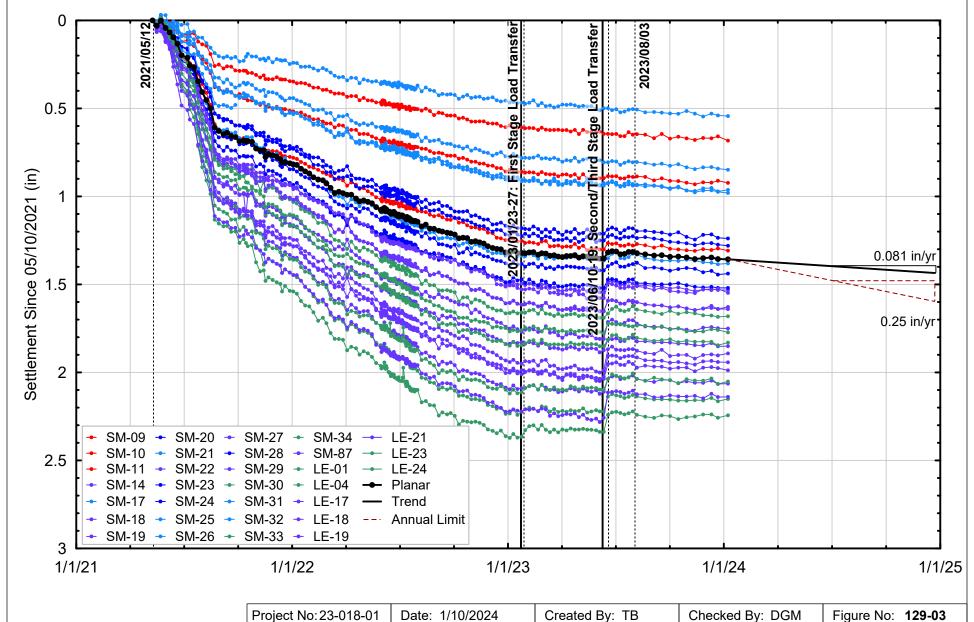
SETTLEMENT MARKER DATA SINCE 05/10/2021 THROUGH 01/08/2024

<sup>&</sup>lt;sup>5</sup> As plotted on Figure 03. The annual rate is calculated starting on the settlement monitoring date closest to one year prior to the current date or on June 19, 2023 (the settlement monitoring date corresponding to the last day of jacking load application), whichever is later, and ending on the current date.
<sup>6</sup> As plotted on Figure 05, relative to a plumb condition.

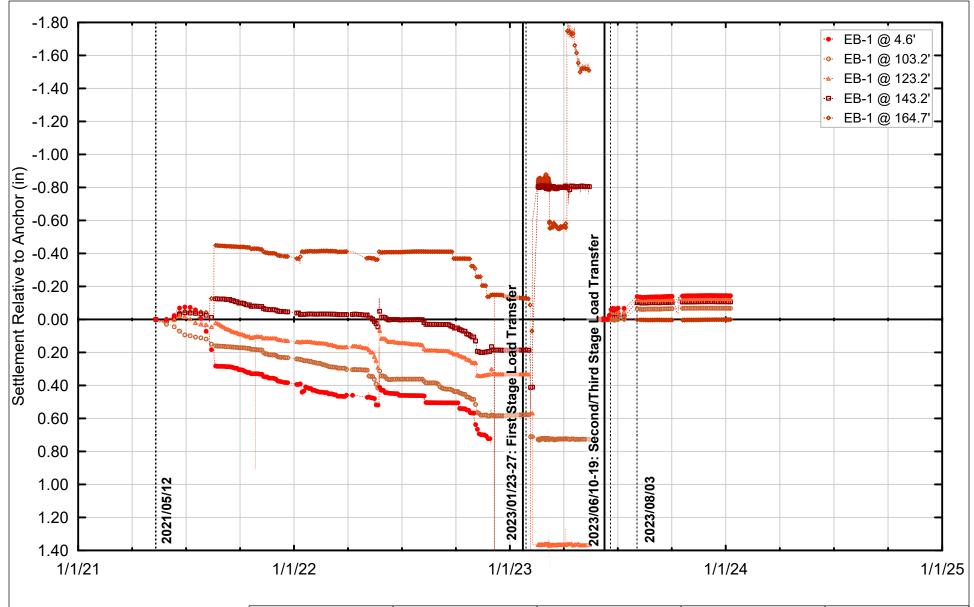
Figure No: **129-11**

Figure 10 presents extensometer data from within the Tower basement since the start of production pile installation (May 12, 2021) through January 9, 2024. Figure 11 presents extensometer data from Fremont Street since the start of production pile installation (May 12, 2021) through May 16, 2023, and from the restart after fixing the extensometer (May 30, 2023) through January 9, 2024. Figure 12 presents extensometer data from Mission Street since the start of production pile installation (May 12, 2021) through January 9, 2024.

Note: EB-1 was repaired and reset on 2023/05/30
