Date: January 24, 2024 Project Number: 23-018-01 Subject: 301 Mission Retrofit Monitoring Report 130: Results as of January 22, 2024

301 Mission Retrofit Monitoring: Results as of January 22, 2024 Project No. 23-018-01 January 24, 2024

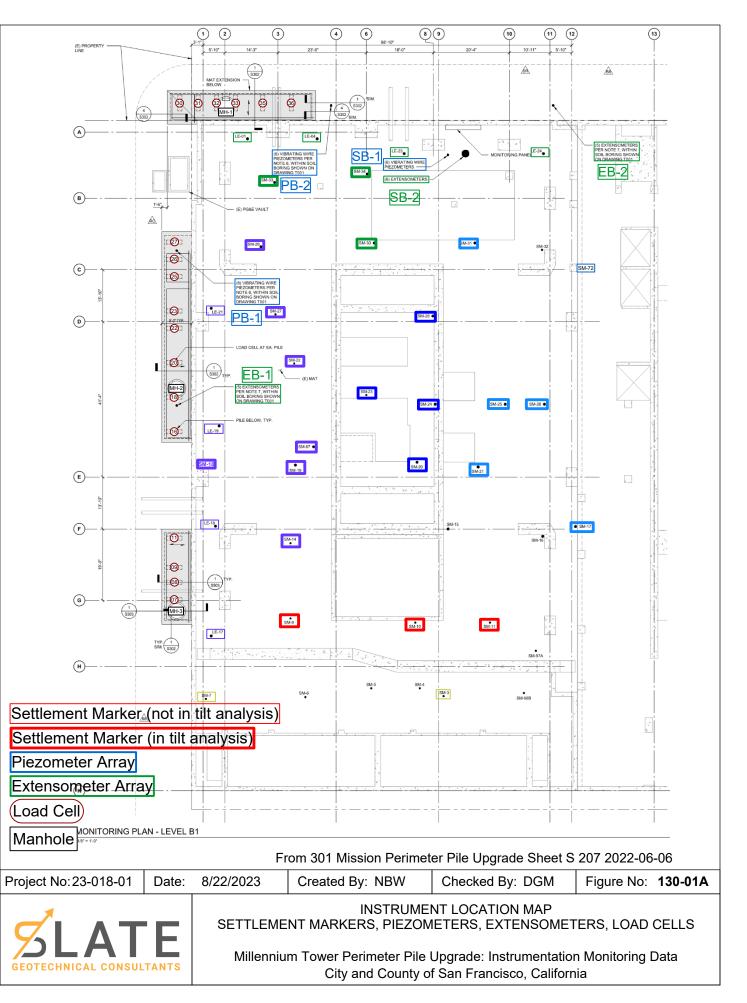
Figure 01 presents the instrument locations as referenced in later figures.

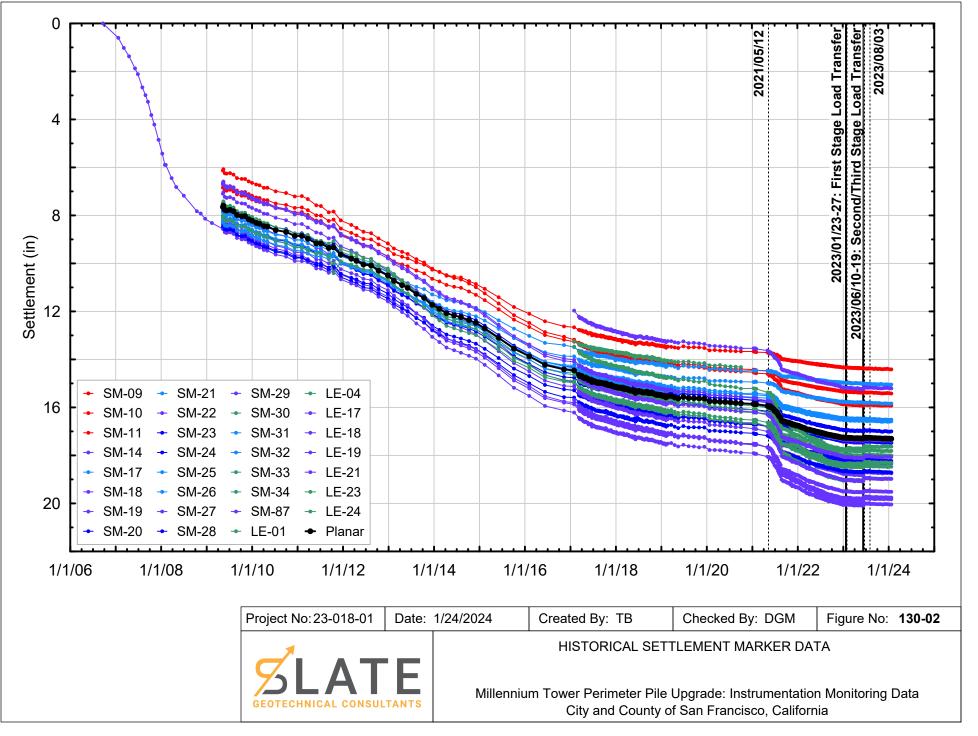
Figure 02 presents the historical settlement data interpreted from settlement markers installed on the B-1 Level of 301 Mission Tower. In addition, data from surveys performed during the retrofit are included. Figure 03 presents settlement data since the start of production pile installation (May 12, 2021; baseline readings on May 10, 2021) through January 22, 2024. Figure 04 presents current settlement contours (in inches) on January 22, 2024.

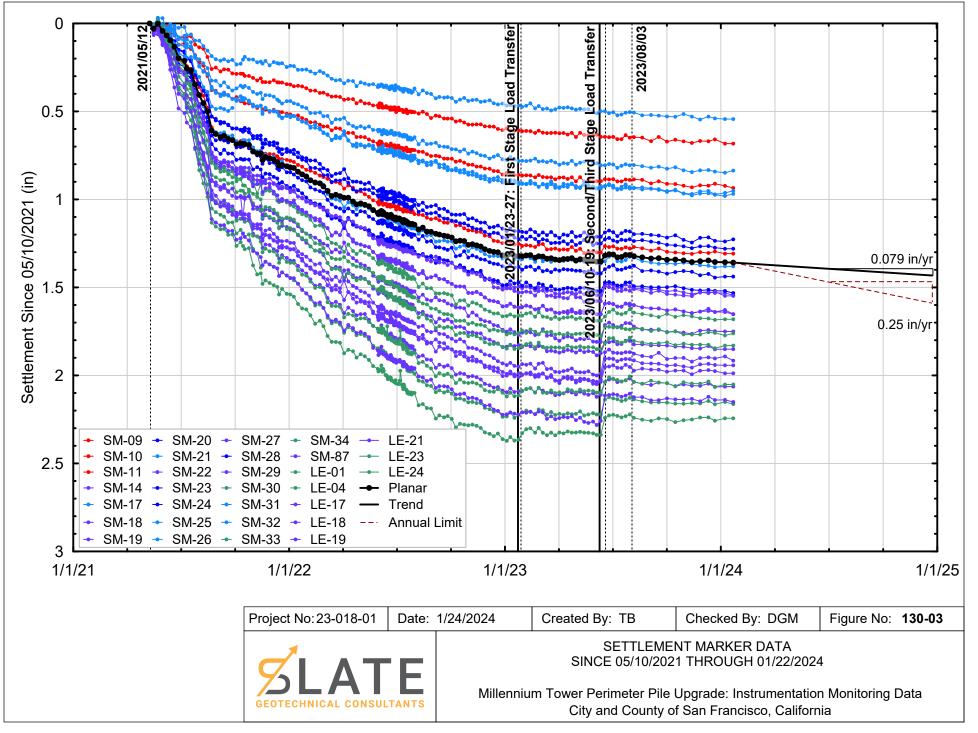
⁵ As plotted on Figure 03. The annual rate is calculated starting on the settlement monitoring date closest to one year prior to the current date or on June 19, 2023 (the settlement monitoring date corresponding to the last day of jacking load application), whichever is later, and ending on the current date. ⁶ As plotted on Figure 05, relative to a plumb condition.

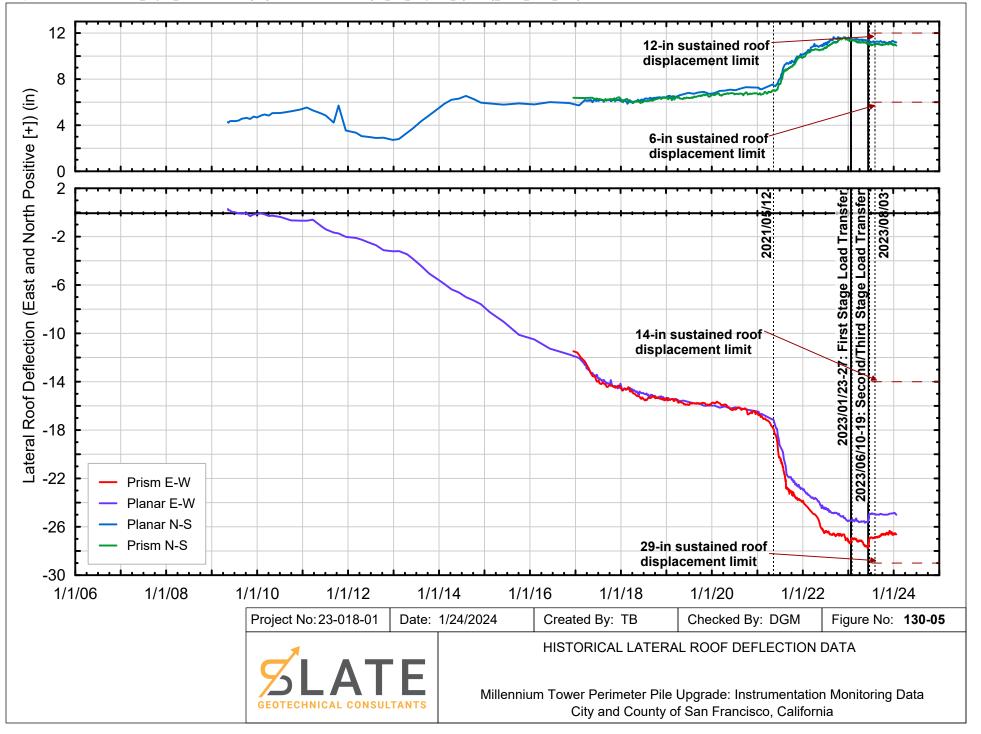
Figure 05 presents historical lateral roof deflections in the project north-south and project east-west directions interpreted from survey prisms mounted on the exterior of the Tower, from InSAR data, and from a planar fit of the settlement marker data. In addition, data from surveys performed during the retrofit are included. Figure 06A presents lateral roof deflection data from a planar fit of the settlement marker data and from survey prisms mounted on the exterior of the Tower since the start of production pile installation (May 12, 2021; baseline readings on May 10 and 13, 2021, respectively) through January 22, 2024.

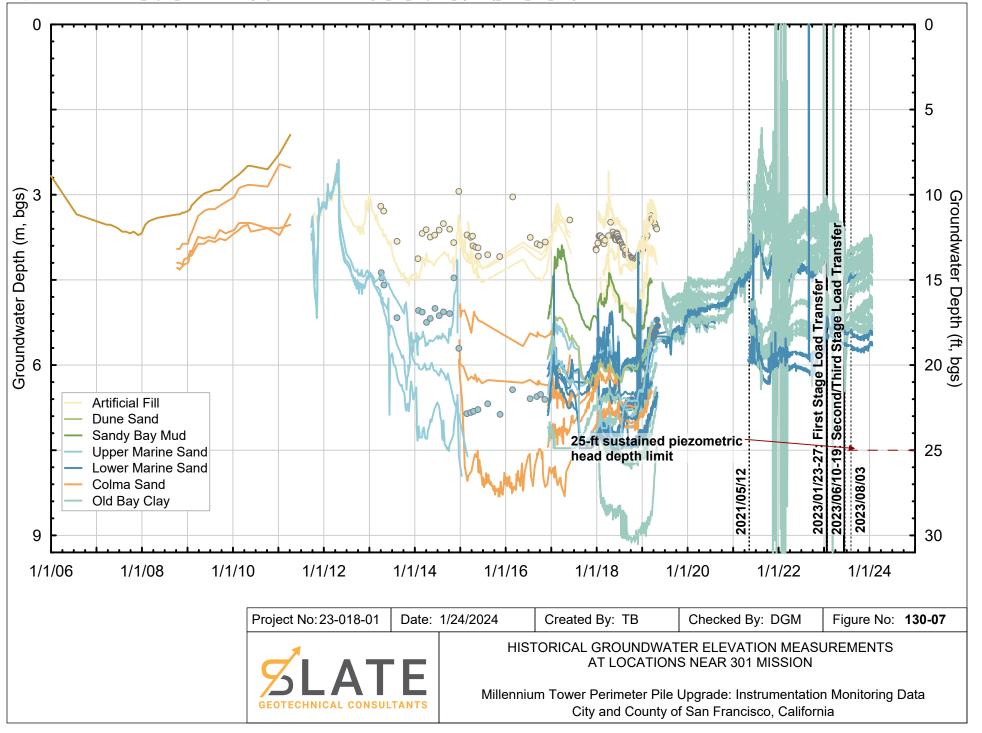
Figure 07 presents the historical groundwater elevation interpreted from piezometer readings at locations near 301 Mission. In addition, data from piezometers installed to monitor groundwater elevation during the retrofit are included. Figures 08 and 09 present groundwater elevation interpreted from piezometer readings

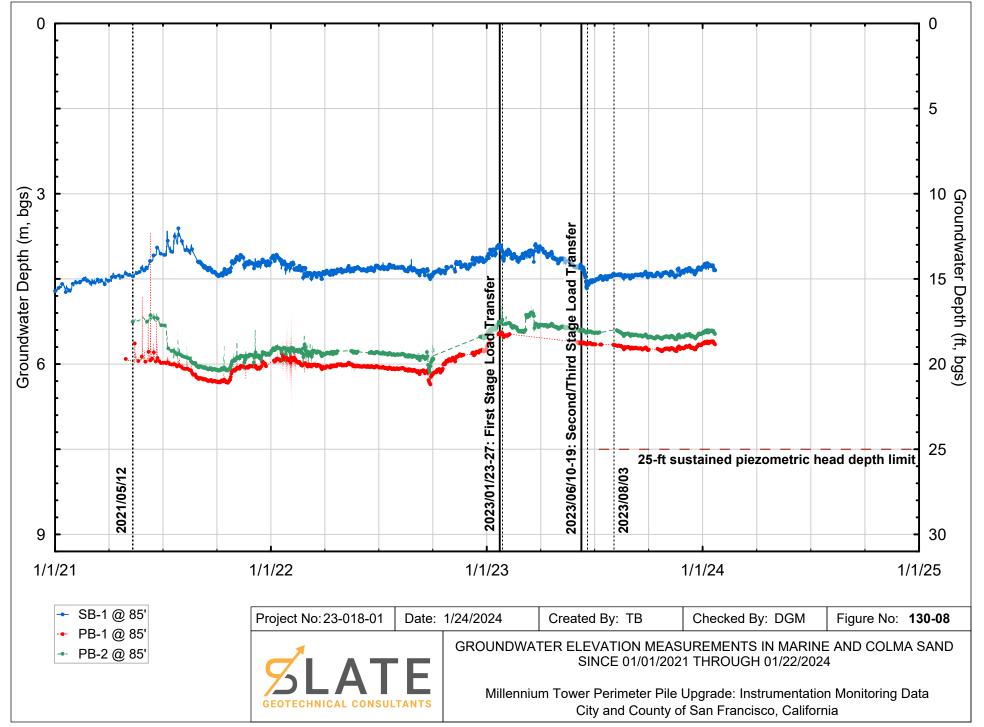
in the Marine/Colma Sand and the Old Bay Clay, respectively, for the time period prior to the start of production pile installation (January 1, 2021) through January 22, 2024.

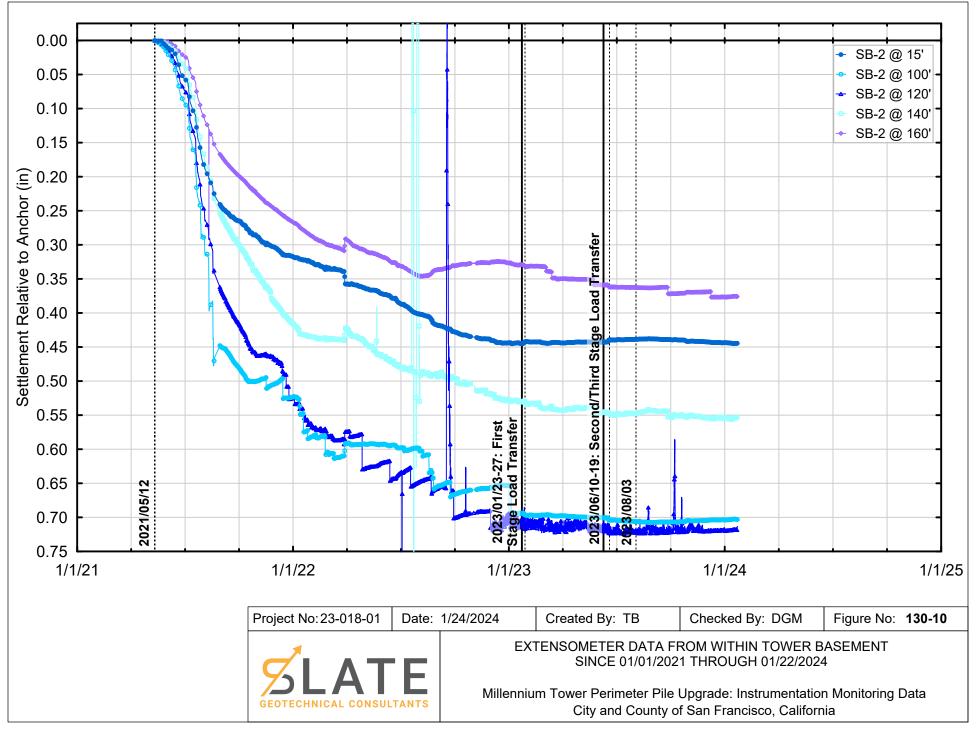
Figure 10 presents extensometer data from within the Tower basement since the start of production pile installation (May 12, 2021) through January 22, 2024. Figure 11 presents extensometer data from Fremont Street since the start of production pile installation (May 12, 2021) through May 16, 2023, and from the restart after fixing the extensometer (May 30, 2023) through January 22, 2024. Figure 12 presents extensometer data from Mission Street since the start of production pile installation (May 12, 2021) through January 22, 2024.

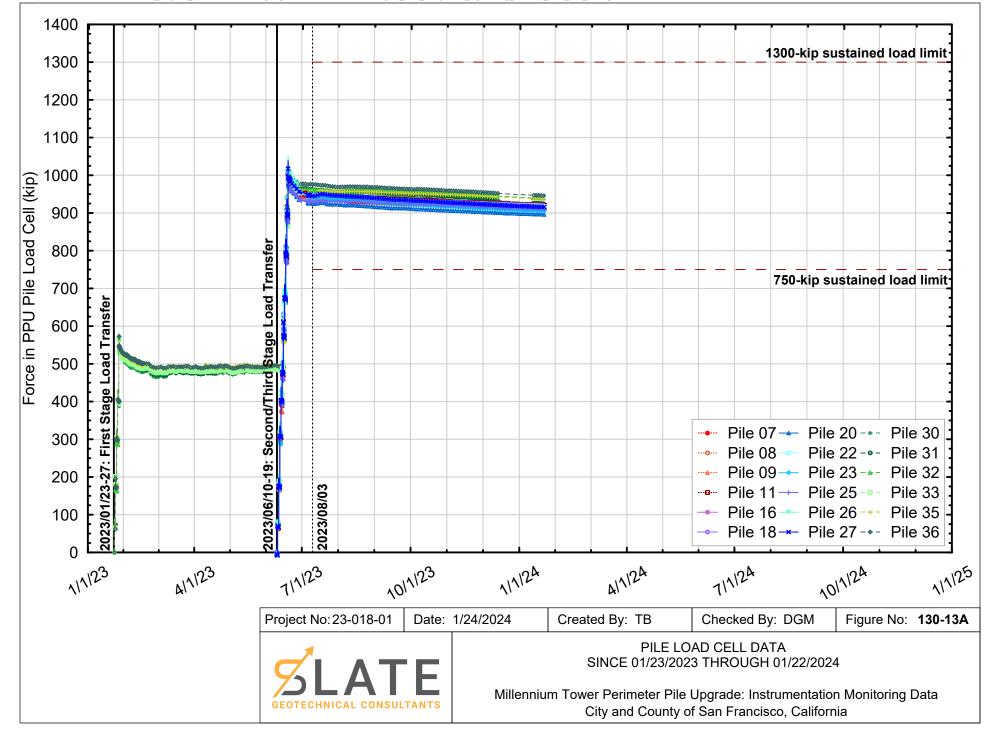
Figure 13A presents pile load cell data since the start of the First Stage Load Transfer (January 23, 2023) through January 22, 2024. Figure 13B presents the total pile load cell data since July 15, 2023, through January 22, 2024.

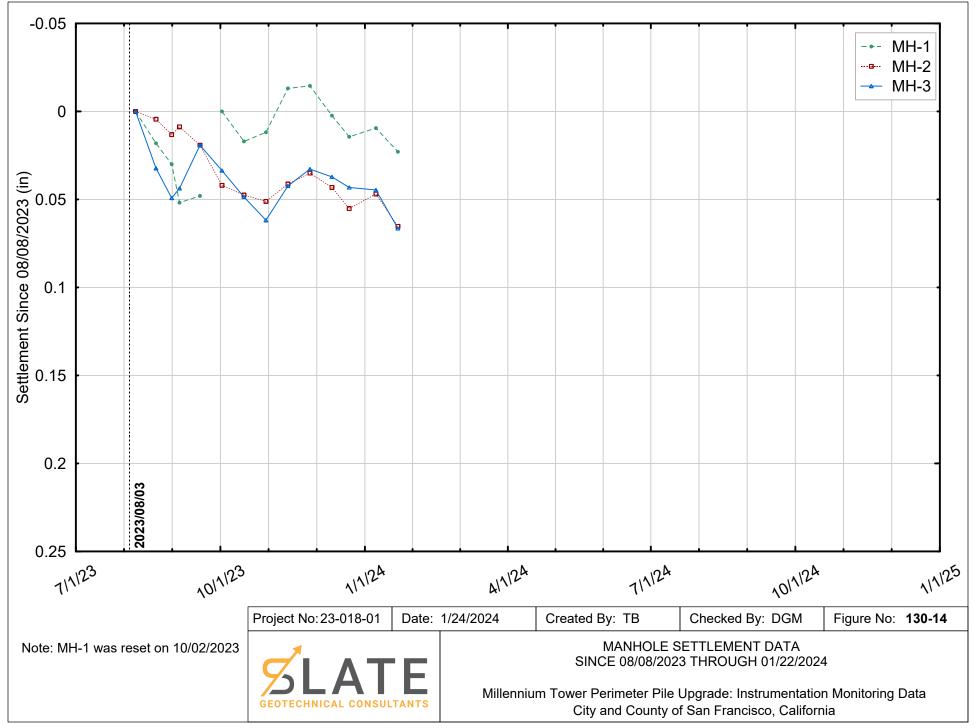
Figure 14 presents settlement data interpreted from survey points located on manholes around the Tower since August 8, 2023, through January 22, 2024.
