Date: February 7, 2024 Project Number: 23-018-01 Subject: 301 Mission Retrofit Monitoring Report 131: Results as of February 5, 2024

301 Mission Retrofit Monitoring: Results as of February 5, 2024 Project No. 23-018-01 February 7, 2024

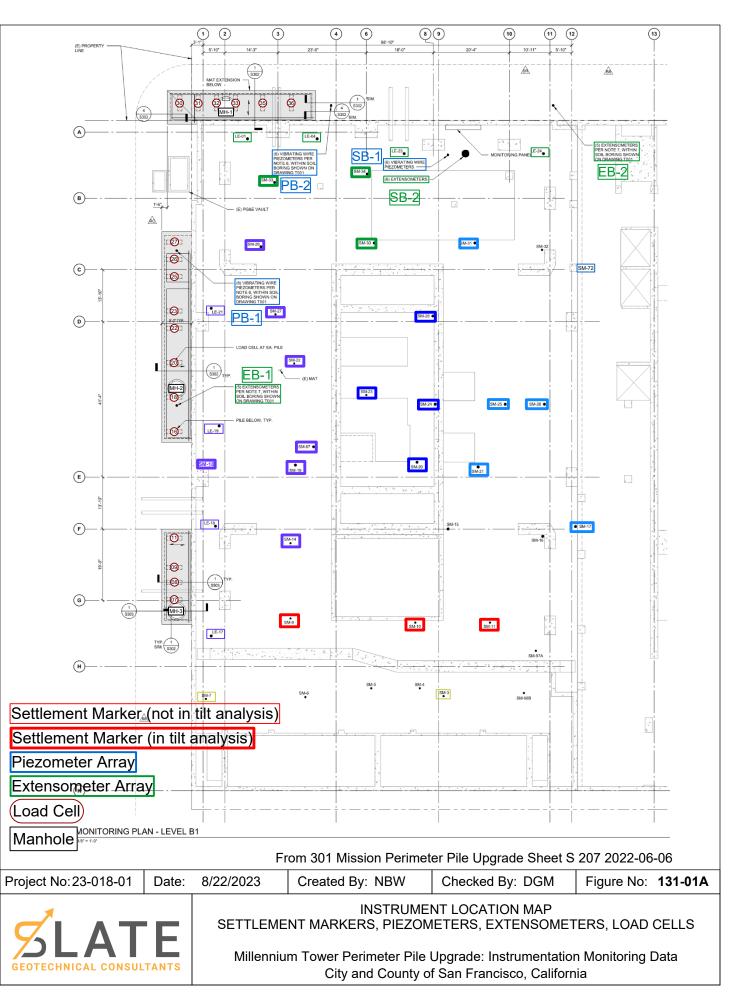
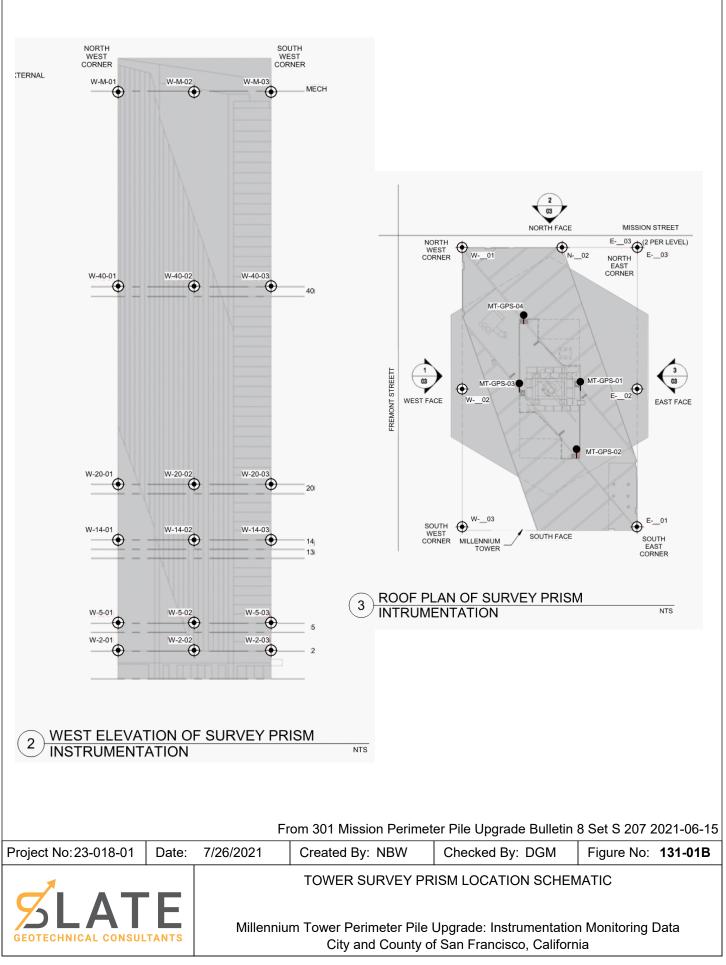
Figure 01 presents the instrument locations as referenced in later figures.

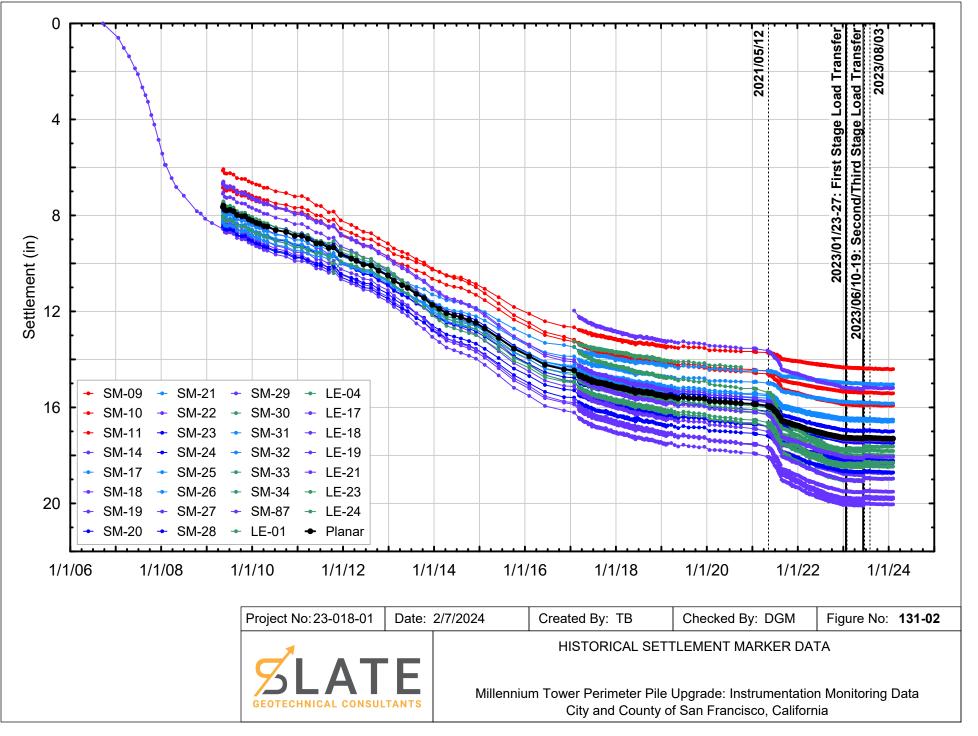
Figure 02 presents the historical settlement data interpreted from settlement markers installed on the B-1 Level of 301 Mission Tower. In addition, data from surveys performed during the retrofit are included. Figure 03 presents settlement data since the start of production pile installation (May 12, 2021; baseline readings on May 10, 2021) through February 5, 2024. Figure 04 presents current settlement contours (in inches) on February 5, 2024.

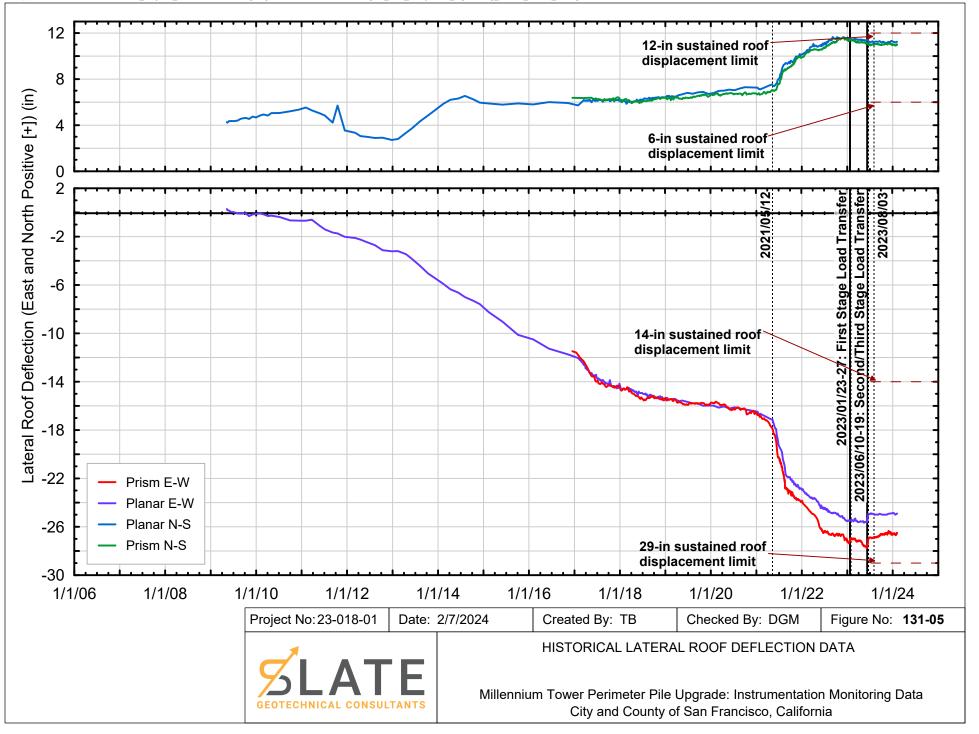
Figure 05 presents historical lateral roof deflections in the project north-south and project east-west directions interpreted from survey prisms mounted on the exterior of the Tower, from InSAR data, and from a planar fit of the settlement marker data. In addition, data from surveys performed during the retrofit are included. Figure 06A presents lateral roof deflection data from a planar fit of the settlement marker data and from survey prisms mounted on the exterior of the Tower since the start of production pile installation (May 12, 2021; baseline readings on May 10 and 13, 2021, respectively) through February 5, 2024.

⁵ As plotted on Figure 03. The annual rate is calculated starting on the settlement monitoring date closest to one year prior to the current date or on June 19, 2023 (the settlement monitoring date corresponding to the last day of jacking load application), whichever is later, and ending on the current date. ⁶ As plotted on Figure 05, relative to a plumb condition.

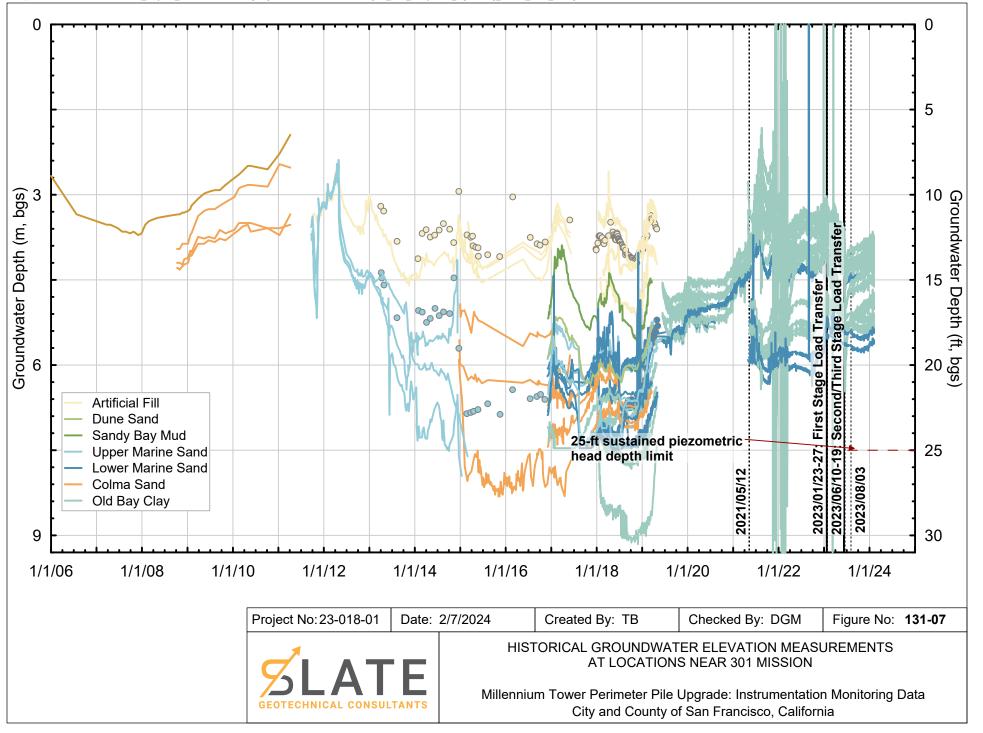
Figure 07 presents the historical groundwater elevation interpreted from piezometer readings at locations near 301 Mission. In addition, data from piezometers installed to monitor groundwater elevation during the retrofit are included. Figures 08 and 09 present groundwater elevation interpreted from piezometer readings

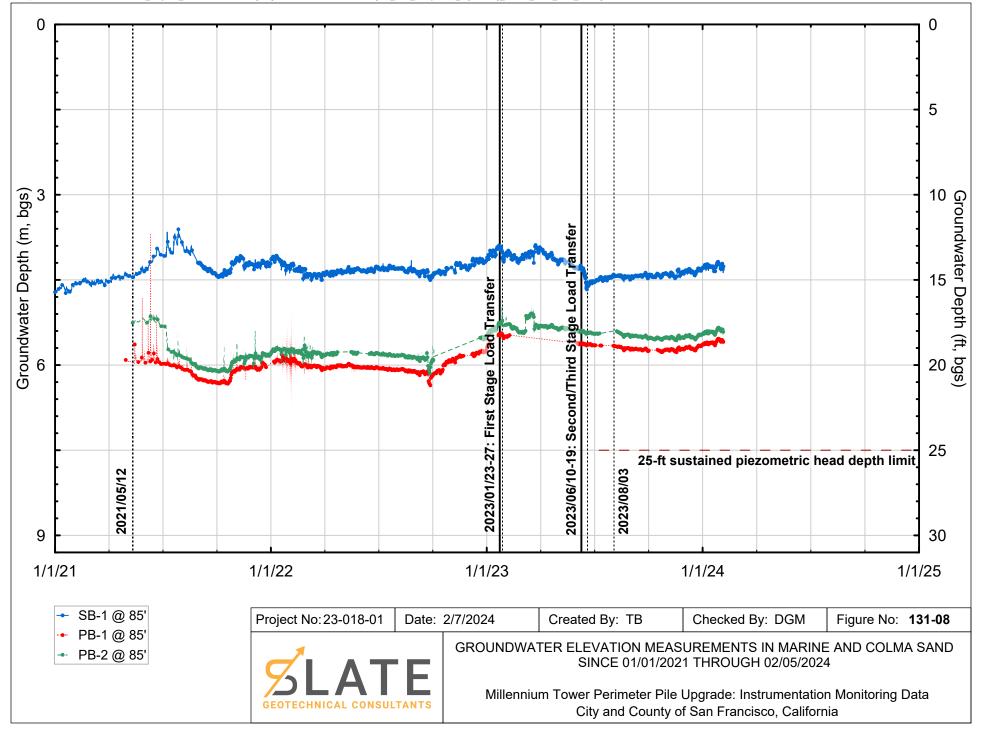
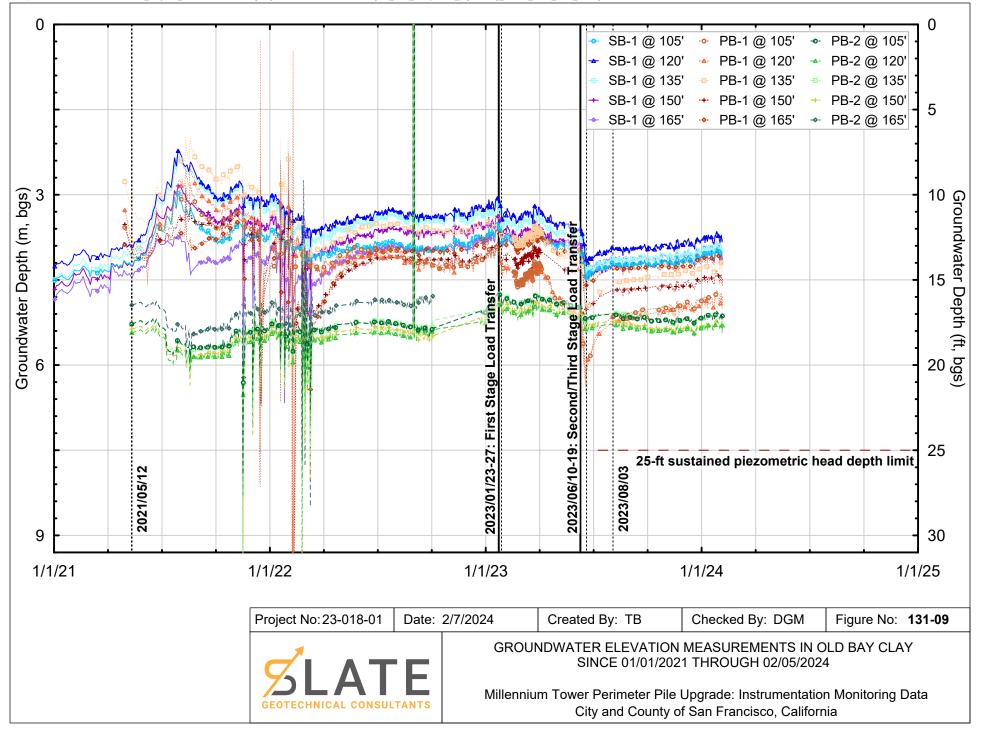
in the Marine/Colma Sand and the Old Bay Clay, respectively, for the time period prior to the start of production pile installation (January 1, 2021) through February 5, 2024.

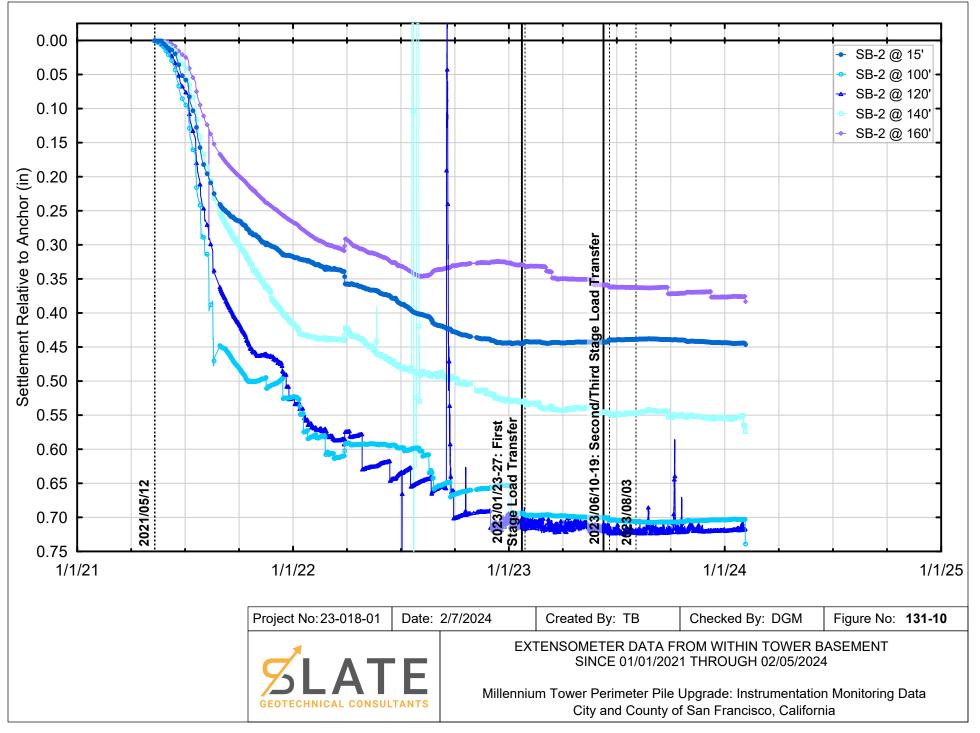
Figure 10 presents extensometer data from within the Tower basement since the start of production pile installation (May 12, 2021) through February 5, 2024. Figure 11 presents extensometer data from Fremont Street since the start of production pile installation (May 12, 2021) through May 16, 2023, and from the restart after fixing the extensometer (May 30, 2023) through February 5, 2024. Figure 12 presents extensometer data from Mission Street since the start of production pile installation (May 12, 2021) through February 5, 2024.

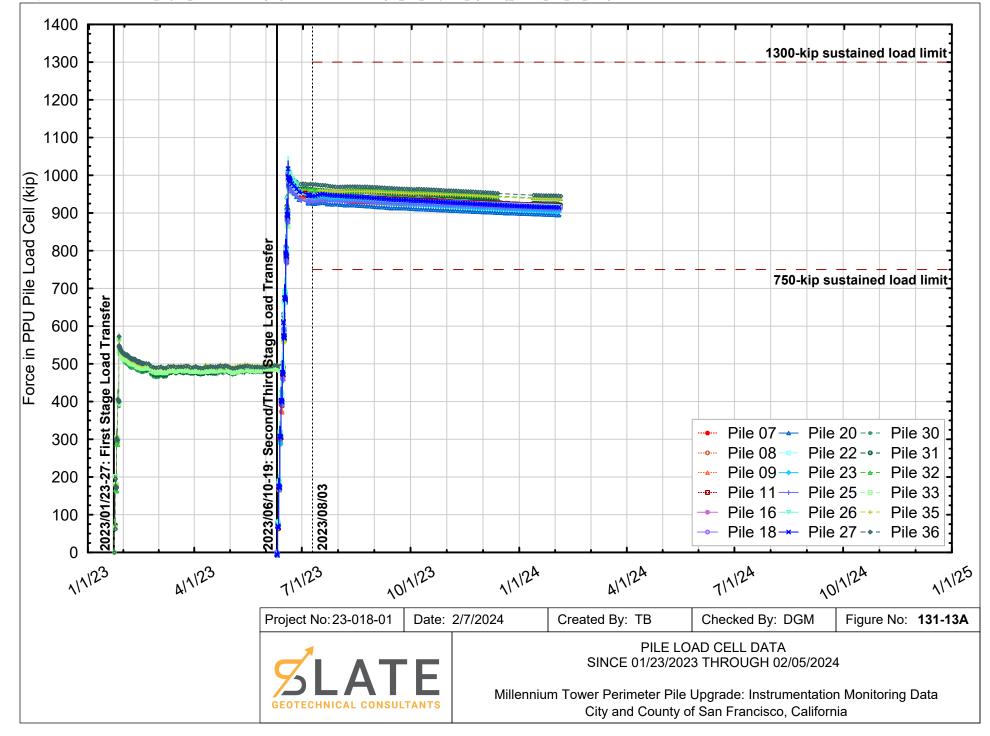
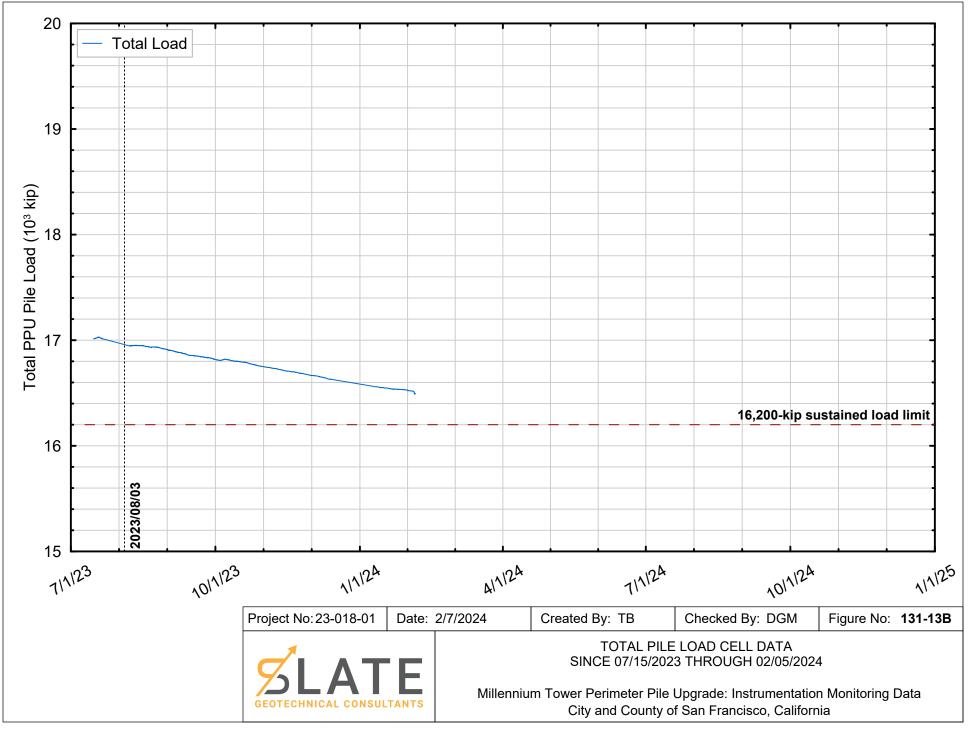
Figure 13A presents pile load cell data since the start of the First Stage Load Transfer (January 23, 2023) through February 5, 2024. Figure 13B presents the total pile load cell data since July 15, 2023, through February 5, 2024.

⁴ The load transfer rods have a maximum safe loading of 375 kips per rod, or 1,500 kips per pile. The 1,300-kip threshold is set to allow sufficient time to evaluate building behavior, should excessive load develop in one or more piles.

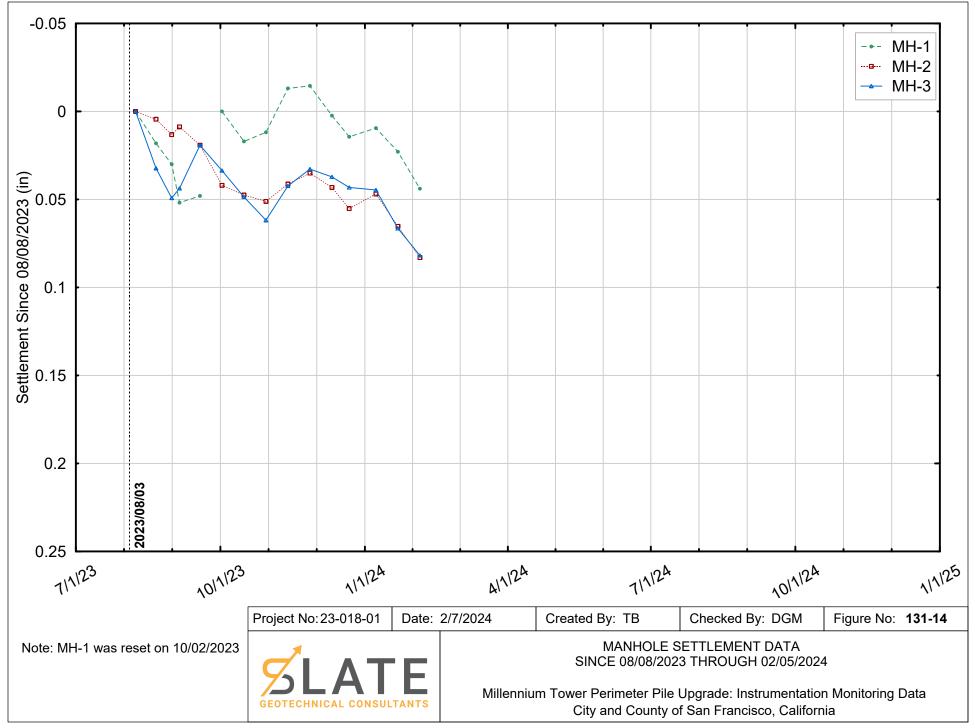
Figure 14 presents settlement data interpreted from survey points located on manholes around the Tower since August 8, 2023, through February 5, 2024.
