AEI Consultants

PROPERTY CONDITION REPORT - EQUITY

1979 and 1985 Mission Street and 2950, 2960, 2970 and 2978 16th Street
San Francisco, San Francisco County, California 94132

AEI Project No. 425780
Client Reference No.
Client Reference Name:

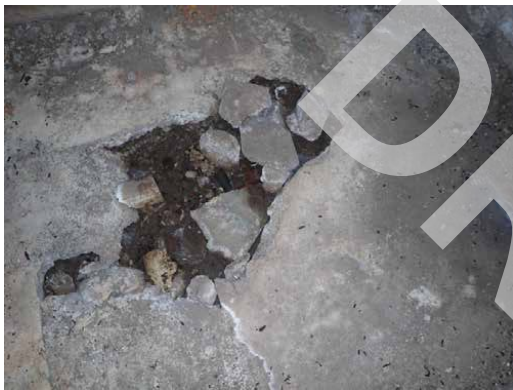
1985 Mission St / 2950-2978 16th St basement area-damaged concrete slab floor

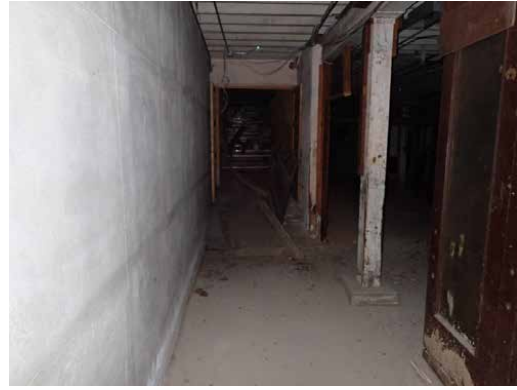
1985 Mission St / 2950-2978 16th St wood column support in basement area

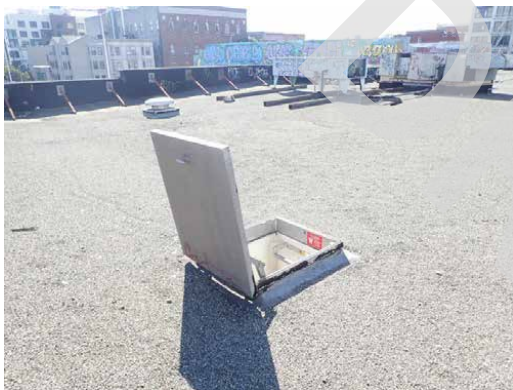
1979 Mission St roof hatch

Based on the condition and estimated RUL of roof hatch units (3 units), replacement should be budgeted during the evaluation period. An opinion of cost for this work is included in the Tables.

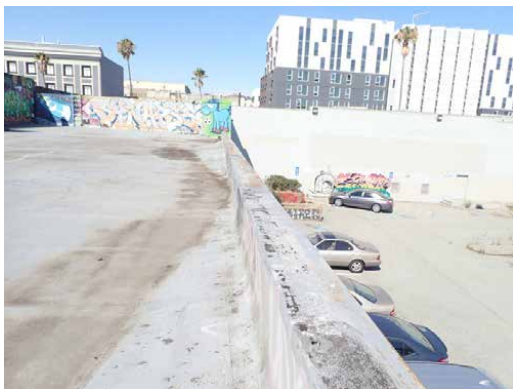
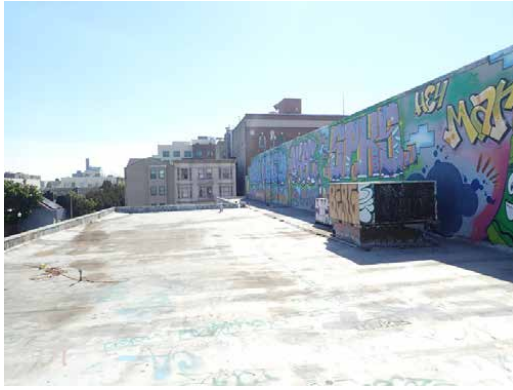
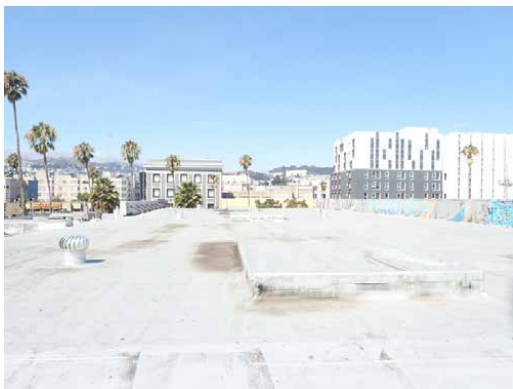
1985 Mission St modified bitumen cap sheet roof

Based on the condition and estimated RUL of these type of roofing, replacement should be budgeted during the evaluation period. An opinion of cost for this work is included in the Tables.

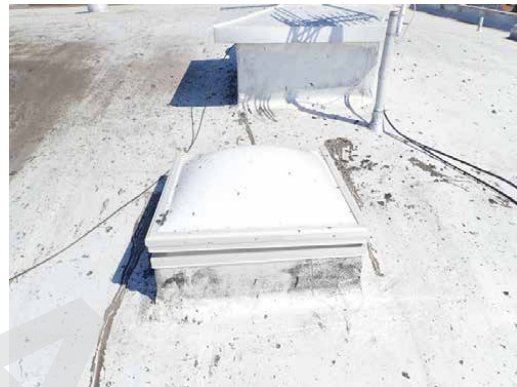
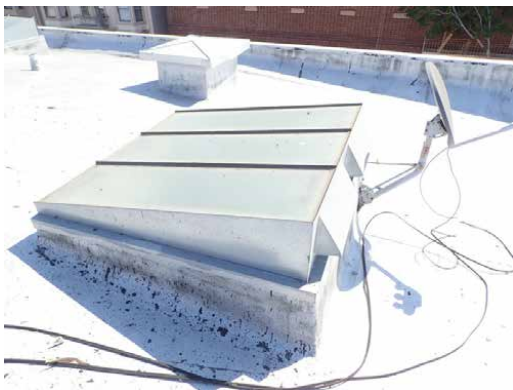
2950-2978 16th St St roof skylight

Based on the condition and estimated RUL of skylights (3 skylight), replacement should be budgeted during the evaluation period. An opinion of cost for this work is included in the Tables.

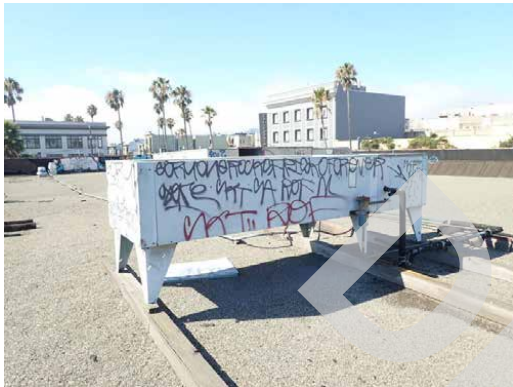
AEI observed that the HVAC units for tenant space 1979 appeared to be no longer operational and should be replaced. All other HVAC units observed have reached their EUL and should be replaced. An opinion of cost for this work is included in the Tables.

1979 Mission St- condenser unit

Cost Recommendation	EUL	EFF AGE	RUL	Year	Cost
Packaged rooftop unit, Replace	15	15	0	Short Term	\$132,000
Air Handling Unit, Replace	30	30	0	Short Term	\$9,000
Total					\$141,000

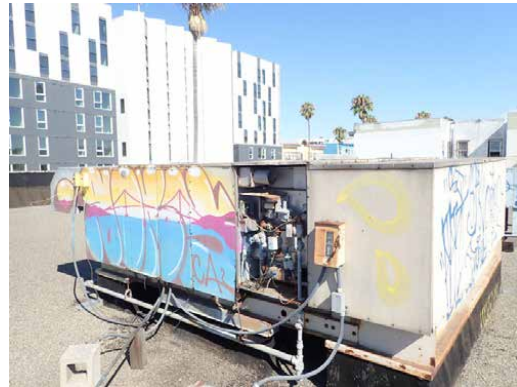
1979 Mission St- air handler with furnace

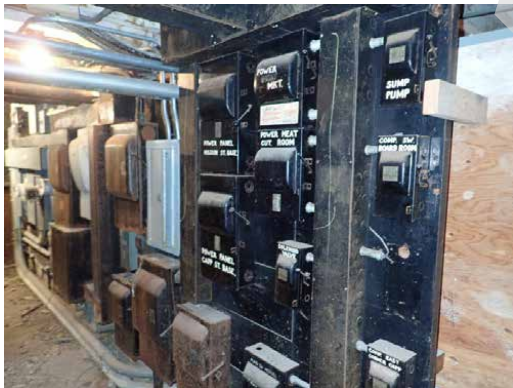
AEI did have access to the electrical room at 1985 Mission St / 2950-2978 16th St. Eight electrical meters were observed in this building and appeared to still be active circuits. Ground Fault Circuit Interrupter (GFCI) receptacles were not observed in any of the tenant units. There is a lot of old abandoned electrical equipment (main switch board, old electrical conduit, exposed wiring, fuses, motor, freezer equipment, electric motors, etc.) some dating back to about 100 years ago. Most of main switches for the tenant units are over 50 years (estimated) and some of these panels were rusted. It is recommended all the old abandoned electrical equipment (main switch board, old electrical conduit, exposed wiring, fuses, electric motors, etc.)

1985 Mission St / 2950-2978 16th St- old electrical switch equipment

be removed from the building. It is also recommended that all electrical systems be inspected to determine what repairs and upgrades are needed. An Opinion of Cost is included in the Tables. Note that additional costs are anticipated based of the results for the electrical system inspection.

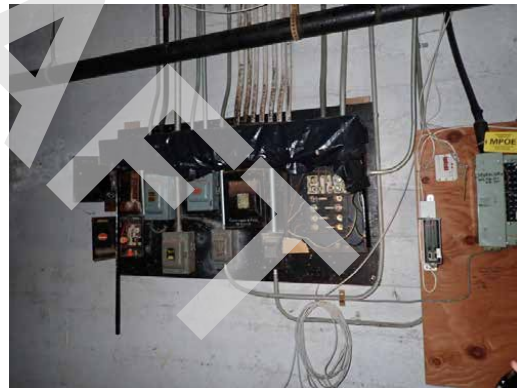
1985 Mission St / 2950-2978 16th St- old electrical equipment

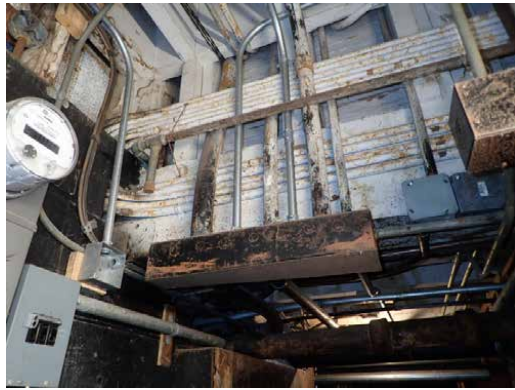
1985 Mission St / 2950-2978 16th St
Electrical conduit bundle

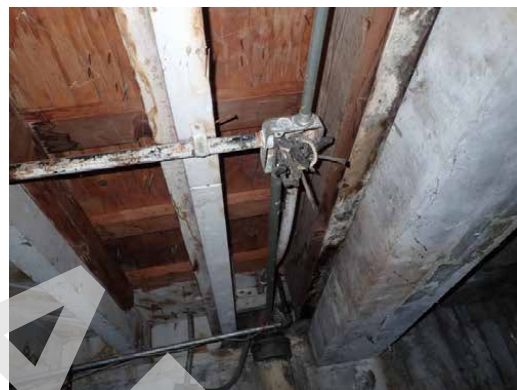
1985 Mission St / 2950-2978 16th St Exposed
wires

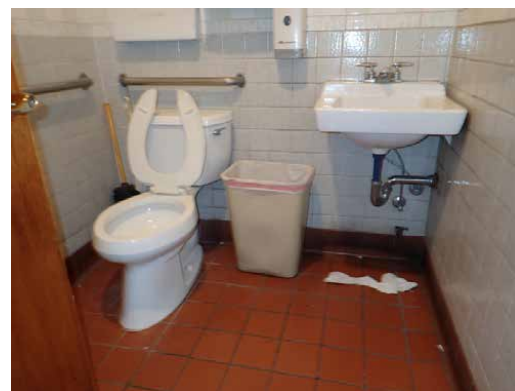
2960 16th St- area under sink not protected

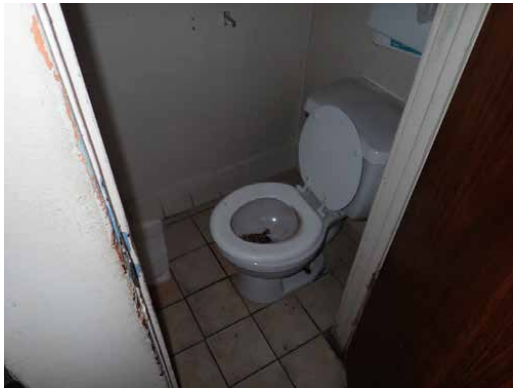
2950 16th St- restroom toilet area not ADA compliant

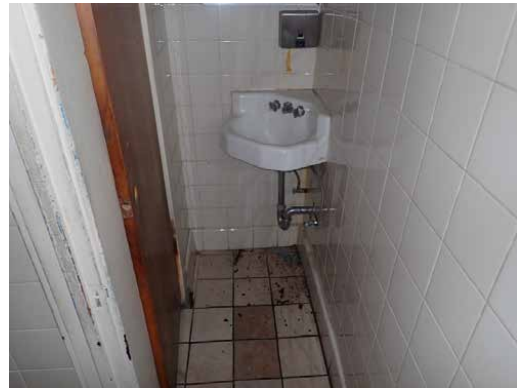
2950 16th St- clearance area around sink not ADA compliant

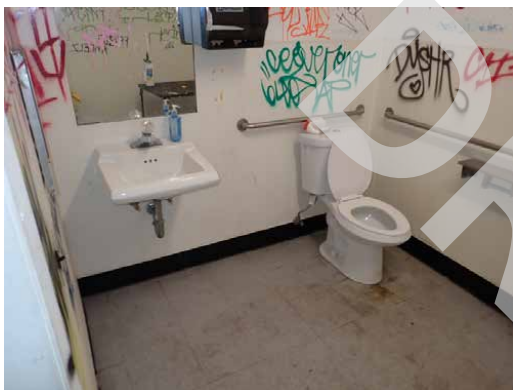
Unit 1985- area under sink not protected

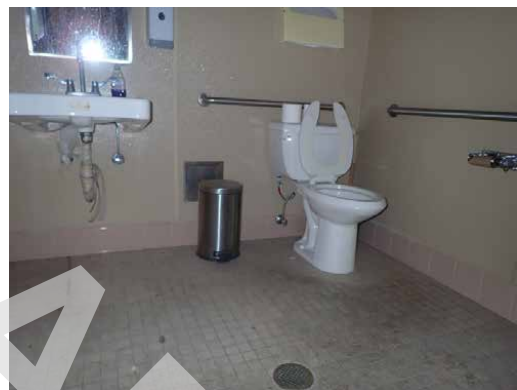
1979 Mission St- piping wrapping is starting to fall off

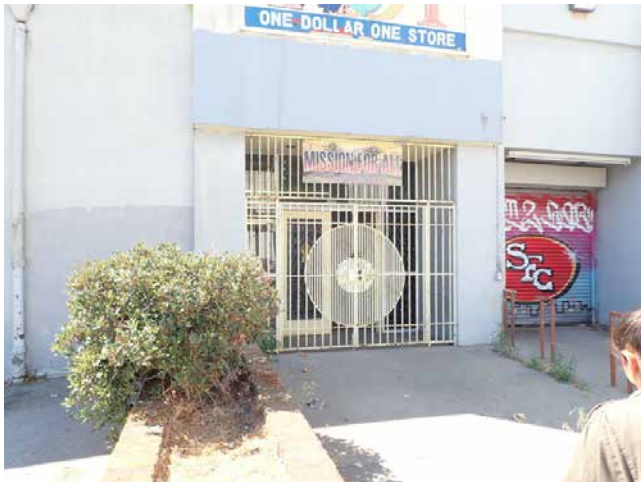
14. Public sidewalk area- east elevation

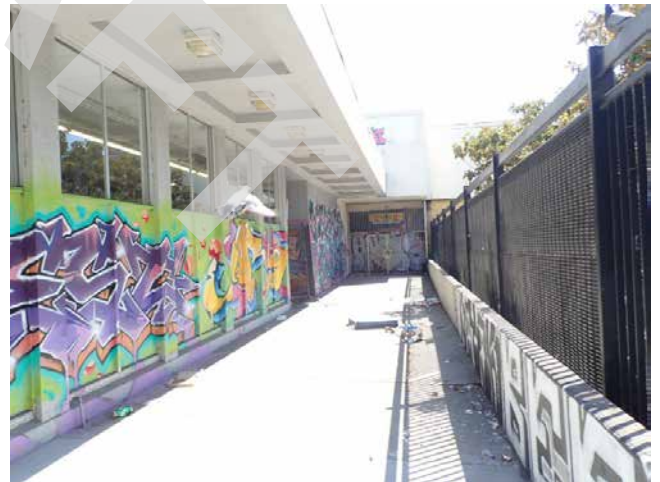
15. Sidewalk area to entrance to 1985 Mission St from Capp St.

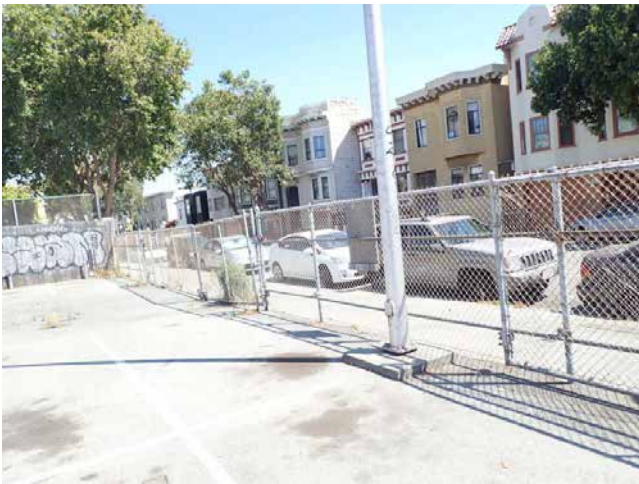
30. Alligatoring asphalt area

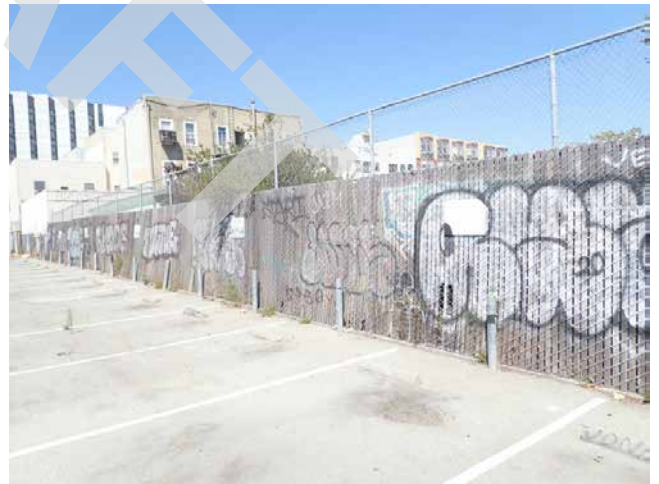
31. Parking lot chain link fence

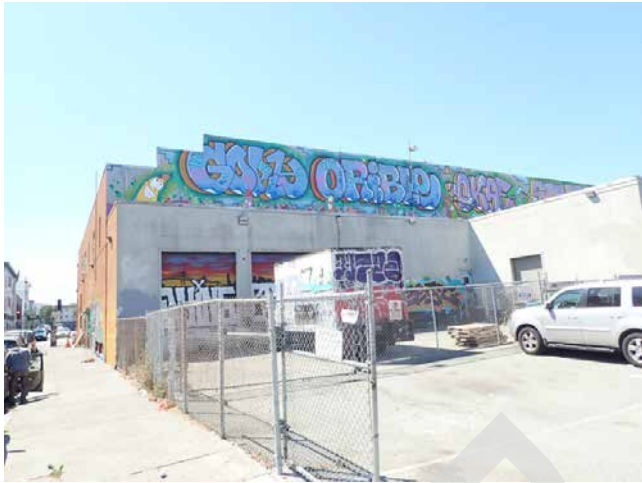
32. Parking lot chain link fence

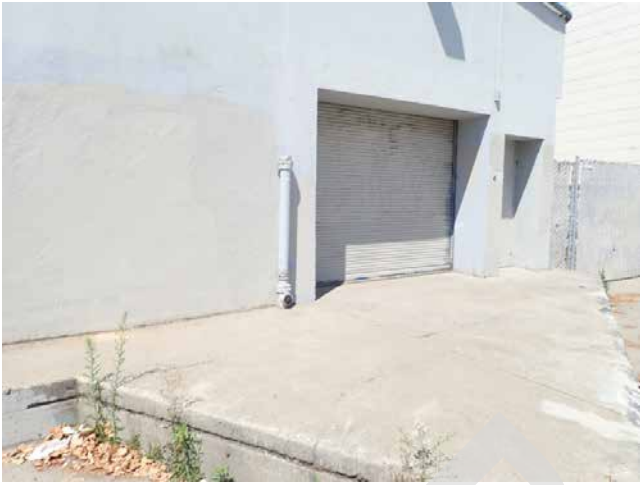
36. Loading dock area- 1985 Mission St

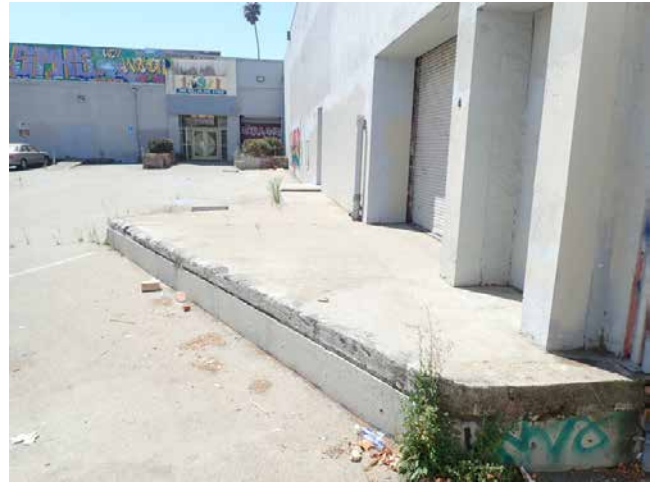
37. Loading dock area- 1979 Mission St

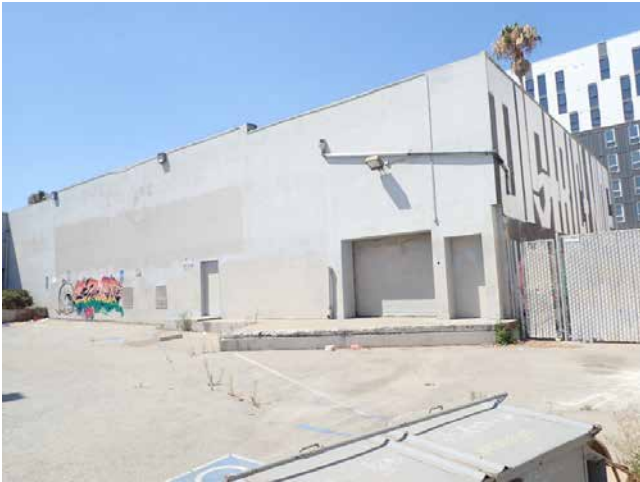
38. Loading dock area- 1979 Mission St

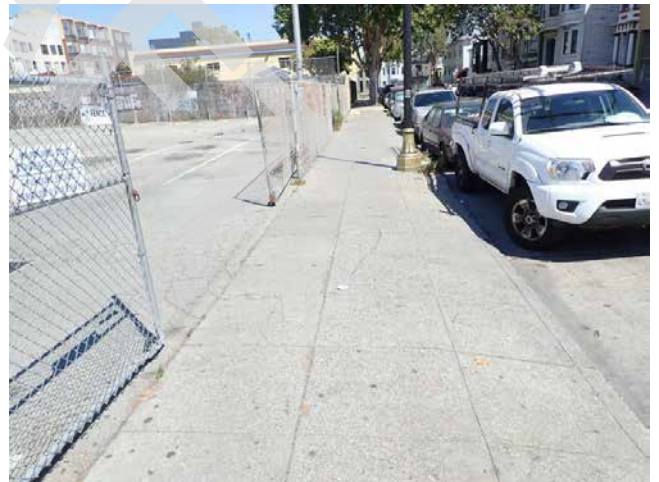
43. Weeds in aphalt

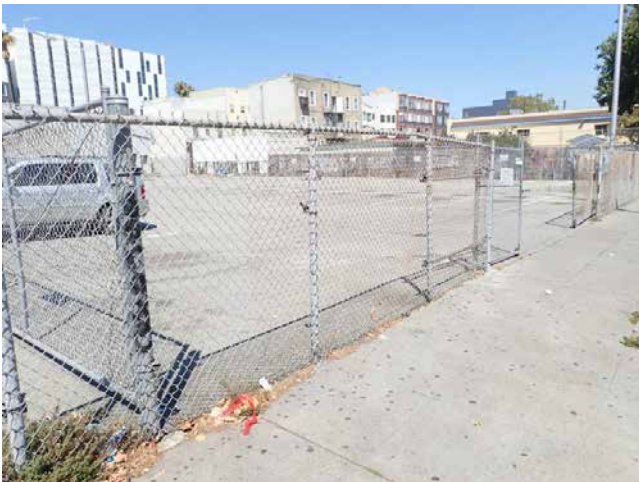
46. Gated driveway area- north-west side area along Mission

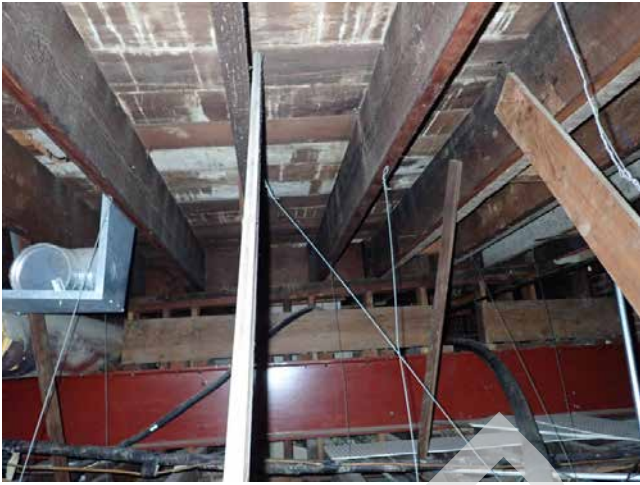
56. Brick and wood framing Unit 2978

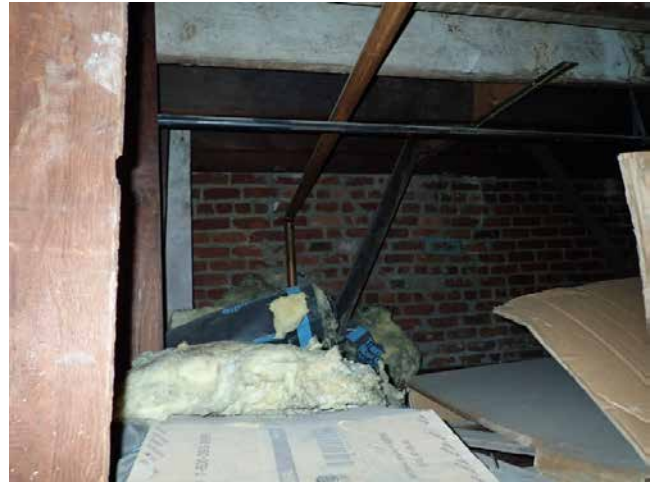
57. Steel and wood framing Unit 2978

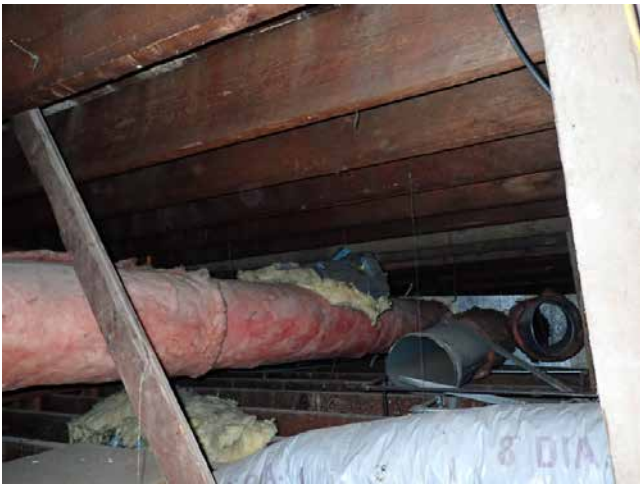
58. Brick and wood framing Unit 2978

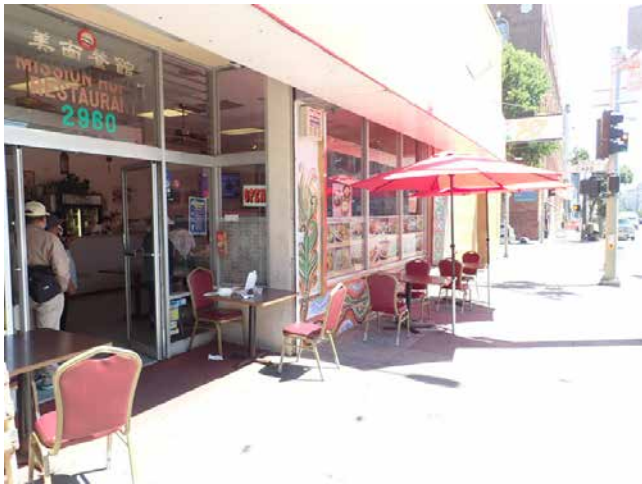
66. Storefront windows and doors- 2970-2972 16th St.

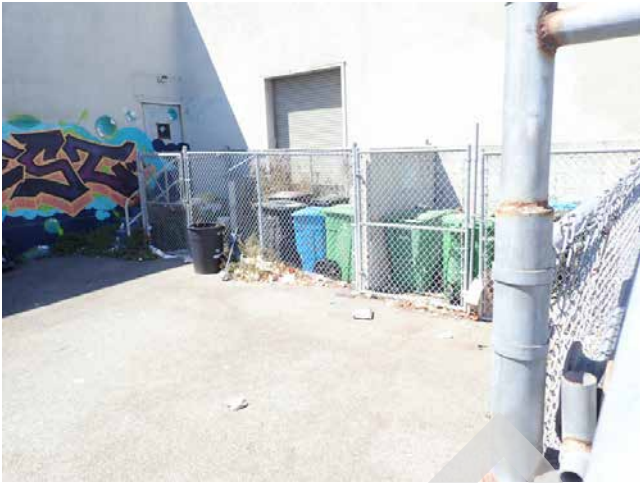
68. Entrance

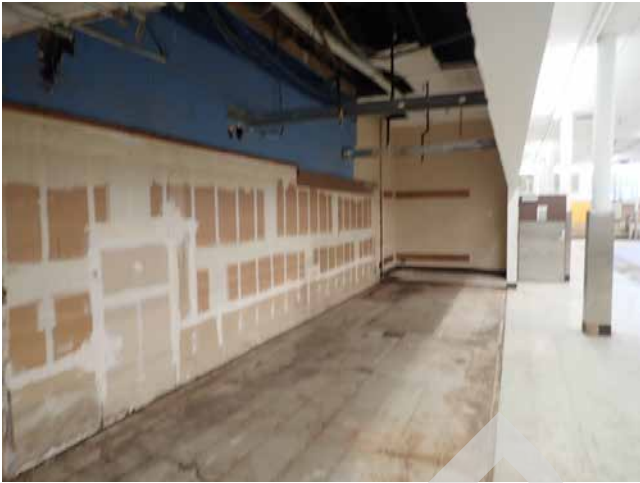
76. Concrete slab foundation in 1985 Mission St at loading dock area

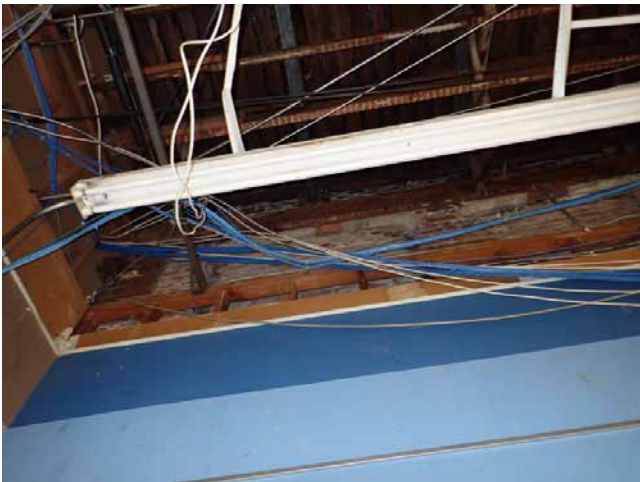
78. 1979 Mission St Framing

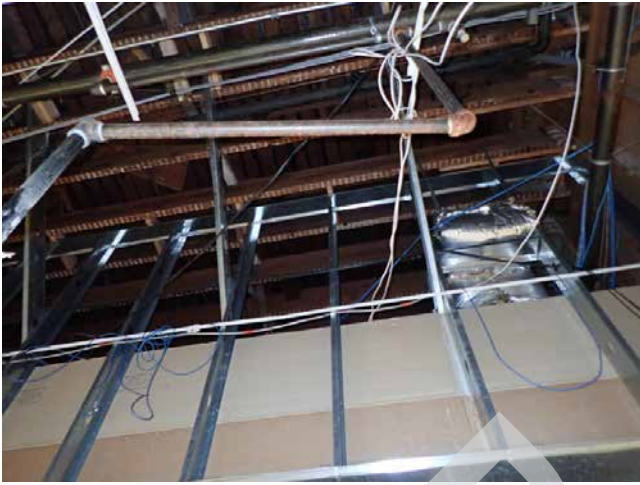
80. 1979 Mission St Framing

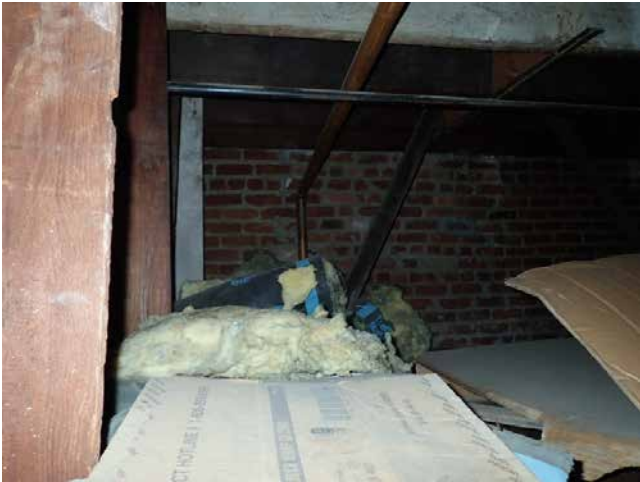
82. 1979 Mission St Foundation

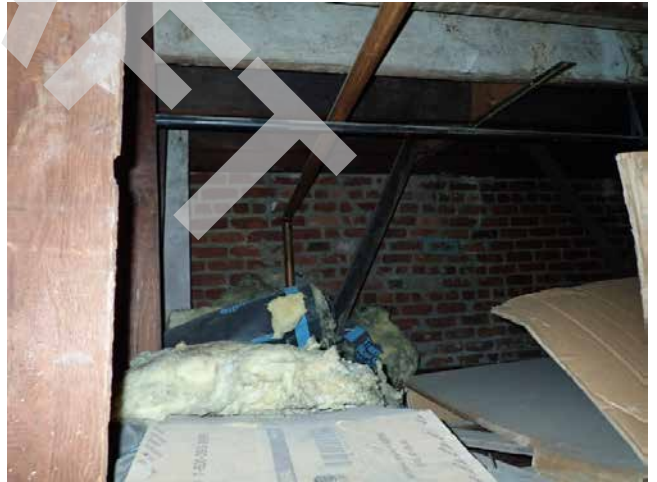
83. 1985 Mission St / 2950-2978 16th St framing

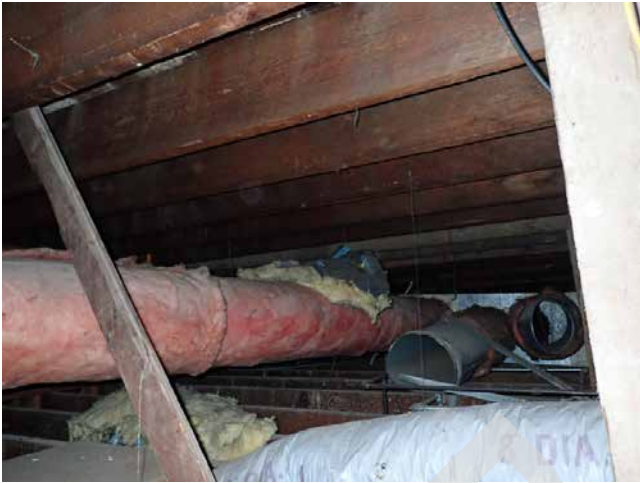
84. 1985 Mission St / 2950-2978 16th St framing

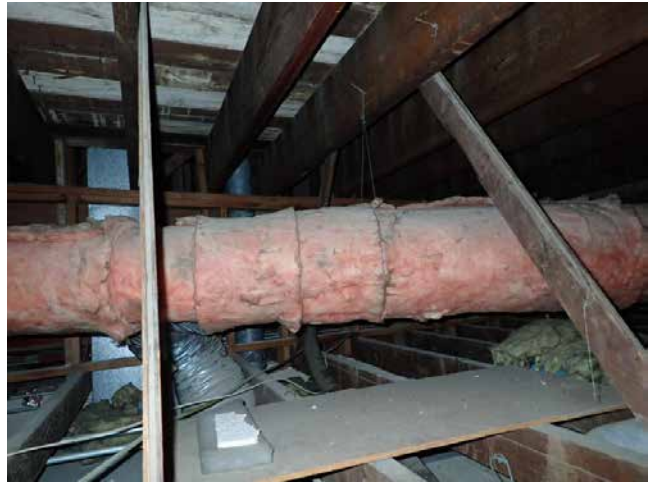
85. 1985 Mission St / 2950-2978 16th St framing

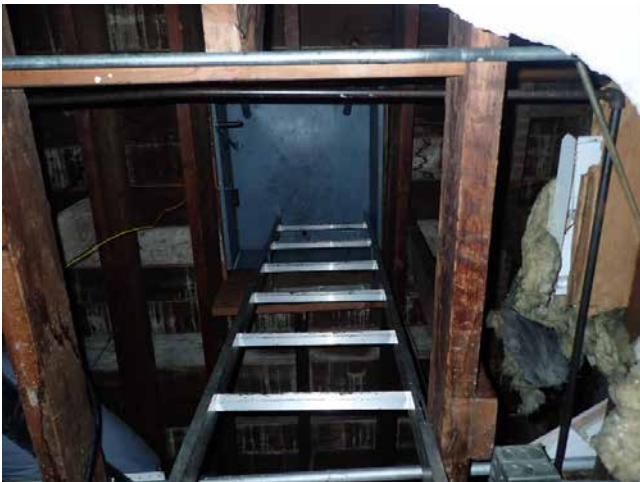
86. 1985 Mission St / 2950-2978 16th St framing

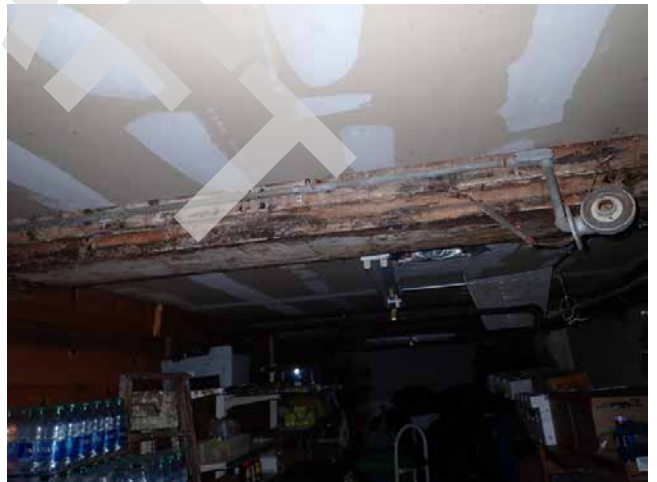
87. 1985 Mission St / 2950-2978 16th St framing

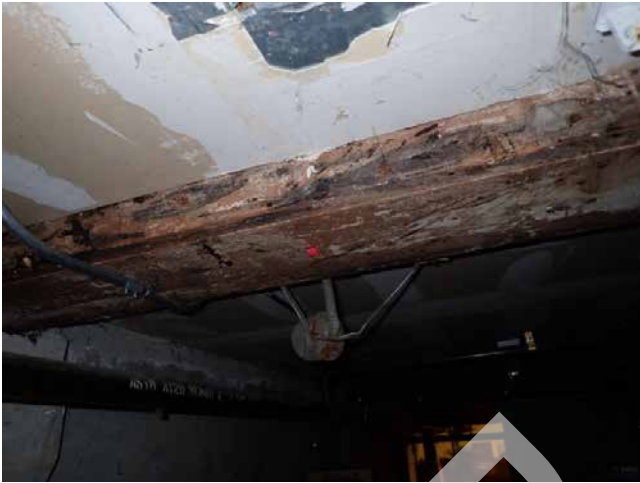
88. 1985 Mission St / 2950-2978 16th St framing

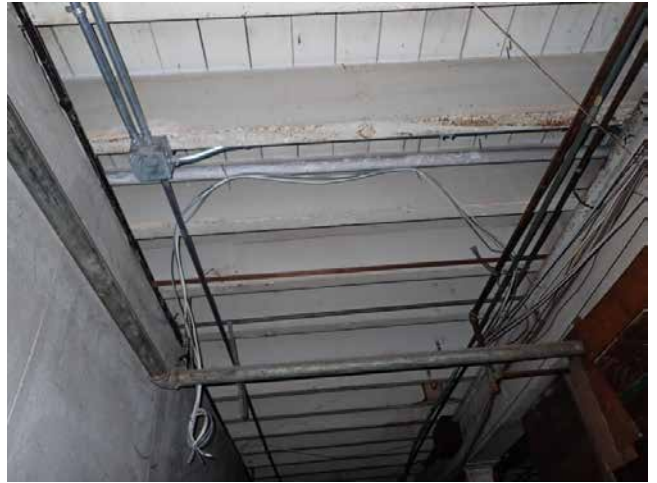
89. 1985 Mission St / 2950-2978 16th St framing

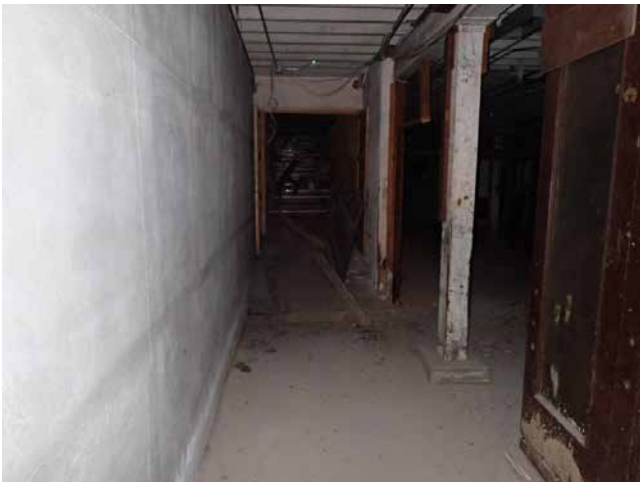
90. 1985 Mission St / 2950-2978 16th St framing

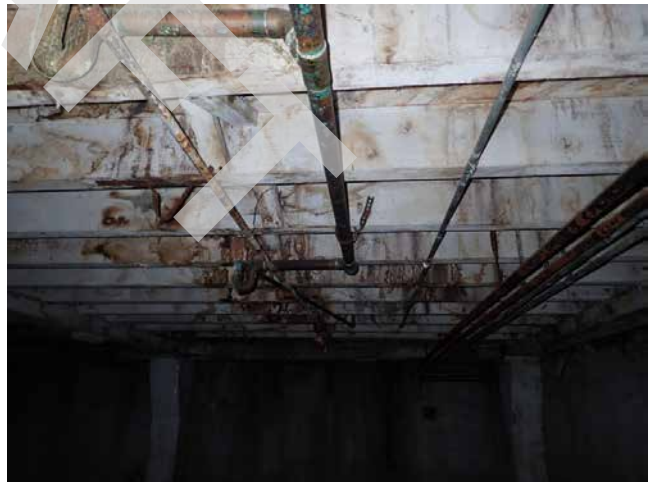
91. 1985 Mission St / 2950-2978 16th St framing

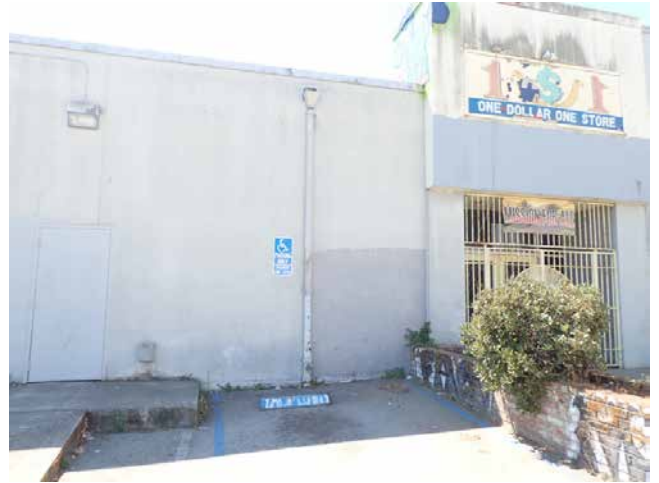
173. Disconnect drain boot

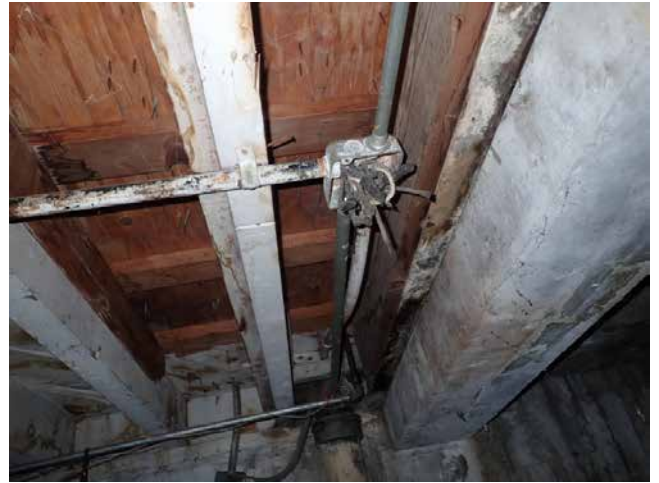
197. 1985 Mission St / 2950-2978 16th St Electrical conduit bundle

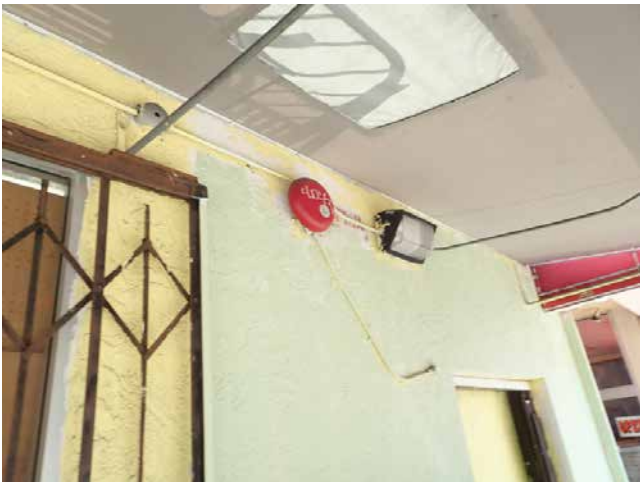
198. 1985 Mission St / 2950-2978 16th St Exposed wires
