JACKSON PLAYGROUND

1645 17TH STREET SAN FRANCISCO, CA 94107

PUBLIC PROJECT APPLICATION FOR ENVIRONMENTAL REVIEW

JACKSON PARK CLUBHOUSE RELOCATION & ADDITION

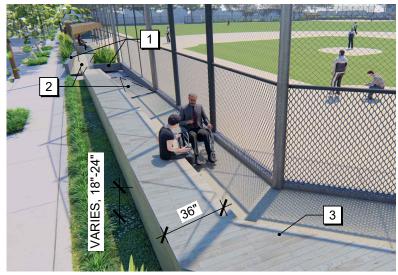
- **BALLFIELD SEATING AREA**
- CONC RETAINING WALL
- RAMP & ANODIZED ALUMINUM HANDRAILS
- SPECTATOR SEATING, 36"W TYP. X 18"H, THERMALLY **MODIFIED WOOD**

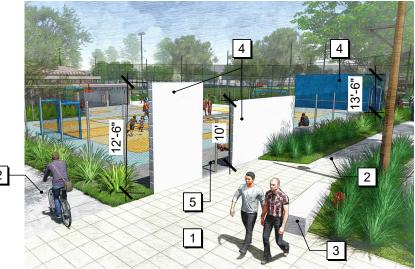
- **BULB-OUT ENTRANCE PLAZA**
- INTEGRAL COLOR CONC. PAVERS 8|L1.09
- CITY STD. CONC PAVING
- TAPERED CIP CONC. SEAT WALL, 24"W MIN. X 18" H
- FREESTANDING HALF-BLOCK CMU WALLS, BURNISHED FINISH WITH MURALS ON OPPOSITE SIDES (HEIGHT VARIES 8'-14')
- 5 CHAINLINK ENTRY GATE

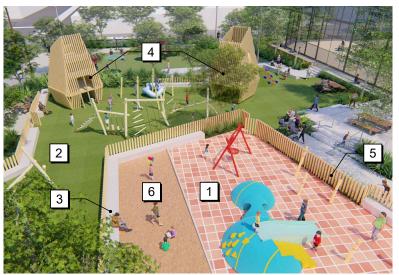
- **PLAY AREA**
- POURED-IN-PLACE RUBBER SURFACING, PATTERN TBD 7|L1.09
- SYNTHETIC TURF PLAY AREA SURFACING
- CONC. SEAT WALL, 24"W X 18"H, LENGTH VARIES
- 'NATURAL' ROBINIA PLAY ELEMENTS, EXACT DESIGN
- TBD WITH FURTHER COMMUNITY INPUT
- THERMALLY MODIFIED WOOD FENCE
- SAND PLAY AREA

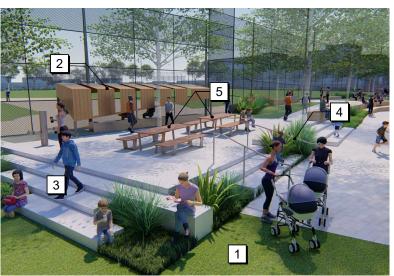
- **ELEVATED OPEN SPACE**
- SYNTHETIC TURF PLAY AREA SURFACING
- DUGOUT W/ SCULPTURAL ALUMINUM ROOF, STANDING SEAM W/ SLOT OPENINGS
- SCULPTURAL CONC STEPS, 24" W TREADS TYP. WITH **SEAT WALL EXTENSIONS**
- ANODIZED ALUMINUM HANDRAILS, TYP.
- 'MULTIPLICITY' PICNIC TABLES & BENCHES, THERMALLY MODIFIED WOOD, 8' W X 7'-10" L
- 2|L1.09

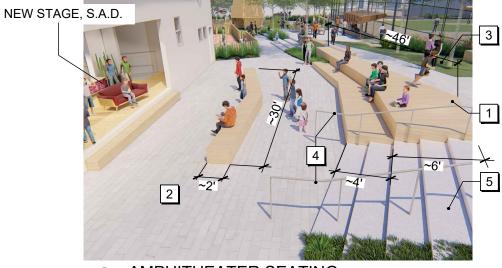
- **AMPHITHEATER SEATING**
- SCULPTURAL SEATING ELEMENTS, THERMALLY MODIFIED WOOD, HOLLOW WITH PT FRAMING
- SAND-SET CONC. UNIT PAVERS W/ METAL EDGING | 5|L1.09
- NATURAL GRASS
- ANODIZED ALUMINUM HANDRAILS, TYP.
- WIDE CONCRETE STEPS, 24" W TREADS

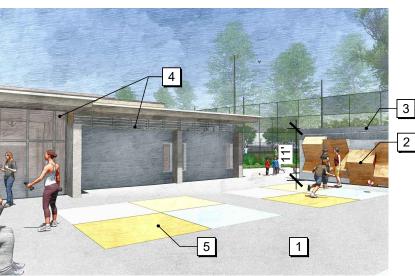
MULTI-PURPOSE COURT

- ACRYLIC SPORTS COURTS SURFACING (WITH **CUSHIONING, ON CONCRETE SLAB)**
- THERMORY WOOD TRAVERSE WALLS WITH CLIMBING HANDHOLDS
- FREESTANDING HALF-BLOCK CMU WALLS, BURNISHED FINISH WITH MURALS ON OPPOSITE SIDES (HEIGHT VARIES 8'-14')
- CLUBHOUSE ADDITION FACADE, MURAL BY LOCAL ARTIST TBD
- "BLACK-TOP" STYLE GAMES (FOUR SQUARE, HOPSCOTCH, ETC.), ACRYLIC SURFACING ON CONCRETE SLAB

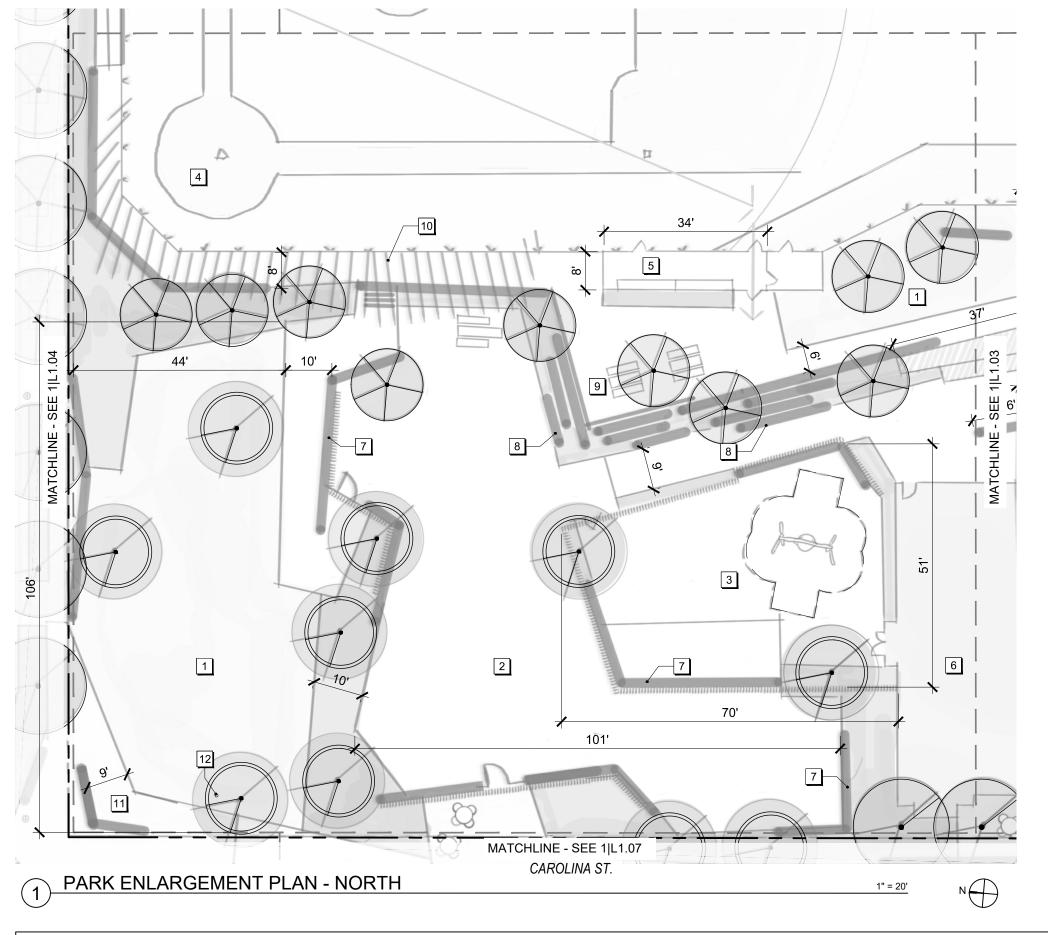
- 1 PASSIVE OPEN SPACE
- 2 PLAY AREA (AGES 7-12)
- PLAY AREA (AGES 0-6), INCLUDING SAND PLAY AREA
- 4 BASEBALL FIELD
- 5 DUGOUT
- 6 CLUBHOUSE (RELOCATED)
- 7 SEAT WALL, TYP.
- SCULPTURAL CONCRETE STEPS
- PICNIC AREA
- 10 SCULPTURAL FIELD FENCE
- 1 ENTRY PLAZA
- RELOCATED SFRPD PARK SIGN

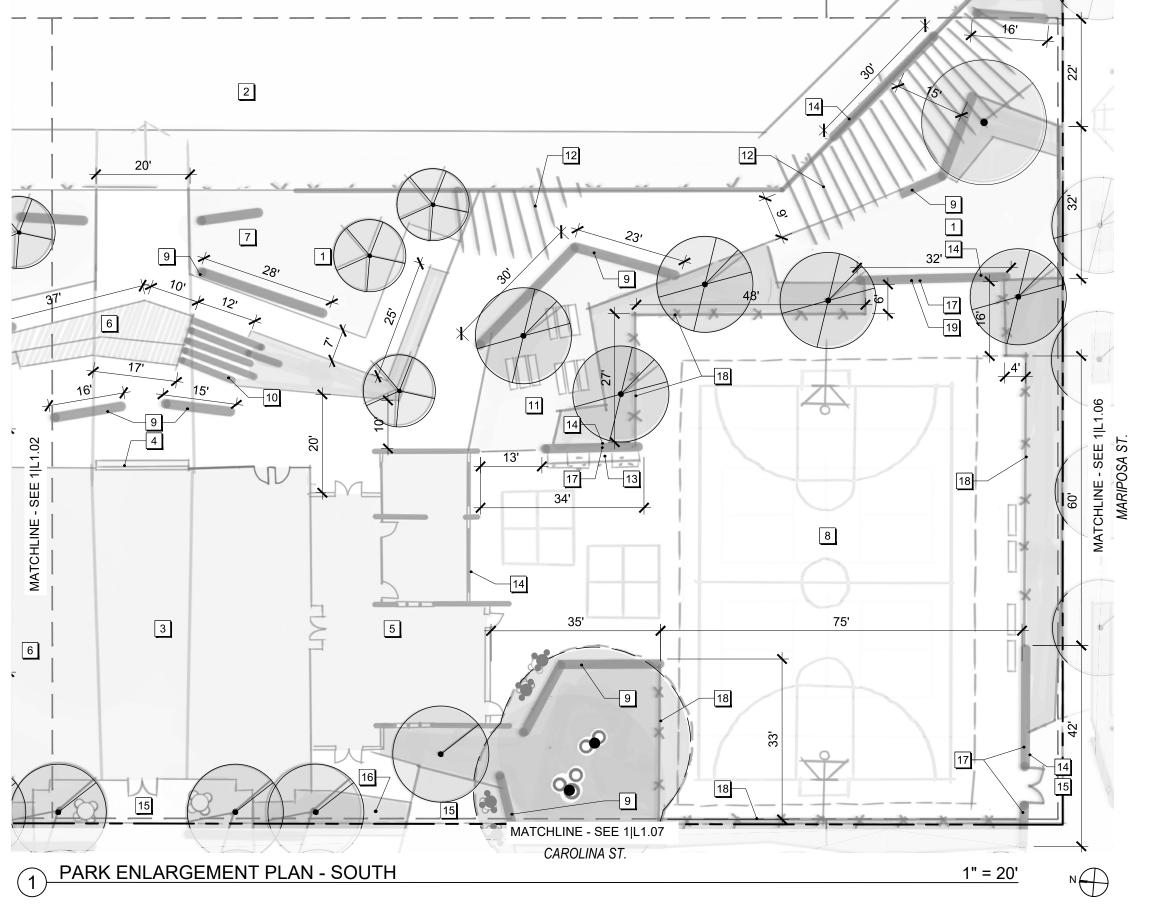
- 1 PASSIVE OPEN SPACE
- 2 BASEBALL FIELD
- 3 CLUBHOUSE (RELOCATED)
- CLUBHOUSE STAGE, S.A.D.
- CLUBHOUSE ADDITION, S.A.D.
- AMPHITHEATER SEATING
- 7 ELEVATED OPEN SPACE
 - MULTI-PURPOSE COURT: 1 BASKETBALL COURT, 1 FUTSAL COURT, 2 PICKLEBALL COURTS
 - SEAT WALL, TYP.
 - SCULPTURAL CONCRETE STEPS
- PICNIC AREA
- SCULPTURAL FIELD FENCE
- TRAVERSE WALL
- 14 MURAL
- ENTRY PLAZA
- RELOCATED FLAGPOLE
- FREESTANDING WALLS
- COURT FENCE
- TENNIS PRACTICE BACKBOARD

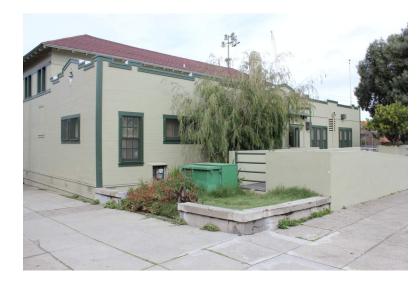
(E) CLUBHOUSE EXTERIOR - EAST

(3) EXAMPLE OF PLEXIGLASS INFILL AT WINDOWS

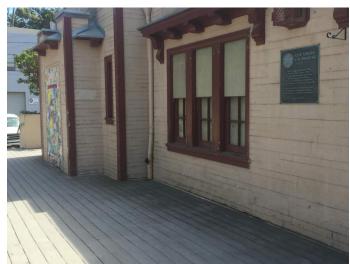
(E) CLUBHOUSE EXTERIOR - NORTH

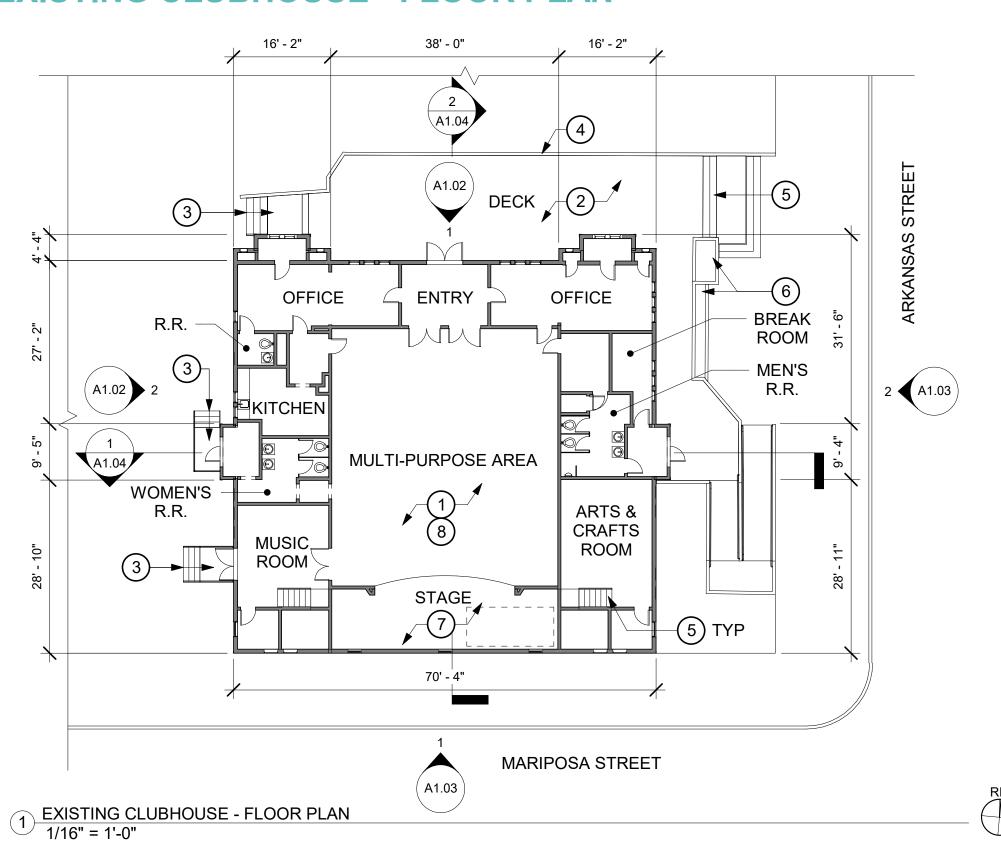
EXISTING CLUBHOUSE - FLOOR PLAN 1/16" = 1'-0" 03/18/2022 A1.01

EXISTING CLUBHOUSE - FLOOR PLAN

- 1 T&G WOOD FLOORING OVER WOOD FRAMING, CRAWL SPACE BENEATH
- 2 RAISED TREX DECK OVER WOOD FRAMING, CRAWL SPACE BELOW
- (3) CONC STAIR AND LANDING
- (4) CONC LOW WALL
- (5) WOOD STAIR
- 6 CONC PLANTERS AND LOW WALL AT EDGE OF DECK
- 7) RAISED STAGE W/ STORAGE BELOW
- (8) PAINTED WOOD PANELING AND TRIM AT MULTI-PURPOSE ROOM WALLS AND CEILING

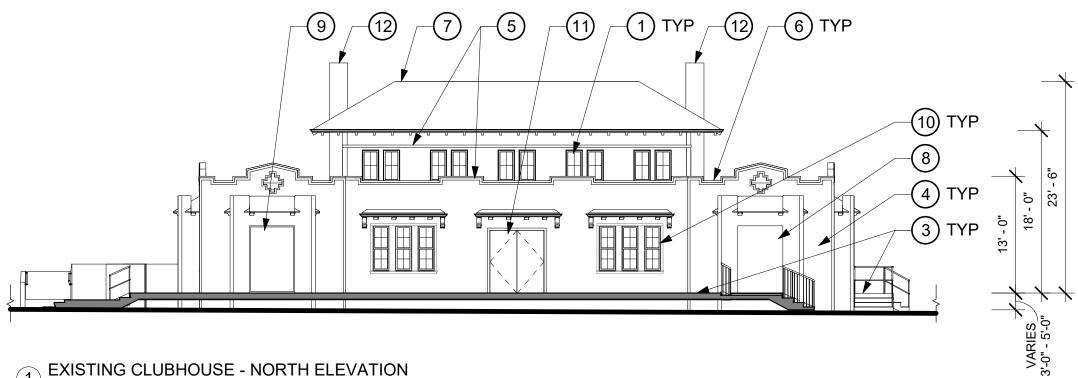
1 EXISTING CLUBHOUSE - NORTH ELEVATION 3/32" = 1'-0"

- (1) WOOD WINDOW W/ WOOD TRIM
- (2) HOLLOW MTL DOOR W/ MTL TRIM
- 3 RAISED TREX DECK & LOW CEMENT PLASTER WALLS
- 4 EXTERIOR FINISH PAINTED FLUSH (T&G) WOOD SIDING
- (5) EXTERIOR WOOD TRIM, TYP
- (6) GA SHT MTL CAP FLASHING AT PARAPET
- (7) COMPOSITION SHINGLE ROOFING
- (8) INFILL PANEL AT OPENING
- (9) INFILL PANEL W/ TILE MURAL
- (10) SECURITY GRILLE AT ALL LEVEL 1 WINDOWS
- (11) METAL DOOR
- (12) CHIMNEY

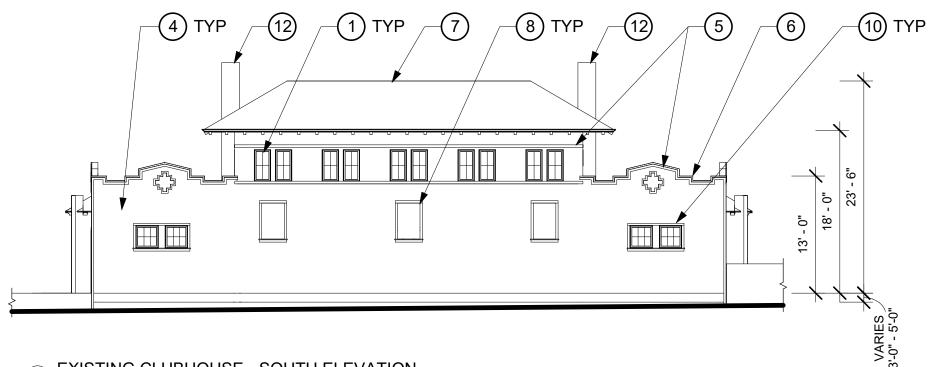
1 EXISTING CLUBHOUSE - SOUTH ELEVATION 3/32" = 1'-0"

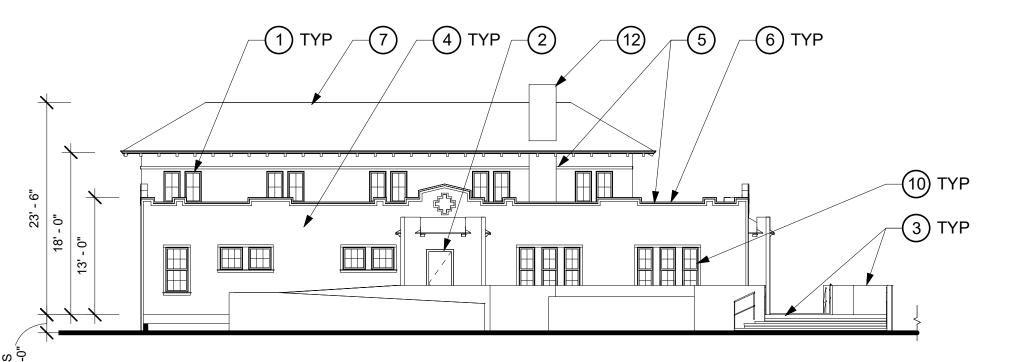
EXISTING CLUBHOUSE - EAST ELEVATION 3/32" = 1'-0"

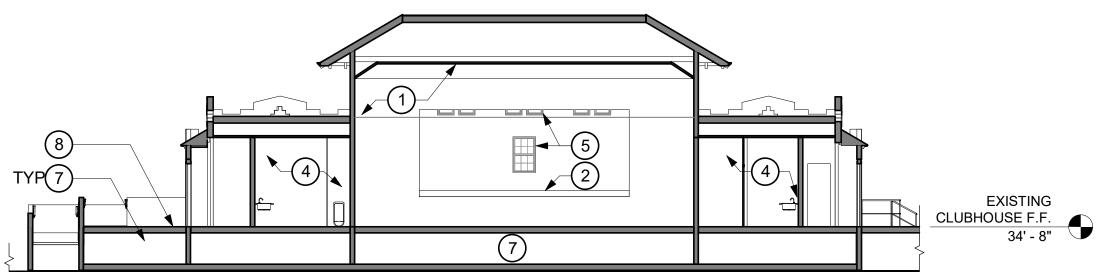
EXISTING CLUBHOUSE - SECTION 3/32" = 1'-0"

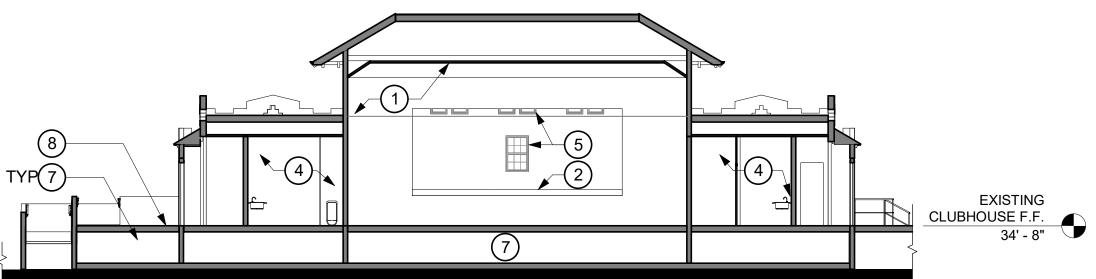
SHEET NOTES

- (1) PAINTED WOOD PANELING & TRIM, TYP
- (2) RAISED WOOD STAGE
- (3) STORAGE UNDER STAGE
- 4 PAINTED WOOD PANELING & TRIM W/ TILE WAINSCOT AT RESTROOMS, TYP
- (5) WINDOW W/ WOOD TRIM
- (6) WOOD DOOR W/ WOOD TRIM
- (7) CRAWL SPACE
- (8) RAISED WOOD DECK AND LOW WALLS

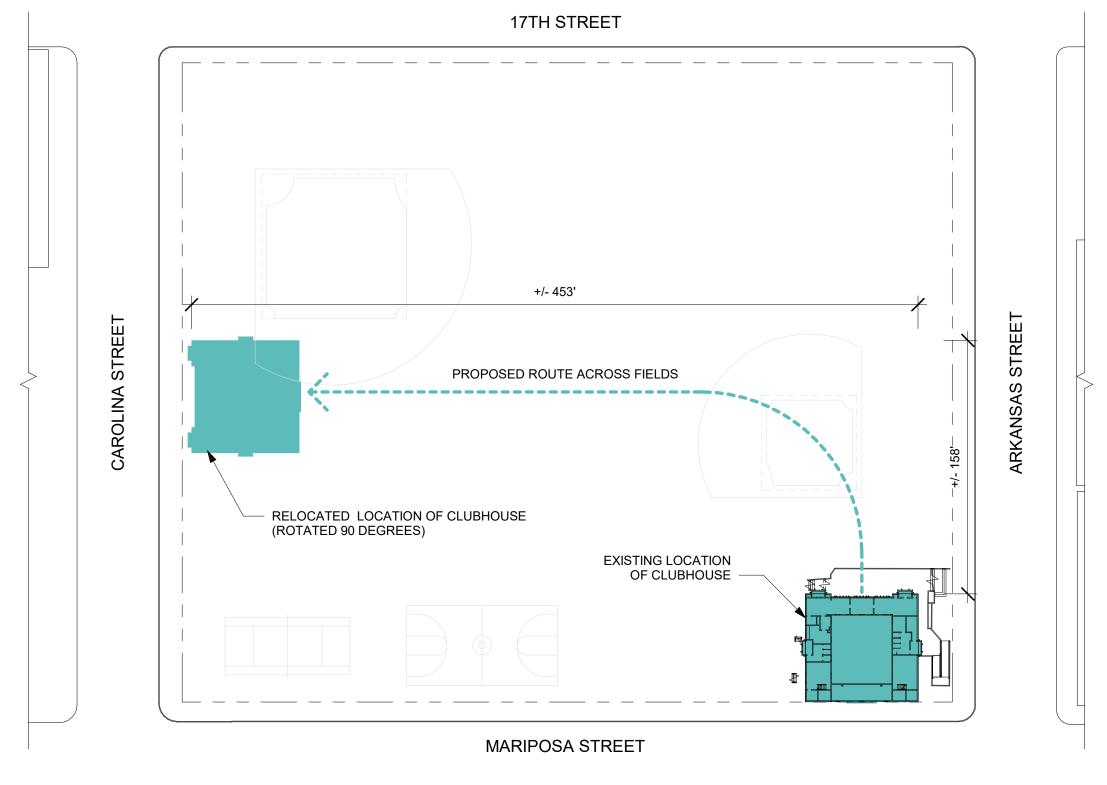
CLUBHOUSE RELOCATION PLAN

- A. BACKSTOP, BLEACHERS, LIGHT POLES, FENCING, ETC. TO BE DEMOLISHED IN ADVANCE OF BUILDING RELOCATION
- B. REFER TO RELOCATION REPORT FOR SPECIFIC ACTIVITIES AND REQUIREMENTS ASSOCIATED WITH BUILDING RELOCATION

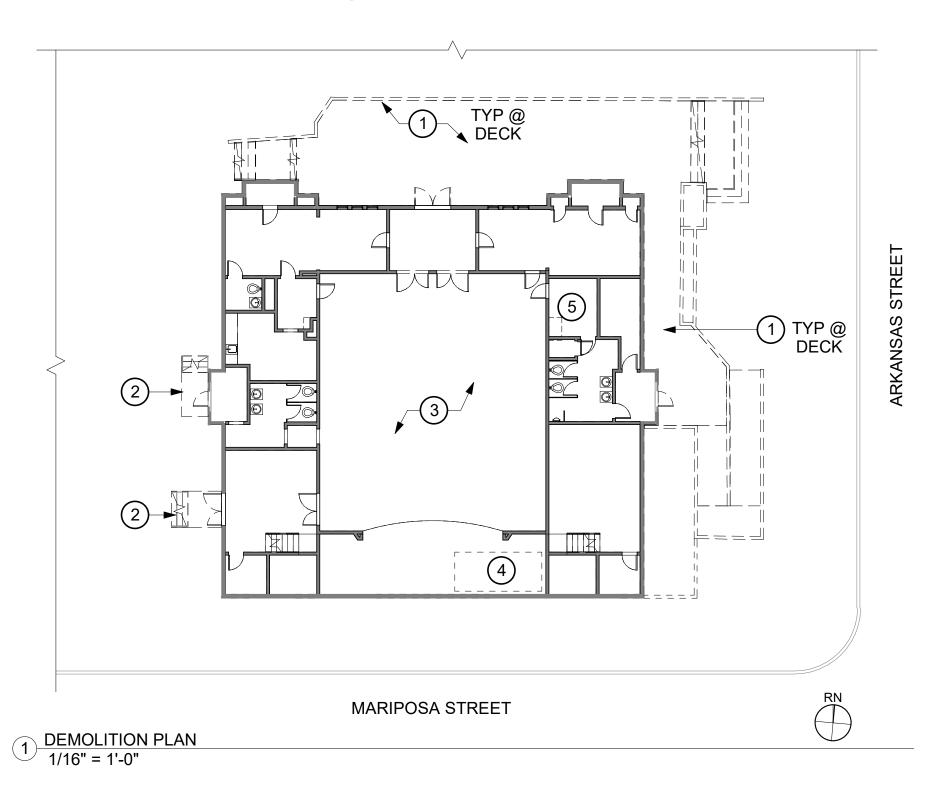
CLUBHOUSE RELOCATION DEMOLITION PLAN (PHASE 1 DEMOLITION)

- A. THIS DEMOLITION IS TO OCCUR IN PREPARATION FOR BUILDING RELOCATION
- B. PREPARE (E) CLUBHOUSE FOR RELOCATION
- C. PROTECT ALL COMPONENTS OF THE BUILDING WHICH ARE TO REMAIN & BE RENOVATED, INCLUDING EXTERIOR FINISHES, DOORS & WINDOWS, AND OTHER ARCHITECTURAL ELEMENTS
- D. DISCONNECT ALL UTILITIES AND REMOVE PIPING, CONDUITS, WIRING, ETC. THAT EXTEND UNDER THE BUILDING OR BEYOND THE BUILDNG ENVELOPE
- E. RETAIN INTERIOR PARTITIONS SLATED FOR FUTURE DEMOLITION AS NEEDED FOR BRACING
- F. COMPLETE DEMOLITION OF INTERIOR CABINETRY, HVAC AND PLUMBING EQUIPMENT, ELECTRICAL TRANSFORMERS AND MAIN PANELS, WALL MOUNTED ITEMS, AND ANY OTHER ITEMS INDICATED ON THE DRAWINGS

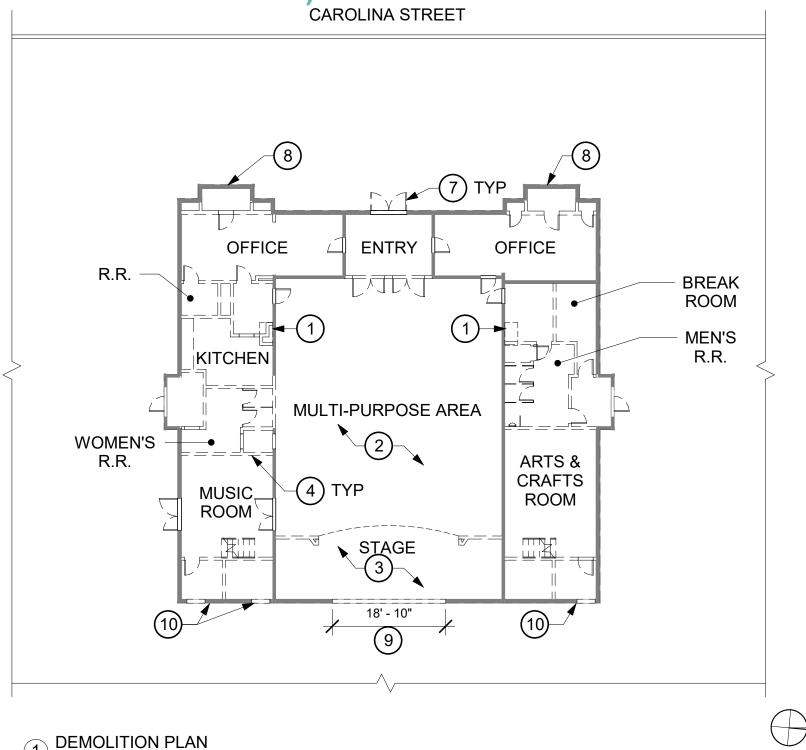
CLUBHOUSE RENOVATION DEMOLITION PLAN (PHASE 2 DEMOLITION)

1 DEMOLITION PLAN 1/16" = 1'-0"

- A. THIS DEMOLITION IS TO OCCUR AFTER THE BUILDING HAS BEEN RELOCATED.
- B. AFTER BUILDING IS RELOCATED TO NEW LOCATION IT WILL BE RAISED ON CRIBBING SO THE NEW FOUNDATION CAN BE BUILT BELOW THE BUILDING
- C. WHEN FOUNDATION IS COMPLETE, LOWER THE CLUBHOUSE SUCH THAT IT IS BROUGHT DOWN TO GRADE ON A NEW FOUNDATION WITH CRAWL SPACE
- D. RETAIN & PROTECT INTERIOR TRIM FOR ALL WINDOWS & DOORS TO REMAIN
- E. REMOVE (E) INTERIOR WALL AND CEILING FINISHES.
- F. REMOVE (E) PLUMBING, LIGHT, AND MECHANICAL FIXTURES AND OTHER COMPONENTS
- G. REMOVE BRICK CHIMNEYS
- H. REMOVE ALL ROOFING & BUILDING PAPER

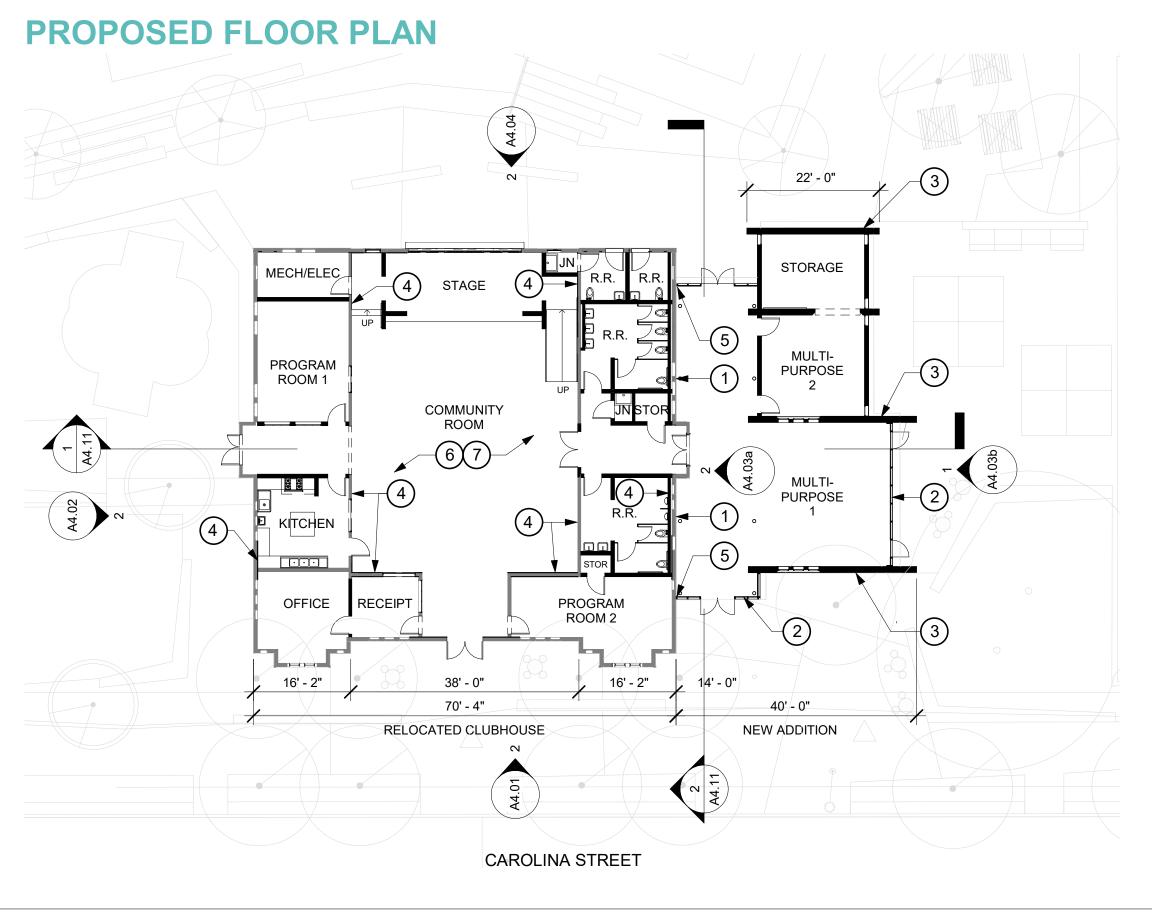
PROPOSED FLOOR PLAN 1/16" = 1'-0" 03/18/2022 A3.01

- (E) EXTERIOR WALL OF RELOCATED CLUBHOUSE TO REMAIN AND BECOME INTERIOR SURFACE OF ADDITION
- (2) (N) CURTAIN WALL TO PROVIDE TRANSPARENCY TO SEE FULL EXTERIOR OF CLUBHOUSE
- (N) HORIZONTAL BOARD FORM CONCRETE WALL, CLEAR MATTE FINISH
- (4) POTENTIAL SHEAR WALL LOCATION
- 5 SINGLE POINT OF CONTACT ON FACADE OF EXISTING BUILDING. NEW STOREFRONT TO BE INSTALLED TO ALLOW FOR FUTURE POTENTIAL REMOVAL, IF NECESSARY
- (6) (N) WOOD PANELING & TRIM AT WALLS
- (7) (N) WOOD FLOOR

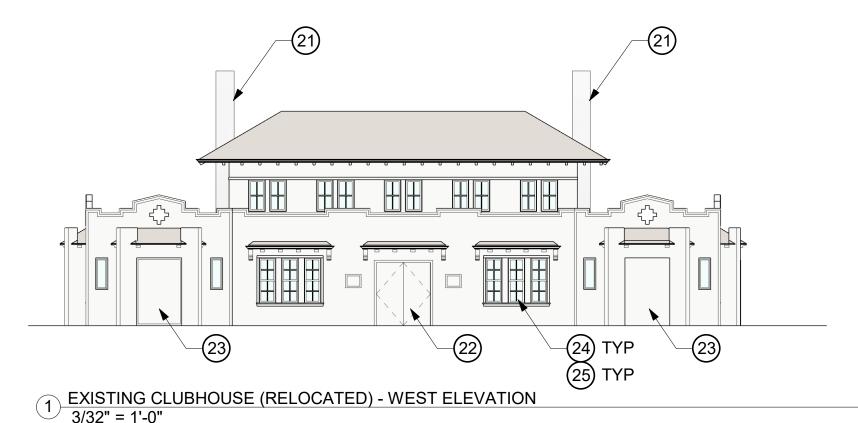
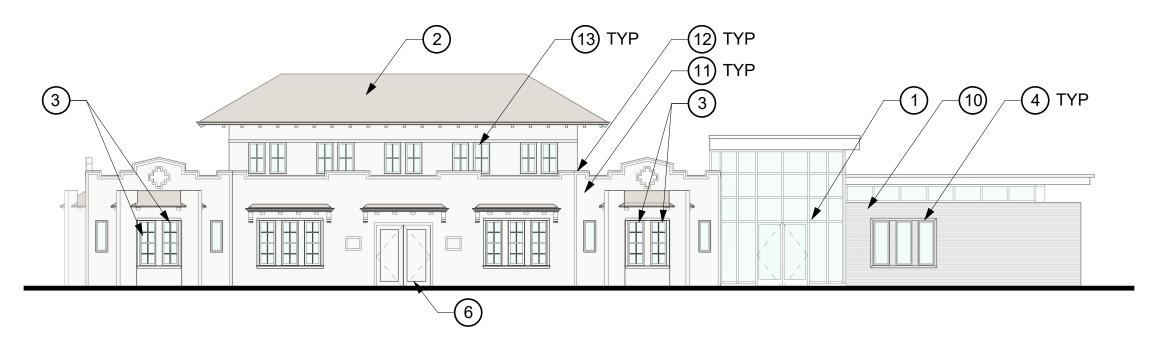
WEST ELEVATIONS - EXISTING & PROPOSED

PROPOSED - WEST ELEVATION
3/32" = 1'-0"

- (12) PREP, PRIME, AND PAINT FLASHING, REPLACE AS REQ'D TO MATCH (E)
- (13) REHABILITATE (E) WINDOW FRAME, SASH, AND TRIM, REPLACE GLASS
- (14) PATCH / INFILL / REPAIR AREA & FINISH TO MATCH ADJ SURFACE TREATMENT

- 21) (E) CHIMNEY TO BE REMOVED
- (E) NON-HISTORIC HOLLOW MTL DOOR TO BE REPLACED
- (E) NON-ORIGINAL INFILL PANEL TO BE REMOVED
- (E) NON-ORIGINAL SECURITY GRATING TO BE REMOVED AT WINDOWS, TYP

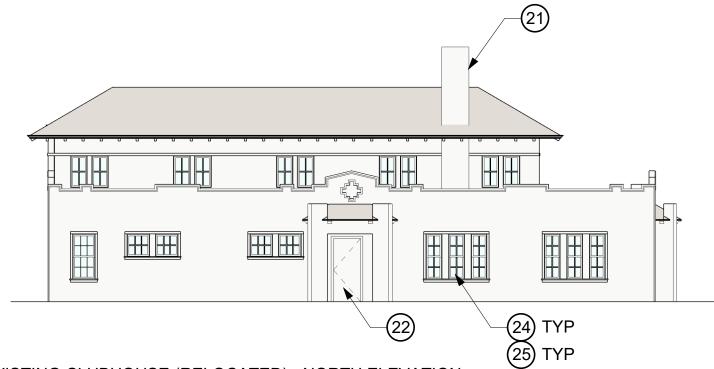
1 EXISTING CLUBHOUSE (RELOCATED) - NORTH ELEVATION 3/32" = 1'-0"

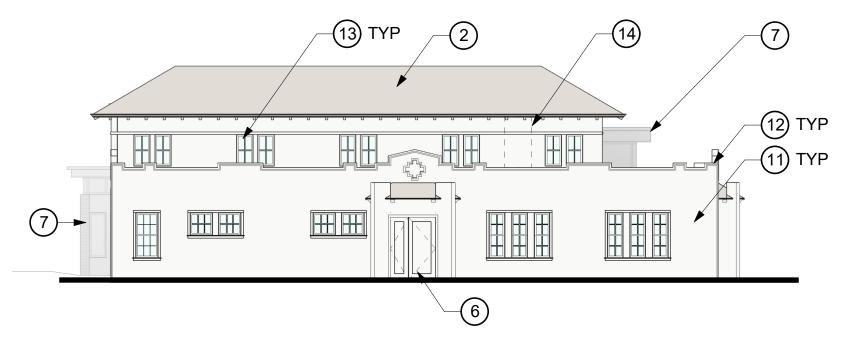
2 PROPOSED - NORTH ELEVATION 3/32" = 1'-0"

- (12) PREP, PRIME, AND PAINT FLASHING, REPLACE AS REQ'D TO MATCH (E)
- (13) REHABILITATE (E) WINDOW FRAME, SASH, AND TRIM, REPLACE GLASS
- 14) PATCH / INFILL / REPAIR AREA & FINISH TO MATCH ADJ SURFACE TREATMENT

- 21) (E) CHIMNEY TO BE REMOVED
- (E) NON-HISTORIC HOLLOW MTL DOOR TO BE REPLACED
- (E) NON-ORIGINAL INFILL PANEL TO BE REMOVED
- (E) NON-ORIGINAL SECURITY GRATING TO BE REMOVED AT WINDOWS, TYP

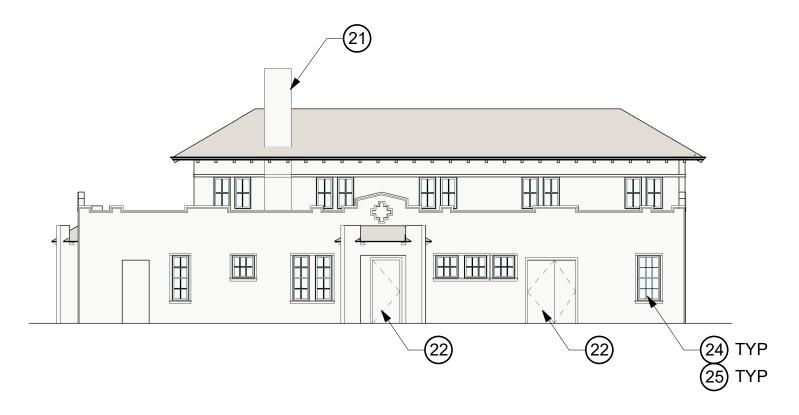
EXISTING CLUBHOUSE (RELOCATED) - SOUTH ELEVATION

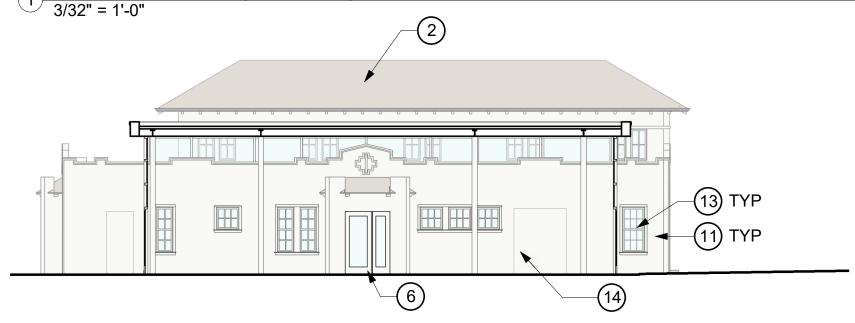
PROPOSED - SOUTH SECTION THROUGH NEW ADDITION
3/32" = 1'-0"

- 11) PREP, PRIME, AND PAINT WOOD CLADDING & TRIM
- (12) PREP, PRIME, AND PAINT FLASHING, REPLACE AS REQ'D TO MATCH (E)
- (13) REHABILITATE (E) WINDOW FRAME, SASH, AND TRIM, REPLACE GLASS

- (14) PATCH / INFILL / REPAIR AREA & FINISH TO MATCH ADJ SURFACE TREATMENT
- 21) (E) CHIMNEY TO BE REMOVED
- (E) NON-HISTORIC HOLLOW MTL DOOR TO BE REPLACED

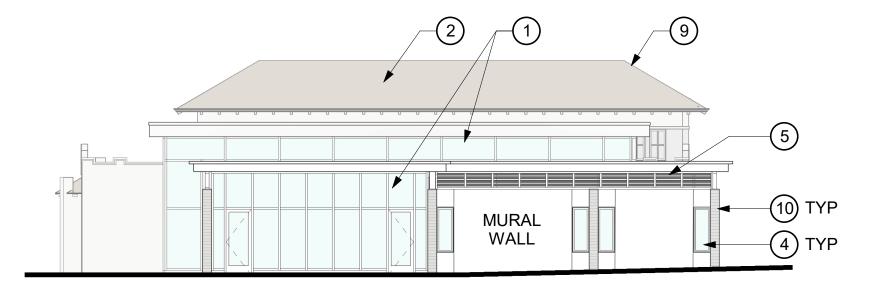
PROPOSED - SOUTH ELEVATION
3/32" = 1'-0"

- (12) PREP, PRIME, AND PAINT FLASHING, REPLACE AS REQ'D TO MATCH (E)
- (13) REHABILITATE (E) WINDOW FRAME, SASH, AND TRIM, REPLACE GLASS
- (14) PATCH / INFILL / REPAIR AREA & FINISH TO MATCH ADJ SURFACE TREATMENT

- 21) (E) CHIMNEY TO BE REMOVED
- (E) NON-HISTORIC HOLLOW MTL DOOR TO BE REPLACED
- (E) NON-ORIGINAL INFILL PANEL TO BE REMOVED
- (E) NON-ORIGINAL SECURITY GRATING TO BE REMOVED AT WINDOWS, TYP

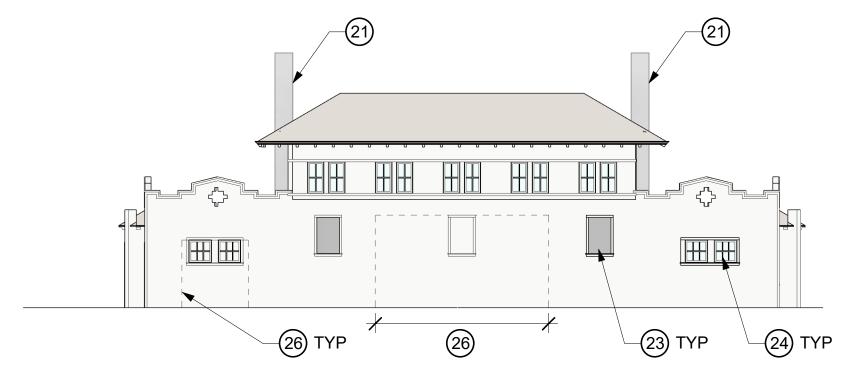
1 EXISTING CLUBHOUSE (RELOCATED) - EAST ELEVATION 3/32" = 1'-0"

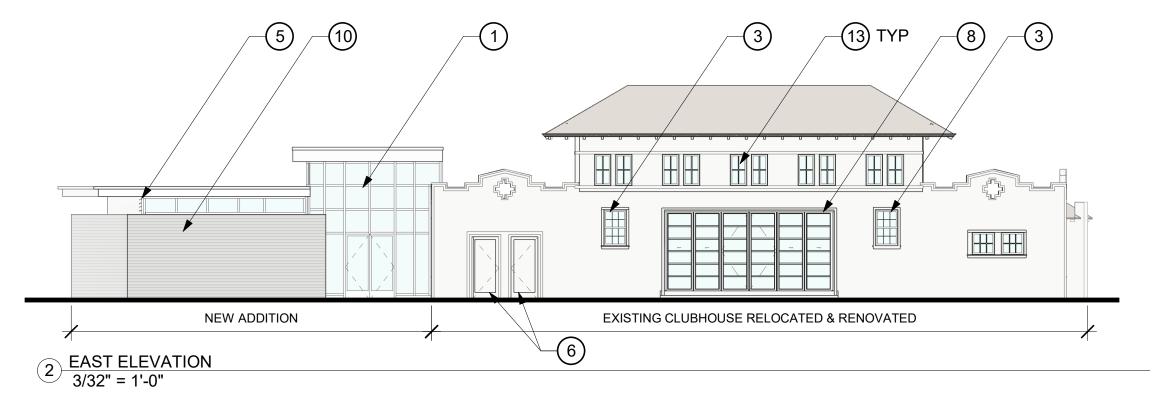
- (11) PREP, PRIME, AND PAINT WOOD CLADDING & TRIM
- (12) PREP, PRIME, AND PAINT FLASHING, REPLACE AS REQ'D TO MATCH (E)
- (13) REHABILITATE (E) WINDOW FRAME, SASH, AND TRIM, REPLACE GLASS

- (14) PATCH / INFILL / REPAIR AREA & FINISH TO MATCH ADJ SURFACE TREATMENT
- 21) (E) CHIMNEY TO BE REMOVED
- (E) NON-HISTORIC HOLLOW MTL DOOR TO BE REPLACED

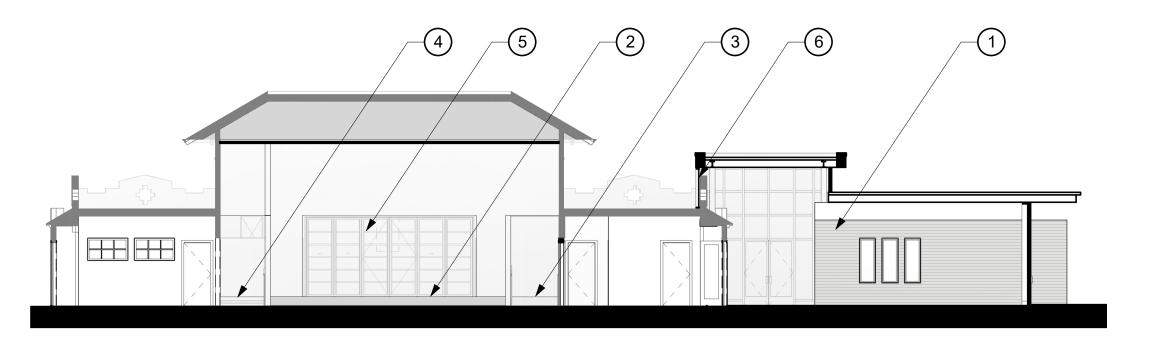
PROPOSED - SECTION
3/32" = 1'-0"

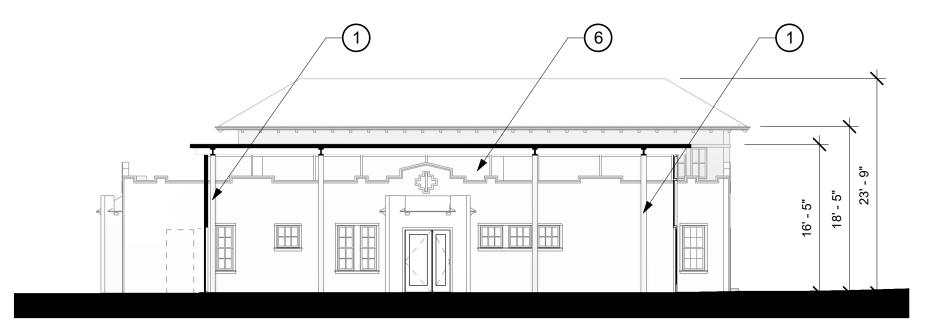
2 PROPOSED - SECTION 3/32" = 1'-0"

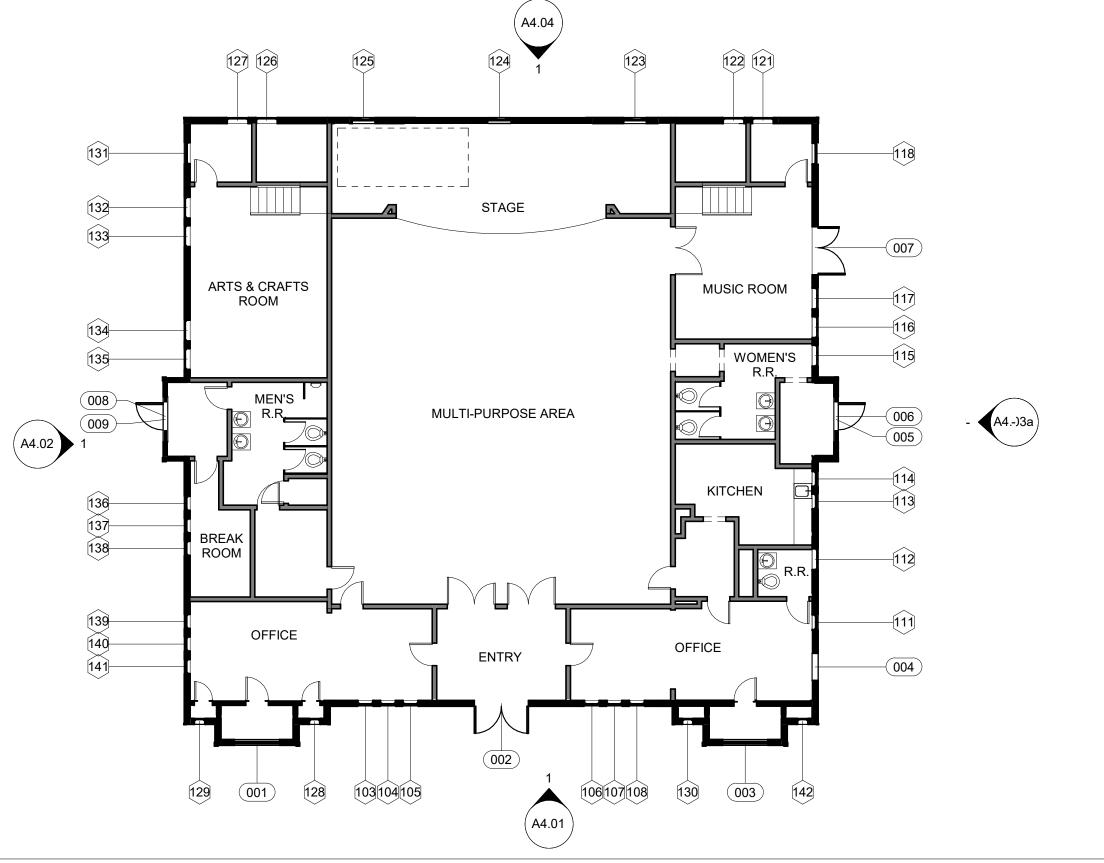
EXISTING WINDOW & DOOR KEY PLAN - LEVEL 1

NOTE: SEE A1.01 & A1.02 FOR EXISTING FLOOR PLAN SHEET NOTES

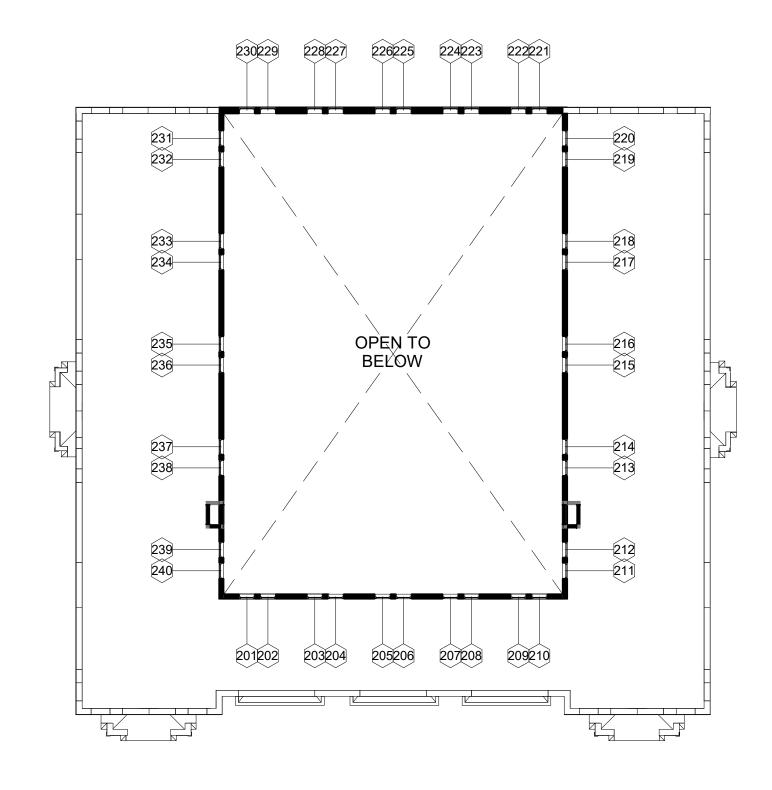
EXISTING WINDOW KEY PLAN - CLERESTORY

NOTE: SEE A1.01 & A1.02 FOR EXISTING FLOOR PLAN SHEET NOTES

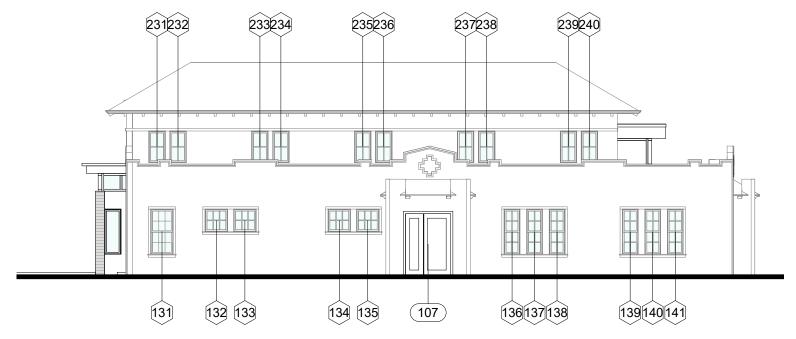
1 NORTH ELEVATION 3/32" = 1'-0"

PROPOSED WINDOW & DOOR KEY - ELEVATIONS

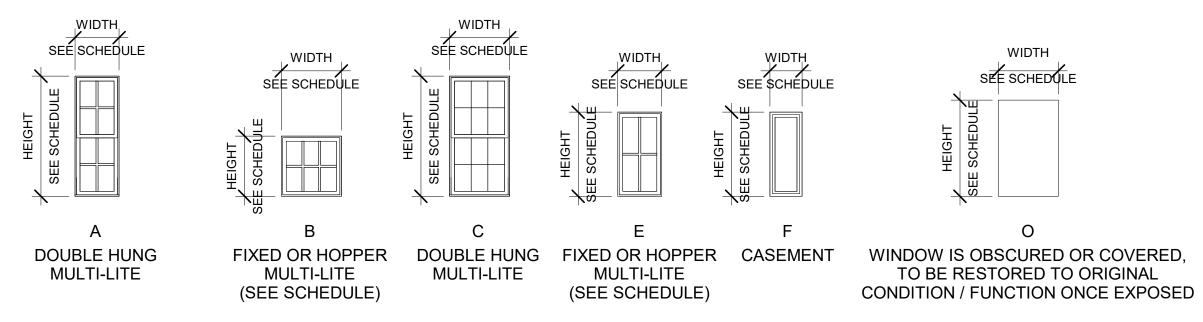
1 WINDOW LEGEND DRAWINGS ABOVE DO NOT INDICATE WOOD TRIM
1/4" = 1'-0"

WINDOW LEGEND - EXISTING & NEW

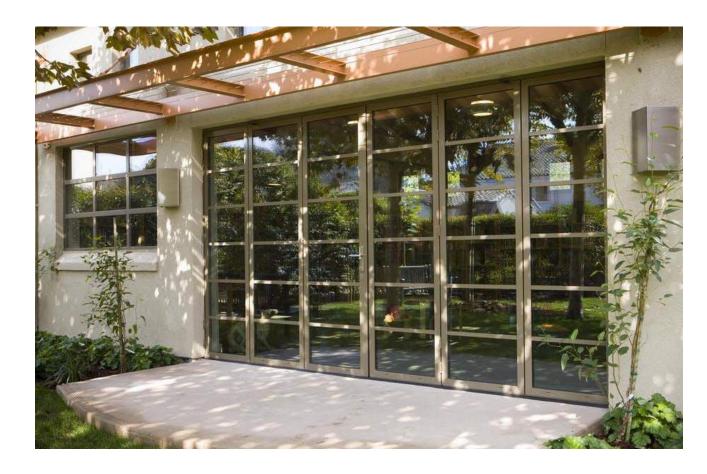
1 NANAWALL FOLDING GLAZED DOOR EXTERIOR

The Palo Alto Children's Library Renovation by Architecture Resources Group (ARG) incorporated a bronze Nanawall folder glazed door into a historic 1939 Spanish Colonial Revival children's library. The programmatic function, scale and historic integration of the door of this project illustrate the approach towards the new Stage Door at the renovated Jackson Park Clubhouse.

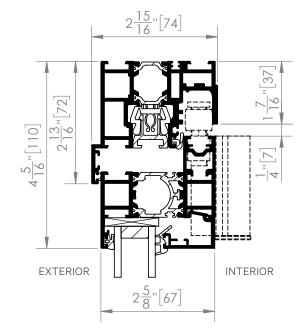
2 HEAD AT STAGE DOOR

GLAZED FOLDING DOOR
