To: Millennium Tower Association

Date: November 1, 2023 Project Number: 23-018-01 Subject: 301 Mission Retrofit Monitoring Report 124: Results as of October 30, 2023

CONTEXT

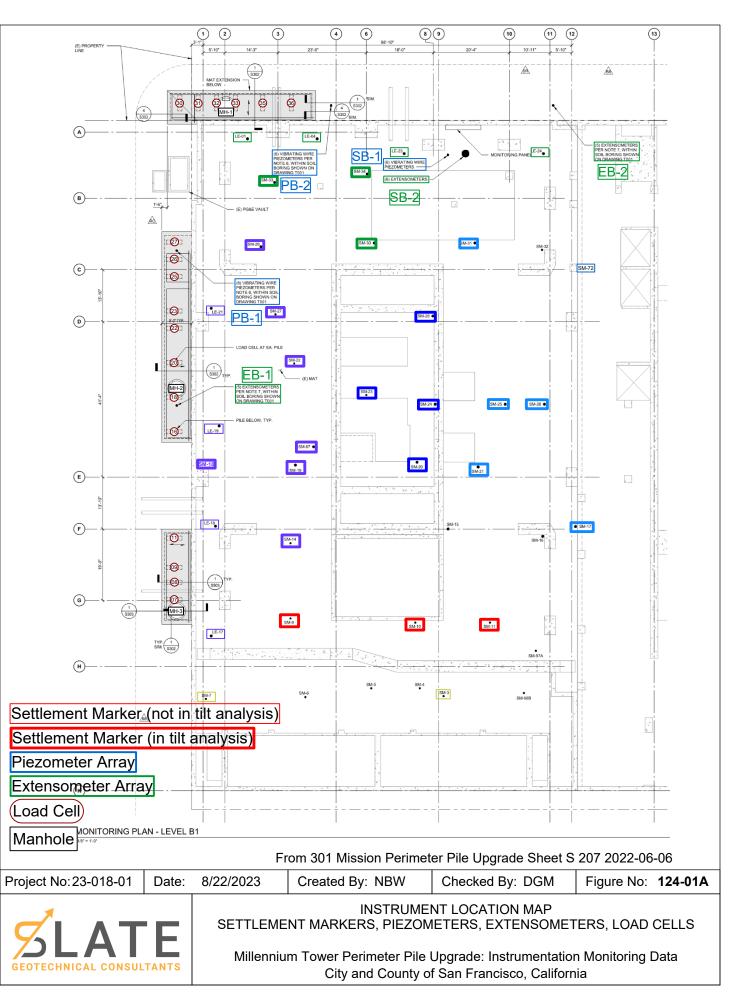
Figure 01 presents the instrument locations as referenced in later figures.
