Date: March 22, 2024 Project Number: 23-018-01 Subject: 301 Mission Retrofit Monitoring Report 132: Results as of March 18, 2024

CONTEXT

This memorandum summarizes results from the monitoring plan implemented at the 301 Mission property. Instrumentation to monitor the structure prior to, during and after the retrofit was installed in January 2021, including piezometers and extensometers. Settlement markers installed in April 2009 and January 2017, survey prisms mounted on the exterior of the structure in December 2016, and crack gauges installed in April 2009 have also been monitored. Pile load cells were installed on the Mission Street piles in January 2023, and on the Fremont Street piles in June 2023. Survey points were established on the manhole covers around the Tower and a baseline reading was performed on August 8, 2023. This memorandum is for review only. It only contains ongoing monitoring information. This memorandum does not contain recommendations based upon the ongoing monitoring information.

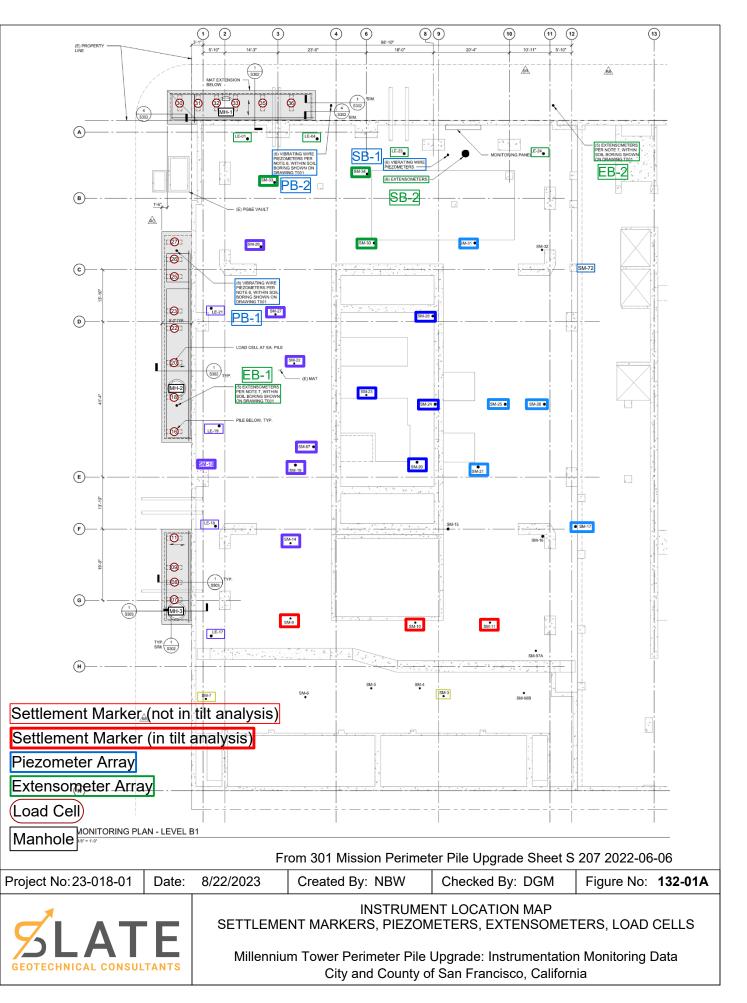
Figure 01 presents the instrument locations as referenced in later figures.
