To: Millennium Tower Association

Date: June 17, 2024 Project Number: 23-018-01 Subject: 301 Mission Retrofit Monitoring Report 134: Results as of June 17, 2024

This memorandum summarizes results from the monitoring plan implemented at the 301 Mission property. Instrumentation to monitor the structure prior to, during and after the retrofit was installed in January 2021, including piezometers and extensometers. Settlement markers installed in April 2009 and January 2017, survey prisms mounted on the exterior of the structure in December 2016, and crack gauges installed in April 2009 have also been monitored. Pile load cells were installed on the Mission Street piles in January 2023, and on the Fremont Street piles in June 2023. Survey points were established on the manhole covers around the Tower and a baseline reading was performed on August 8, 2023. This memorandum is for review only. It only contains ongoing monitoring information. This memorandum does not contain recommendations based upon the ongoing monitoring information.

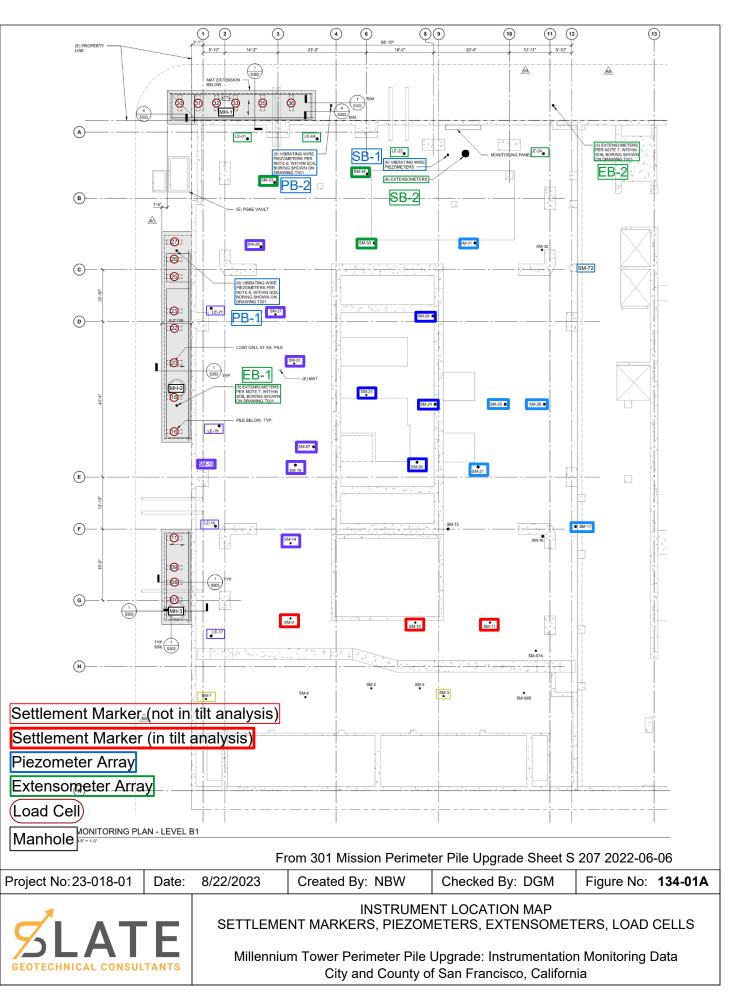
Figure 01 presents the instrument locations as referenced in later figures.
