Date: March 15, 2023 Project Number: 19-009 Subject: 301 Mission Retrofit Supplemental Monitoring Report 097: Results as of March 14, 2023

CONTEXT

This supplemental memorandum summarizes results from the monitoring plan implemented at the 301 Mission property following the process established in a letter from Simpson, Gumpertz and Heger (SGH) to the San Francisco Department of Building Inspection (SFDBI) dated March 23, 2022. Instrumentation to temporarily monitor the structure during the excavation and shoring project phases was installed on April 20, 2022, including survey prisms installed at approximately one floor level above grade on the exterior of the building. This supplemental memorandum is for review only. It only contains ongoing monitoring information.

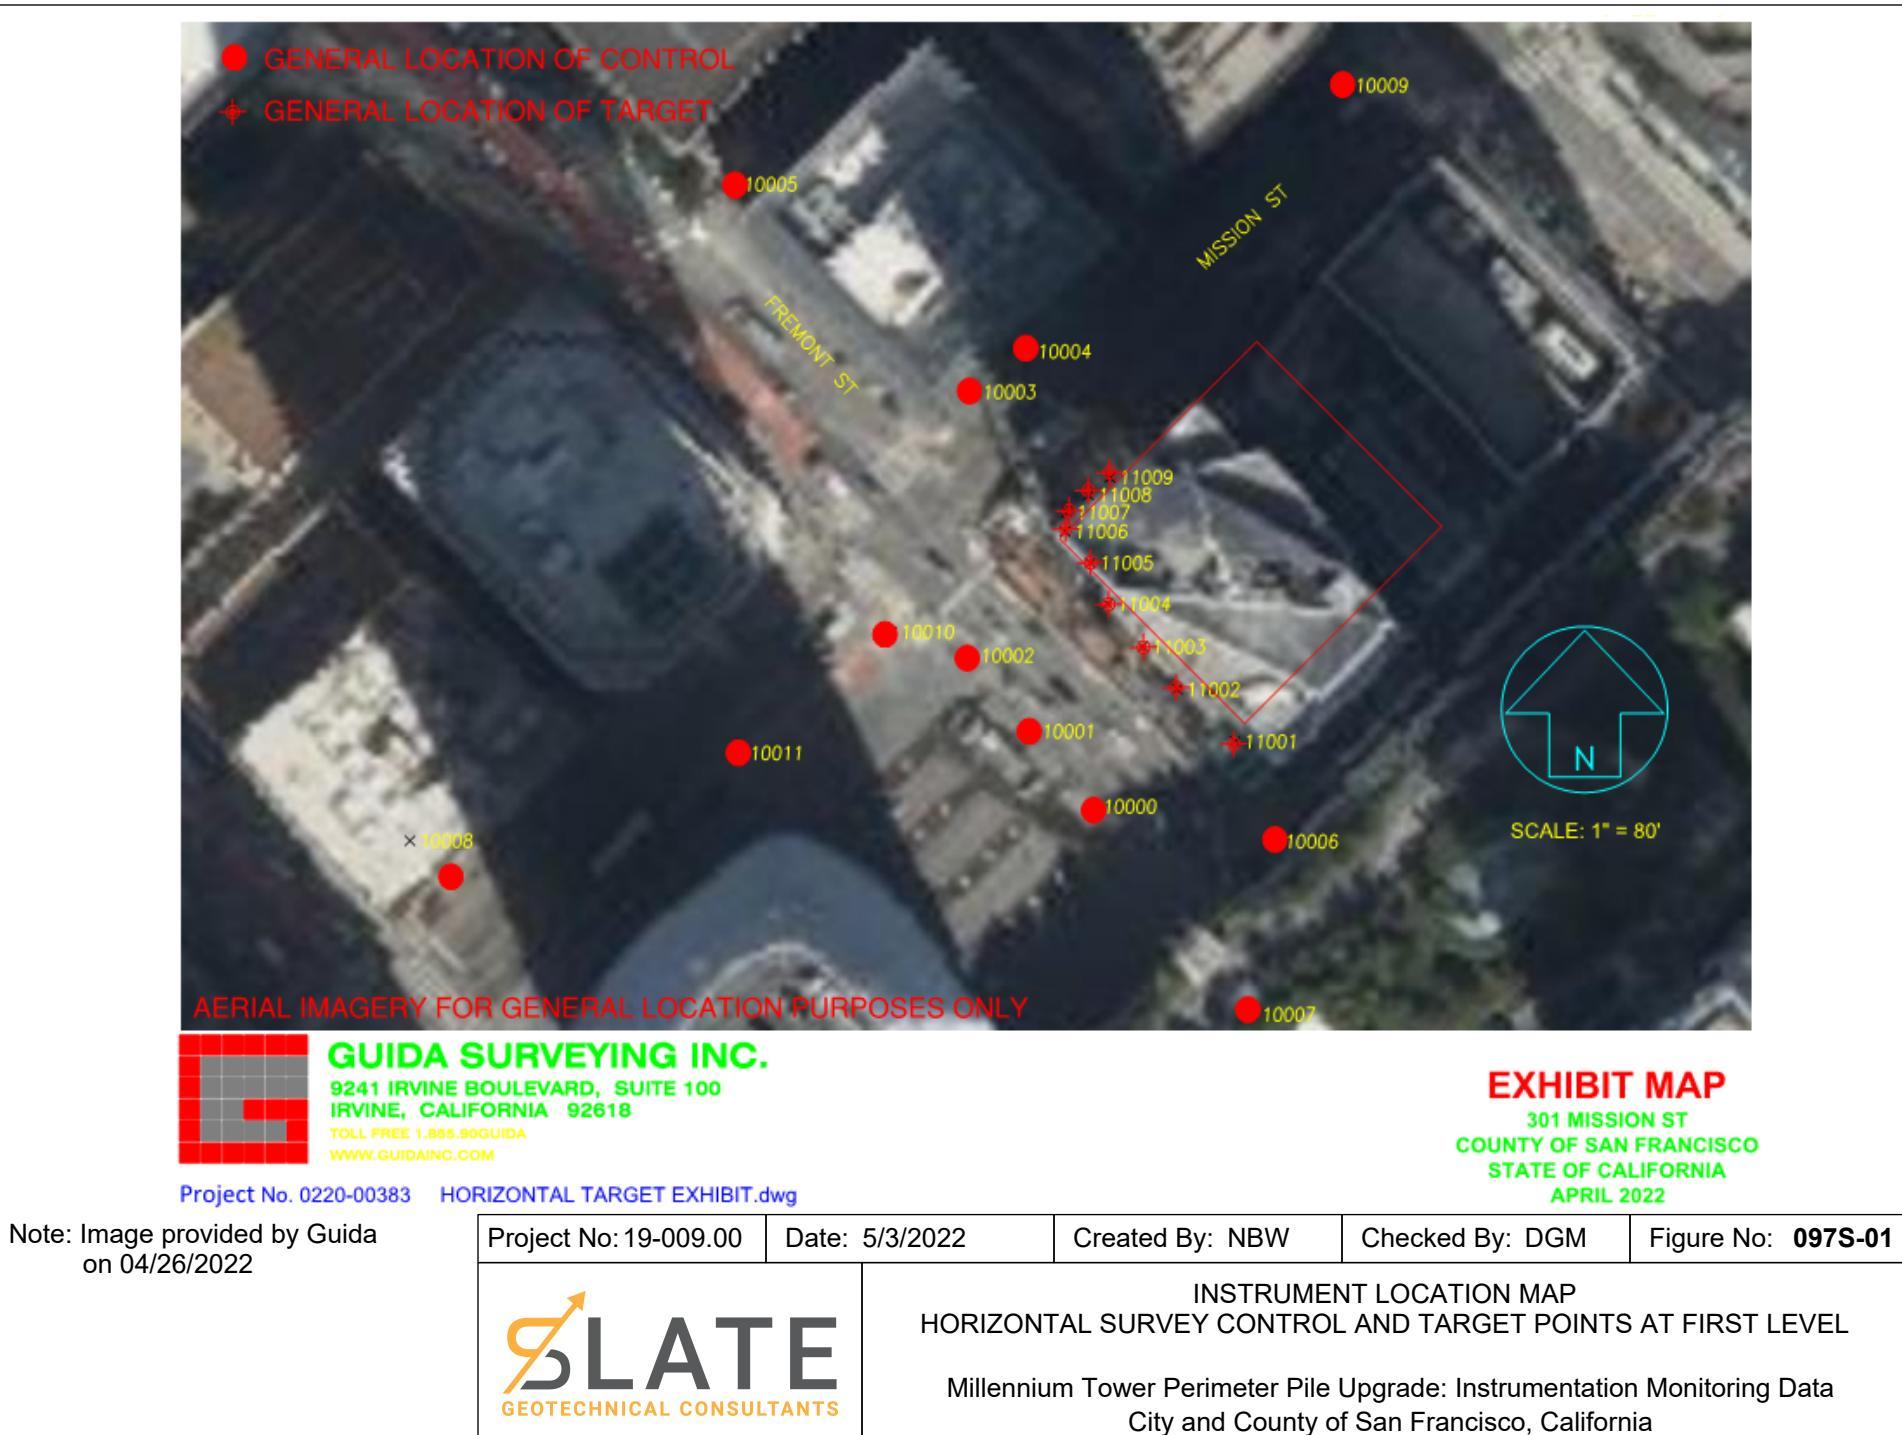
Figure S-01 presents the locations of the survey prisms (including both control and target prisms) as referenced in later figures.

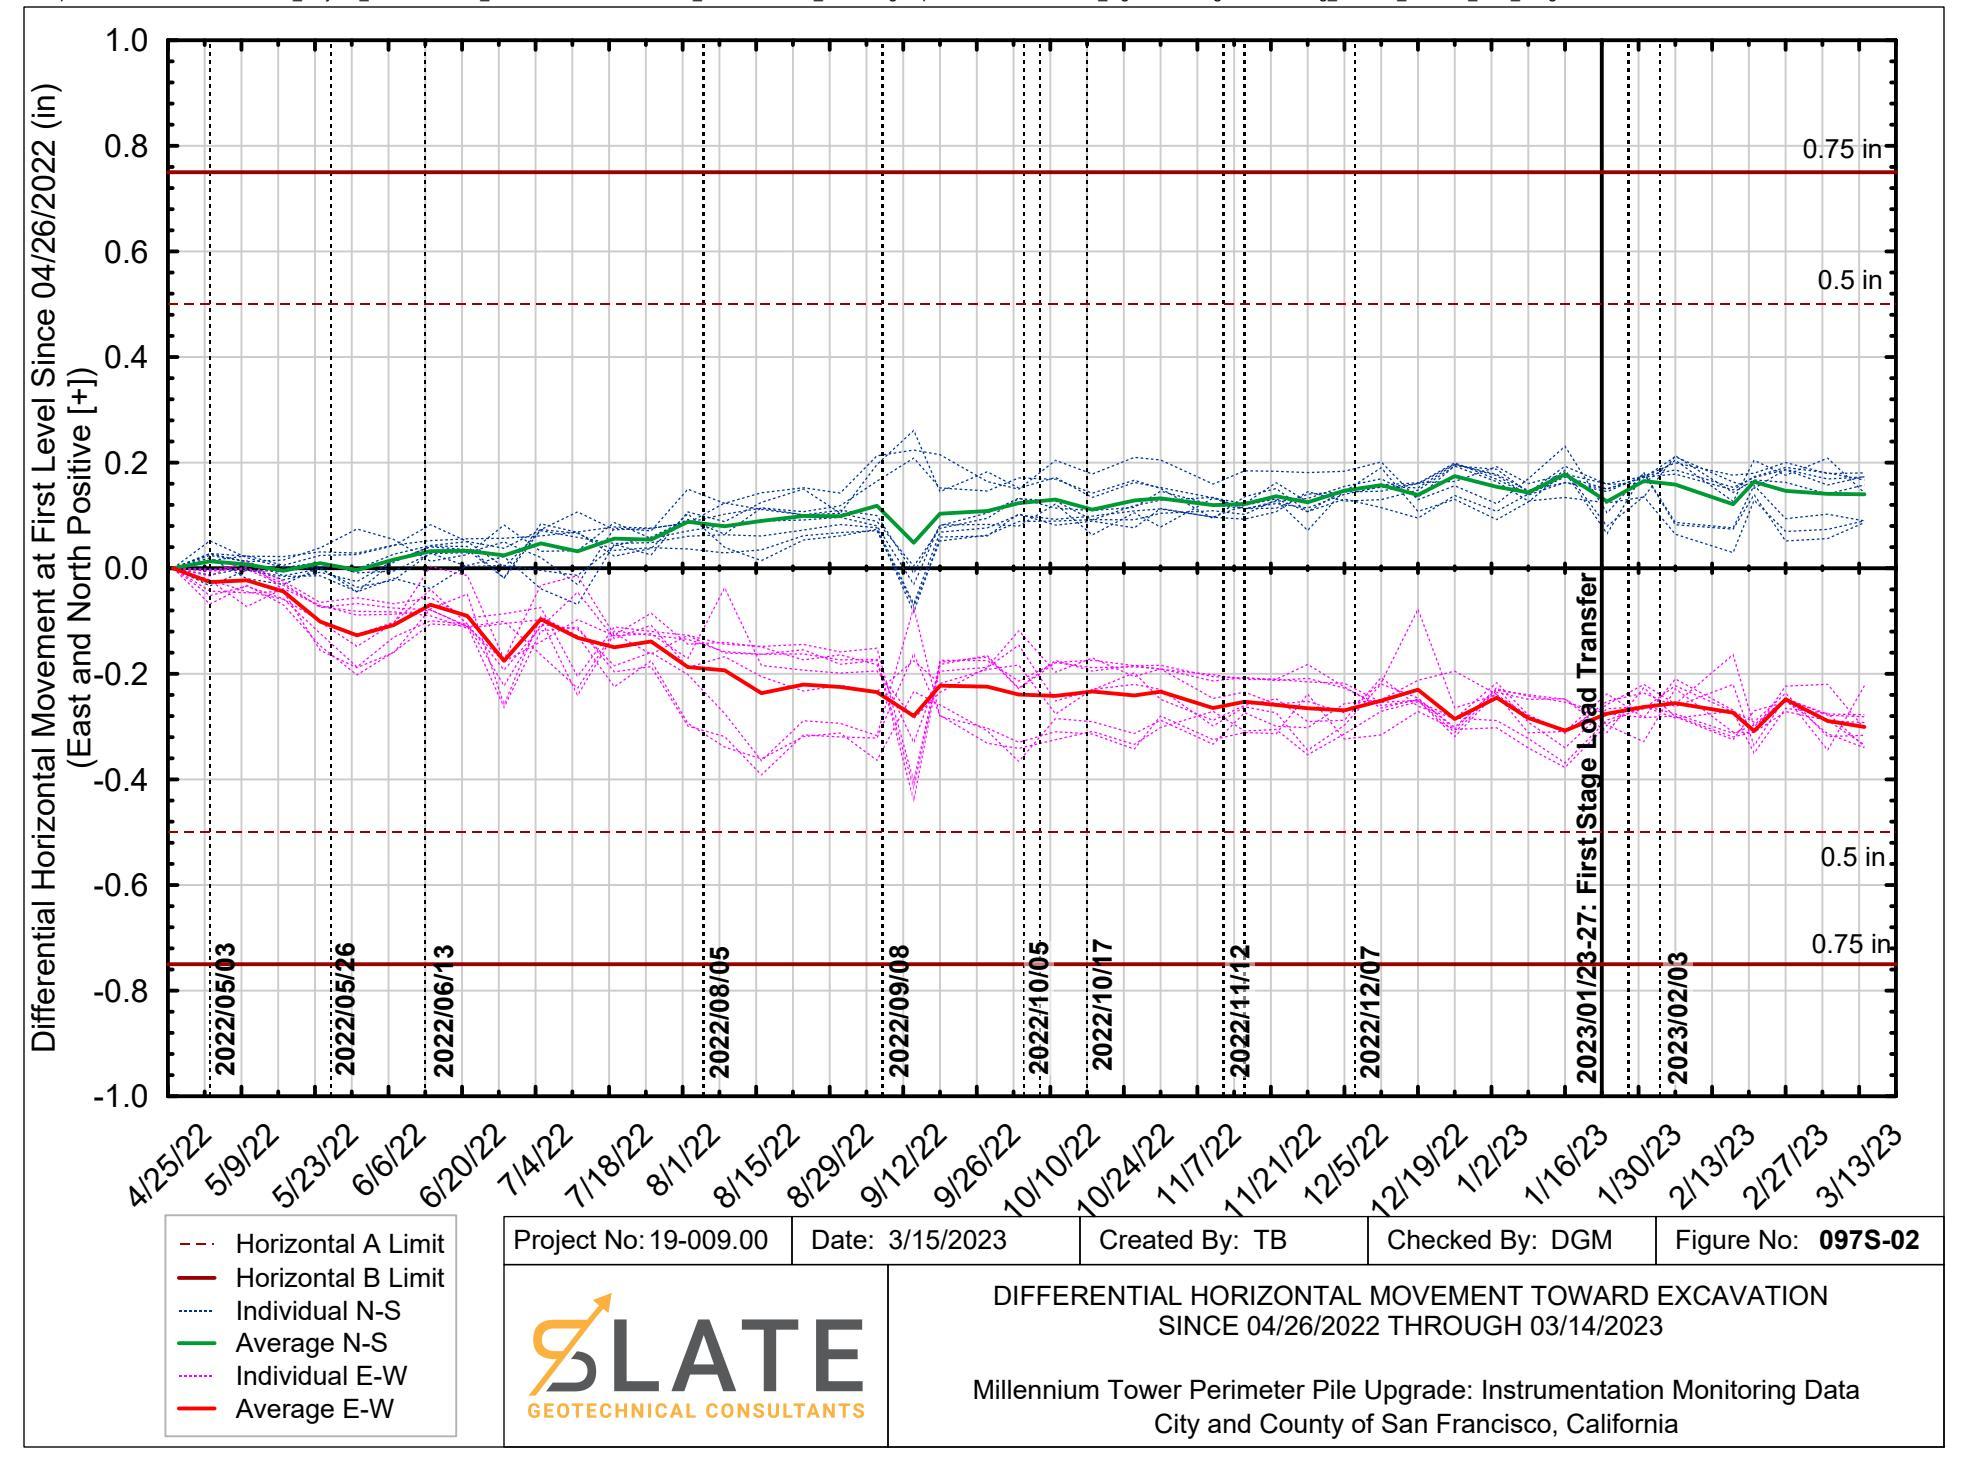
Figure S-02 presents the differential horizontal movement toward the excavation at survey prisms installed at approximately one floor level above grade on the exterior of the building, as well as the average in each of the project north-south and east-west direction, since April 26, 2022, through March 14, 2023. Limits established in the aforementioned letter are included for reference.

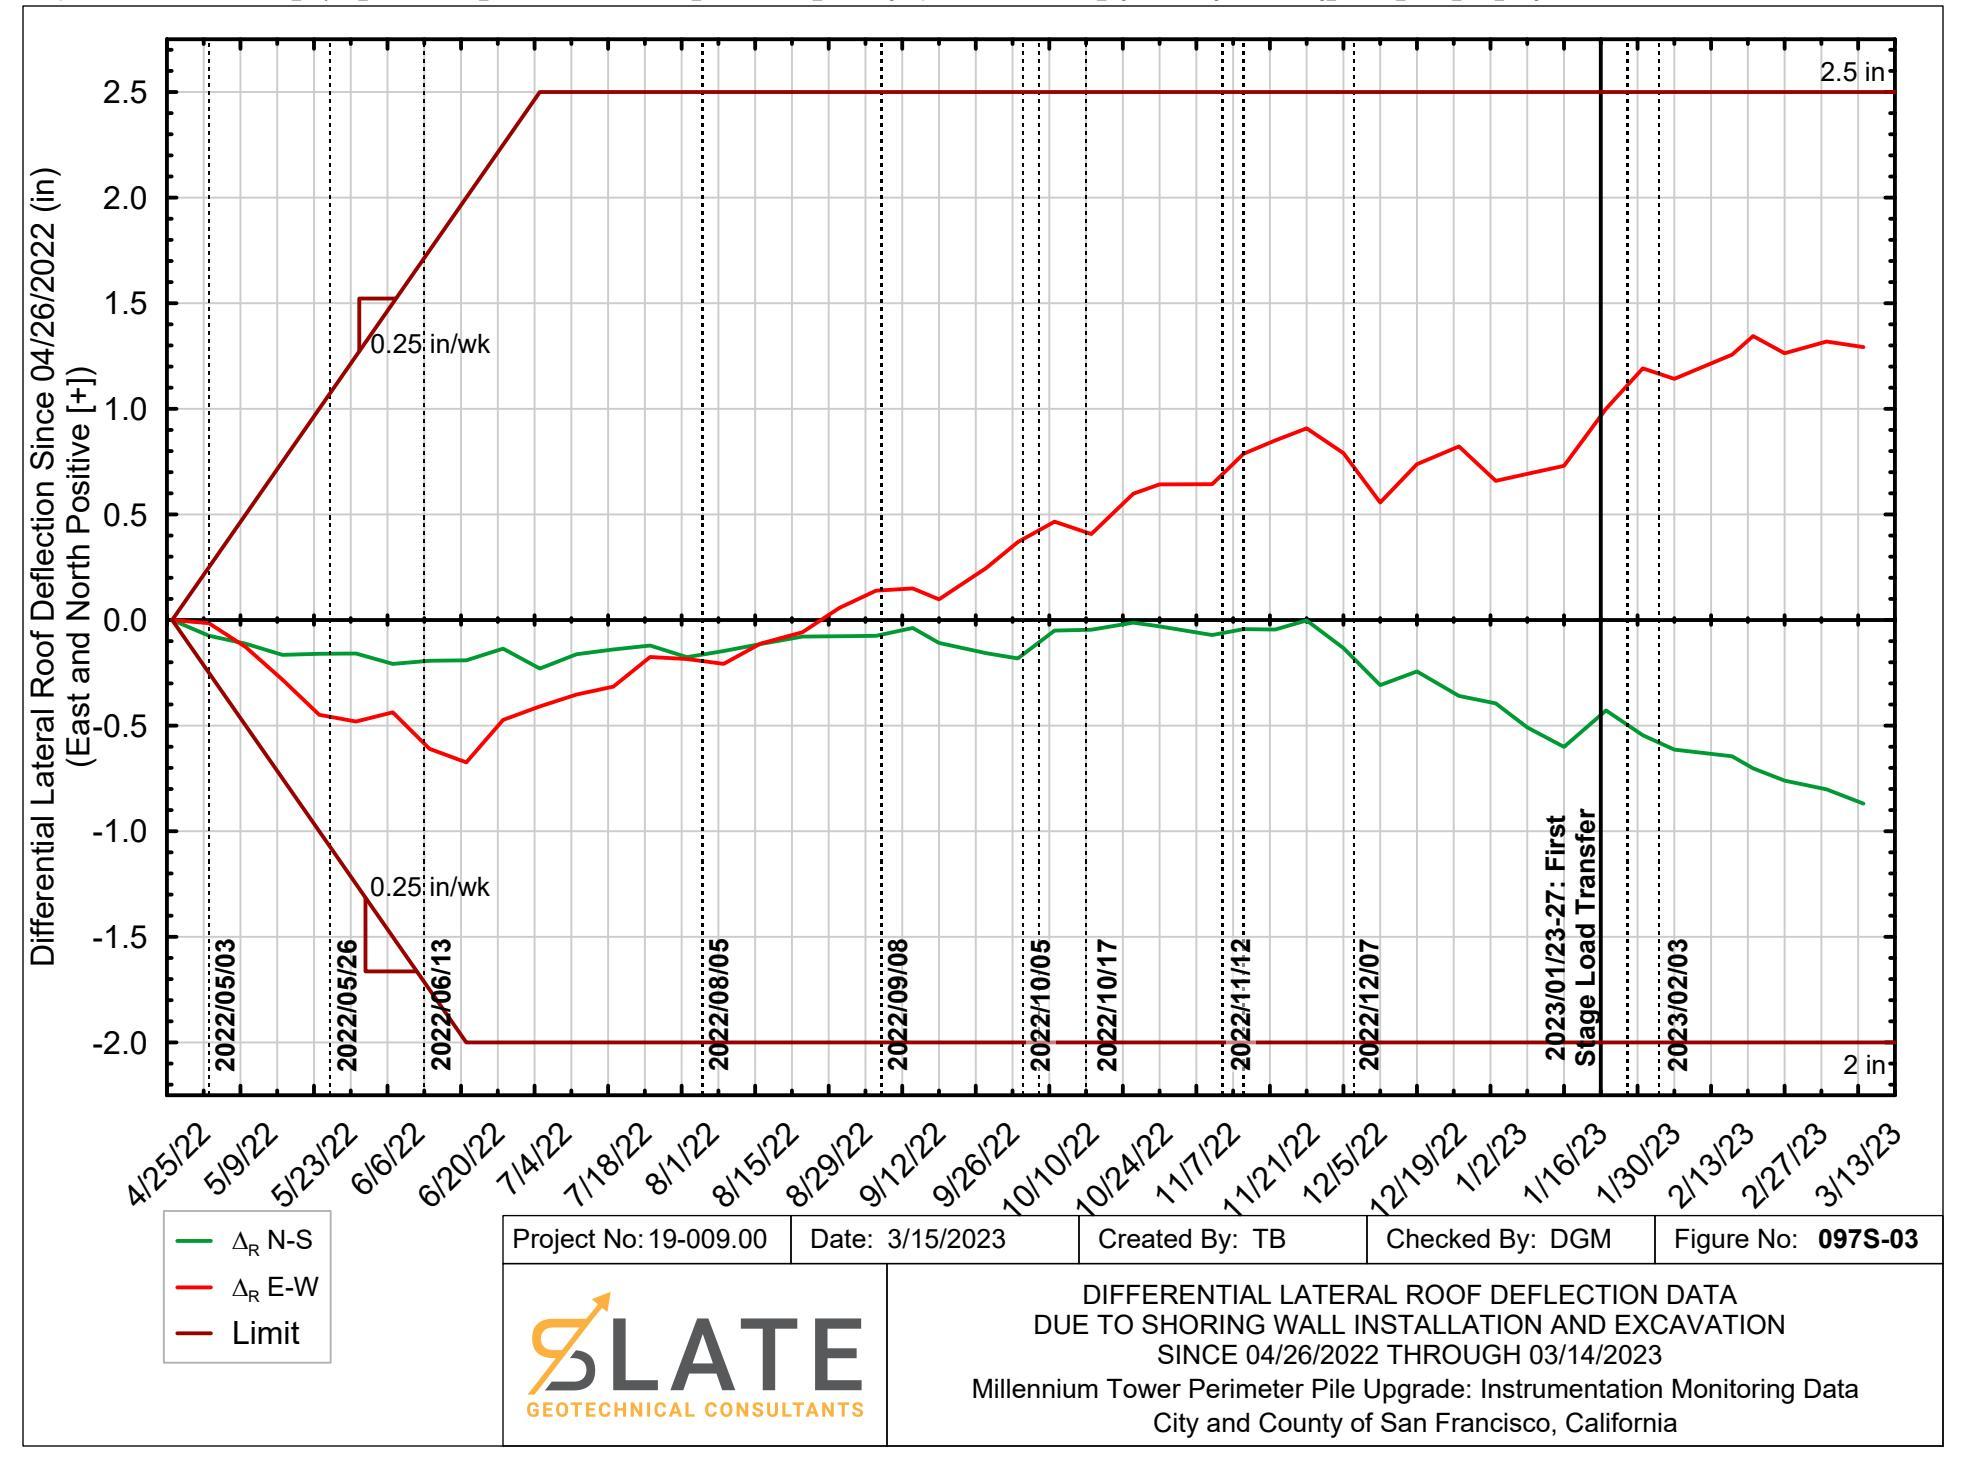
Figure S-03 presents differential lateral roof deflection data due to shoring wall installation and excavation since April 26, 2022, through March 14, 2023. Limits established in the aforementioned letter are included for reference. Note that differential lateral roof deflection due to shoring wall installation and excavation is calculated following the aforementioned letter as:

$$\Delta_{R,NS} = \Delta_{R-prism,NS} - \Delta_{H,NS} - \alpha_0 T \tag{a}$$

$$\Delta_{R,NS} = \Delta_{R-prism,NS} - \Delta_{H,NS} - \alpha_{1,NS} \left(T - T_{1,NS} \right) - \alpha_0 T_{1,NS} \tag{b}$$

$$\Delta_{R,EW} = \Delta_{R-prism,EW} - \Delta_{H,EW} - \alpha_0 T \tag{c}$$

$$\Delta_{R,EW} = \Delta_{R-prism,EW} - \Delta_{H,EW} - \alpha_{1,EW} \left(T - T_{1,EW}\right) - \alpha_0 T_{1,EW} \tag{d}$$

- where: Δ_R is the computed differential lateral roof deflection due to shoring wall installation and excavation during shoring wall installation (a or c) or during excavation (b or d) for the project north-south (a and b) and project east-west (c and d) directions;

- $\Delta_{R-prism}$ is the differential lateral roof deflection obtained from prism data for the project north-south (a and b) and project east-west (c and d) directions;

- Δ_H is the average differential horizontal movement "at-grade" for the project north-south (a and b) and project east-west (c and d) directions;
 - α_0 is the weekly lateral roof deflection rate from the two months of monitoring conducted immediately prior to the shoring wall installation (i.e., monitoring data from February 22, 2022, through April 26, 2022);

- $\alpha_{1,NS}$ is the weekly lateral roof deflection rate from the two months of monitoring conducted immediately prior to starting the Mission Street excavation (i.e., monitoring data from August 15, 2022, through October 16, 2022);

- $\alpha_{1,EW}$ is the weekly lateral roof deflection rate from the two months of monitoring conducted immediately prior to starting the Fremont Street excavation (i.e., monitoring data from December 1, through February 2, 2023);

- *T* is the number of weeks since initiation of shoring wall installation or excavation;
 - $T_{1,NS}$ is the number of weeks between the initiation of shoring wall installation and starting the Mission Street excavation (i.e., between April 26, 2022, and October 18, 2022); and,

- $T_{1,EW}$ is the number of weeks between the initiation of shoring wall installation and starting the Fremont Street excavation (i.e., between December 1, 2022, and February 2, 2023).

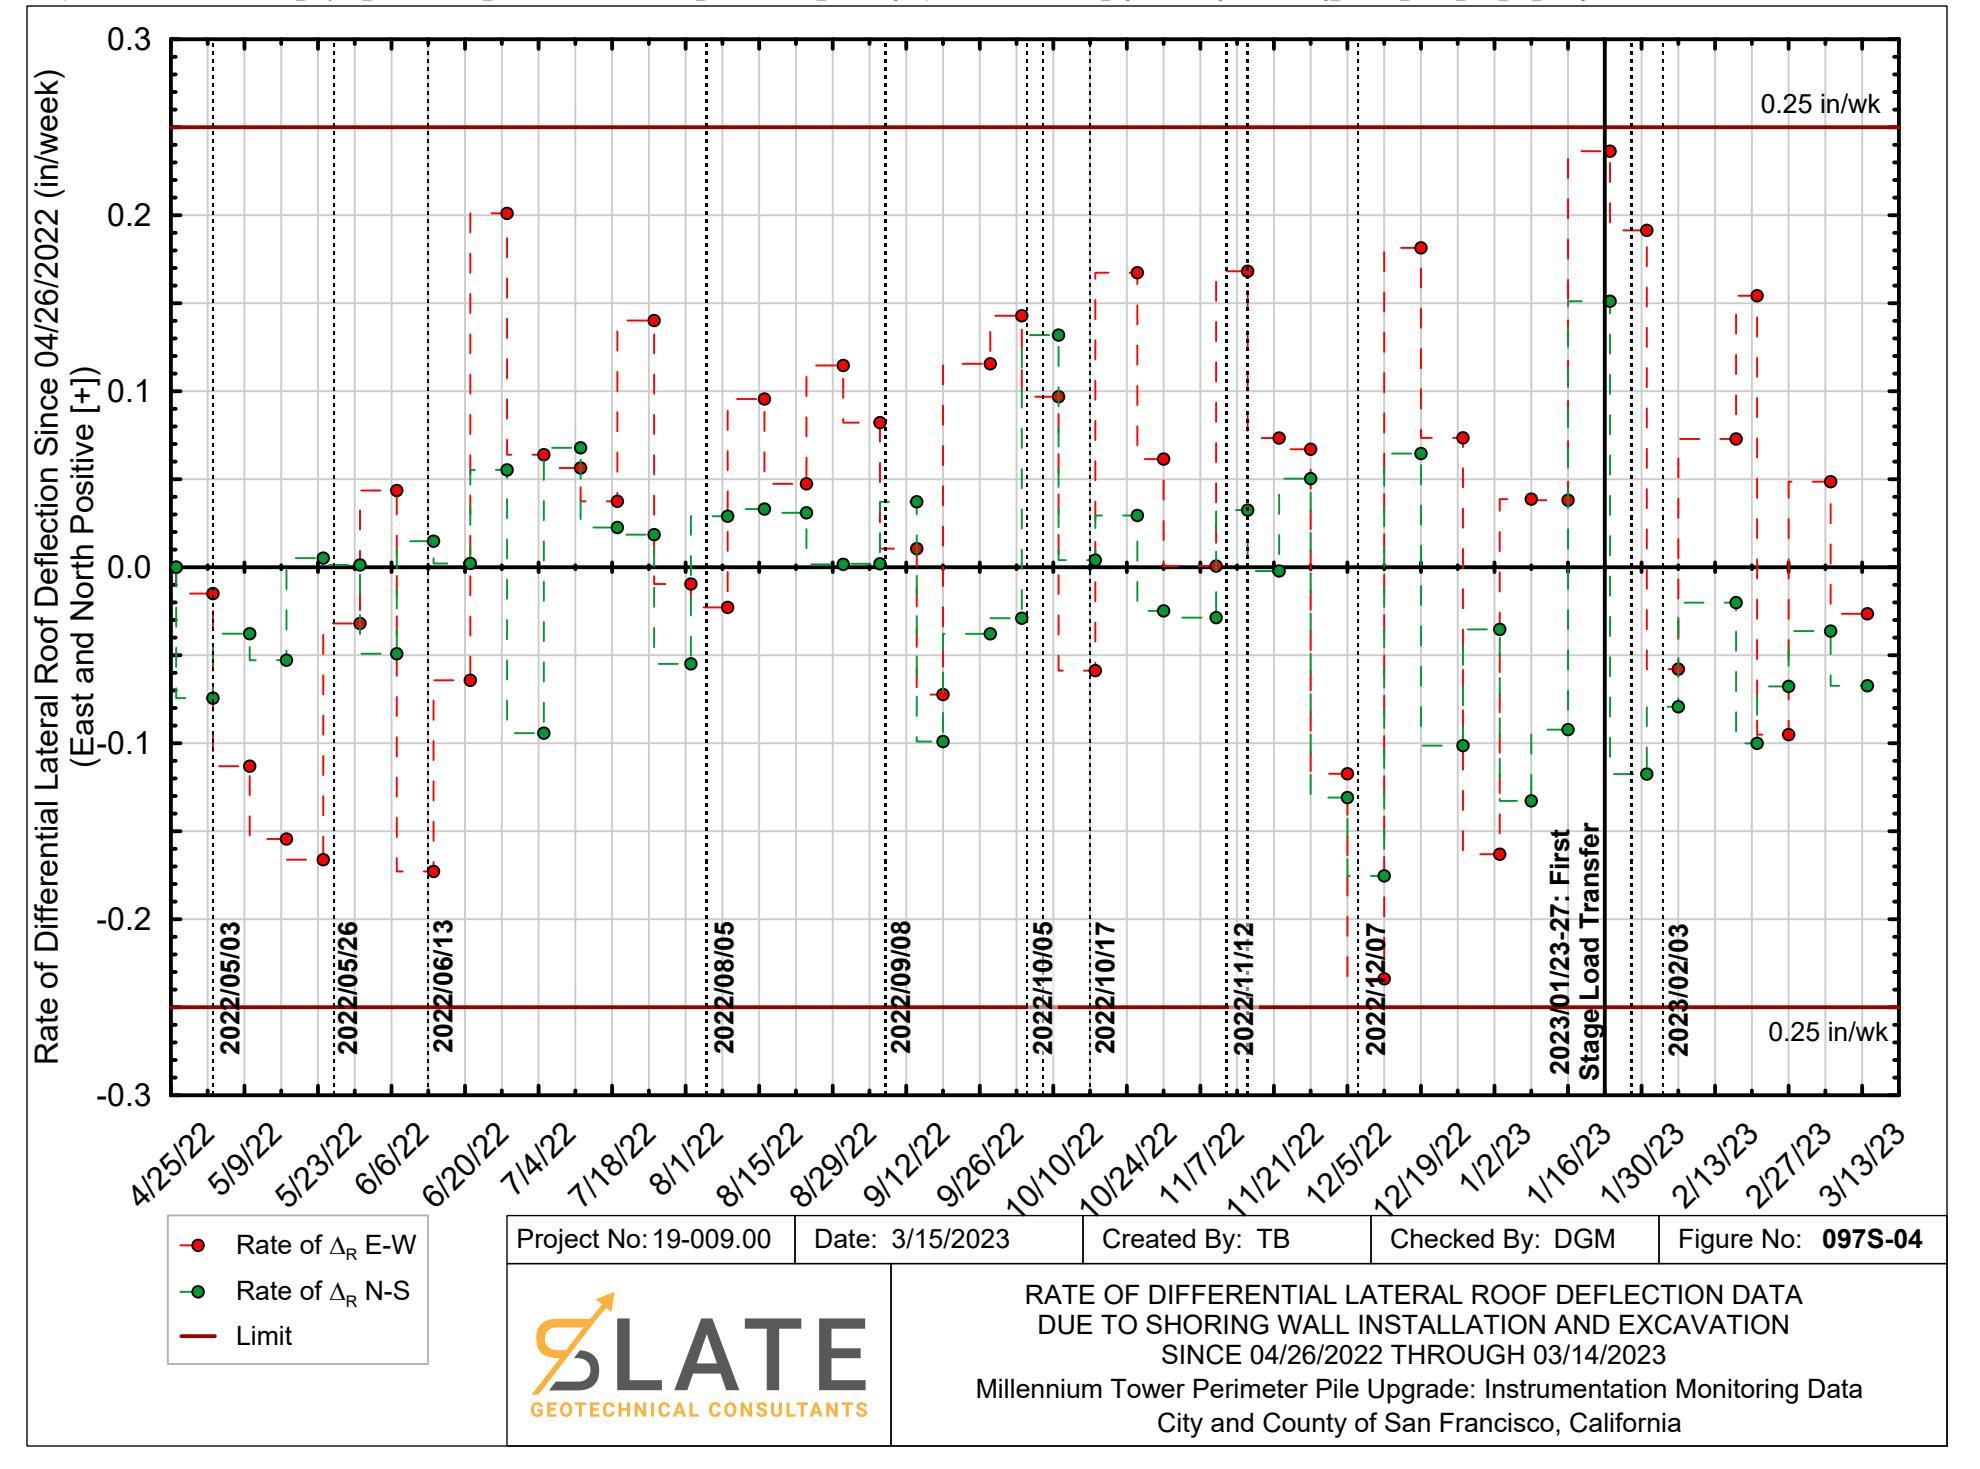
Figure S-04 presents rates of differential lateral roof deflection data due to shoring wall installation and excavation since April 26, 2022, through March 14, 2023. Limits established in the aforementioned letter are included for reference. Note that the rates are calculated as:

$$\frac{d\Delta_R}{dT}\approx \frac{\Delta_{R,t}-\Delta_{R,t-1}}{T_t-T_{t-1}}$$

where: t is an index representing the current instance in time; and

t-1 is an index representing the previous instance in time.
