Project Number: 19-009

Subject: 301 Mission Retrofit Monitoring Report 014: Results as of August 6, 2021

Millennium Tower Perimeter Pile Upgrade: Instrumentation Monitoring Data
City and County of San Francisco, California

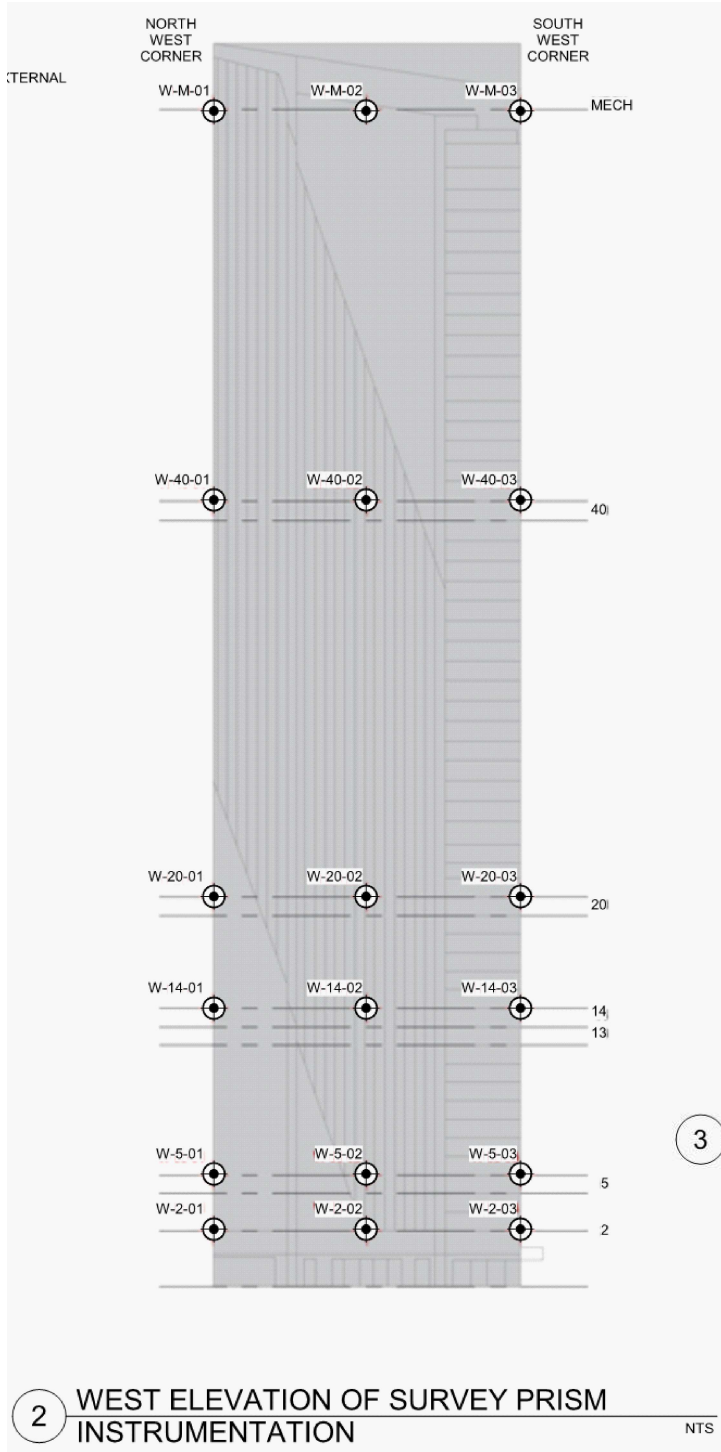
Project No: 19-009.00	Date: 7/26/2021	Created By: NBW	Checked By: DGM	Figure No: 014-01B
-----------------------	-----------------	-----------------	-----------------	---------------------------

TOWER SURVEY PRISM LOCATION SCHEMATIC
