Subject: 301 Mission Retrofit Monitoring Report 109: Results as of June 6, 2023

This memorandum summarizes results from the monitoring plan implemented at the 301 Mission property. Instrumentation to monitor the structure prior to, during and after the retrofit was installed in January 2021, including piezometers and extensometers. Settlement markers installed in April 2009 and January 2017, survey prisms mounted on the exterior of the structure in December 2016, and crack gauges installed in April 2009 have also been monitored. Pile load cells were installed on the Mission Street piles in January 2023. Survey markers were installed on the Mission Street mat extension in January 2023. This memorandum is for review only. It only contains ongoing monitoring information. This memorandum does not contain recommendations based upon the ongoing monitoring information.

Millennium Tower Perimeter Pile Upgrade: Instrumentation Monitoring Data  
City and County of San Francisco, California

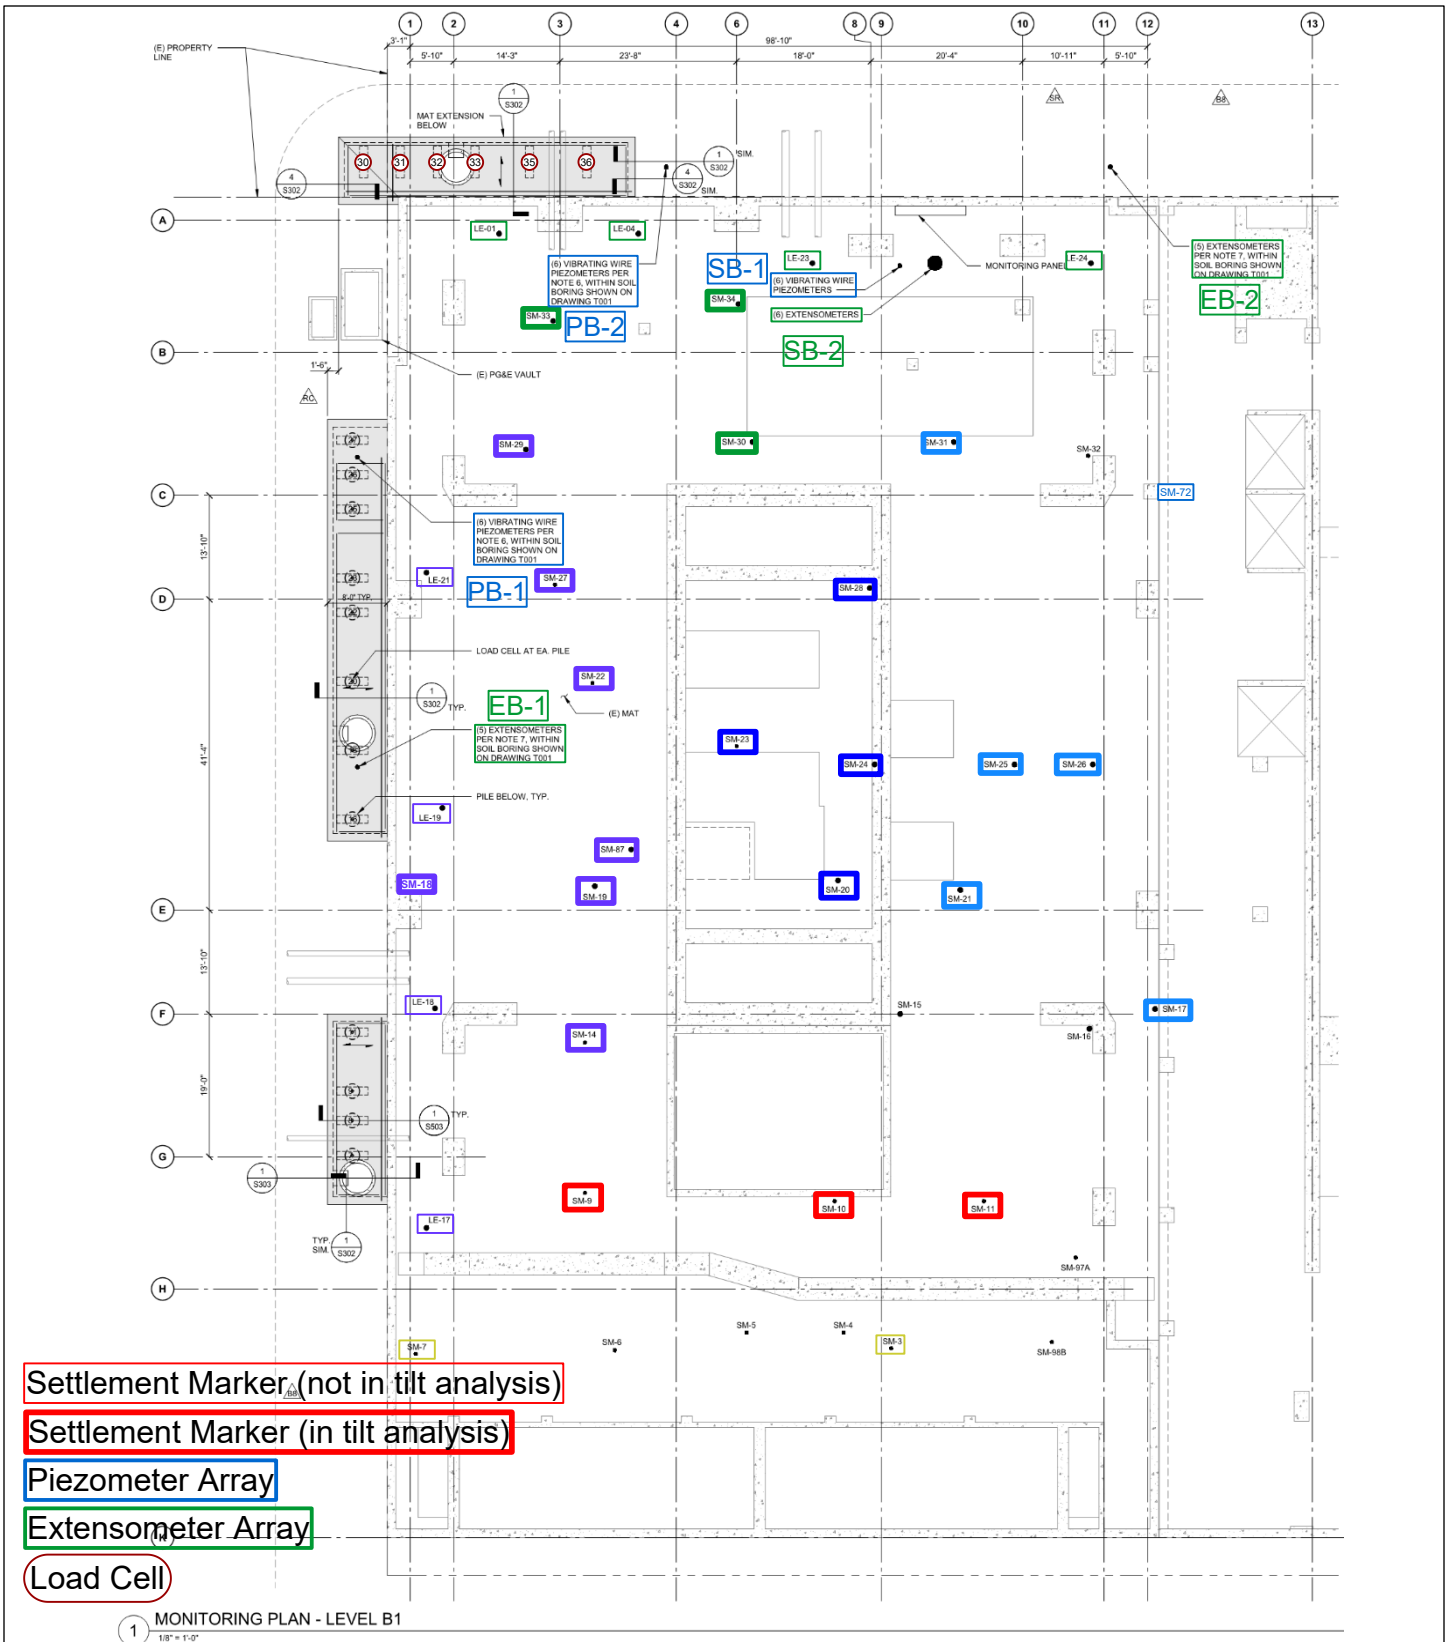
Project No: 19-009.00	Date: 2/1/2023	Created By: NBW	Checked By: DGM	Figure No: 109-01A
-----------------------	----------------	-----------------	-----------------	--------------------

Figure 01 presents the instrument locations as referenced in later figures.

**INSTRUMENT LOCATION MAP**  
SETTLEMENT MARKERS, PIEZOMETERS, EXTENSOMETERS, LOAD CELLS

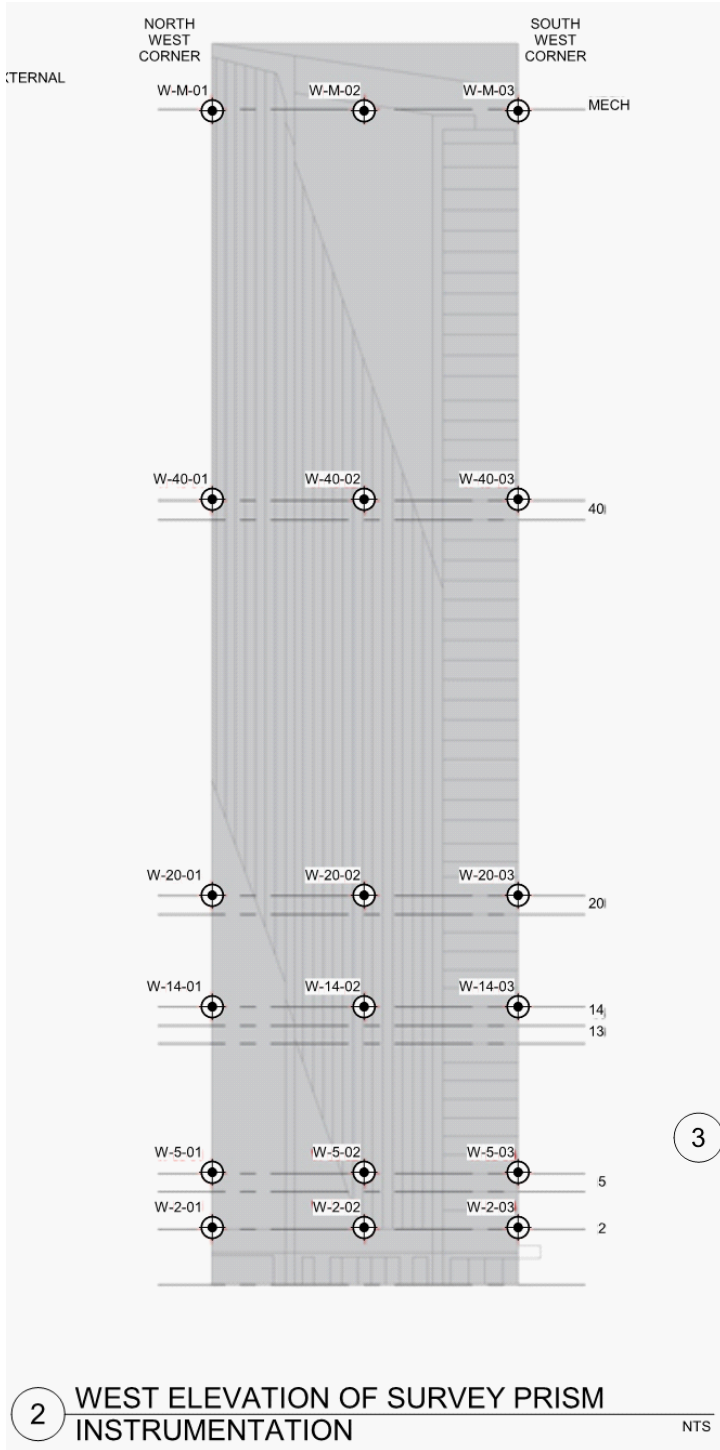
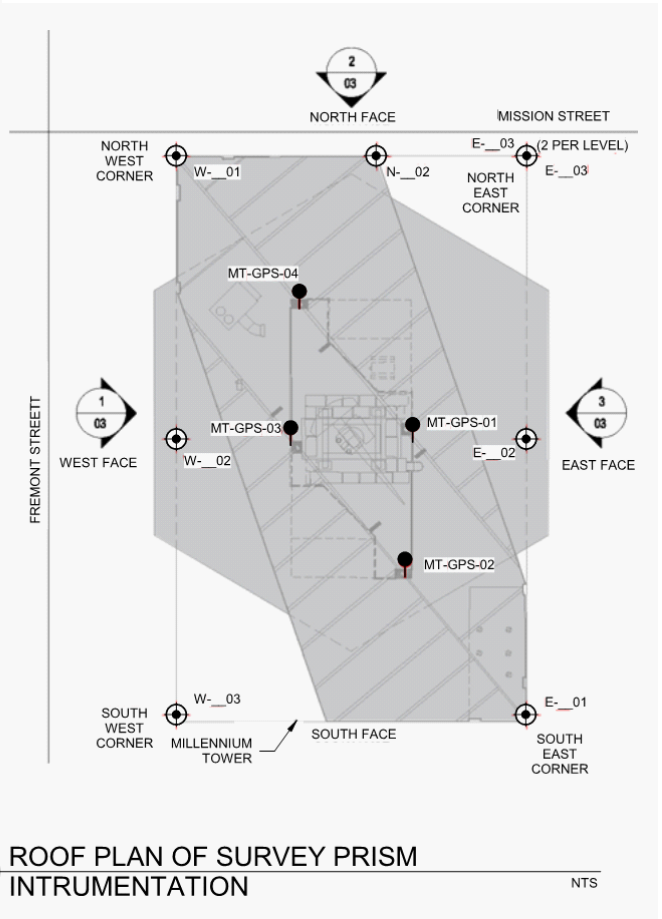
Project No: 19-009.00	Date: 7/26/2021	Created By: NBW	Checked By: DGM	Figure No: <b>109-01B</b>
-----------------------	-----------------	-----------------	-----------------	---------------------------

**TOWER SURVEY PRISM LOCATION SCHEMATIC**

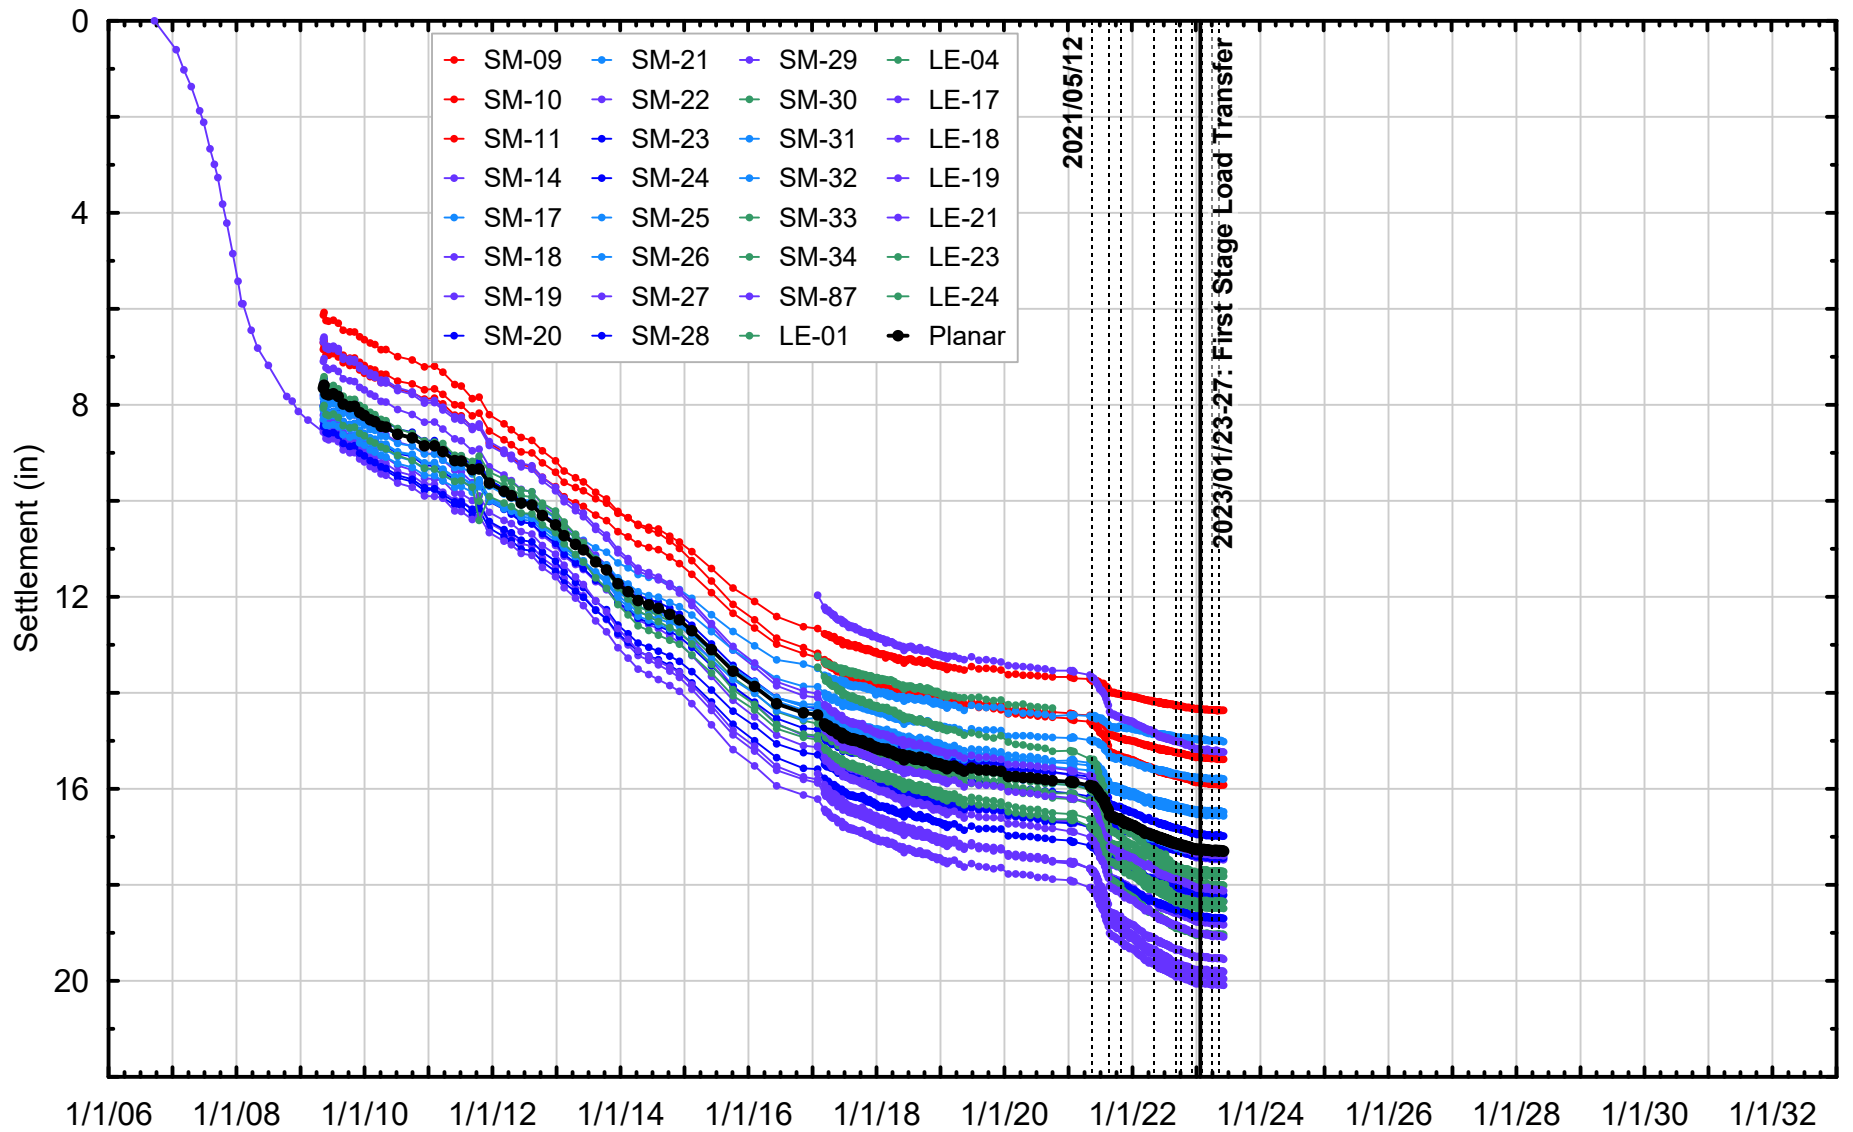
Project No: 19-009.00	Date: 6/7/2023	Created By: NBW	Checked By: DGM	Figure No: <b>109-02</b>
-----------------------	----------------	-----------------	-----------------	--------------------------

Figure 02 presents the historical settlement data interpreted from settlement markers installed on the B-1 Level of 301 Mission Tower. In addition, data from surveys performed during the retrofit are included. Figure 03A presents settlement data since the start of production pile installation (May 12, 2021; baseline readings on May 10, 2021) through June 5, 2023. Figure 03B presents settlement data since January 11, 2021, through June 5, 2023. Figure 04 presents current settlement contours (in inches) on June 5, 2023.

HISTORICAL SETTLEMENT MARKER DATA

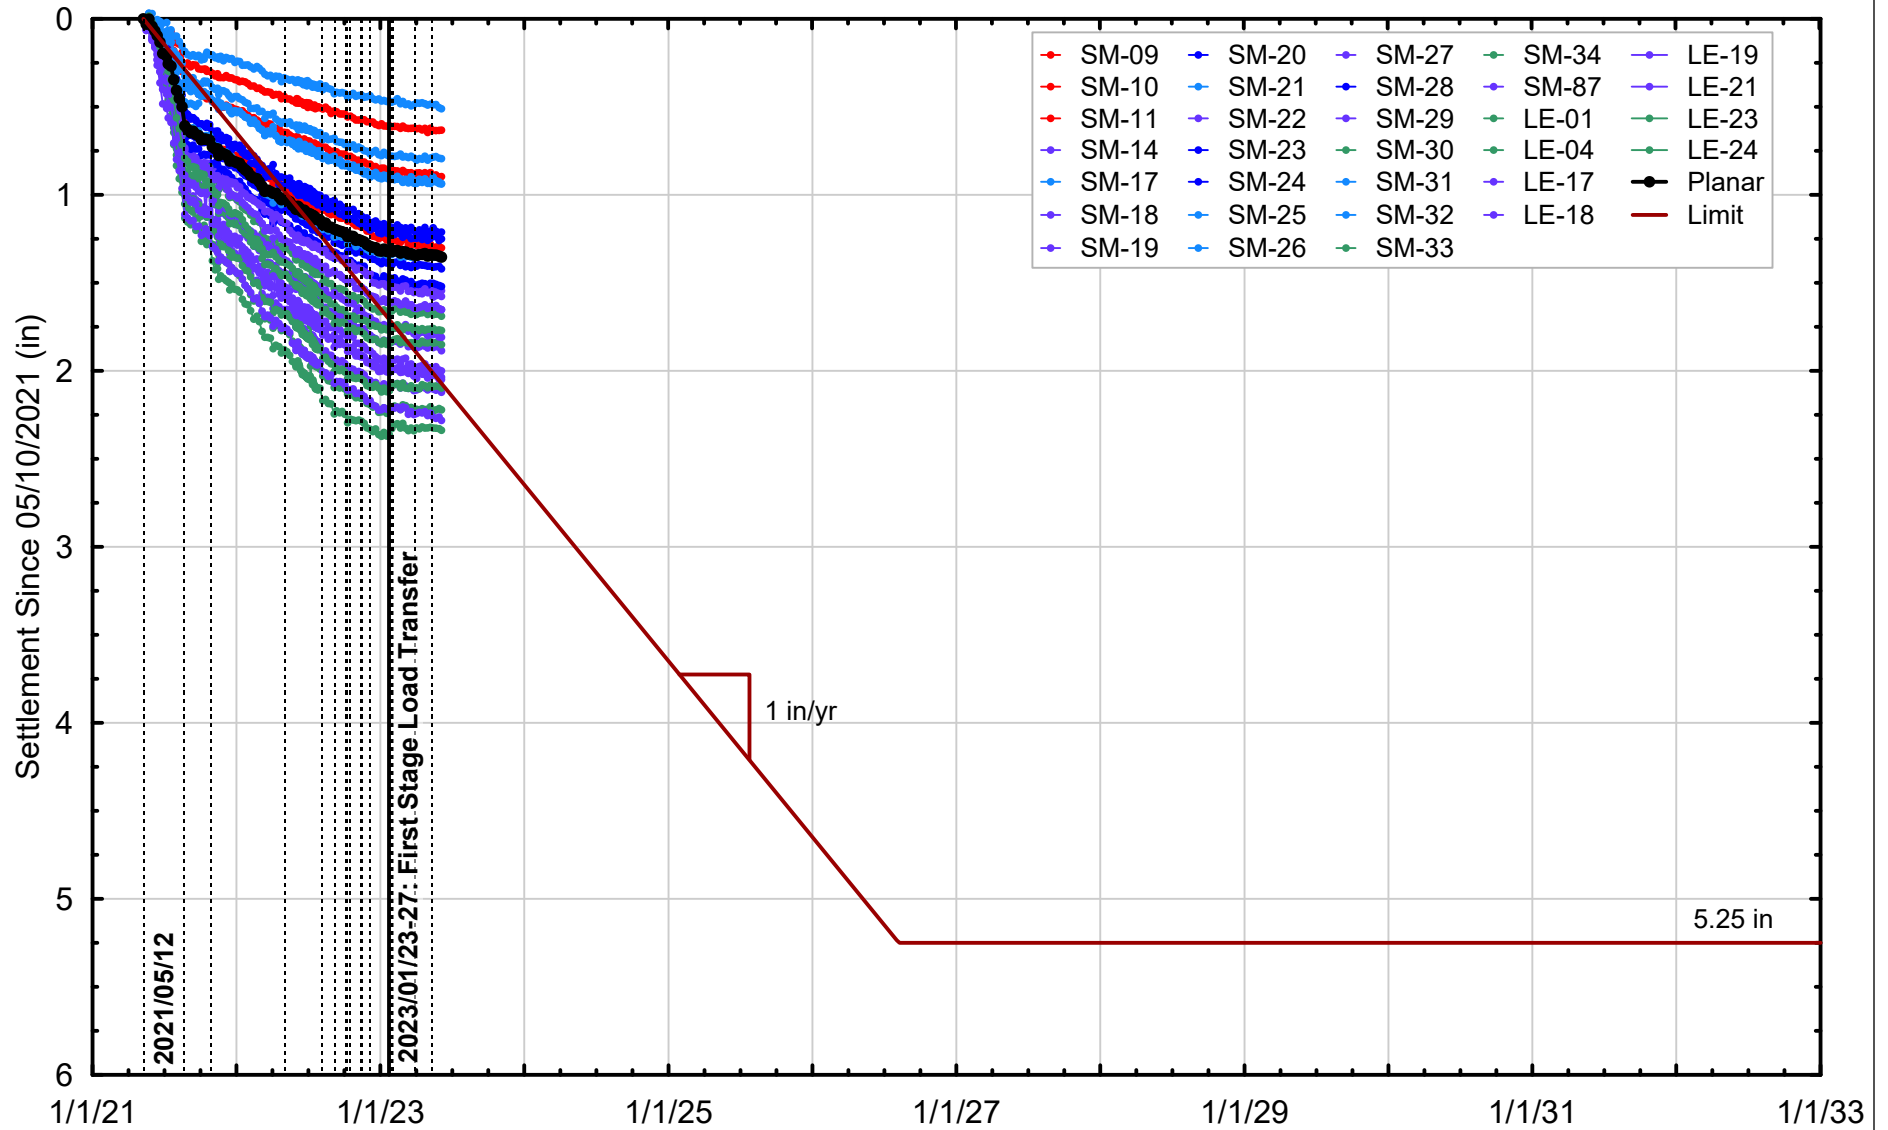
Project No: 19-009.00	Date: 6/7/2023	Created By: NBW	Checked By: DGM	Figure No: <b>109-03A</b>
-----------------------	----------------	-----------------	-----------------	---------------------------

SETTLEMENT MARKER DATA  
SINCE 05/10/2021 THROUGH 06/05/2023

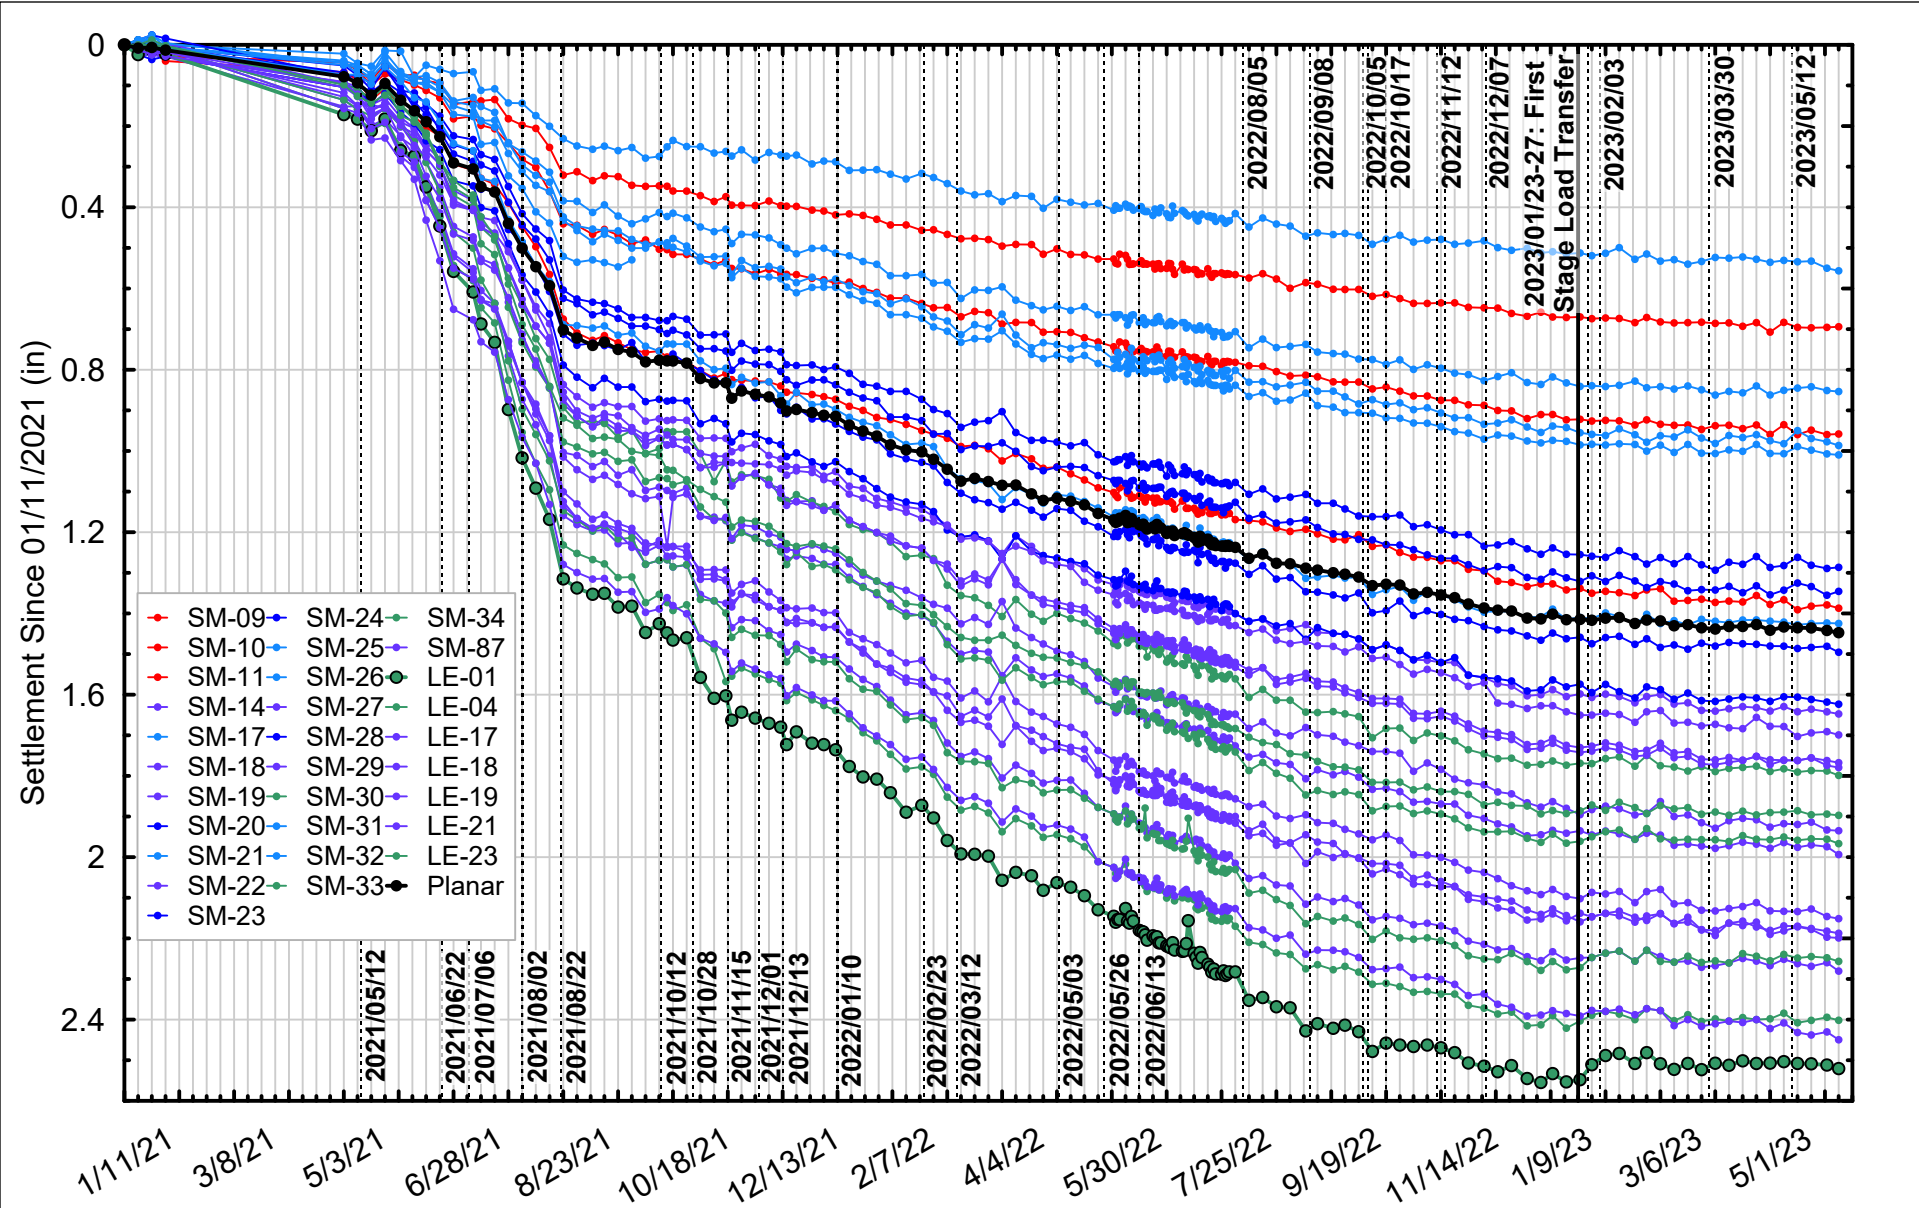
Project No: 19-009.00	Date: 6/7/2023	Created By: NBW	Checked By: DGM	Figure No: <b>109-03B</b>
-----------------------	----------------	-----------------	-----------------	---------------------------

SETTLEMENT MARKER DATA  
SINCE 01/11/2021 THROUGH 06/05/2023

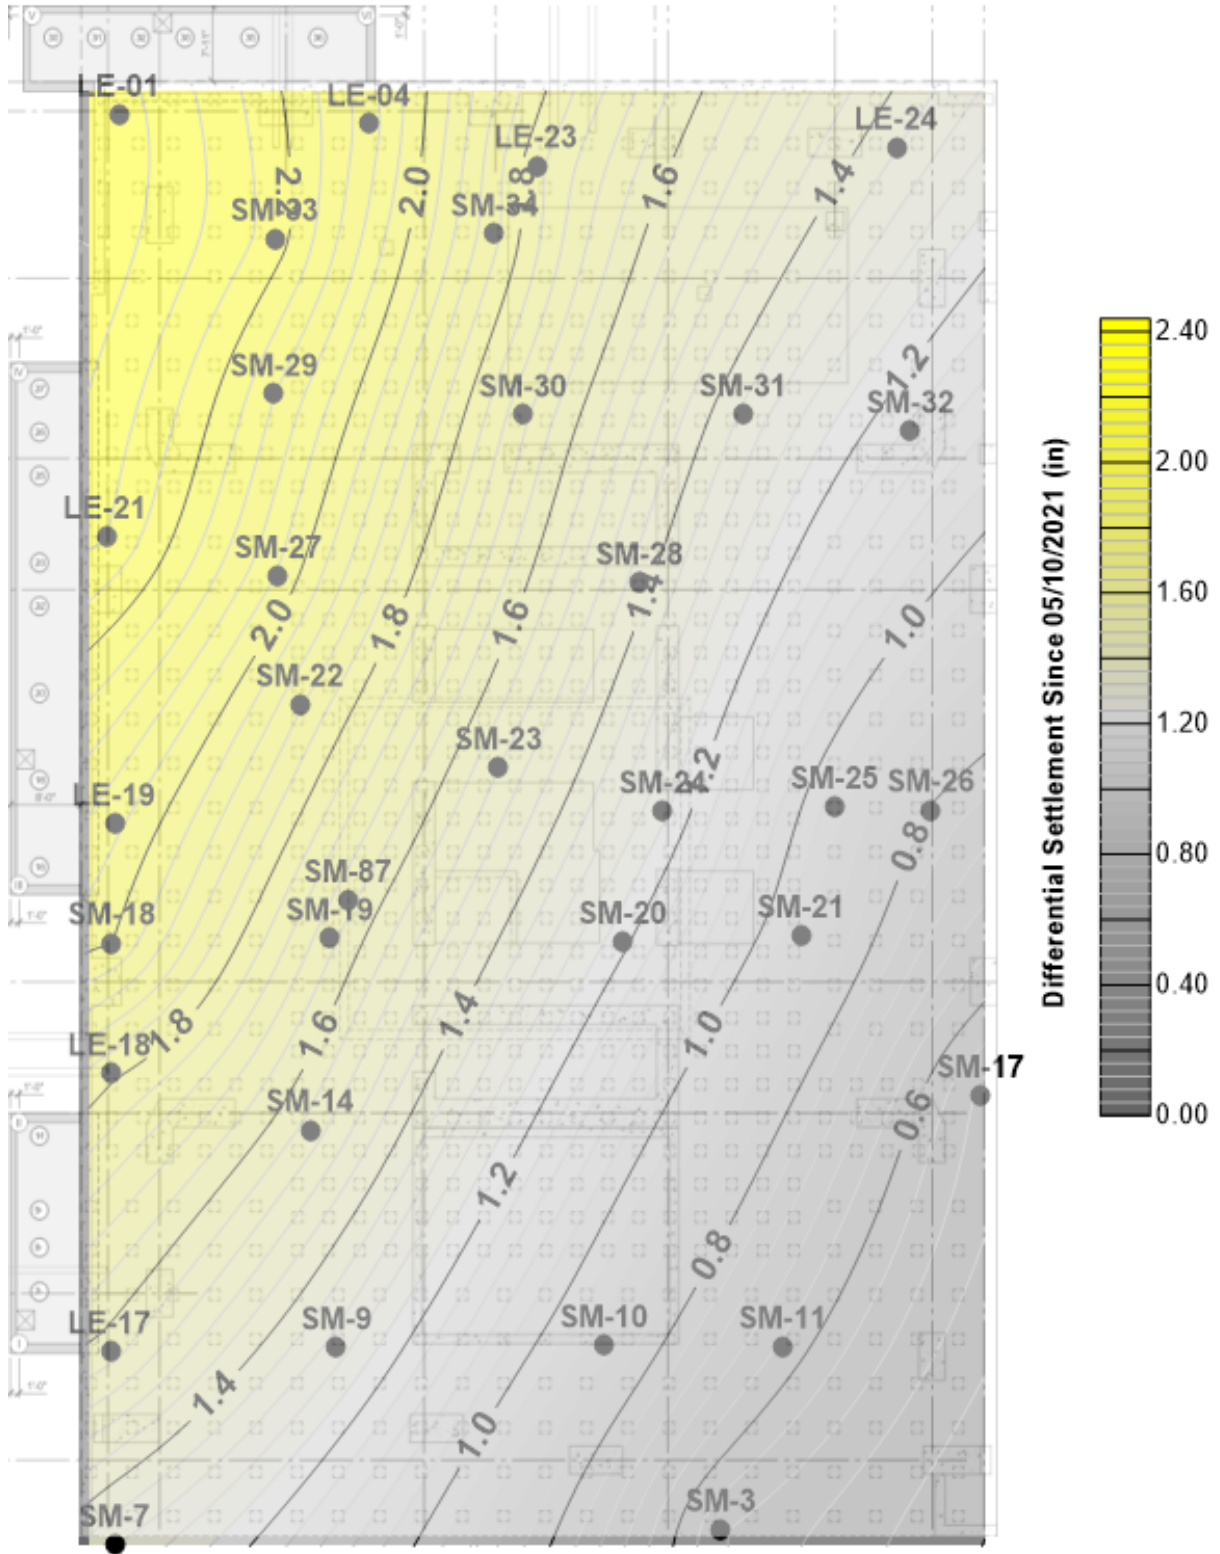
Figure No: **109-04**

SETTLEMENT CONTOURS  
SINCE 05/10/2021 THROUGH 06/05/2023

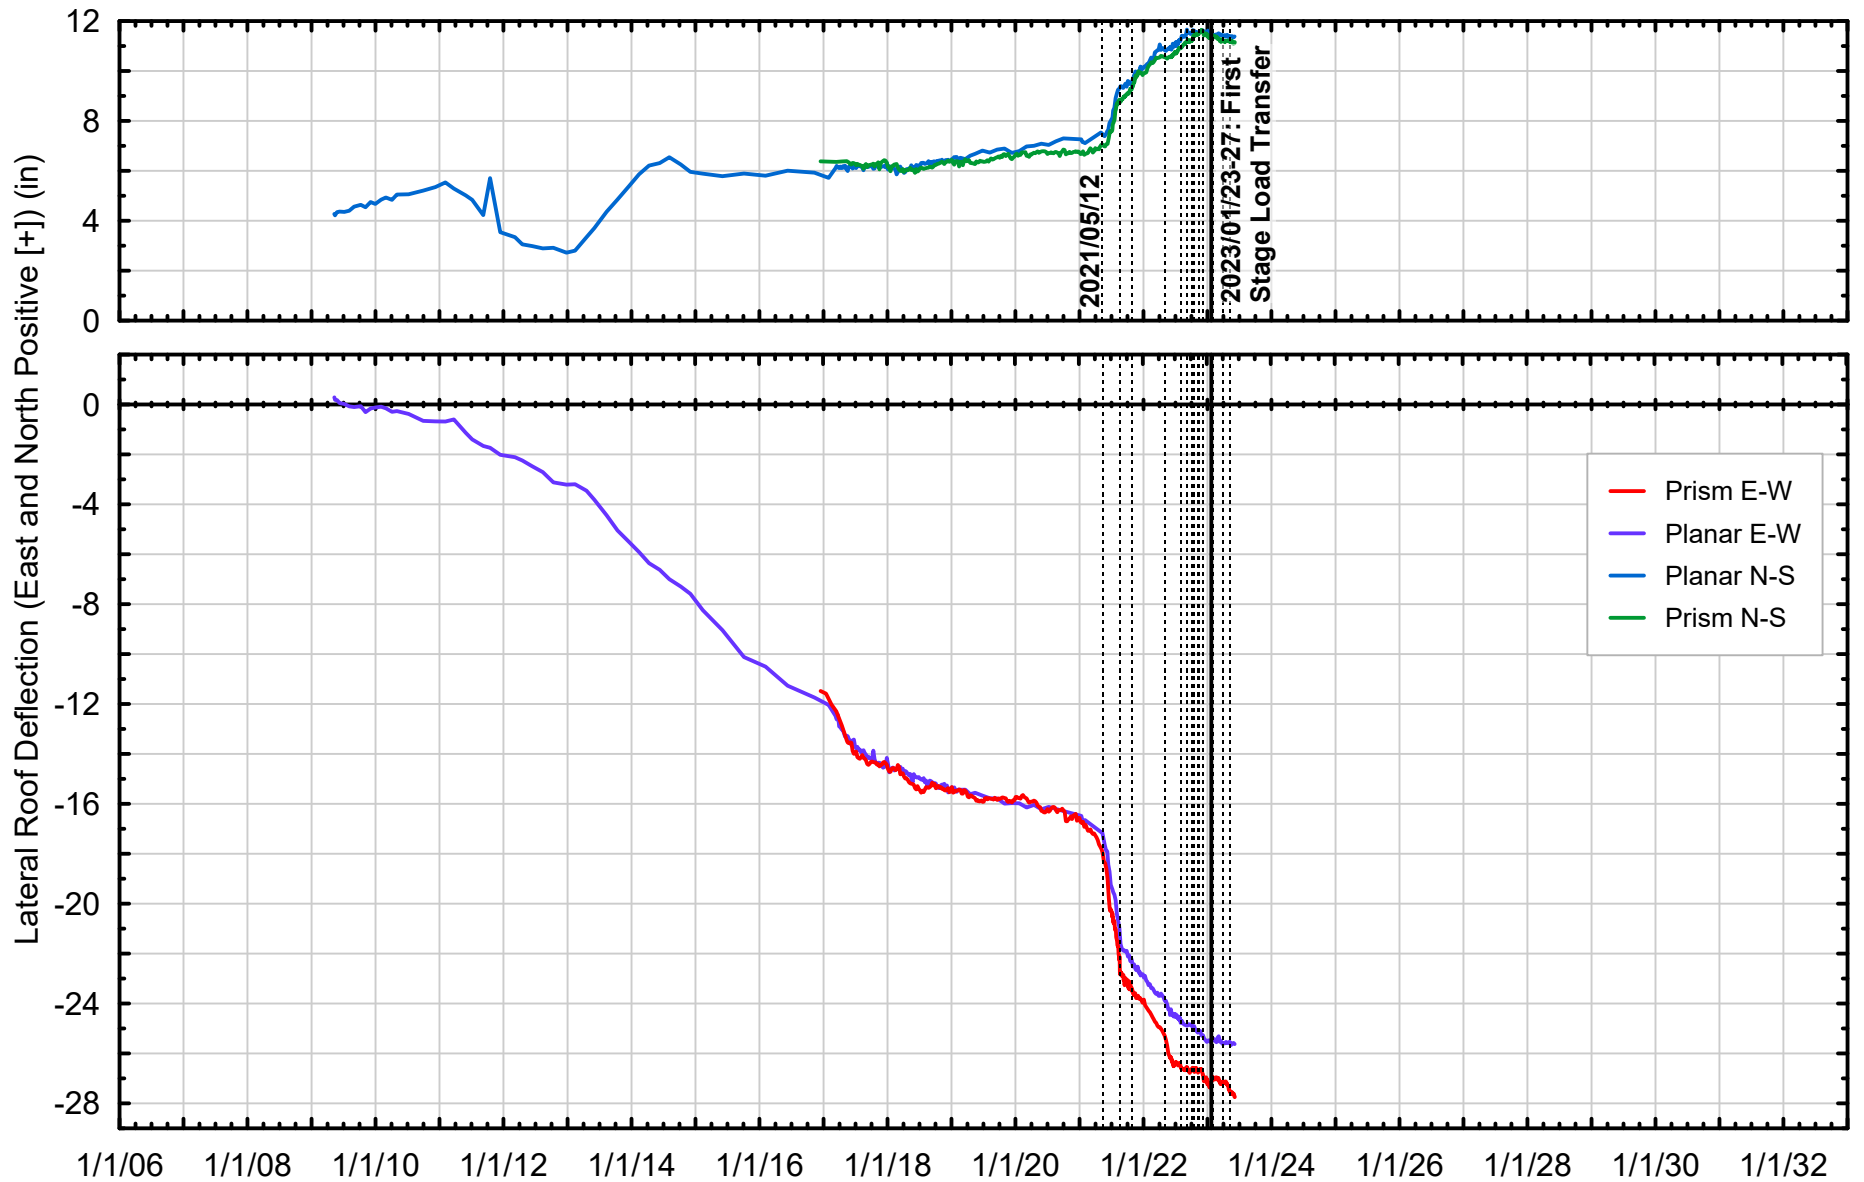
Project No: 19-009.00	Date: 6/7/2023	Created By: NBW	Checked By: DGM	Figure No: <b>109-05</b>
-----------------------	----------------	-----------------	-----------------	--------------------------

Figure 05 presents historical lateral roof deflections in the project north-south and project east-west directions interpreted from survey prisms mounted on the exterior of the Tower, from InSAR data, and from a planar fit of the settlement marker data. In addition, data from surveys performed during the retrofit are included. Figure 06A presents lateral roof deflection data from a planar fit of the settlement marker data and from survey prisms mounted on the exterior of the Tower since the start of production pile installation (May 12, 2021; baseline readings on May 10 and 13, 2021, respectively) through June 6, 2023. Figure 06B presents lateral roof deflection data from a planar fit of the settlement marker data and from survey prisms mounted on the exterior of the Tower since January 11, 2021, through June 6, 2023.

HISTORICAL LATERAL ROOF DEFLECTION DATA

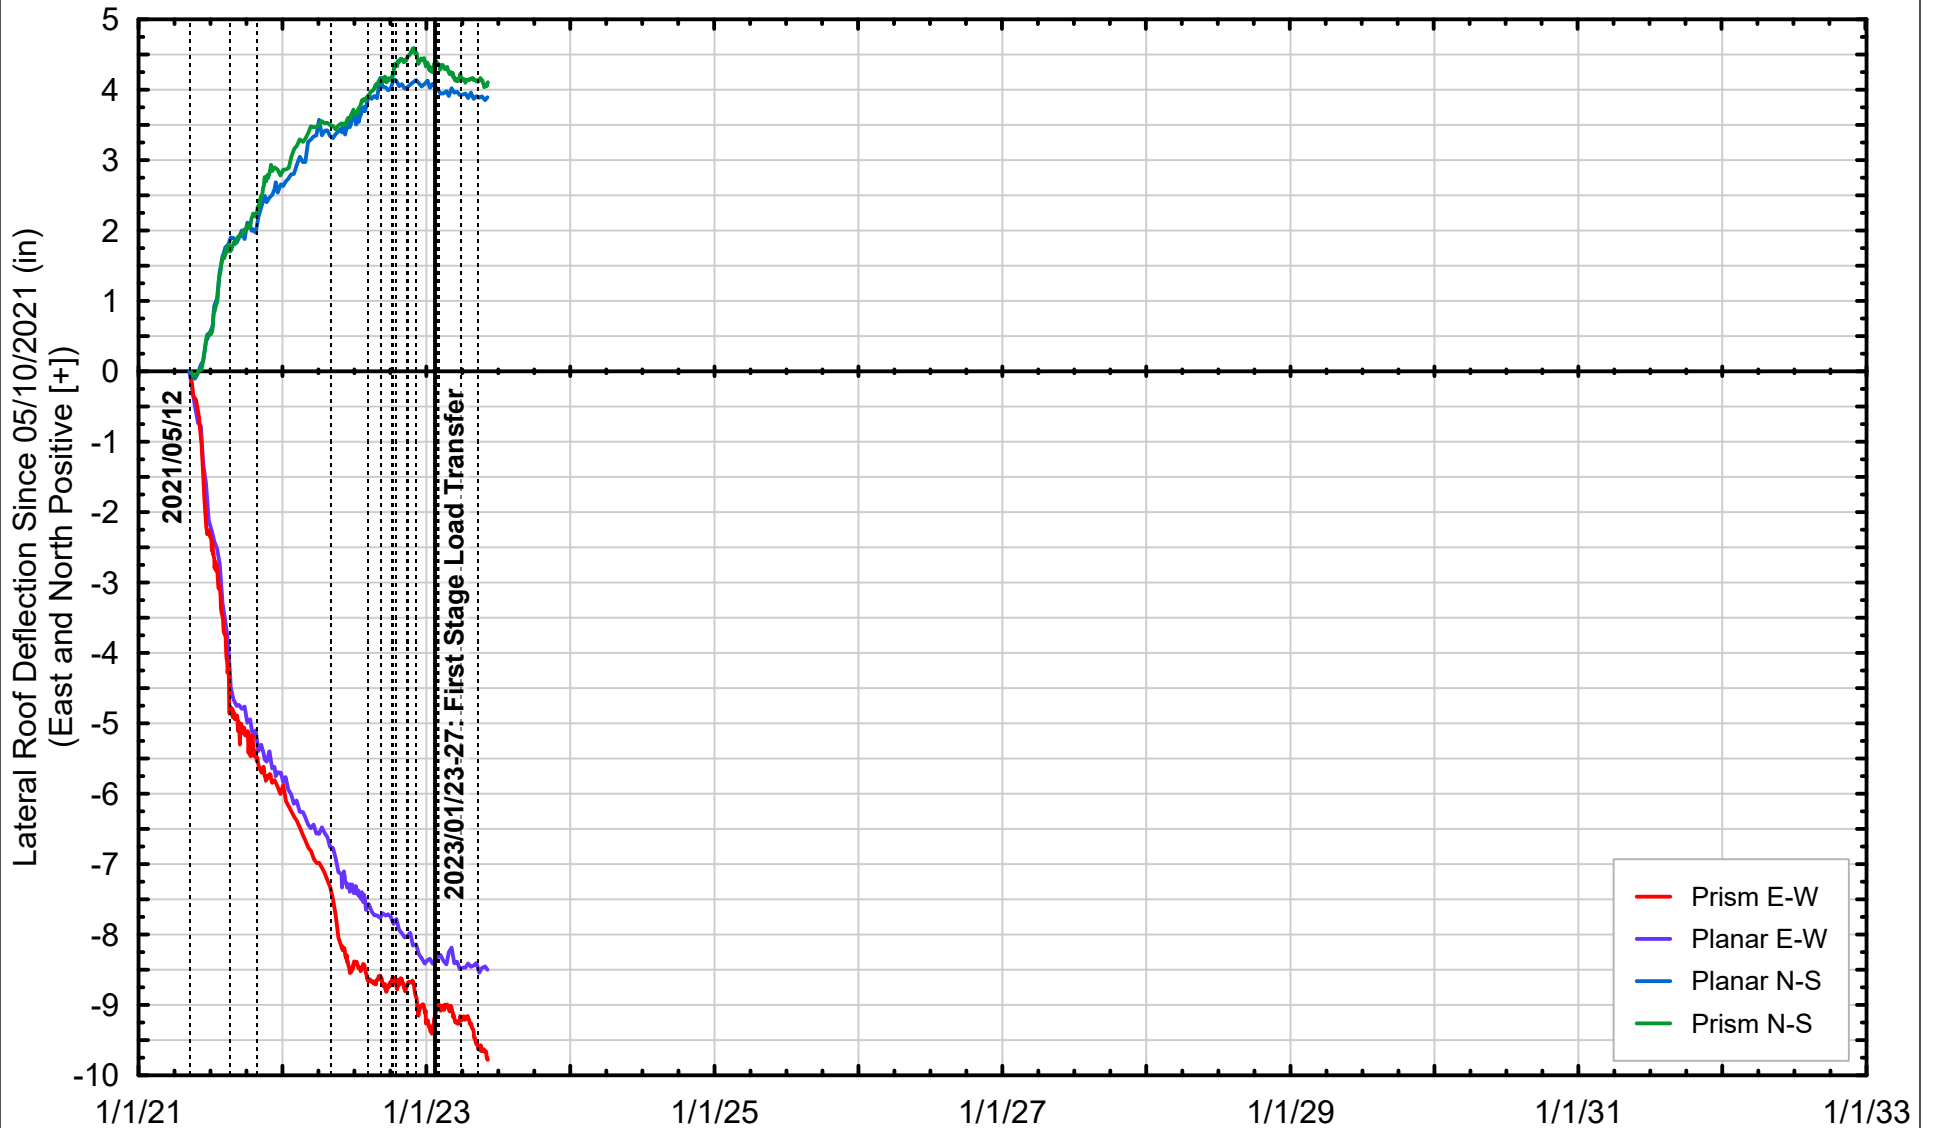
Project No: 19-009.00	Date: 6/7/2023	Created By: NBW	Checked By: DGM	Figure No: 109-06A
-----------------------	----------------	-----------------	-----------------	--------------------

LATERAL ROOF DEFLECTION DATA  
SINCE 05/10/2021 THROUGH 06/06/2023

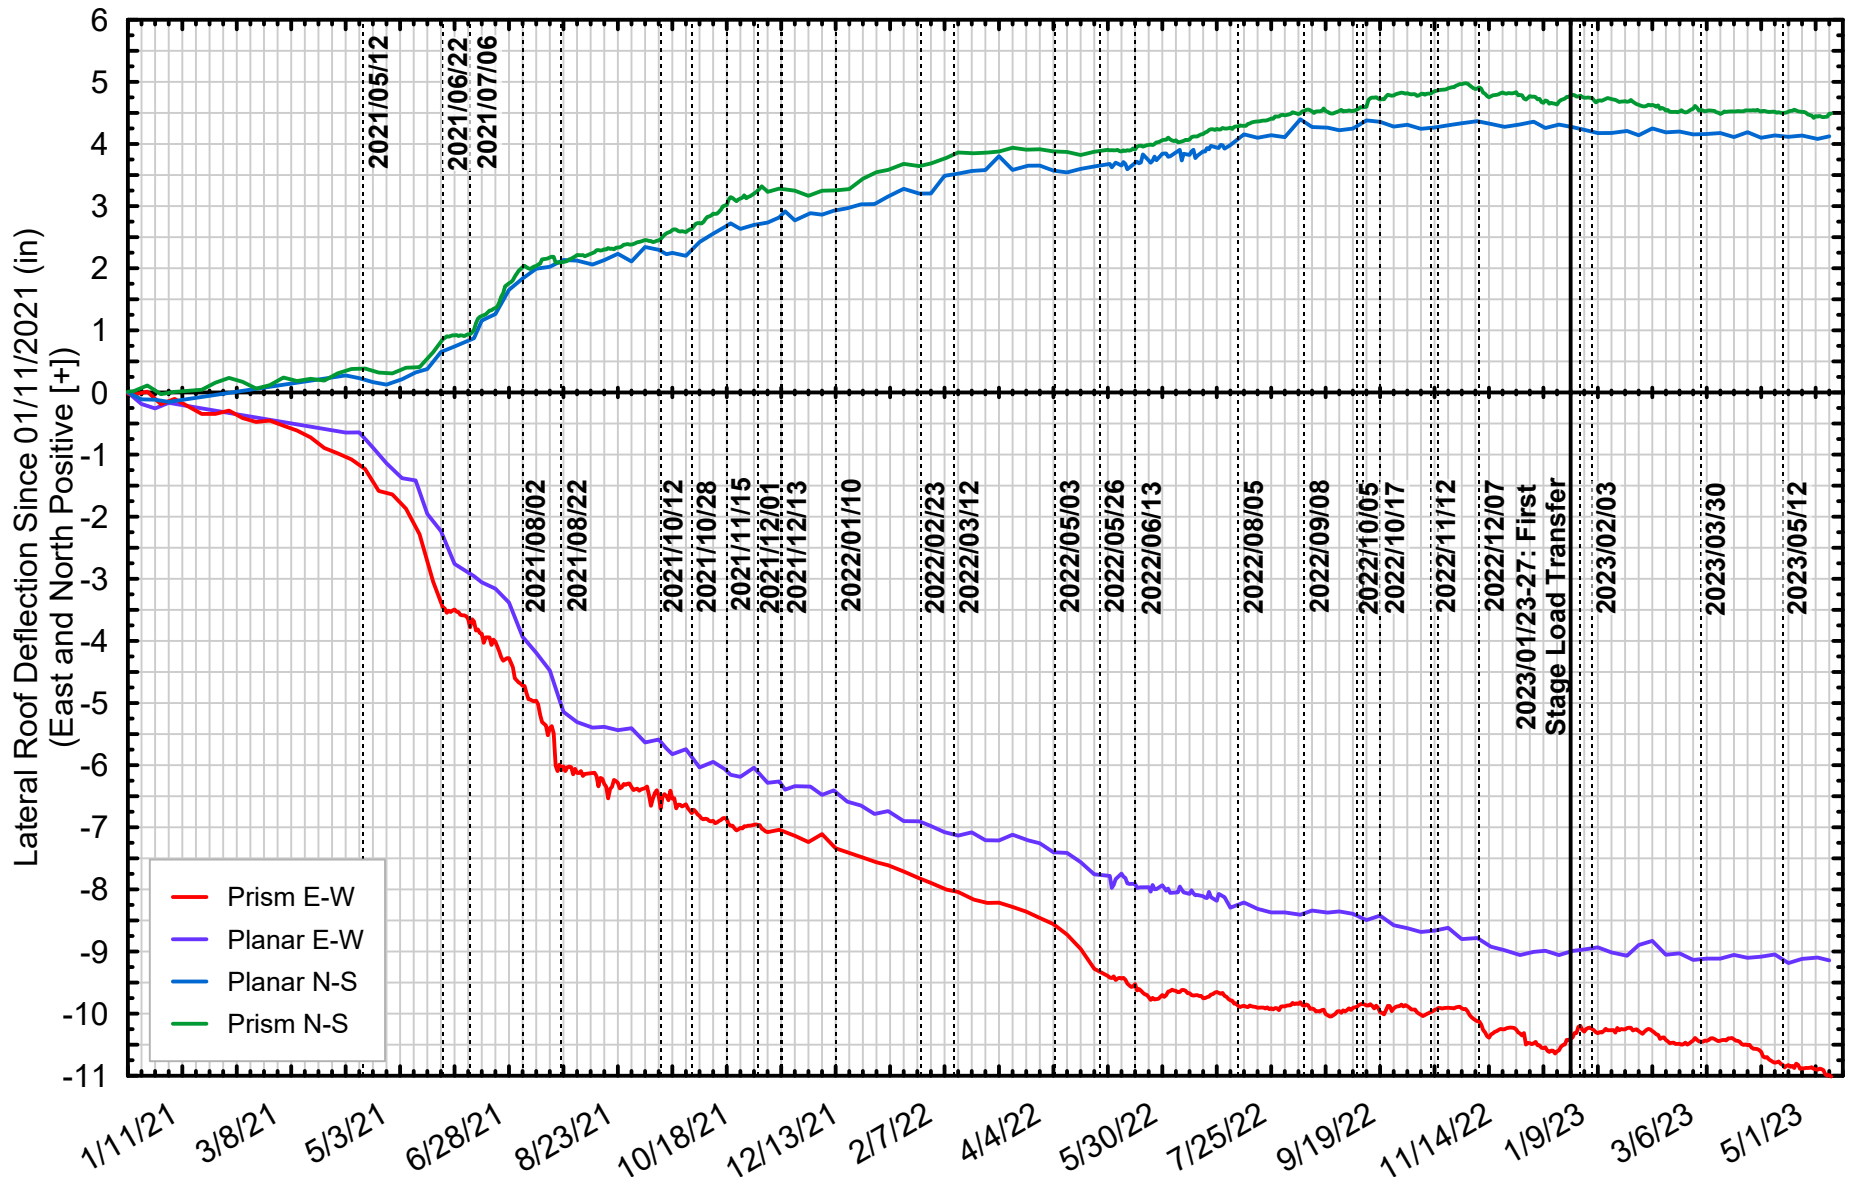
Project No: 19-009.00	Date: 6/7/2023	Created By: NBW	Checked By: DGM	Figure No: 109-06B
-----------------------	----------------	-----------------	-----------------	--------------------

LATERAL ROOF DEFLECTION DATA  
SINCE 01/11/2021 THROUGH 06/06/2023

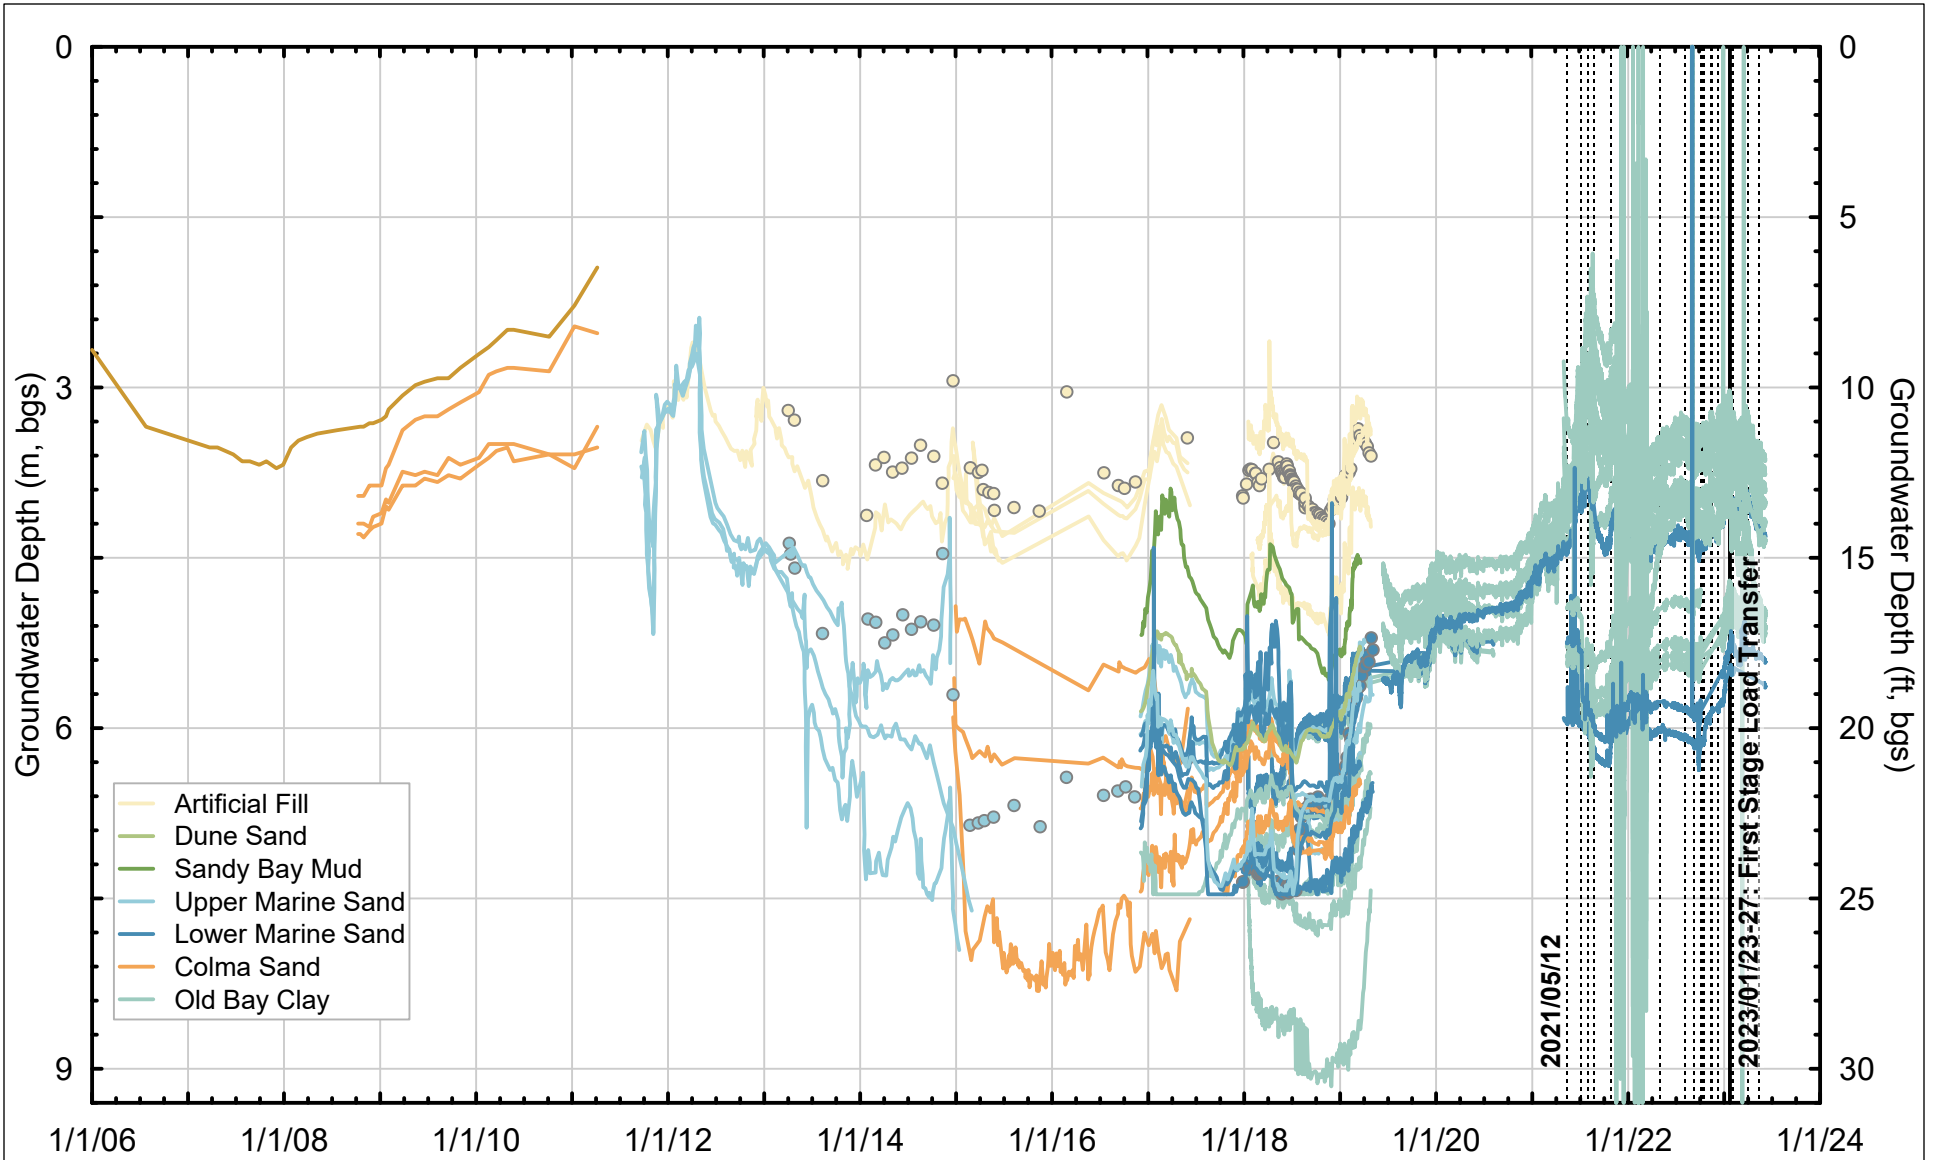
Project No: 19-009.00	Date: 6/7/2023	Created By: NBW	Checked By: DGM	Figure No: <b>109-07</b>
-----------------------	----------------	-----------------	-----------------	--------------------------

Figure 07 presents the historical groundwater elevation interpreted from piezometer readings at locations near 301 Mission. In addition, data from piezometers installed to monitor groundwater elevation during the retrofit are included. Figures 08 and 09 present groundwater elevation interpreted from piezometer readings in the Marine/Colma Sand and the Old Bay Clay, respectively, for the time period prior to the start of production pile installation (January 1, 2021) through June 6, 2023.

HISTORICAL GROUNDWATER ELEVATION MEASUREMENTS  
AT LOCATIONS NEAR 301 MISSION
