Subject: 301 Mission Retrofit Monitoring Report 109: Results as of June 6, 2023

This memorandum summarizes results from the monitoring plan implemented at the 301 Mission property. Instrumentation to monitor the structure prior to, during and after the retrofit was installed in January 2021, including piezometers and extensometers. Settlement markers installed in April 2009 and January 2017, survey prisms mounted on the exterior of the structure in December 2016, and crack gauges installed in April 2009 have also been monitored. Pile load cells were installed on the Mission Street piles in January 2023. Survey markers were installed on the Mission Street mat extension in January 2023. This memorandum is for review only. It only contains ongoing monitoring information. This memorandum does not contain recommendations based upon the ongoing monitoring information.

Millennium Tower Perimeter Pile Upgrade: Instrumentation Monitoring Data  
City and County of San Francisco, California

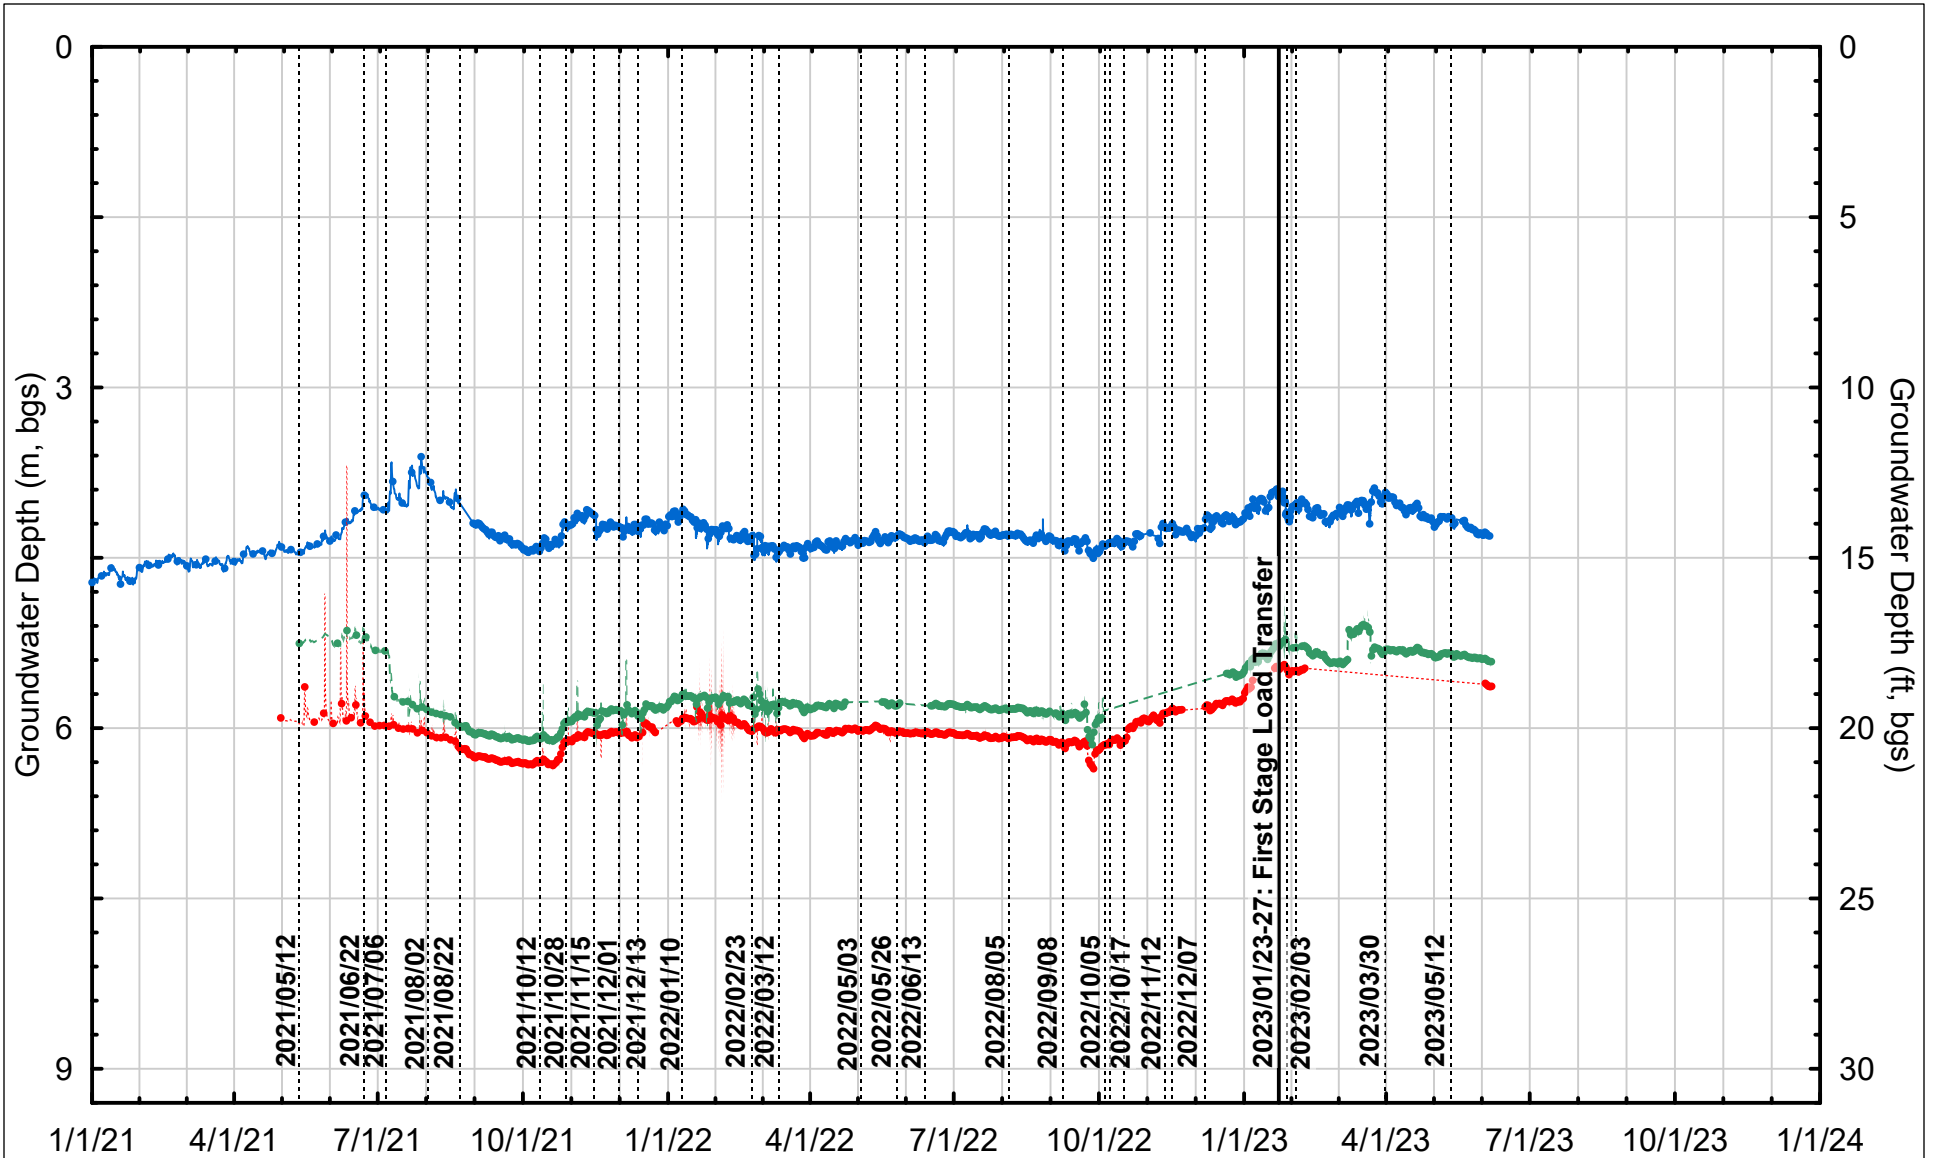
Figure No: **109-08A**

Note that one of the Mission Street piezometers, PB-2, has been offline since October 3, 2022. Please contact us if you have any comments or questions, or if you would like to discuss the results presented in this memorandum.

GROUNDWATER ELEVATION MEASUREMENTS IN MARINE AND COLMA SAND  
SINCE 01/01/2021 THROUGH 06/06/2023

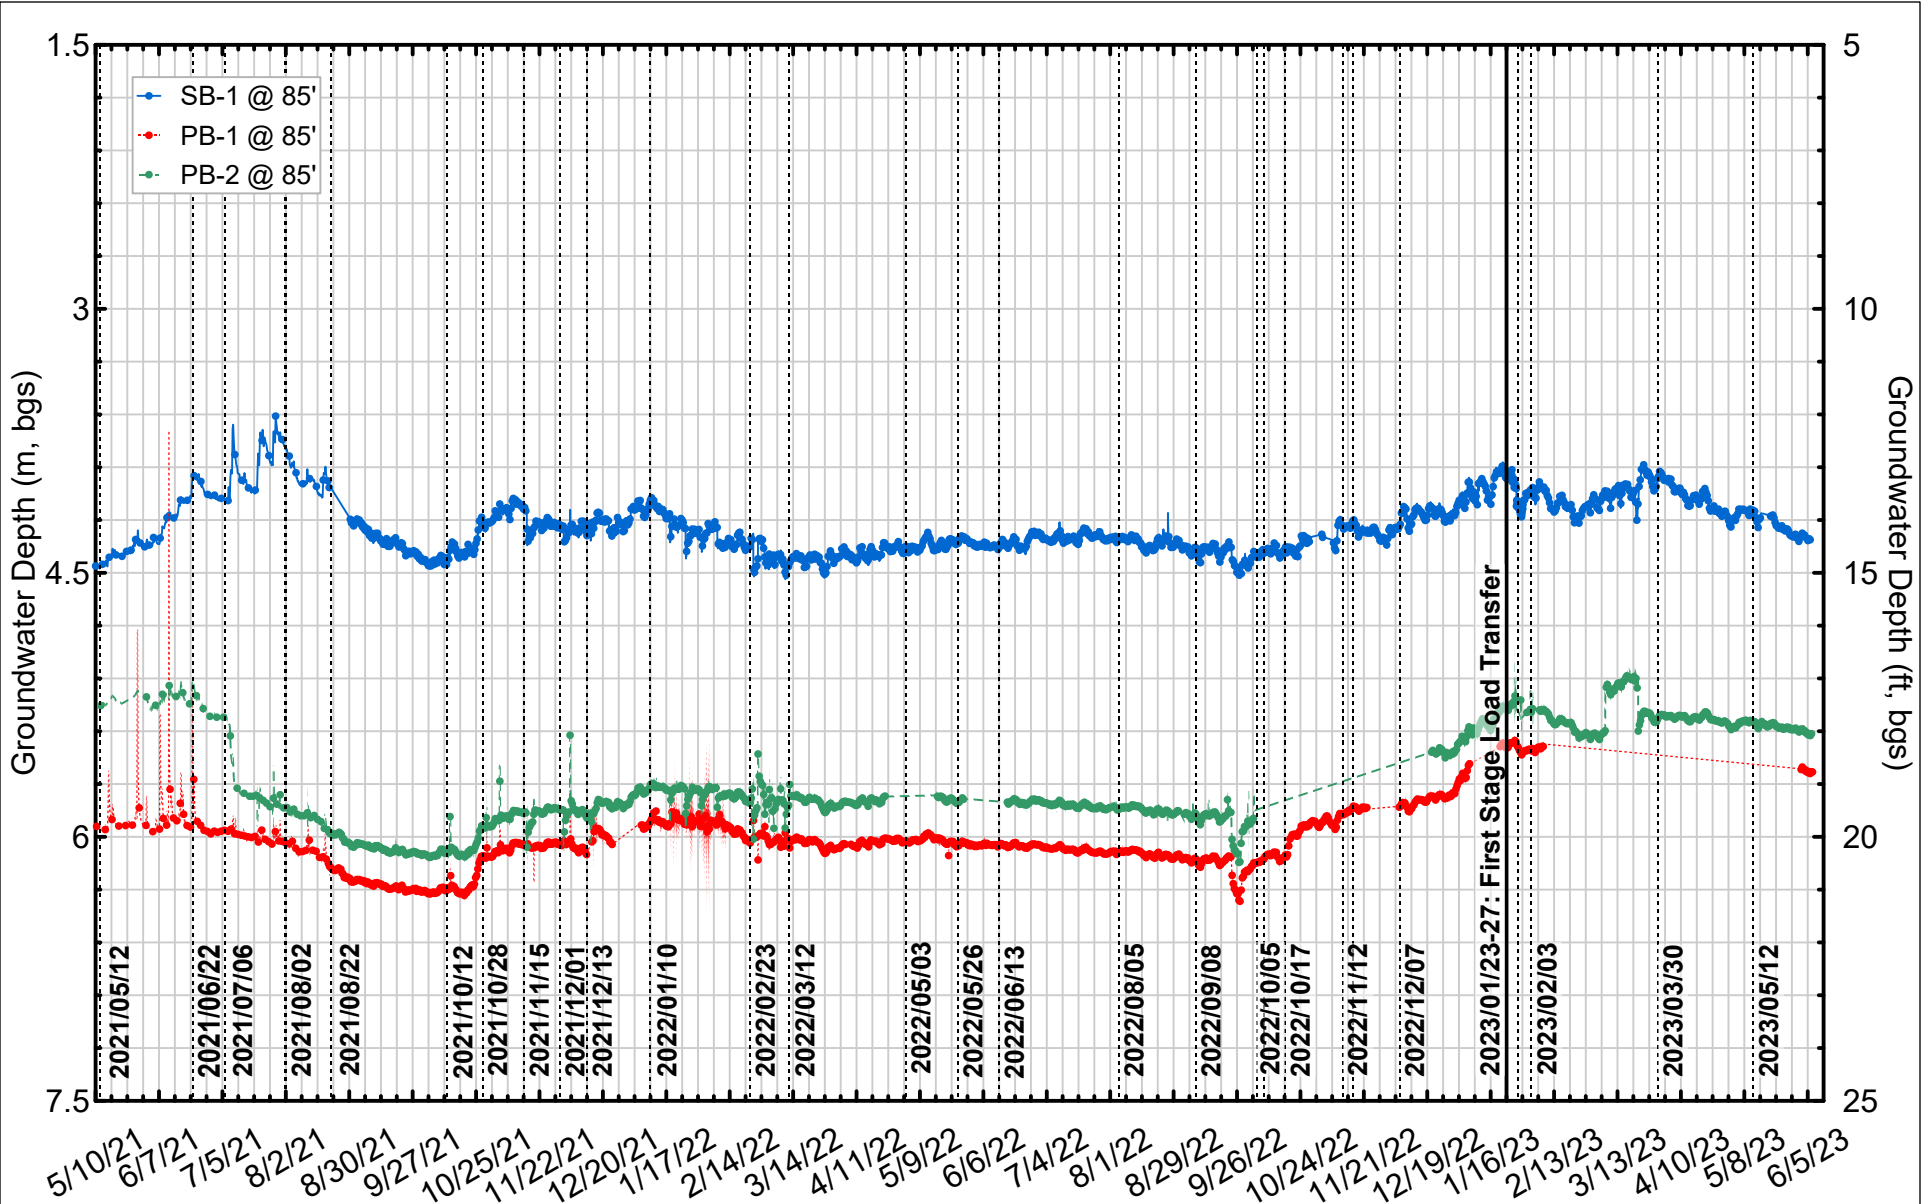
Project No: 19-009.00 | Date: 6/7/2023 | Created By: NBW | Checked By: DGM | Figure No: 109-08B

GROUNDWATER ELEVATION MEASUREMENTS IN MARINE AND COLMA SAND  
SINCE 05/10/2021 THROUGH 06/06/2023

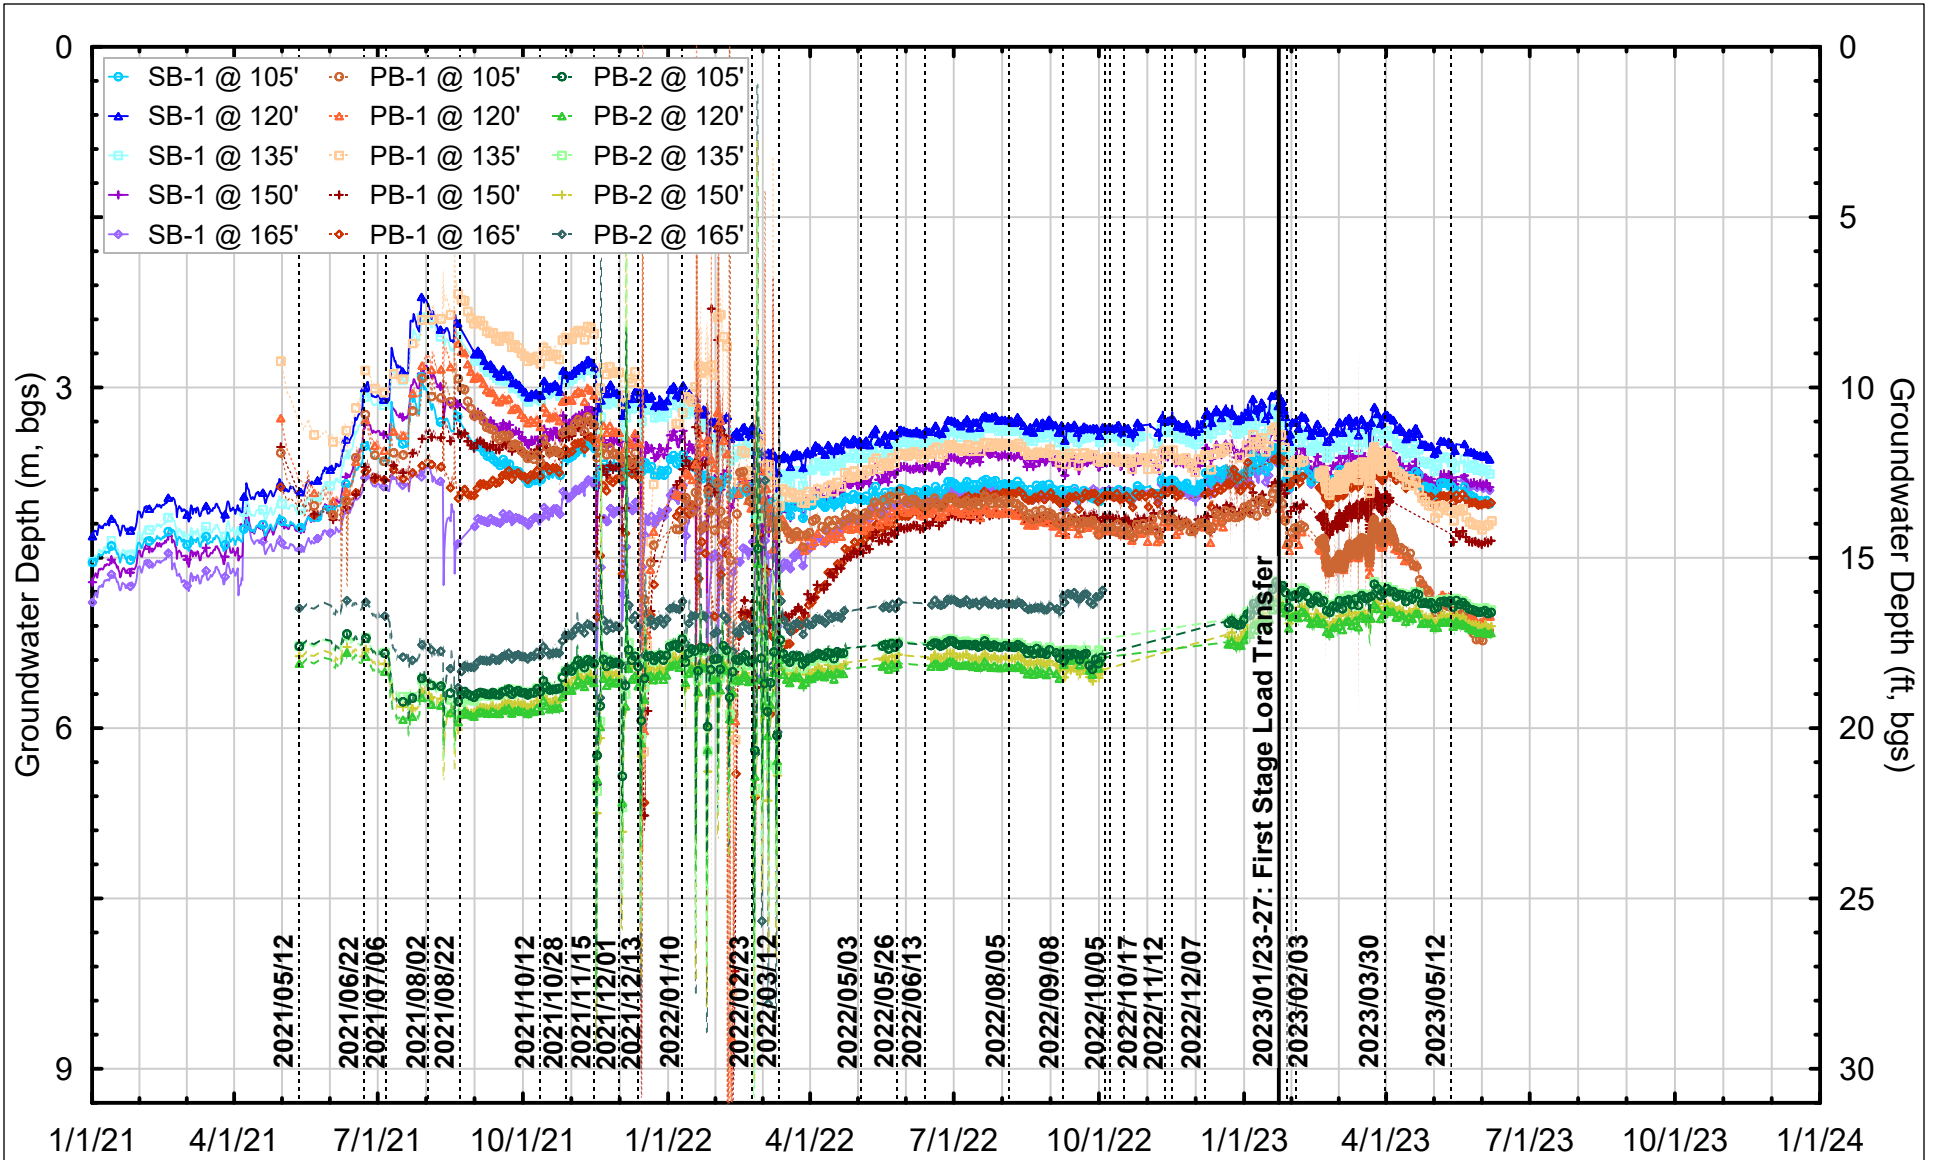
Project No: 19-009.00	Date: 6/7/2023	Created By: NBW	Checked By: DGM	Figure No: <b>109-09A</b>
-----------------------	----------------	-----------------	-----------------	---------------------------

GROUNDWATER ELEVATION MEASUREMENTS IN OLD BAY CLAY  
SINCE 01/01/2021 THROUGH 06/06/2023

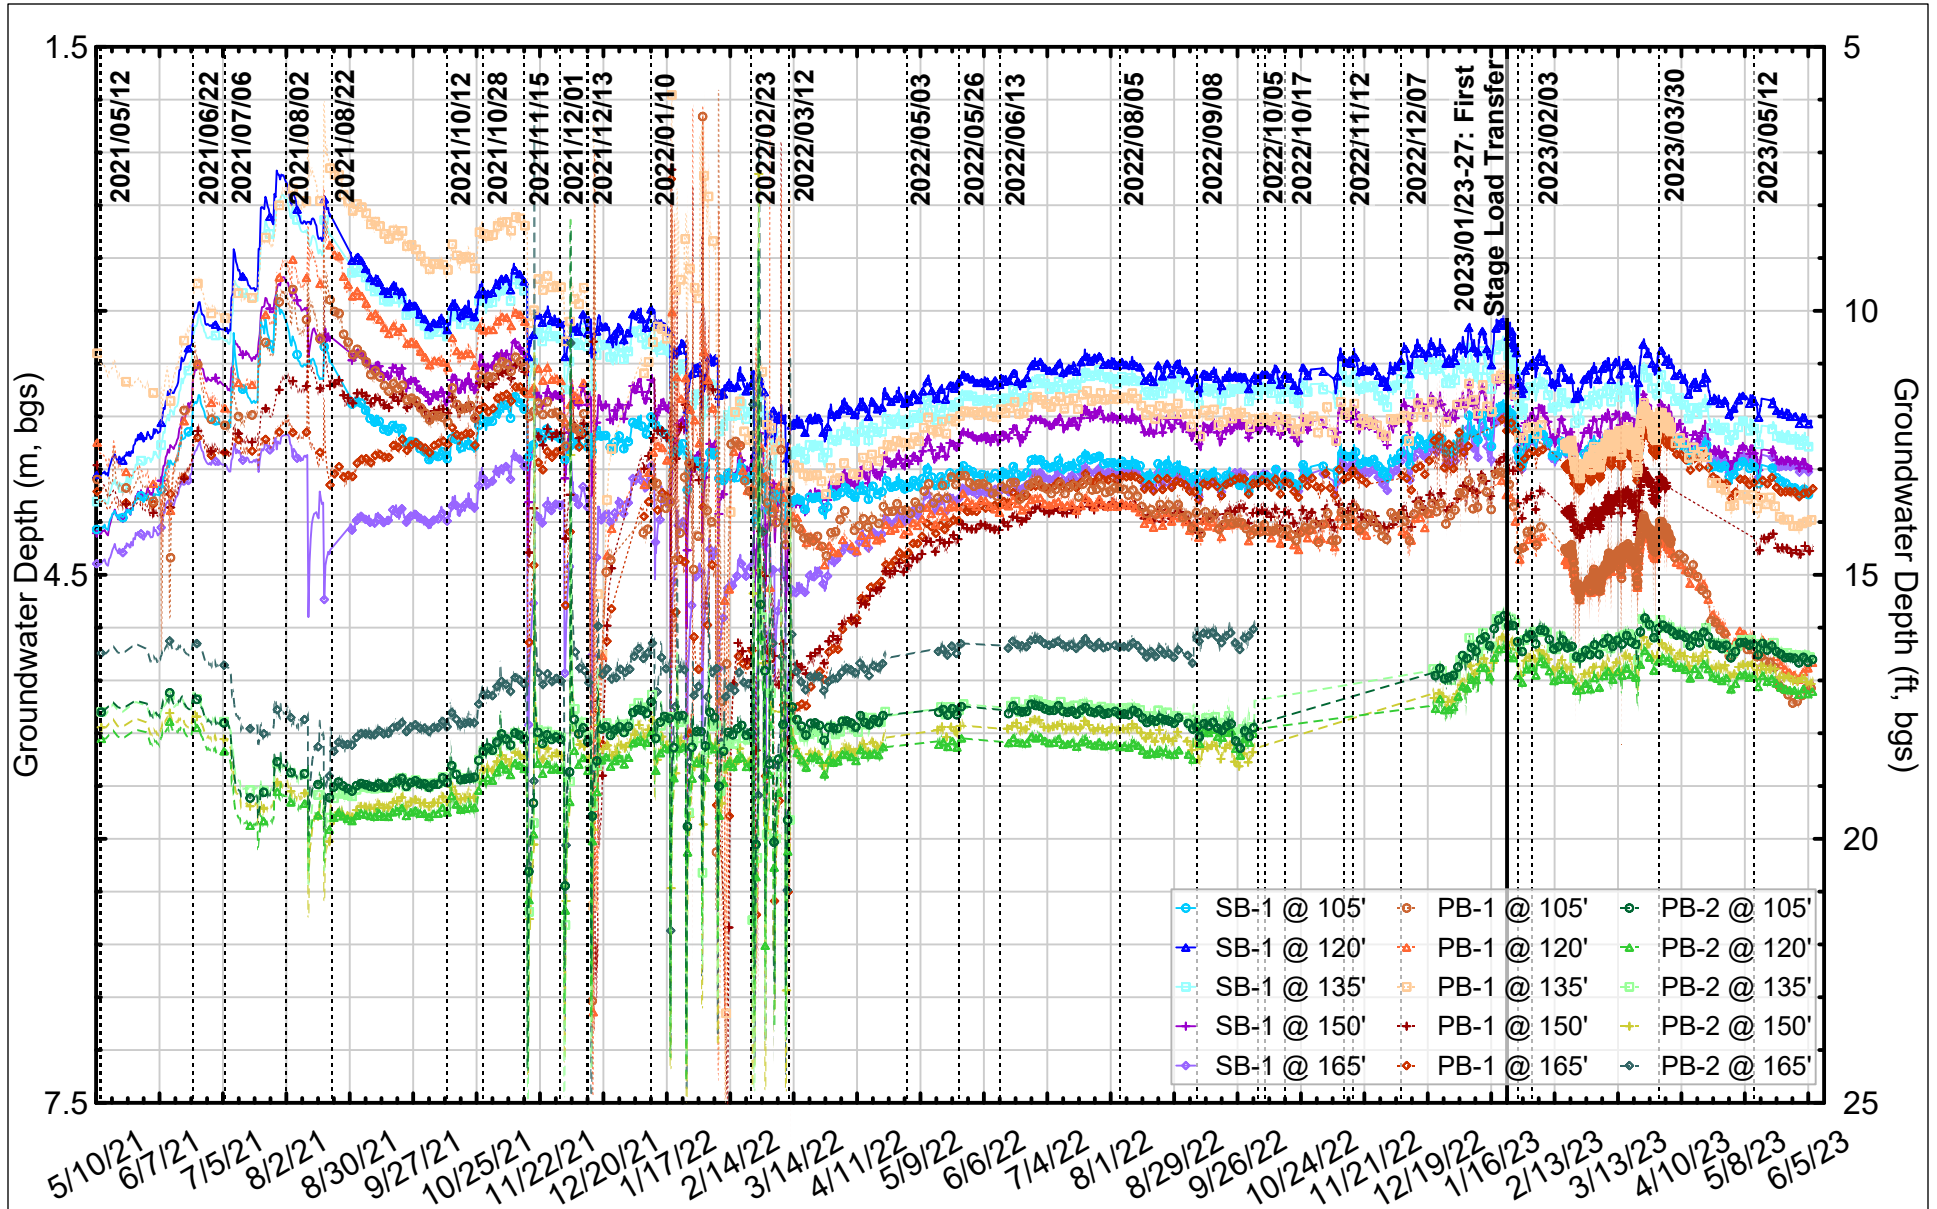
Project No: 19-009.00    Date: 6/7/2023    Created By: NBW    Checked By: DGM    Figure No: **109-09B**

GROUNDWATER ELEVATION MEASUREMENTS IN OLD BAY CLAY  
 SINCE 05/10/2021 THROUGH 06/06/2023  
 Millennium Tower Perimeter Pile Upgrade: Instrumentation Monitoring Data  
 City and County of San Francisco, California

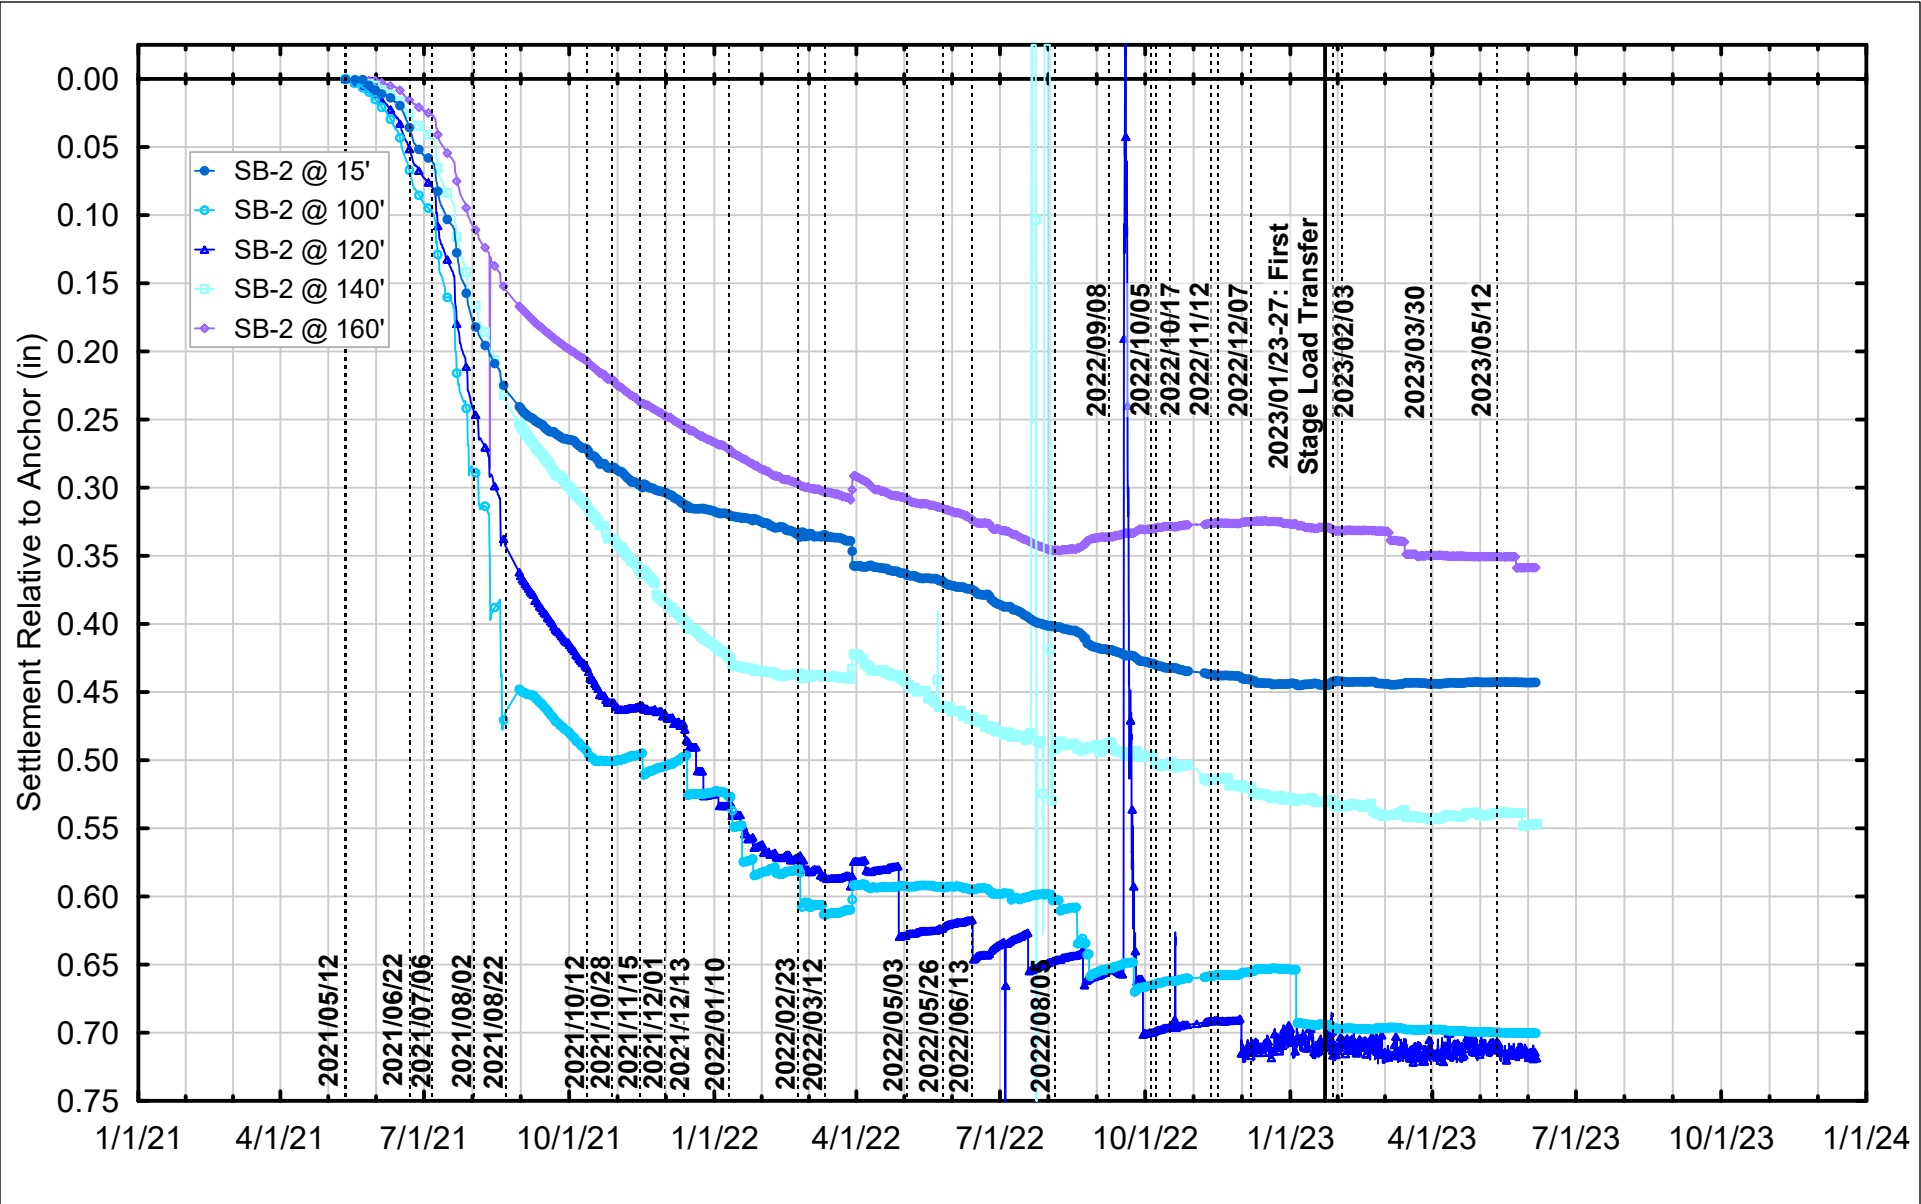
Project No: 19-009.00	Date: 6/7/2023	Created By: NBW	Checked By: DGM	Figure No: <b>109-10A</b>

Figure 10 presents extensometer data from within the Tower basement since the start of production pile installation (May 12, 2021) through June 5, 2023. Figure 11 presents extensometer data from Fremont Street since the start of production pile installation (May 12, 2021) through May 16, 2023, and from the restart after fixing the extensometer (May 30, 2023) through June 6. Figure 12 presents extensometer data from Mission Street since the start of production pile installation (May 12, 2021) through June 6, 2023.

EXTENSOMETER DATA FROM WITHIN TOWER BASEMENT SINCE 01/01/2021 THROUGH 06/05/2023  Millennium Tower Perimeter Pile Upgrade: Instrumentation Monitoring Data City and County of San Francisco, California

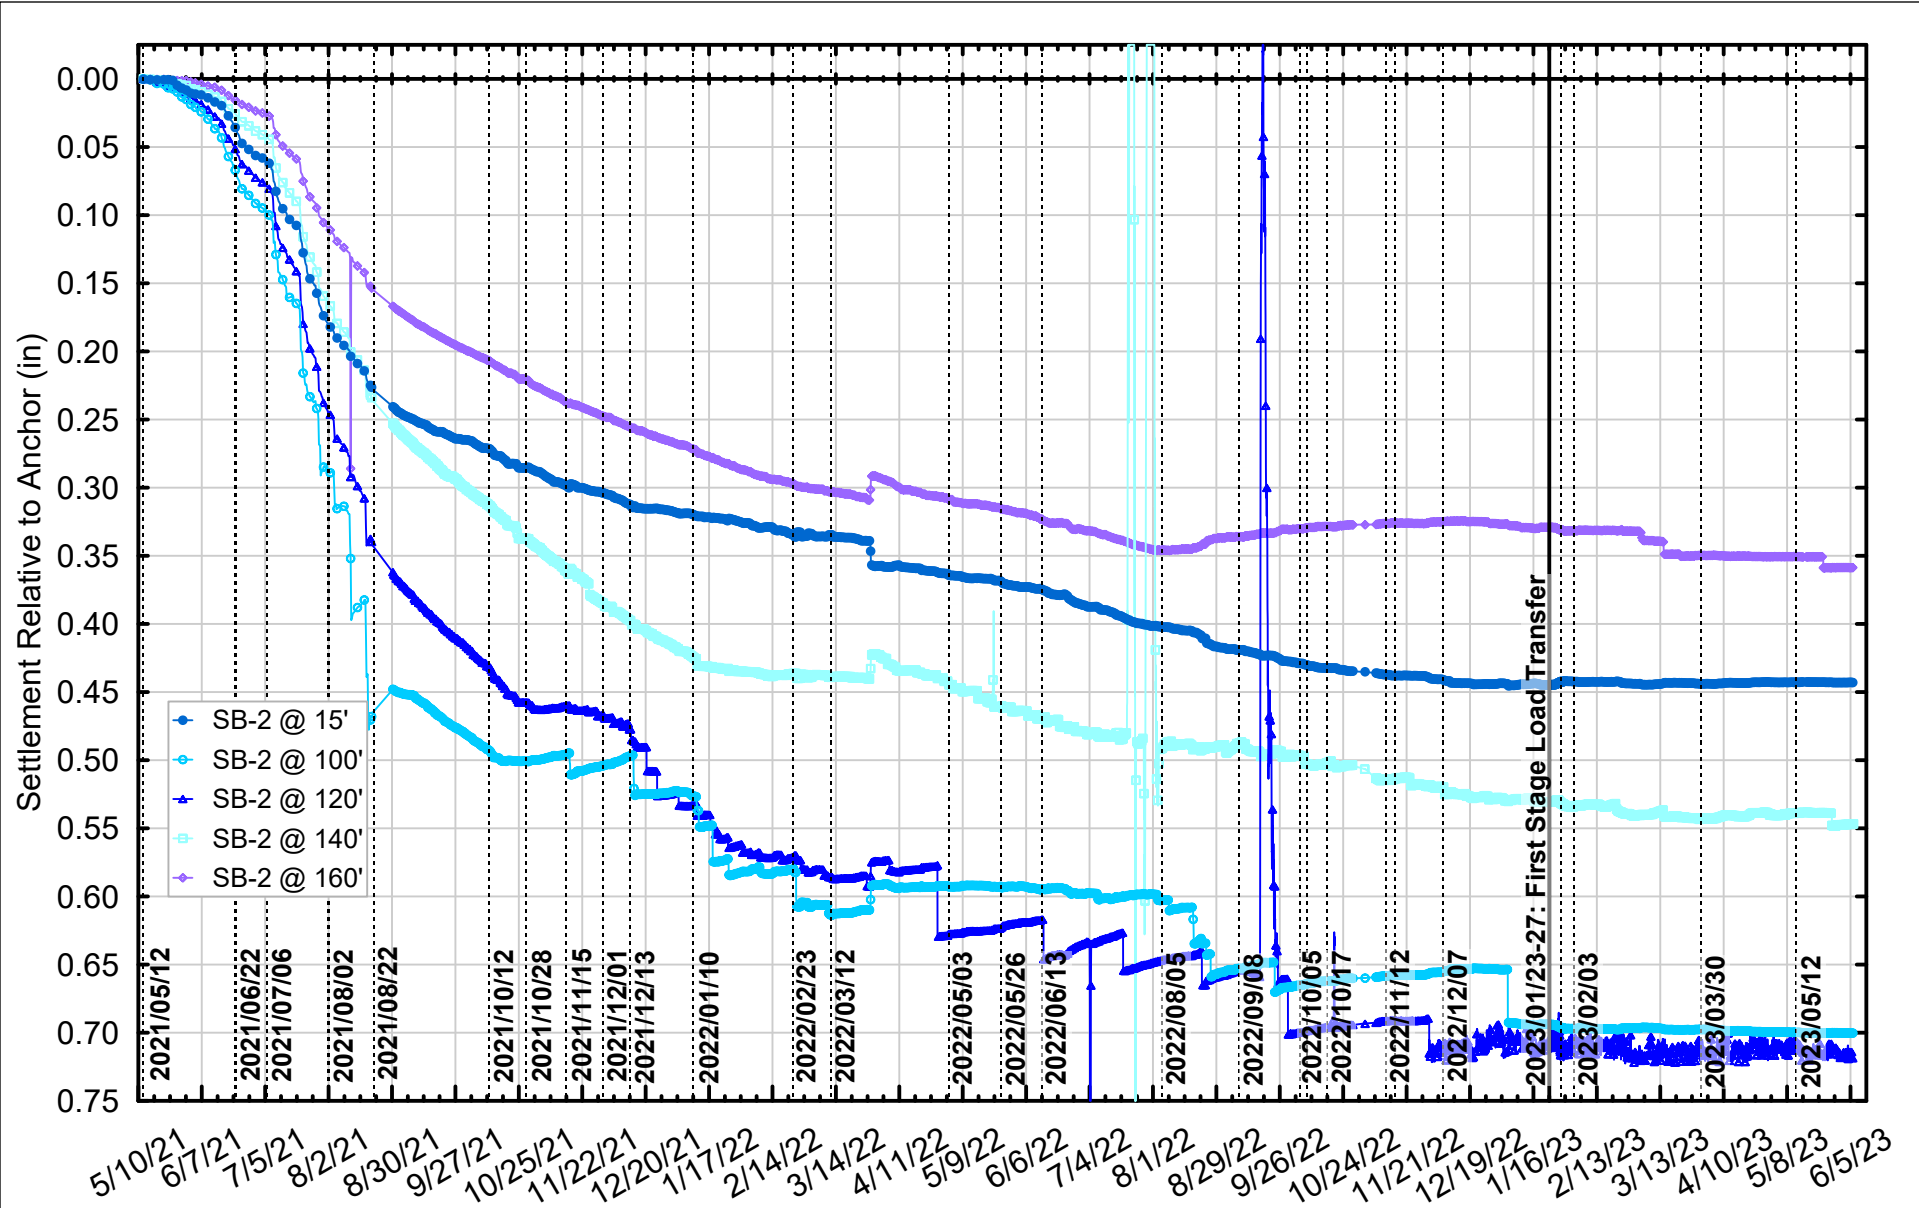
Figure No: 109-10B

EXTENSOMETER DATA FROM WITHIN TOWER BASEMENT  
SINCE 05/10/2021 THROUGH 06/05/2023

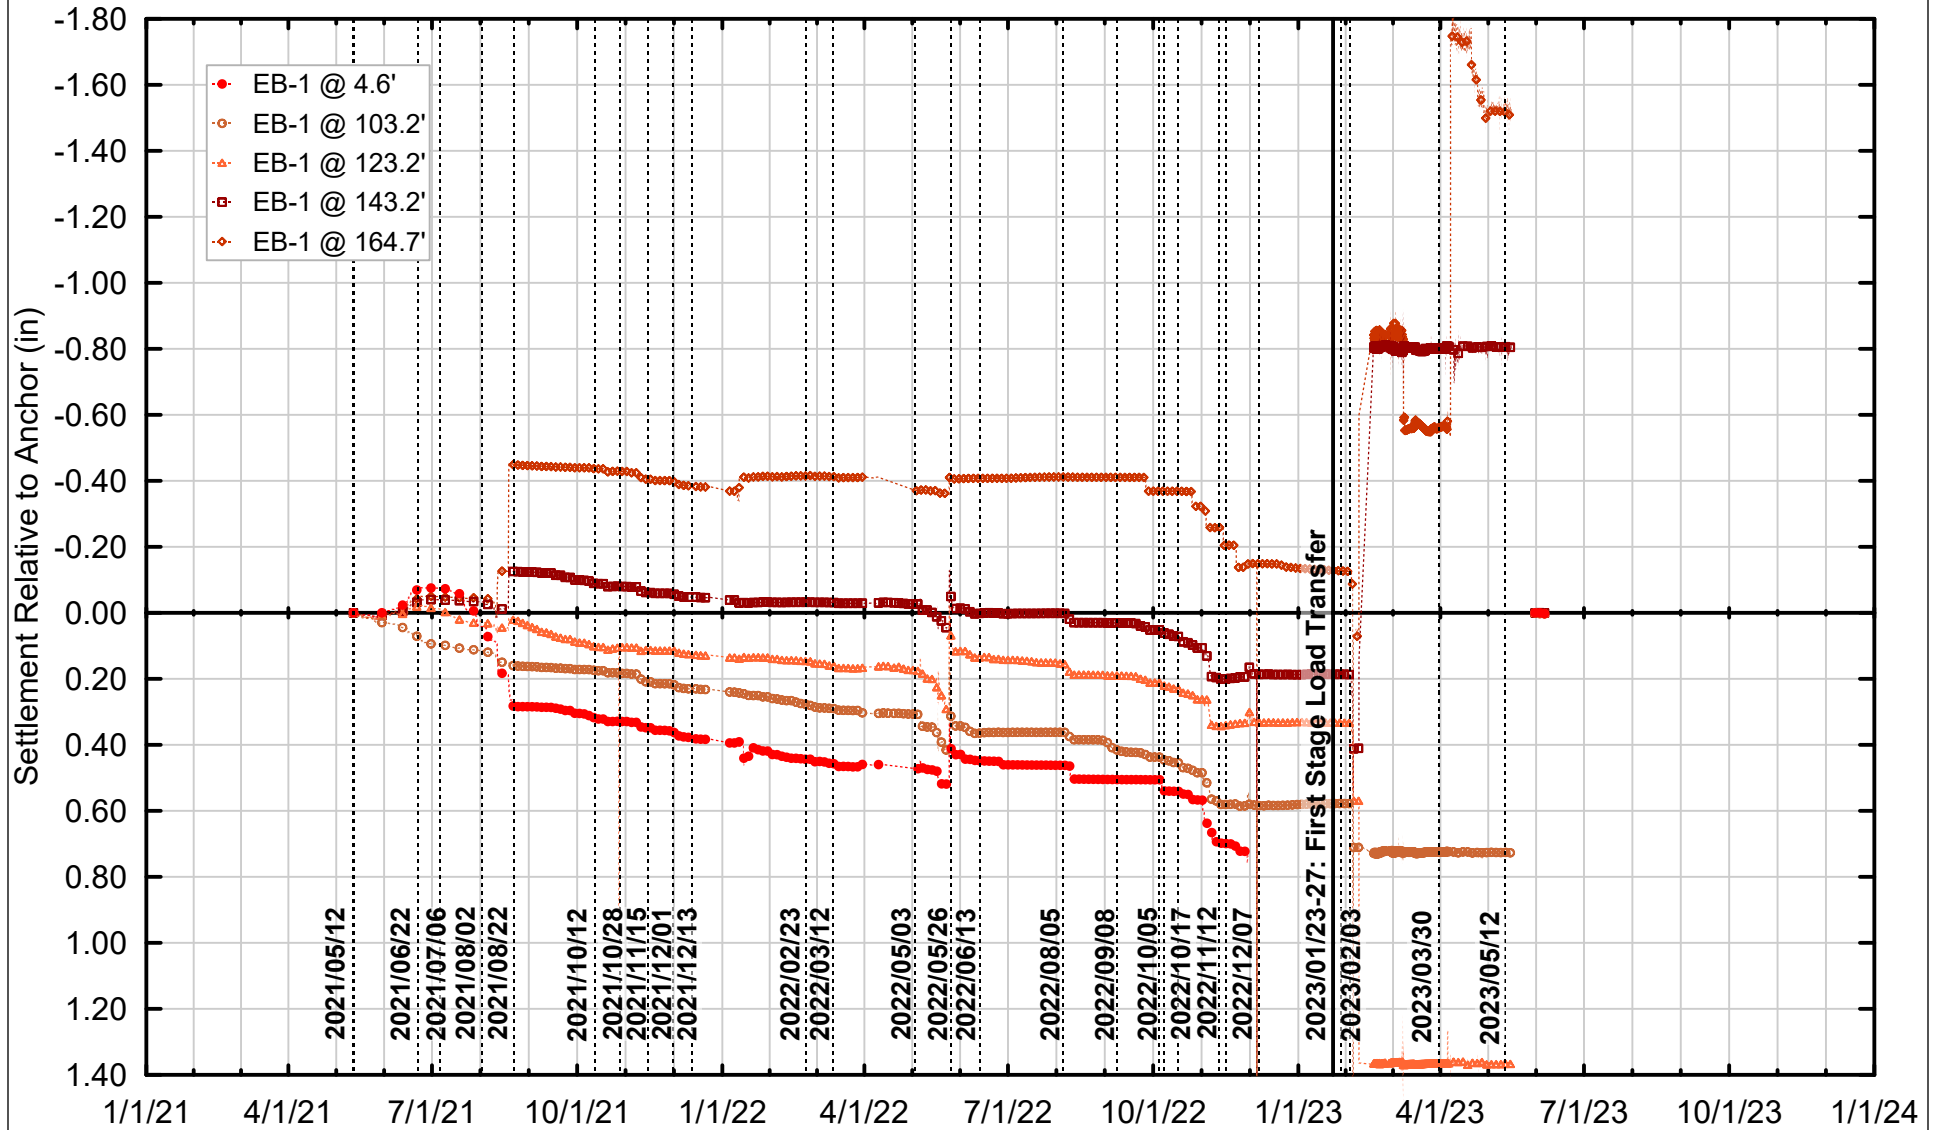
Figure No: 109-11A

Note: EB-1 was repaired and rest on 2023/05/30

EXTENSOMETER DATA FROM FREMONT STREET  
 SINCE 05/10/2021 THROUGH 05/16/2023  
 SINCE 05/30/2023 THROUGH 06/06/2023  
 Millennium Tower Perimeter Pile Upgrade: Instrumentation Monitoring Data  
 City and County of San Francisco, California

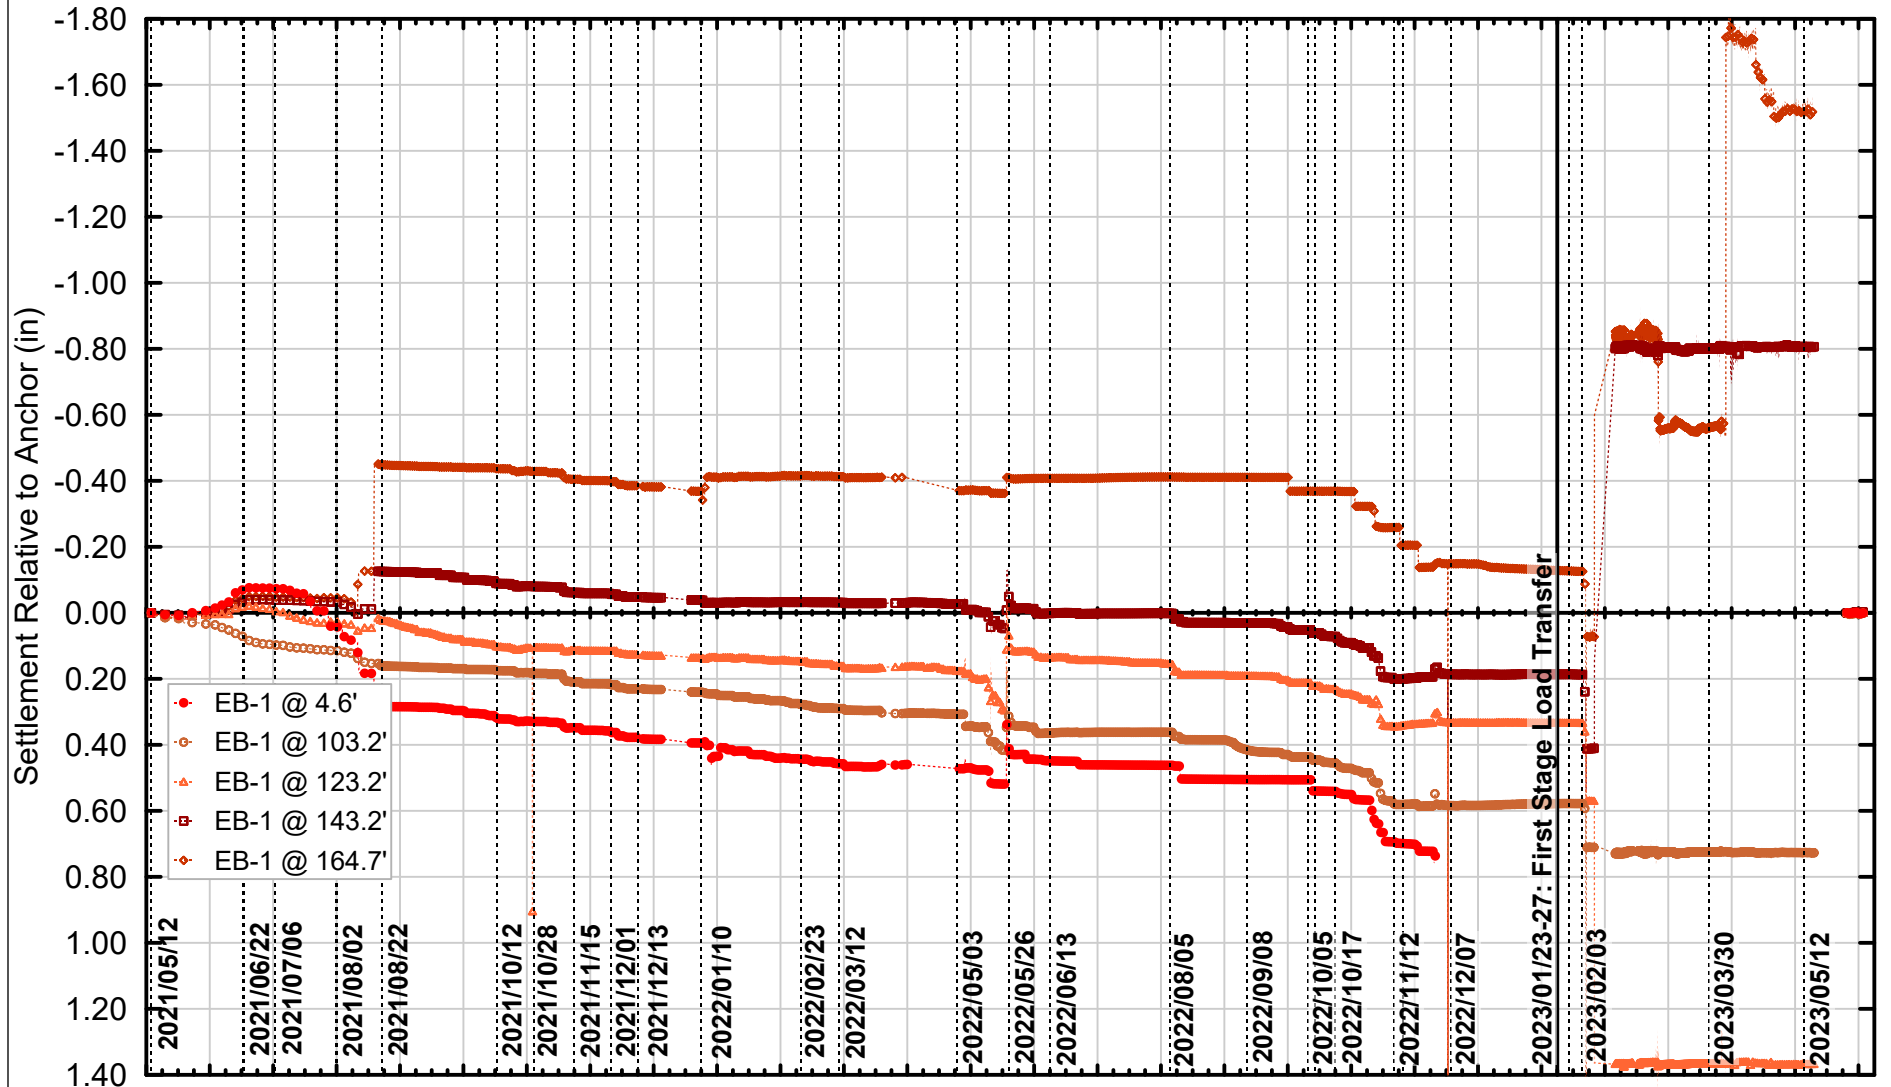
Figure No: 109-11B

Note: EB-1 was repaired and rest on 2023/05/30

EXTENSOMETER DATA FROM FREMONT STREET  
 SINCE 05/10/2021 THROUGH 05/16/2023  
 SINCE 05/30/2023 THROUGH 06/06/2023  
 Millennium Tower Perimeter Pile Upgrade: Instrumentation Monitoring Data  
 City and County of San Francisco, California

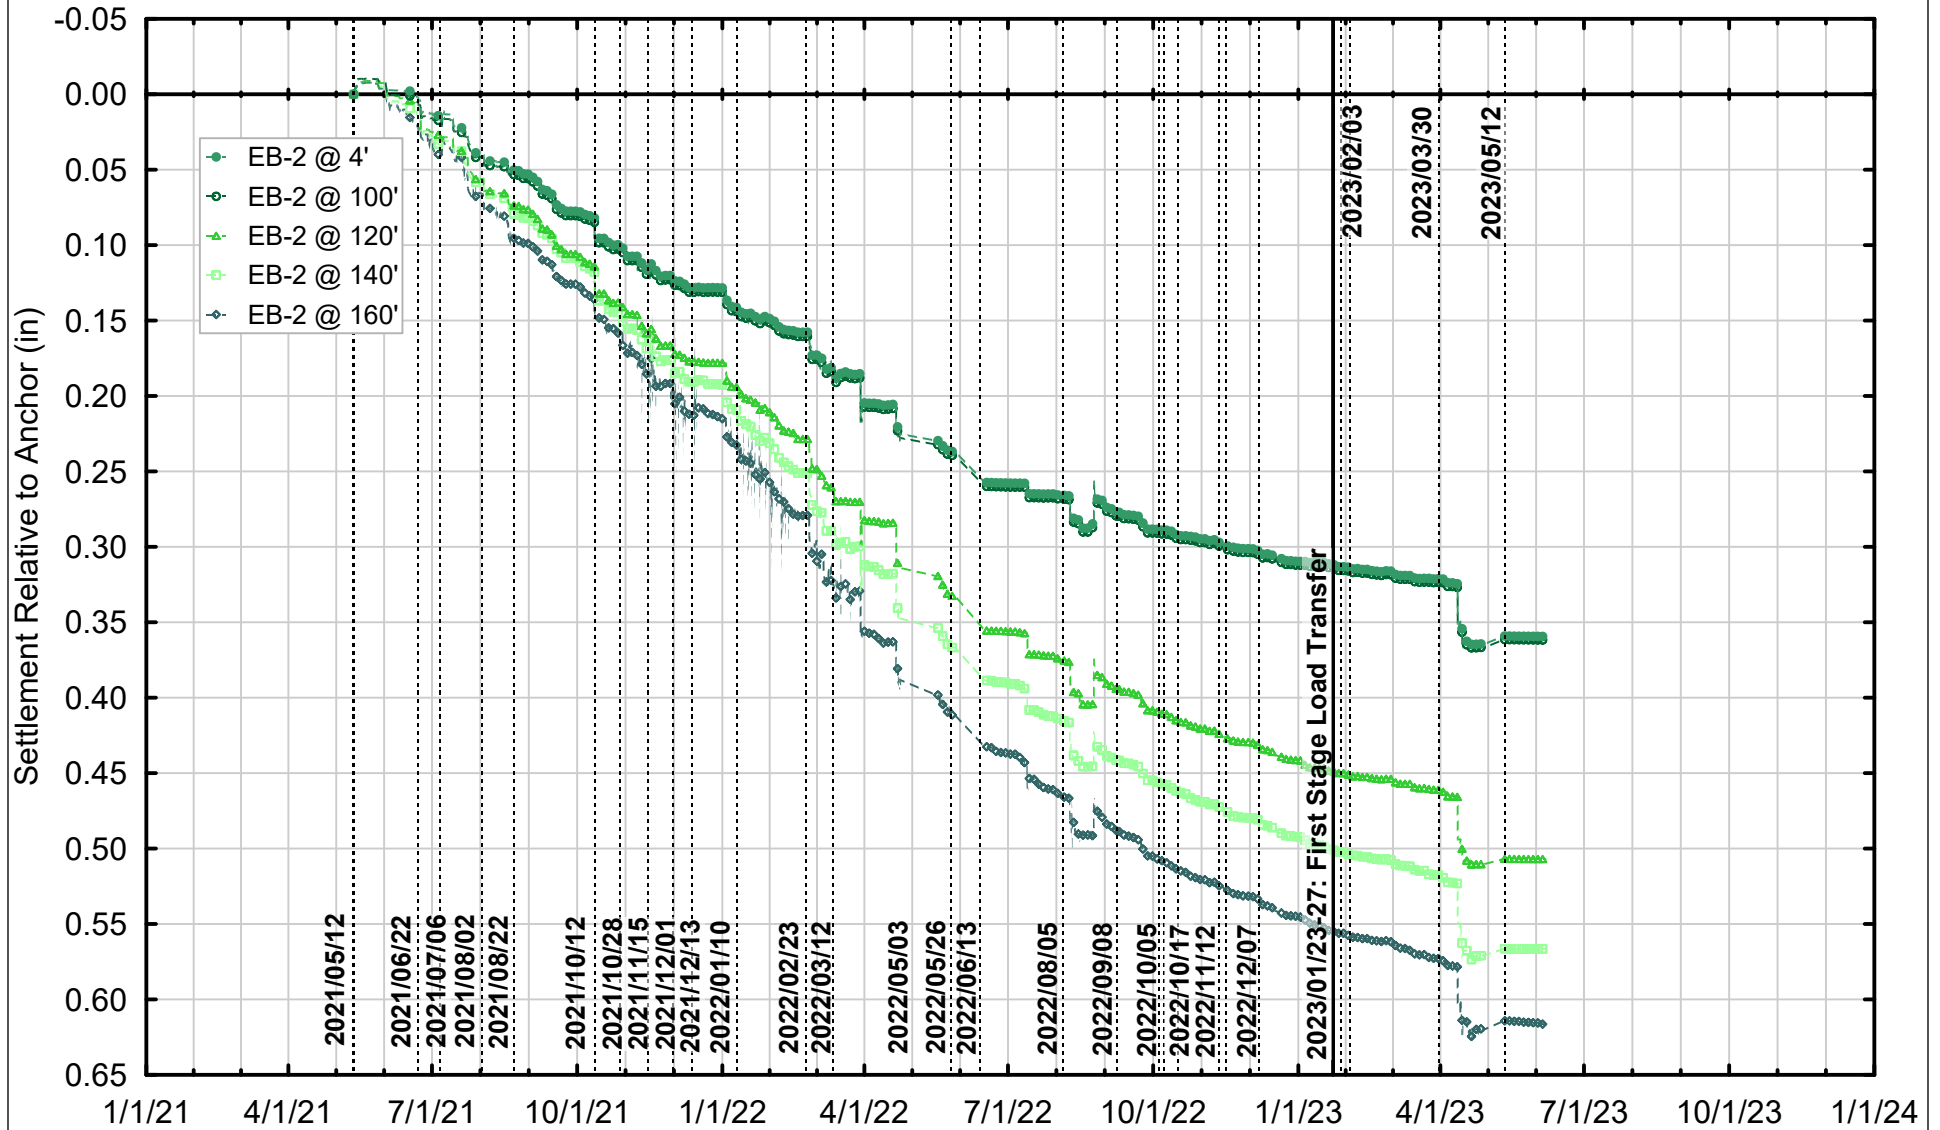
Project No: 19-009.00	Date: 6/7/2023	Created By: NBW	Checked By: DGM	Figure No: <b>109-12A</b>
-----------------------	----------------	-----------------	-----------------	---------------------------

EXTENSOMETER DATA FROM MISSION STREET  
SINCE 01/01/2021 THROUGH 06/06/2023
