Subject: 301 Mission Retrofit Monitoring Report 109: Results as of June 6, 2023

This memorandum summarizes results from the monitoring plan implemented at the 301 Mission property. Instrumentation to monitor the structure prior to, during and after the retrofit was installed in January 2021, including piezometers and extensometers. Settlement markers installed in April 2009 and January 2017, survey prisms mounted on the exterior of the structure in December 2016, and crack gauges installed in April 2009 have also been monitored. Pile load cells were installed on the Mission Street piles in January 2023. Survey markers were installed on the Mission Street mat extension in January 2023. This memorandum is for review only. It only contains ongoing monitoring information. This memorandum does not contain recommendations based upon the ongoing monitoring information.

Millennium Tower Perimeter Pile Upgrade: Instrumentation Monitoring Data  
City and County of San Francisco, California

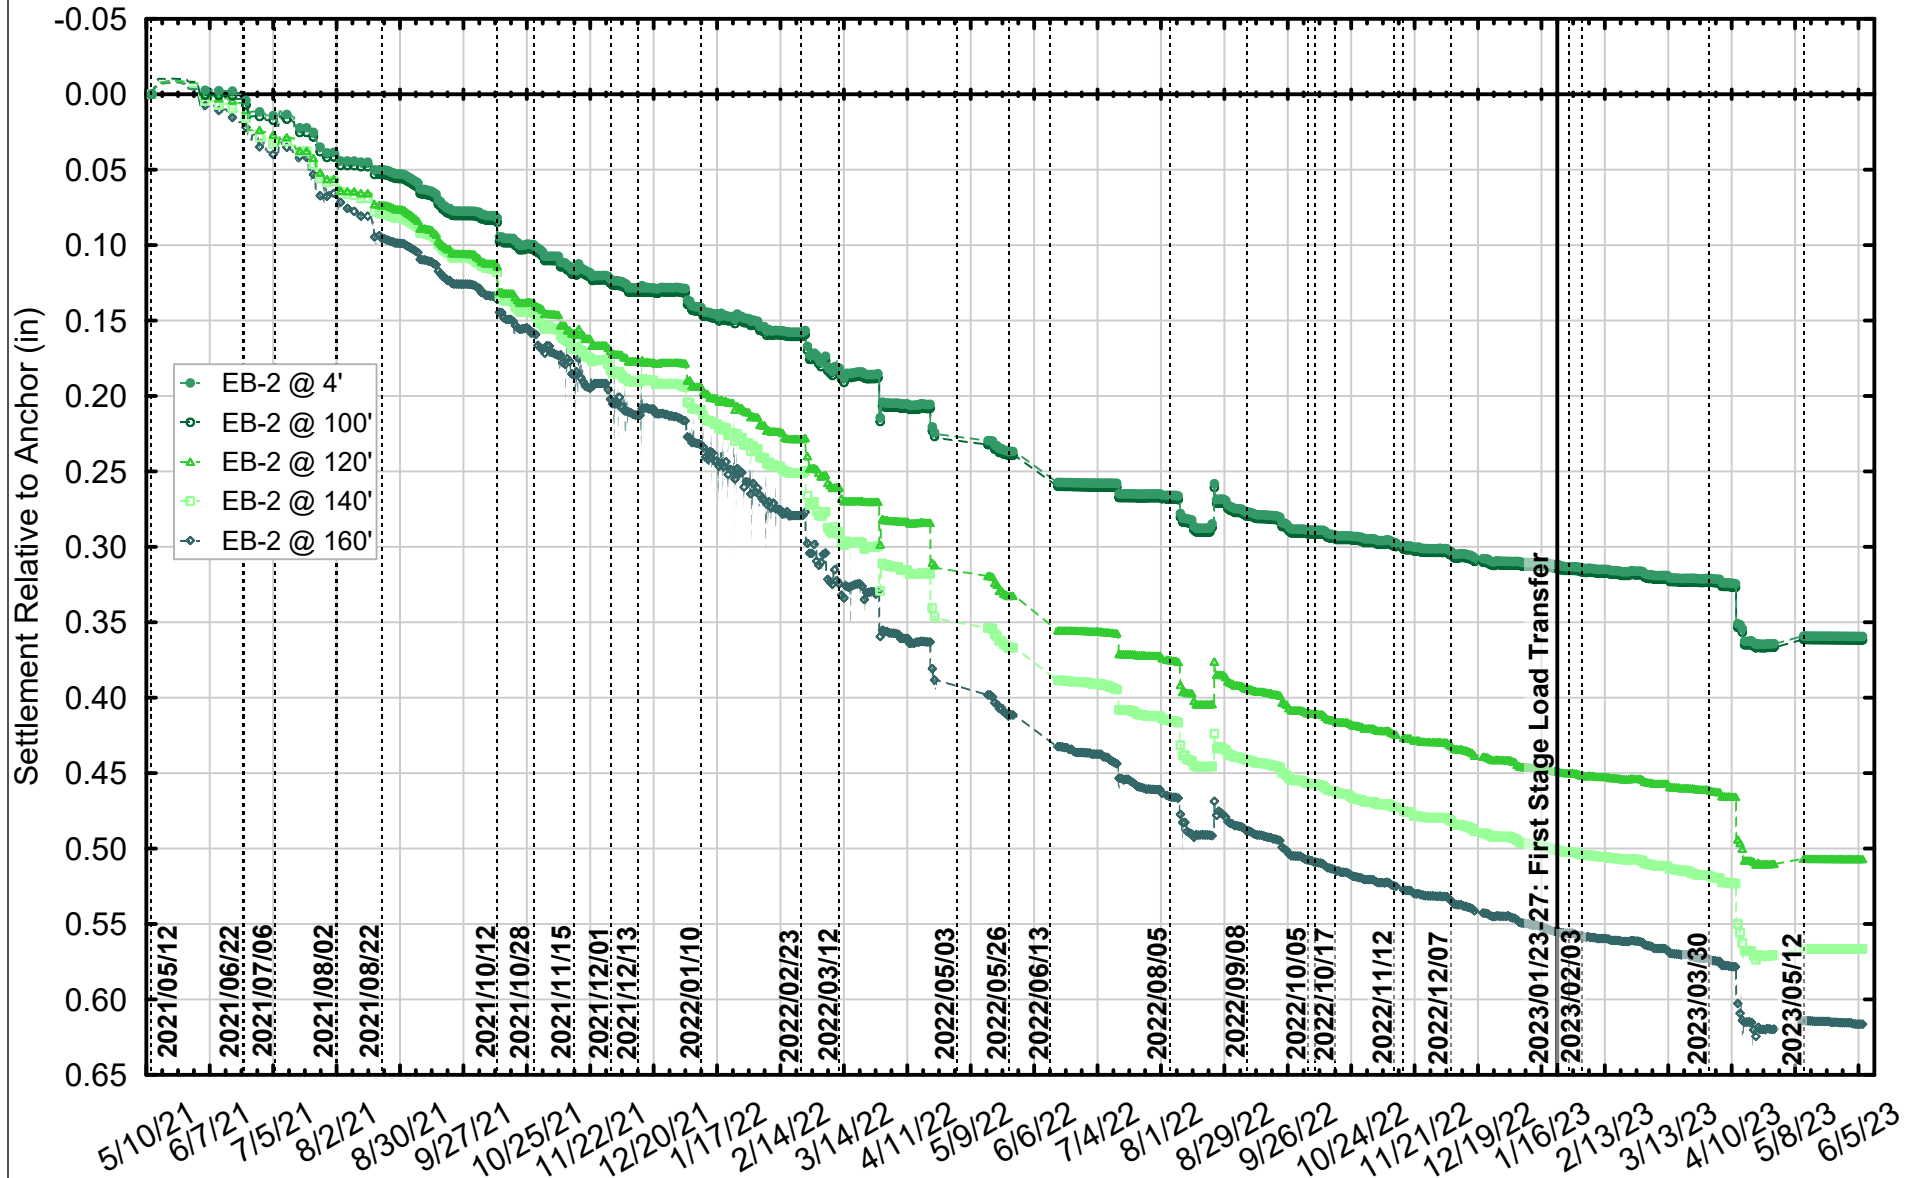
Project No: 19-009.00    Date: 6/7/2023    Created By: NBW    Checked By: DGM    Figure No: 109-12B

EXTENSOMETER DATA FROM MISSION STREET  
SINCE 05/10/2021 THROUGH 06/06/2023

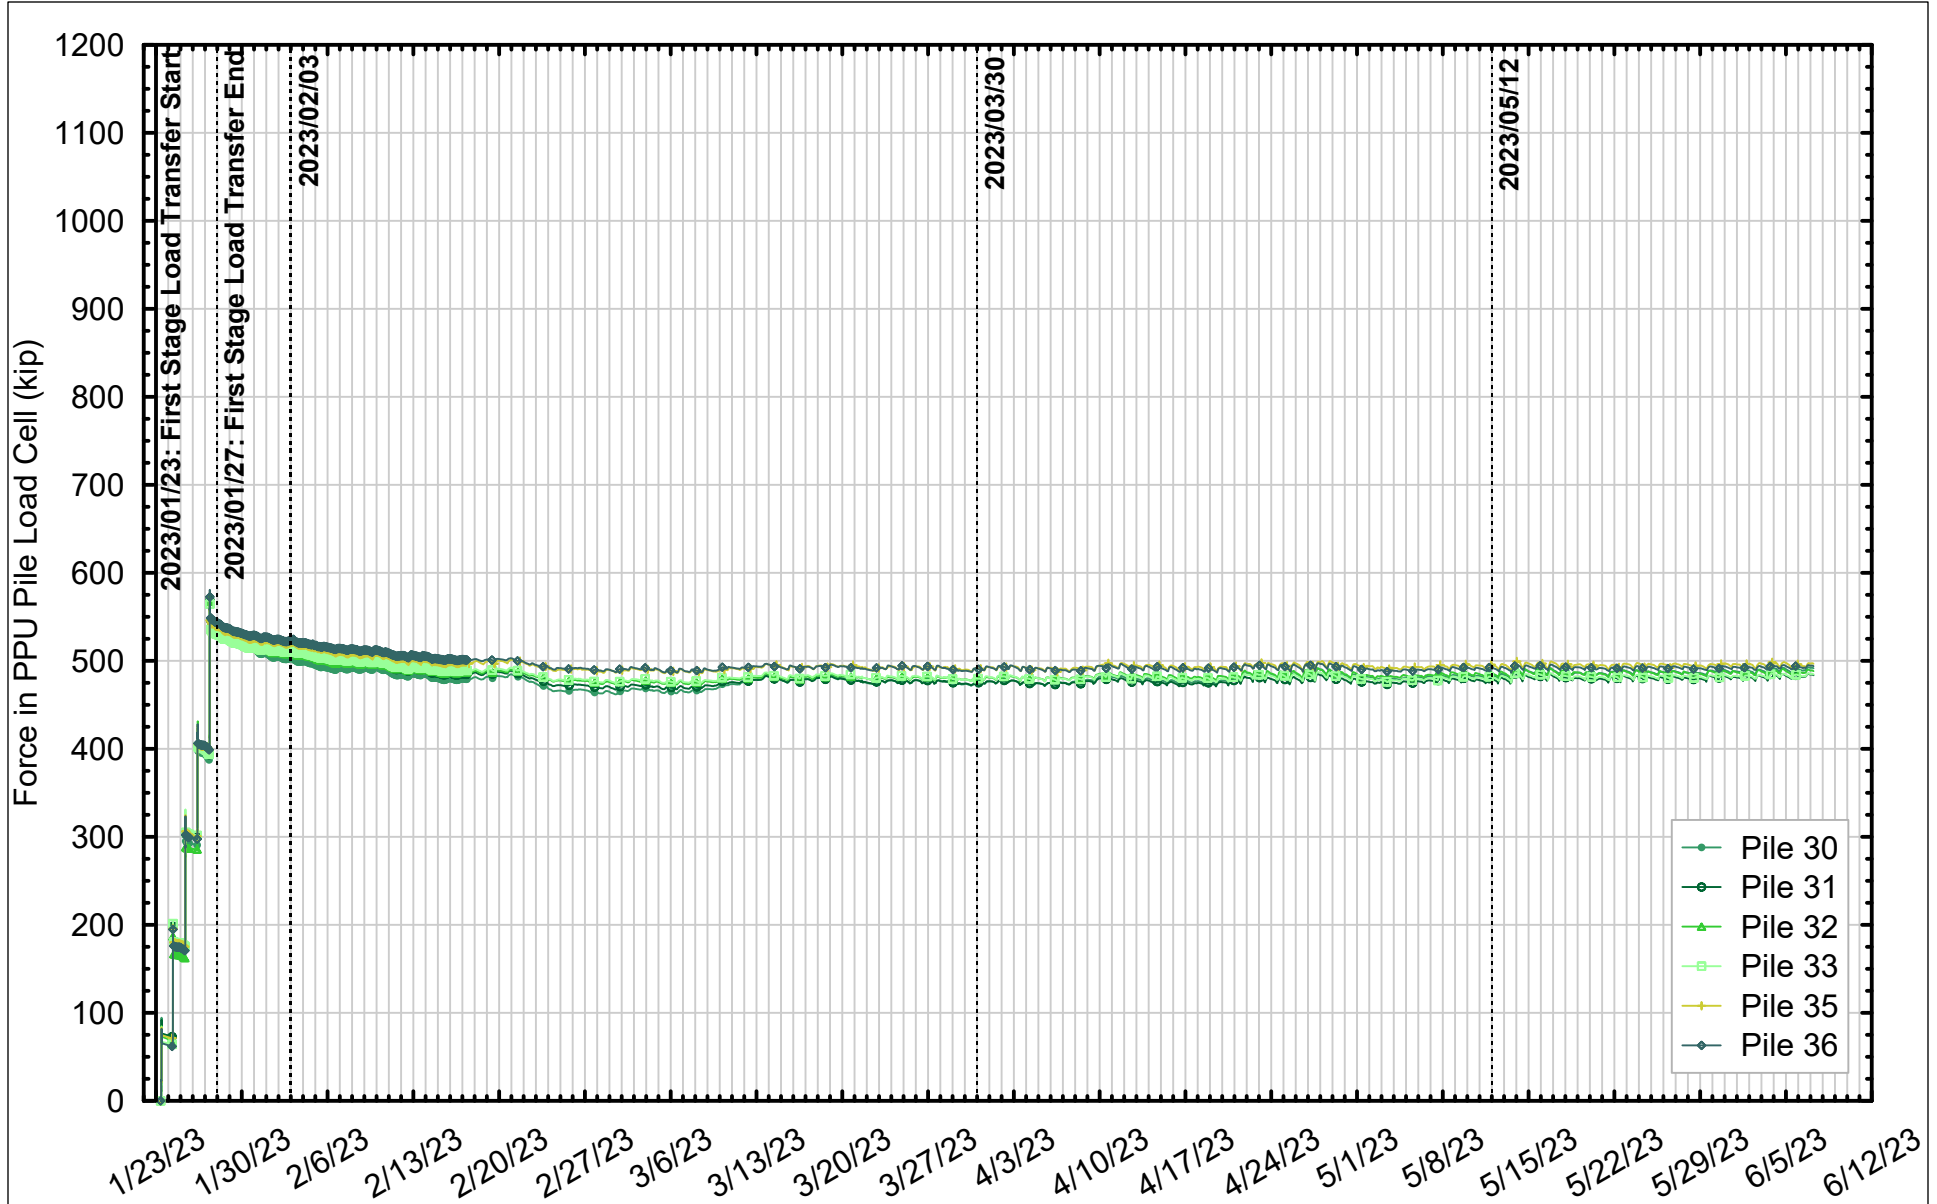
Project No: 19-009.00	Date: 6/7/2023	Created By: NBW	Checked By: DGM	Figure No: 109-13
-----------------------	----------------	-----------------	-----------------	-------------------

Figure 13 presents pile load cell data since the start of the First Stage Load Transfer (January 23, 2023) through June 6, 2023.

PILE LOAD CELL DATA  
SINCE 01/23/2023 THROUGH 06/06/2023
