Date: June 7, 2023 Project Number: 19-009 Subject: 301 Mission Retrofit Supplemental Monitoring Report 109: Results as of June 6, 2023

This supplemental memorandum summarizes results from the monitoring plan implemented at the 301 Mission property following the process established in a letter from Simpson, Gumpertz and Heger (SGH) to the San Francisco Department of Building Inspection (SFDBI) dated March 23, 2022. Instrumentation to temporarily monitor the structure during the excavation and shoring project phases was installed on April 20, 2022, including survey prisms installed at approximately one floor level above grade on the exterior of the building. This supplemental memorandum is for review only. It only contains ongoing monitoring information.

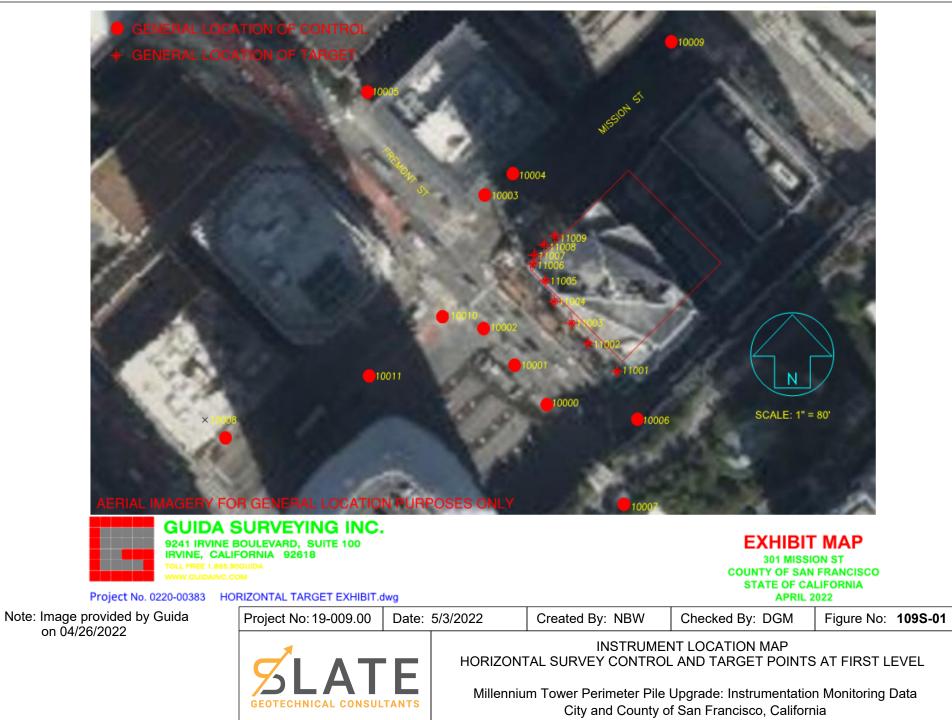
Figure S-01 presents the locations of the survey prisms (including both control and target prisms) as referenced in later figures.

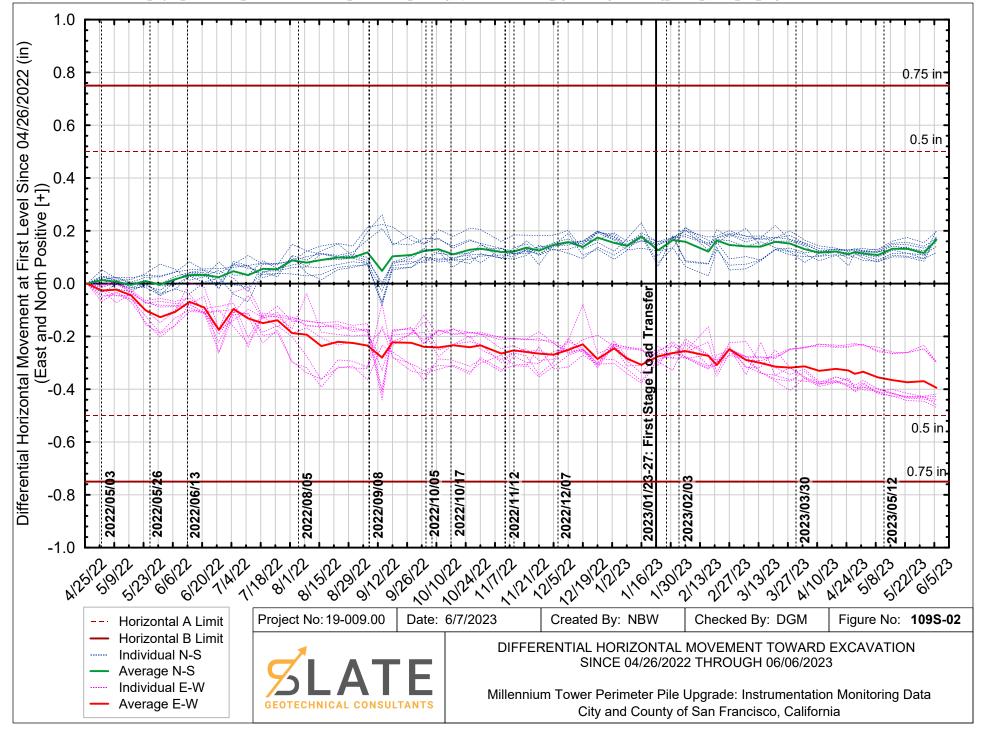
Figure S-02 presents the differential horizontal movement toward the excavation at survey prisms installed at approximately one floor level above grade on the exterior of the building, as well as the average in each of the project north-south and east-west direction, since April 26, 2022, through June 6, 2023. Limits established in the aforementioned letter are included for reference.

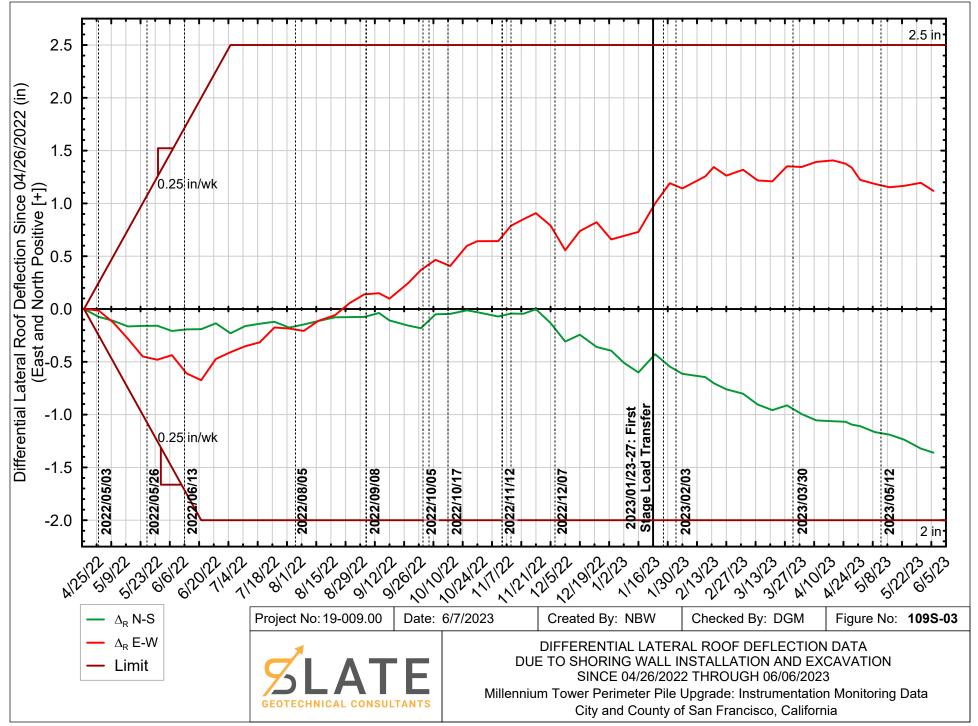
Figure S-03 – Differential Lateral Roof Deflection Data due to Shoring Wall Installation and Excavation since 04/26/2022 through 06/06/2023

Figure S-03 presents differential lateral roof deflection data due to shoring wall installation and excavation since April 26, 2022, through June 6, 2023. Limits established in the aforementioned letter are included for reference. Note that differential lateral roof deflection due to shoring wall installation and excavation is calculated following the aforementioned letter as:

- where: Δ_R is the computed differential lateral roof deflection due to shoring wall installation and excavation during shoring wall installation (a or c) or during excavation (b or d) for the project north-south (a and b) and project east-west (c and d) directions;

- $\Delta_{R-prism}$ is the differential lateral roof deflection obtained from prism data for the project north-south (a and b) and project east-west (c and d) directions;

- Δ_H is the average differential horizontal movement "at-grade" for the project north-south (a and b) and project east-west (c and d) directions;
 - α_0 is the weekly lateral roof deflection rate from the two months of monitoring conducted immediately prior to the shoring wall installation (i.e., monitoring data from February 22, 2022, through April 26, 2022);

- $\alpha_{1,NS}$ is the weekly lateral roof deflection rate from the two months of monitoring conducted immediately prior to starting the Mission Street excavation (i.e., monitoring data from August 15, 2022, through October 16, 2022);

- $\alpha_{1,EW}$ is the weekly lateral roof deflection rate from the two months of monitoring conducted immediately prior to starting the Fremont Street excavation (i.e., monitoring data from December 1, through February 2, 2023);

- *T* is the number of weeks since initiation of shoring wall installation or excavation;
 - $T_{1,NS}$ is the number of weeks between the initiation of shoring wall installation and starting the Mission Street excavation (i.e., between April 26, 2022, and October 18, 2022); and,

- $T_{1,EW}$ is the number of weeks between the initiation of shoring wall installation and starting the Fremont Street excavation (i.e., between December 1, 2022, and February 2, 2023).

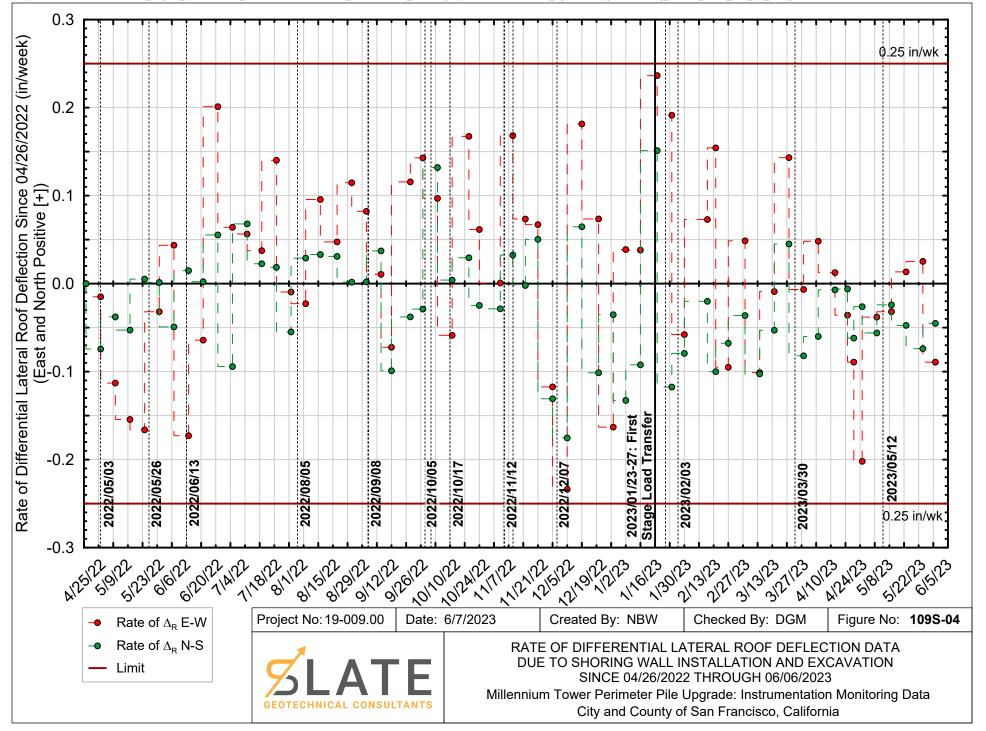
Figure S-04 – Rate of Differential Lateral Roof Deflection Data due to Shoring Wall Installation and Excavation since 04/26/2022 through 06/06/2023

Figure S-04 presents rates of differential lateral roof deflection data due to shoring wall installation and excavation since April 26, 2022, through June 6, 2023. Limits established in the aforementioned letter are included for reference. Note that the rates are calculated as:

$$\frac{d\Delta_R}{dT} \approx \frac{\Delta_{R,t} - \Delta_{R,t-1}}{T_t - T_{t-1}}$$

where: t is an index representing the current instance in time; and

t - 1 is an index representing the previous instance in time.
