Subject: 301 Mission Retrofit Monitoring Report 110: Results as of June 14, 2023

This memorandum summarizes results from the monitoring plan implemented at the 301 Mission property. Instrumentation to monitor the structure prior to, during and after the retrofit was installed in January 2021, including piezometers and extensometers. Settlement markers installed in April 2009 and January 2017, survey prisms mounted on the exterior of the structure in December 2016, and crack gauges installed in April 2009 have also been monitored. Pile load cells were installed on the Mission Street piles in January 2023. Survey markers were installed on the Mission Street mat extension in January 2023. This memorandum is for review only. It only contains ongoing monitoring information. This memorandum does not contain recommendations based upon the ongoing monitoring information.

Millennium Tower Perimeter Pile Upgrade: Instrumentation Monitoring Data
City and County of San Francisco, California

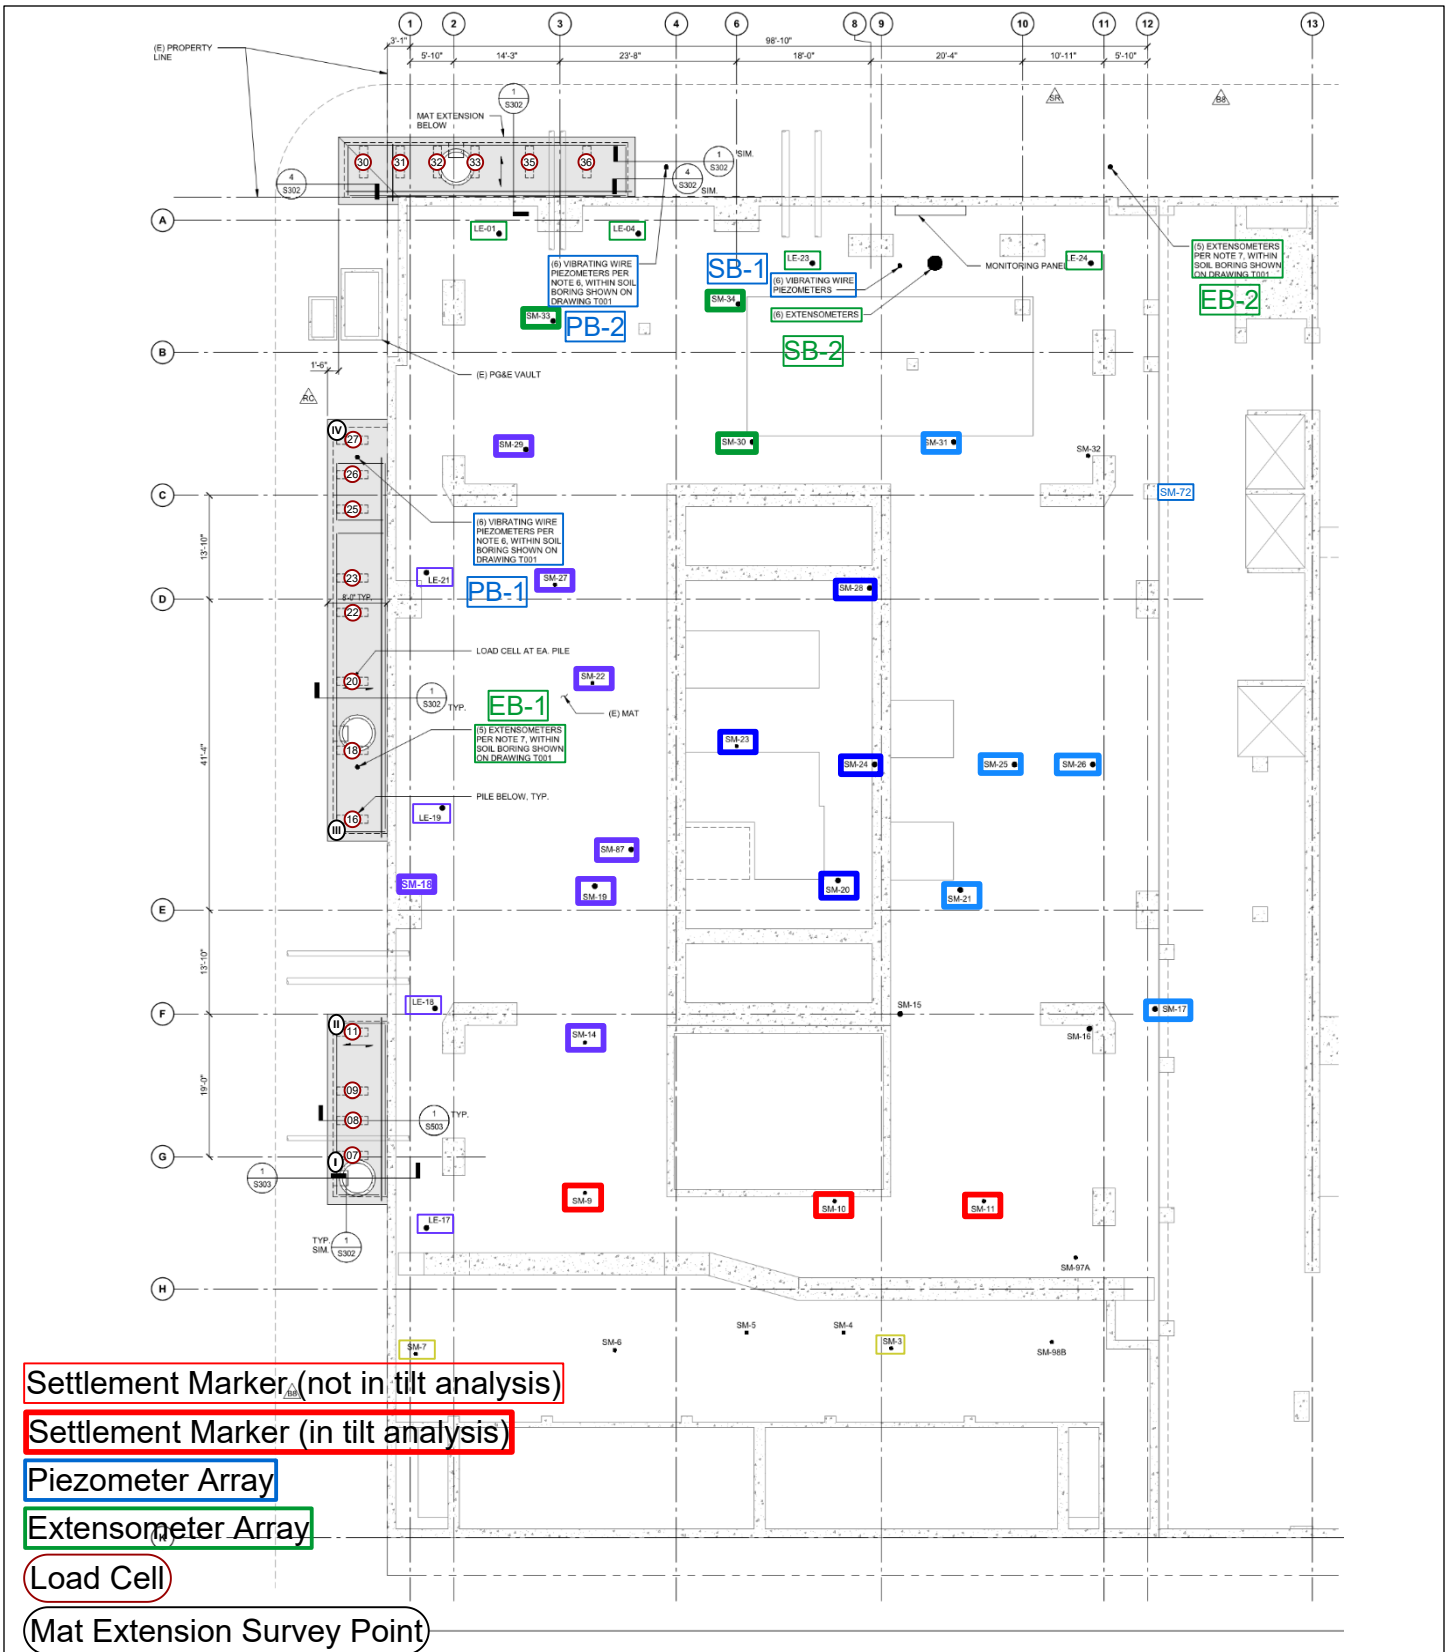
Project No: 19-009.00	Date: 6/15/2023	Created By: NBW	Checked By: DGM	Figure No: 110-01A
-----------------------	-----------------	-----------------	-----------------	--------------------

Figure 01 presents the instrument locations as referenced in later figures.

**INSTRUMENT LOCATION MAP
SETTLEMENT MARKERS, PIEZOMETERS, EXTENSOMETERS, LOAD CELLS**

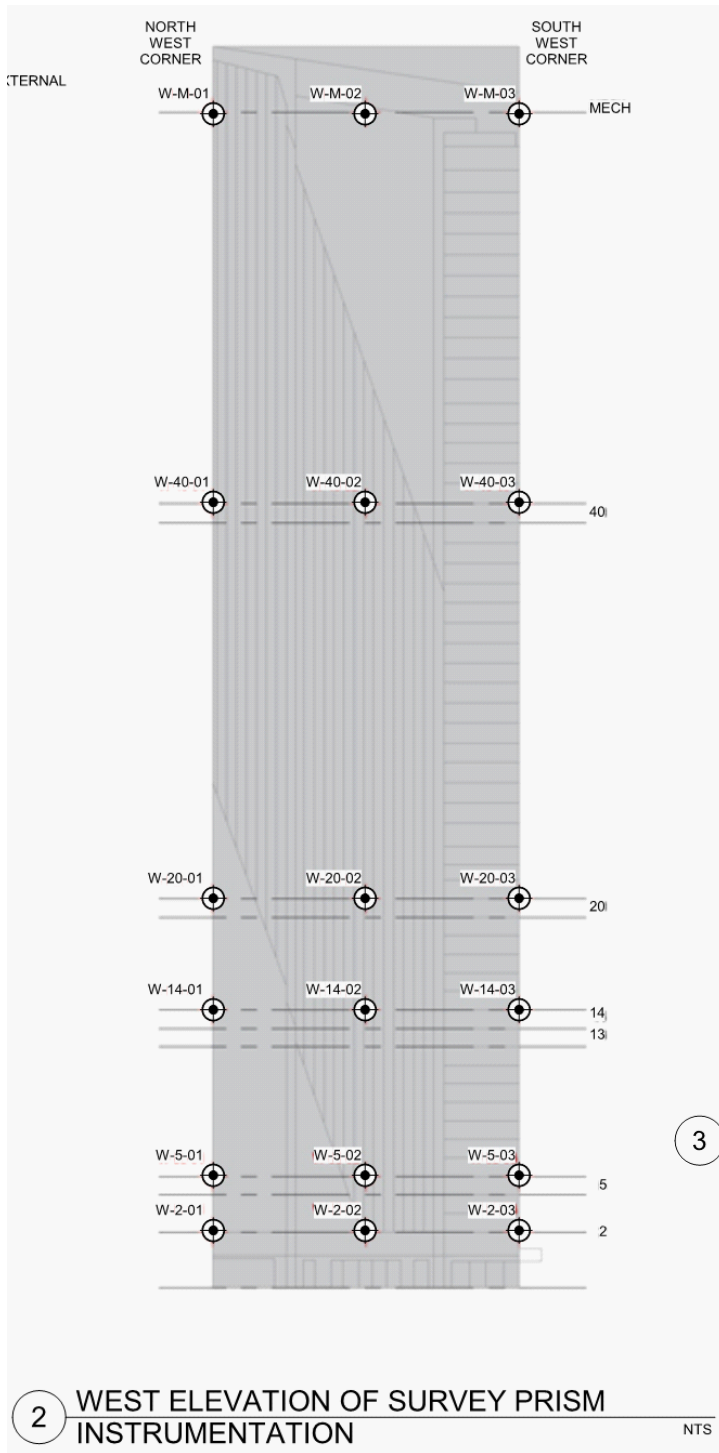
Project No: 19-009.00	Date: 7/26/2021	Created By: NBW	Checked By: DGM	Figure No: 110-01B
-----------------------	-----------------	-----------------	-----------------	---------------------------

TOWER SURVEY PRISM LOCATION SCHEMATIC

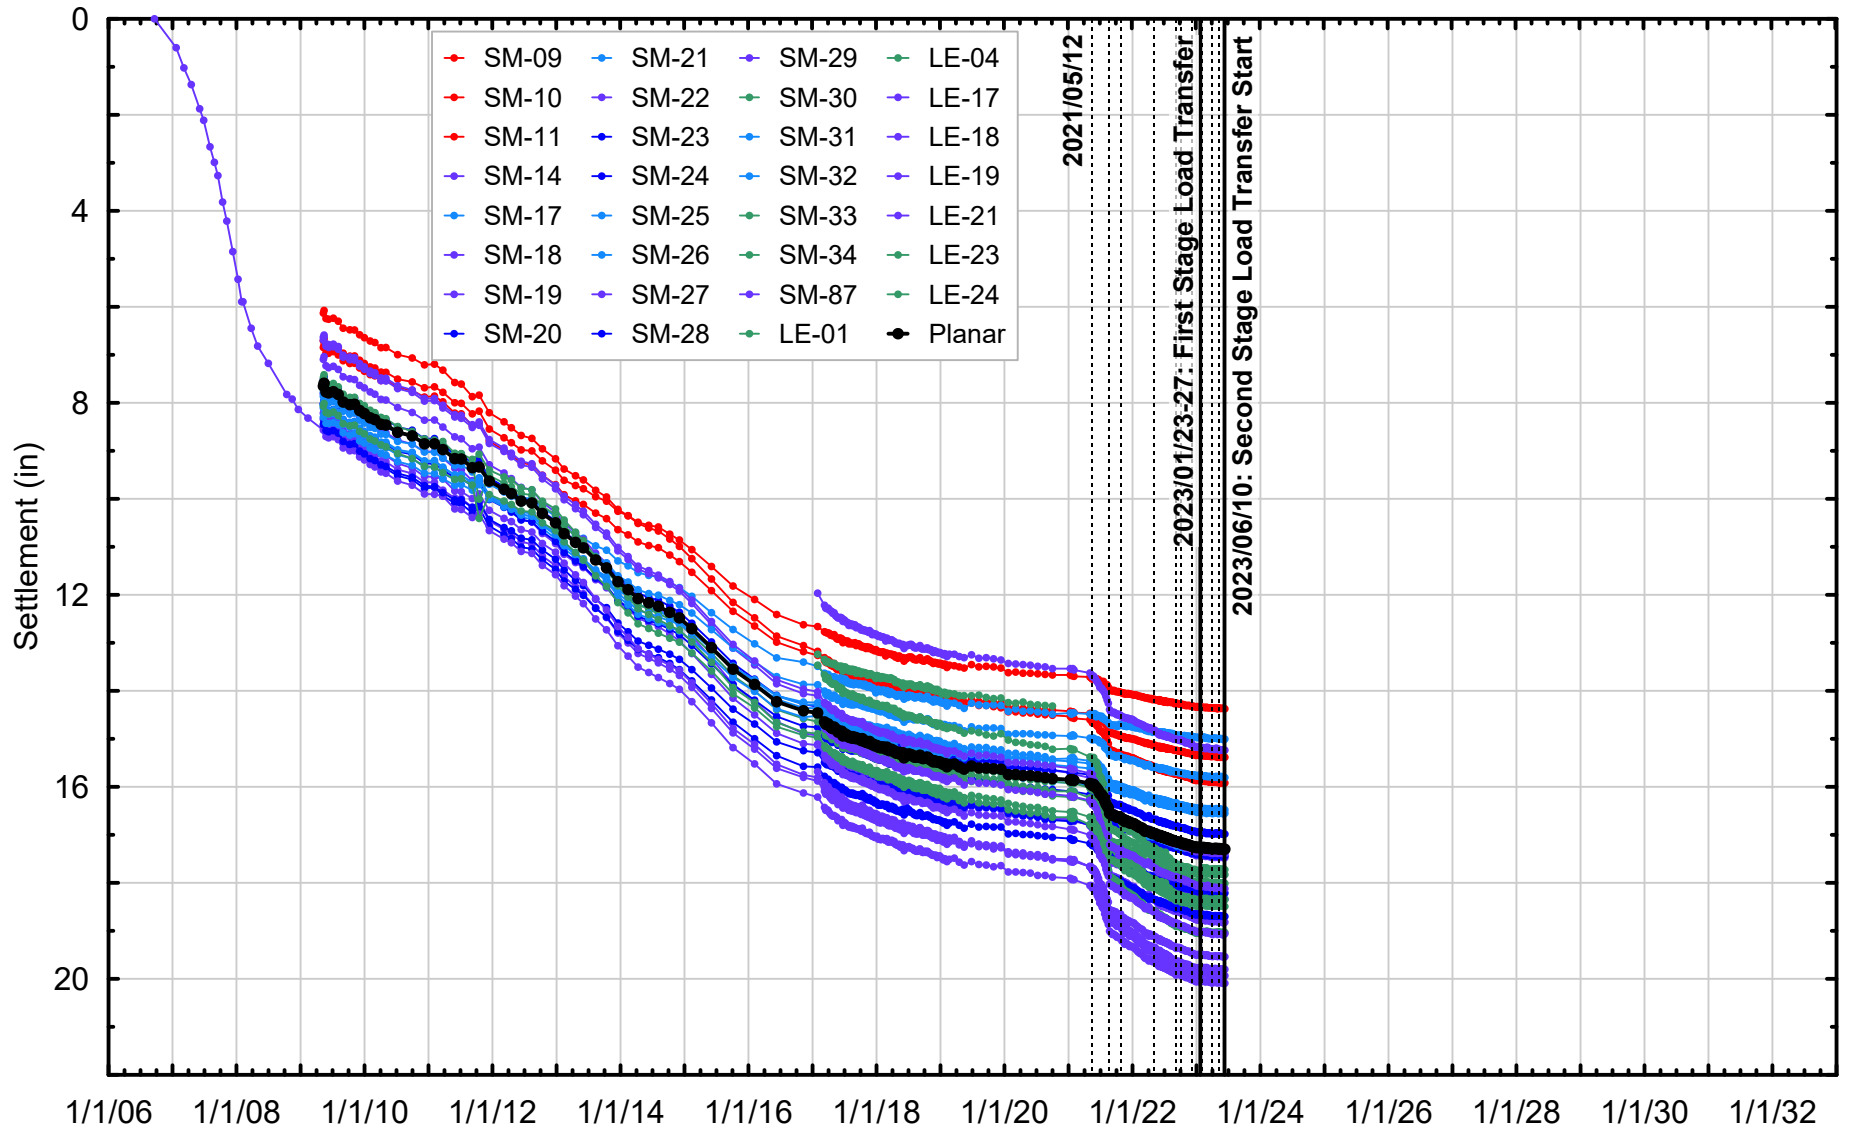
Project No: 19-009.00	Date: 6/15/2023	Created By: NBW	Checked By: DGM	Figure No: 110-02
-----------------------	-----------------	-----------------	-----------------	--------------------------

Figure 02 presents the historical settlement data interpreted from settlement markers installed on the B-1 Level of 301 Mission Tower. In addition, data from surveys performed during the retrofit are included. Figure 03A presents settlement data since the start of production pile installation (May 12, 2021; baseline readings on May 10, 2021) through June 12, 2023. Figure 03B presents settlement data since January 11, 2021, through June 12, 2023. Figure 03C presents settlement data during the Second Stage Load Transfer for a subset of the settlement markers and the mat extension survey points from June 10, 2023, through June 14, 2023. Figure 04 presents current settlement contours (in inches) on June 12, 2023.

HISTORICAL SETTLEMENT MARKER DATA

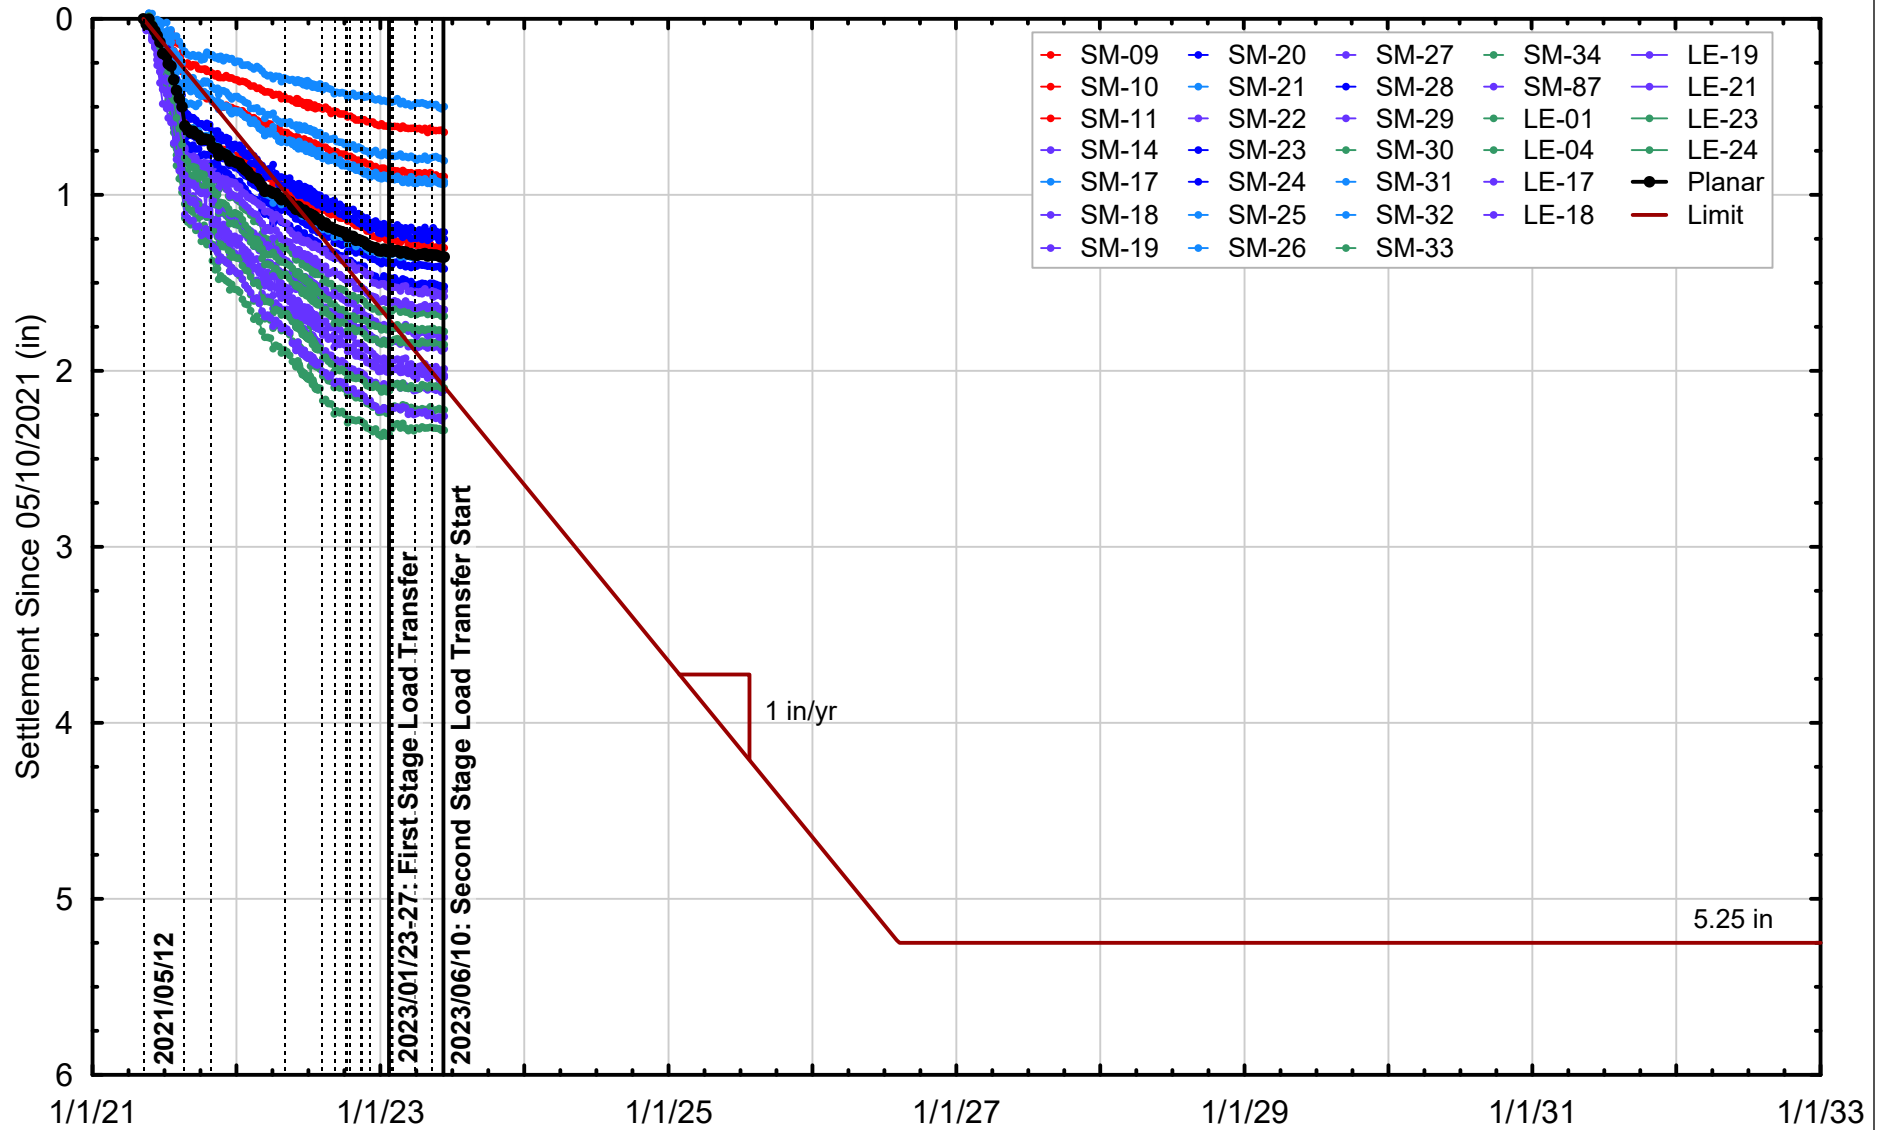
Figure No: **110-03A**

SETTLEMENT MARKER DATA
SINCE 05/10/2021 THROUGH 06/12/2023

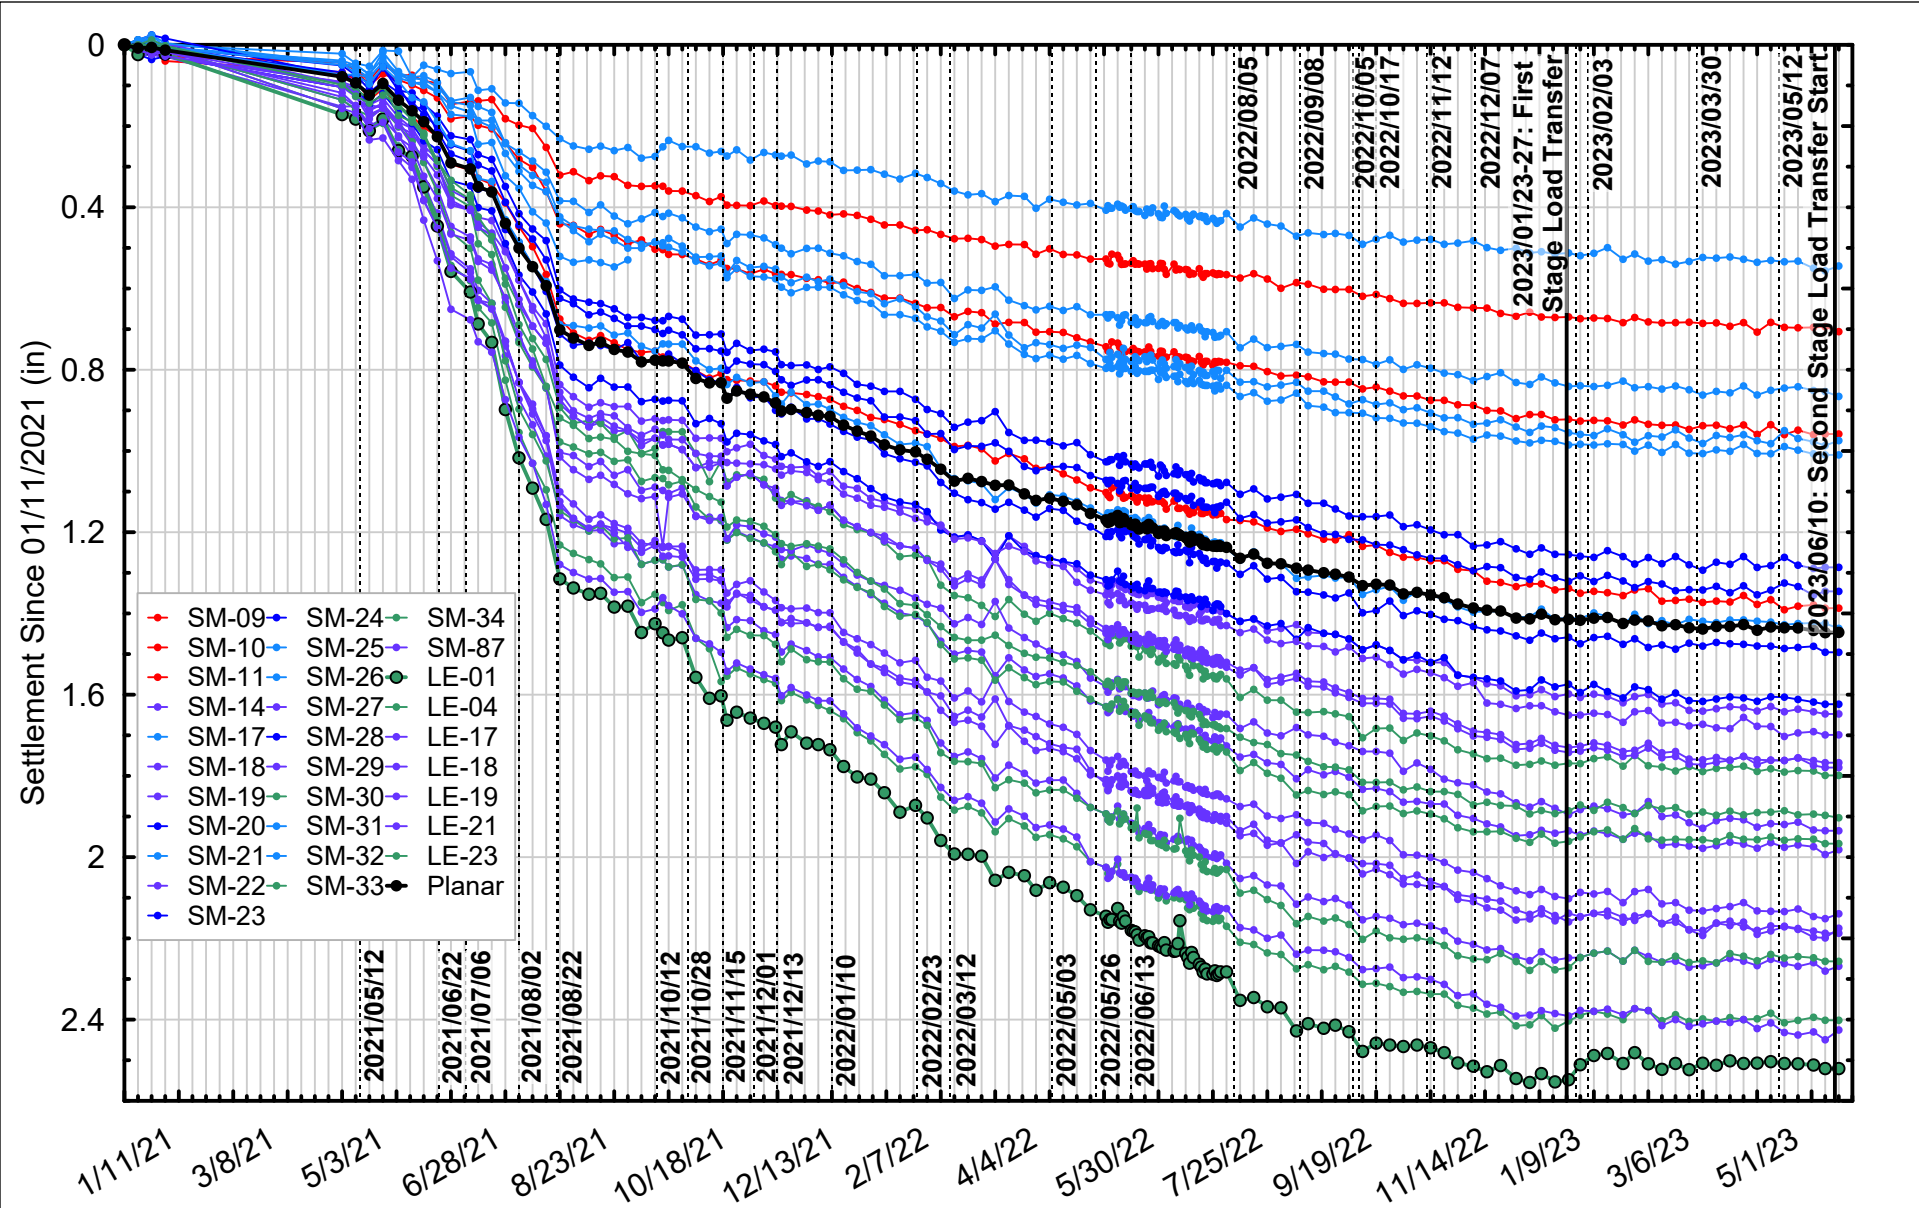
Project No: 19-009.00 Date: 6/15/2023 Created By: NBW Checked By: DGM Figure No: 110-03B

SETTLEMENT MARKER DATA
SINCE 01/11/2021 THROUGH 06/12/2023
Millennium Tower Perimeter Pile Upgrade: Instrumentation Monitoring Data
City and County of San Francisco, California

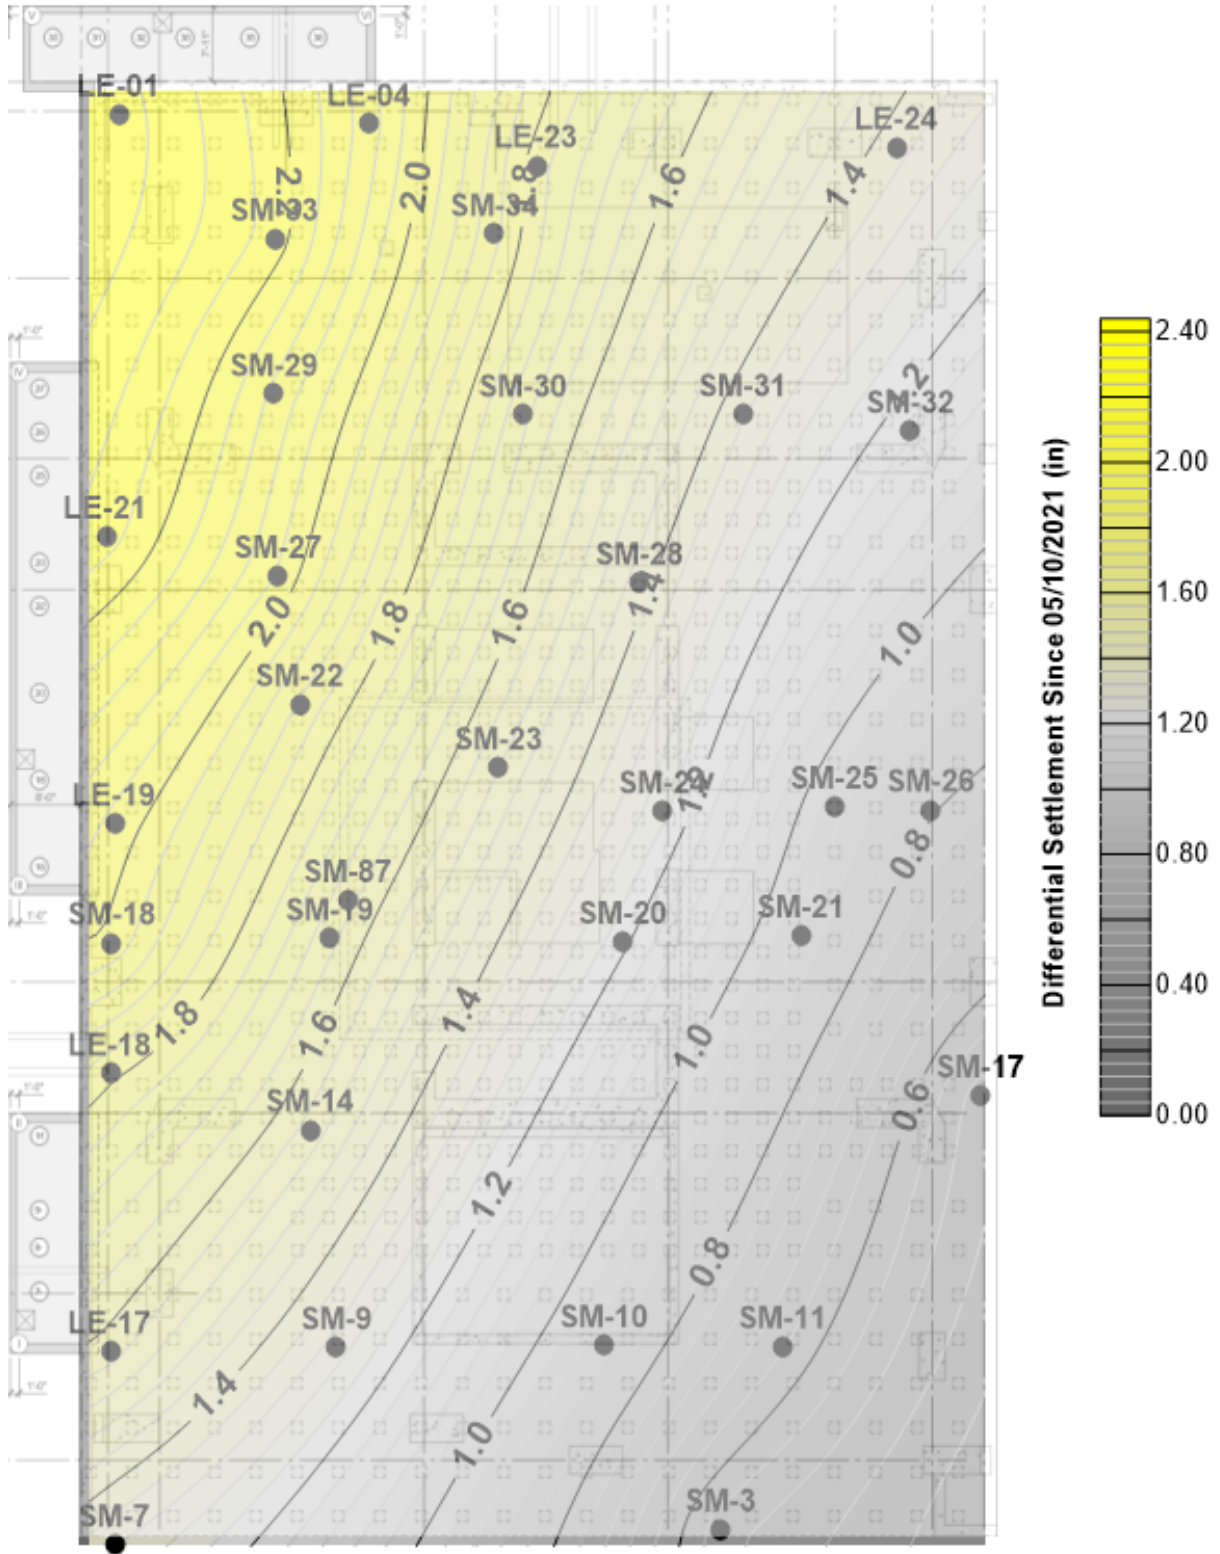
Figure No: **110-04**

SETTLEMENT CONTOURS
SINCE 05/10/2021 THROUGH 06/12/2023

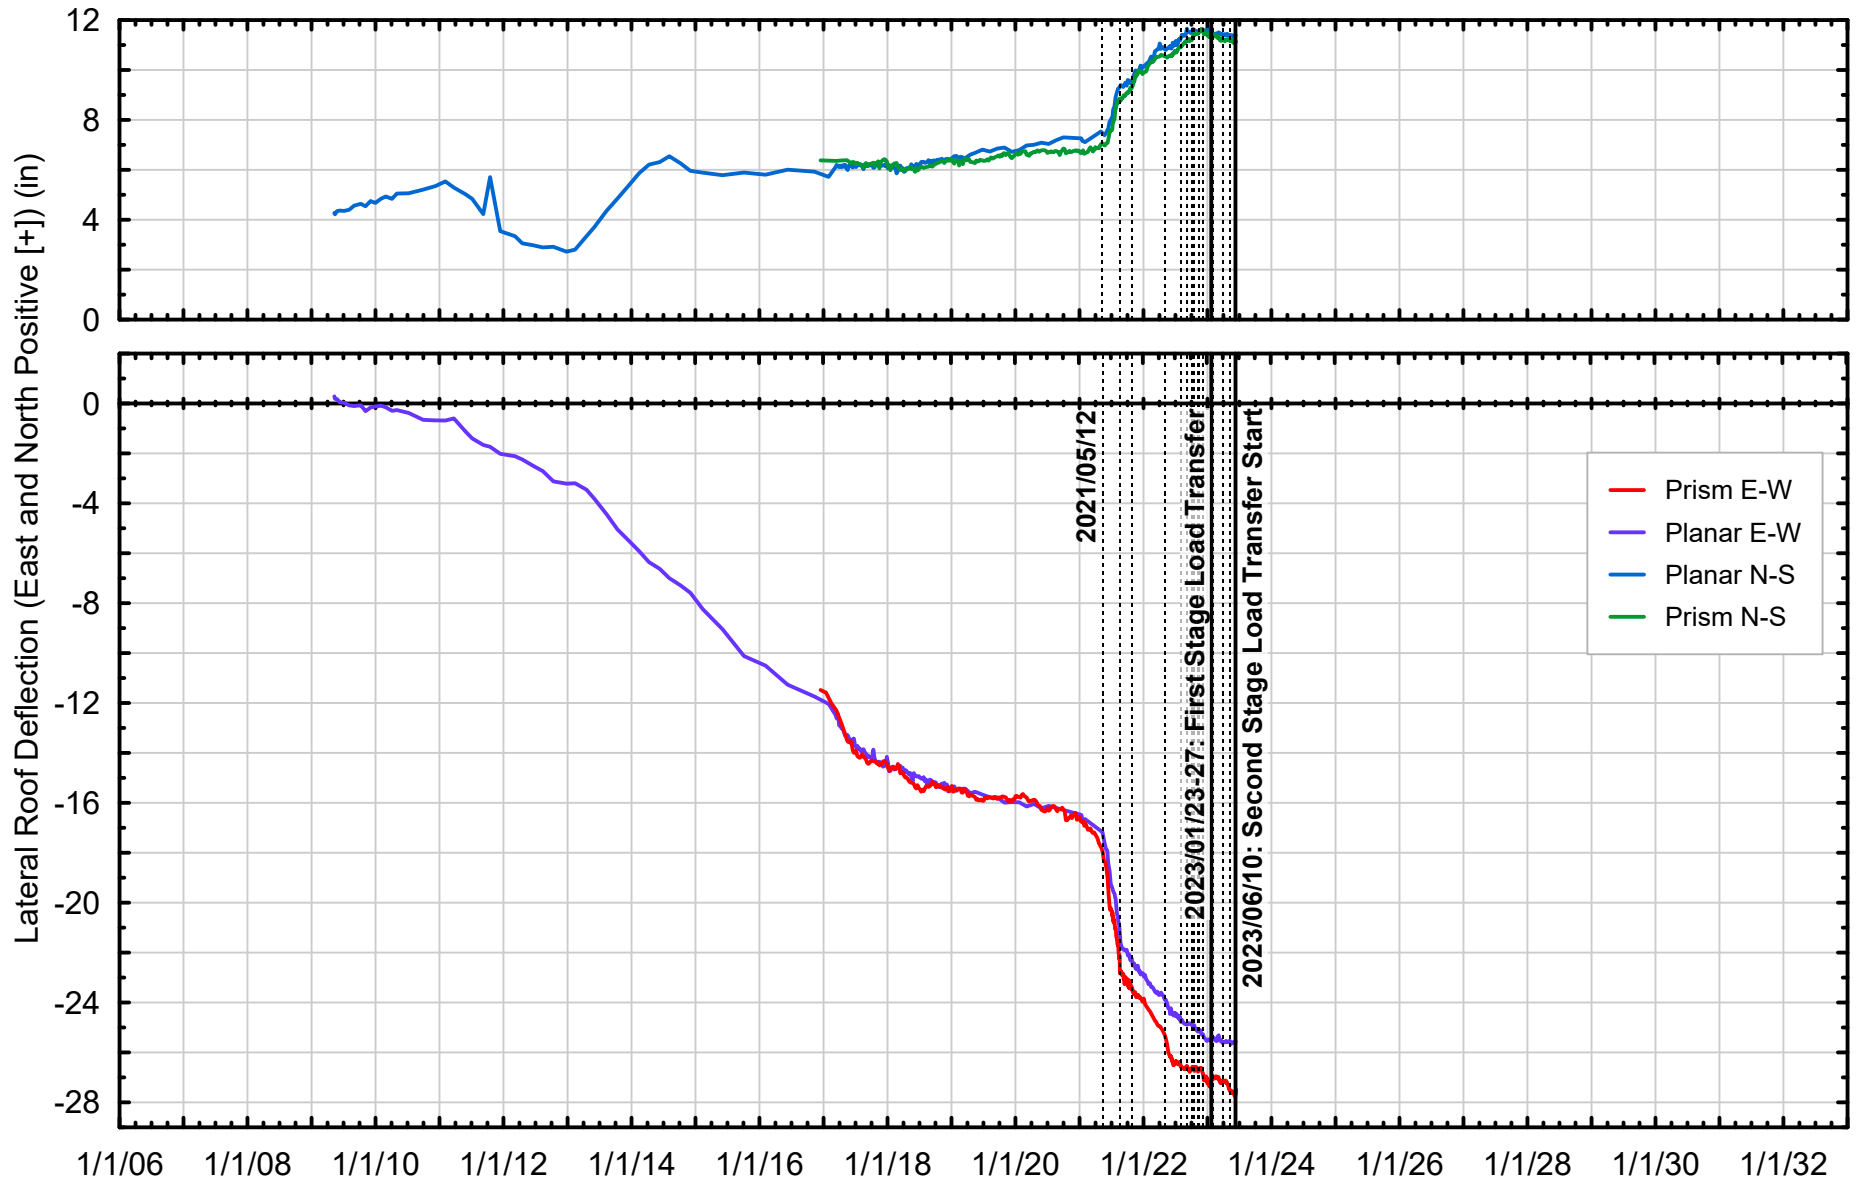
Project No: 19-009.00	Date: 6/15/2023	Created By: NBW	Checked By: DGM	Figure No: 110-05
-----------------------	-----------------	-----------------	-----------------	--------------------------

Figure 05 presents historical lateral roof deflections in the project north-south and project east-west directions interpreted from survey prisms mounted on the exterior of the Tower, from InSAR data, and from a planar fit of the settlement marker data. In addition, data from surveys performed during the retrofit are included. Figure 06A presents lateral roof deflection data from a planar fit of the settlement marker data and from survey prisms mounted on the exterior of the Tower since the start of production pile installation (May 12, 2021; baseline readings on May 10 and 13, 2021, respectively) through June 14, 2023. Figure 06B presents lateral roof deflection data from a planar fit of the settlement marker data and from survey prisms mounted on the exterior of the Tower since January 11, 2021, through June 14, 2023.

HISTORICAL LATERAL ROOF DEFLECTION DATA

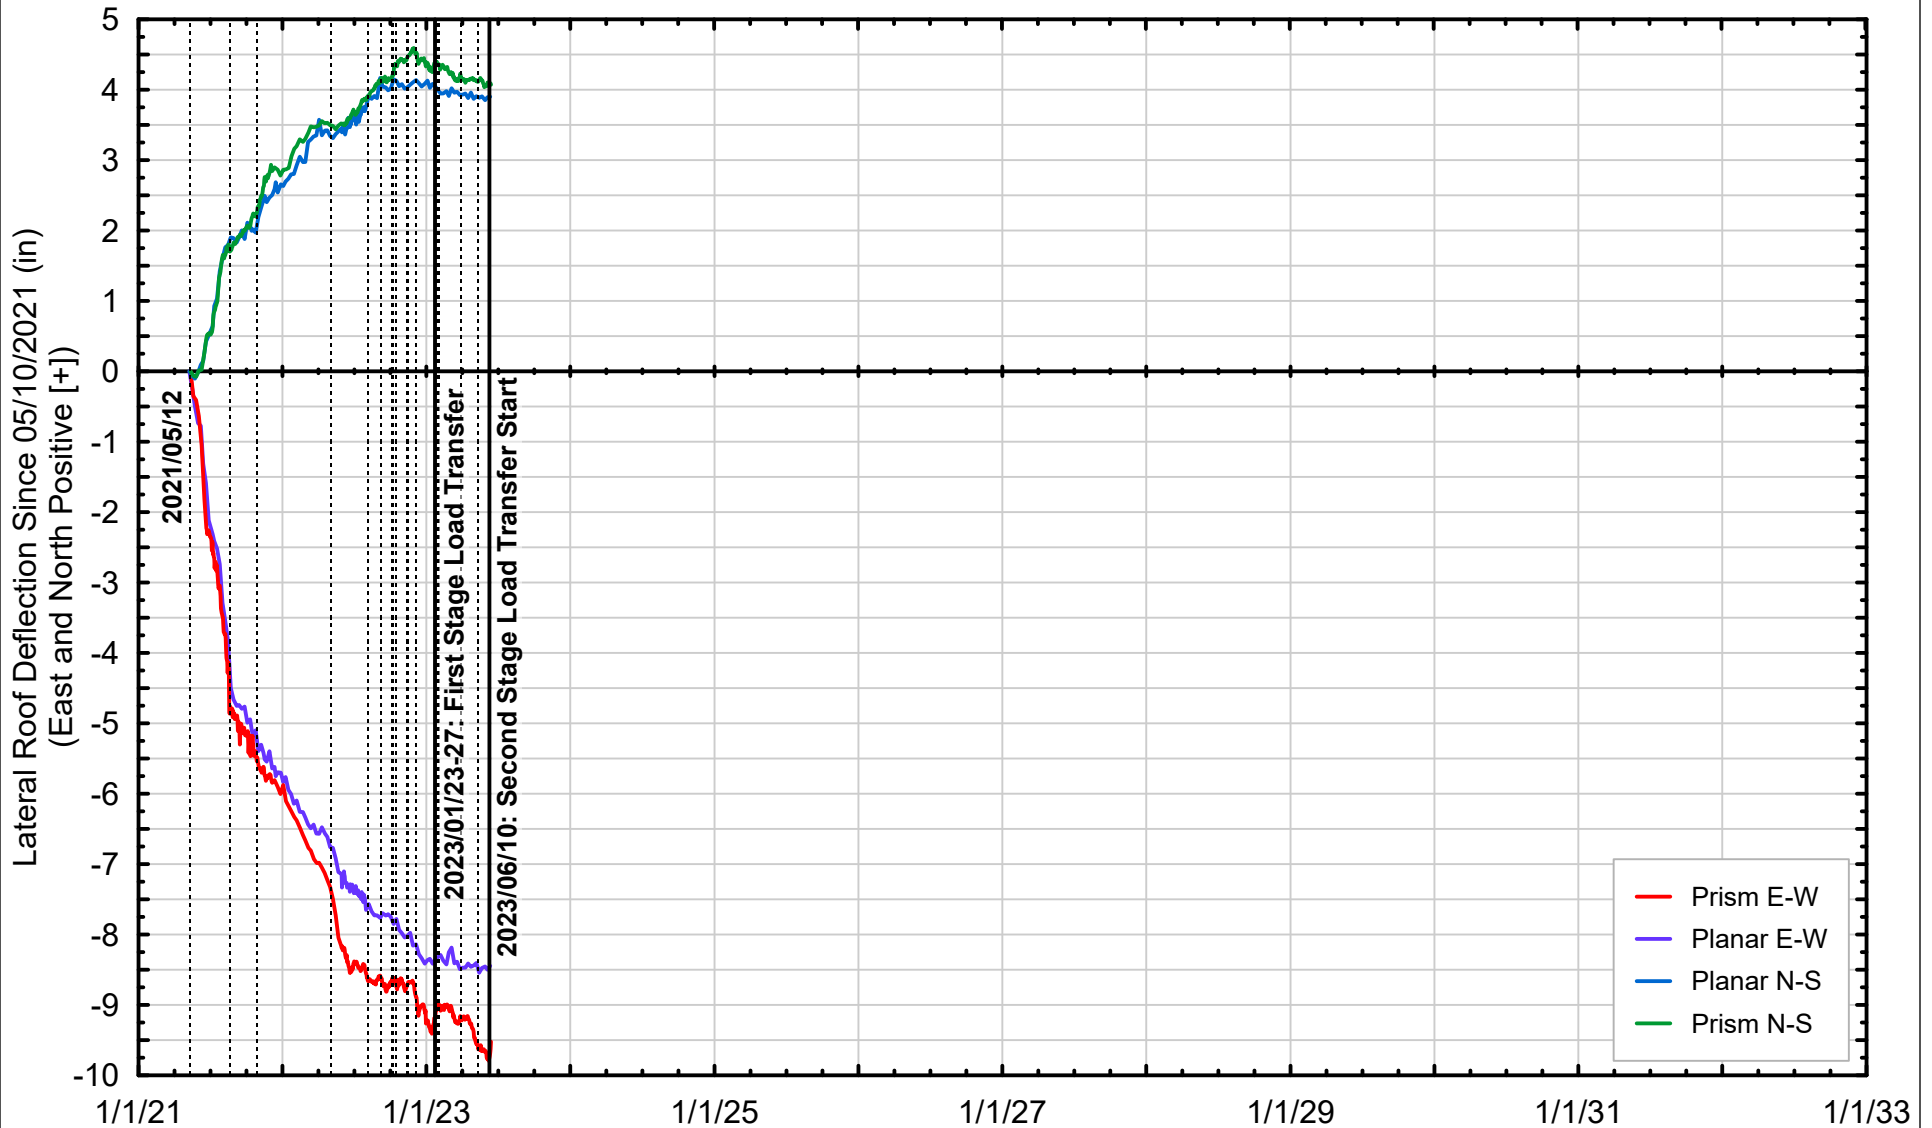
Project No: 19-009.00	Date: 6/15/2023	Created By: NBW	Checked By: DGM	Figure No: 110-06A
-----------------------	-----------------	-----------------	-----------------	---------------------------

LATERAL ROOF DEFLECTION DATA
SINCE 05/10/2021 THROUGH 06/14/2023

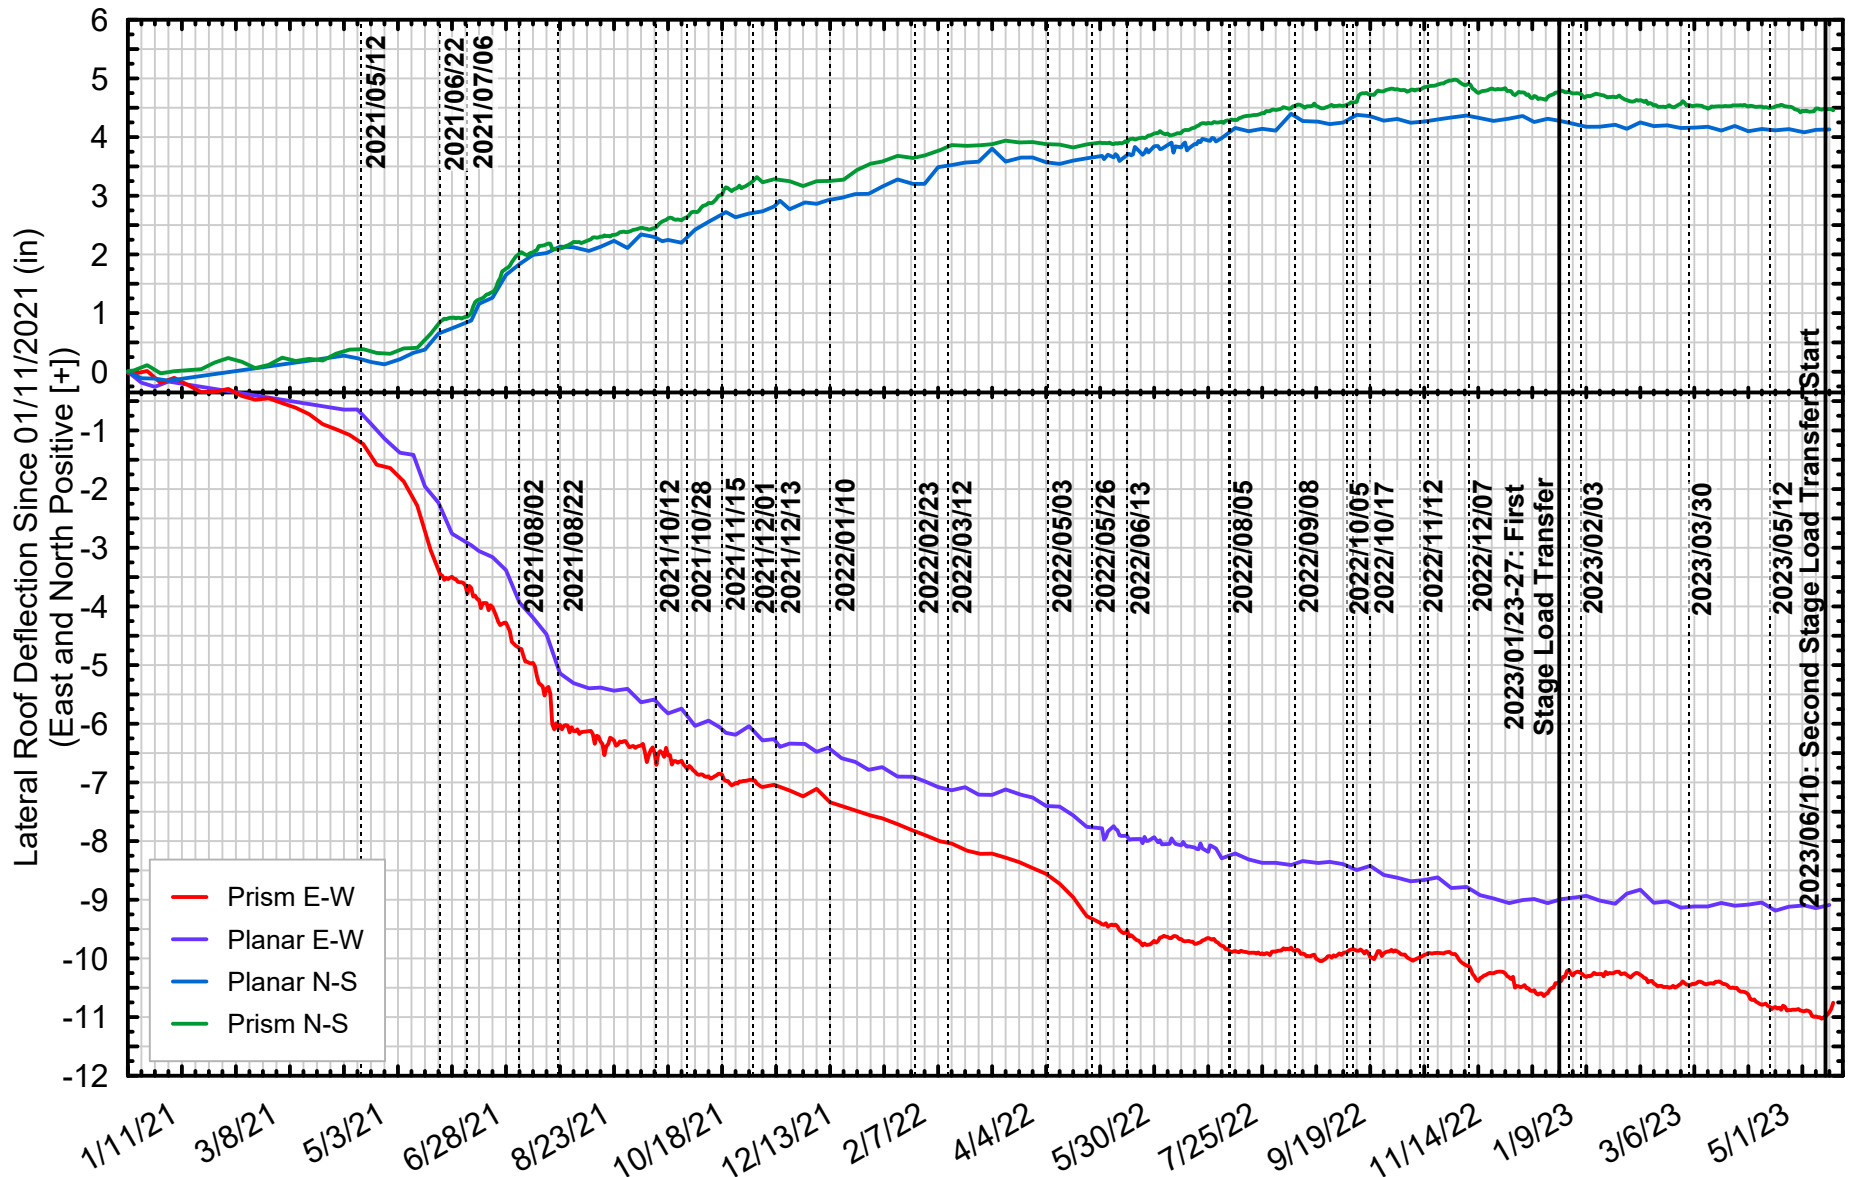
Project No: 19-009.00	Date: 6/15/2023	Created By: NBW	Checked By: DGM	Figure No: 110-06B
-----------------------	-----------------	-----------------	-----------------	---------------------------

LATERAL ROOF DEFLECTION DATA
SINCE 01/11/2021 THROUGH 06/14/2023

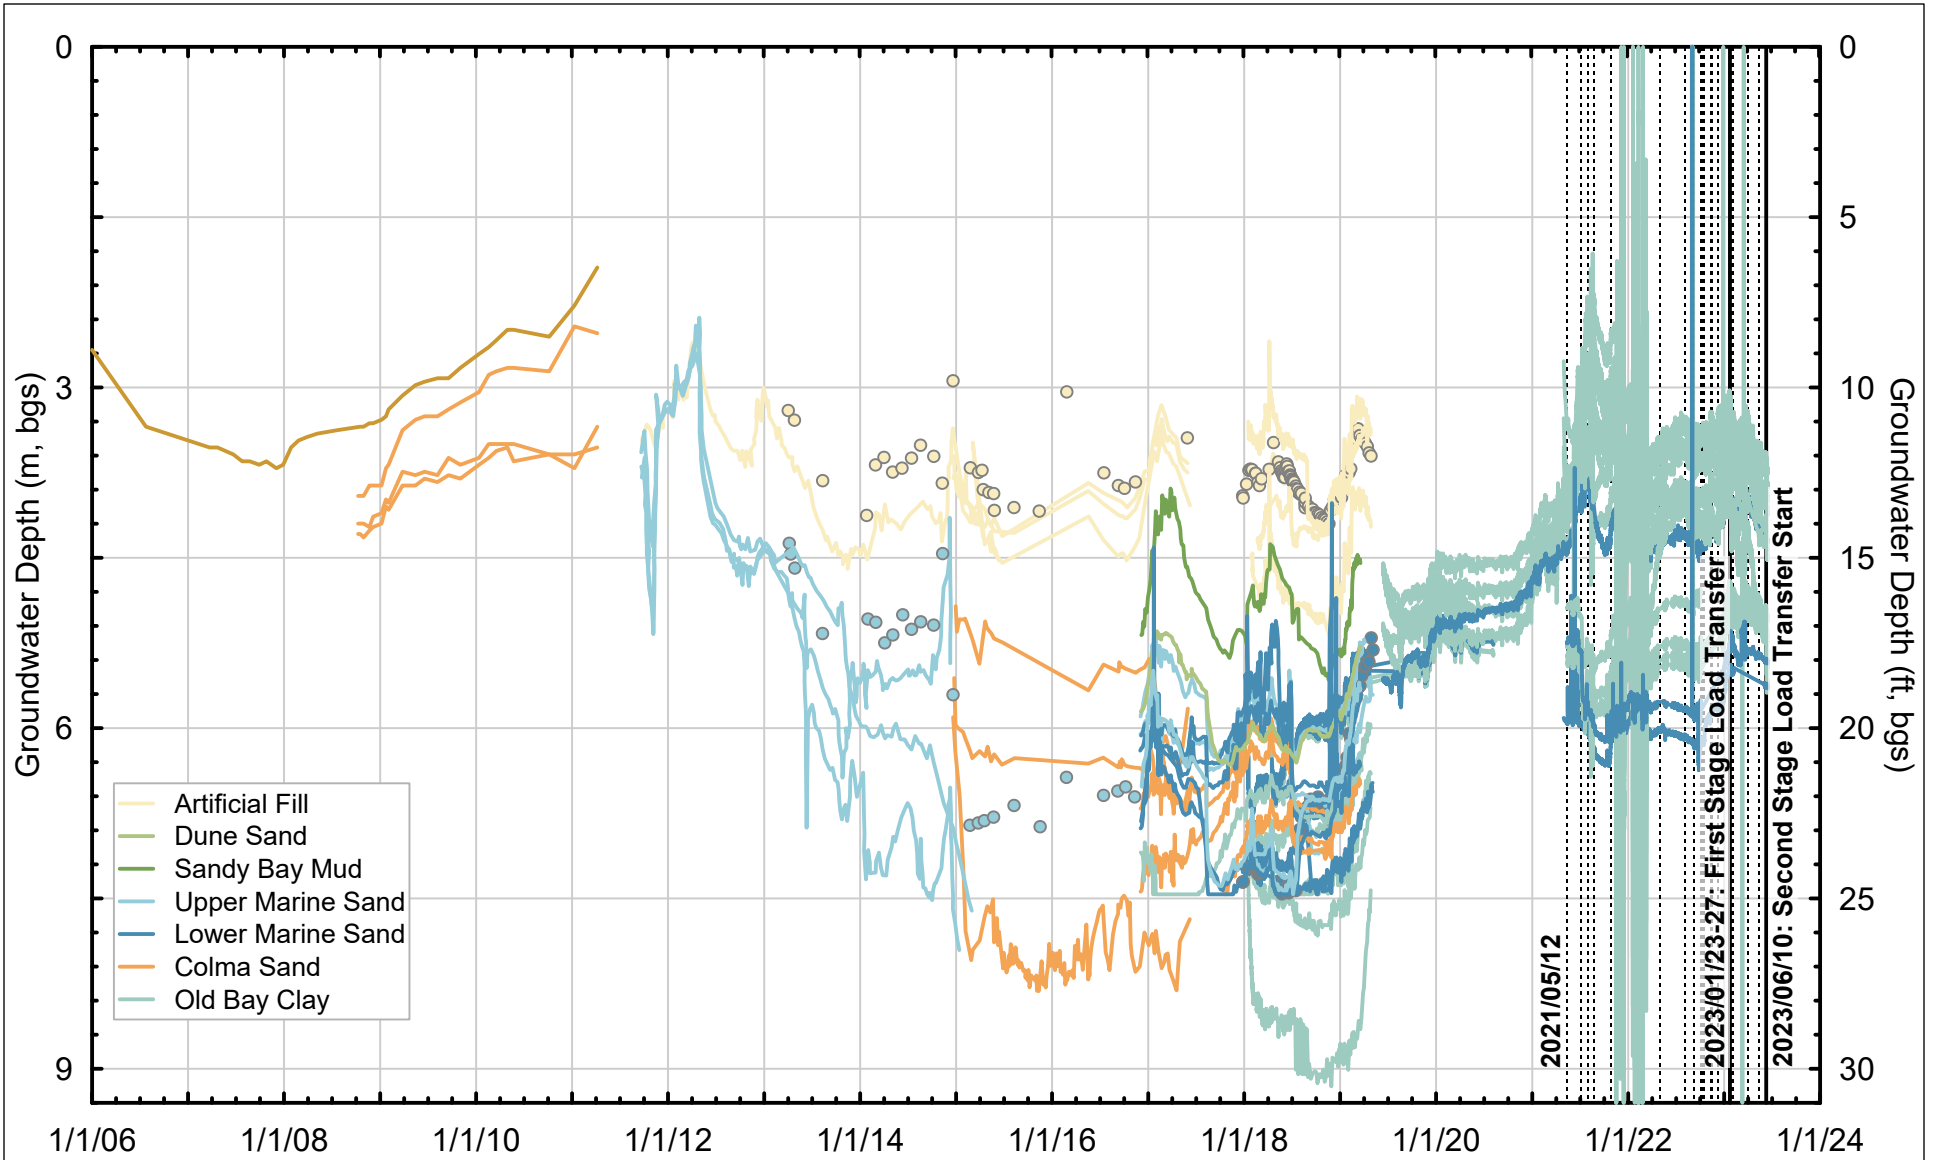
Project No: 19-009.00	Date: 6/15/2023	Created By: NBW	Checked By: DGM	Figure No: 110-07
-----------------------	-----------------	-----------------	-----------------	--------------------------

Figure 07 presents the historical groundwater elevation interpreted from piezometer readings at locations near 301 Mission. In addition, data from piezometers installed to monitor groundwater elevation during the retrofit are included. Figures 08 and 09 present groundwater elevation interpreted from piezometer readings

HISTORICAL GROUNDWATER ELEVATION MEASUREMENTS
AT LOCATIONS NEAR 301 MISSION
