Subject: 301 Mission Retrofit Monitoring Report 110: Results as of June 14, 2023

This memorandum summarizes results from the monitoring plan implemented at the 301 Mission property. Instrumentation to monitor the structure prior to, during and after the retrofit was installed in January 2021, including piezometers and extensometers. Settlement markers installed in April 2009 and January 2017, survey prisms mounted on the exterior of the structure in December 2016, and crack gauges installed in April 2009 have also been monitored. Pile load cells were installed on the Mission Street piles in January 2023. Survey markers were installed on the Mission Street mat extension in January 2023. This memorandum is for review only. It only contains ongoing monitoring information. This memorandum does not contain recommendations based upon the ongoing monitoring information.

Millennium Tower Perimeter Pile Upgrade: Instrumentation Monitoring Data
City and County of San Francisco, California

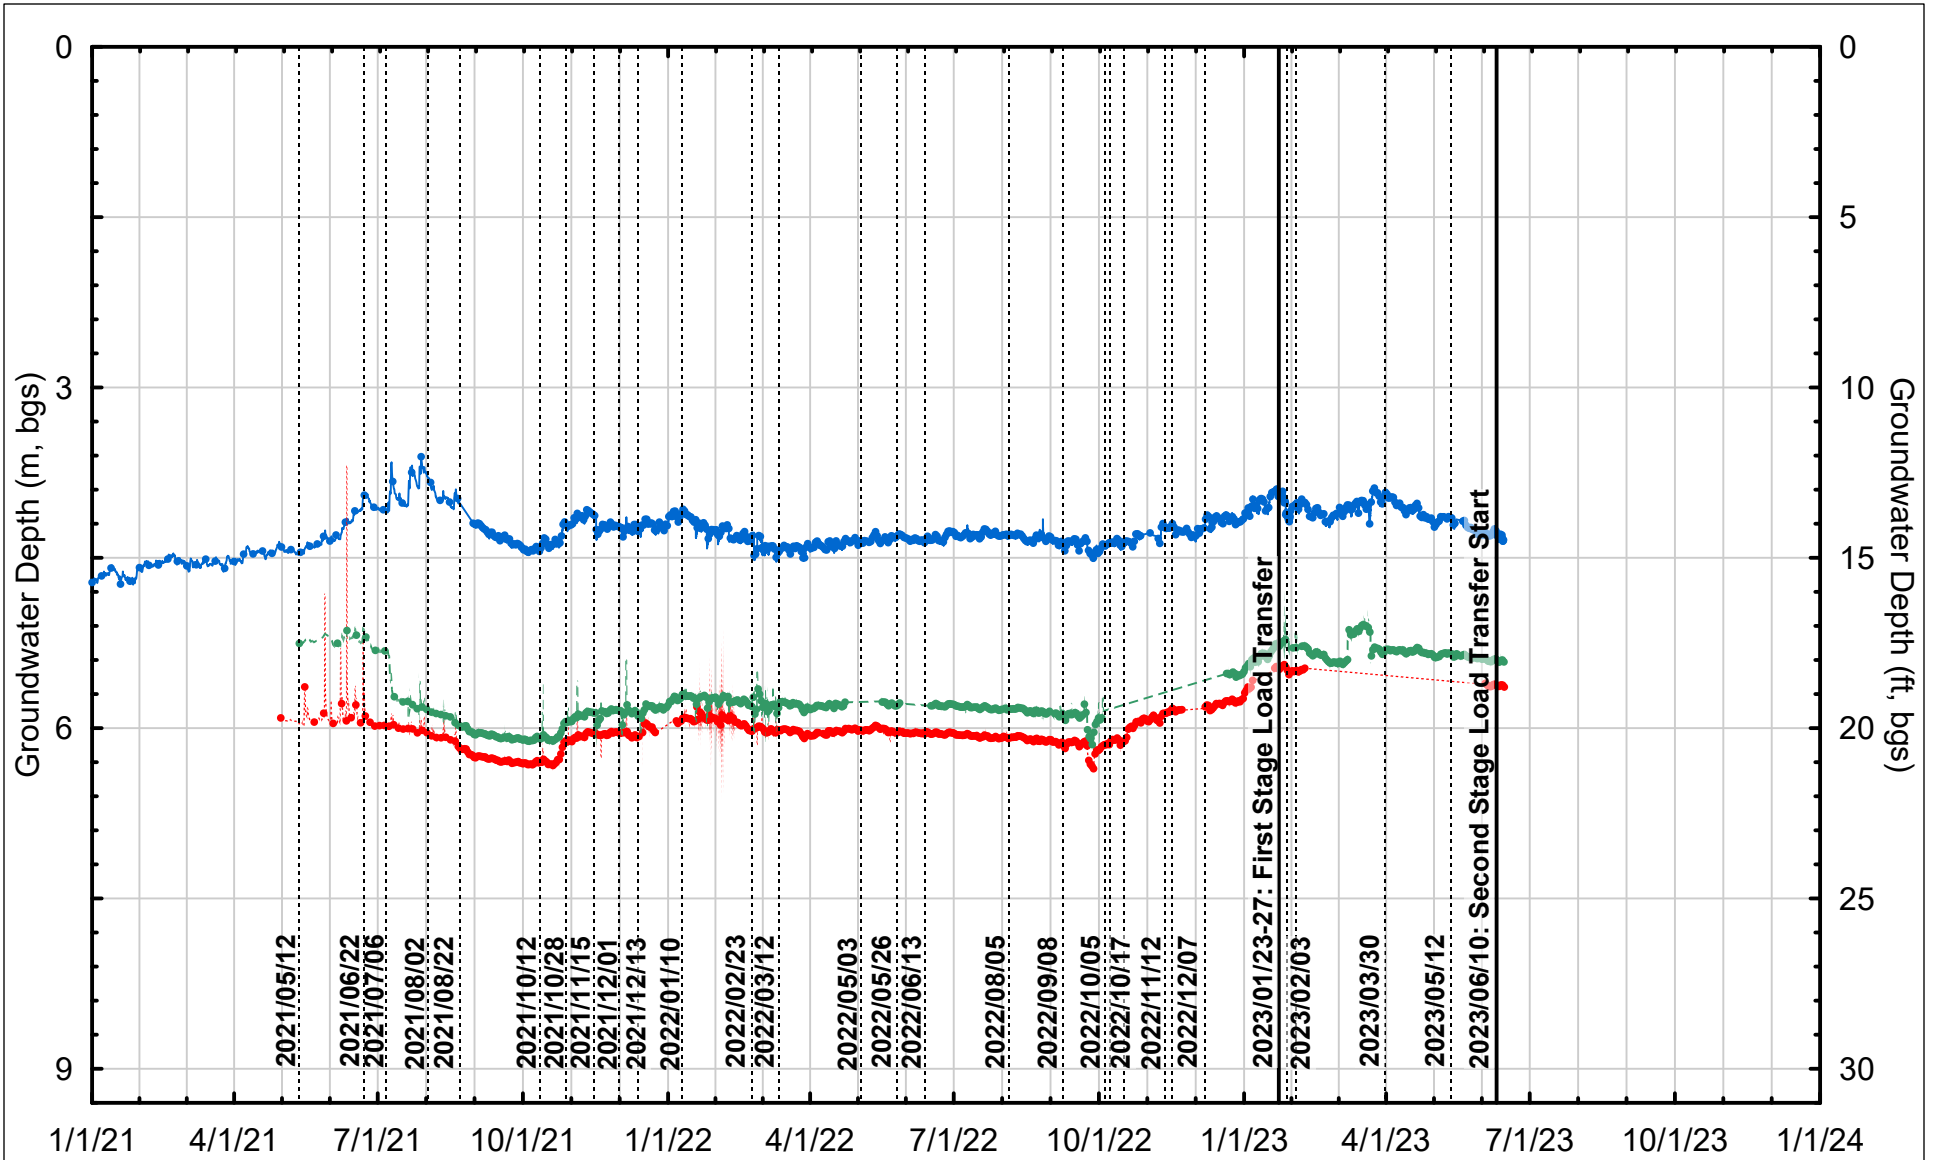
Figure No: 110-08A

GROUNDWATER ELEVATION MEASUREMENTS IN MARINE AND COLMA SAND SINCE 01/01/2021 THROUGH 06/14/2023

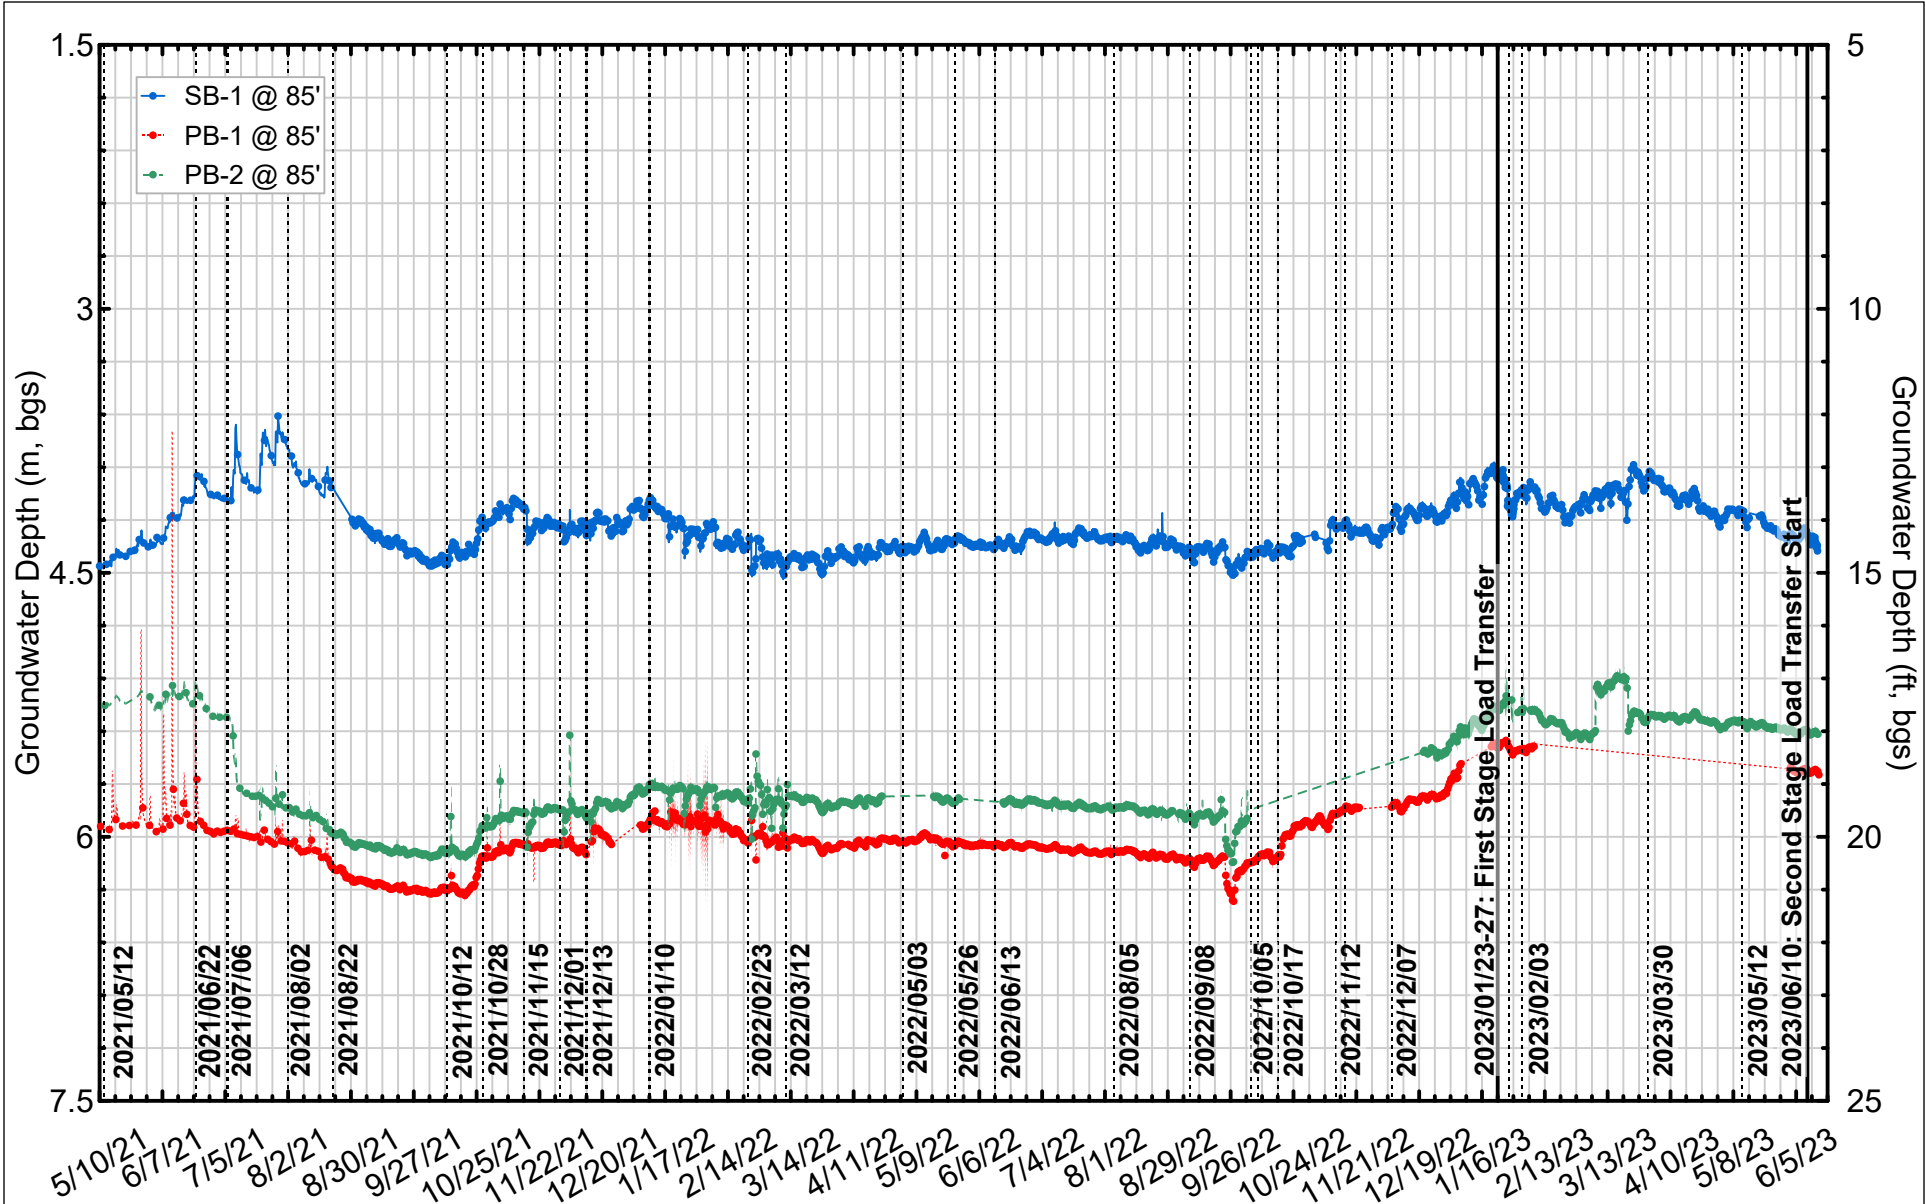
Project No: 19-009.00 Date: 6/15/2023 Created By: NBW Checked By: DGM Figure No: 110-08B

GROUNDWATER ELEVATION MEASUREMENTS IN MARINE AND COLMA SAND
SINCE 05/10/2021 THROUGH 06/14/2023

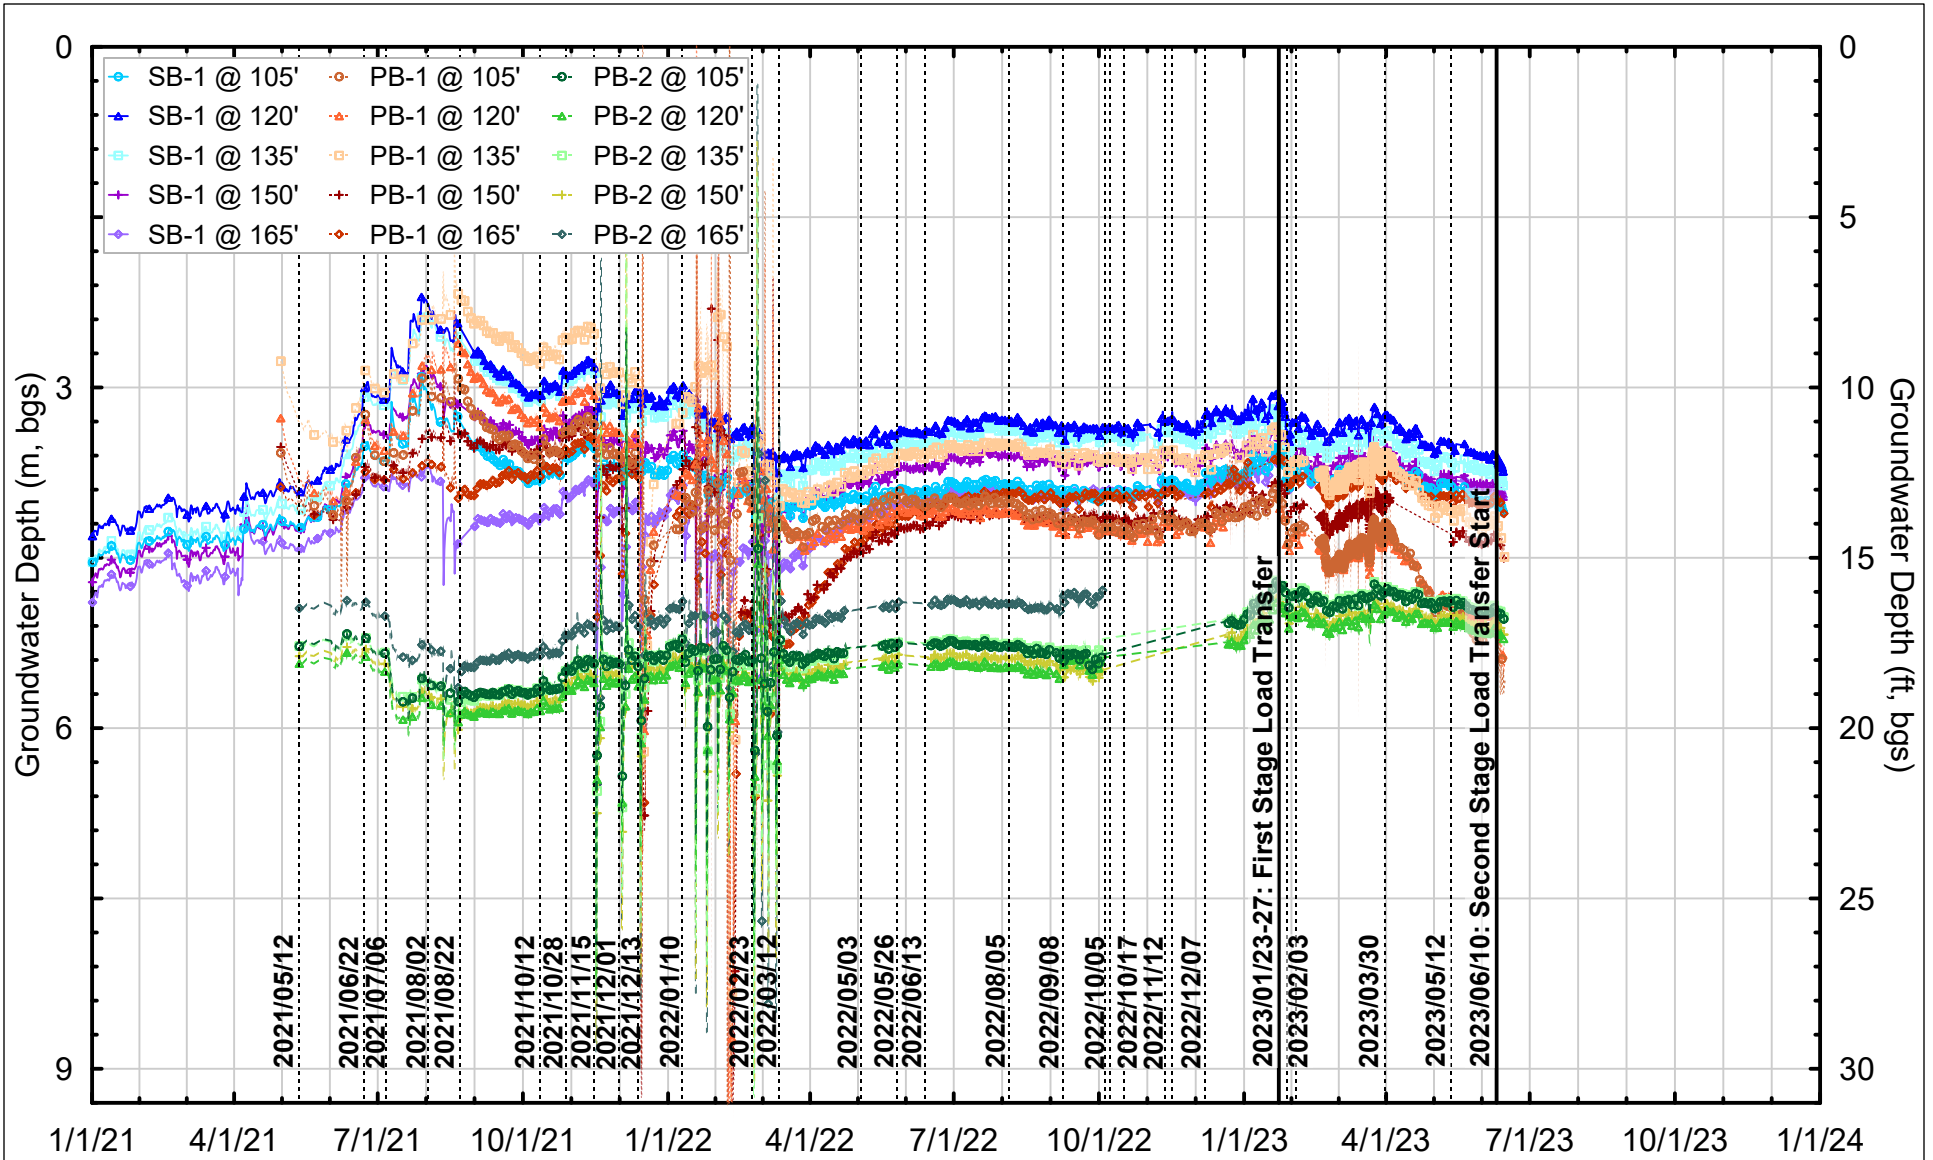
Project No: 19-009.00	Date: 6/15/2023	Created By: NBW	Checked By: DGM	Figure No: 110-09A
-----------------------	-----------------	-----------------	-----------------	---------------------------

GROUNDWATER ELEVATION MEASUREMENTS IN OLD BAY CLAY
 SINCE 01/01/2021 THROUGH 06/14/2023

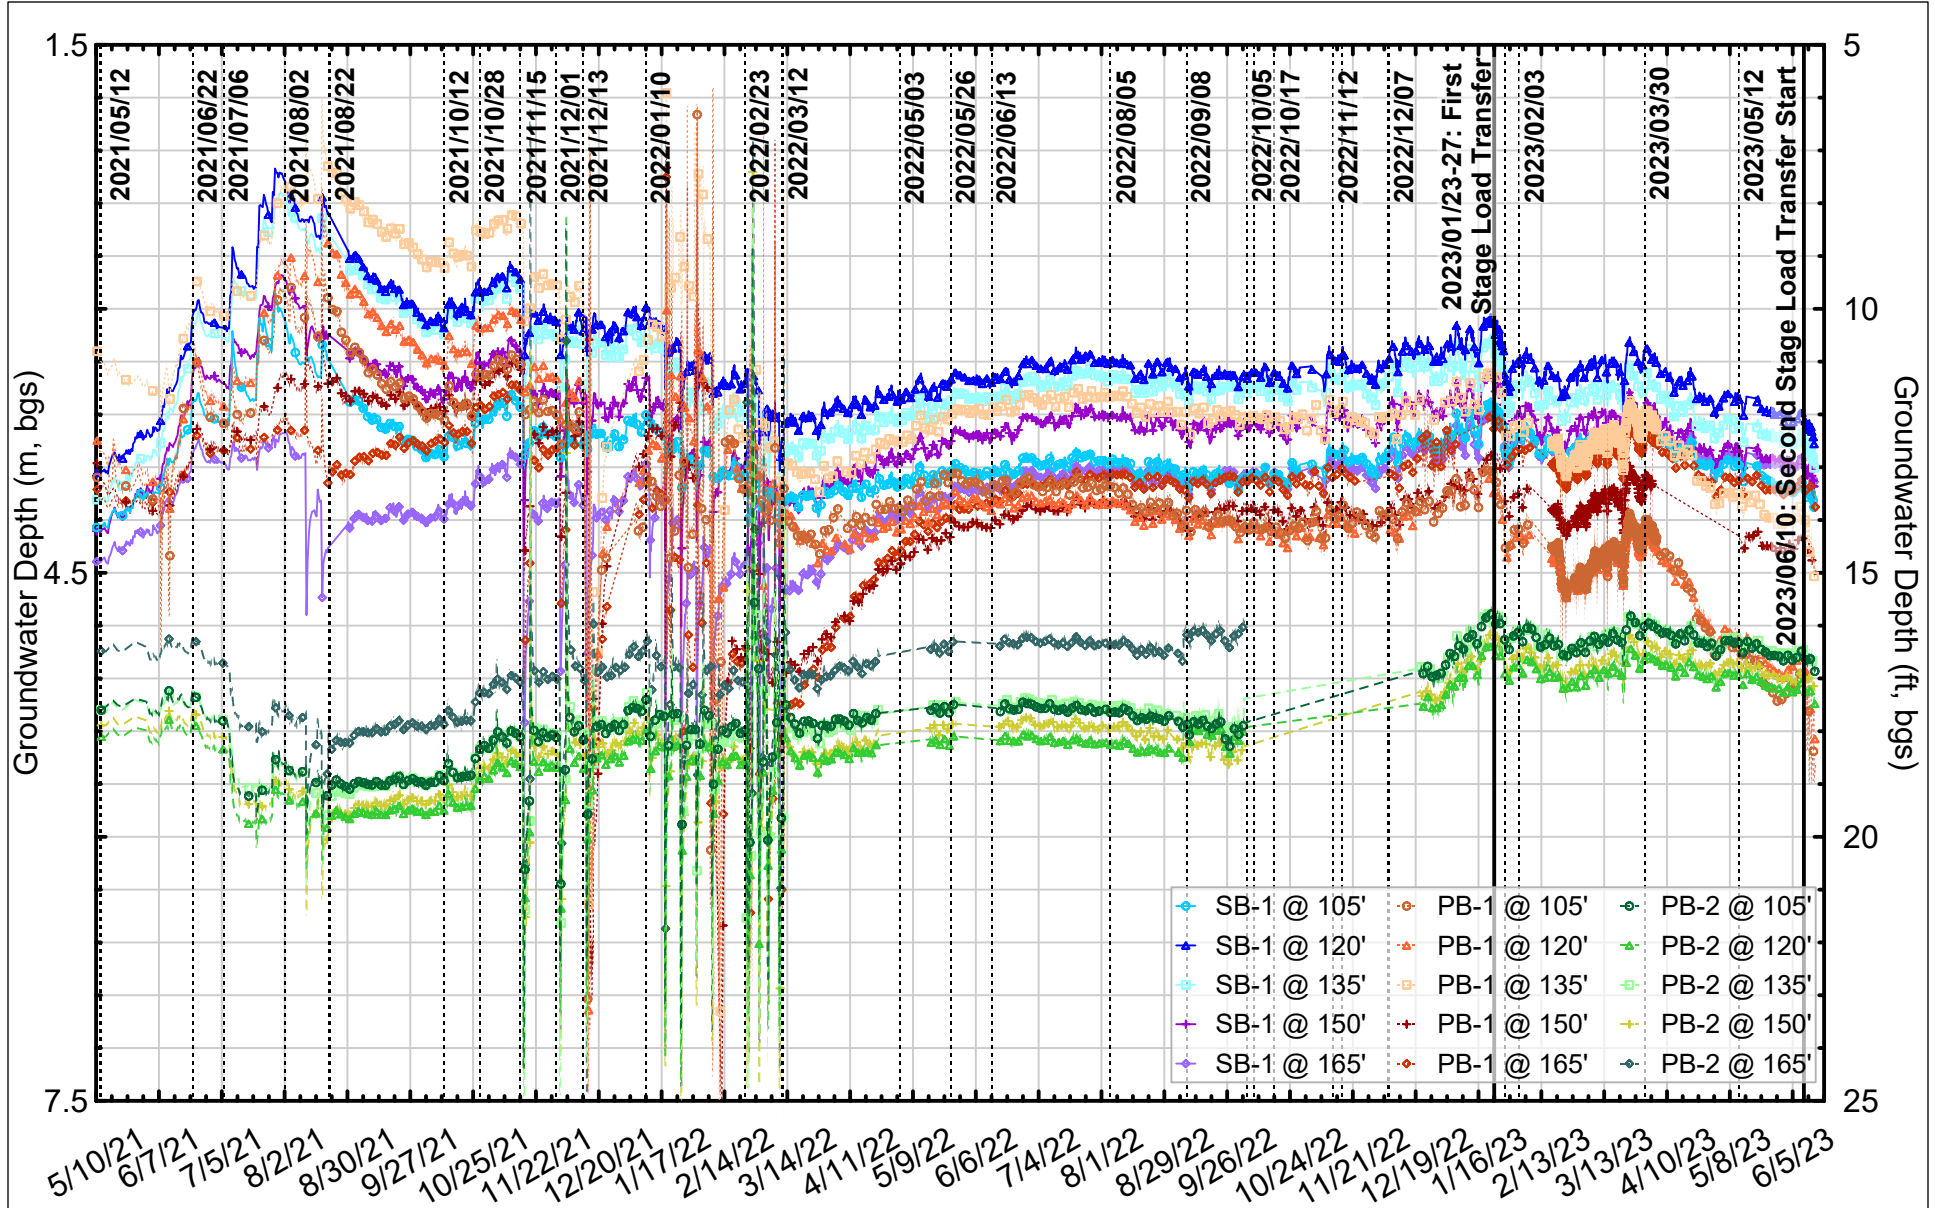
Project No: 19-009.00 Date: 6/15/2023 Created By: NBW Checked By: DGM Figure No: 110-09B

GROUNDWATER ELEVATION MEASUREMENTS IN OLD BAY CLAY
SINCE 05/10/2021 THROUGH 06/14/2023

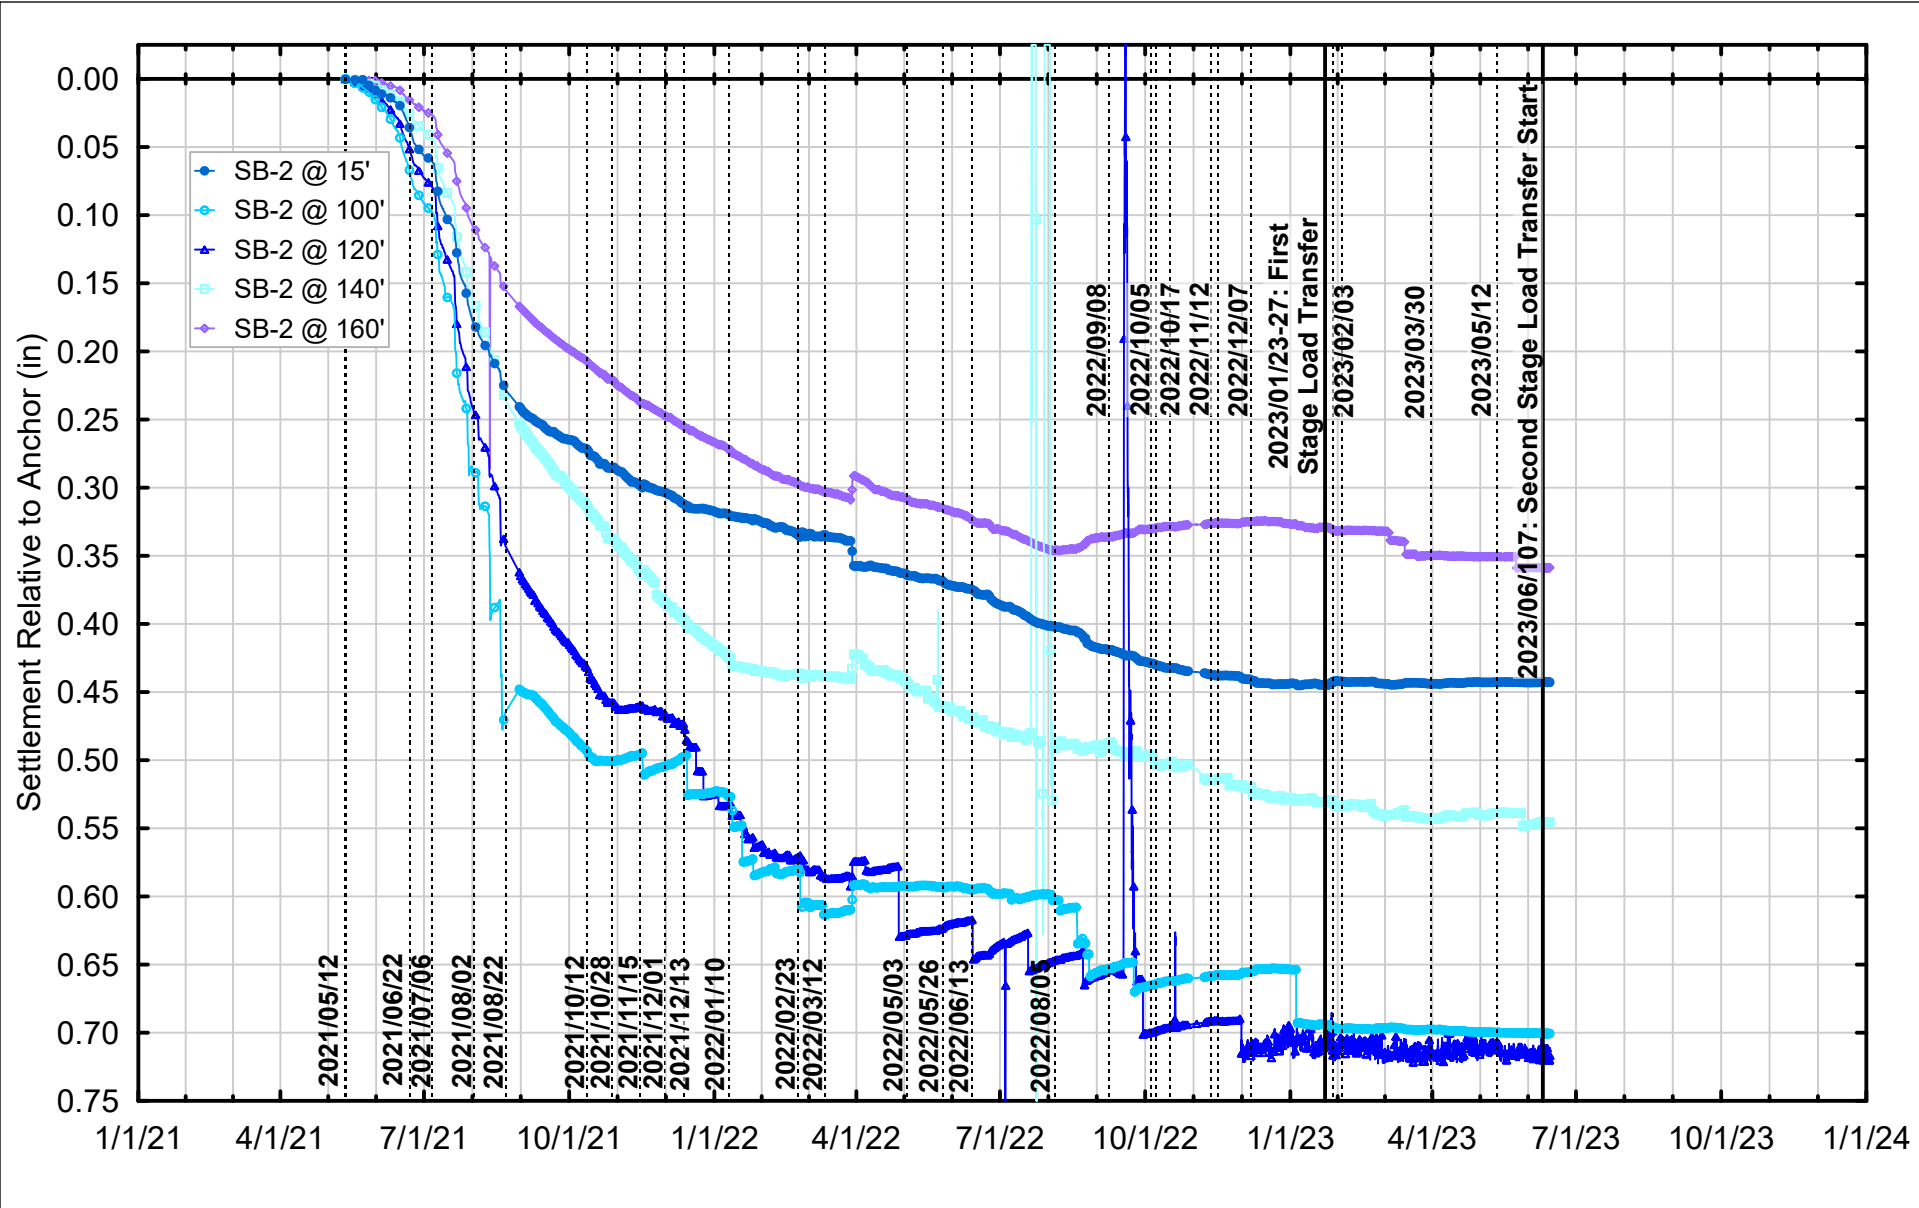
Project No: 19-009.00	Date: 6/15/2023	Created By: NBW	Checked By: DGM	Figure No: 110-10A
-----------------------	-----------------	-----------------	-----------------	--------------------

Figure 10 presents extensometer data from within the Tower basement since the start of production pile installation (May 12, 2021) through June 14, 2023. Figure 11 presents extensometer data from Fremont Street since the start of production pile installation (May 12, 2021) through May 16, 2023, and from the restart after fixing the extensometer (May 30, 2023) through June 14. Figure 12 presents extensometer data from Mission Street since the start of production pile installation (May 12, 2021) through June 14, 2023.

EXTENSOMETER DATA FROM WITHIN TOWER BASEMENT
SINCE 01/01/2021 THROUGH 06/14/2023

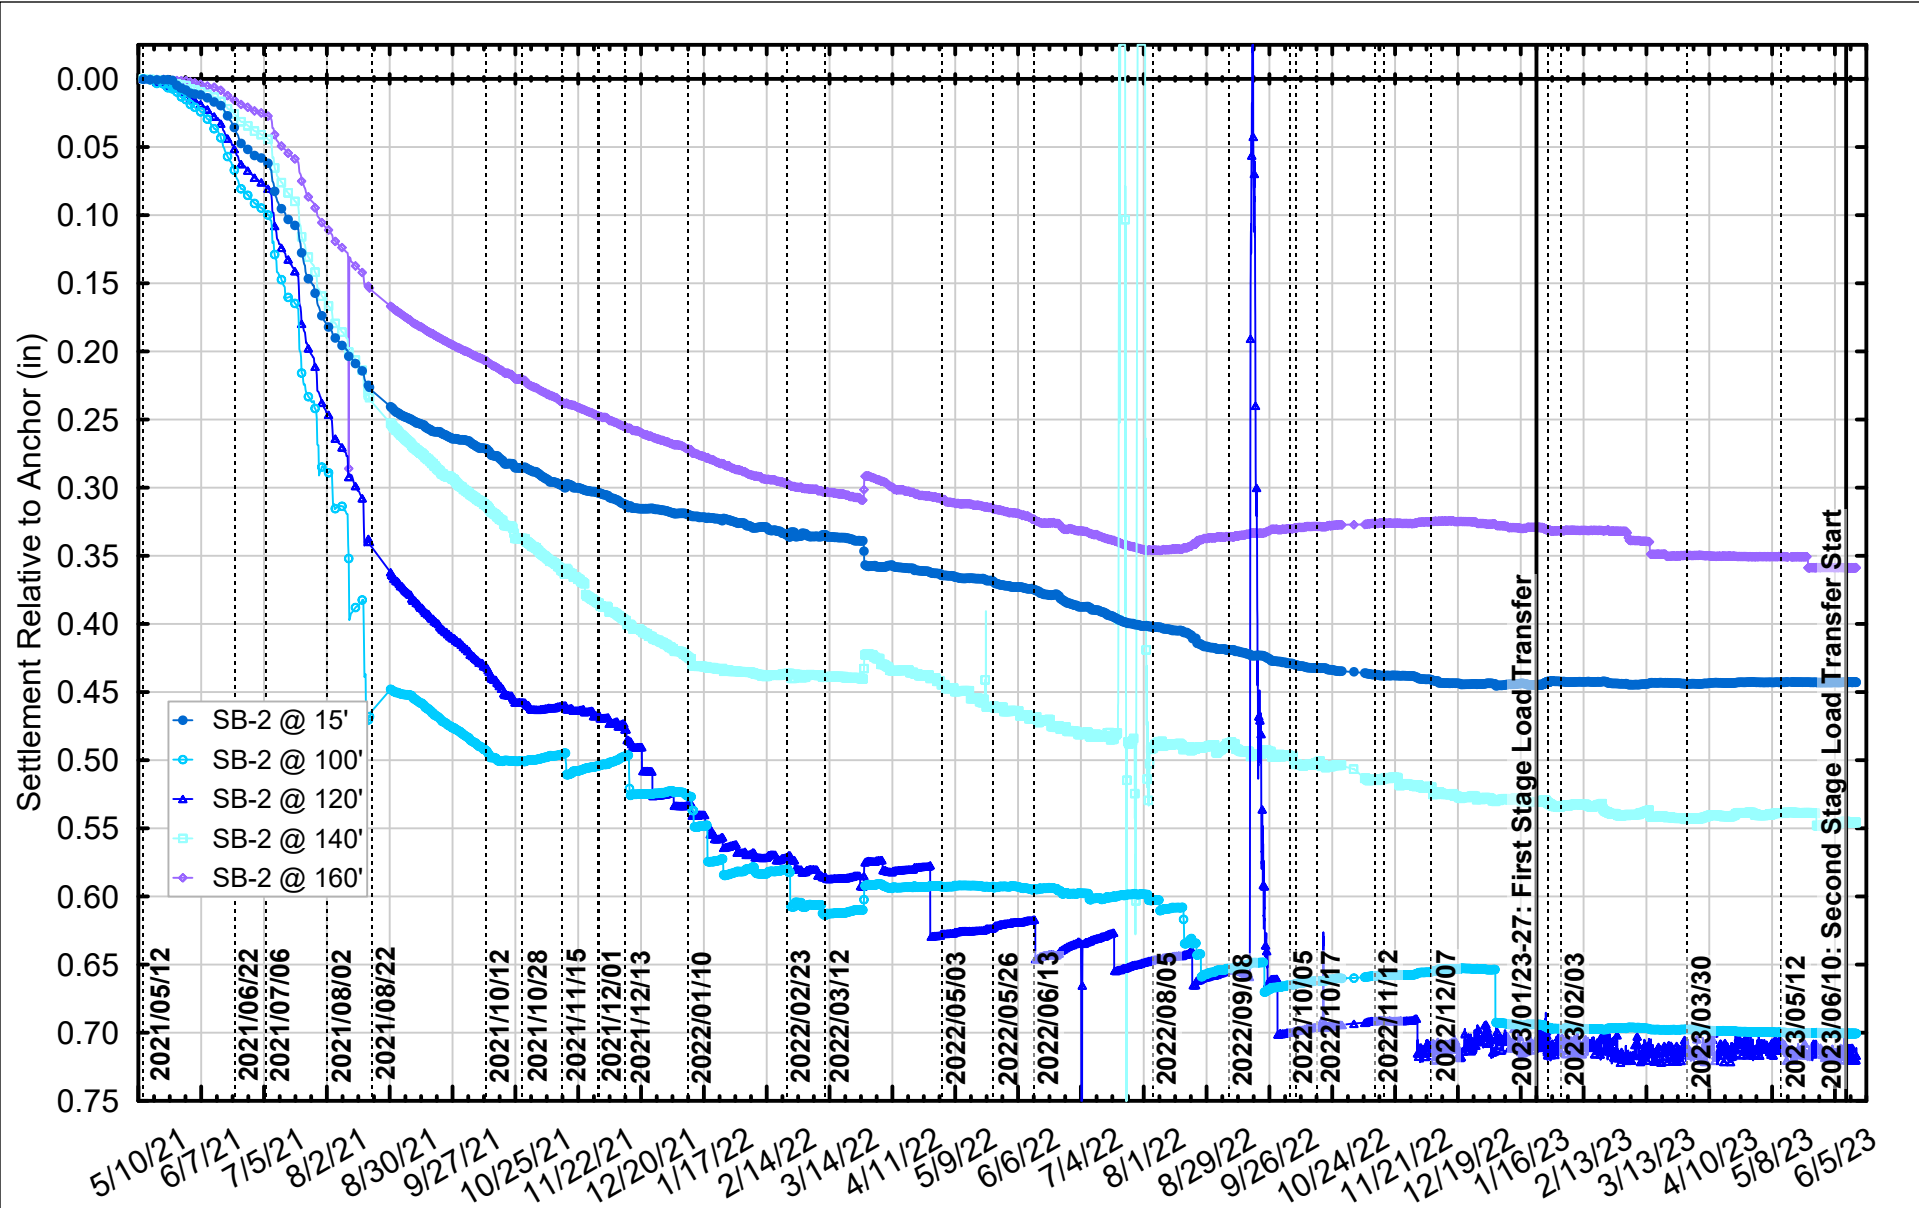
Figure No: 110-10B

EXTENSOMETER DATA FROM WITHIN TOWER BASEMENT
SINCE 05/10/2021 THROUGH 06/14/2023

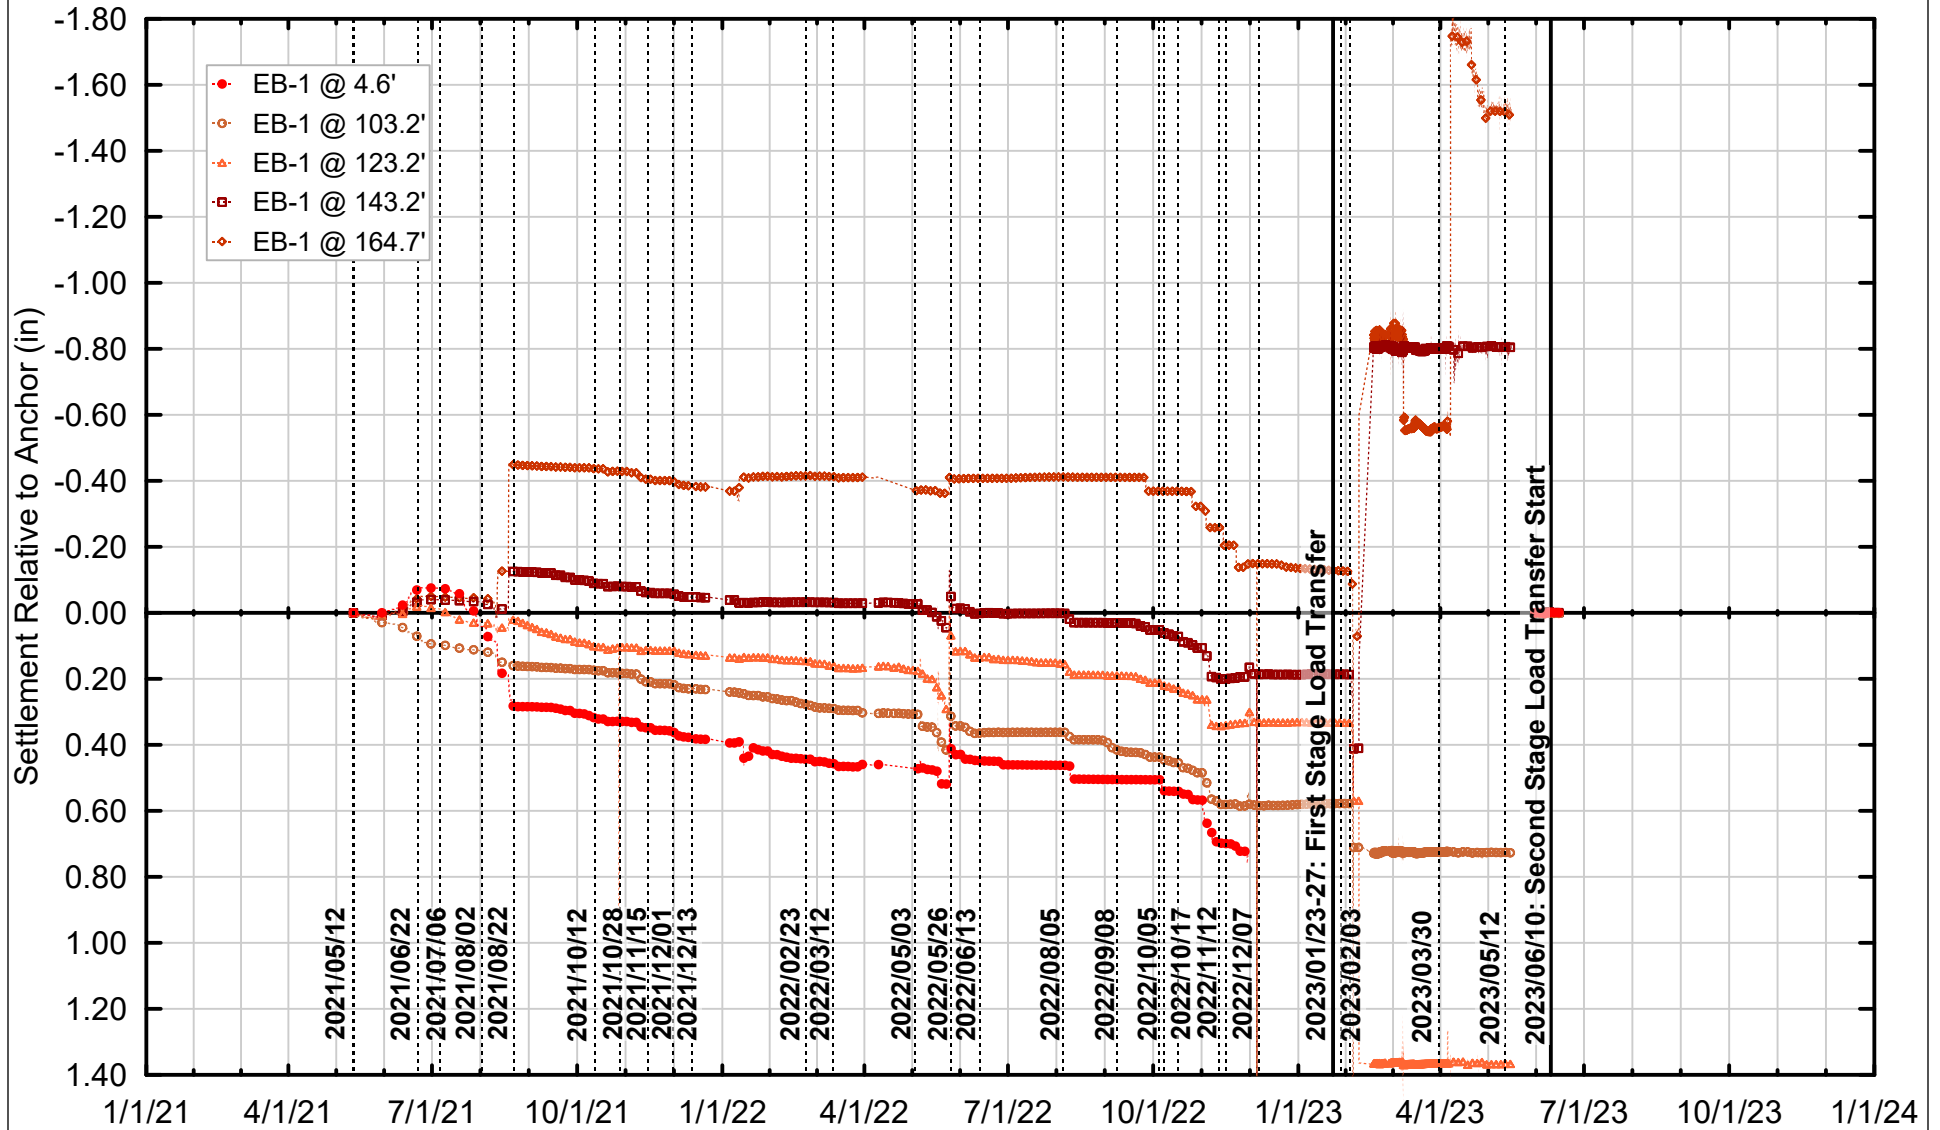
Figure No: 110-11A

Note: EB-1 was repaired and reset on 2023/05/30

EXTENSOMETER DATA FROM FREMONT STREET
 SINCE 05/10/2021 THROUGH 05/16/2023
 SINCE 05/30/2023 THROUGH 06/14/2023
 Millennium Tower Perimeter Pile Upgrade: Instrumentation Monitoring Data
 City and County of San Francisco, California

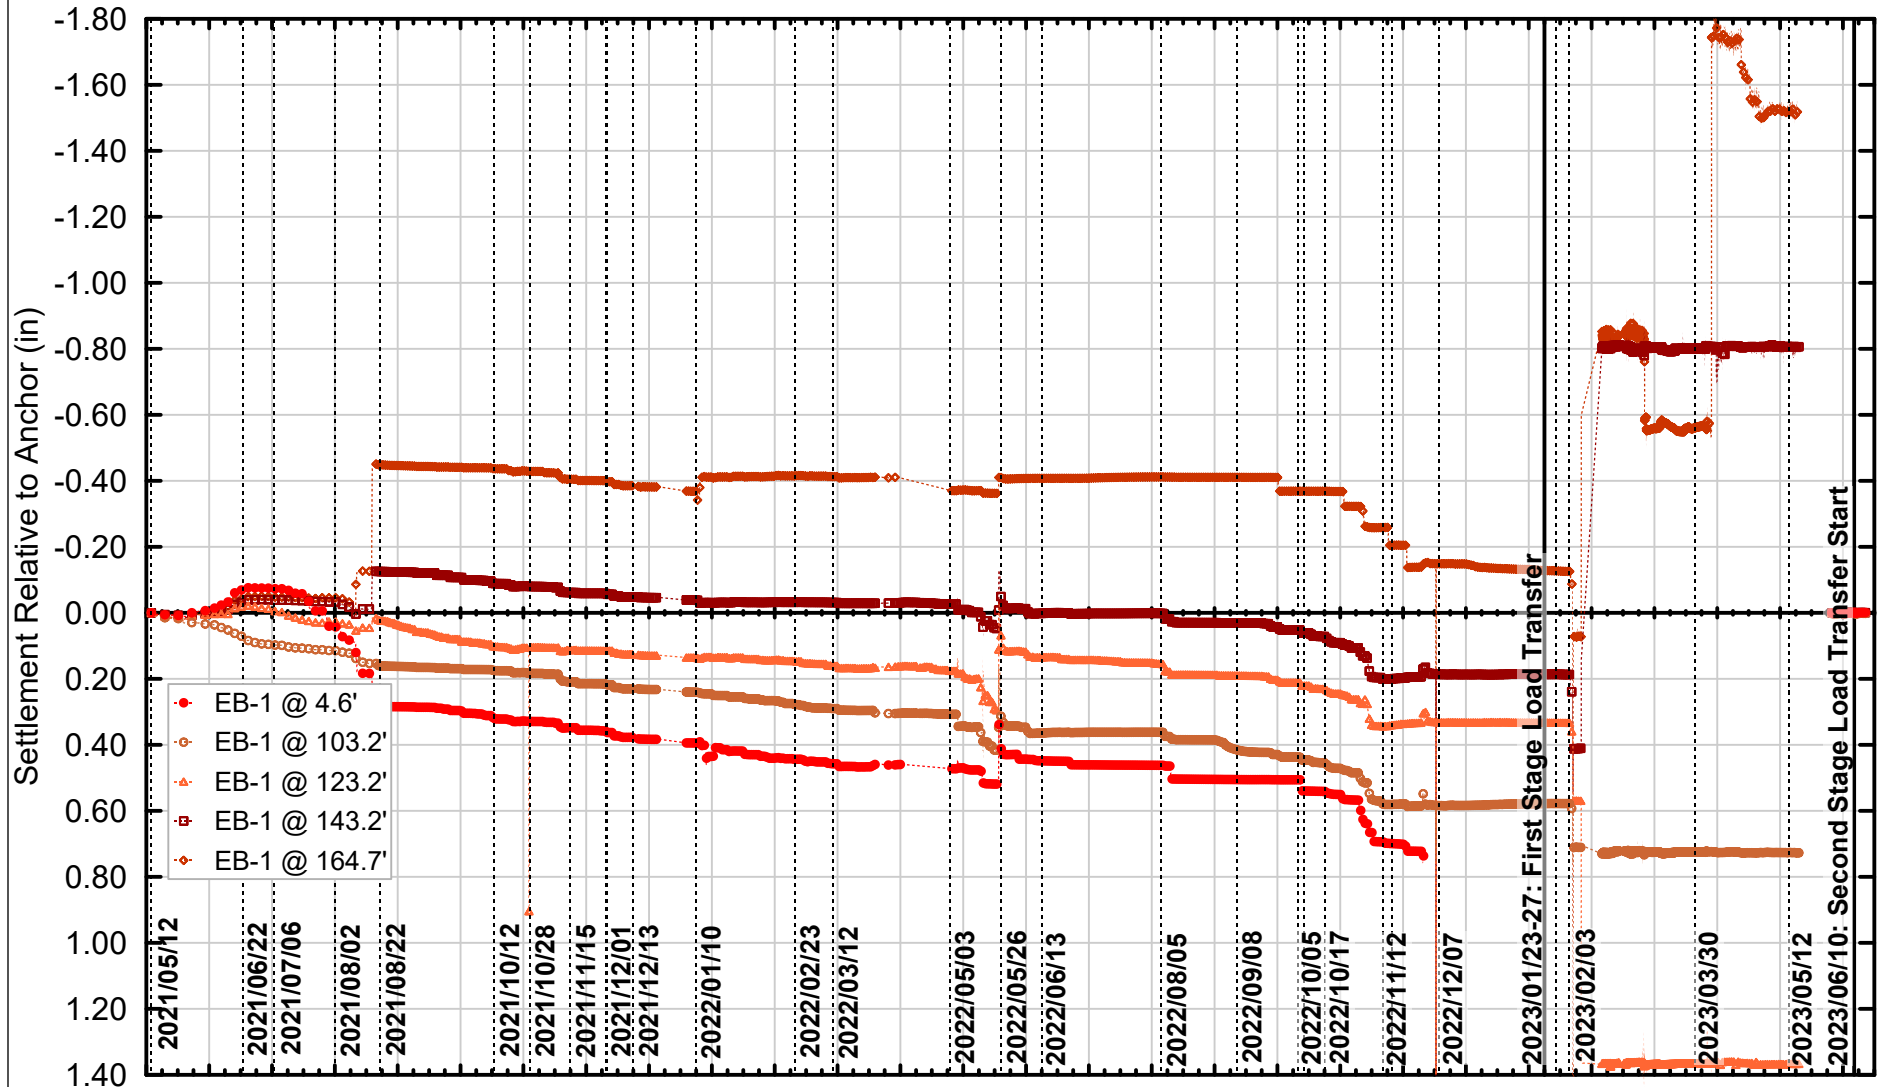
Project No: 19-009.00 Date: 6/15/2023 Created By: NBW Checked By: DGM Figure No: 110-11B

Note: EB-1 was repaired and reset on 2023/05/30

EXTENSOMETER DATA FROM FREMONT STREET
 SINCE 05/10/2021 THROUGH 05/16/2023
 SINCE 05/30/2023 THROUGH 06/14/2023
 Millennium Tower Perimeter Pile Upgrade: Instrumentation Monitoring Data
 City and County of San Francisco, California

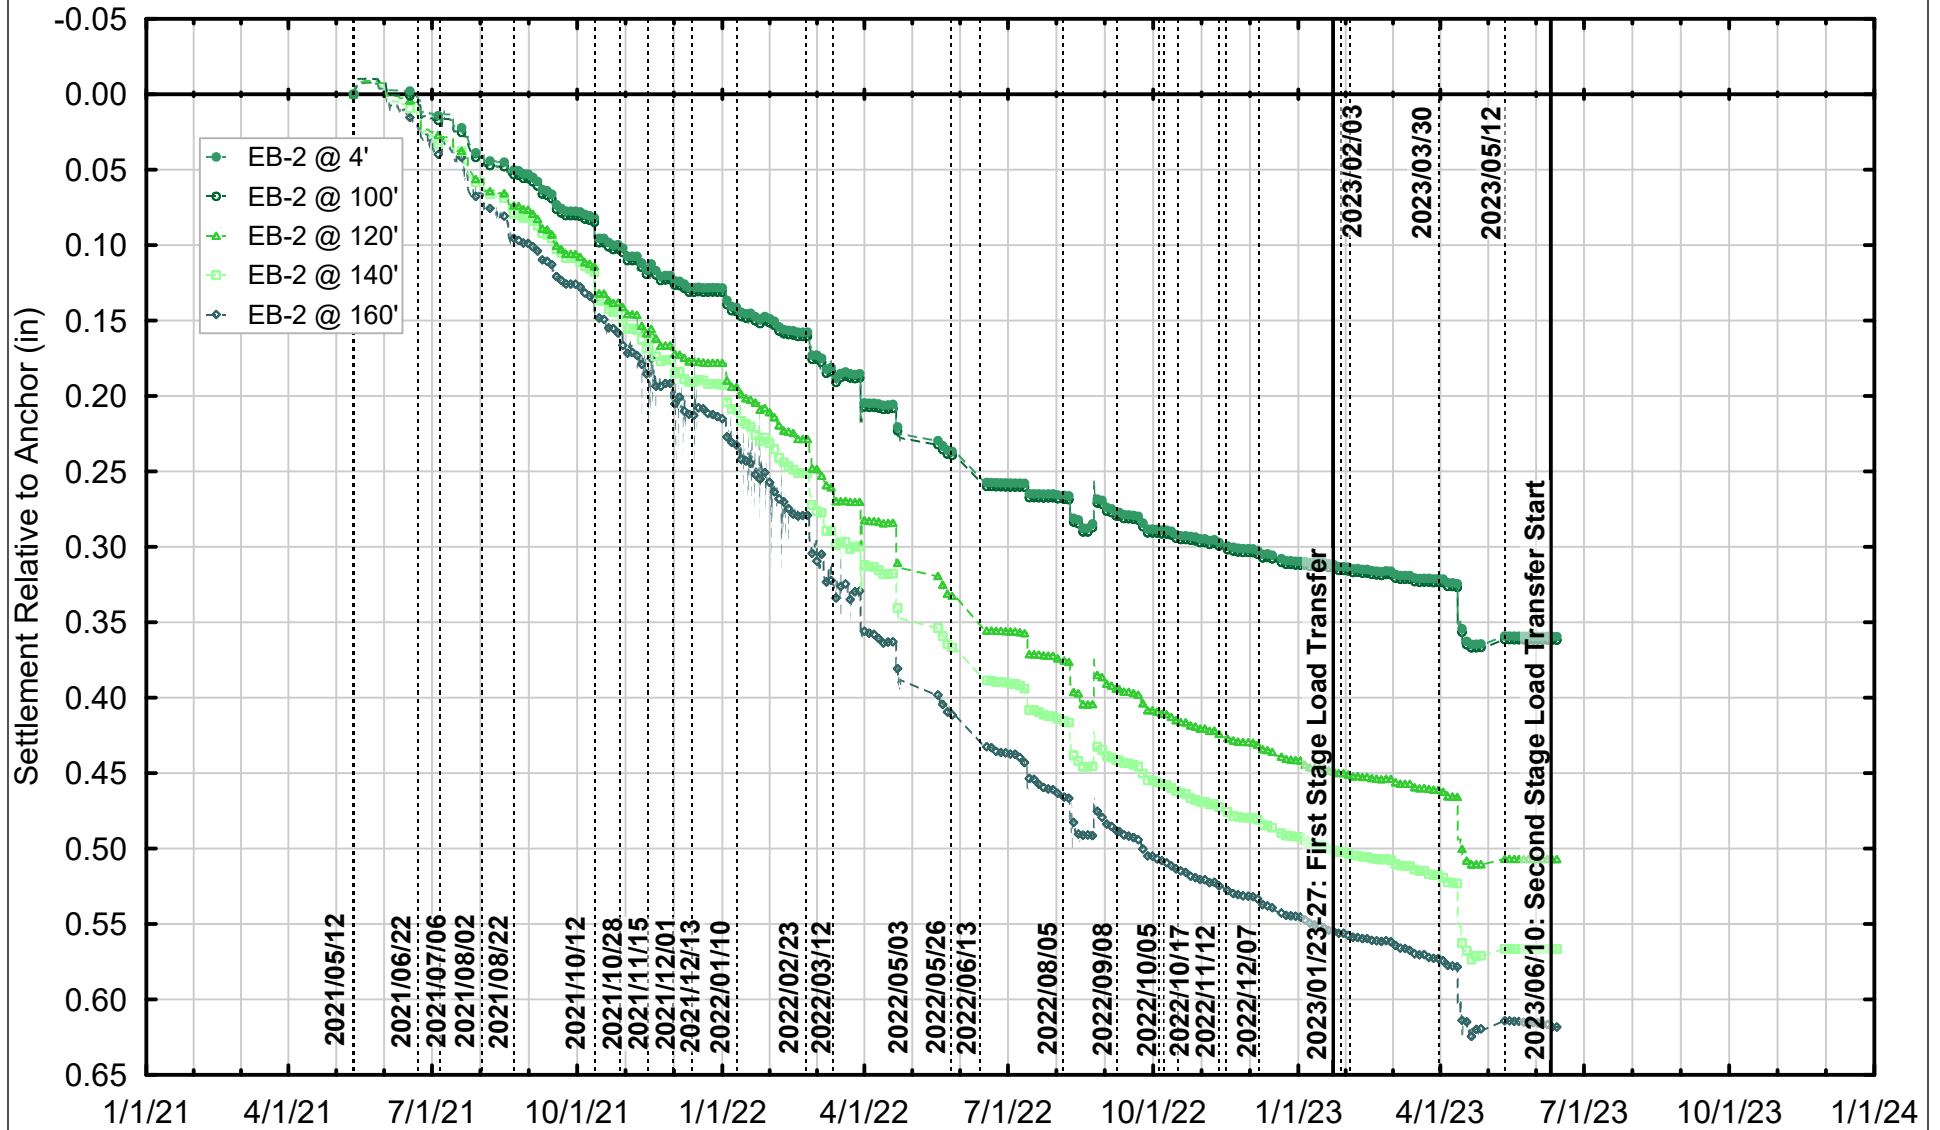
Project No: 19-009.00	Date: 6/15/2023	Created By: NBW	Checked By: DGM	Figure No: 110-12A
-----------------------	-----------------	-----------------	-----------------	---------------------------

EXTENSOMETER DATA FROM MISSION STREET
SINCE 01/01/2021 THROUGH 06/14/2023

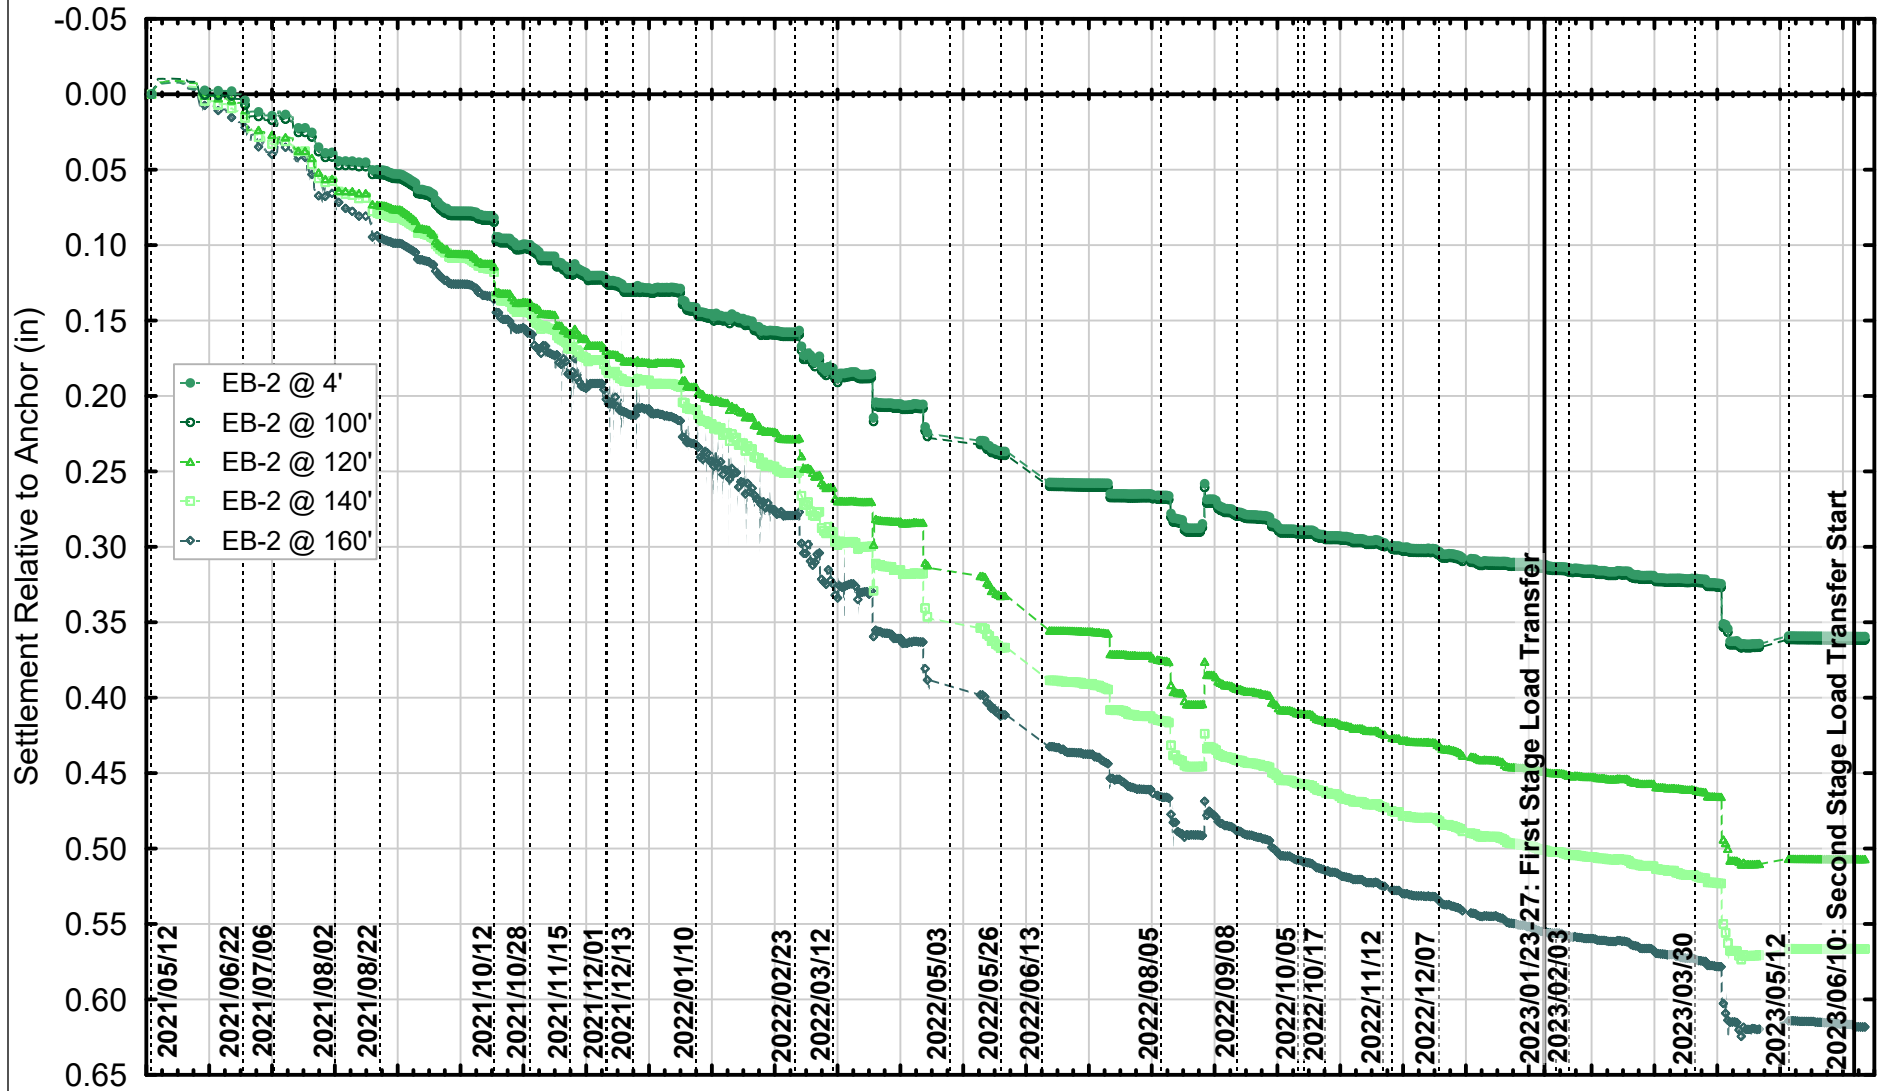
Project No: 19-009.00 Date: 6/15/2023 Created By: NBW Checked By: DGM Figure No: 110-12B

EXTENSOMETER DATA FROM MISSION STREET
SINCE 05/10/2021 THROUGH 06/14/2023
