Subject: 301 Mission Retrofit Monitoring Report 110: Results as of June 14, 2023

This memorandum summarizes results from the monitoring plan implemented at the 301 Mission property. Instrumentation to monitor the structure prior to, during and after the retrofit was installed in January 2021, including piezometers and extensometers. Settlement markers installed in April 2009 and January 2017, survey prisms mounted on the exterior of the structure in December 2016, and crack gauges installed in April 2009 have also been monitored. Pile load cells were installed on the Mission Street piles in January 2023. Survey markers were installed on the Mission Street mat extension in January 2023. This memorandum is for review only. It only contains ongoing monitoring information. This memorandum does not contain recommendations based upon the ongoing monitoring information.

Millennium Tower Perimeter Pile Upgrade: Instrumentation Monitoring Data
City and County of San Francisco, California

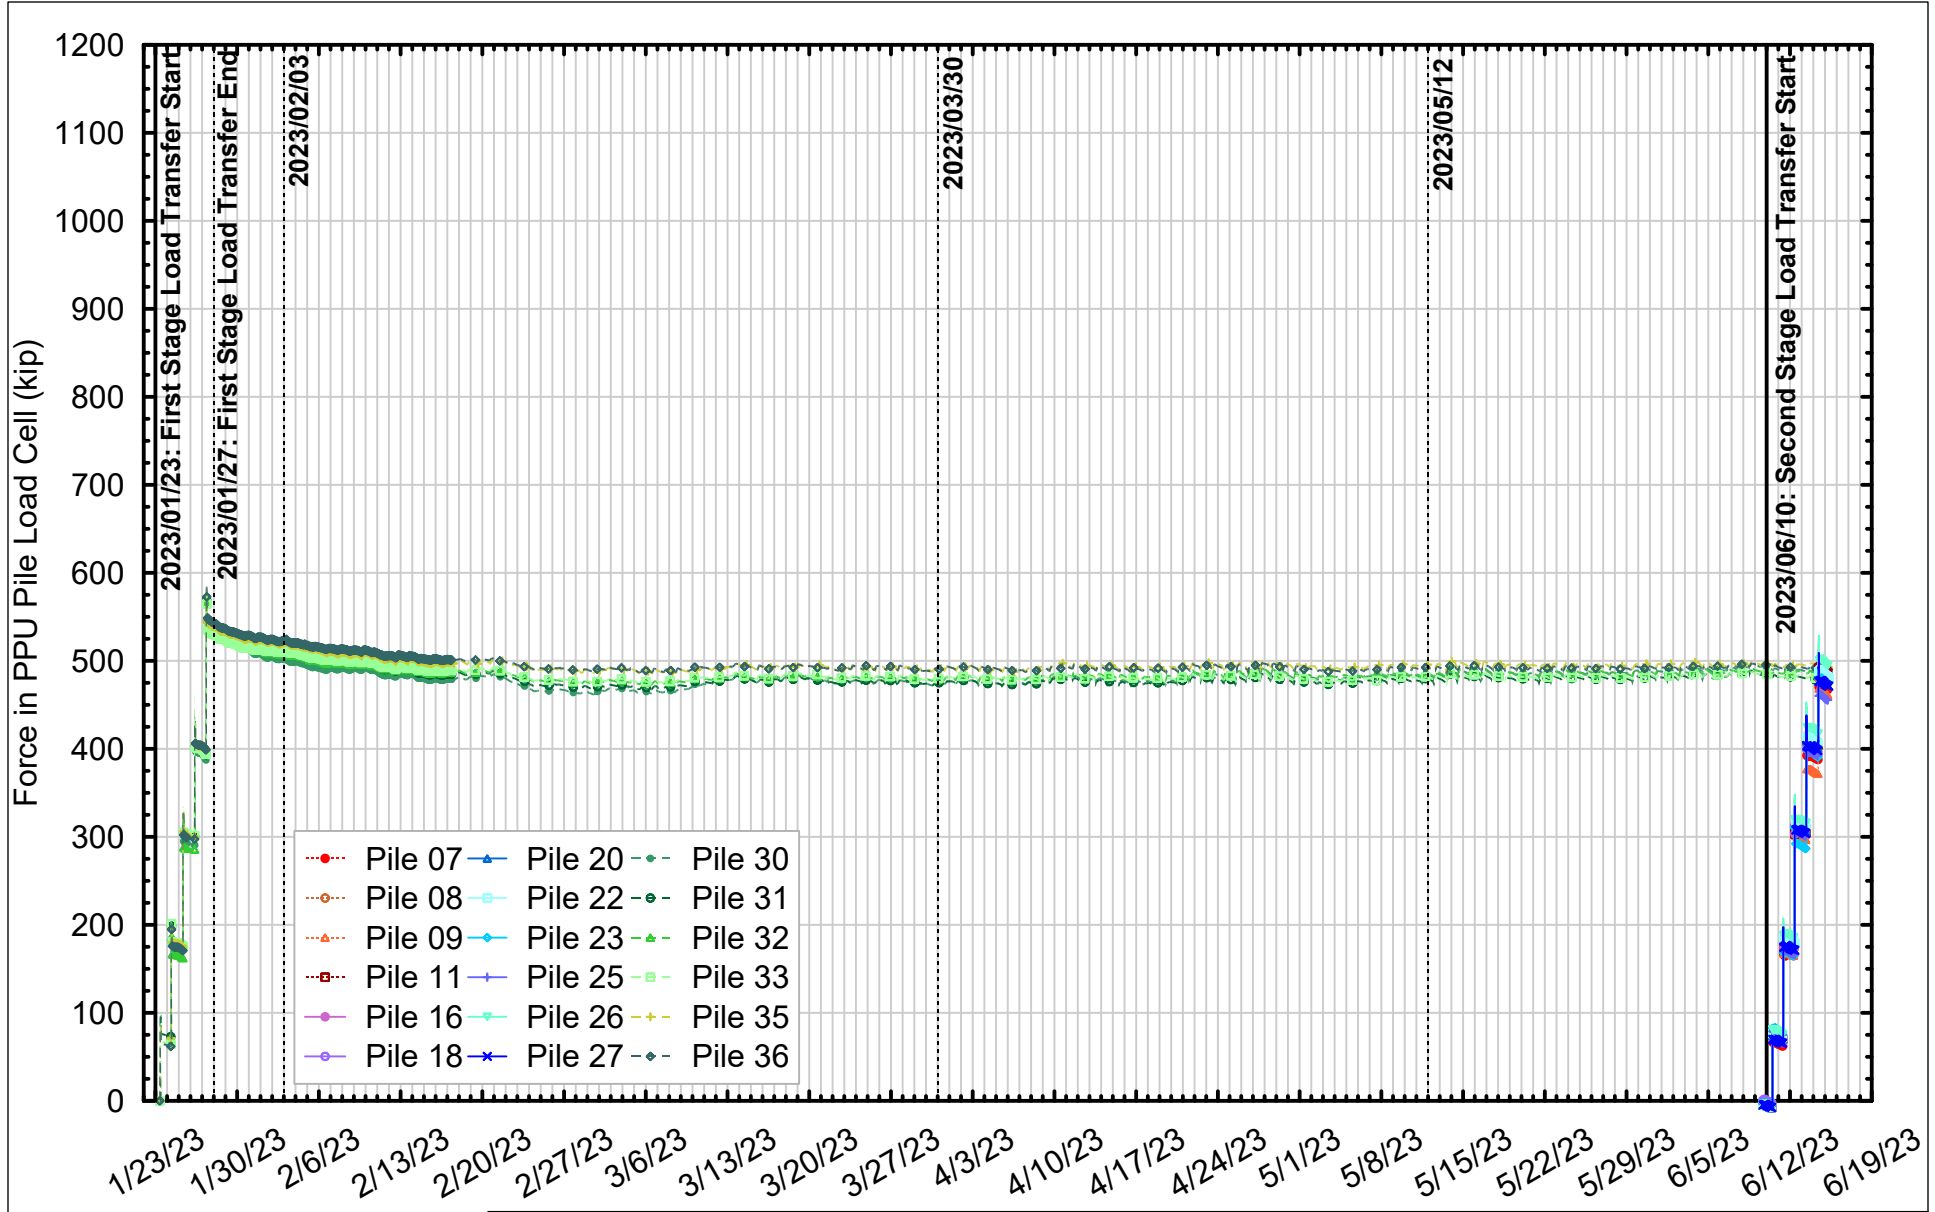
Project No: 19-009.00	Date: 6/15/2023	Created By: NBW	Checked By: DGM	Figure No: 110-13
-----------------------	-----------------	-----------------	-----------------	-------------------

Figure 13 presents pile load cell data since the start of the First Stage Load Transfer (January 23, 2023) through June 14, 2023.

PILE LOAD CELL DATA
 SINCE 01/23/2023 THROUGH 06/14/2023
 Millennium Tower Perimeter Pile Upgrade: Instrumentation Monitoring Data
 City and County of San Francisco, California
