Subject: 301 Mission Retrofit Monitoring Report 113: Results as of July 5, 2023

This memorandum summarizes results from the monitoring plan implemented at the 301 Mission property. Instrumentation to monitor the structure prior to, during and after the retrofit was installed in January 2021, including piezometers and extensometers. Settlement markers installed in April 2009 and January 2017, survey prisms mounted on the exterior of the structure in December 2016, and crack gauges installed in April 2009 have also been monitored. Pile load cells were installed on the Mission Street piles in January 2023. Survey markers were installed on the Mission Street mat extension in January 2023, prior to the Stage 1 load transfer and on the Fremont Street mat extensions in June 2023, prior to the Stages 2 and 3 load transfer. This memorandum is for review only. It only contains ongoing monitoring information. This memorandum does not contain recommendations based upon the ongoing monitoring information.

Millennium Tower Perimeter Pile Upgrade: Instrumentation Monitoring Data
City and County of San Francisco, California

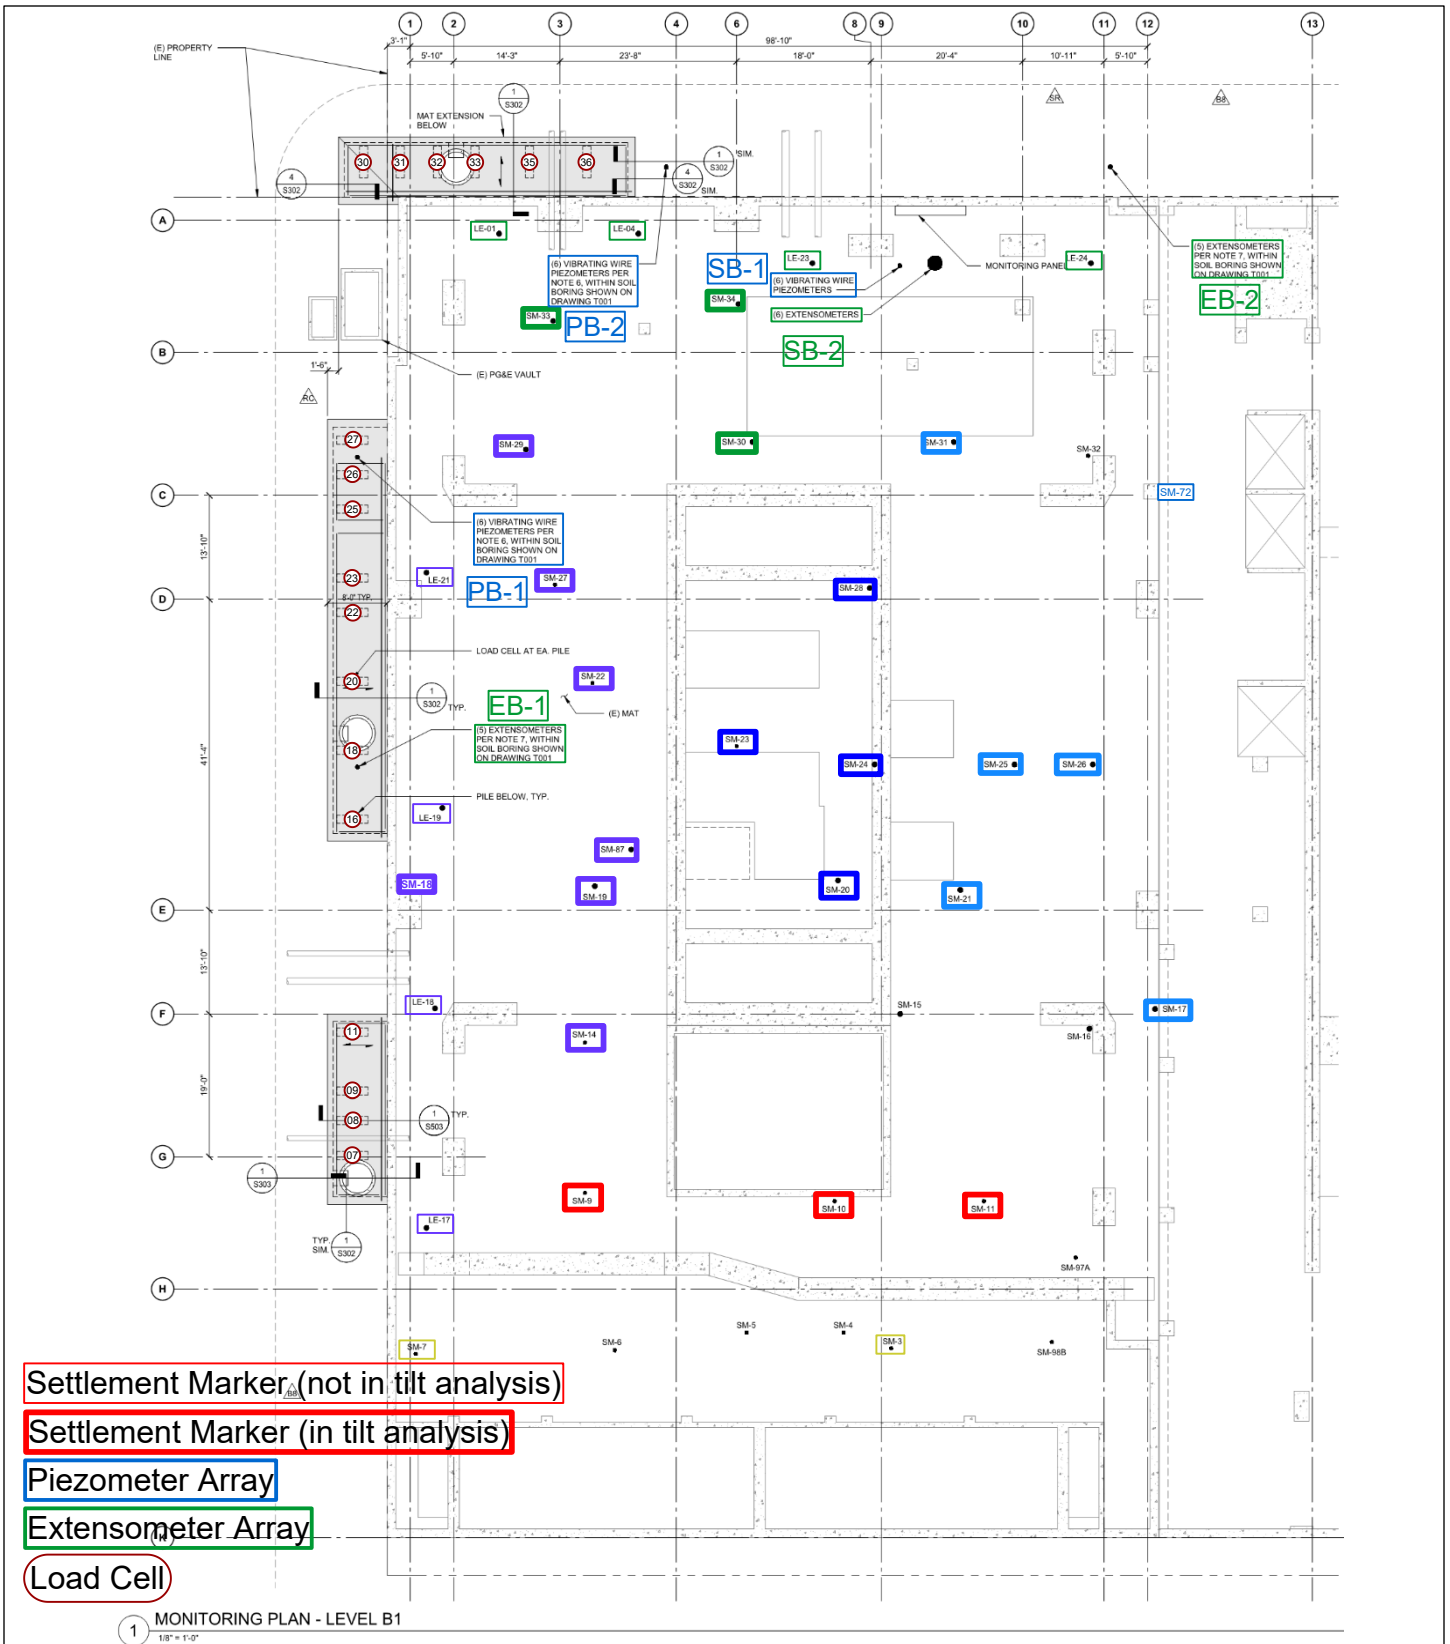
Project No: 19-009.00	Date: 6/28/2023	Created By: NBW	Checked By: DGM	Figure No: 113-01A
-----------------------	-----------------	-----------------	-----------------	--------------------

Figure 01 presents the instrument locations as referenced in later figures.

INSTRUMENT LOCATION MAP
SETTLEMENT MARKERS, PIEZOMETERS, EXTENSOMETERS, LOAD CELLS

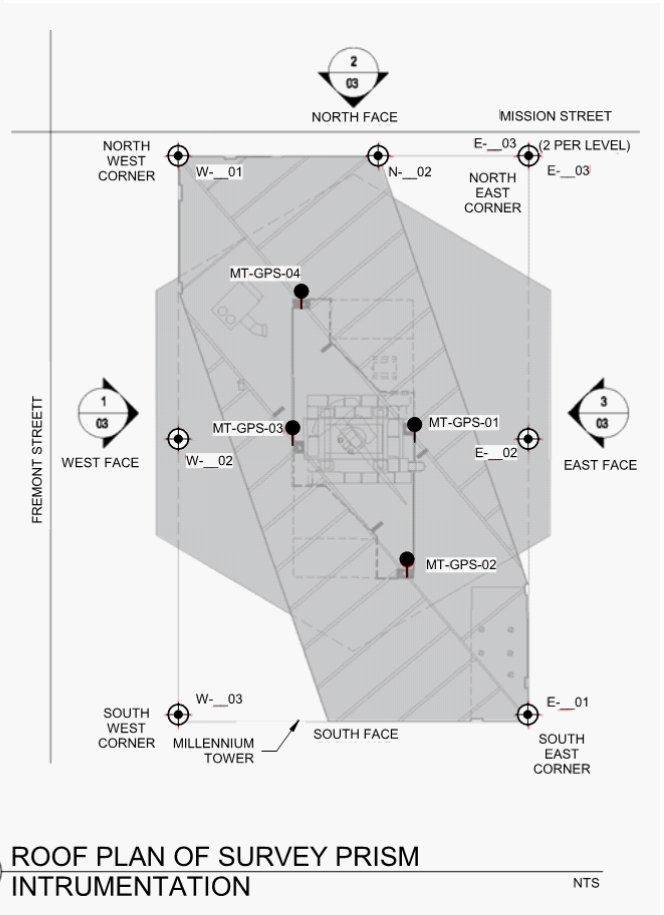
Project No: 19-009.00	Date: 7/26/2021	Created By: NBW	Checked By: DGM	Figure No: 113-01B
-----------------------	-----------------	-----------------	-----------------	--------------------

TOWER SURVEY PRISM LOCATION SCHEMATIC

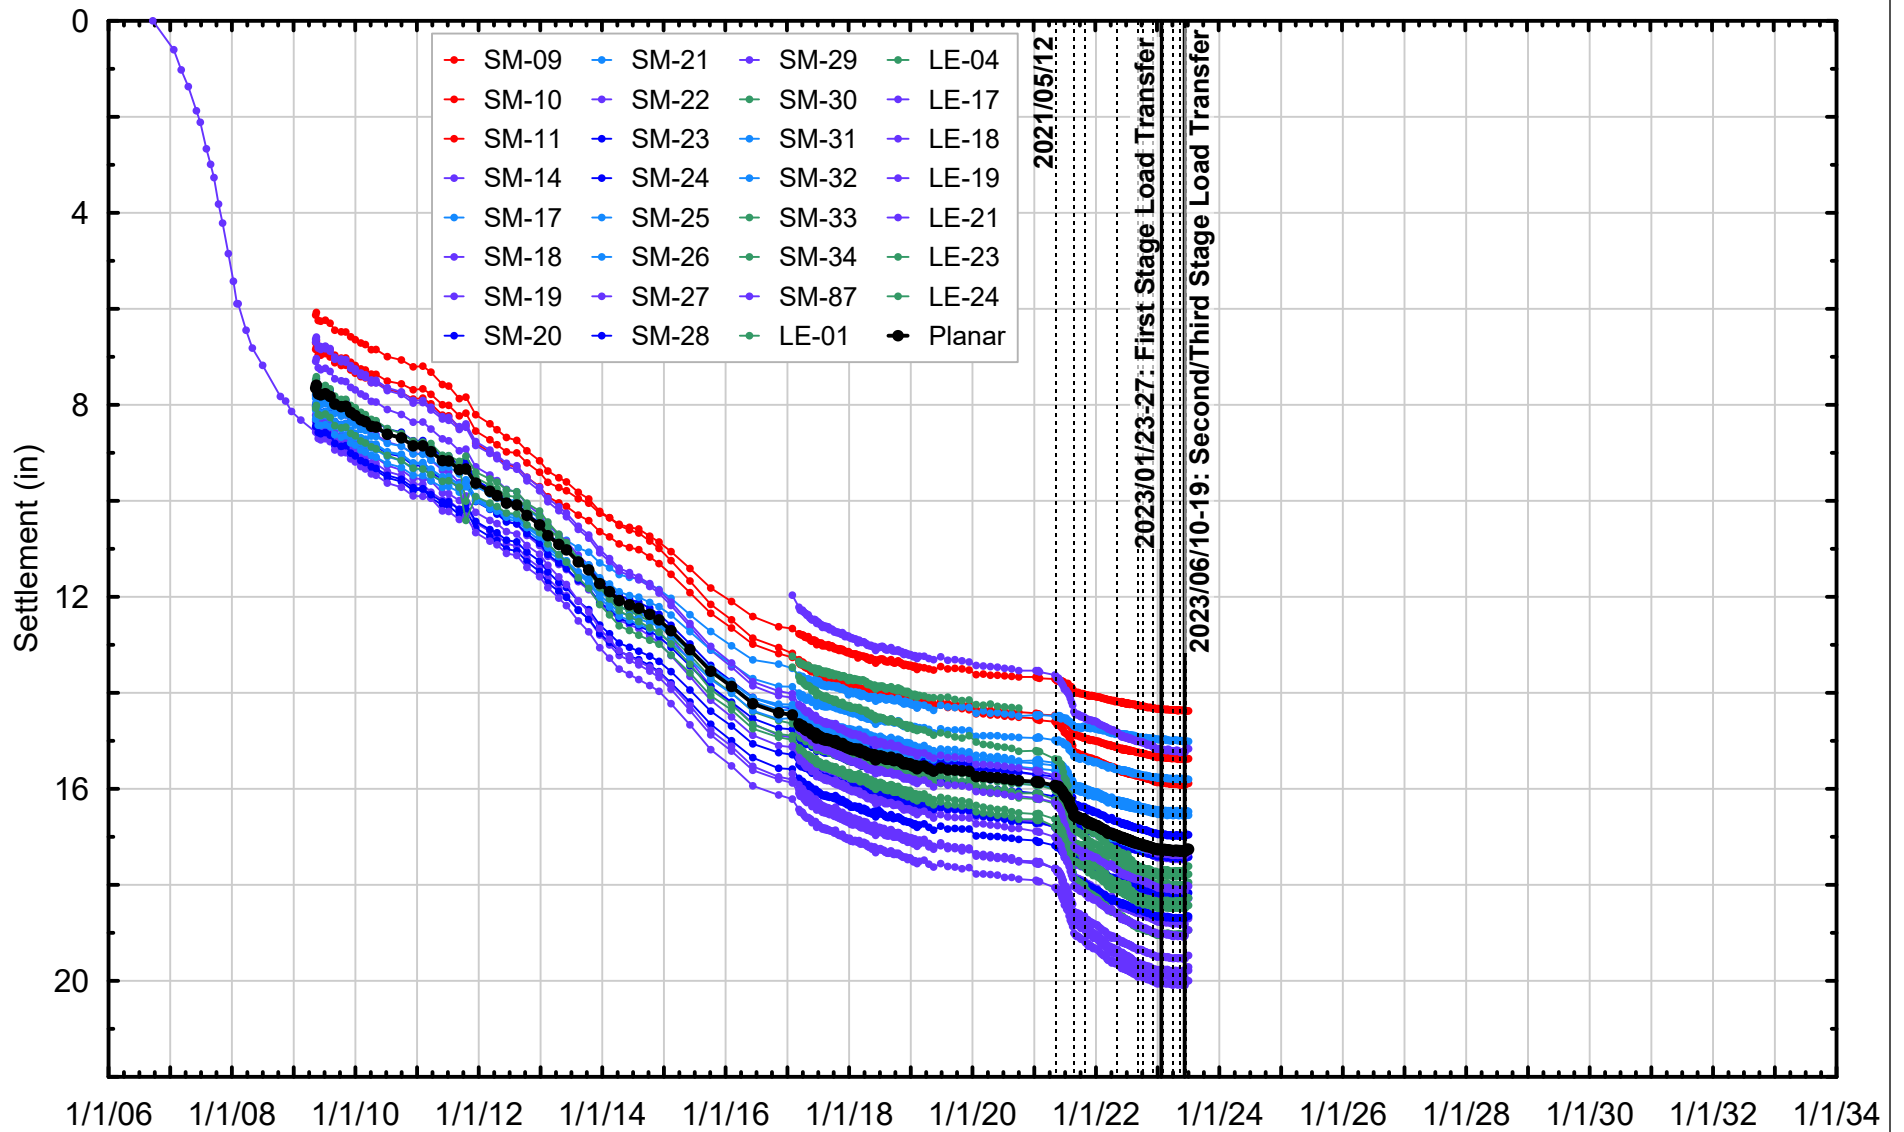
Project No: 19-009.00	Date: 7/6/2023	Created By: NBW	Checked By: DGM	Figure No: 113-02
-----------------------	----------------	-----------------	-----------------	--------------------------

Figure 02 presents the historical settlement data interpreted from settlement markers installed on the B-1 Level of 301 Mission Tower. In addition, data from surveys performed during the retrofit are included. Figure 03A presents settlement data since the start of production pile installation (May 12, 2021; baseline readings on May 10, 2021) through July 3, 2023. Figure 03B presents settlement data since January 11, 2021, through July 3, 2023. Figure 04 presents current settlement contours (in inches) on July 3, 2023.

HISTORICAL SETTLEMENT MARKER DATA

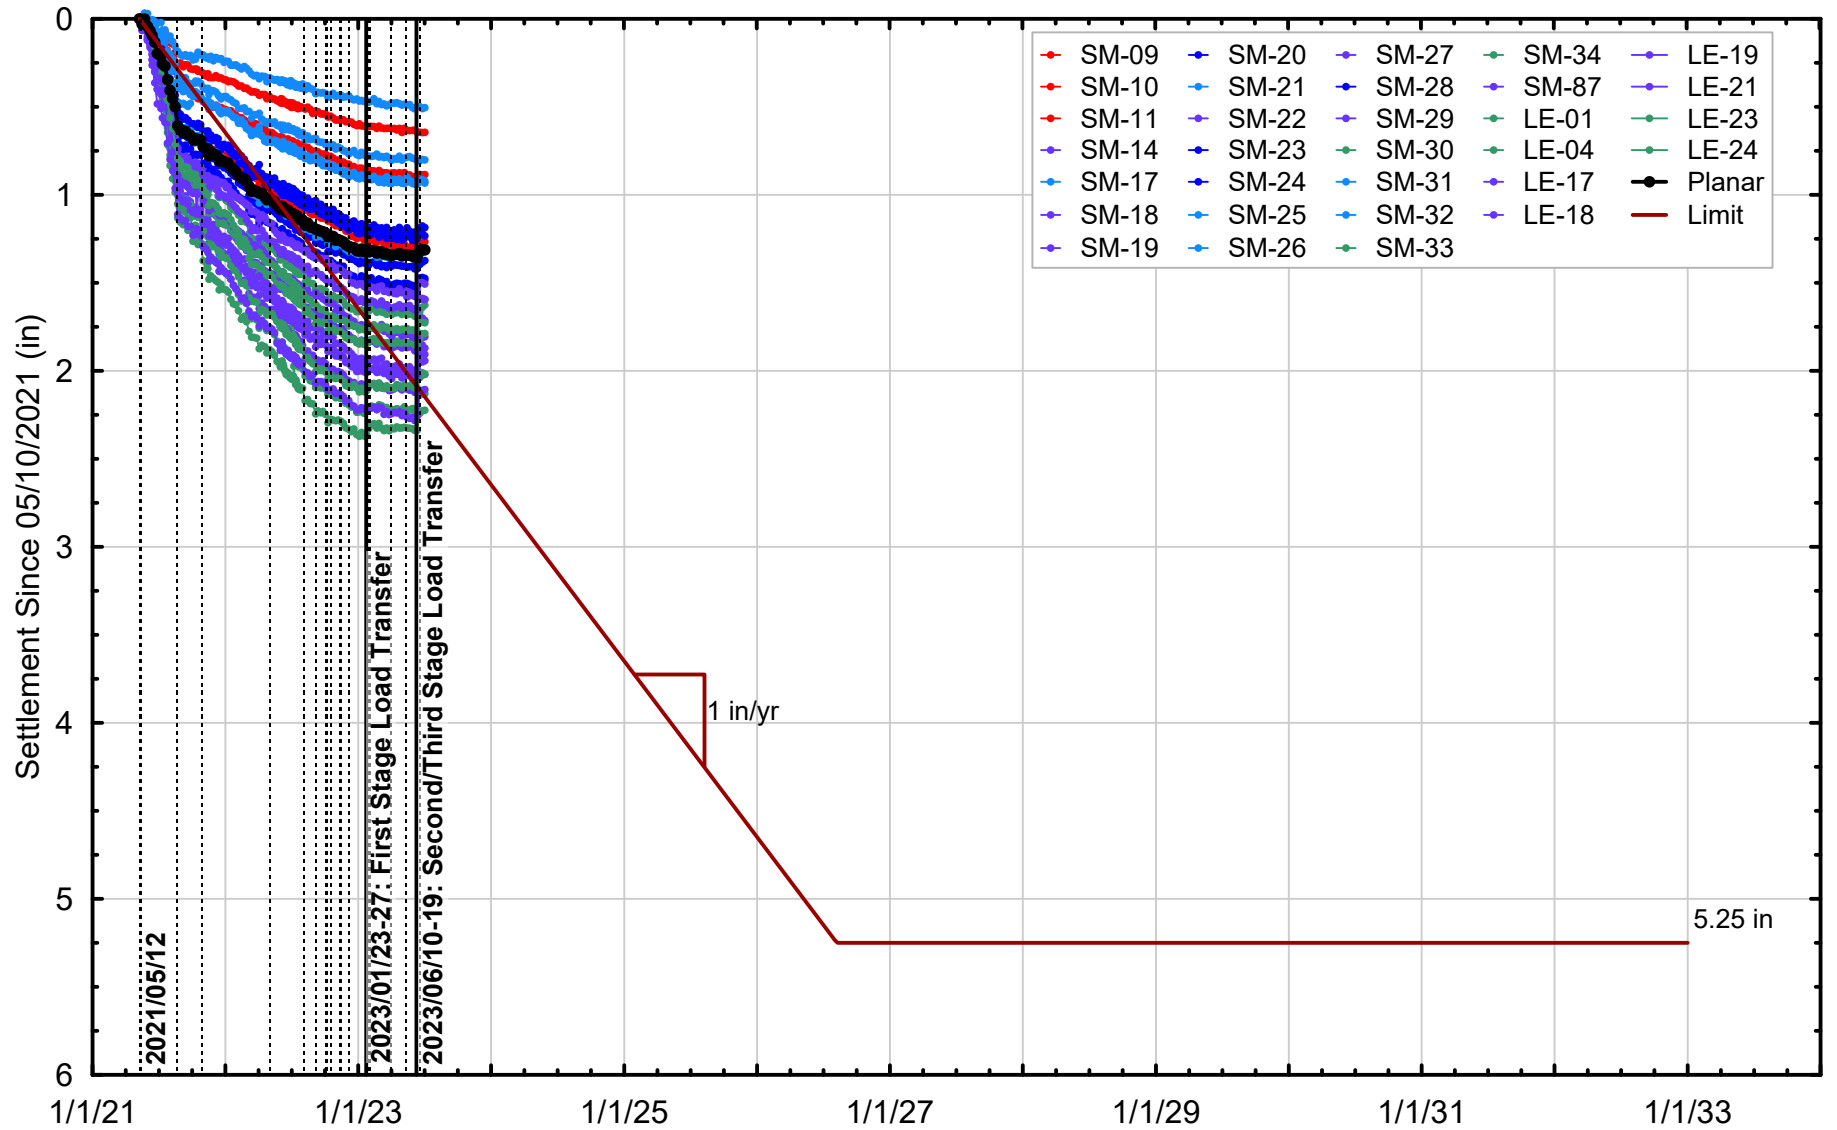
Figure No: **113-03A**

SETTLEMENT MARKER DATA
SINCE 05/10/2021 THROUGH 07/03/2023

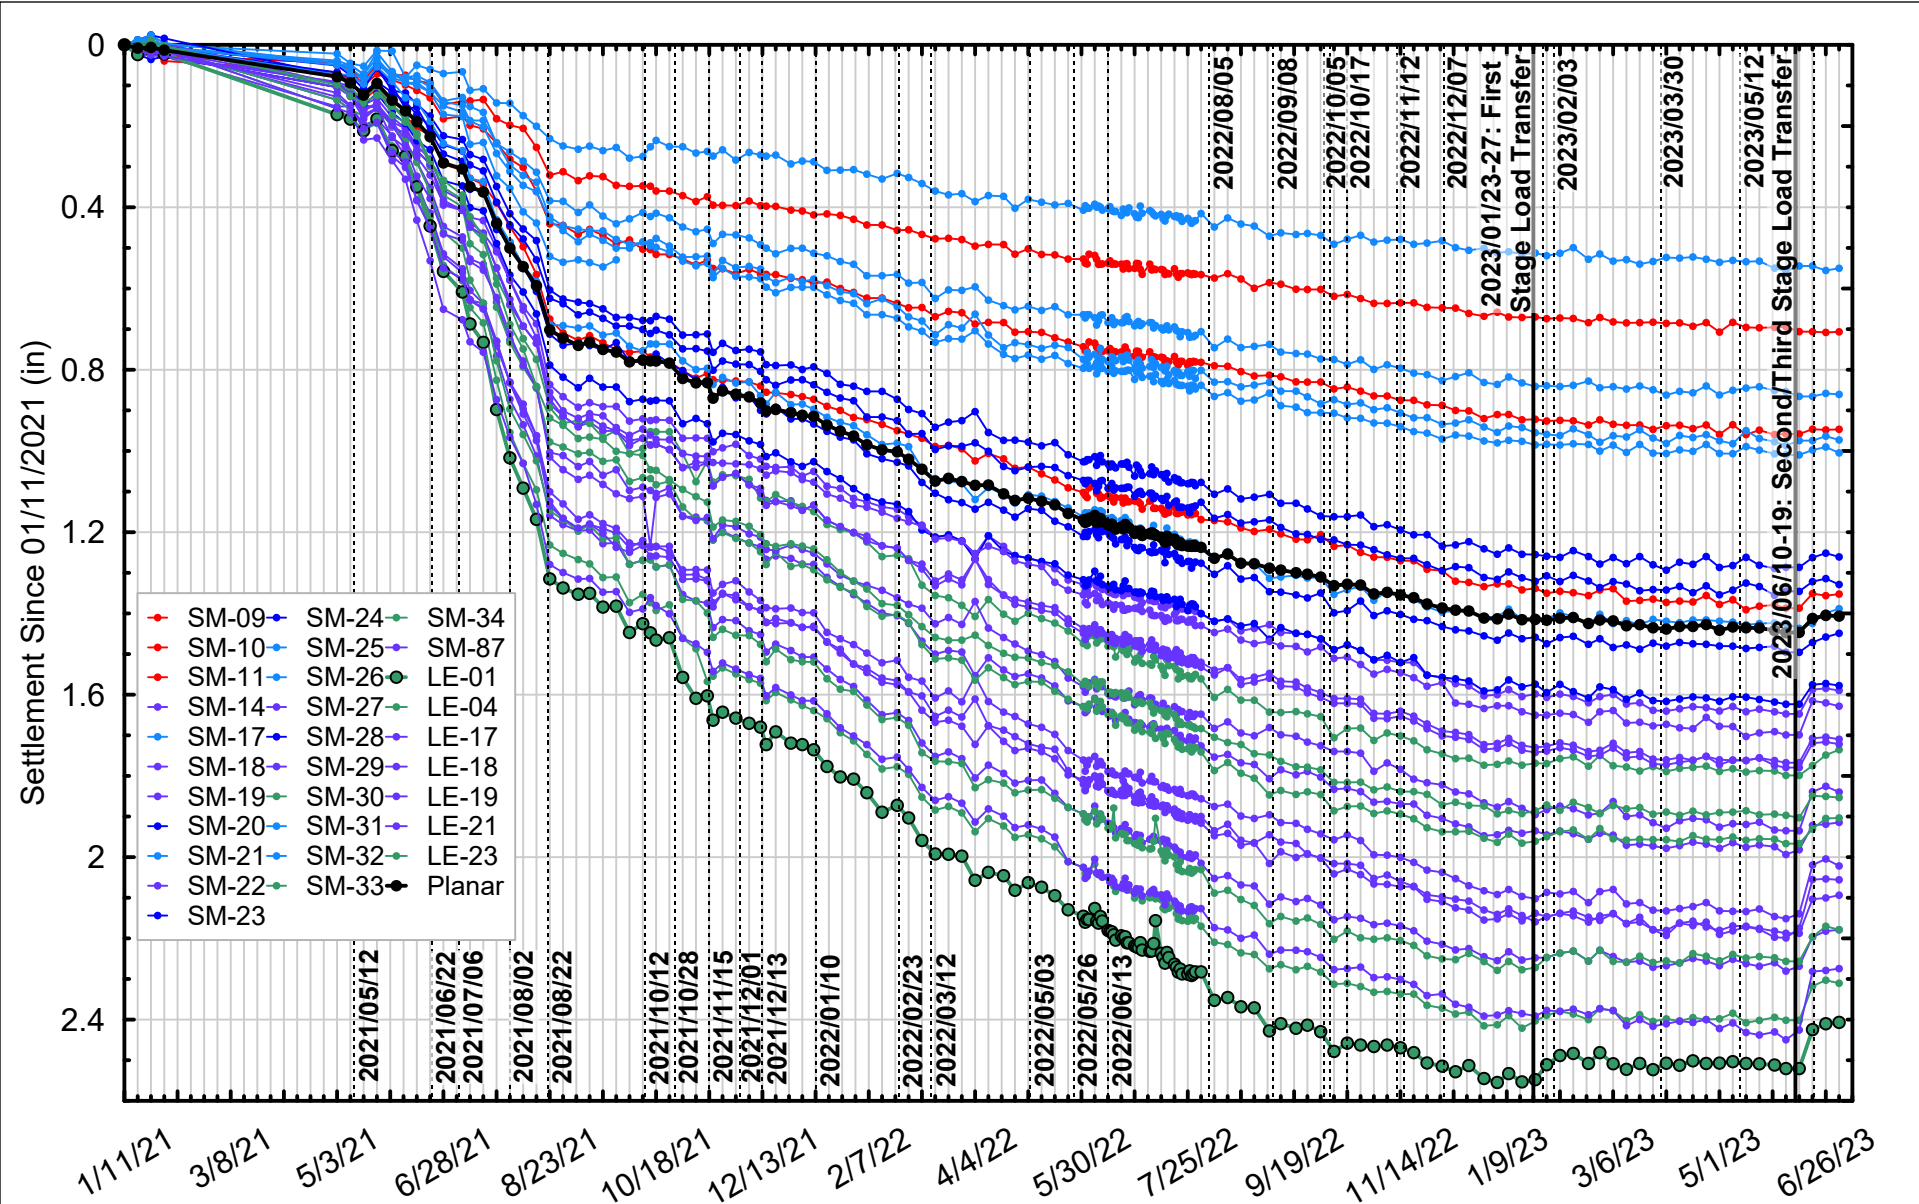
Project No: 19-009.00	Date: 7/6/2023	Created By: NBW	Checked By: DGM	Figure No: 113-03B
-----------------------	----------------	-----------------	-----------------	--------------------

SETTLEMENT MARKER DATA
SINCE 01/11/2021 THROUGH 07/03/2023

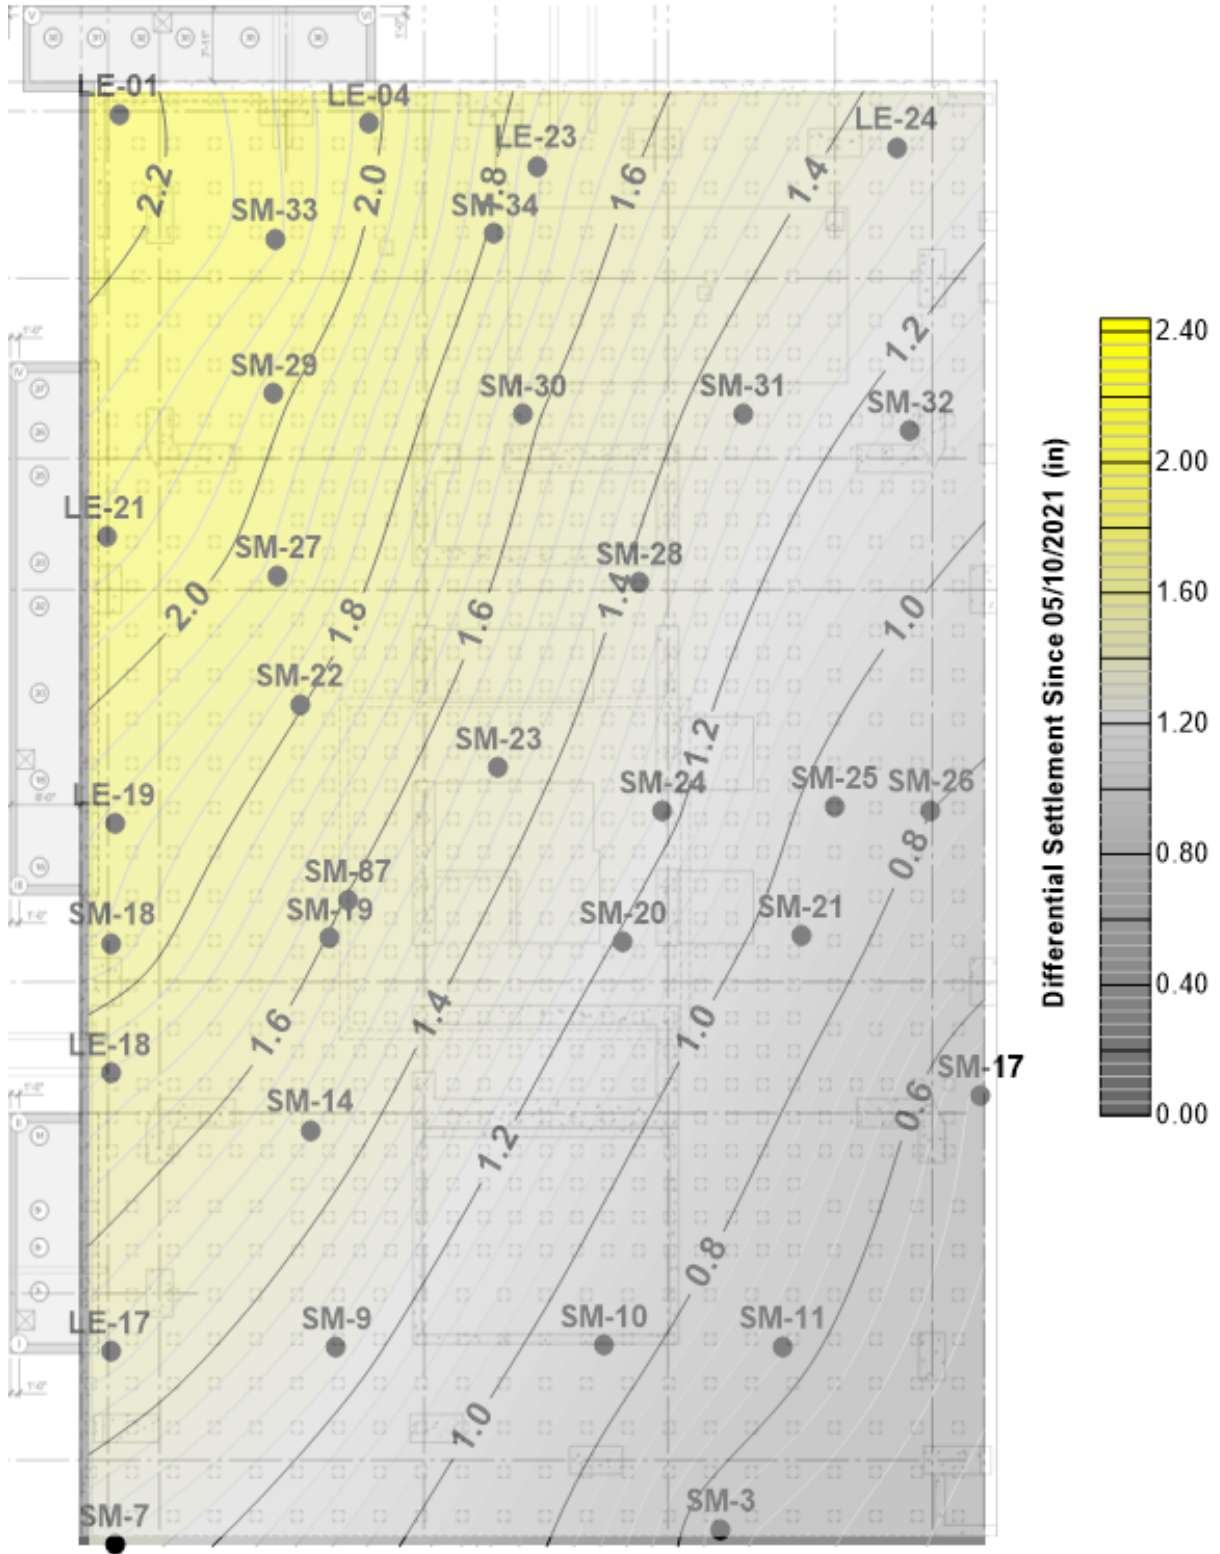
Figure No: **113-04**

SETTLEMENT CONTOURS
SINCE 05/10/2021 THROUGH 07/03/2023

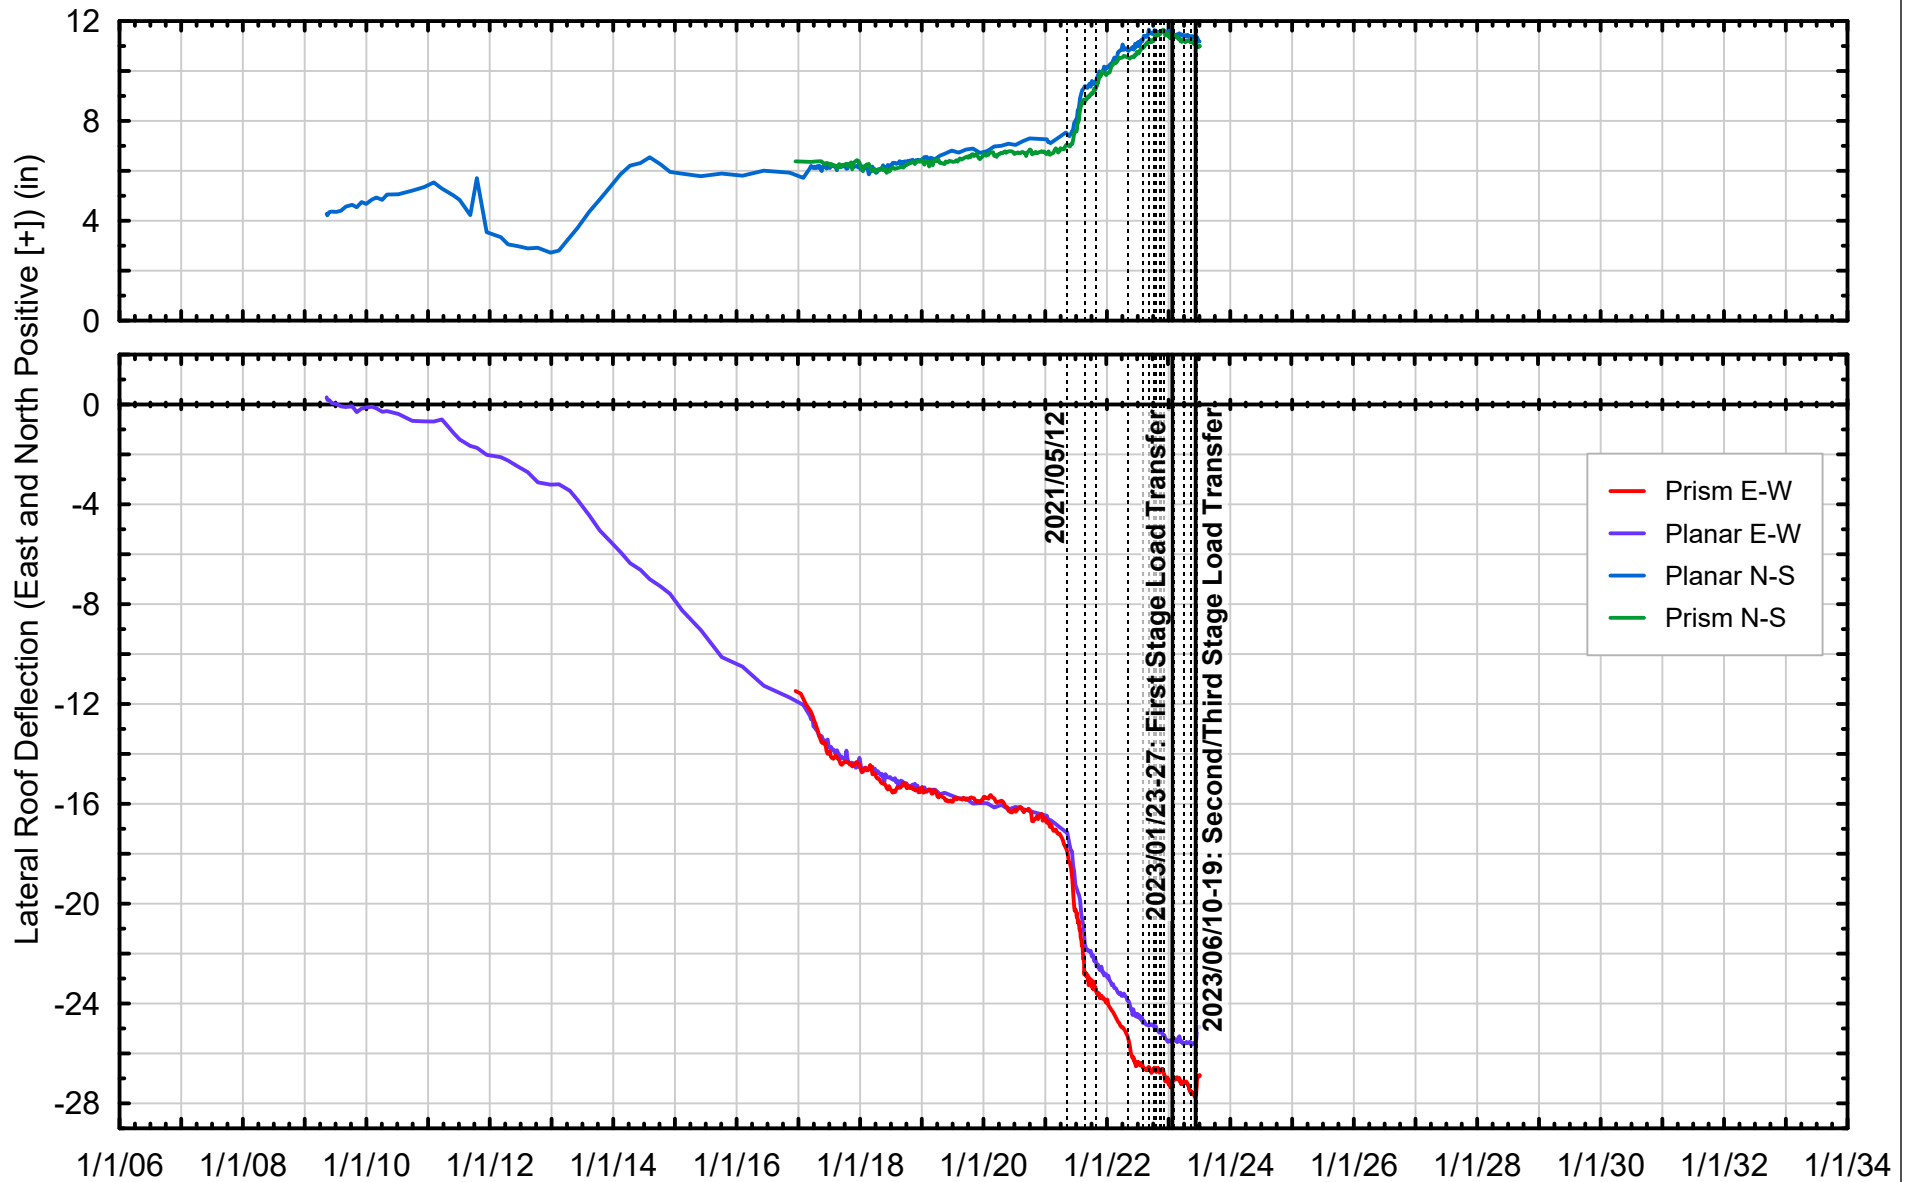
Project No: 19-009.00	Date: 7/6/2023	Created By: NBW	Checked By: DGM	Figure No: 113-05
-----------------------	----------------	-----------------	-----------------	--------------------------

Figure 05 presents historical lateral roof deflections in the project north-south and project east-west directions interpreted from survey prisms mounted on the exterior of the Tower, from InSAR data, and from a planar fit of the settlement marker data. In addition, data from surveys performed during the retrofit are included. Figure 06A presents lateral roof deflection data from a planar fit of the settlement marker data and from survey prisms mounted on the exterior of the Tower since the start of production pile installation (May 12, 2021; baseline readings on May 10 and 13, 2021, respectively) through July 5, 2023. Figure 06B presents lateral roof deflection data from a planar fit of the settlement marker data and from survey prisms mounted on the exterior of the Tower since January 11, 2021, through July 5, 2023.

HISTORICAL LATERAL ROOF DEFLECTION DATA

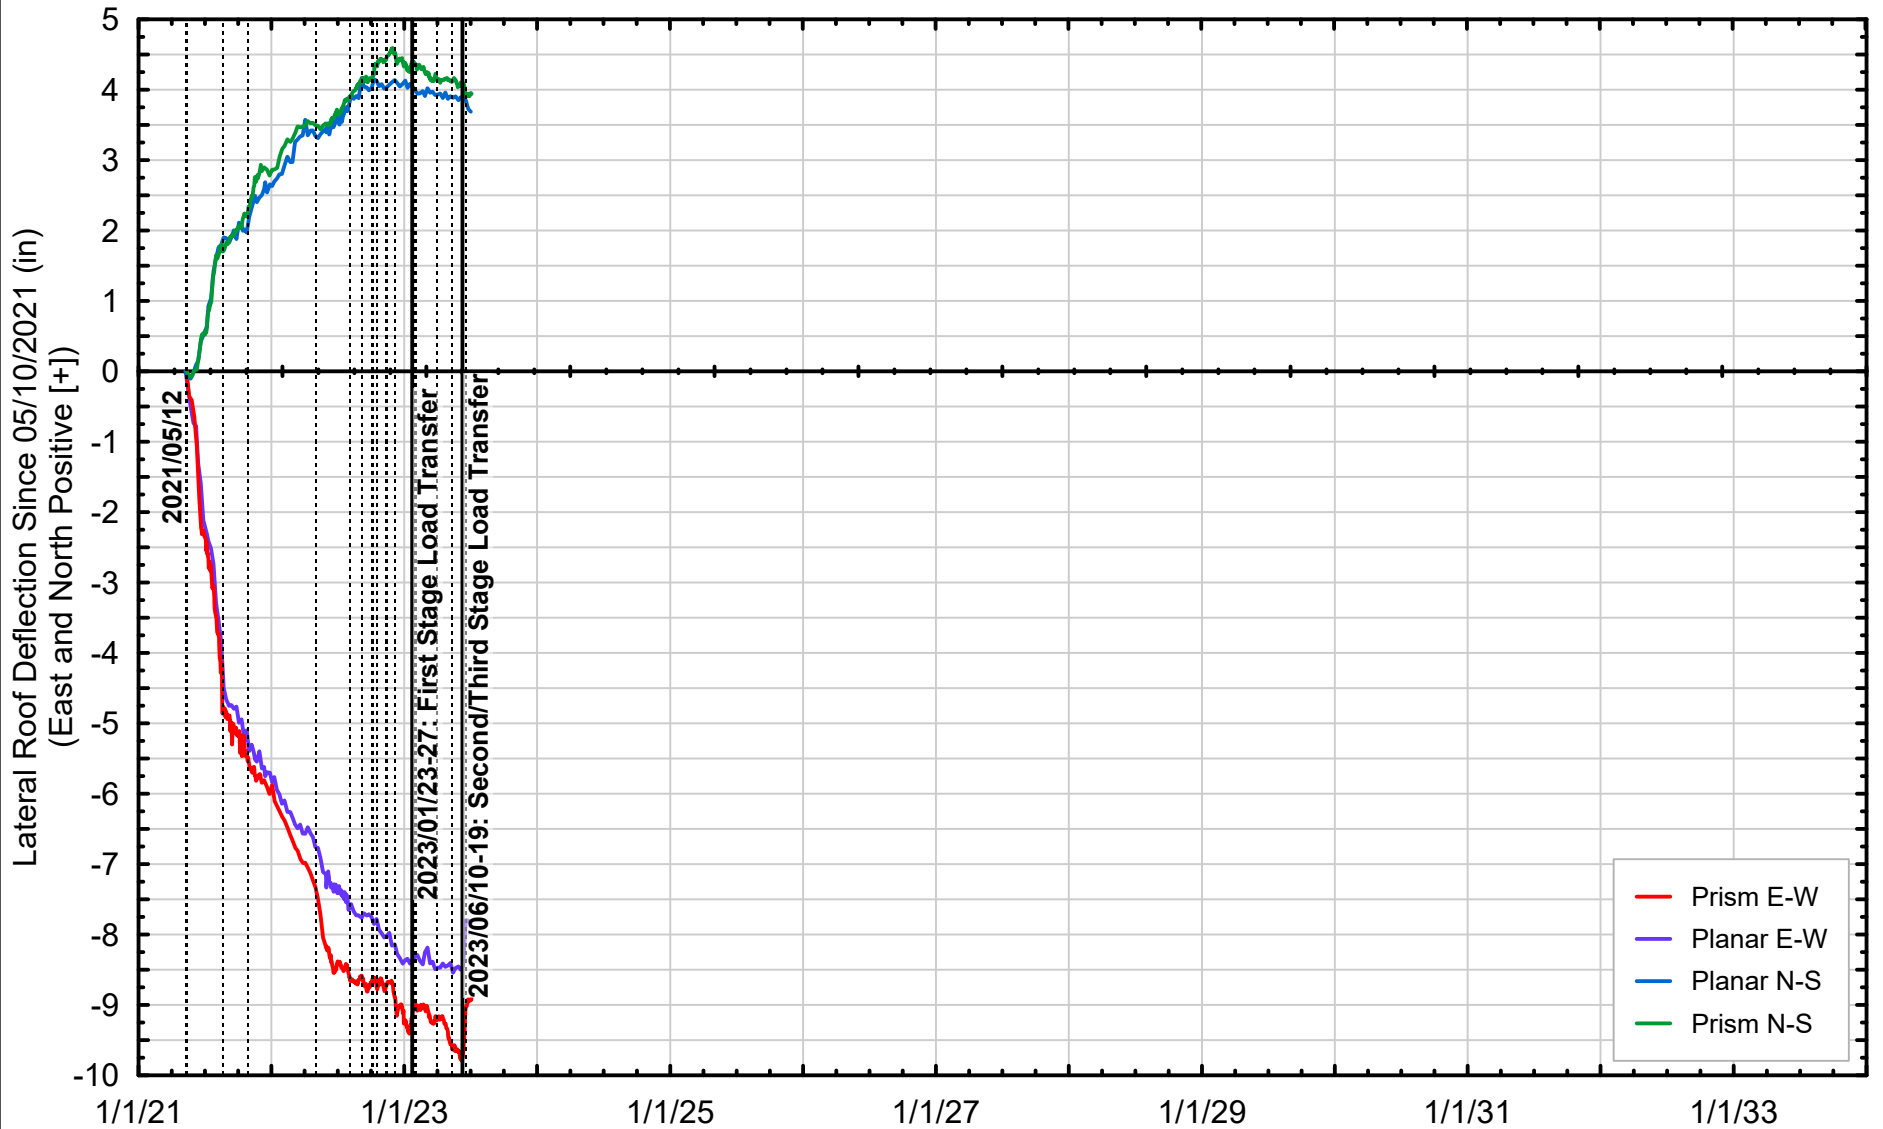
Project No: 19-009.00	Date: 7/6/2023	Created By: NBW	Checked By: DGM	Figure No: 113-06A
-----------------------	----------------	-----------------	-----------------	---------------------------

LATERAL ROOF DEFLECTION DATA
SINCE 05/10/2021 THROUGH 07/05/2023

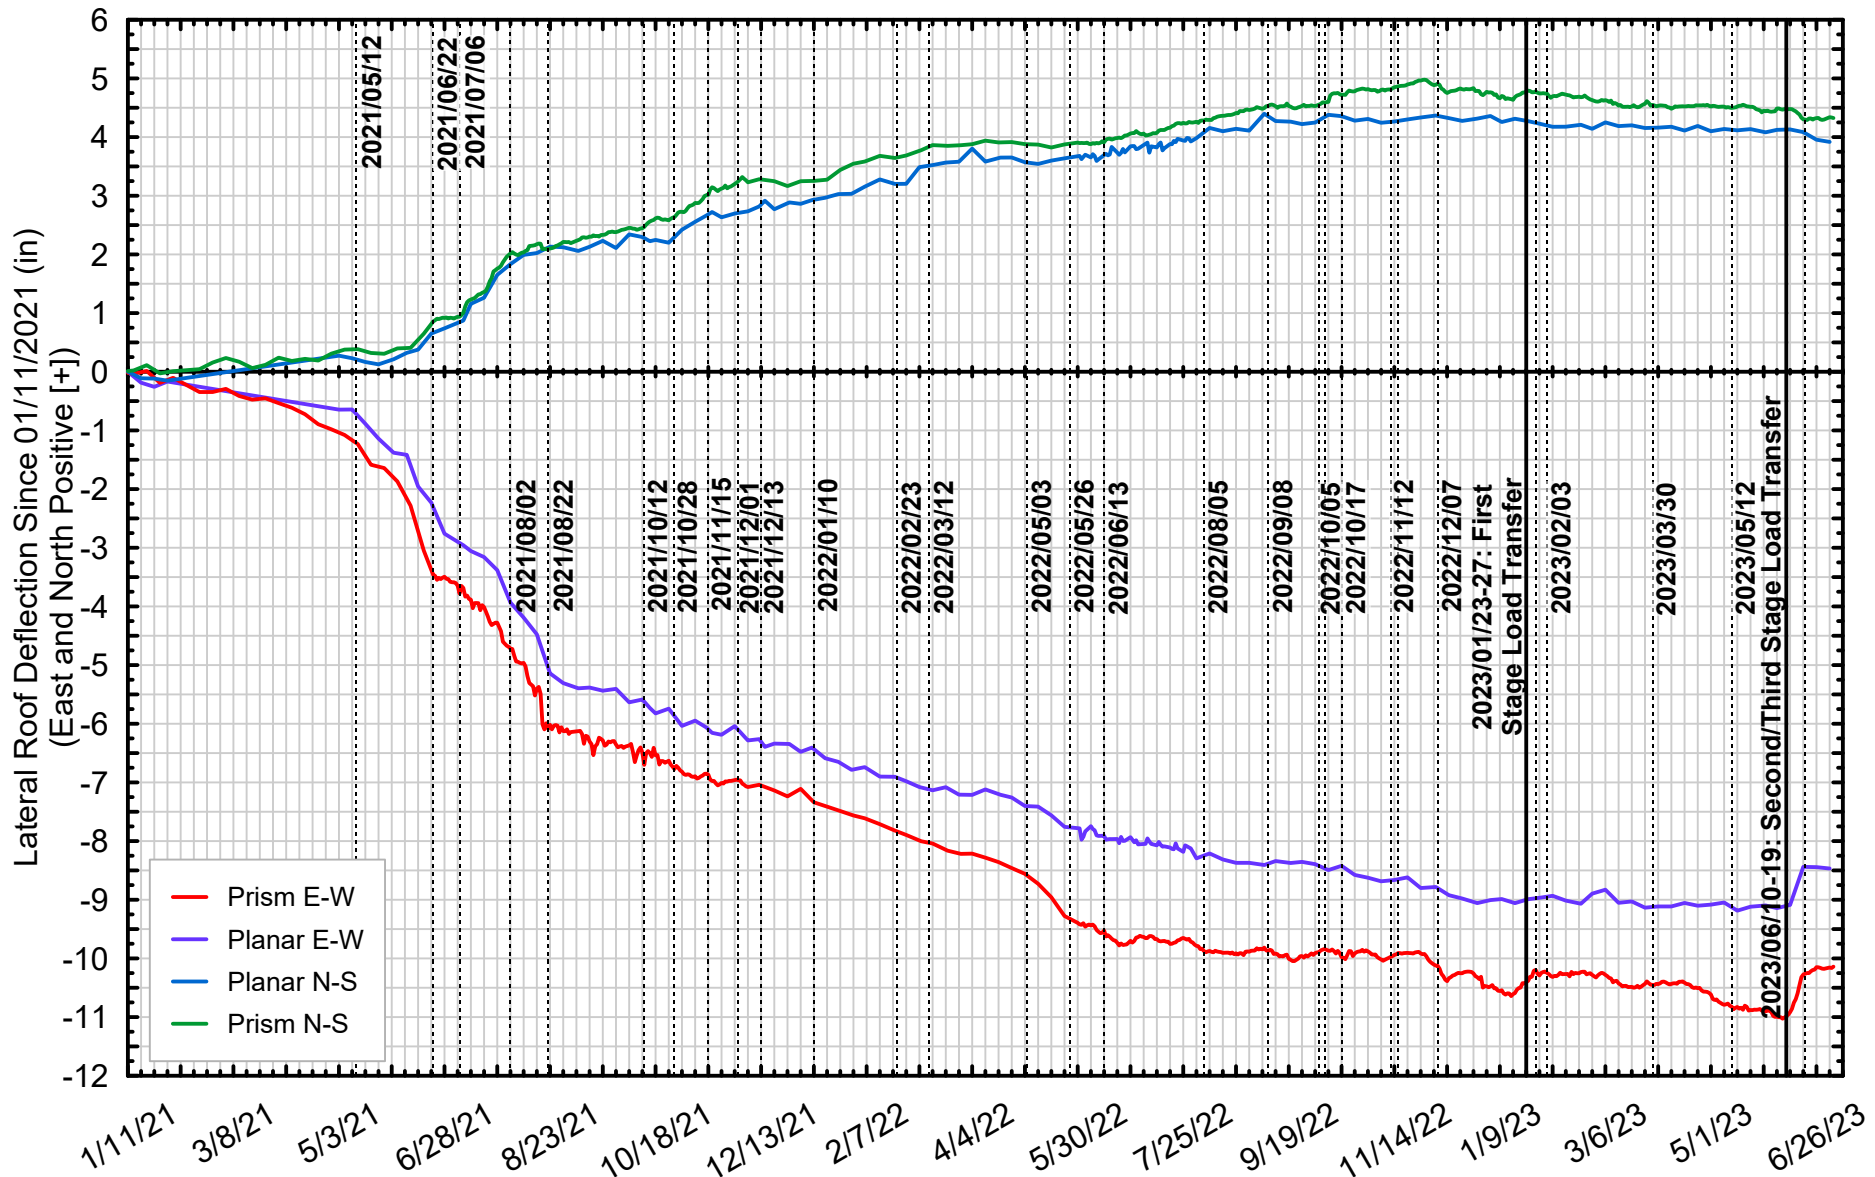
Project No: 19-009.00	Date: 7/6/2023	Created By: NBW	Checked By: DGM	Figure No: 113-06B
-----------------------	----------------	-----------------	-----------------	--------------------

LATERAL ROOF DEFLECTION DATA
 SINCE 01/11/2021 THROUGH 07/05/2023

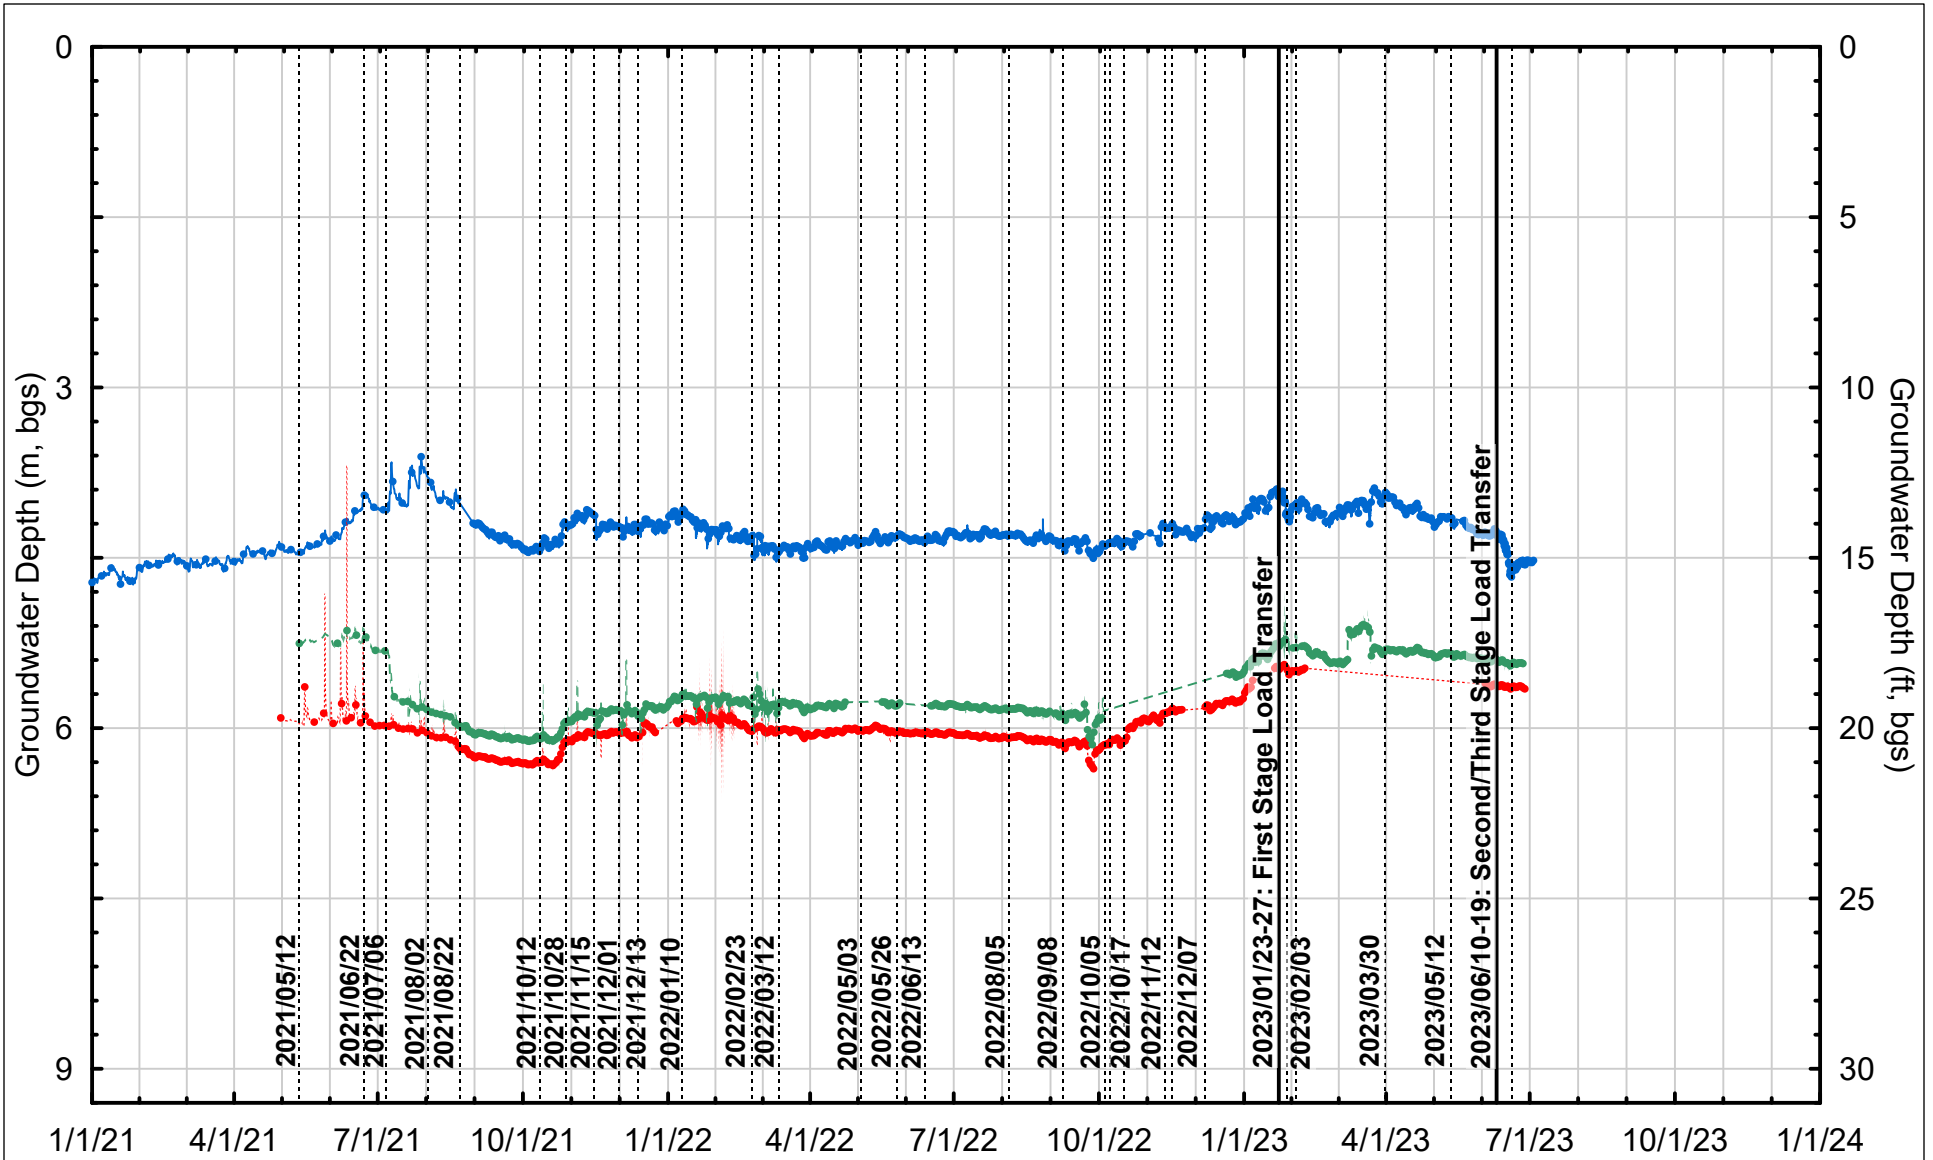
Figure No: 113-08A

Figure 07 presents the historical groundwater elevation interpreted from piezometer readings at locations near 301 Mission. In addition, data from piezometers installed to monitor groundwater elevation during the retrofit are included. Figures 08 and 09 present groundwater elevation interpreted from piezometer readings in the Marine/Colma Sand and the Old Bay Clay, respectively, for the time period prior to the start of production pile installation (January 1, 2021) through July 3, 2023.

GROUNDWATER ELEVATION MEASUREMENTS IN MARINE AND COLMA SAND
SINCE 01/01/2021 THROUGH 07/03/2023
