Subject: 301 Mission Retrofit Monitoring Report 113: Results as of July 5, 2023

This memorandum summarizes results from the monitoring plan implemented at the 301 Mission property. Instrumentation to monitor the structure prior to, during and after the retrofit was installed in January 2021, including piezometers and extensometers. Settlement markers installed in April 2009 and January 2017, survey prisms mounted on the exterior of the structure in December 2016, and crack gauges installed in April 2009 have also been monitored. Pile load cells were installed on the Mission Street piles in January 2023. Survey markers were installed on the Mission Street mat extension in January 2023, prior to the Stage 1 load transfer and on the Fremont Street mat extensions in June 2023, prior to the Stages 2 and 3 load transfer. This memorandum is for review only. It only contains ongoing monitoring information. This memorandum does not contain recommendations based upon the ongoing monitoring information.

Millennium Tower Perimeter Pile Upgrade: Instrumentation Monitoring Data
City and County of San Francisco, California

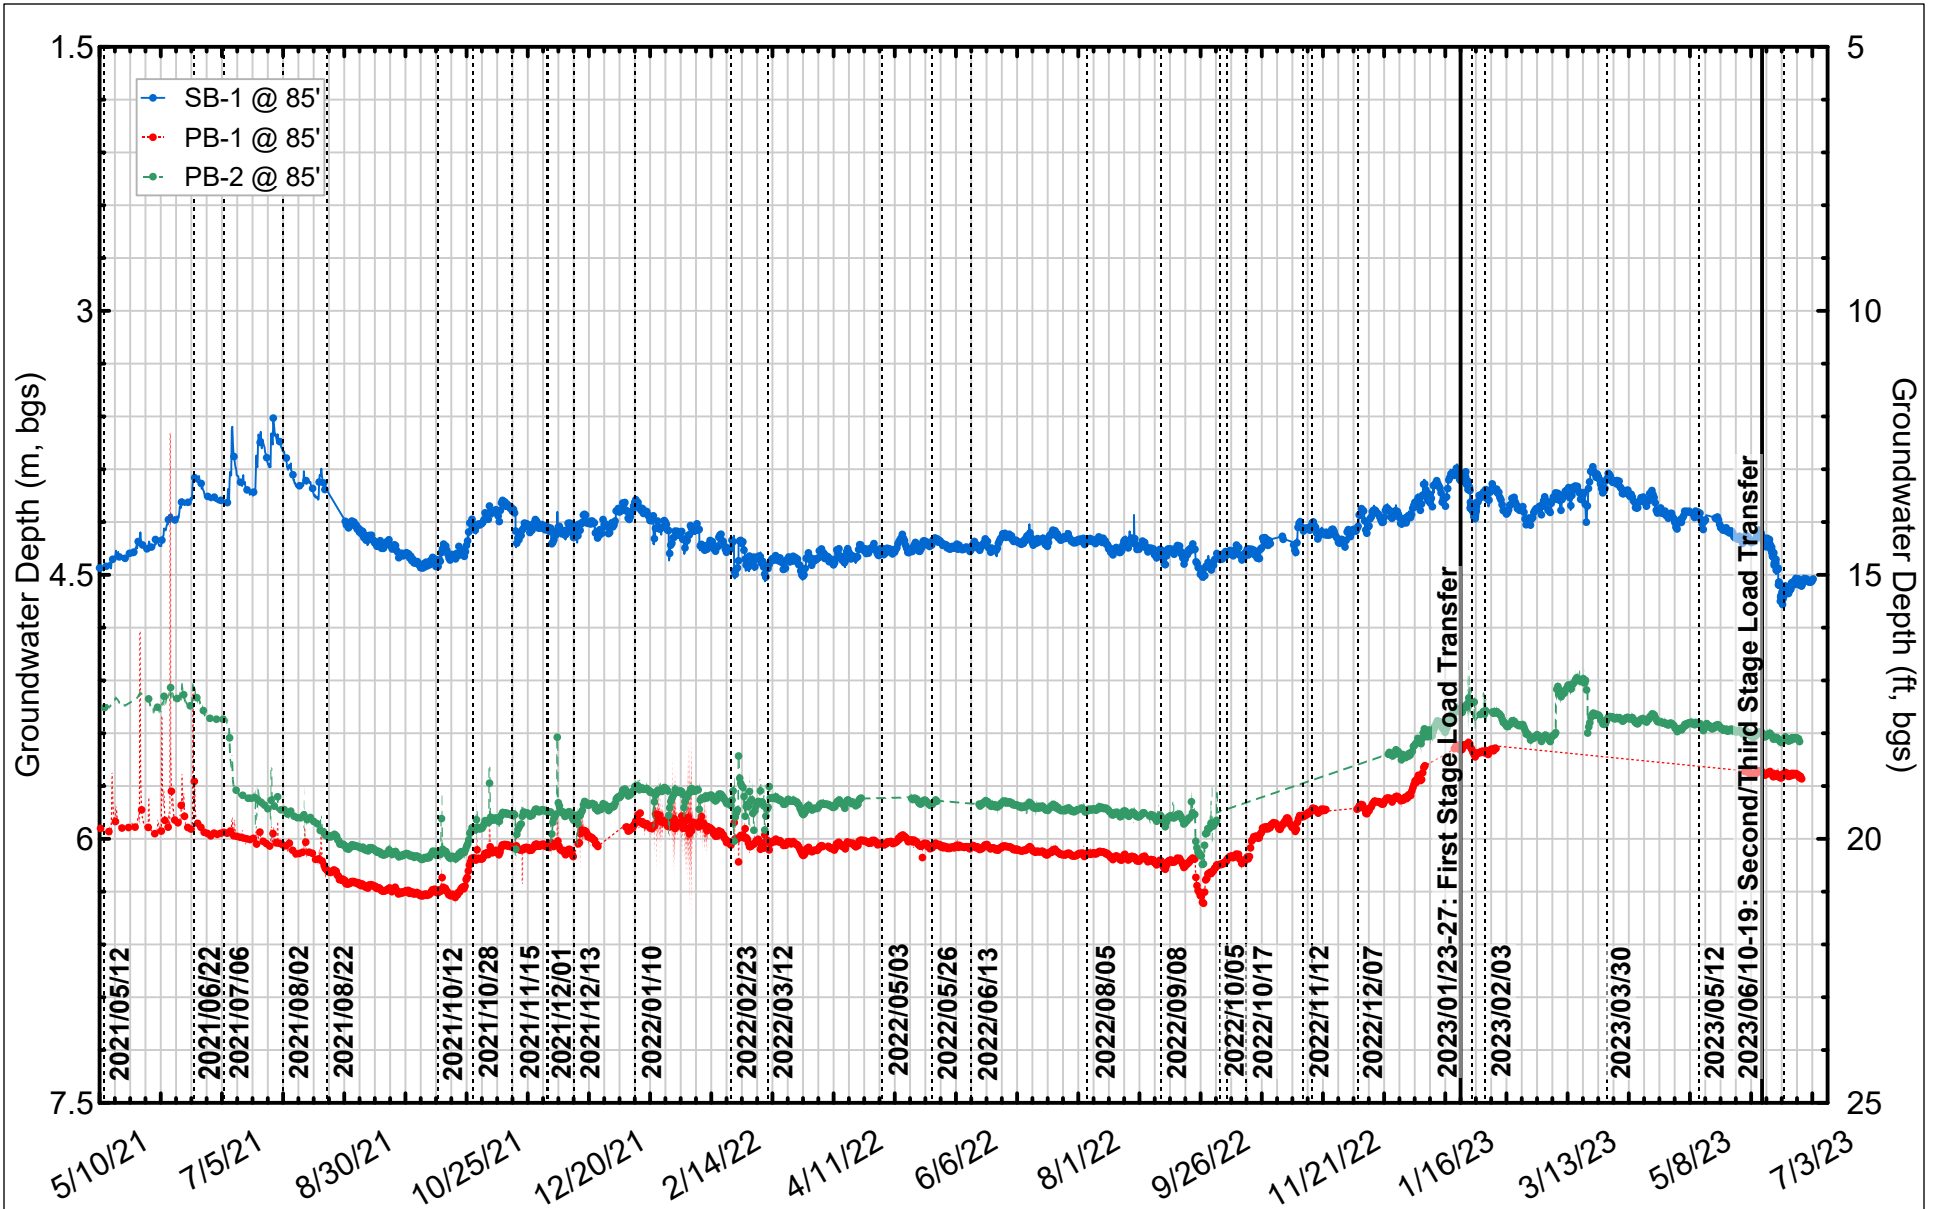
Project No: 19-009.00	Date: 7/6/2023	Created By: NBW	Checked By: DGM	Figure No: 113-08B
-----------------------	----------------	-----------------	-----------------	---------------------------

GROUNDWATER ELEVATION MEASUREMENTS IN MARINE AND COLMA SAND
SINCE 05/10/2021 THROUGH 07/03/2023

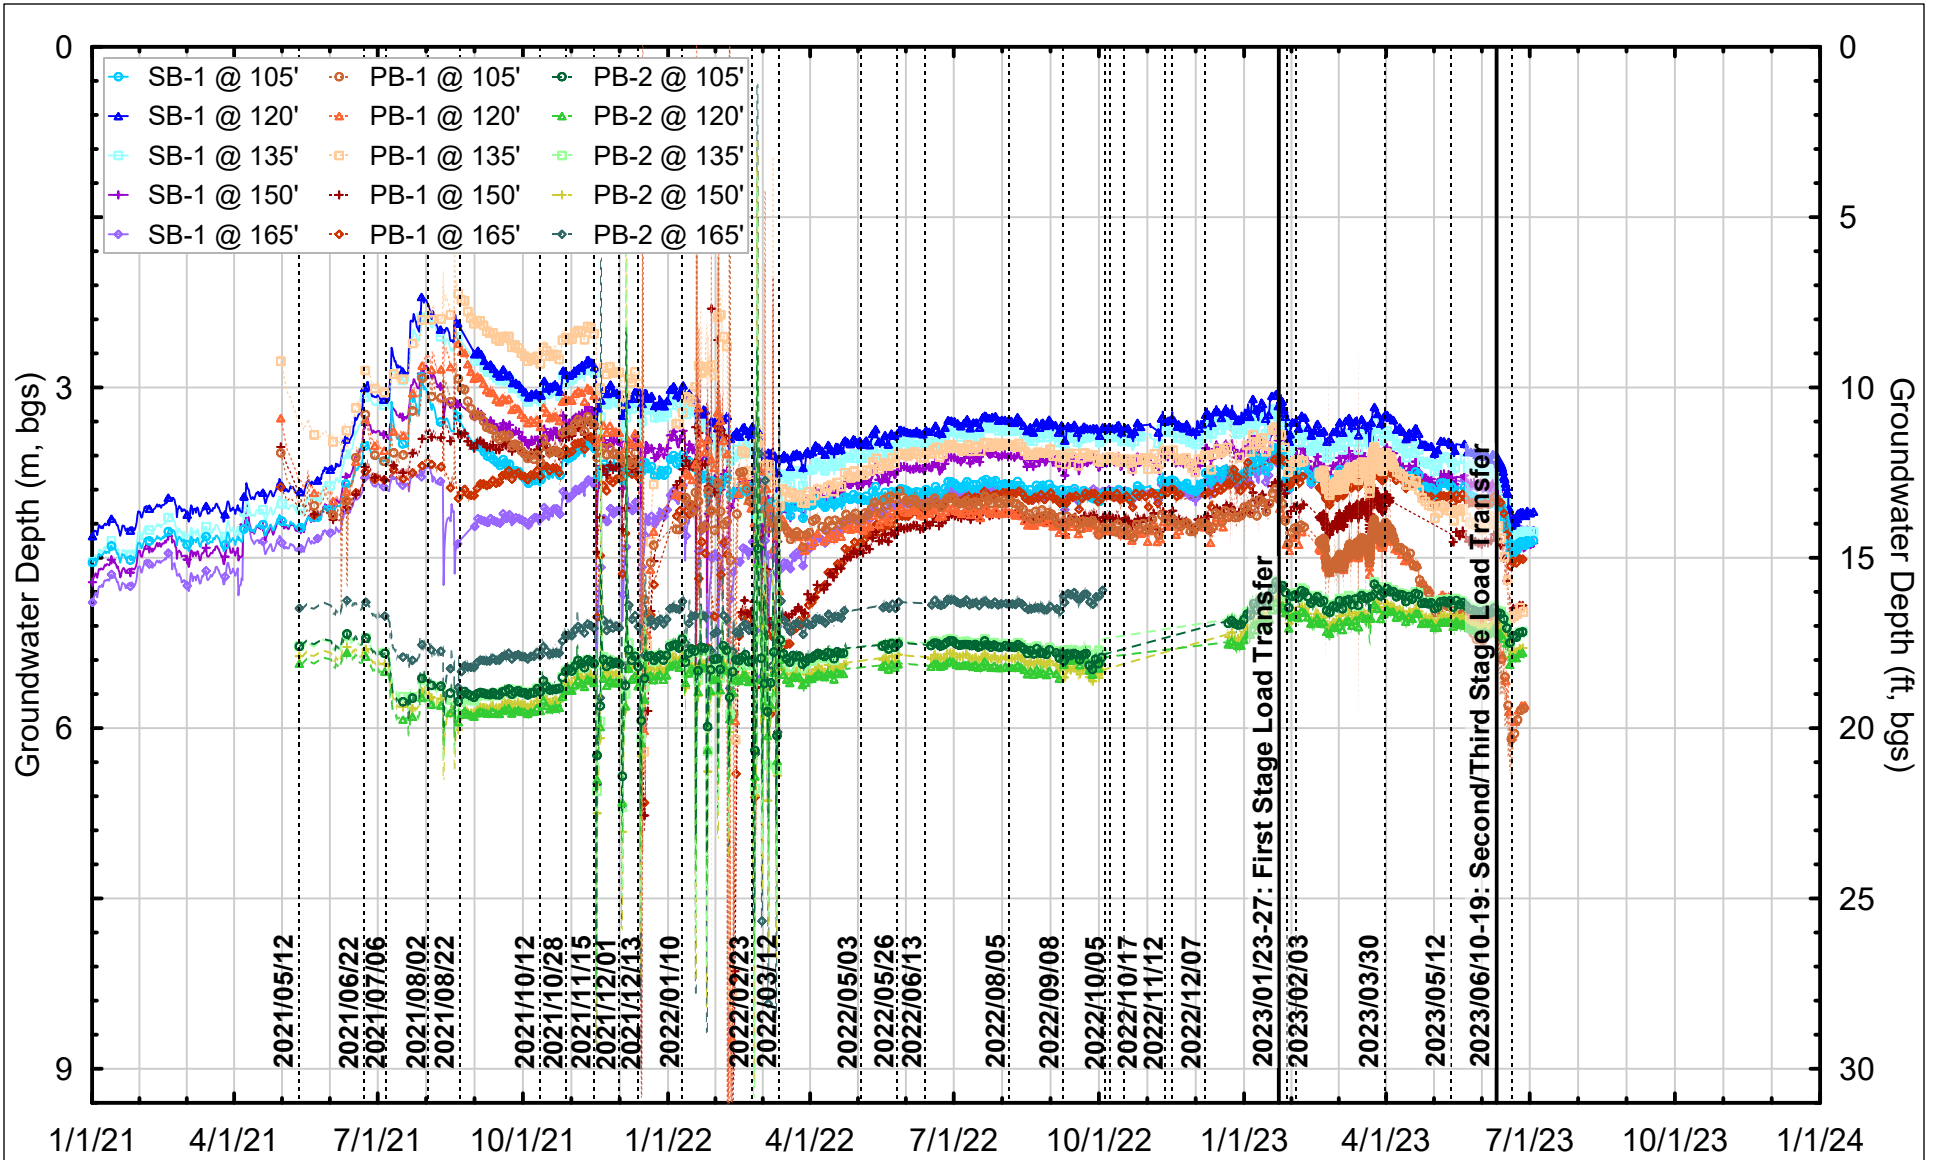
Project No: 19-009.00	Date: 7/6/2023	Created By: NBW	Checked By: DGM	Figure No: 113-09A
-----------------------	----------------	-----------------	-----------------	---------------------------

GROUNDWATER ELEVATION MEASUREMENTS IN OLD BAY CLAY
 SINCE 01/01/2021 THROUGH 07/03/2023

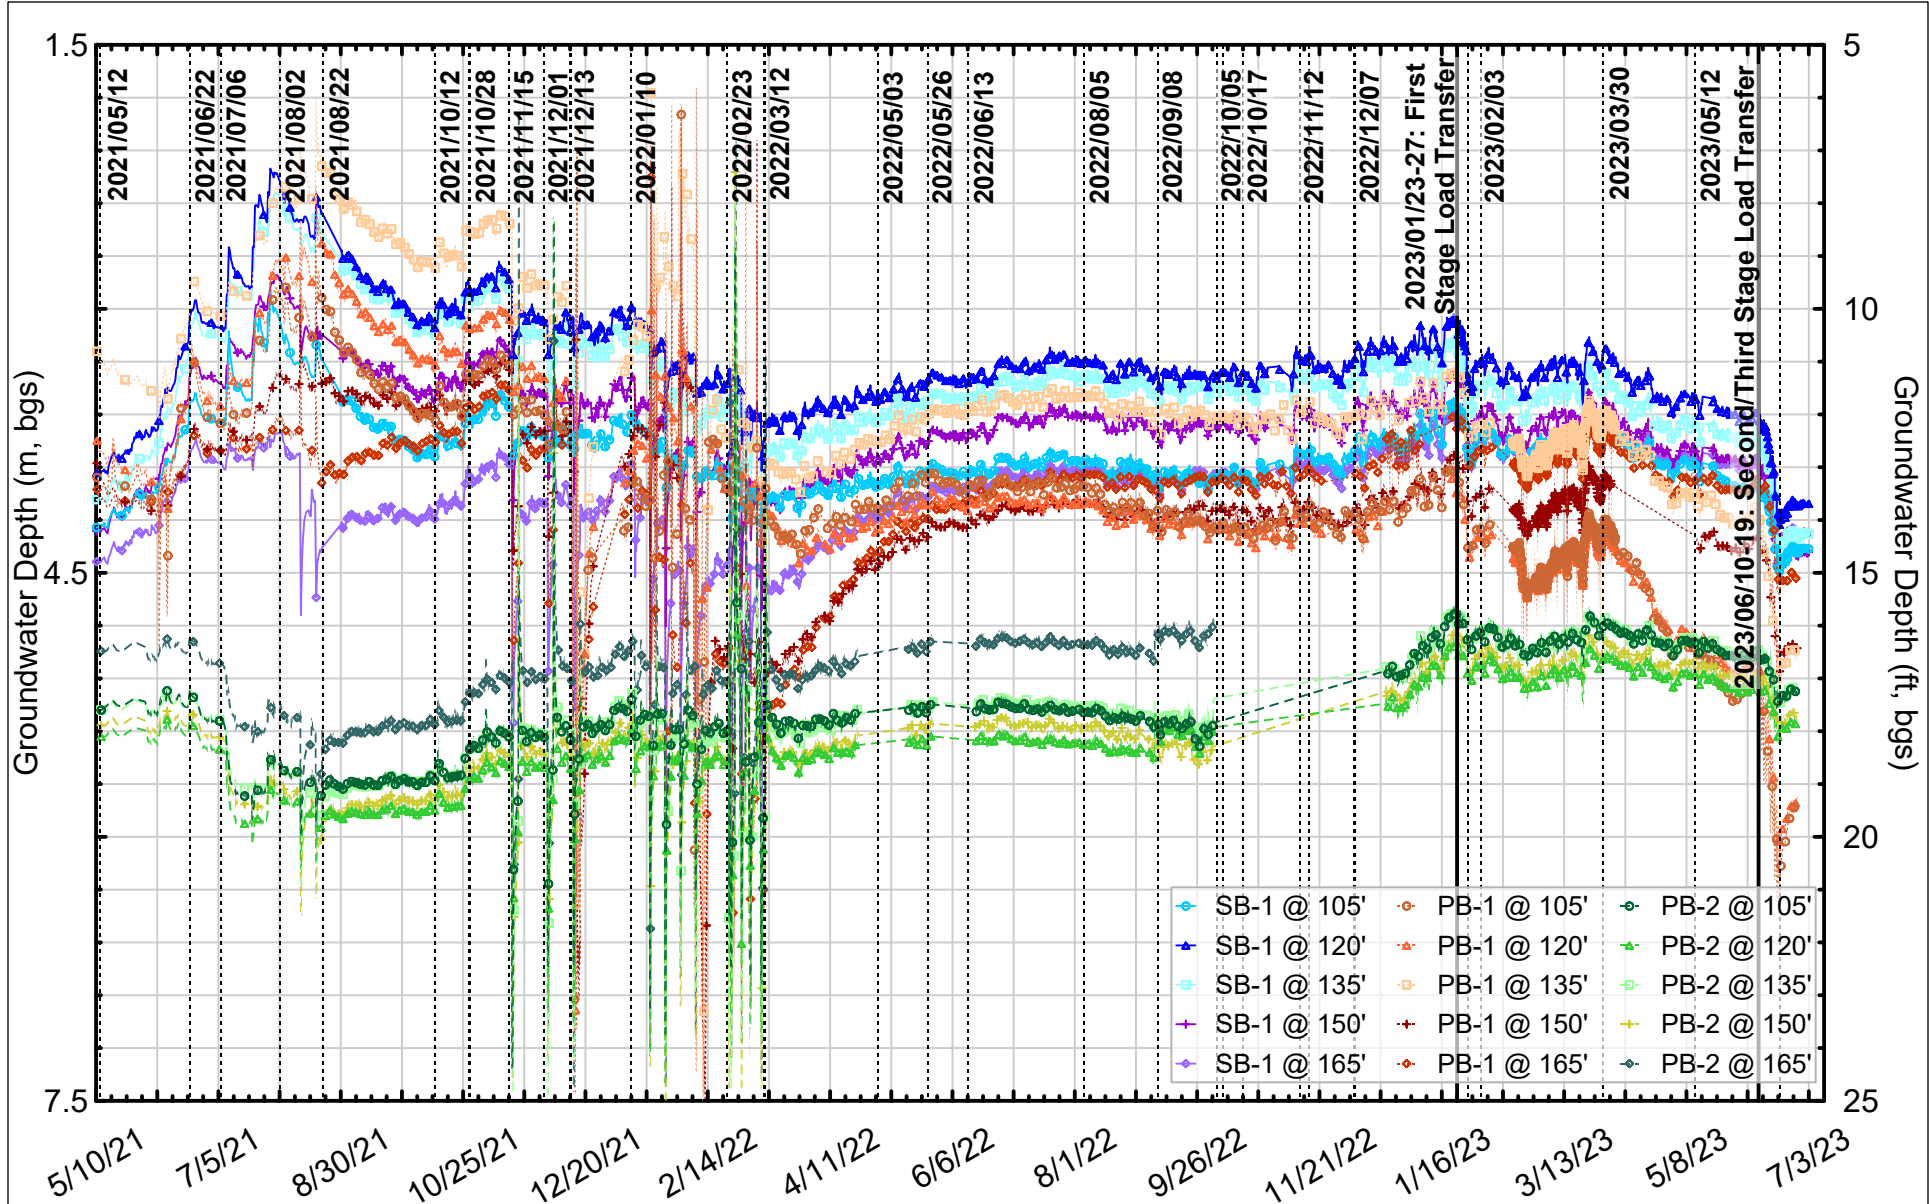
Project No: 19-009.00	Date: 7/6/2023	Created By: NBW	Checked By: DGM	Figure No: 113-09B
-----------------------	----------------	-----------------	-----------------	---------------------------

GROUNDWATER ELEVATION MEASUREMENTS IN OLD BAY CLAY
SINCE 05/10/2021 THROUGH 07/03/2023

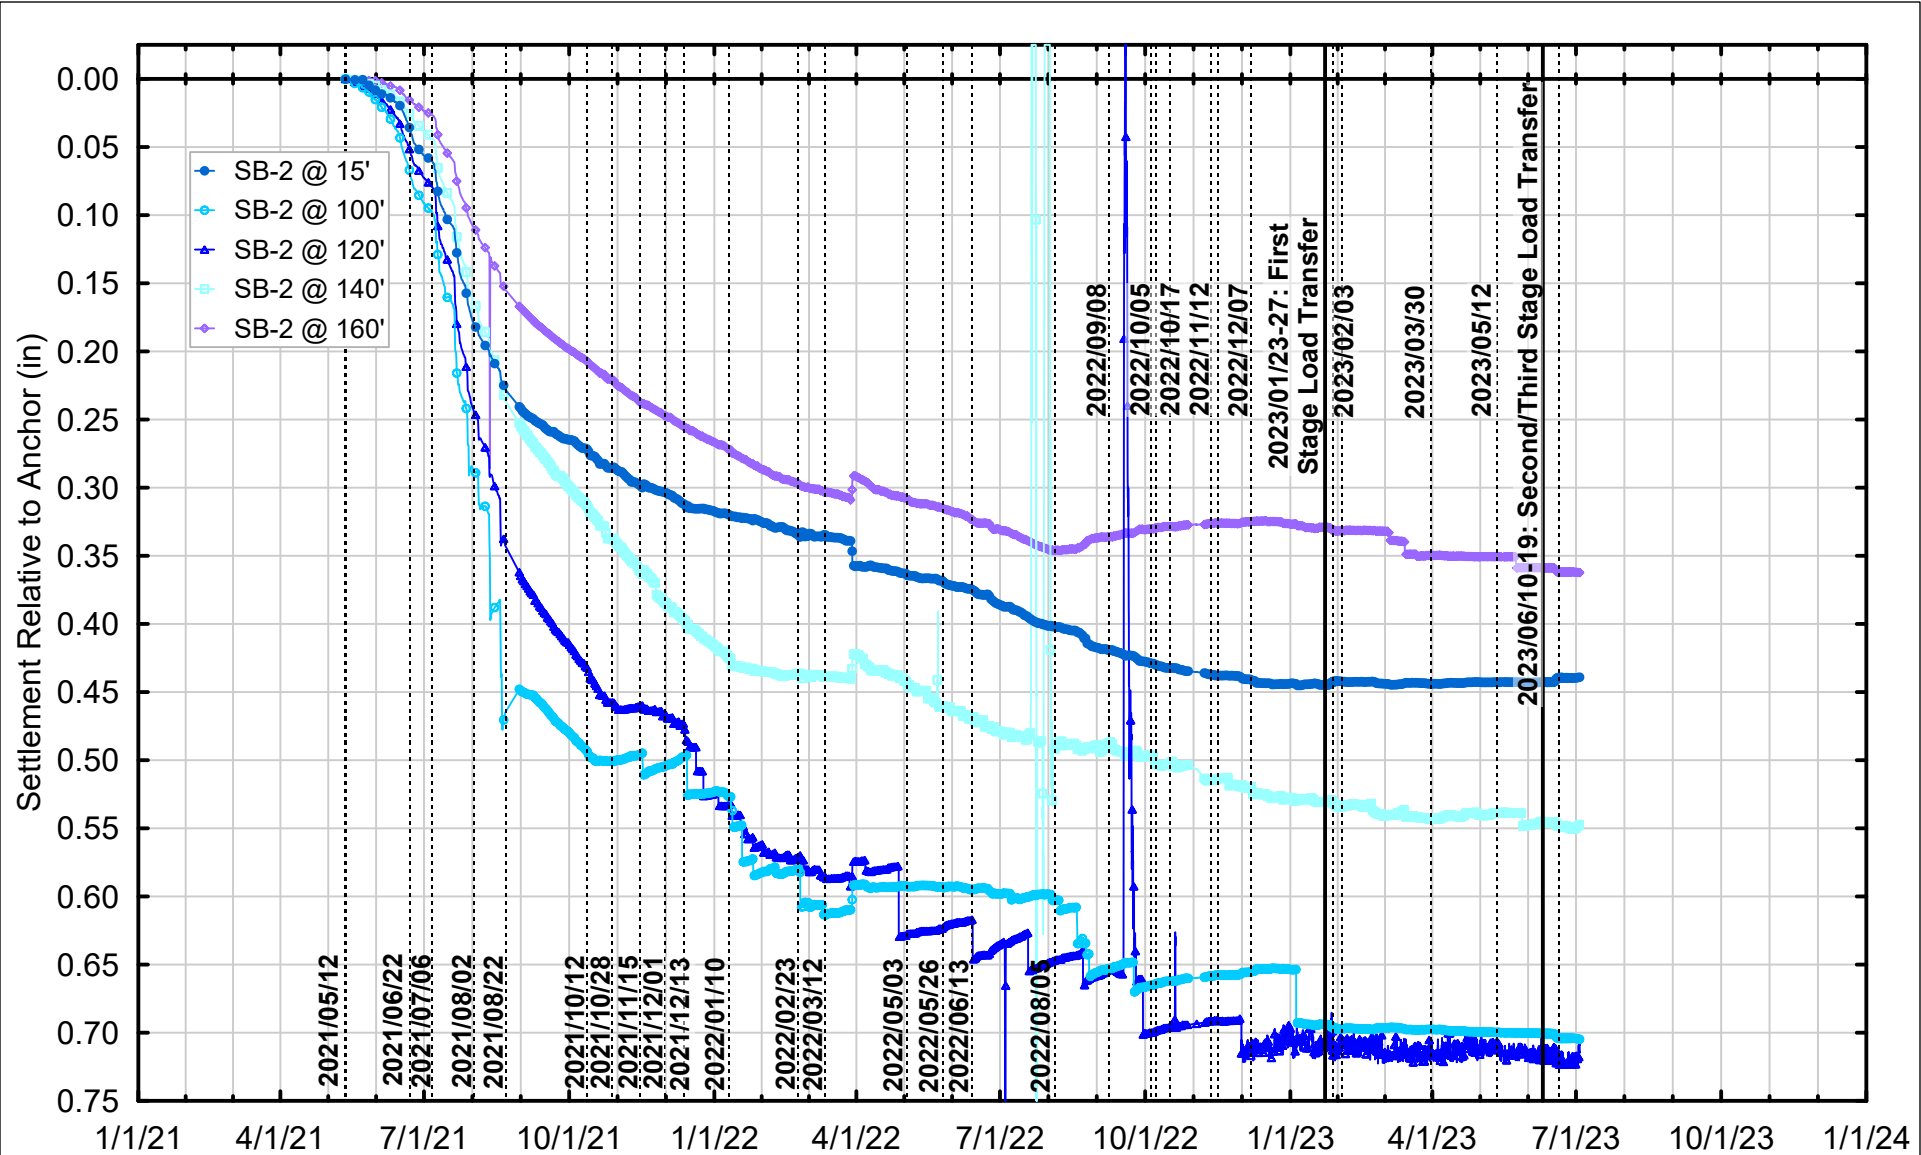
Project No: 19-009.00	Date: 7/6/2023	Created By: NBW	Checked By: DGM	Figure No: 113-10A

Figure 10 presents extensometer data from within the Tower basement since the start of production pile installation (May 12, 2021) through July 3, 2023. Figure 11 presents extensometer data from Fremont Street since the start of production pile installation (May 12, 2021) through May 16, 2023, and from the restart after fixing the extensometer (May 30, 2023) through June 27, 2023. Figure 12 presents extensometer data from Mission Street since the start of production pile installation (May 12, 2021) through June 27, 2023.

EXTENSOMETER DATA FROM WITHIN TOWER BASEMENT SINCE 01/01/2021 THROUGH 07/03/2023		
		Millennium Tower Perimeter Pile Upgrade: Instrumentation Monitoring Data City and County of San Francisco, California

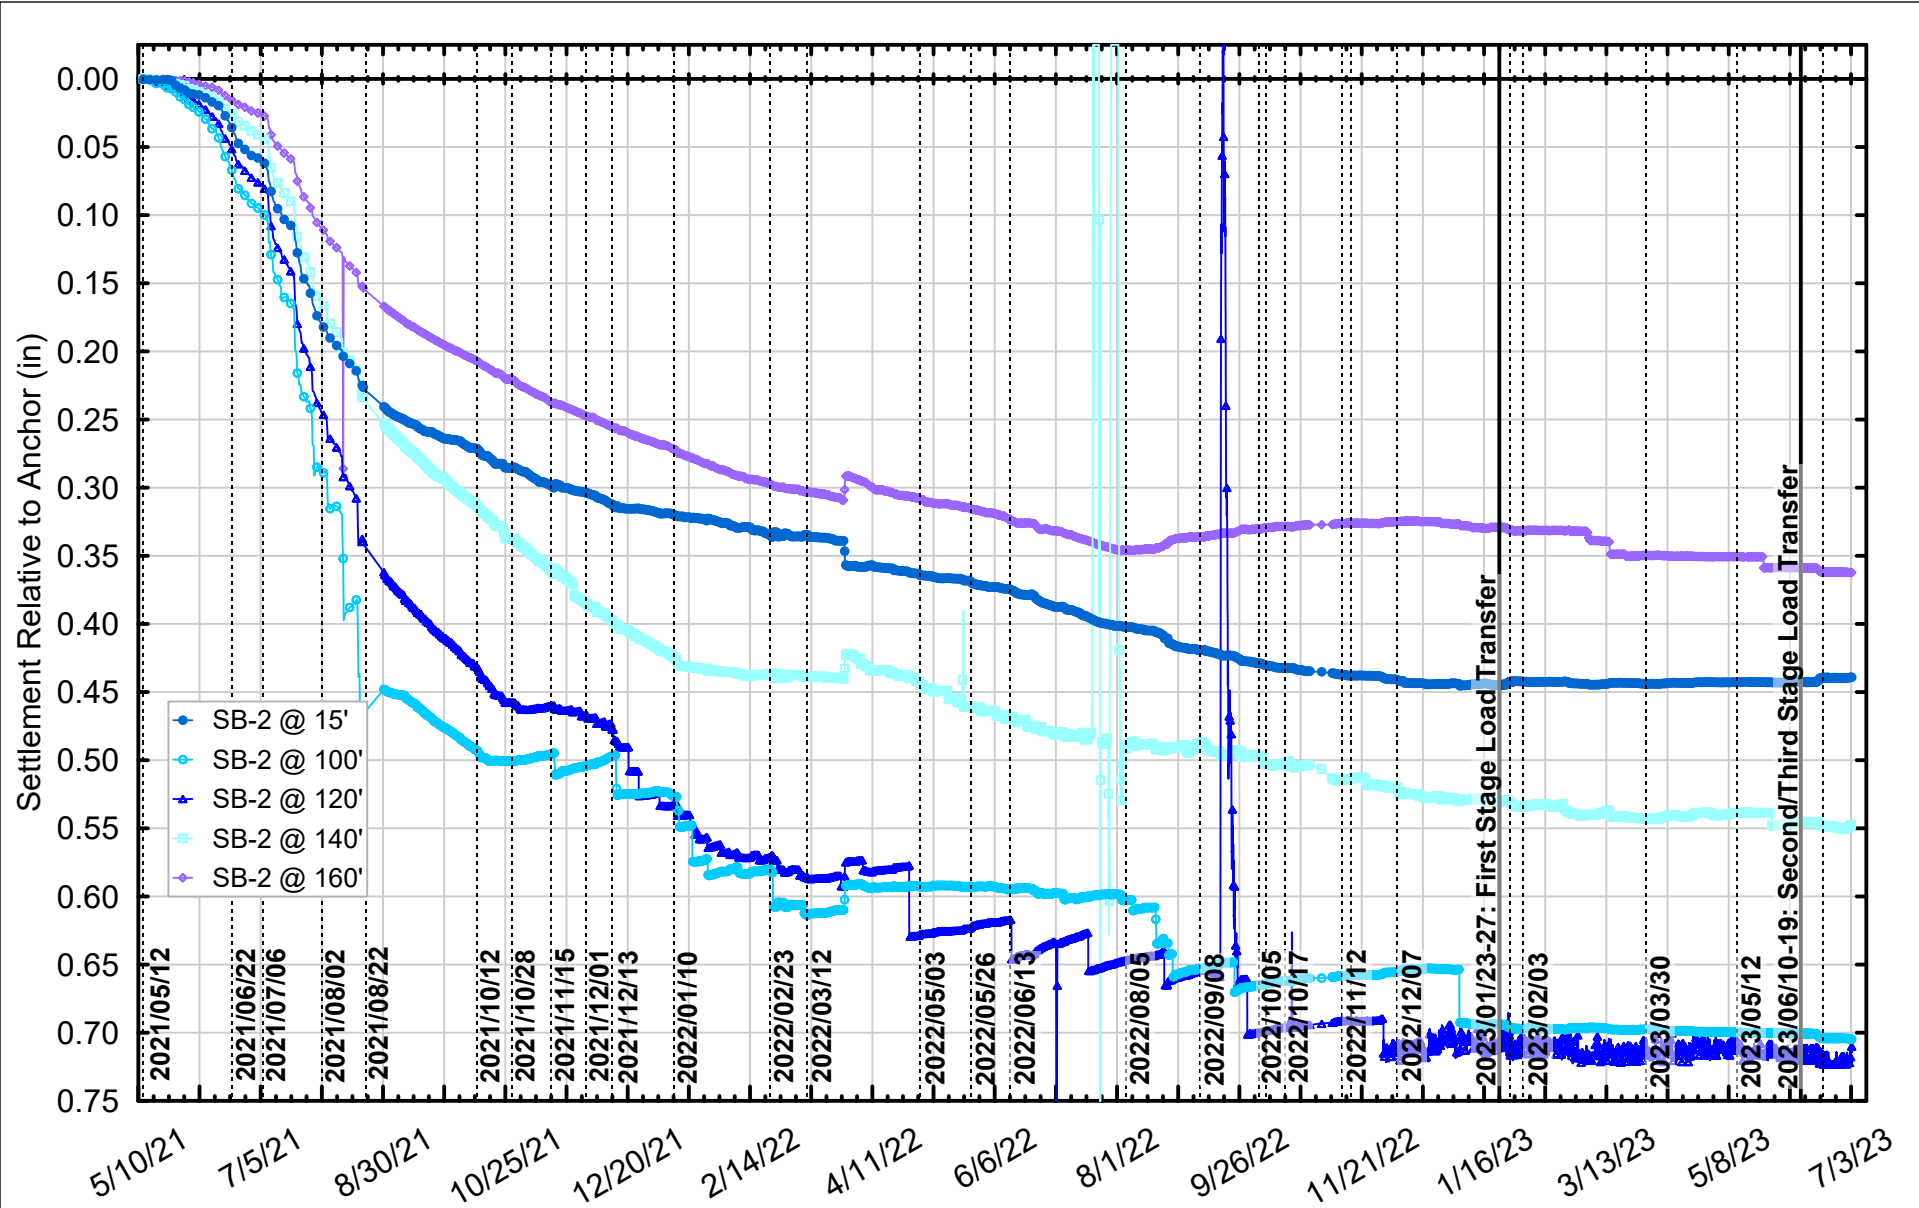
Project No: 19-009.00 Date: 7/6/2023 Created By: NBW Checked By: DGM Figure No: 113-10B

EXTENSOMETER DATA FROM WITHIN TOWER BASEMENT
SINCE 05/10/2021 THROUGH 07/03/2023

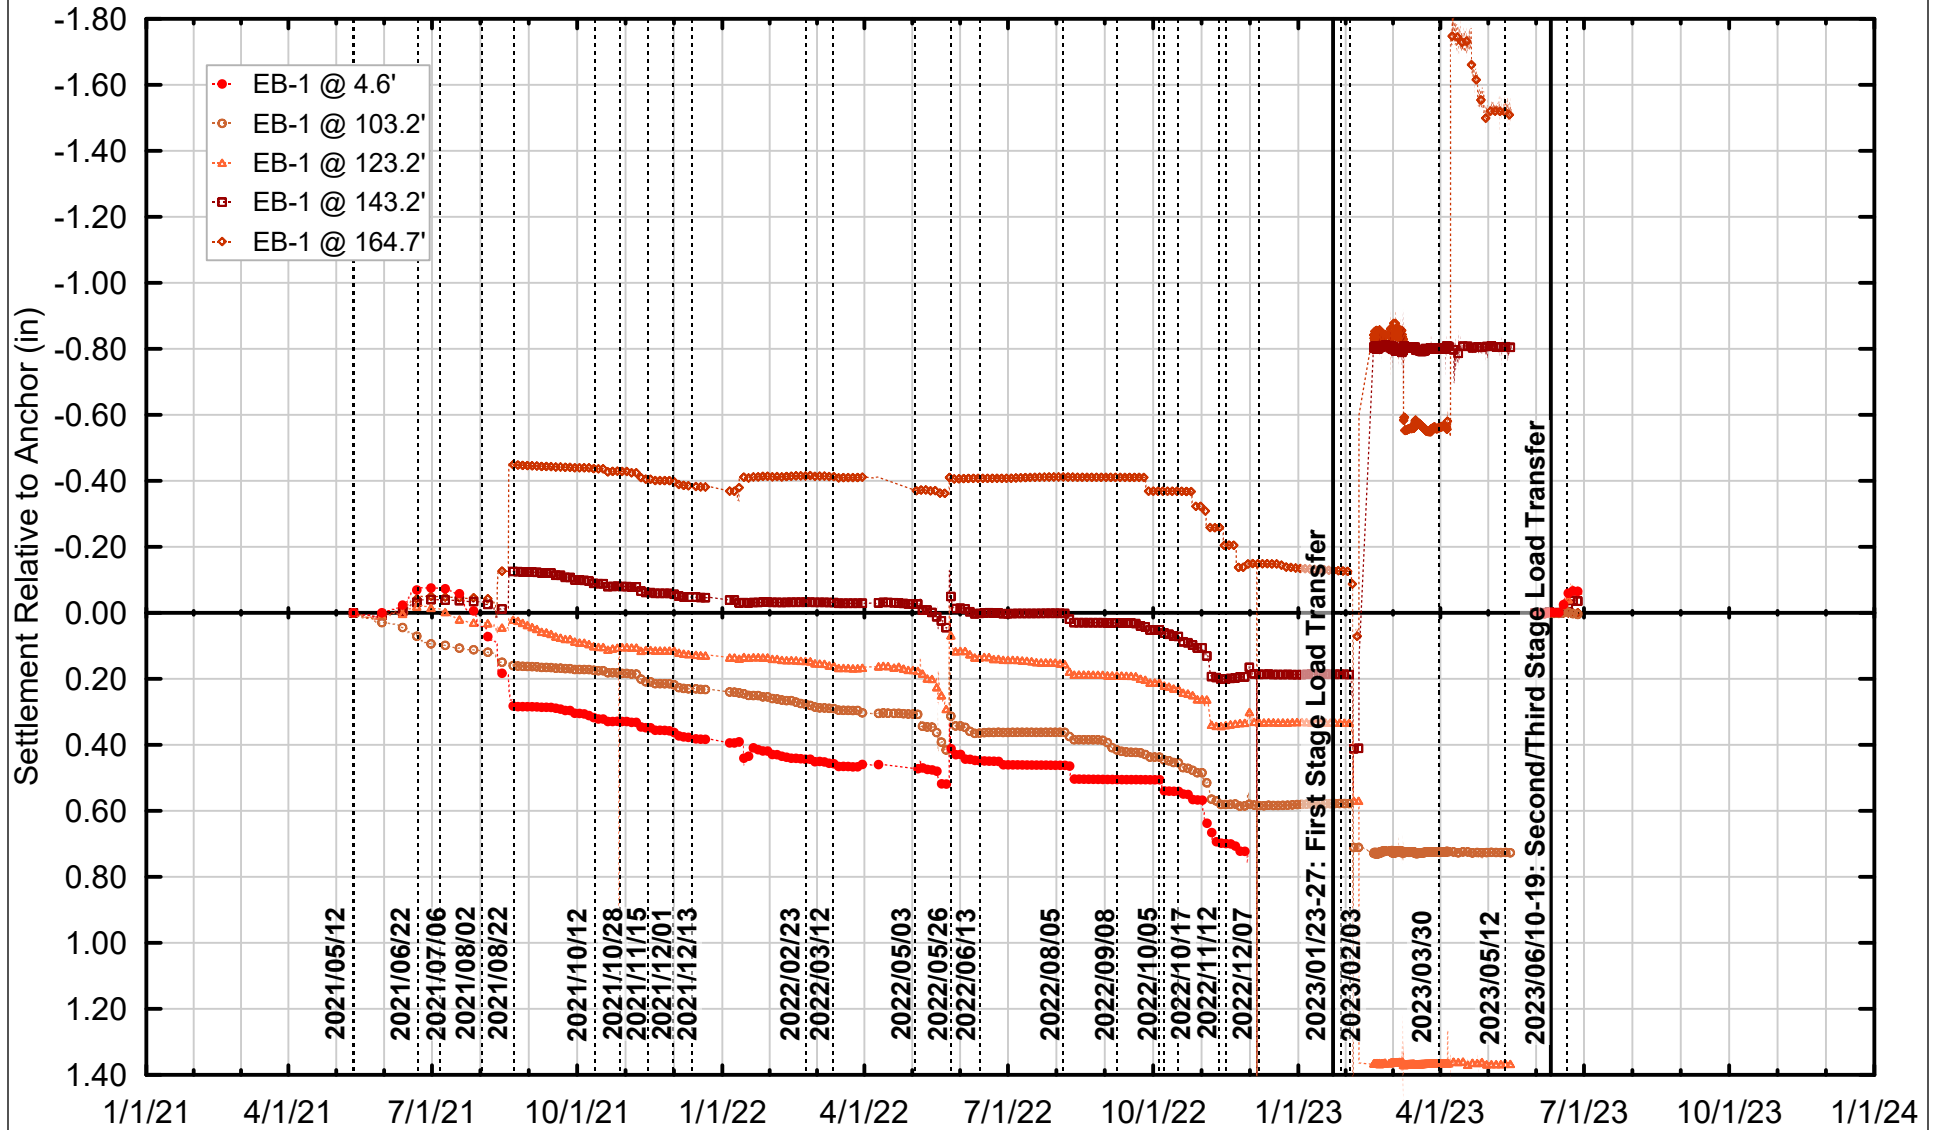
Figure No: 113-11A

Note: EB-1 was repaired and reset on 2023/05/30

EXTENSOMETER DATA FROM FREMONT STREET
 SINCE 05/10/2021 THROUGH 05/16/2023
 SINCE 05/30/2023 THROUGH 06/27/2023
 Millennium Tower Perimeter Pile Upgrade: Instrumentation Monitoring Data
 City and County of San Francisco, California

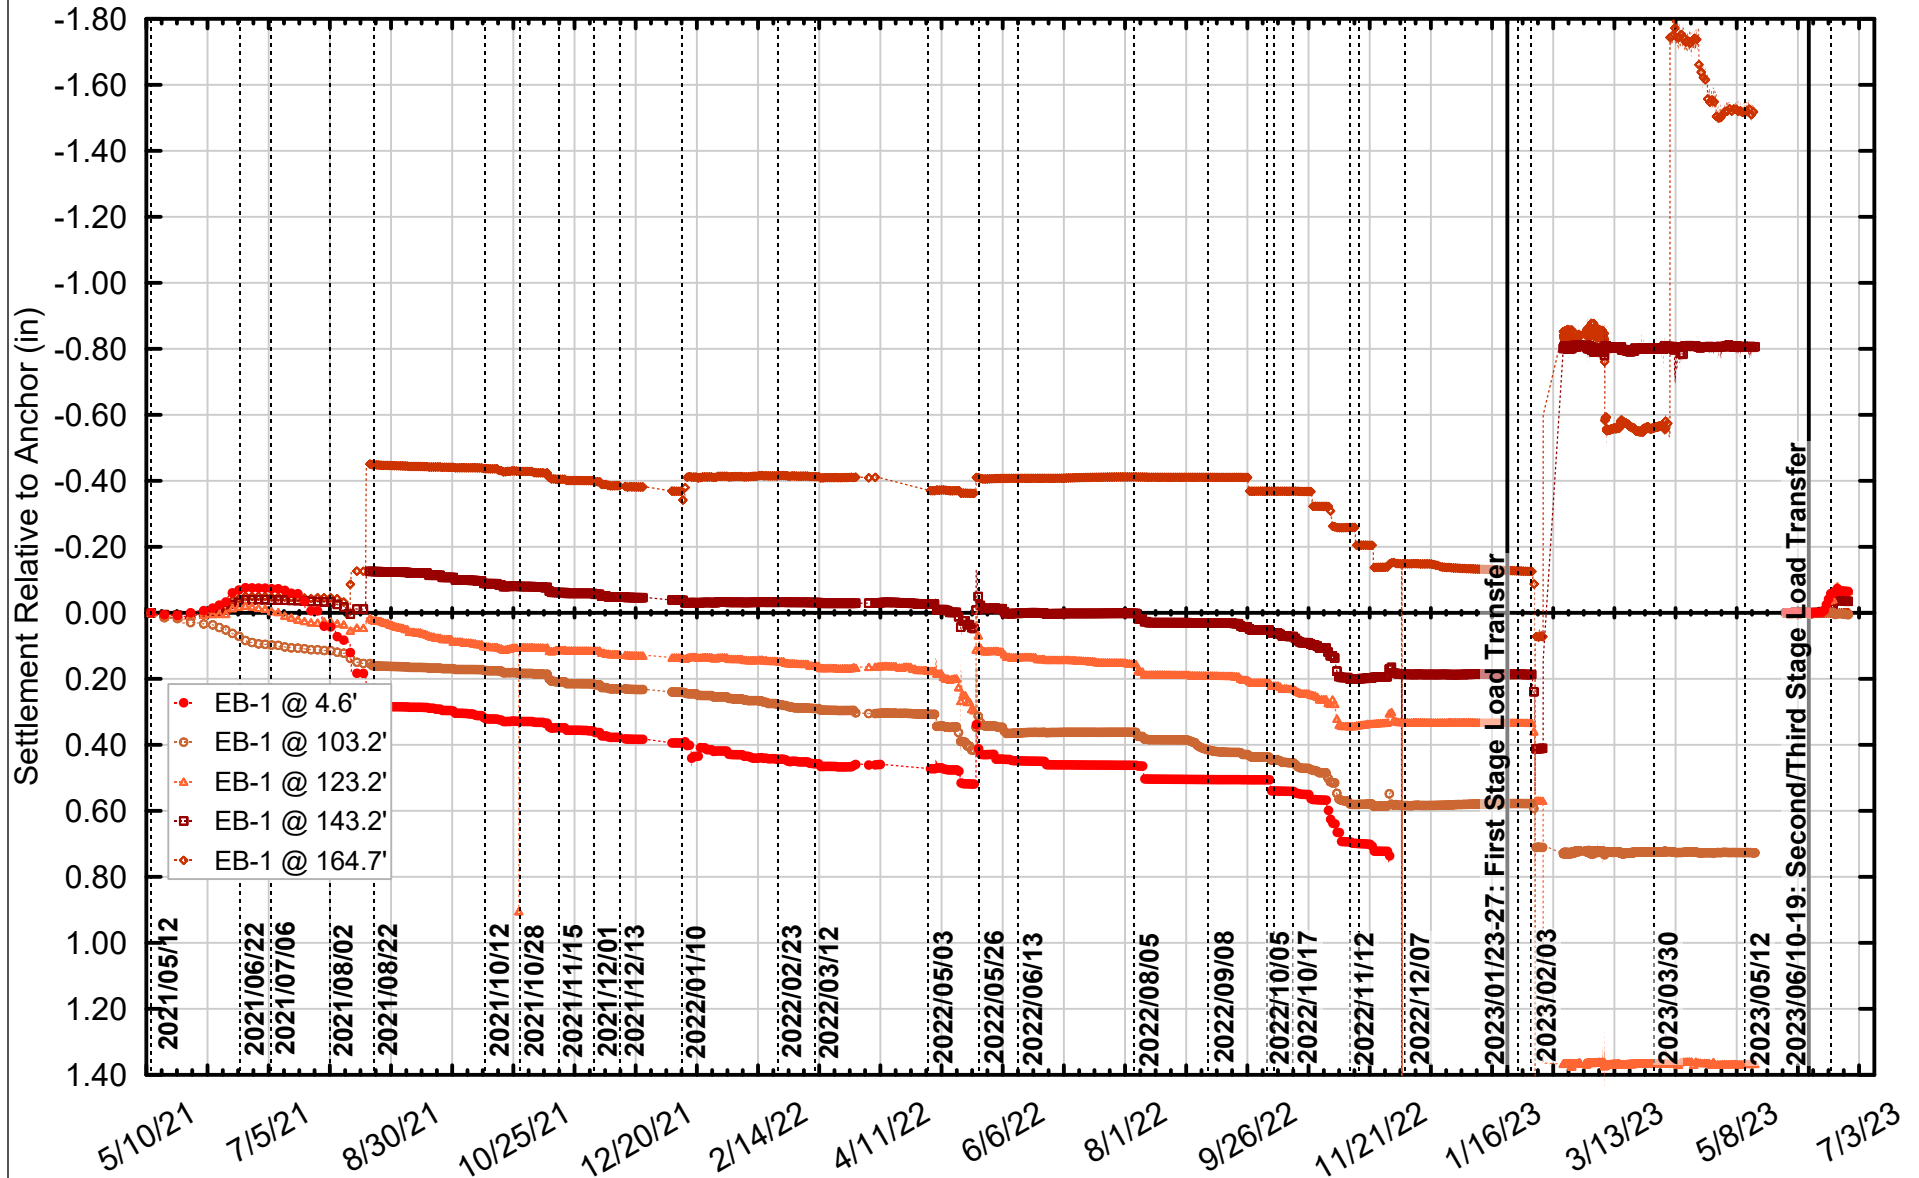
Figure No: 113-11B

Note: EB-1 was repaired and reset on 2023/05/30

EXTENSOMETER DATA FROM FREMONT STREET
 SINCE 05/10/2021 THROUGH 05/16/2023
 SINCE 05/30/2023 THROUGH 06/27/2023
 Millennium Tower Perimeter Pile Upgrade: Instrumentation Monitoring Data
 City and County of San Francisco, California

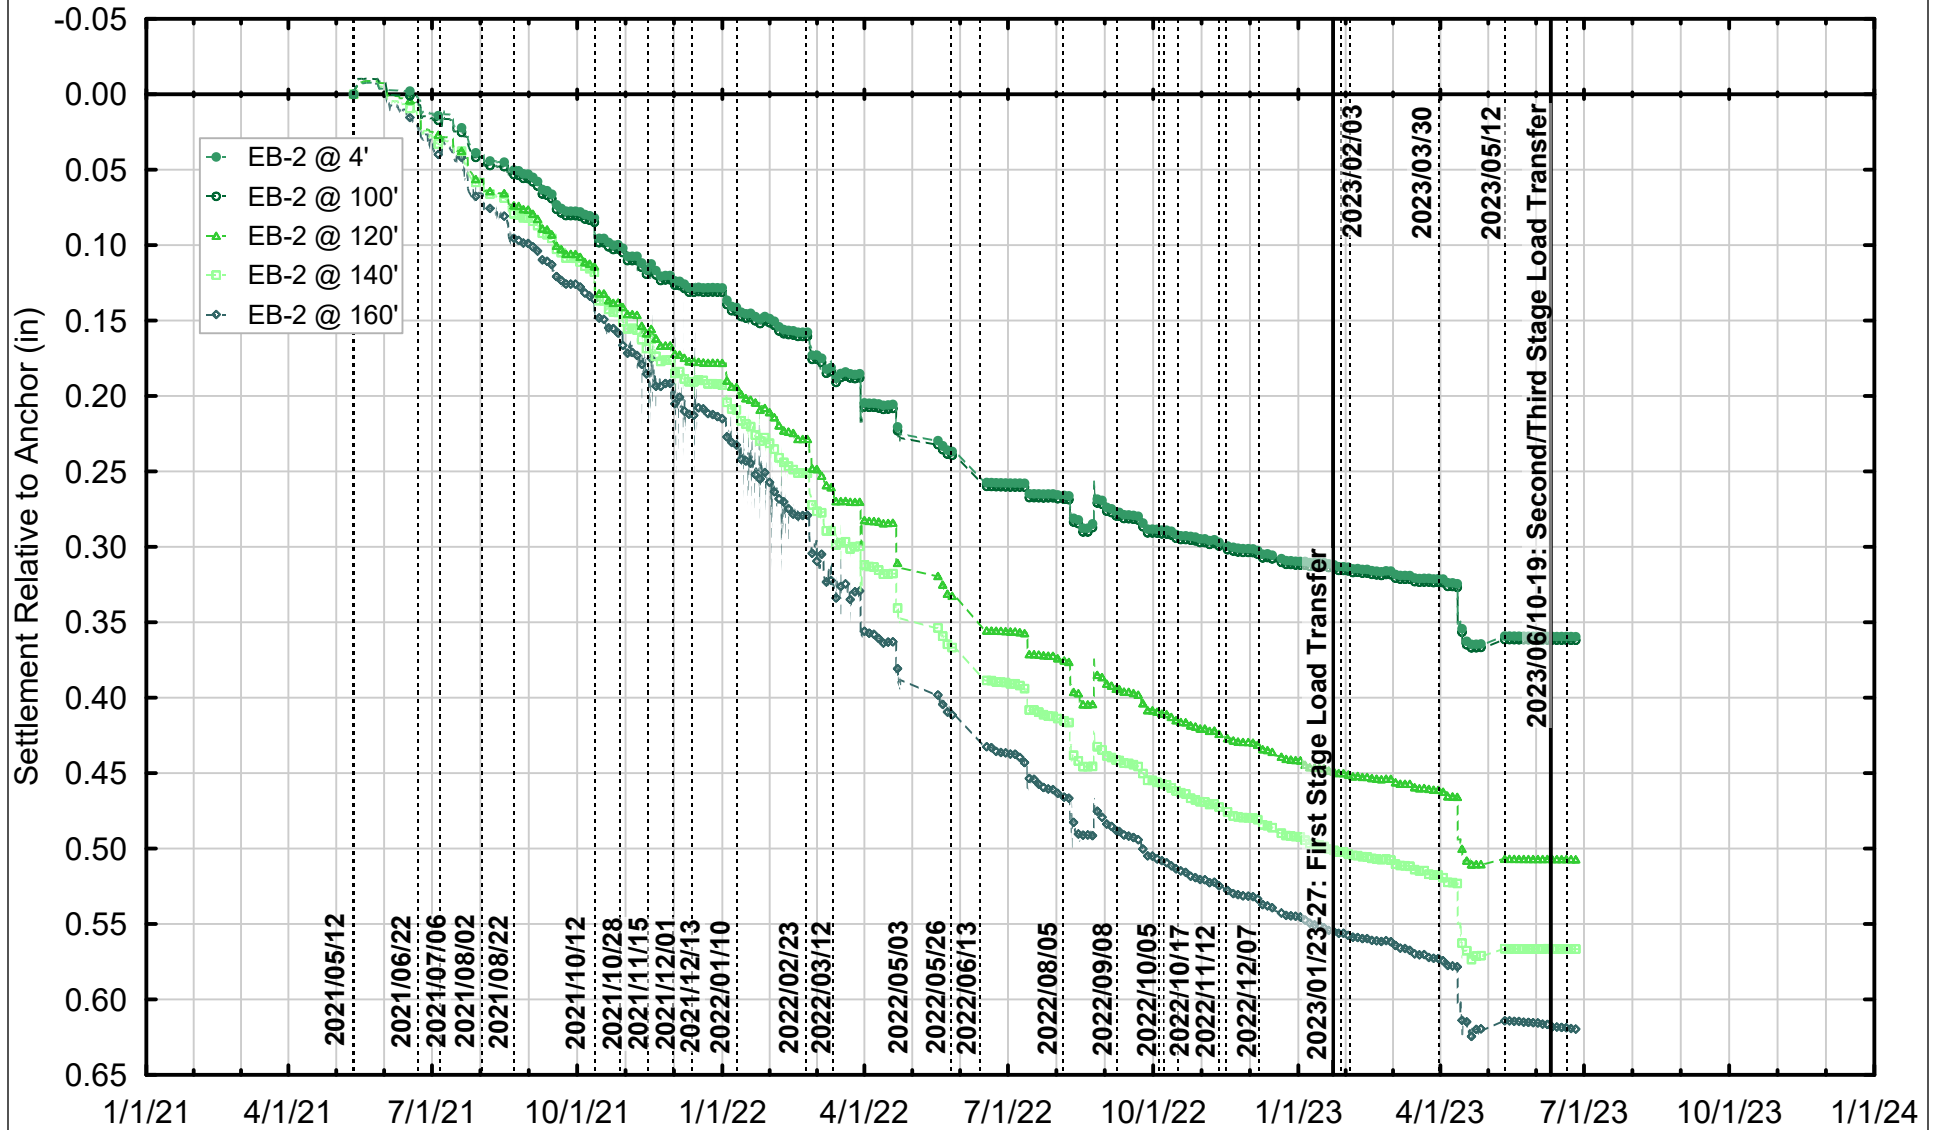
Project No: 19-009.00	Date: 7/6/2023	Created By: NBW	Checked By: DGM	Figure No: 113-12A
-----------------------	----------------	-----------------	-----------------	--------------------

EXTENSOMETER DATA FROM MISSION STREET
SINCE 01/01/2021 THROUGH 06/27/2023

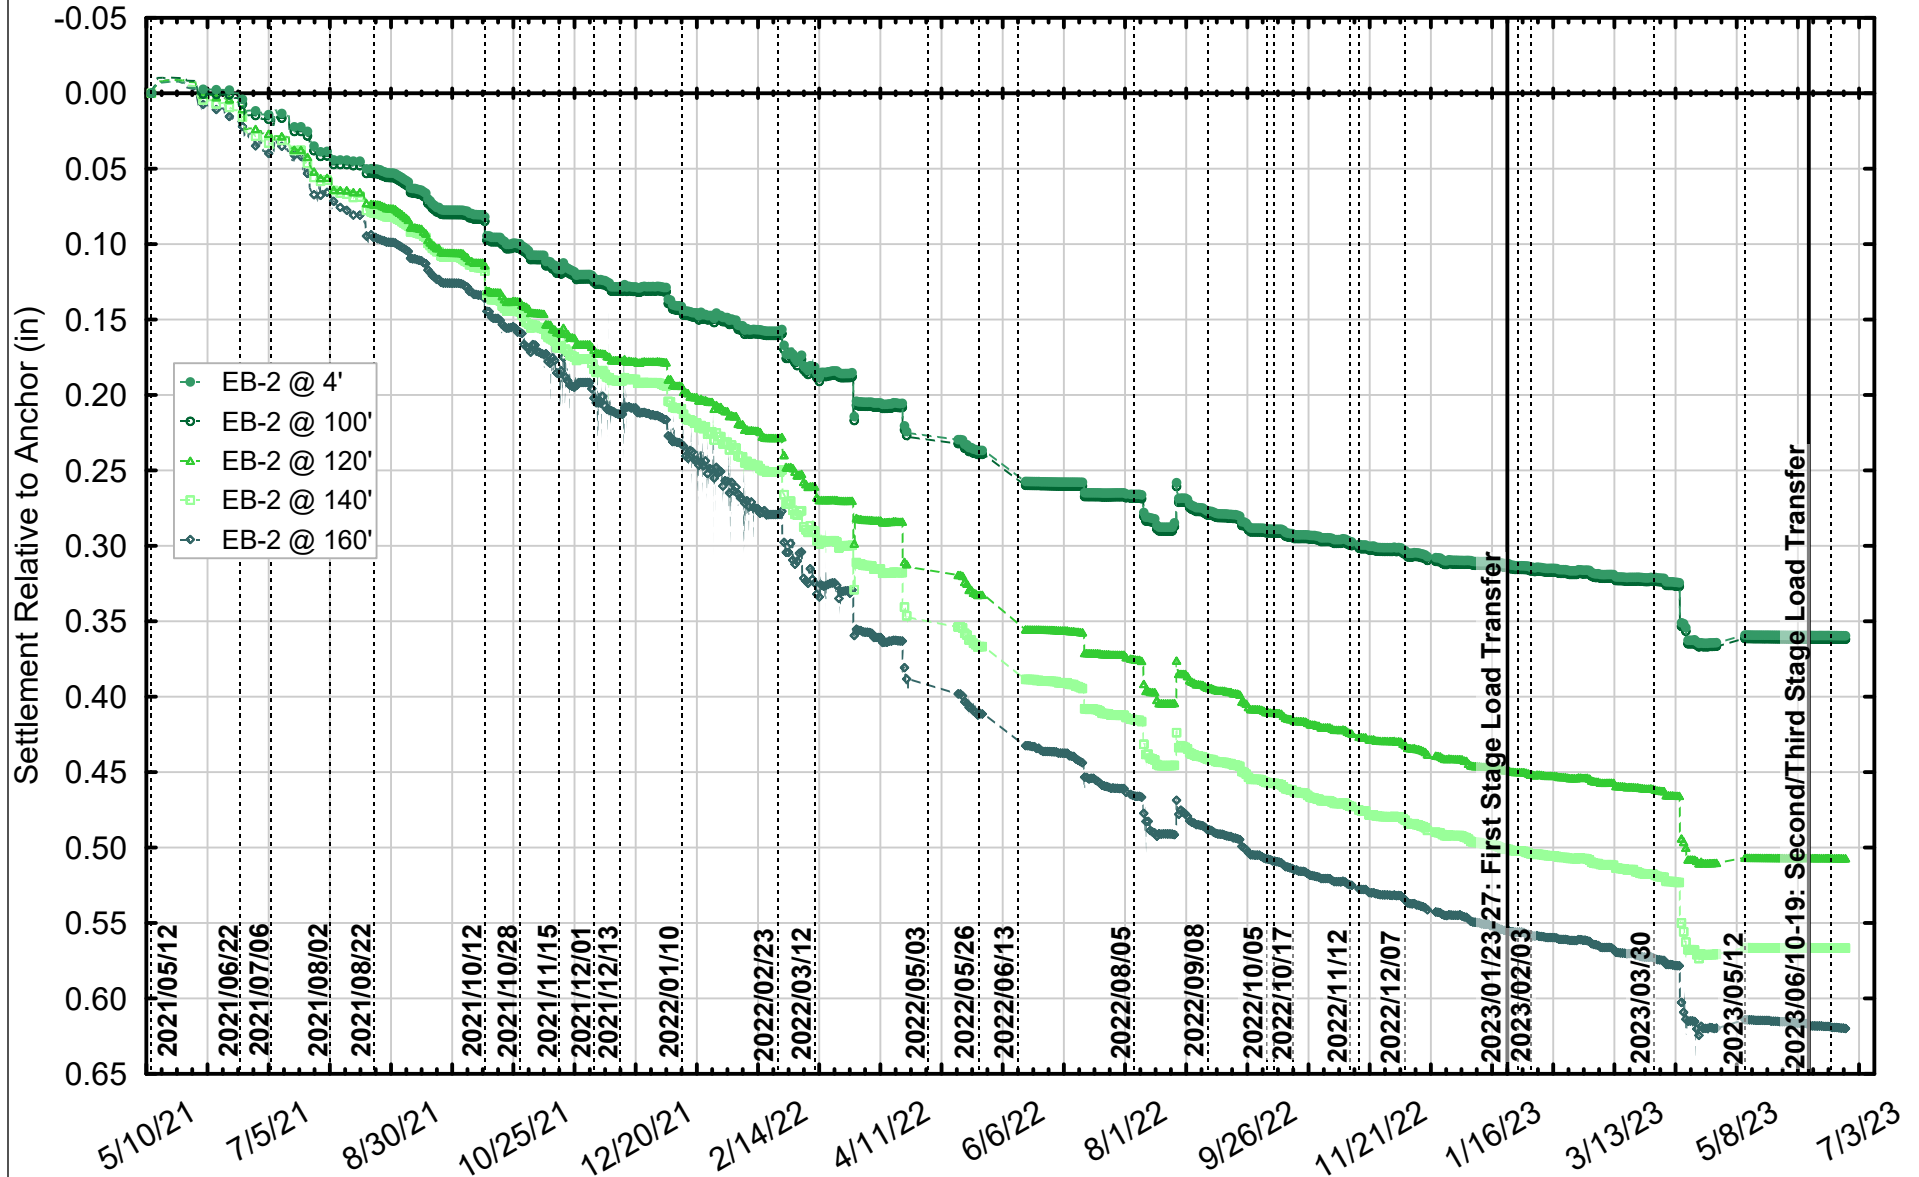
Project No: 19-009.00	Date: 7/6/2023	Created By: NBW	Checked By: DGM	Figure No: 113-12B
-----------------------	----------------	-----------------	-----------------	--------------------

EXTENSOMETER DATA FROM MISSION STREET
SINCE 05/10/2021 THROUGH 06/27/2023
