Subject: 301 Mission Retrofit Monitoring Report 113: Results as of July 5, 2023

This memorandum summarizes results from the monitoring plan implemented at the 301 Mission property. Instrumentation to monitor the structure prior to, during and after the retrofit was installed in January 2021, including piezometers and extensometers. Settlement markers installed in April 2009 and January 2017, survey prisms mounted on the exterior of the structure in December 2016, and crack gauges installed in April 2009 have also been monitored. Pile load cells were installed on the Mission Street piles in January 2023. Survey markers were installed on the Mission Street mat extension in January 2023, prior to the Stage 1 load transfer and on the Fremont Street mat extensions in June 2023, prior to the Stages 2 and 3 load transfer. This memorandum is for review only. It only contains ongoing monitoring information. This memorandum does not contain recommendations based upon the ongoing monitoring information.

Millennium Tower Perimeter Pile Upgrade: Instrumentation Monitoring Data
City and County of San Francisco, California

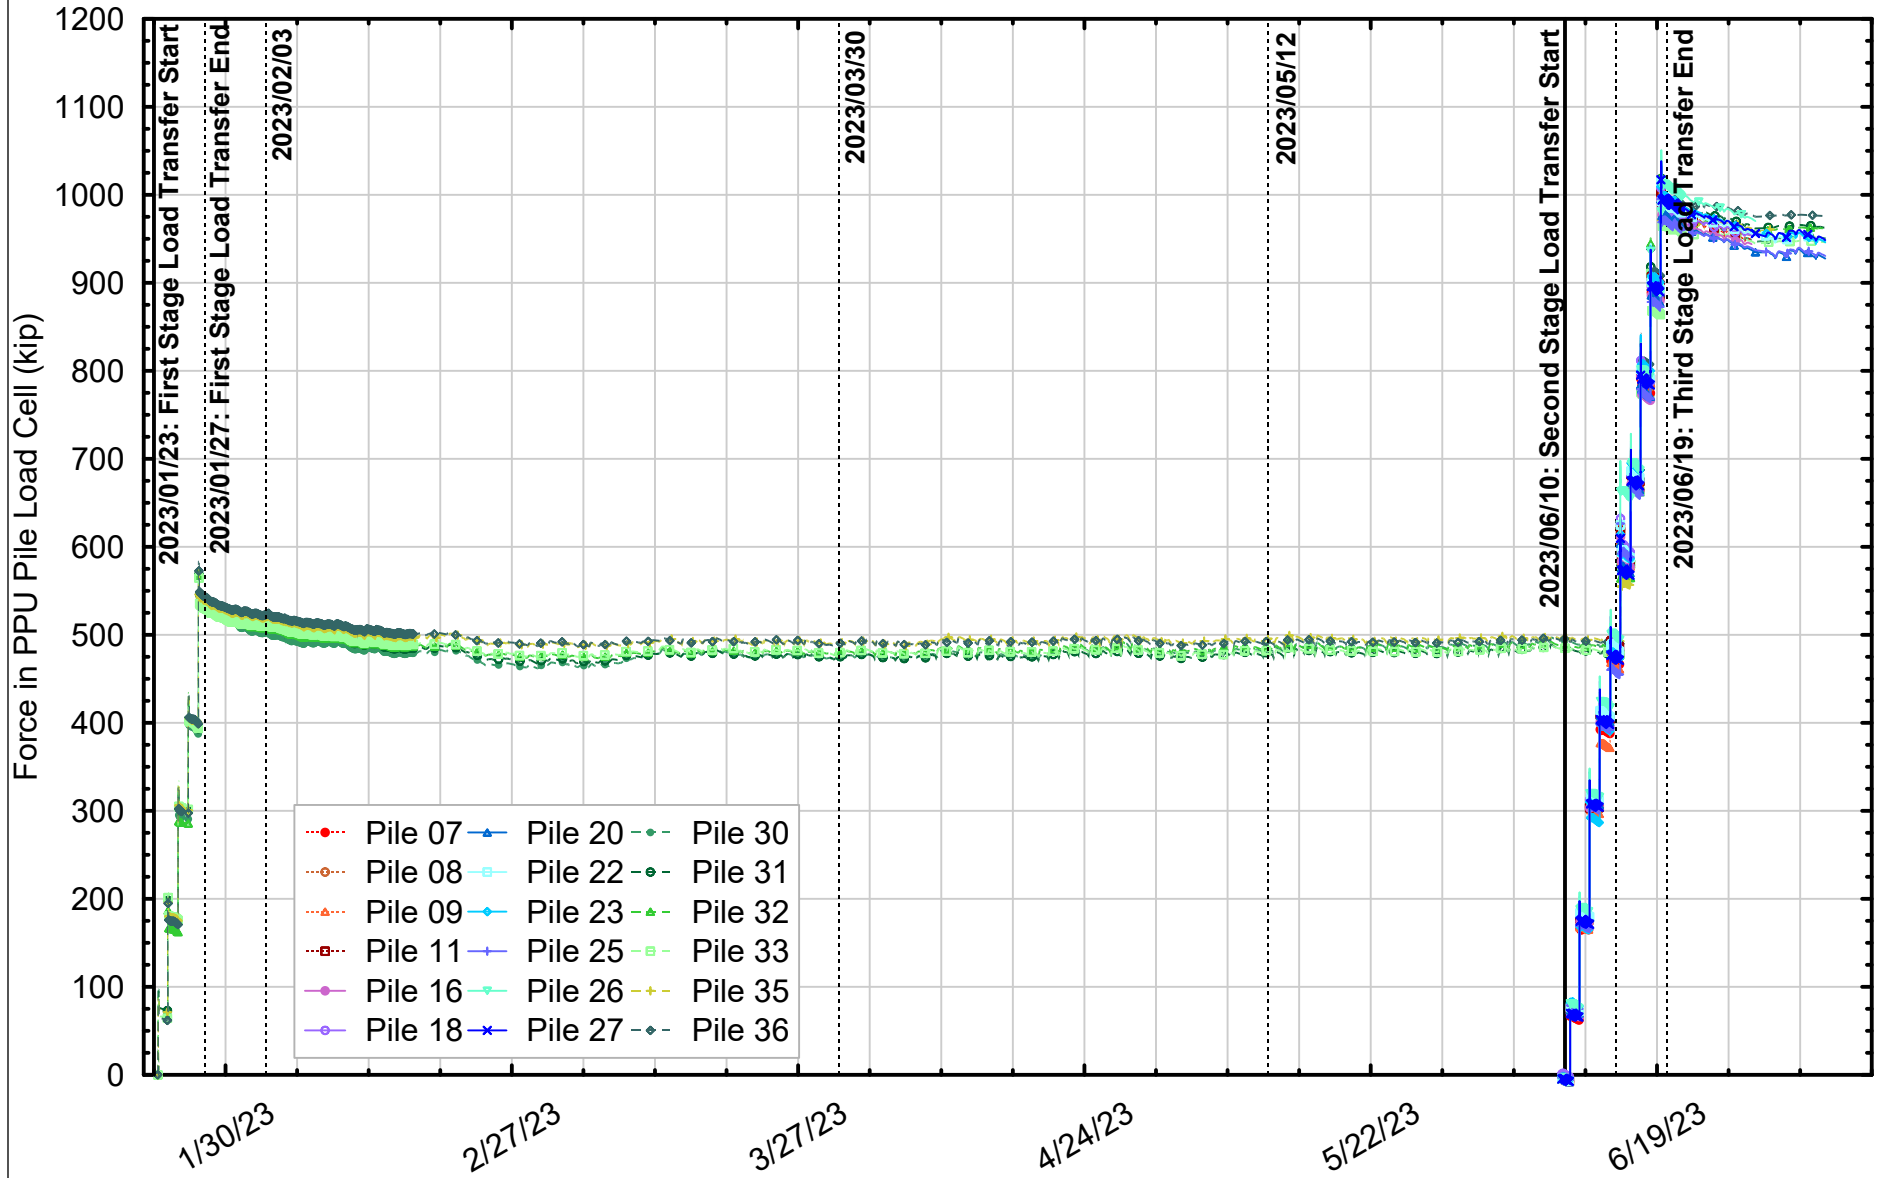
Project No: 19-009.00	Date: 7/6/2023	Created By: NBW	Checked By: DGM	Figure No: 113-13
-----------------------	----------------	-----------------	-----------------	-------------------

Figure 13 presents pile load cell data since the start of the First Stage Load Transfer (January 23, 2023) through July 5, 2023.

PILE LOAD CELL DATA
SINCE 01/23/2023 THROUGH 07/05/2023
