Subject: 301 Mission Retrofit Monitoring Report 116: Results as of July 24, 2023

This memorandum summarizes results from the monitoring plan implemented at the 301 Mission property. Instrumentation to monitor the structure prior to, during and after the retrofit was installed in January 2021, including piezometers and extensometers. Settlement markers installed in April 2009 and January 2017, survey prisms mounted on the exterior of the structure in December 2016, and crack gauges installed in April 2009 have also been monitored. Pile load cells were installed on the Mission Street piles in January 2023. Survey markers were installed on the Mission Street mat extension in January 2023, prior to the Stage 1 load transfer and on the Fremont Street mat extensions in June 2023, prior to the Stages 2 and 3 load transfer. This memorandum is for review only. It only contains ongoing monitoring information. This memorandum does not contain recommendations based upon the ongoing monitoring information.

Millennium Tower Perimeter Pile Upgrade: Instrumentation Monitoring Data  
City and County of San Francisco, California

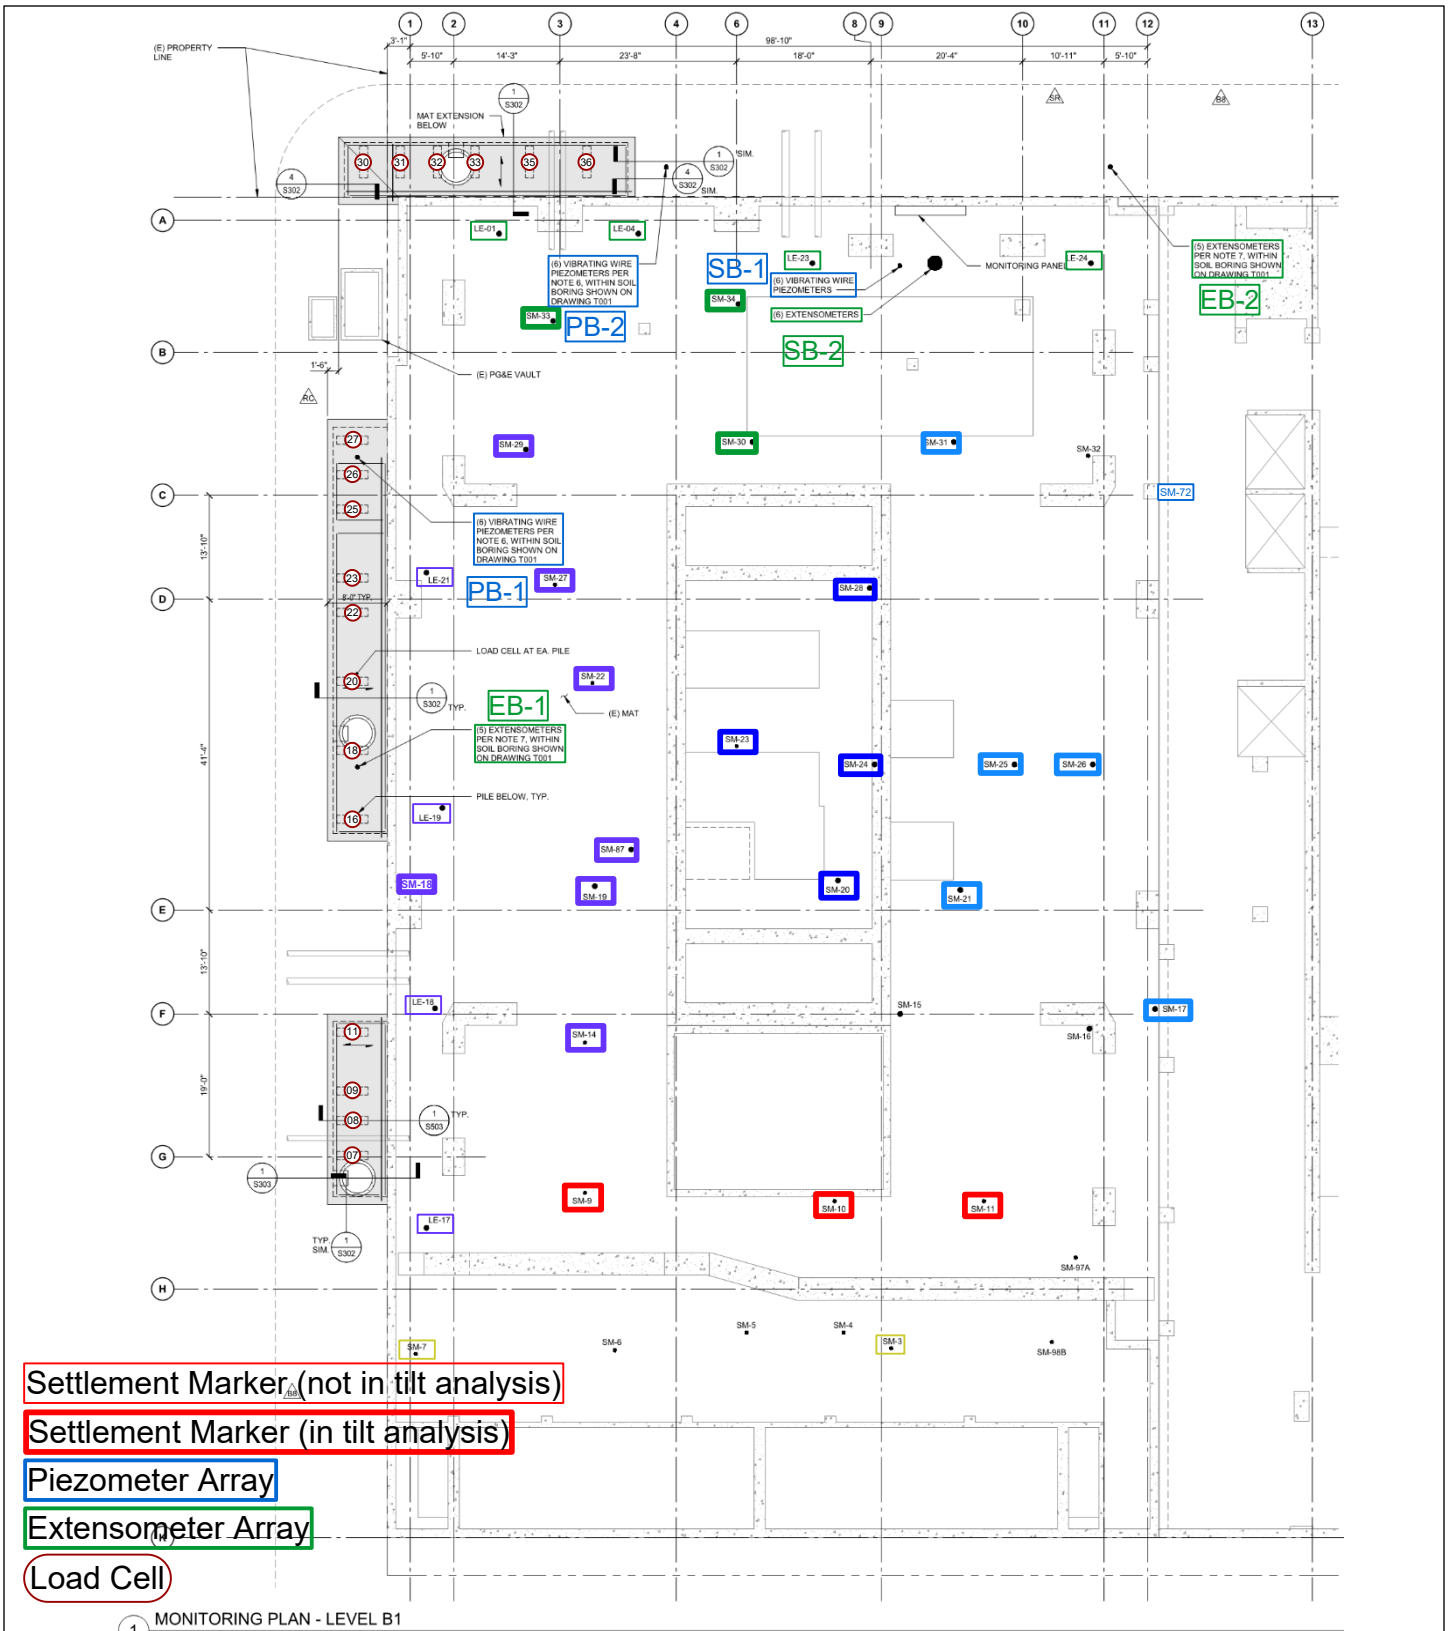
Project No: 19-009.00	Date: 6/28/2023	Created By: NBW	Checked By: DGM	Figure No: 116-01A
-----------------------	-----------------	-----------------	-----------------	--------------------

Figure 01 presents the instrument locations as referenced in later figures.

INSTRUMENT LOCATION MAP  
SETTLEMENT MARKERS, PIEZOMETERS, EXTENSOMETERS, LOAD CELLS

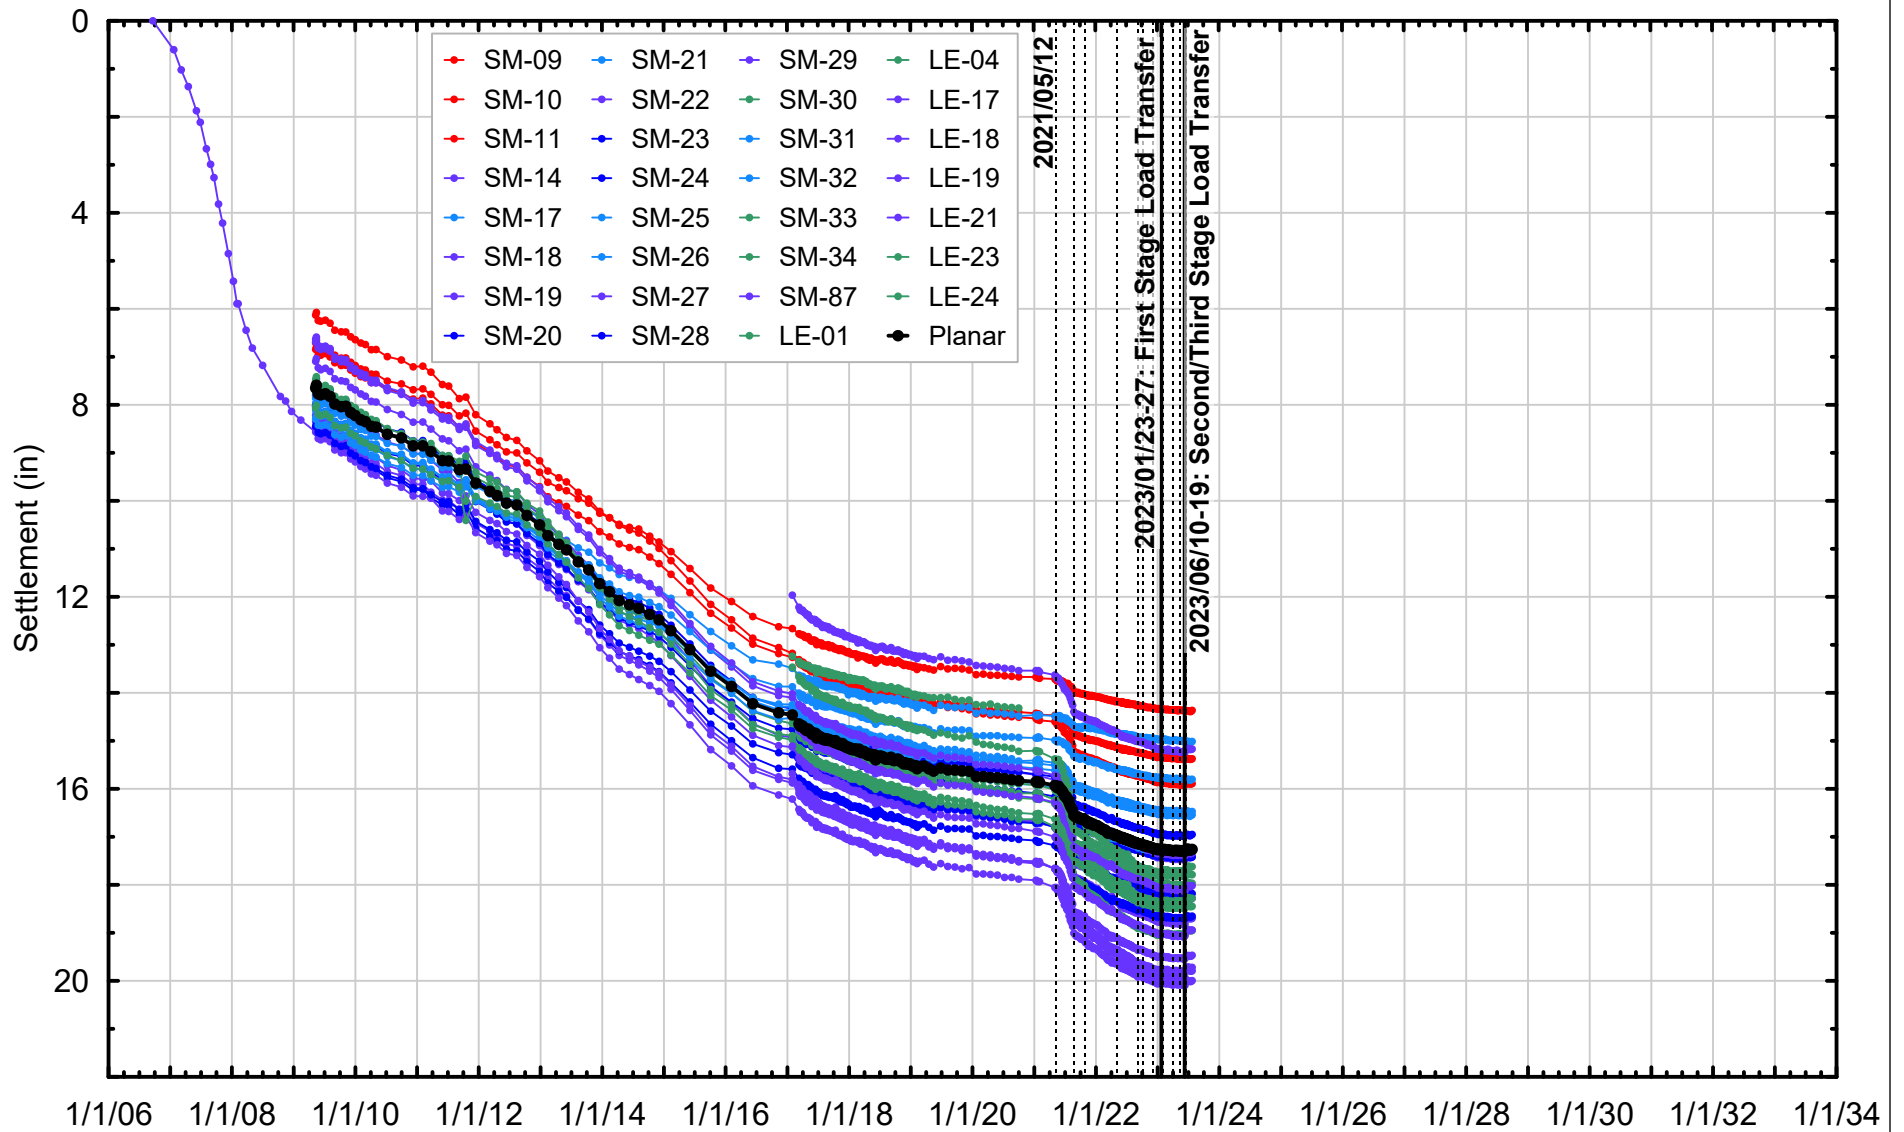
Project No: 19-009.00	Date: 7/25/2023	Created By: NBW	Checked By: DGM	Figure No: <b>116-02</b>
-----------------------	-----------------	-----------------	-----------------	--------------------------

Figure 02 presents the historical settlement data interpreted from settlement markers installed on the B-1 Level of 301 Mission Tower. In addition, data from surveys performed during the retrofit are included. Figure 03A presents settlement data since the start of production pile installation (May 12, 2021; baseline readings on May 10, 2021) through July 24, 2023. Figure 03B presents settlement data since January 11, 2021, through July 24, 2023. Figure 04 presents current settlement contours (in inches) on July 24, 2023.

HISTORICAL SETTLEMENT MARKER DATA

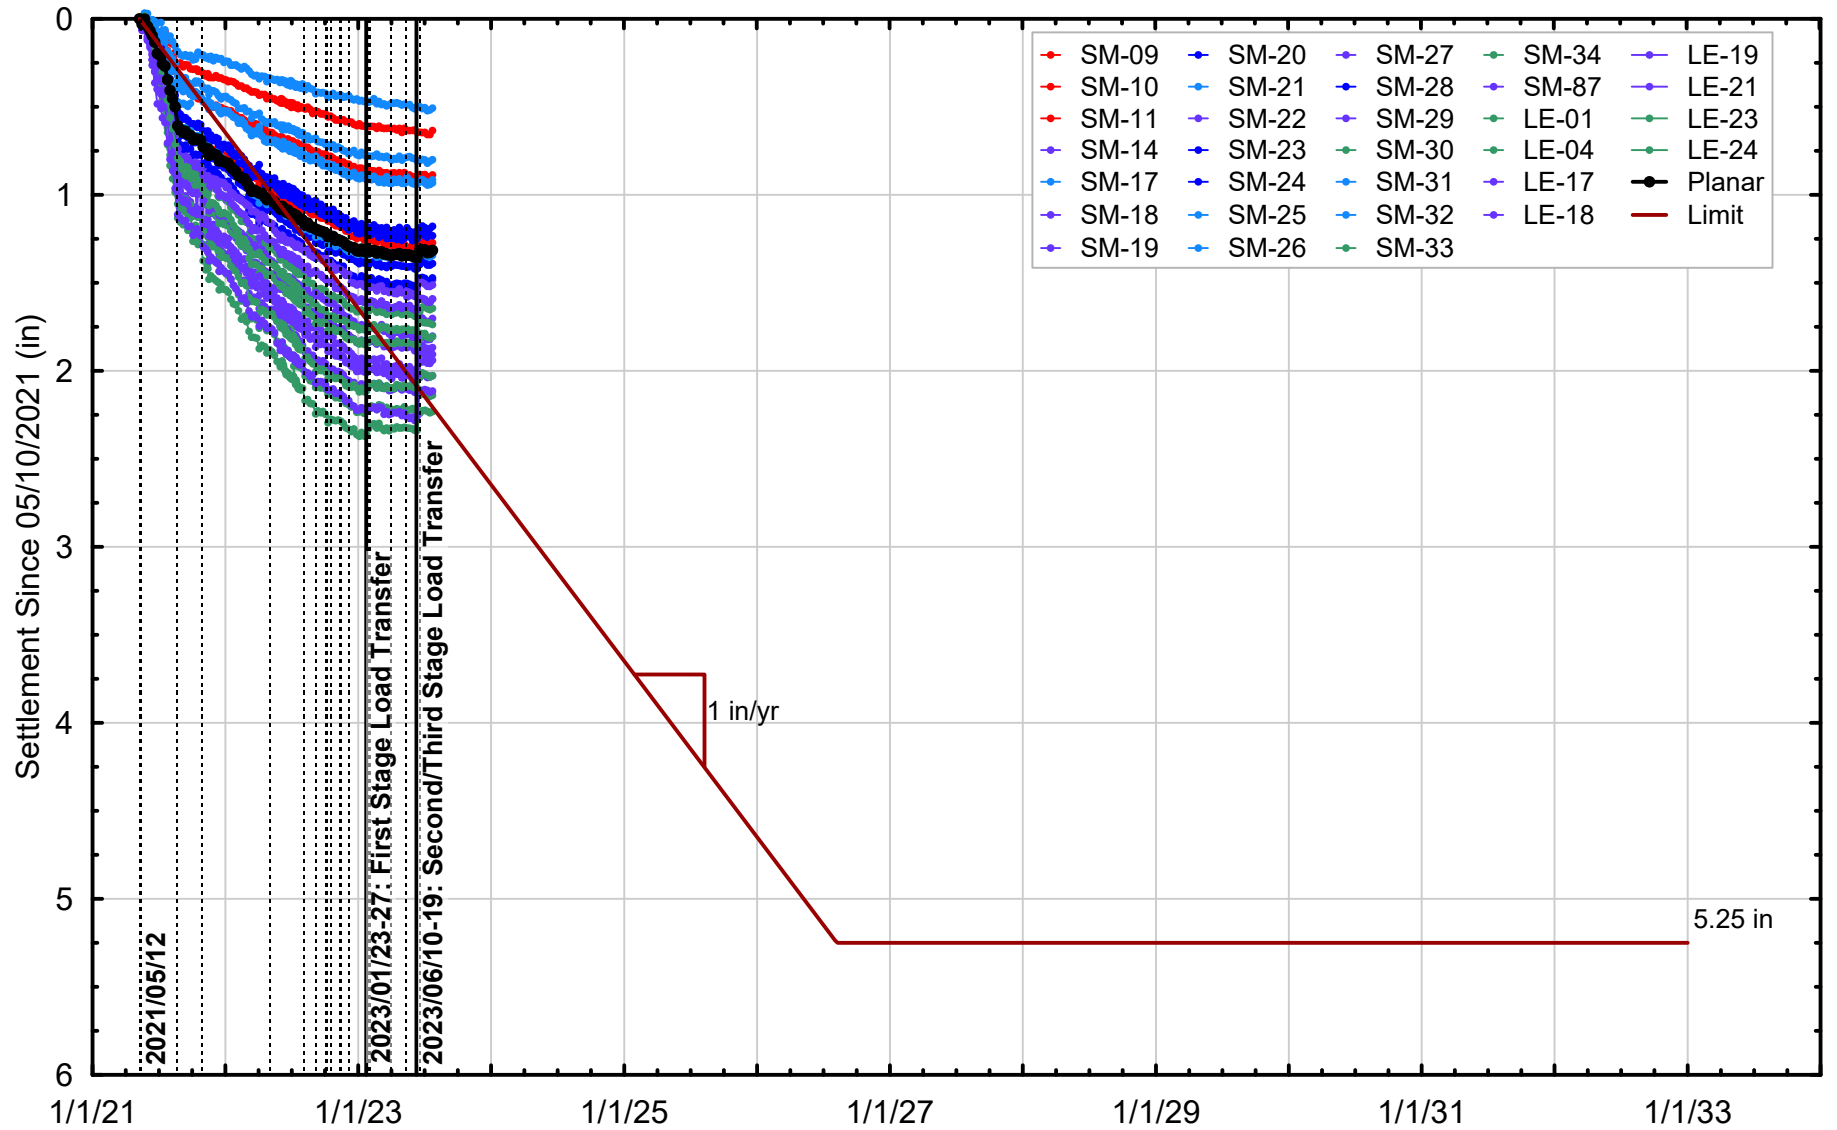
Figure No: 116-03A

SETTLEMENT MARKER DATA  
SINCE 05/10/2021 THROUGH 07/24/2023

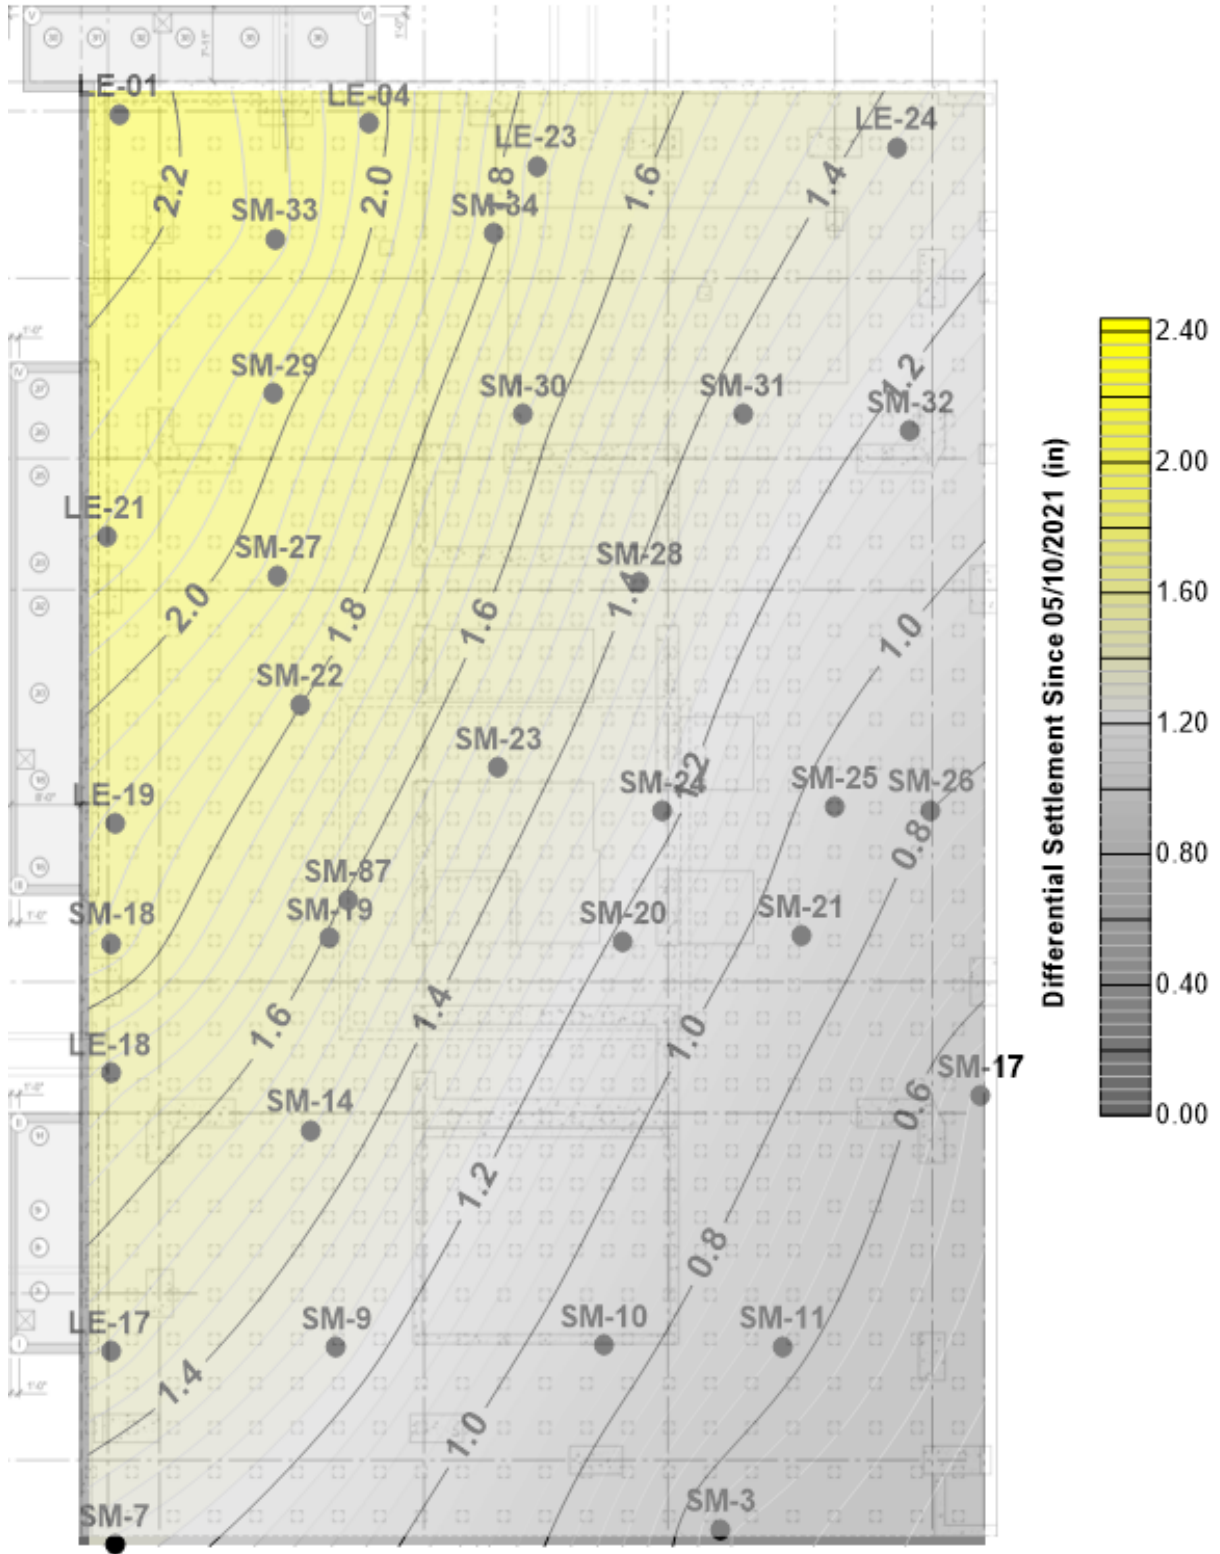
Figure No: 116-04

SETTLEMENT CONTOURS  
SINCE 05/10/2021 THROUGH 07/24/2023

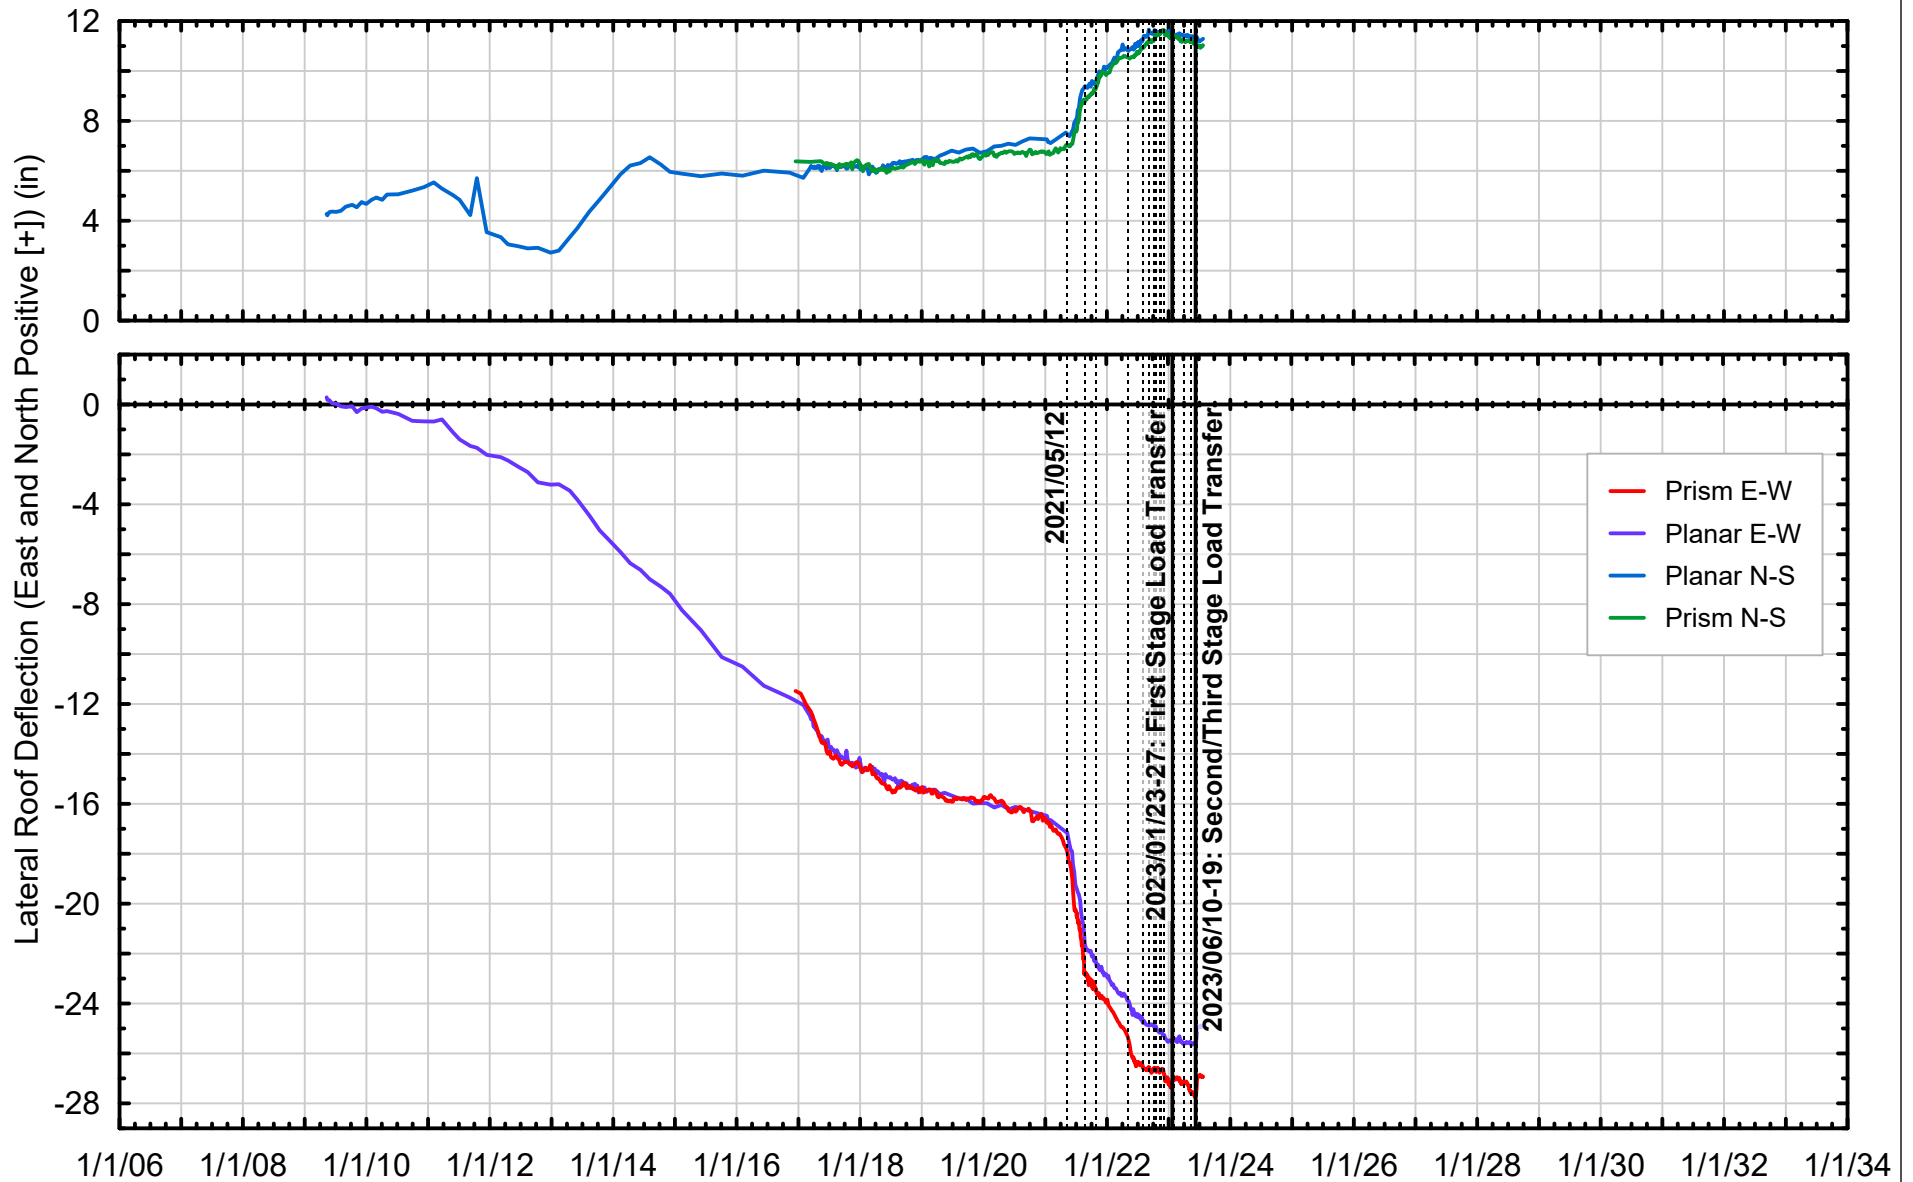
Project No: 19-009.00	Date: 7/25/2023	Created By: NBW	Checked By: DGM	Figure No: <b>116-05</b>
-----------------------	-----------------	-----------------	-----------------	--------------------------

Figure 05 presents historical lateral roof deflections in the project north-south and project east-west directions interpreted from survey prisms mounted on the exterior of the Tower, from InSAR data, and from a planar fit of the settlement marker data. In addition, data from surveys performed during the retrofit are included. Figure 06A presents lateral roof deflection data from a planar fit of the settlement marker data and from survey prisms mounted on the exterior of the Tower since the start of production pile installation (May 12, 2021; baseline readings on May 10 and 13, 2021, respectively) through July 24, 2023. Figure 06B presents lateral roof deflection data from a planar fit of the settlement marker data and from survey prisms mounted on the exterior of the Tower since January 11, 2021, through July 24, 2023.

HISTORICAL LATERAL ROOF DEFLECTION DATA

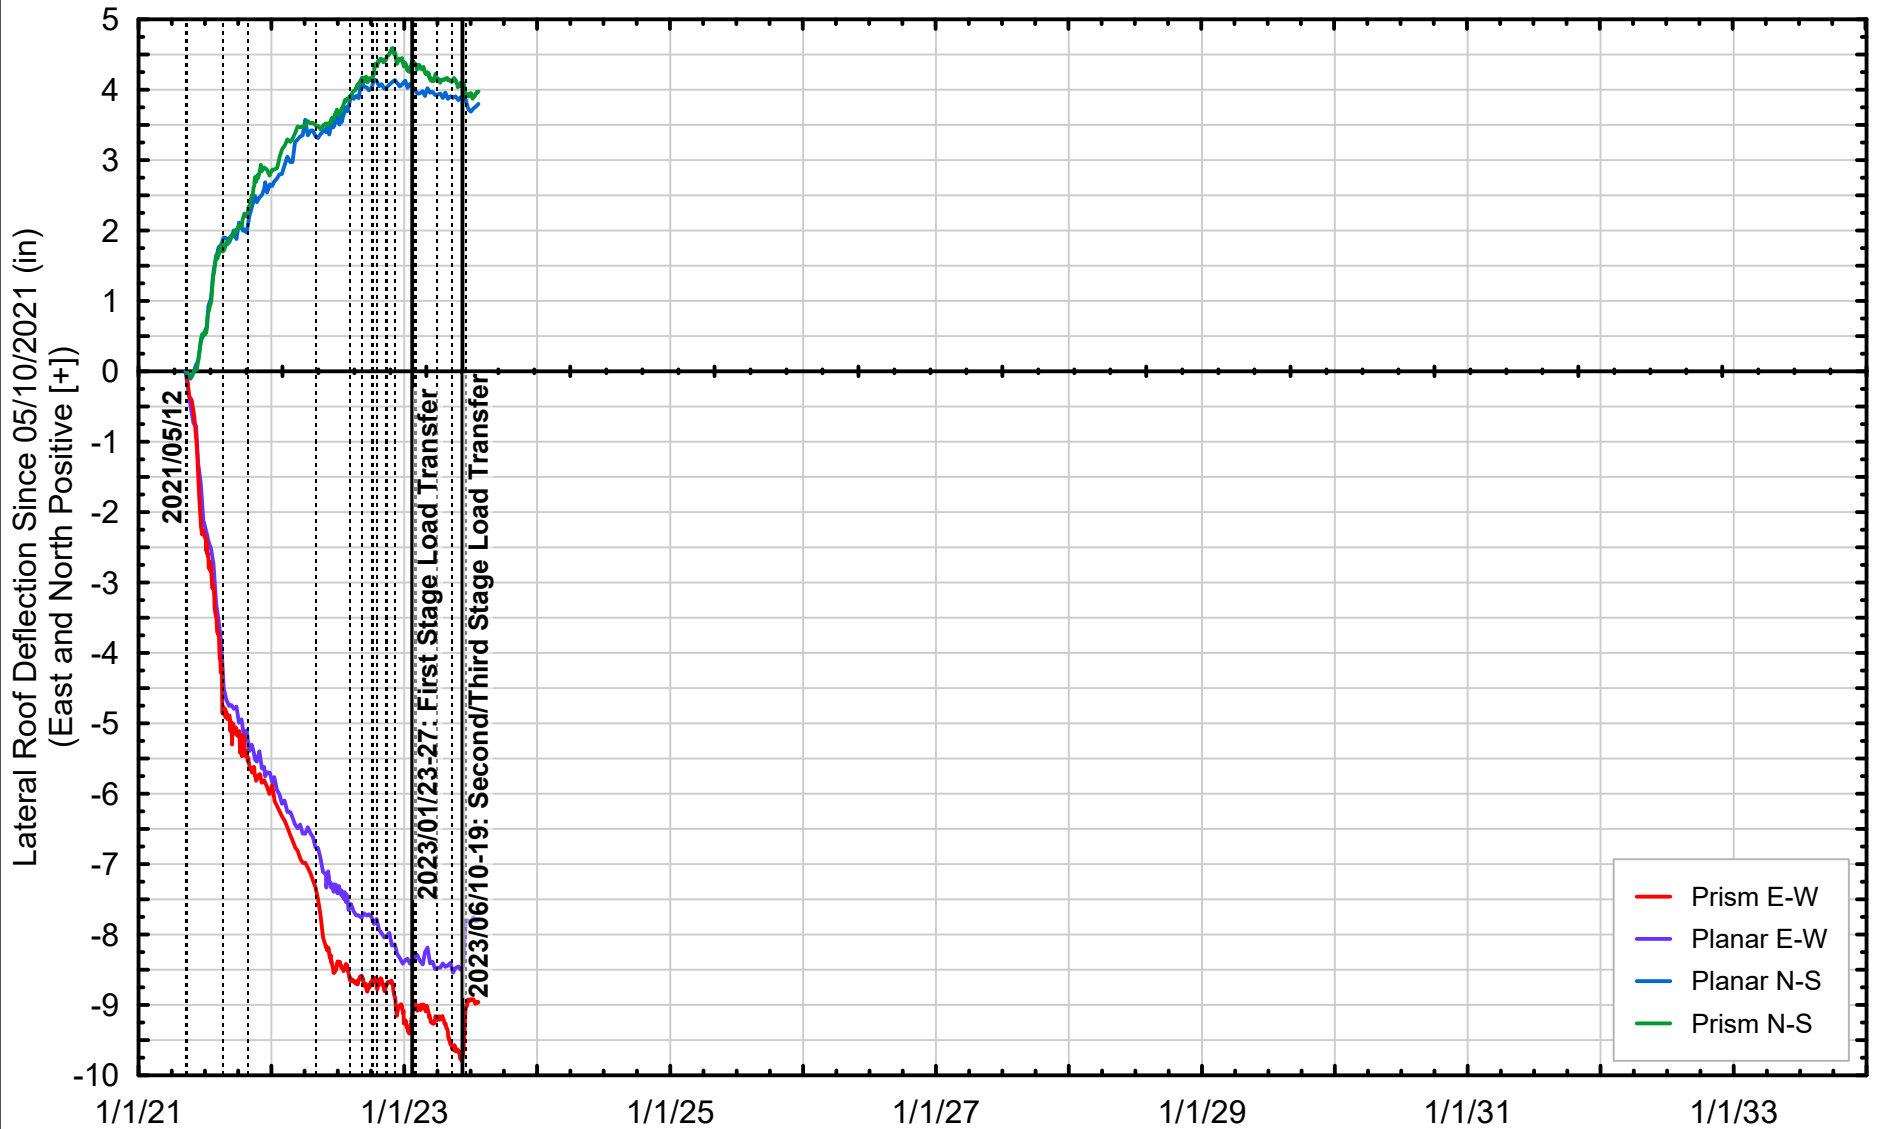
Figure No: 116-06A

LATERAL ROOF DEFLECTION DATA  
SINCE 05/10/2021 THROUGH 07/24/2023

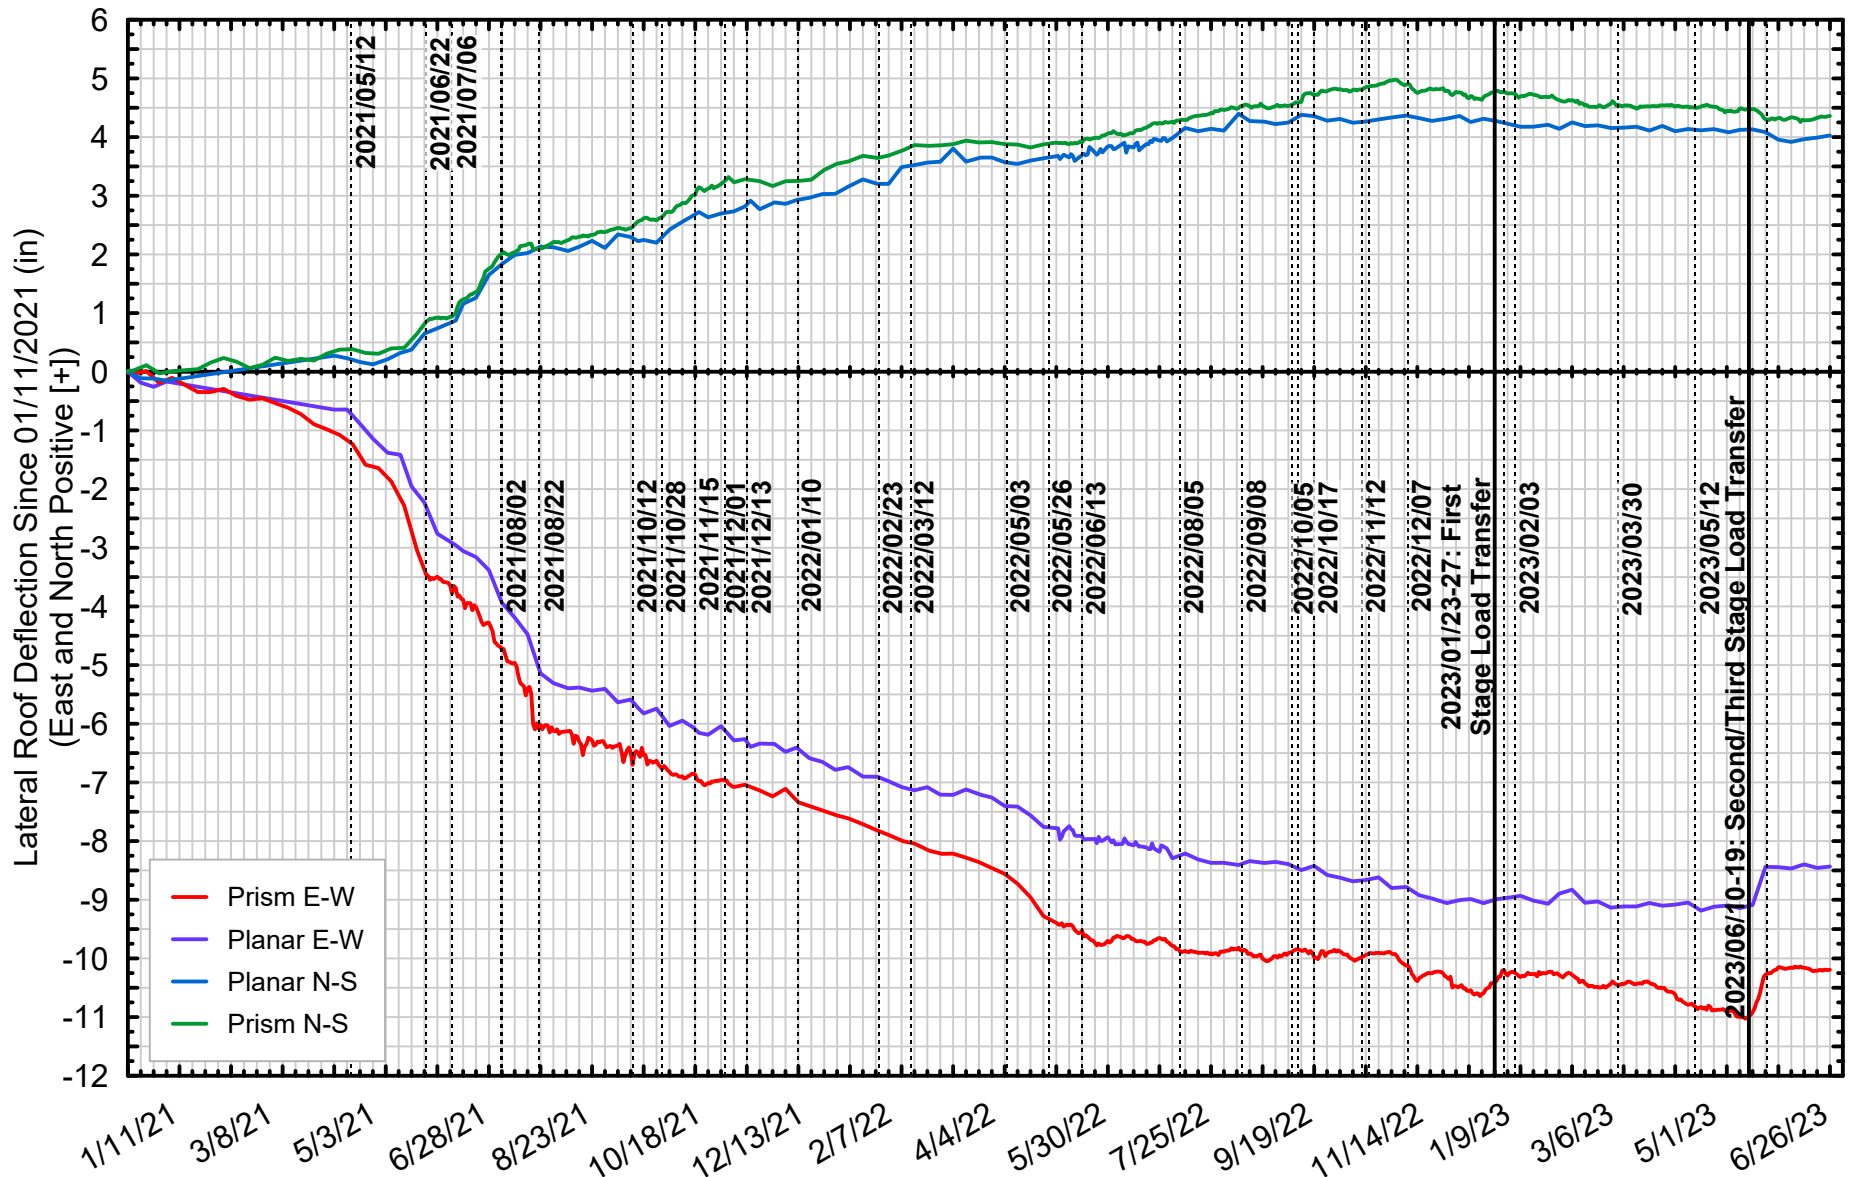
Project No: 19-009.00 | Date: 7/25/2023 | Created By: NBW | Checked By: DGM | Figure No: 116-06B

LATERAL ROOF DEFLECTION DATA  
SINCE 01/11/2021 THROUGH 07/24/2023

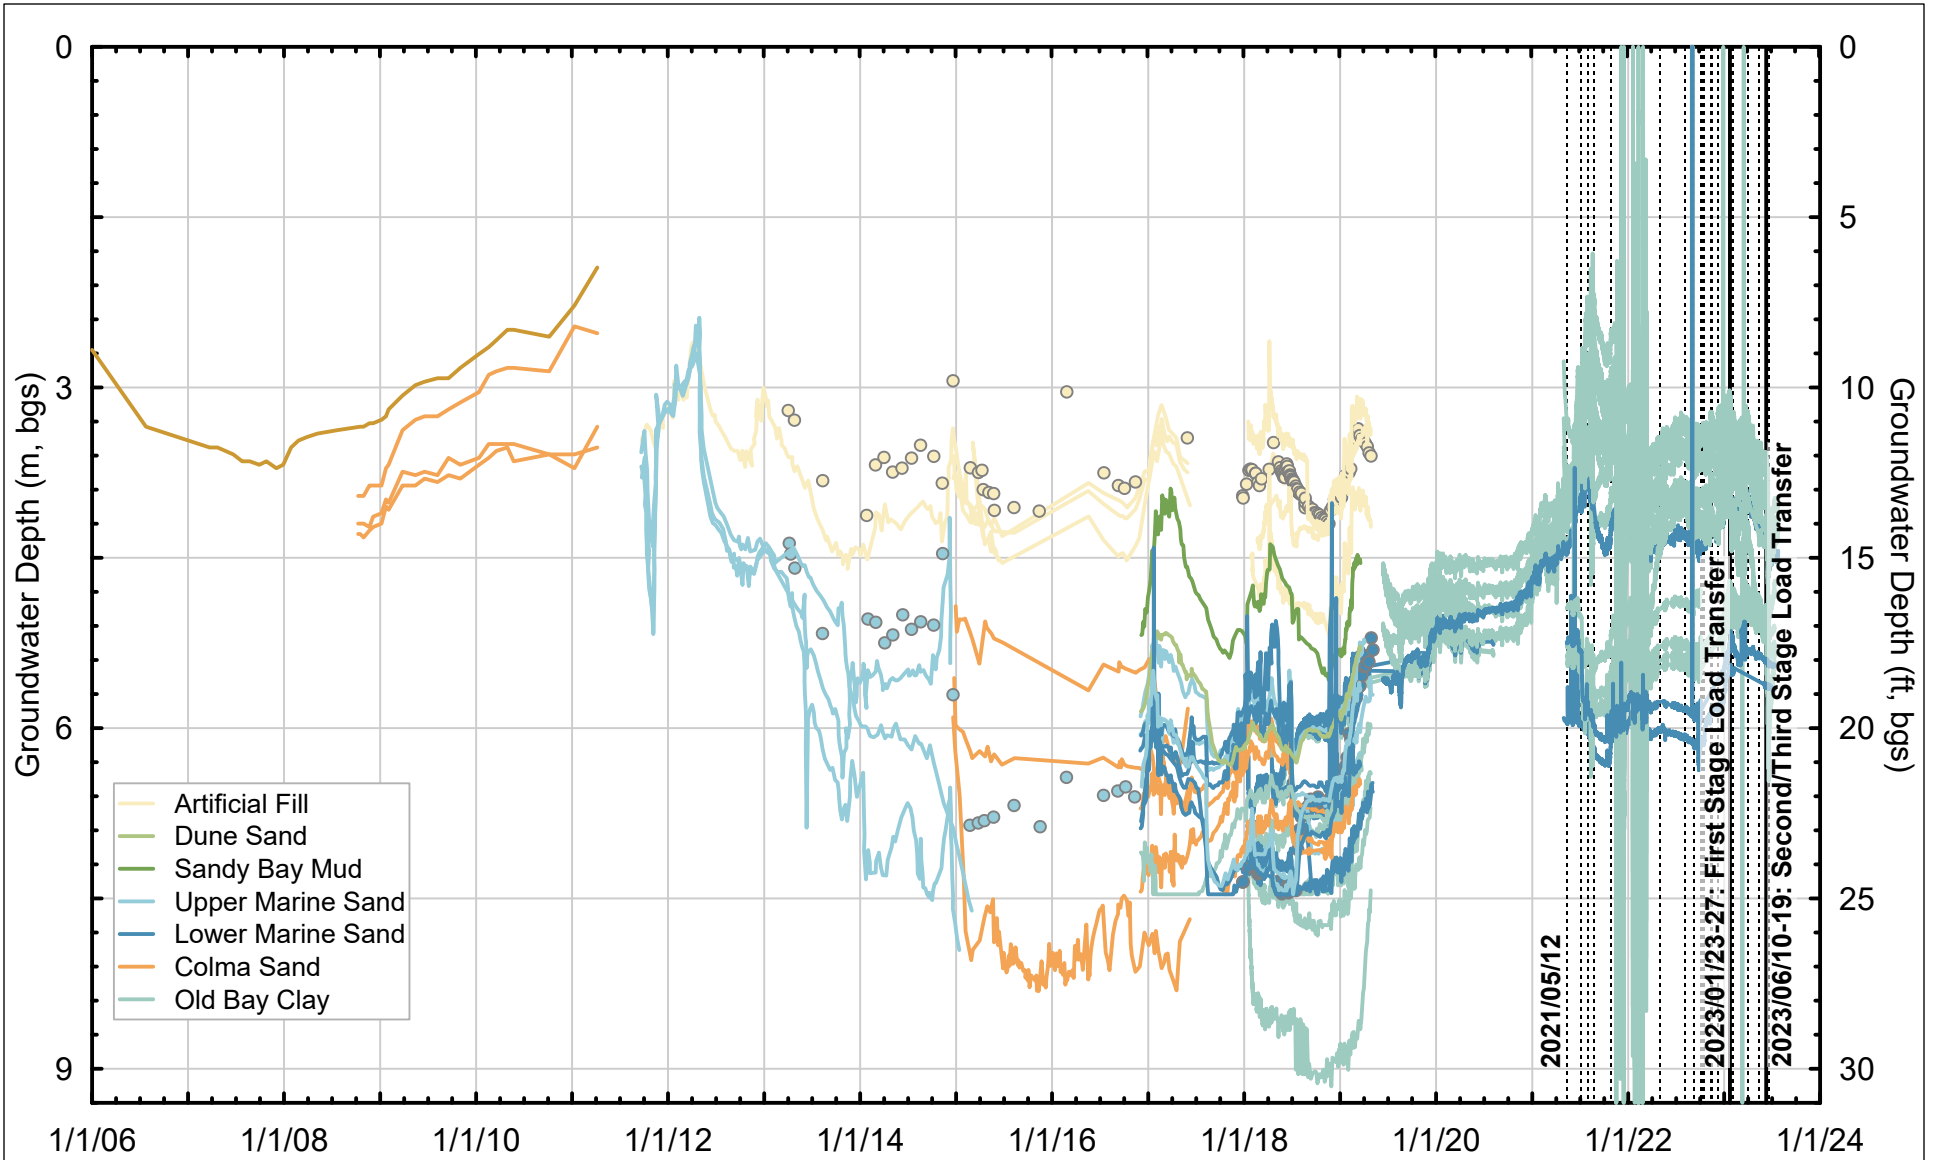
Project No: 19-009.00	Date: 7/25/2023	Created By: NBW	Checked By: DGM	Figure No: <b>116-07</b>
-----------------------	-----------------	-----------------	-----------------	--------------------------

Figure 07 presents the historical groundwater elevation interpreted from piezometer readings at locations near 301 Mission. In addition, data from piezometers installed to monitor groundwater elevation during the retrofit are included. Figures 08 and 09 present groundwater elevation interpreted from piezometer readings in the Marine/Colma Sand and the Old Bay Clay, respectively, for the time period prior to the start of production pile installation (January 1, 2021) through July 24, 2023.

HISTORICAL GROUNDWATER ELEVATION MEASUREMENTS  
AT LOCATIONS NEAR 301 MISSION

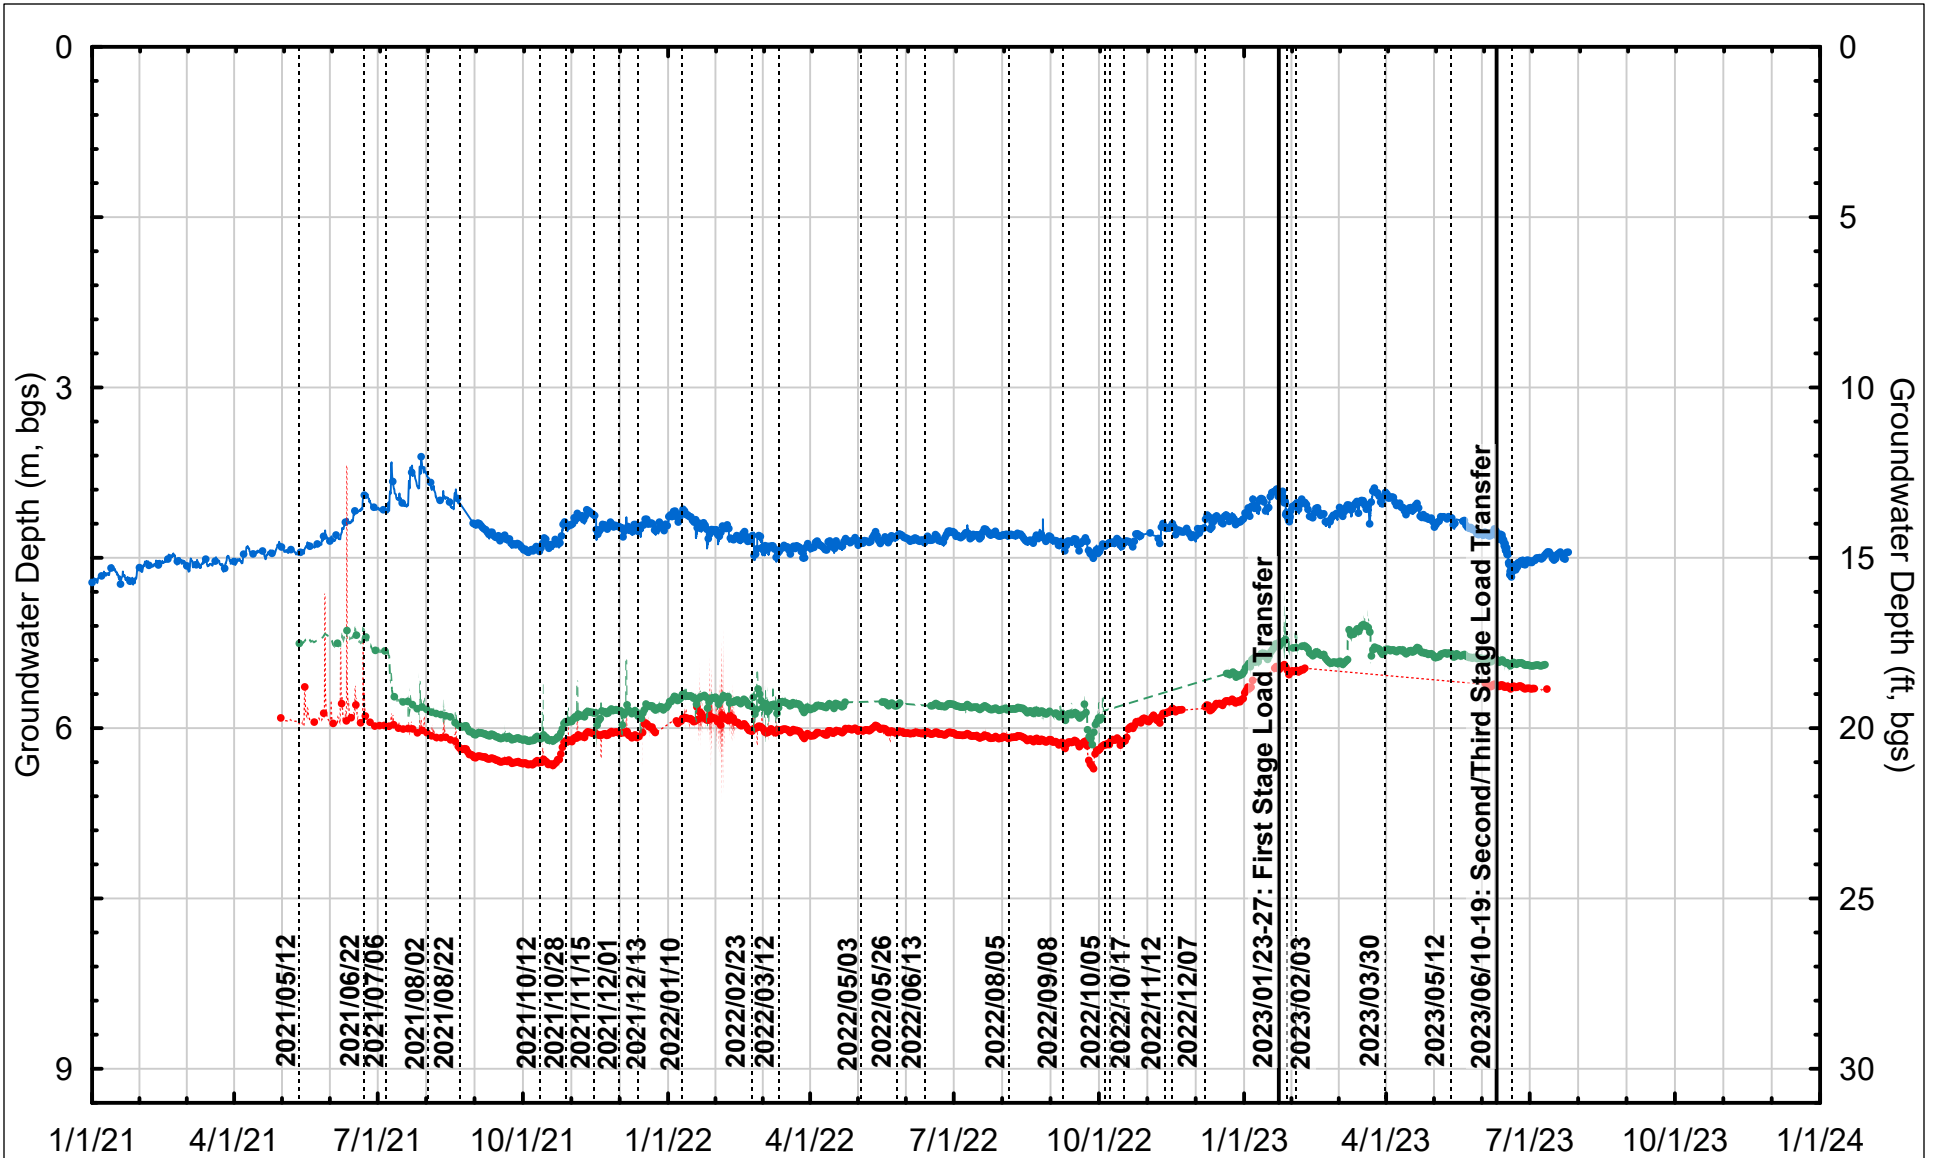
Project No: 19-009.00	Date: 7/25/2023	Created By: NBW	Checked By: DGM	Figure No: <b>116-08A</b>

GROUNDWATER ELEVATION MEASUREMENTS IN MARINE AND COLMA SAND SINCE 01/01/2021 THROUGH 07/24/2023		
		Millennium Tower Perimeter Pile Upgrade: Instrumentation Monitoring Data City and County of San Francisco, California

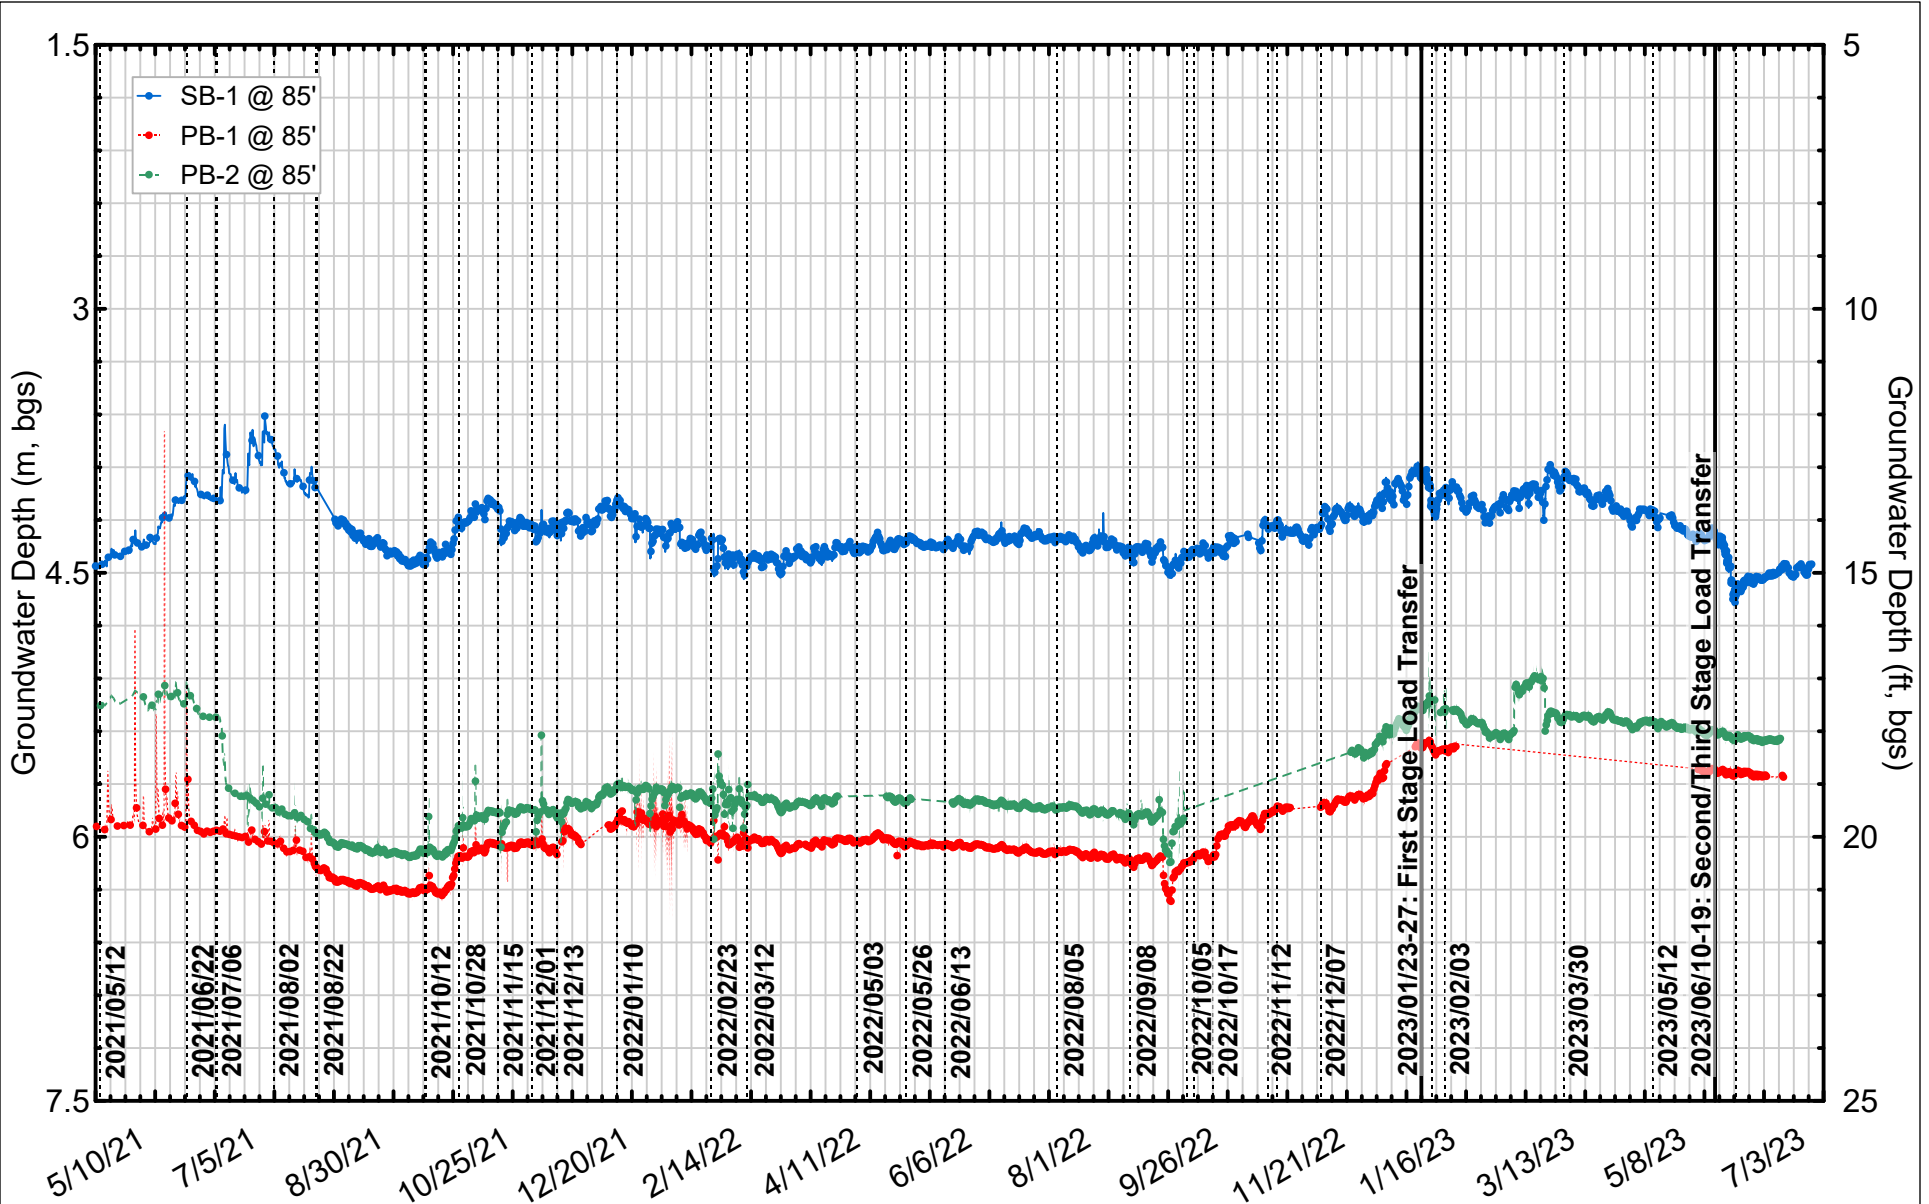
Project No: 19-009.00    Date: 7/25/2023    Created By: NBW    Checked By: DGM    Figure No: **116-08B**

GROUNDWATER ELEVATION MEASUREMENTS IN MARINE AND COLMA SAND  
SINCE 05/10/2021 THROUGH 07/24/2023
