Subject: 301 Mission Retrofit Monitoring Report 116: Results as of July 24, 2023

This memorandum summarizes results from the monitoring plan implemented at the 301 Mission property. Instrumentation to monitor the structure prior to, during and after the retrofit was installed in January 2021, including piezometers and extensometers. Settlement markers installed in April 2009 and January 2017, survey prisms mounted on the exterior of the structure in December 2016, and crack gauges installed in April 2009 have also been monitored. Pile load cells were installed on the Mission Street piles in January 2023. Survey markers were installed on the Mission Street mat extension in January 2023, prior to the Stage 1 load transfer and on the Fremont Street mat extensions in June 2023, prior to the Stages 2 and 3 load transfer. This memorandum is for review only. It only contains ongoing monitoring information. This memorandum does not contain recommendations based upon the ongoing monitoring information.

Millennium Tower Perimeter Pile Upgrade: Instrumentation Monitoring Data  
City and County of San Francisco, California

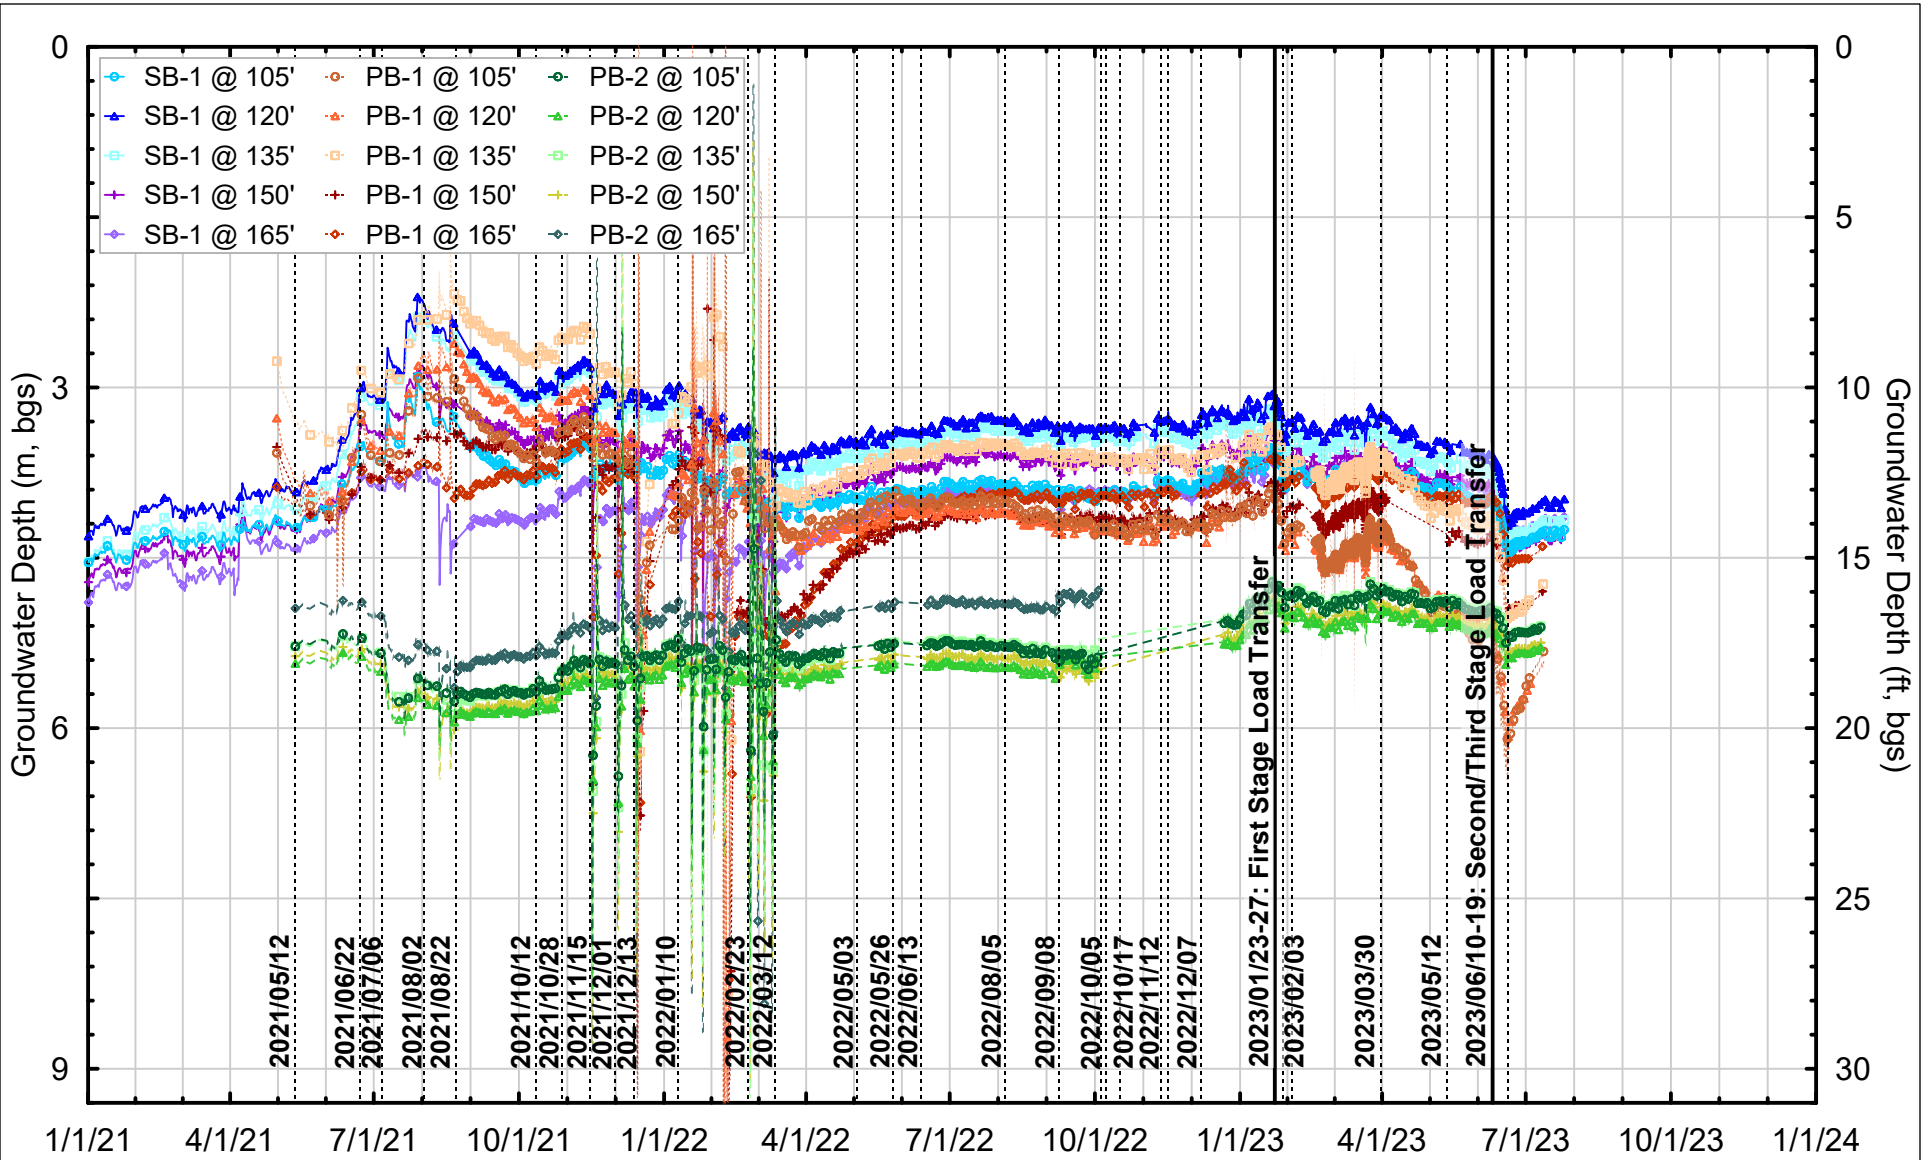
Project No: 19-009.00	Date: 7/25/2023	Created By: NBW	Checked By: DGM	Figure No: <b>116-09A</b>
-----------------------	-----------------	-----------------	-----------------	---------------------------

GROUNDWATER ELEVATION MEASUREMENTS IN OLD BAY CLAY  
 SINCE 01/01/2021 THROUGH 07/24/2023

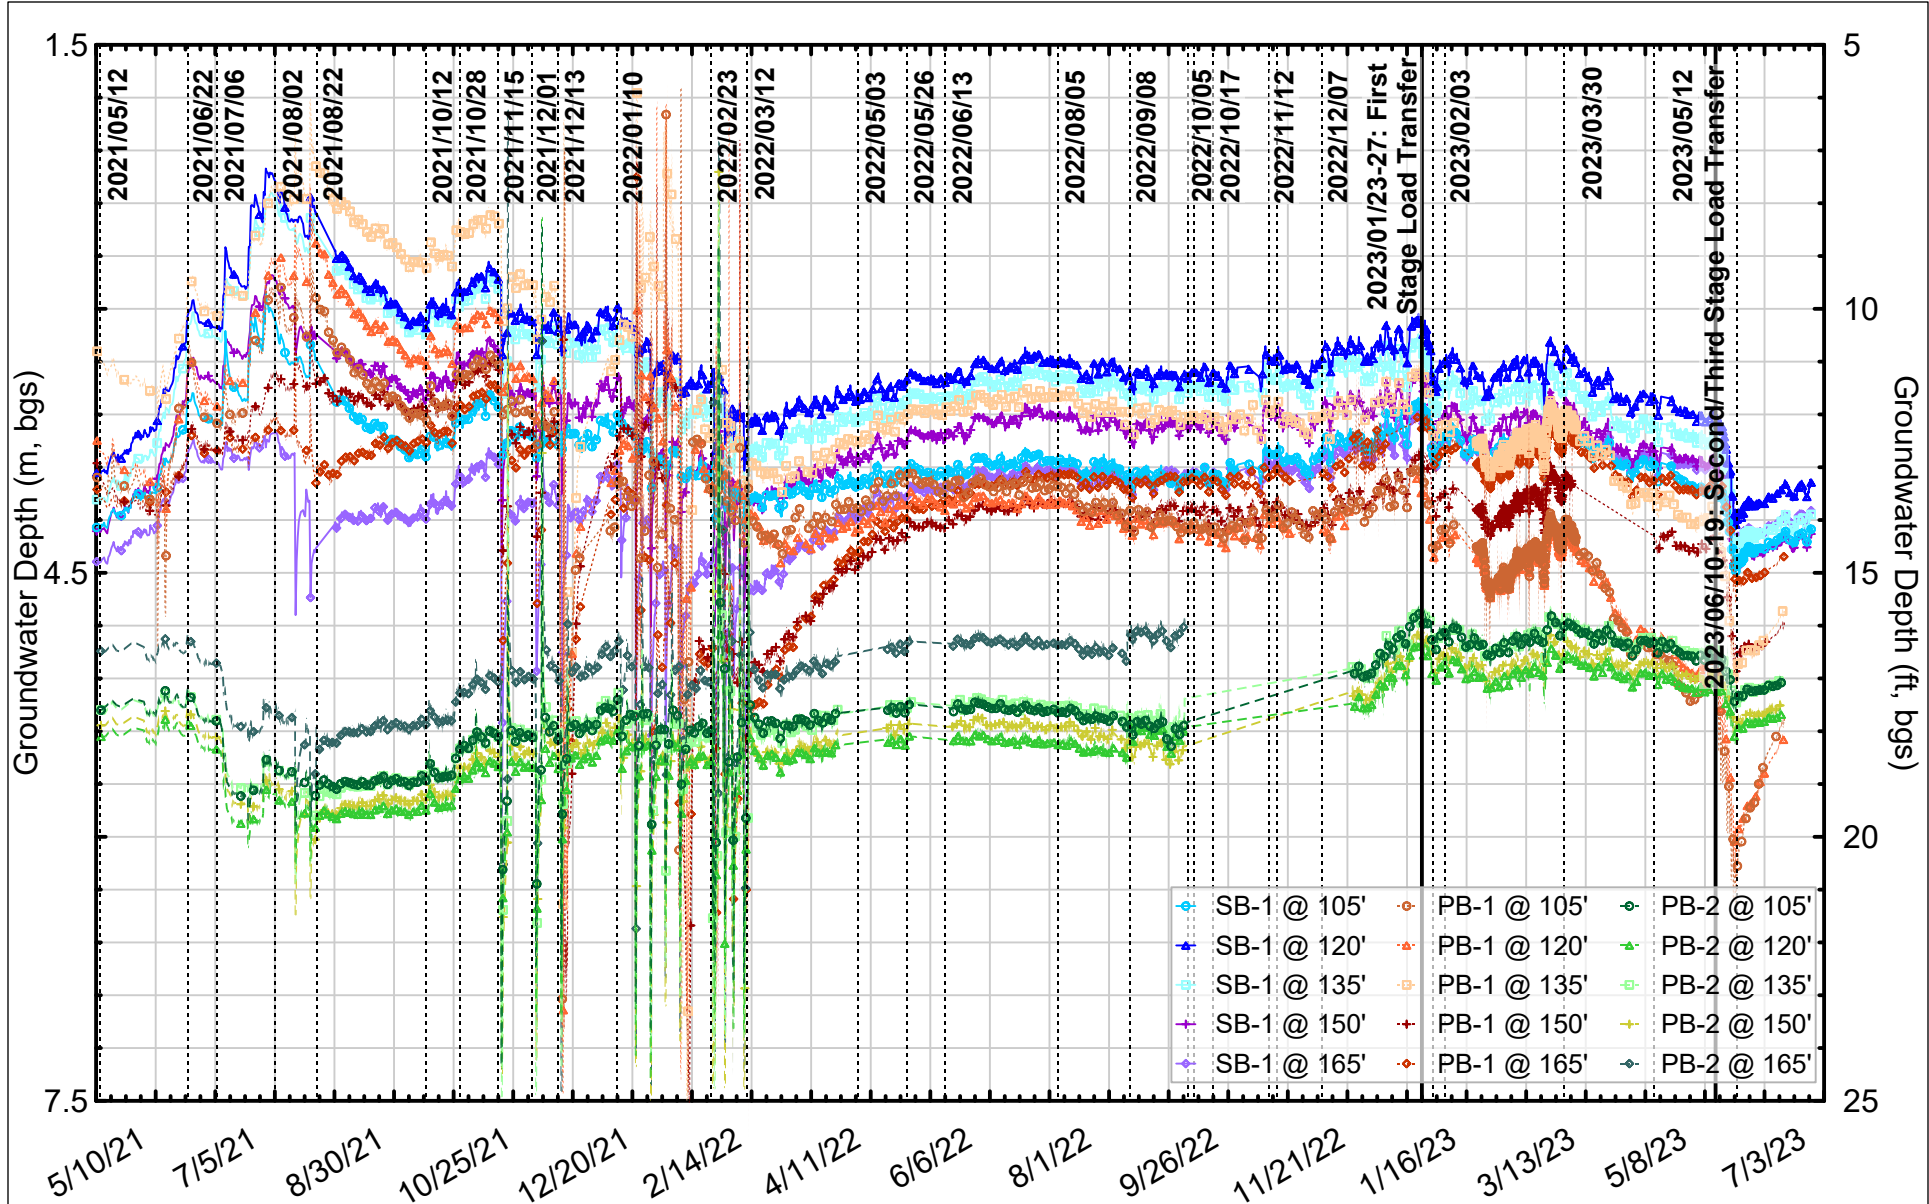
Project No: 19-009.00    Date: 7/25/2023    Created By: NBW    Checked By: DGM    Figure No: **116-09B**

GROUNDWATER ELEVATION MEASUREMENTS IN OLD BAY CLAY  
SINCE 05/10/2021 THROUGH 07/24/2023

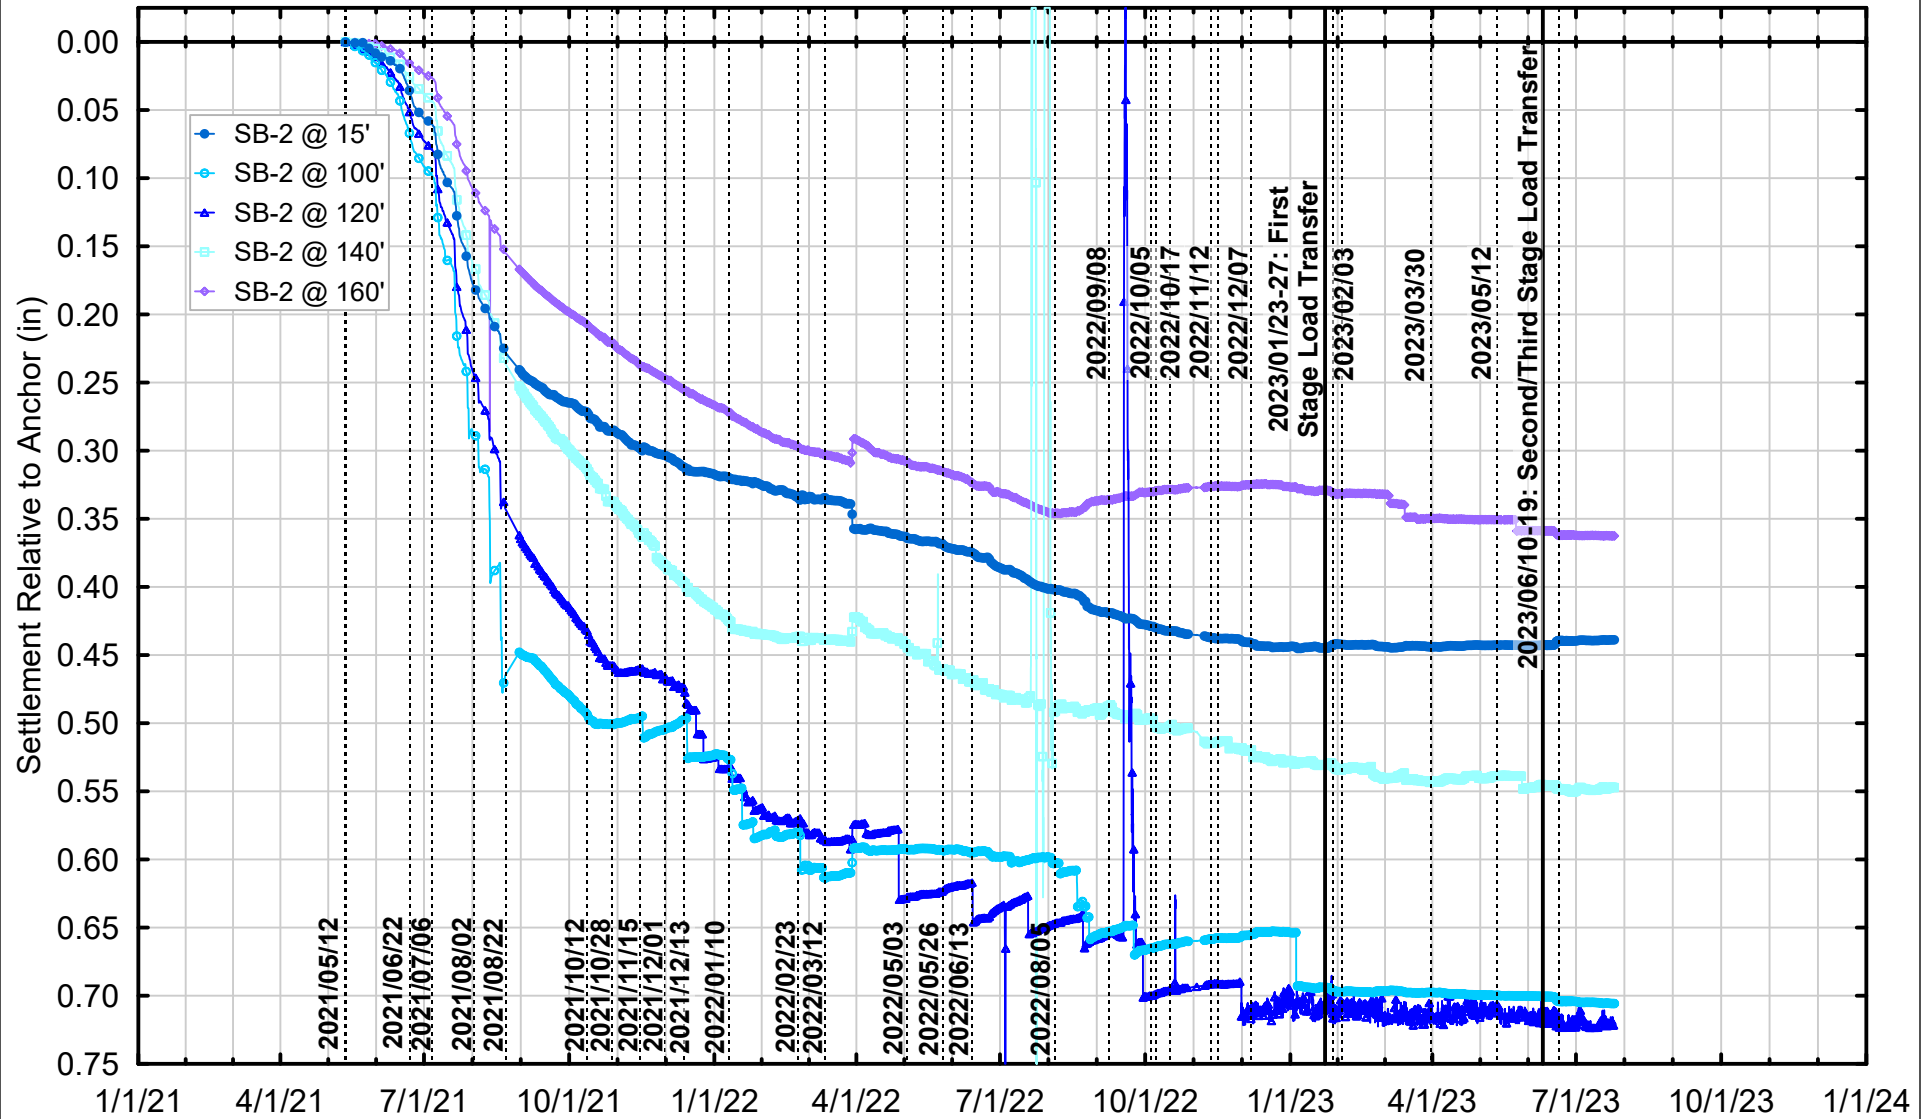
Project No: 19-009.00	Date: 7/25/2023	Created By: NBW	Checked By: DGM	Figure No: 116-10A
-----------------------	-----------------	-----------------	-----------------	--------------------

Figure 10 presents extensometer data from within the Tower basement since the start of production pile installation (May 12, 2021) through July 24, 2023. Figure 11 presents extensometer data from Fremont Street since the start of production pile installation (May 12, 2021) through May 16, 2023, and from the restart after fixing the extensometer (May 30, 2023) through July 14, 2023. Figure 12 presents extensometer data from Mission Street since the start of production pile installation (May 12, 2021) through July 10, 2023.

EXTENSOMETER DATA FROM WITHIN TOWER BASEMENT  
SINCE 01/01/2021 THROUGH 07/24/2023

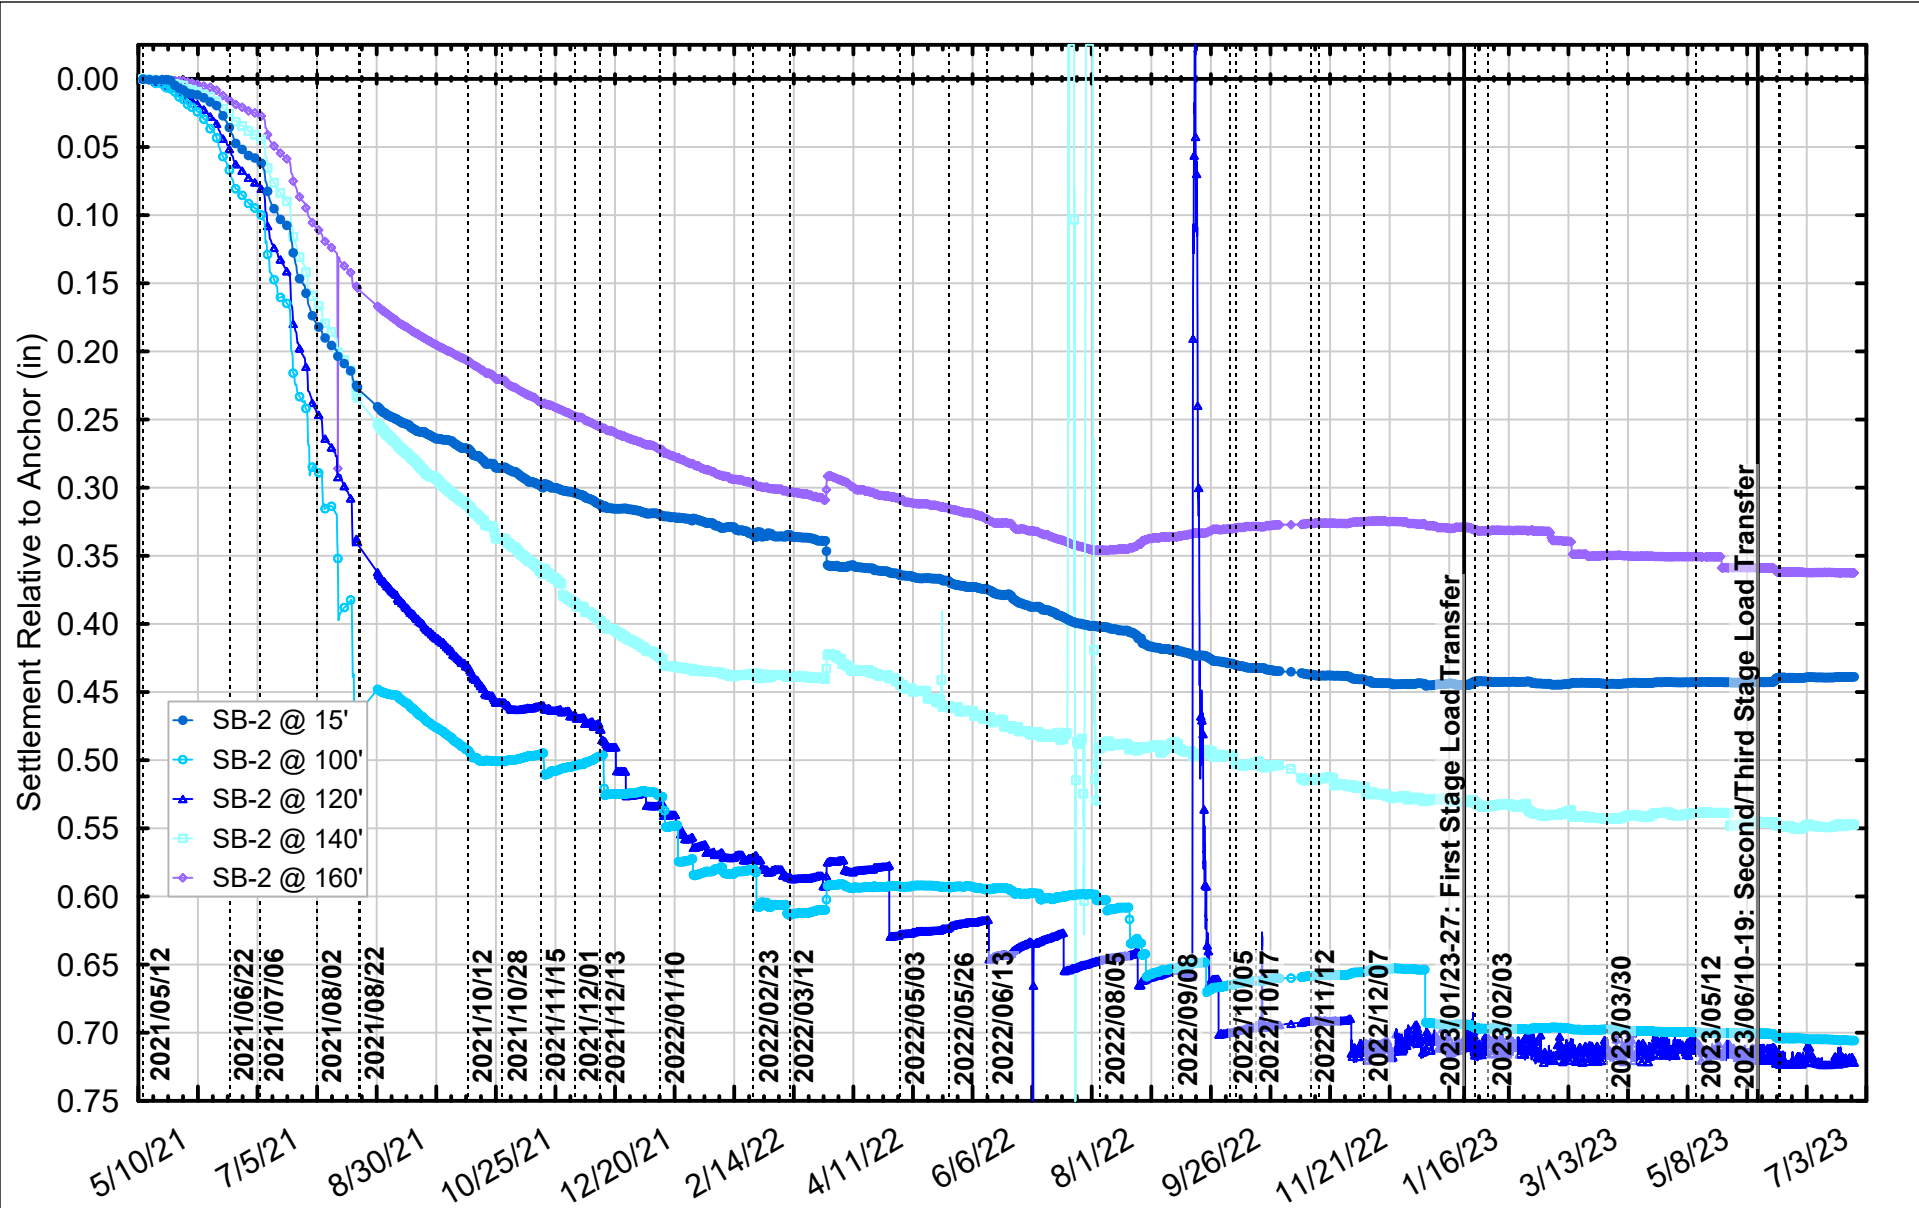
Project No: 19-009.00	Date: 7/25/2023	Created By: NBW	Checked By: DGM	Figure No: 116-10B
-----------------------	-----------------	-----------------	-----------------	--------------------

EXTENSOMETER DATA FROM WITHIN TOWER BASEMENT  
SINCE 05/10/2021 THROUGH 07/24/2023

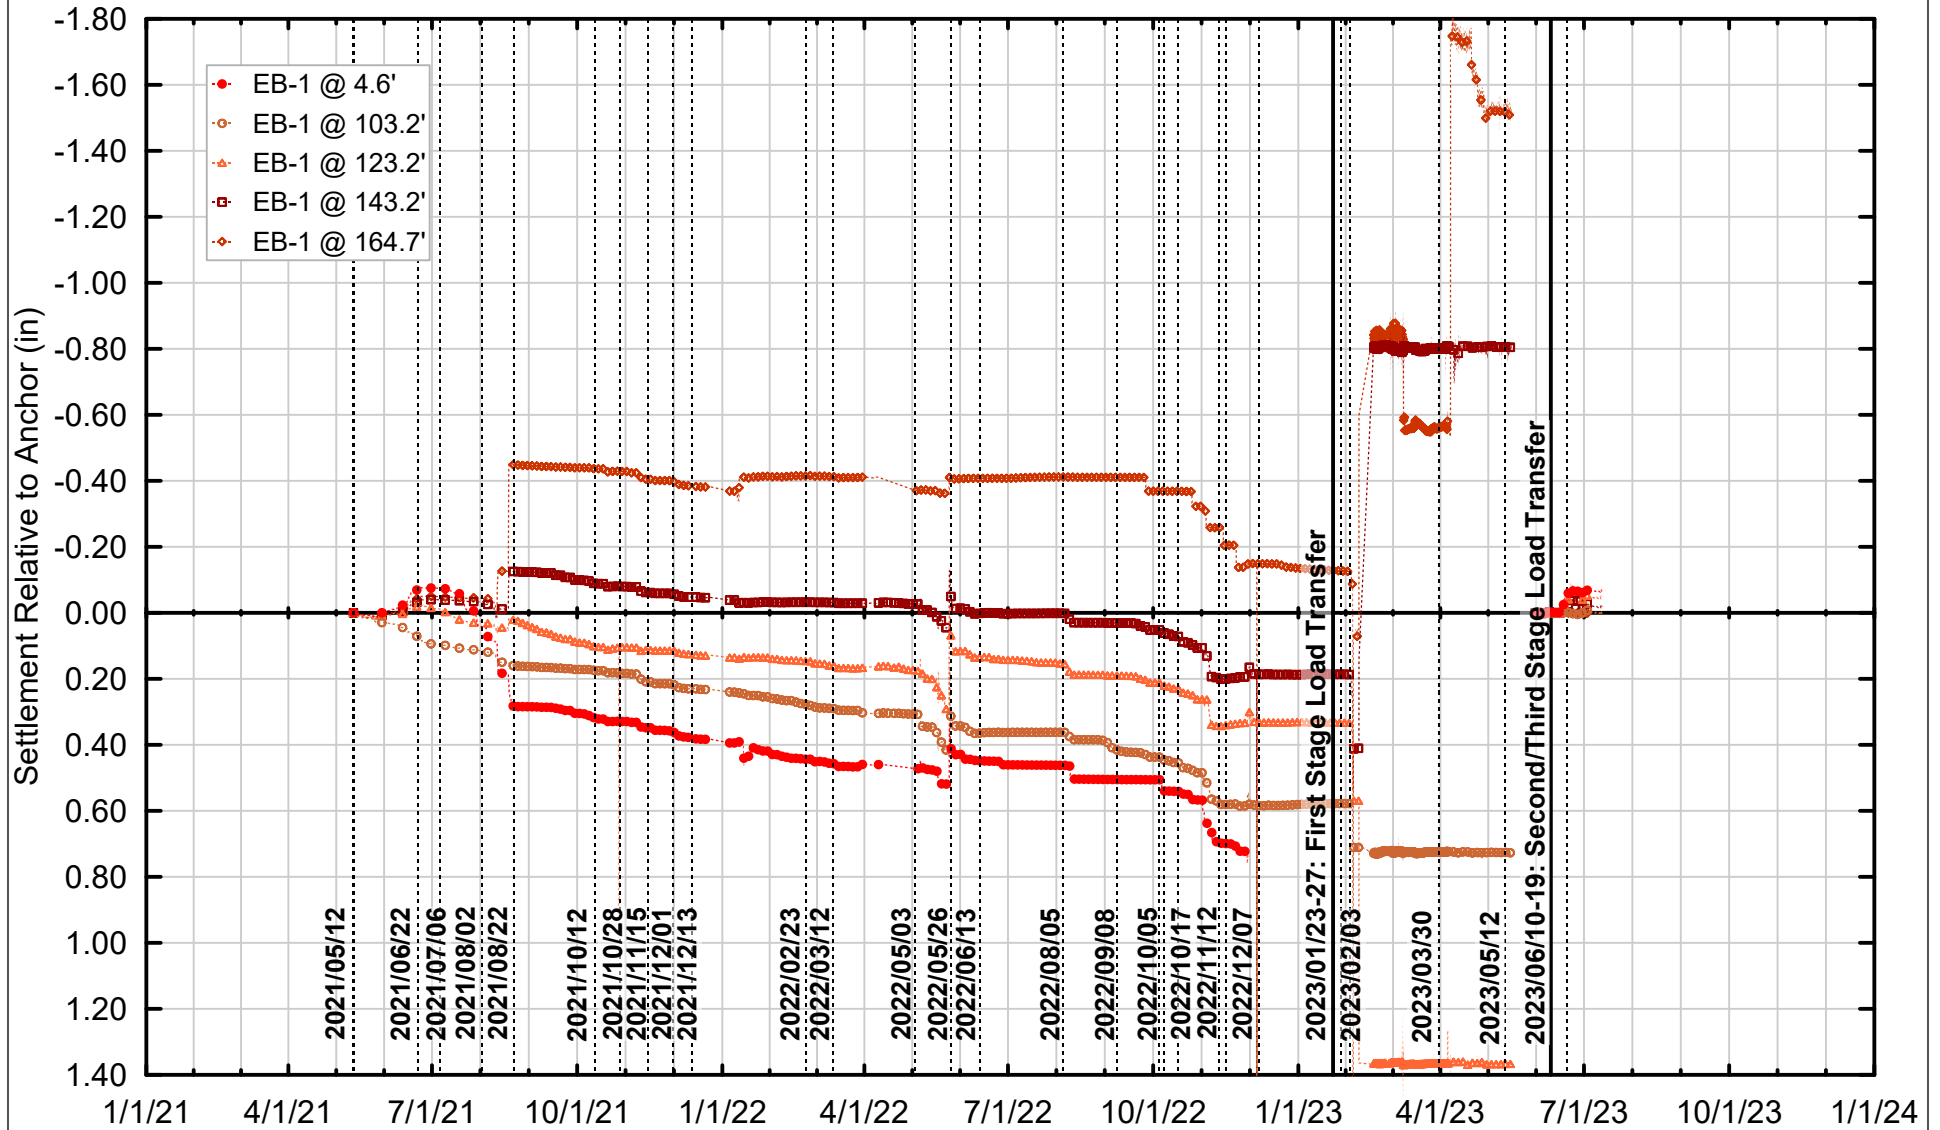
Figure No: 116-11A

Note: EB-1 was repaired and reset on 2023/05/30

EXTENSOMETER DATA FROM FREMONT STREET  
 SINCE 05/10/2021 THROUGH 05/16/2023  
 SINCE 05/30/2023 THROUGH 07/14/2023  
 Millennium Tower Perimeter Pile Upgrade: Instrumentation Monitoring Data  
 City and County of San Francisco, California

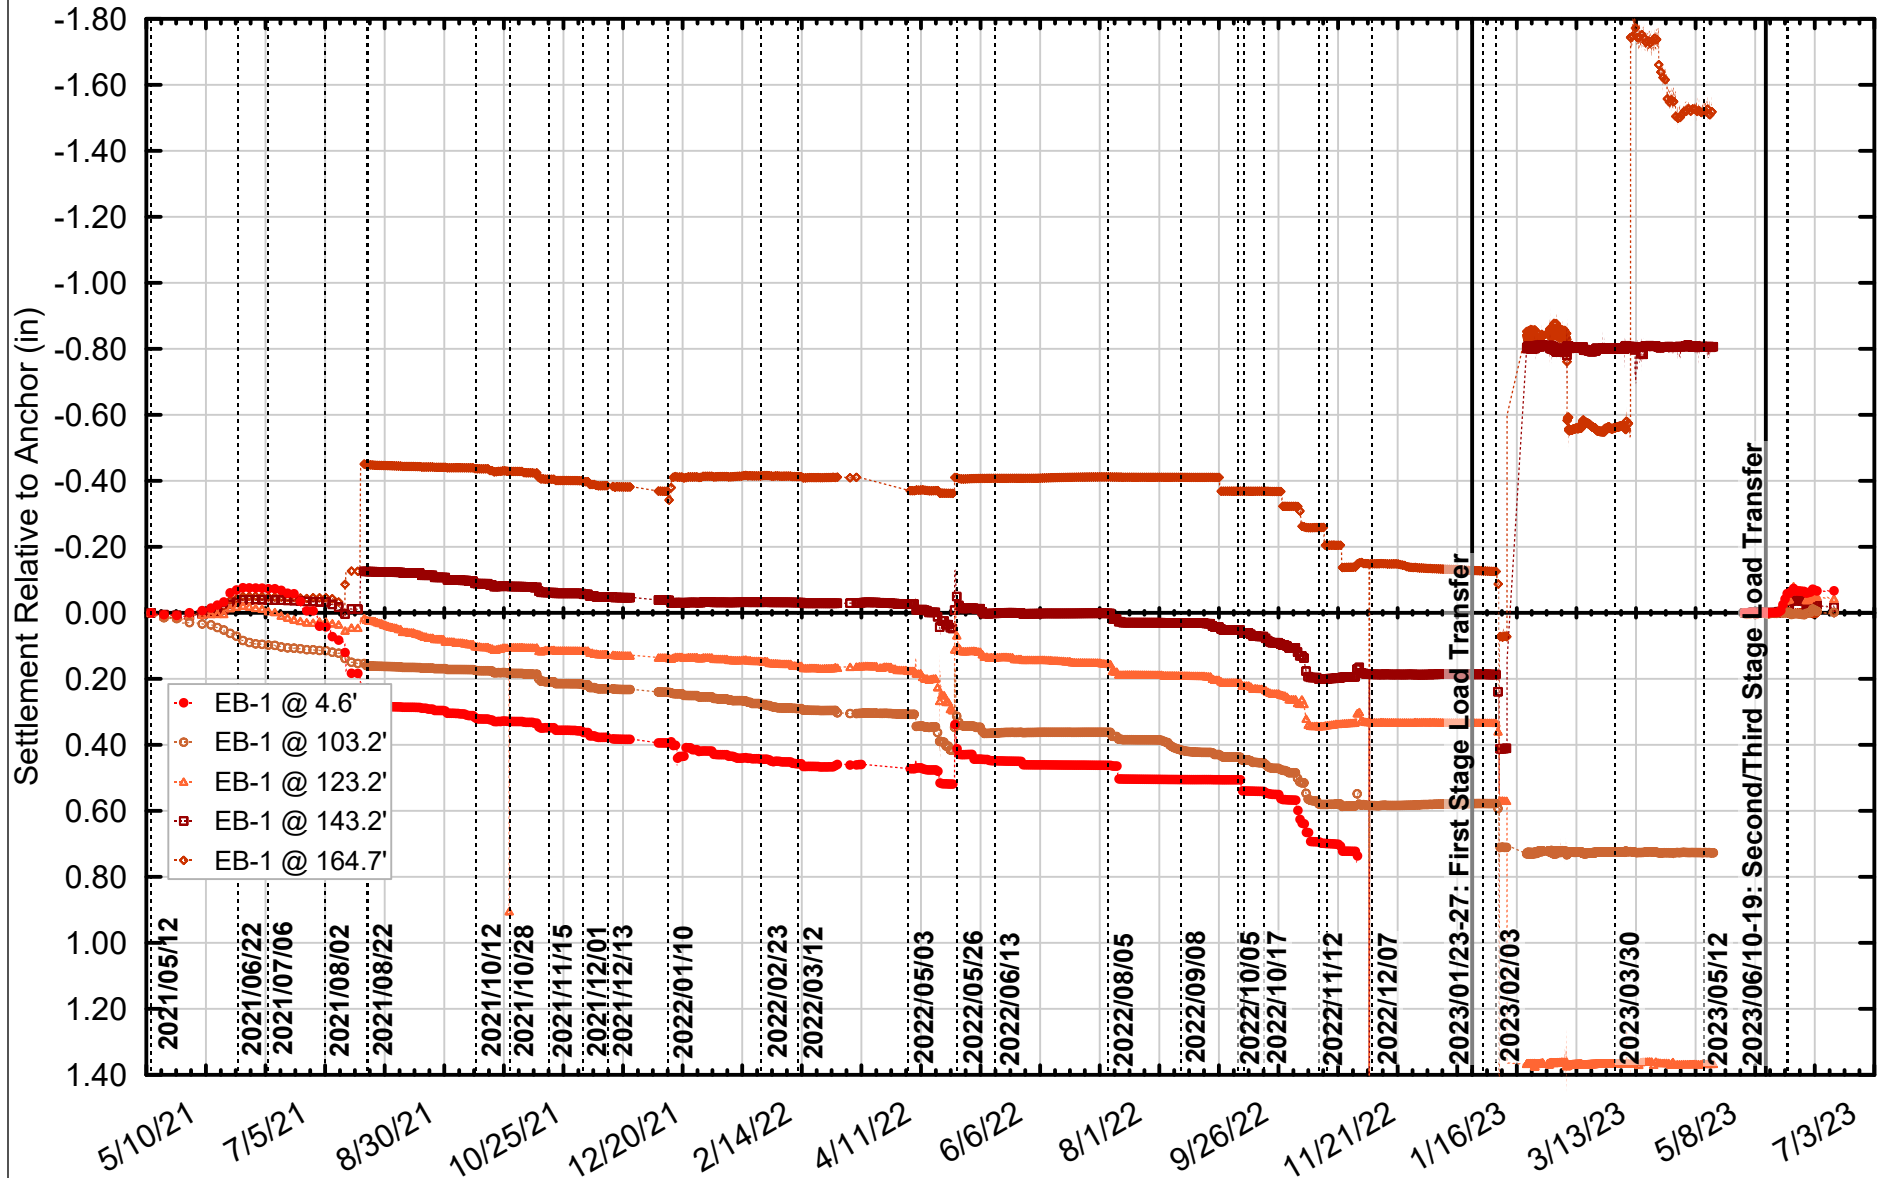
Project No: 19-009.00	Date: 7/25/2023	Created By: NBW	Checked By: DGM	Figure No: 116-11B
-----------------------	-----------------	-----------------	-----------------	--------------------

Note: EB-1 was repaired and reset on 2023/05/30

EXTENSOMETER DATA FROM FREMONT STREET  
 SINCE 05/10/2021 THROUGH 05/16/2023  
 SINCE 05/30/2023 THROUGH 07/14/2023  
 Millennium Tower Perimeter Pile Upgrade: Instrumentation Monitoring Data  
 City and County of San Francisco, California

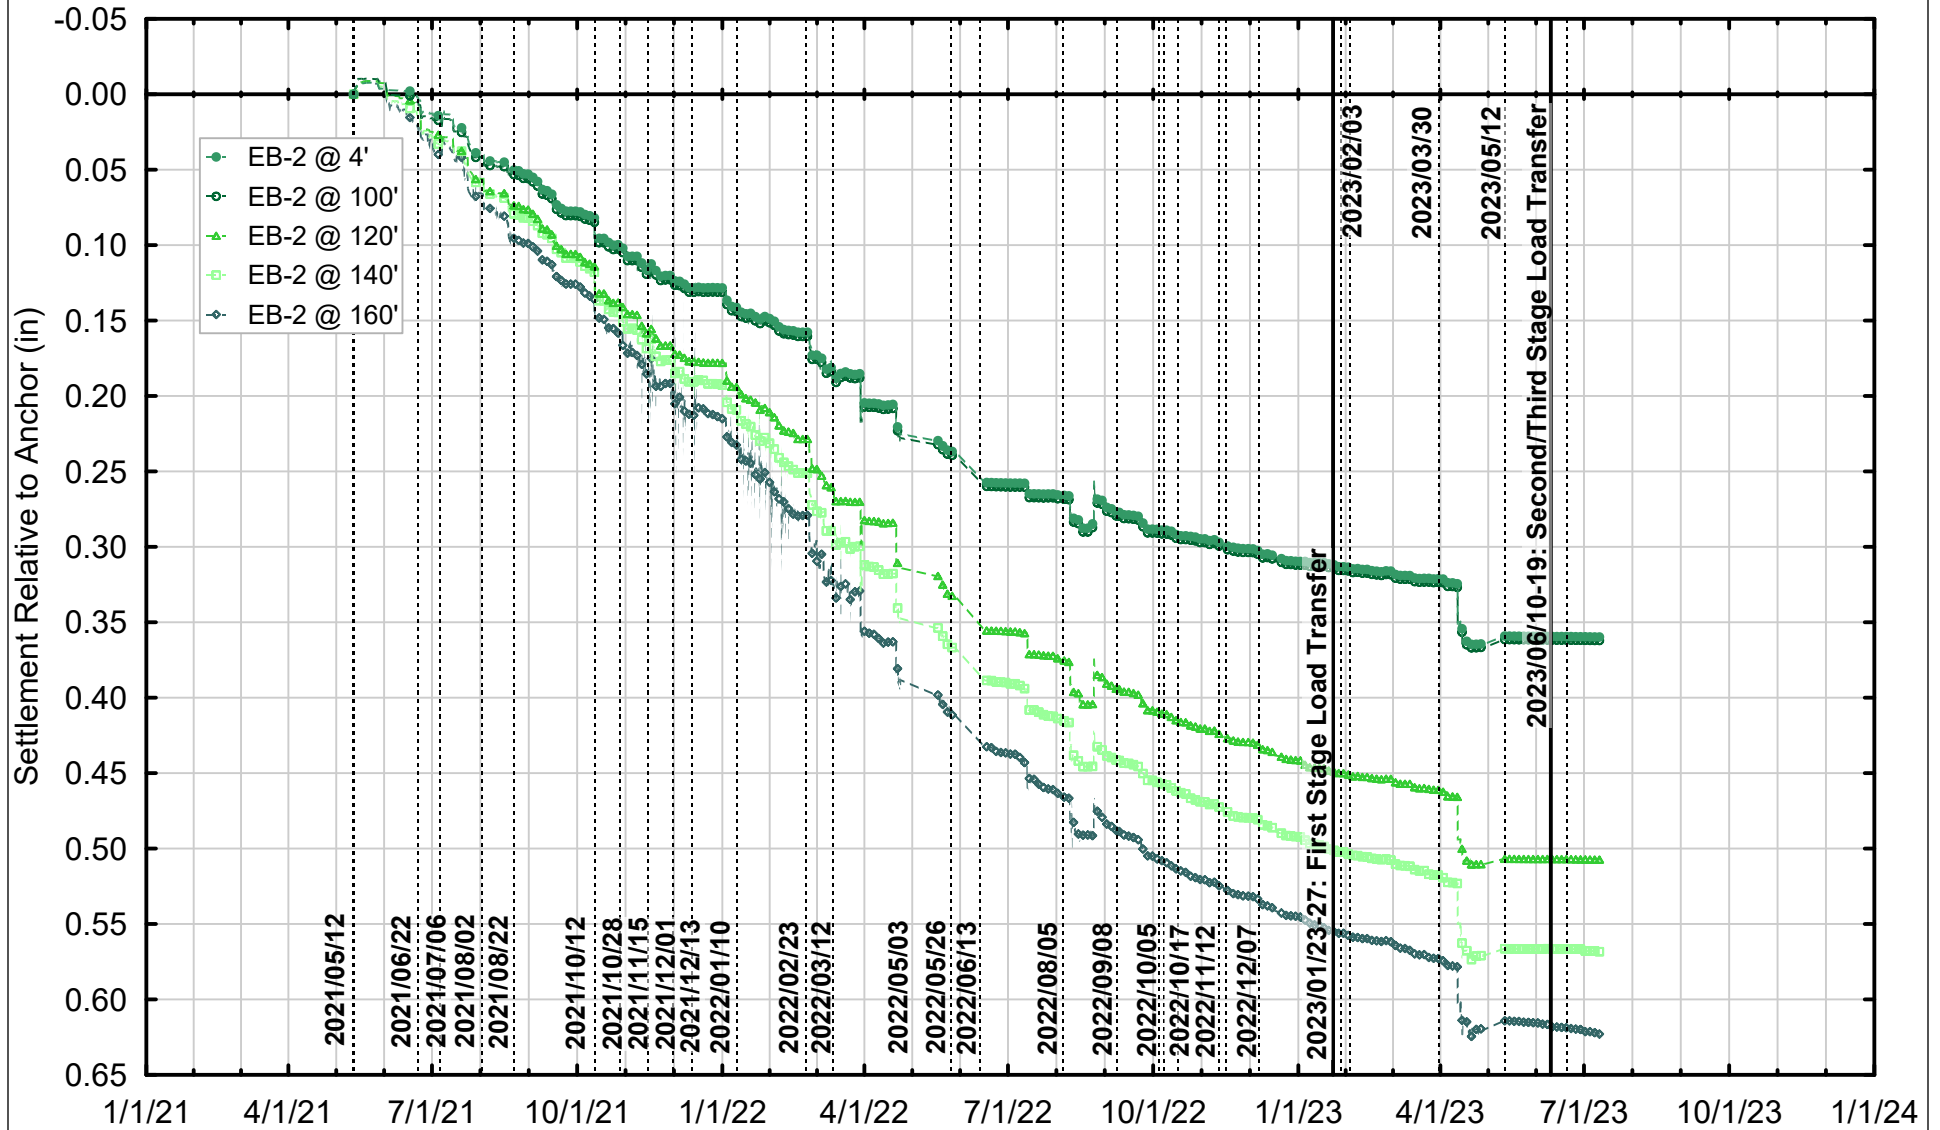
Project No: 19-009.00	Date: 7/25/2023	Created By: NBW	Checked By: DGM	Figure No: 116-12A
-----------------------	-----------------	-----------------	-----------------	--------------------

EXTENSOMETER DATA FROM MISSION STREET  
SINCE 01/01/2021 THROUGH 07/10/2023

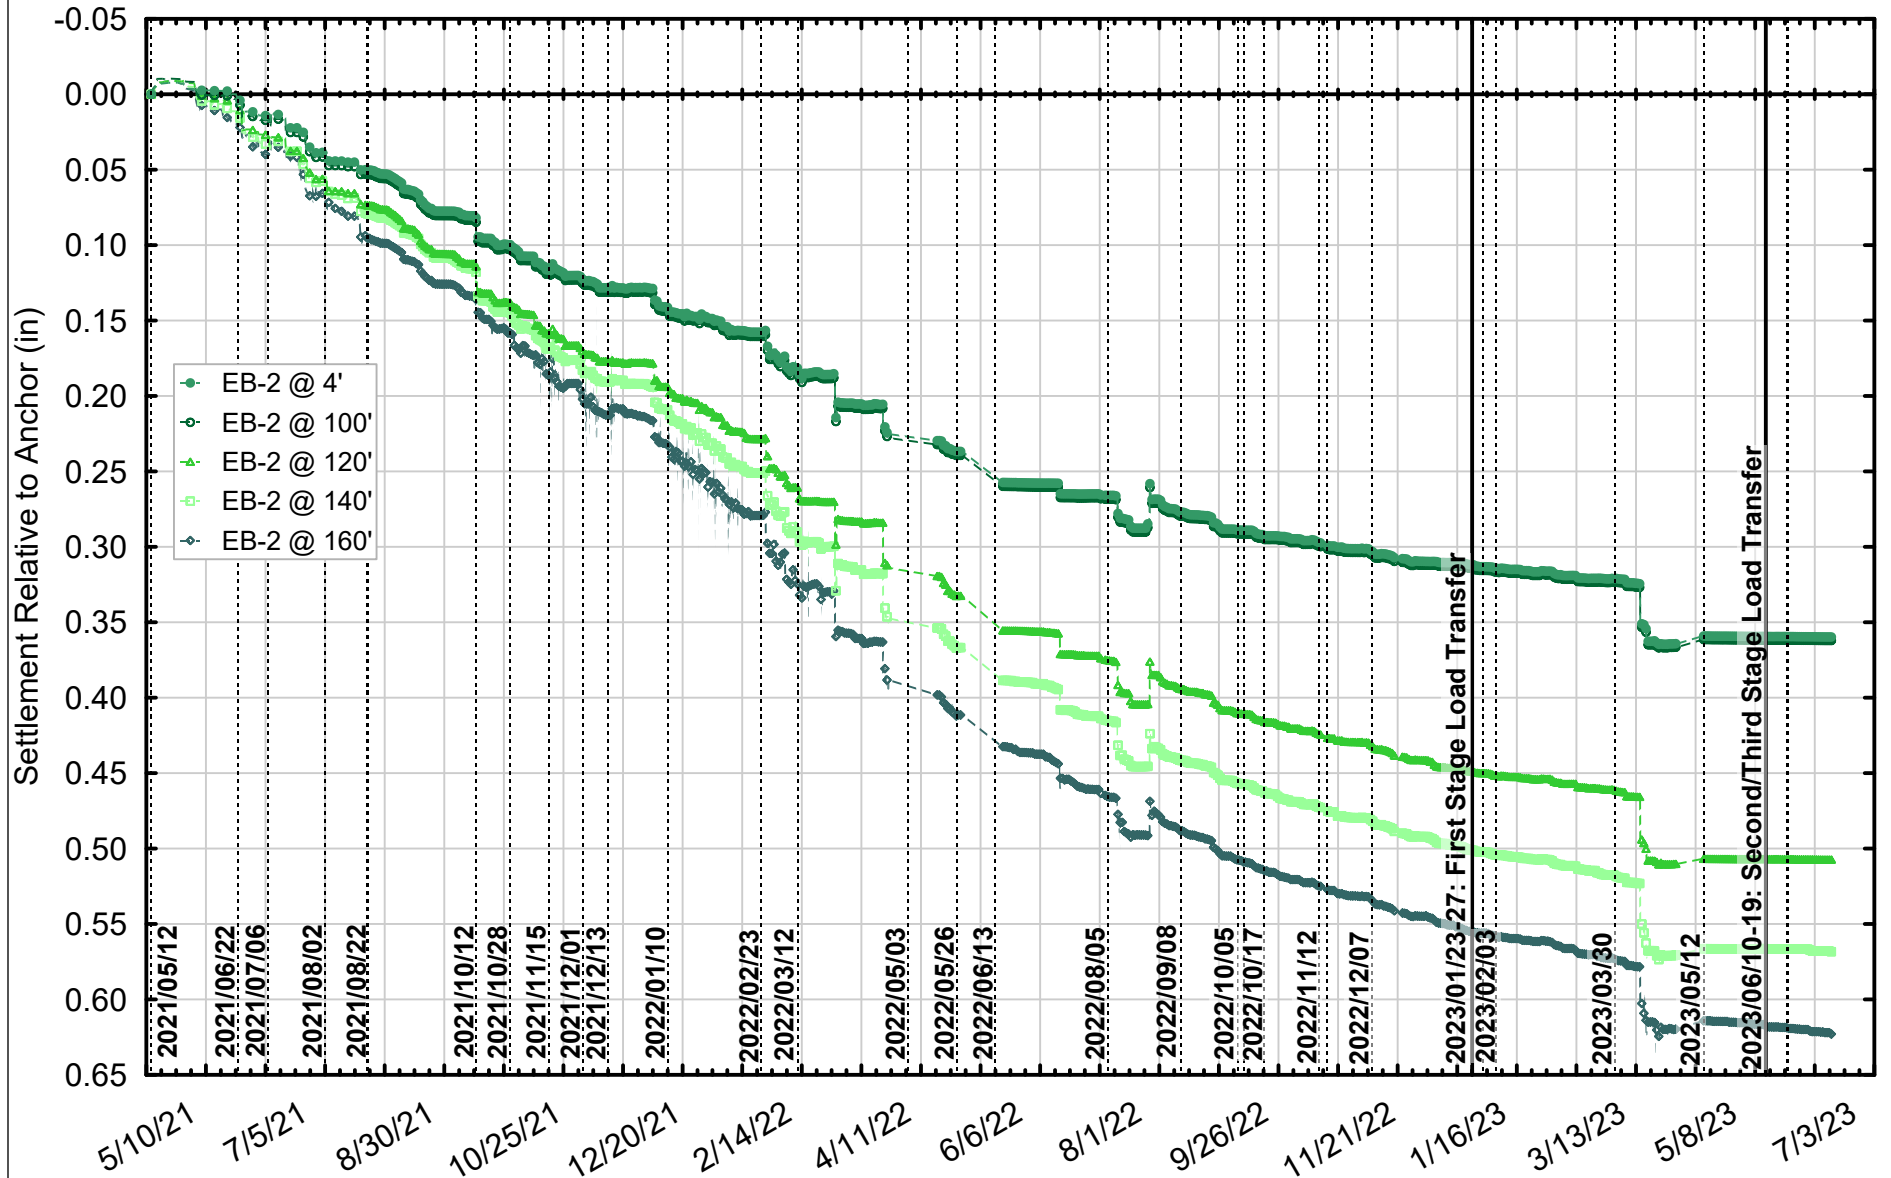
Project No: 19-009.00    Date: 7/25/2023    Created By: NBW    Checked By: DGM    Figure No: 116-12B

EXTENSOMETER DATA FROM MISSION STREET  
SINCE 05/10/2021 THROUGH 07/10/2023

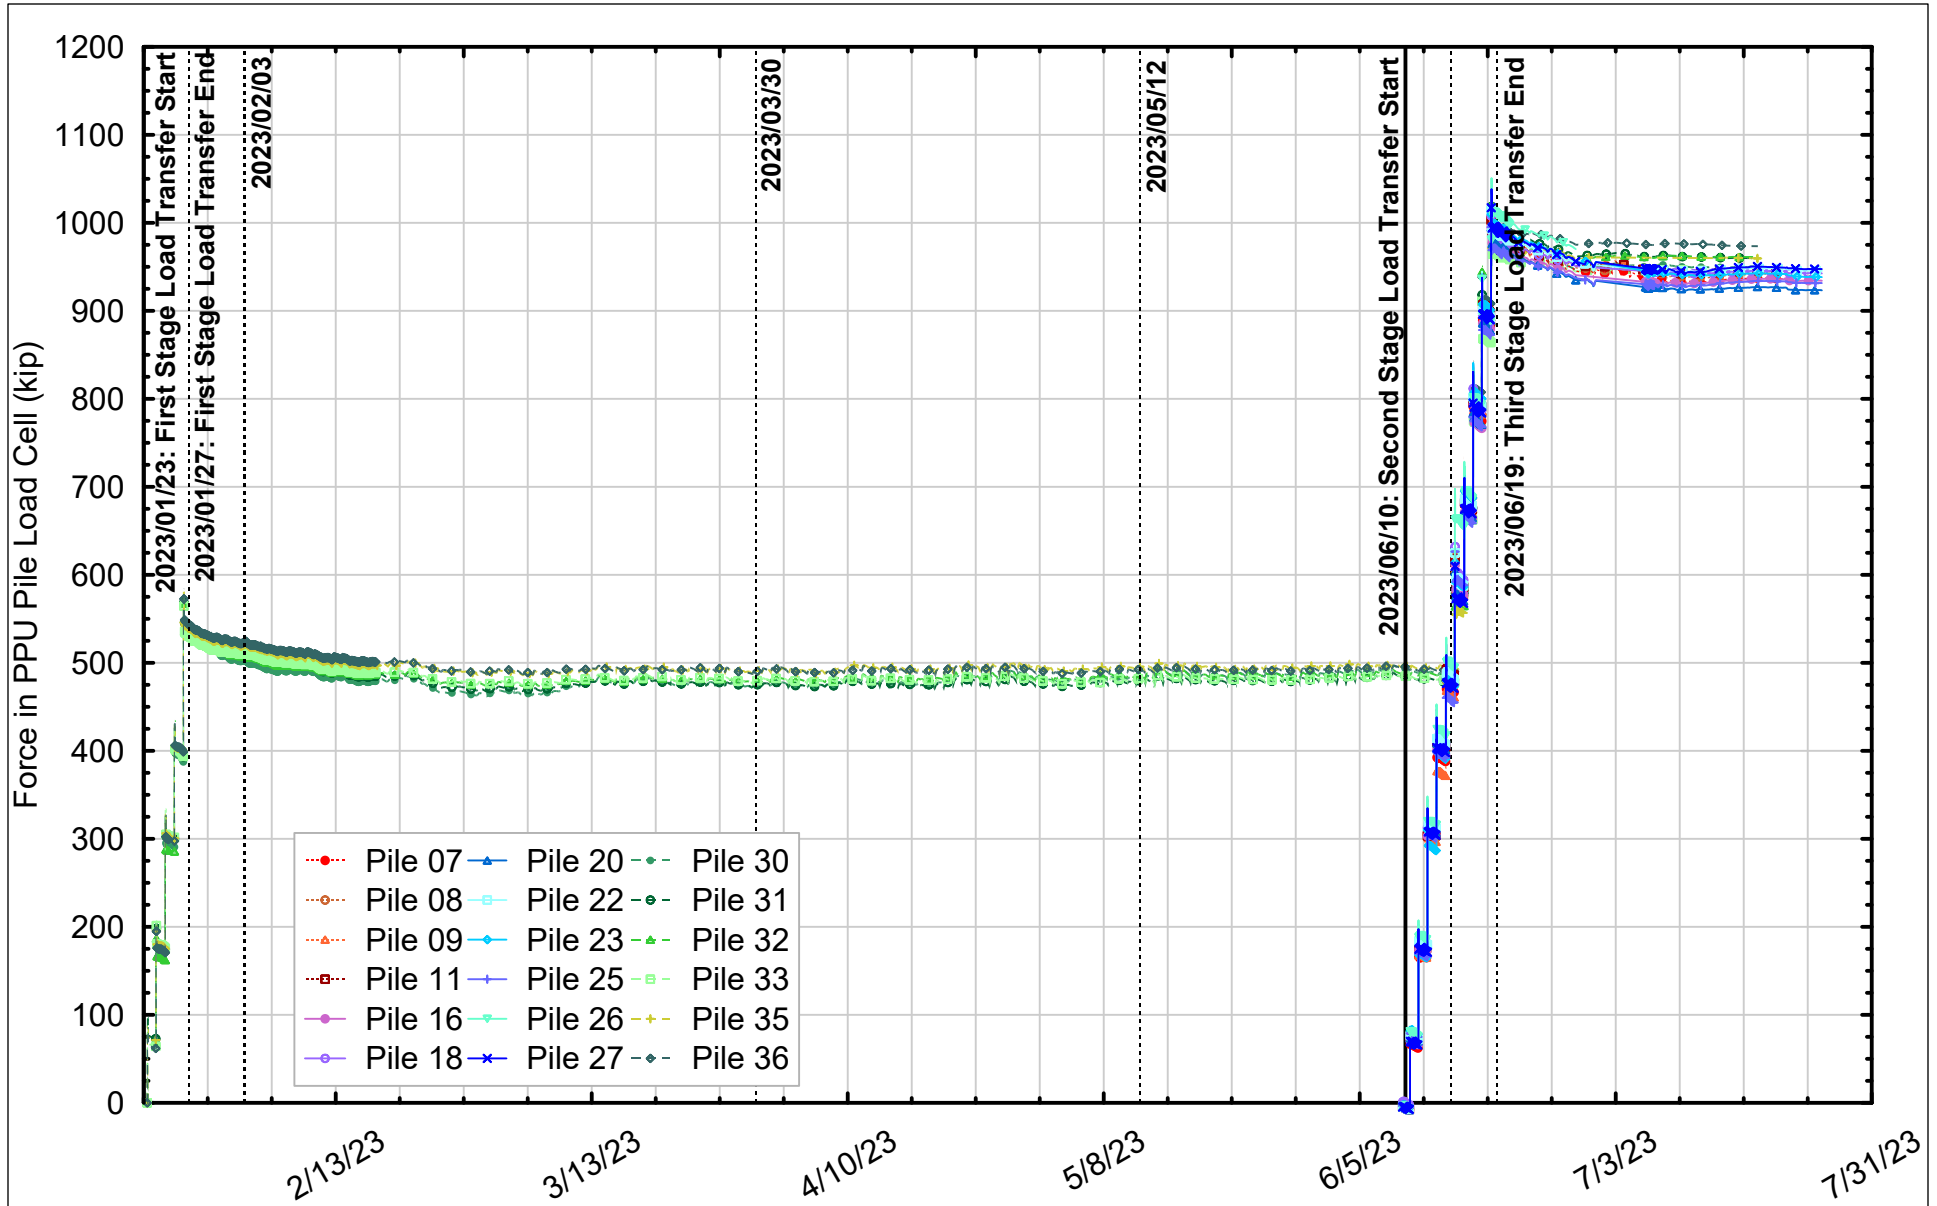
Project No: 19-009.00	Date: 7/25/2023	Created By: NBW	Checked By: DGM	Figure No: 116-13
-----------------------	-----------------	-----------------	-----------------	-------------------

Figure 13 presents pile load cell data since the start of the First Stage Load Transfer (January 23, 2023) through July 24, 2023.

PILE LOAD CELL DATA  
 SINCE 01/23/2023 THROUGH 07/24/2023  
 Millennium Tower Perimeter Pile Upgrade: Instrumentation Monitoring Data  
 City and County of San Francisco, California
