Subject: 301 Mission Retrofit Monitoring Report 118: Results as of August 7, 2023

Millennium Tower Perimeter Pile Upgrade: Instrumentation Monitoring Data
City and County of San Francisco, California

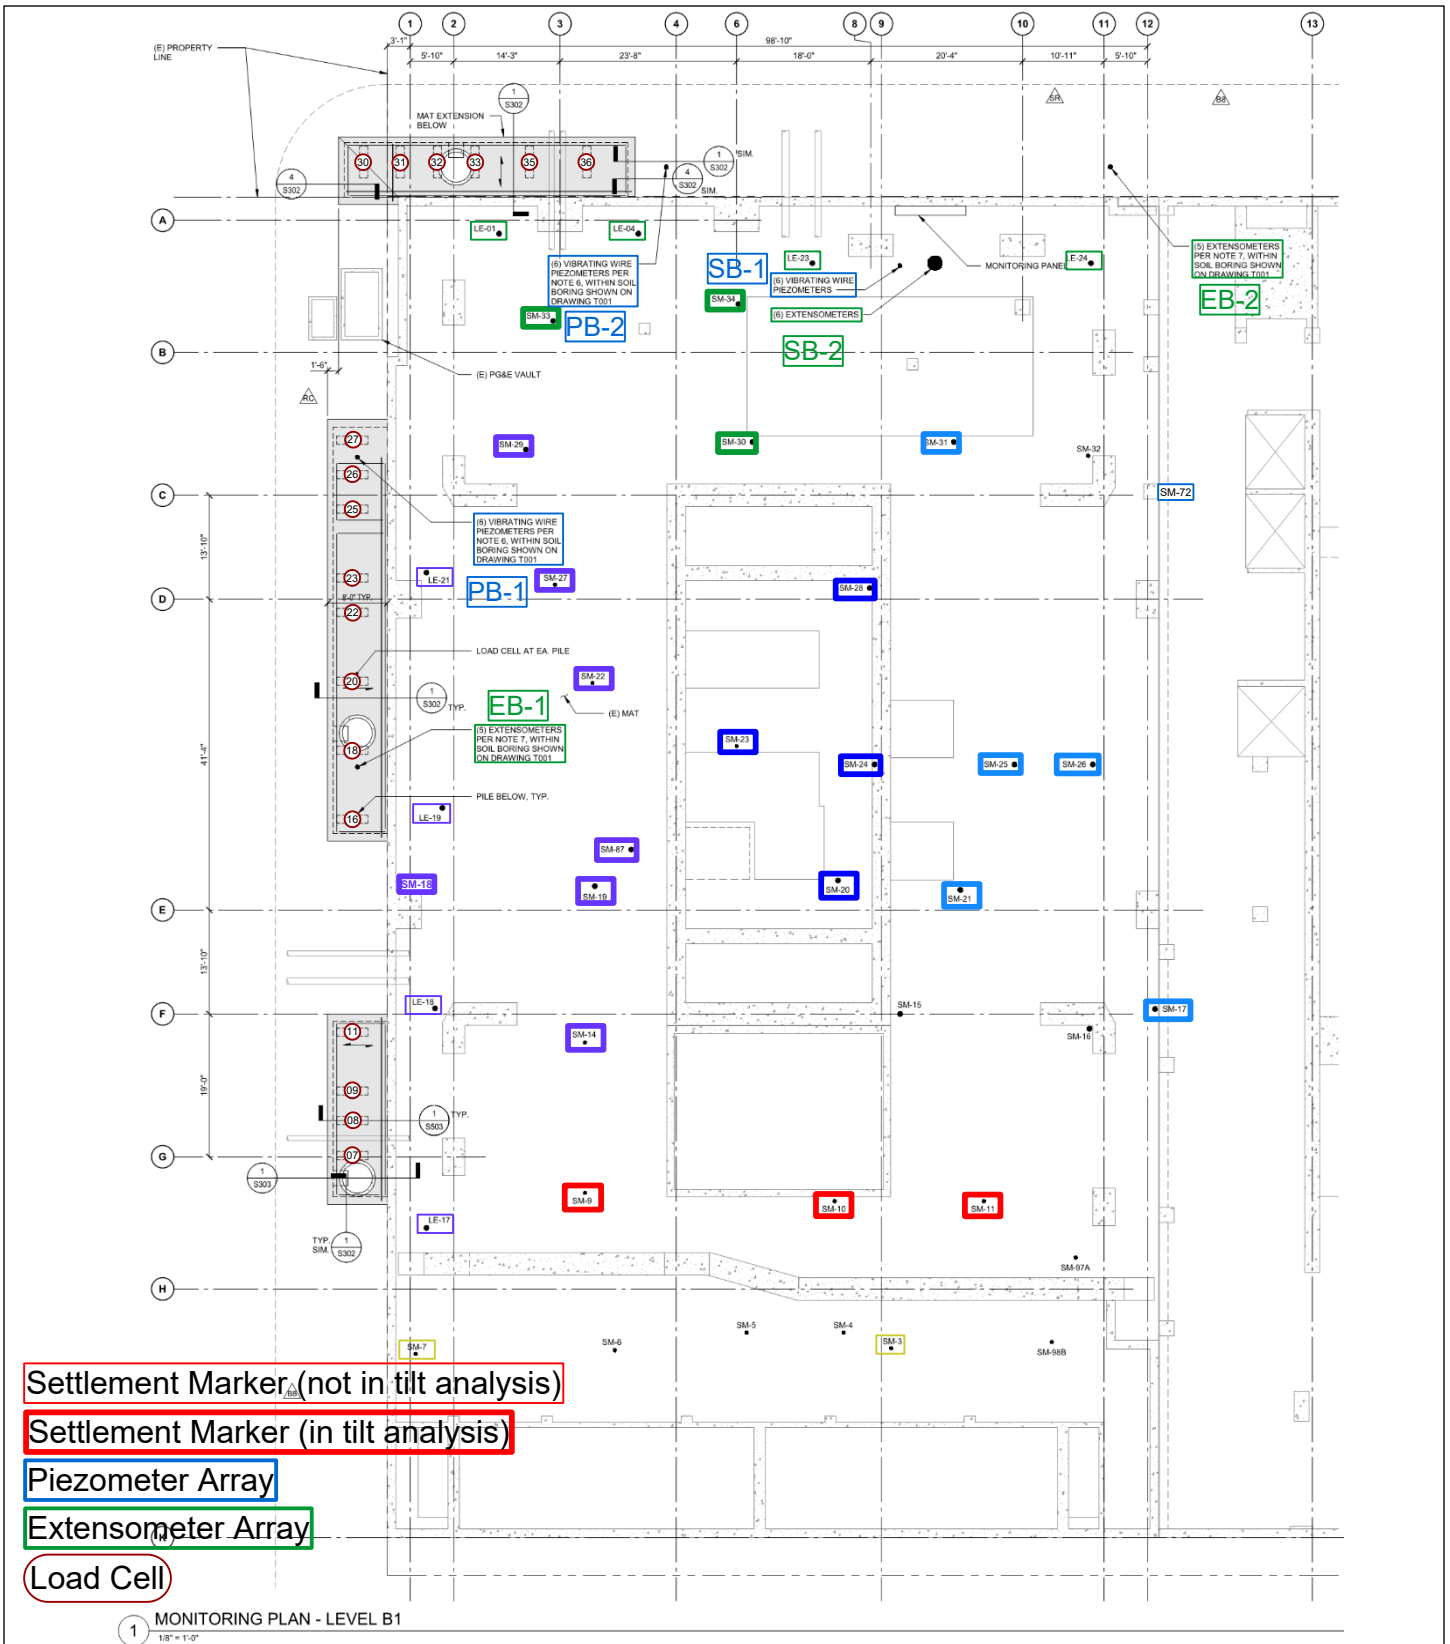
Project No: 19-009.00	Date: 6/28/2023	Created By: NBW	Checked By: DGM	Figure No: 118-01A
-----------------------	-----------------	-----------------	-----------------	---------------------------

**INSTRUMENT LOCATION MAP
SETTLEMENT MARKERS, PIEZOMETERS, EXTENSOMETERS, LOAD CELLS**

Figure 01 presents the instrument locations as referenced in later figures.

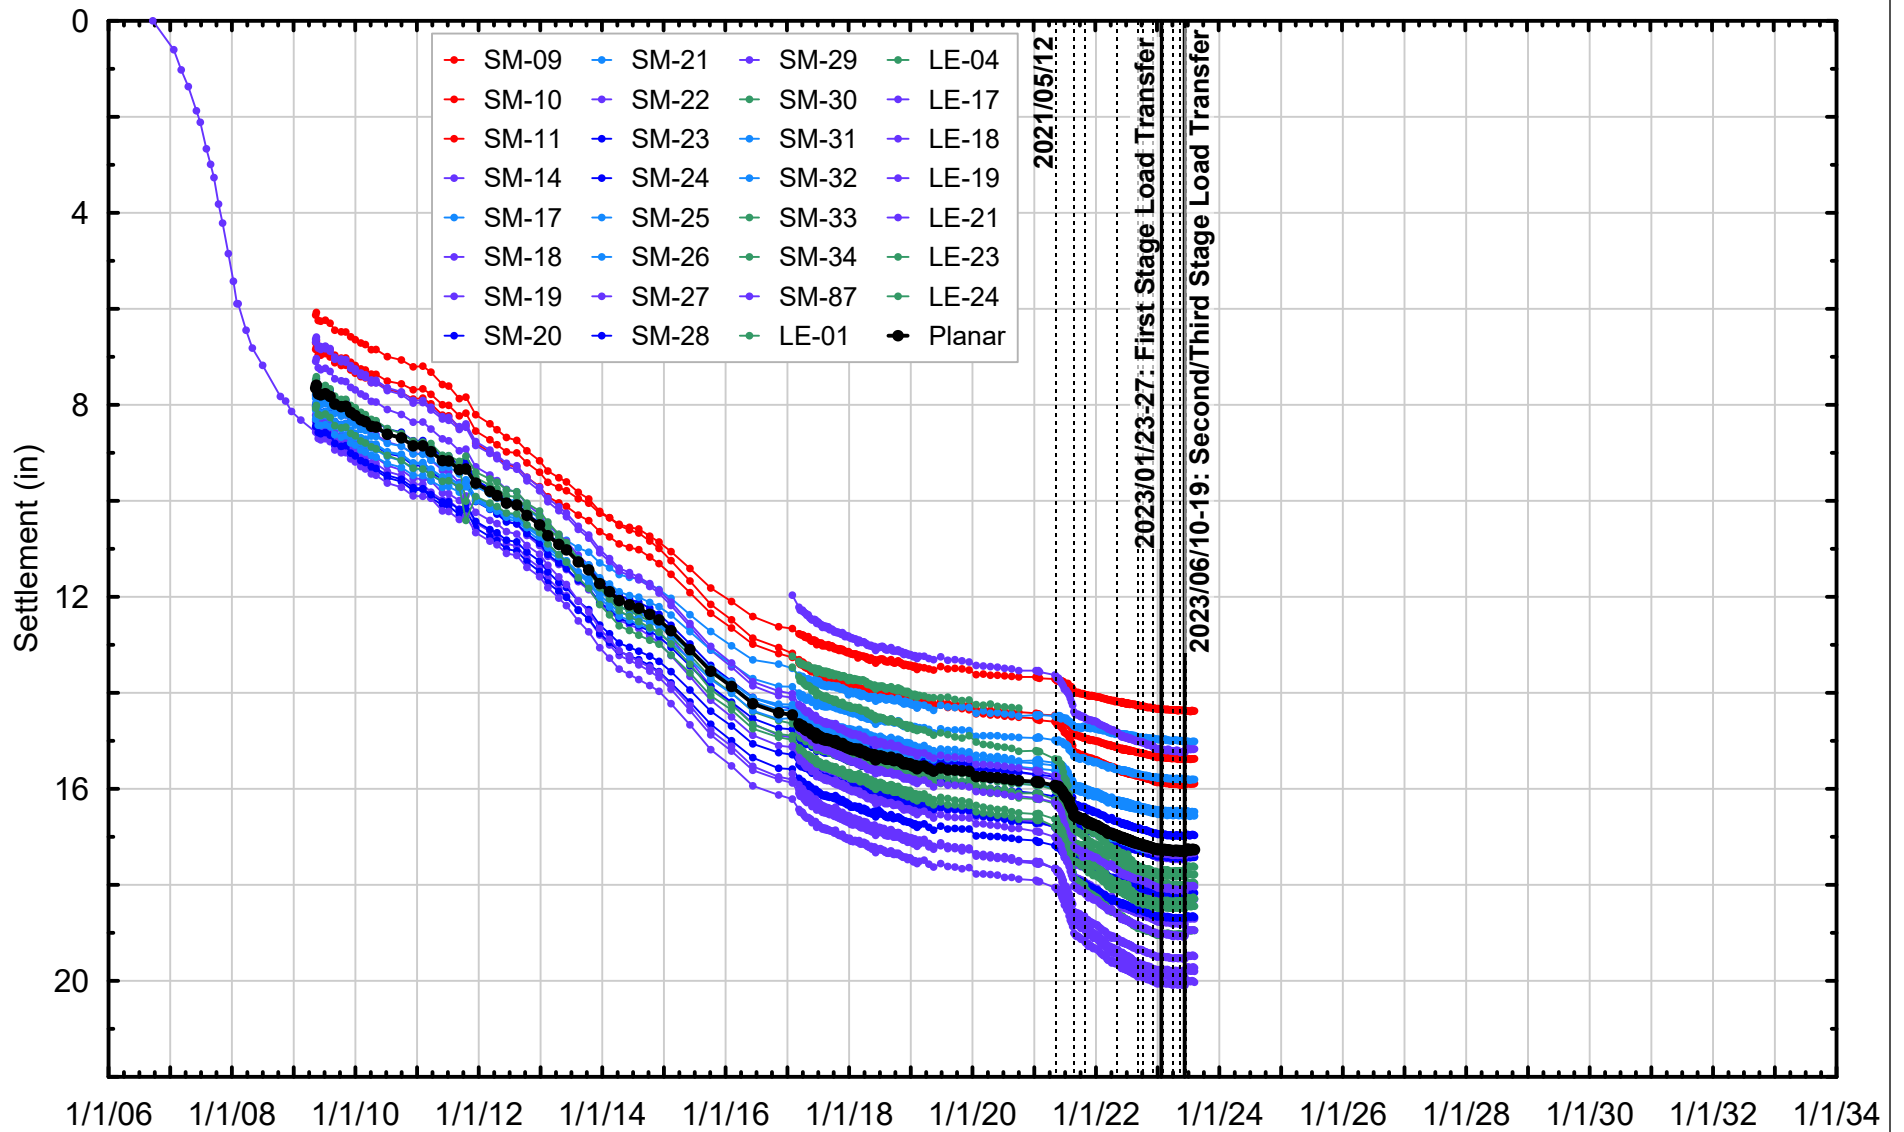
Project No: 19-009.00	Date: 8/8/2023	Created By: NBW	Checked By: DGM	Figure No: 118-02
-----------------------	----------------	-----------------	-----------------	--------------------------

HISTORICAL SETTLEMENT MARKER DATA

Figure 02 presents the historical settlement data interpreted from settlement markers installed on the B-1 Level of 301 Mission Tower. In addition, data from surveys performed during the retrofit are included. Figure 03A presents settlement data since the start of production pile installation (May 12, 2021; baseline readings on May 10, 2021) through August 7, 2023. Figure 03B presents settlement data since January 11, 2021, through August 7, 2023. Figure 04 presents current settlement contours (in inches) on August 7, 2023.

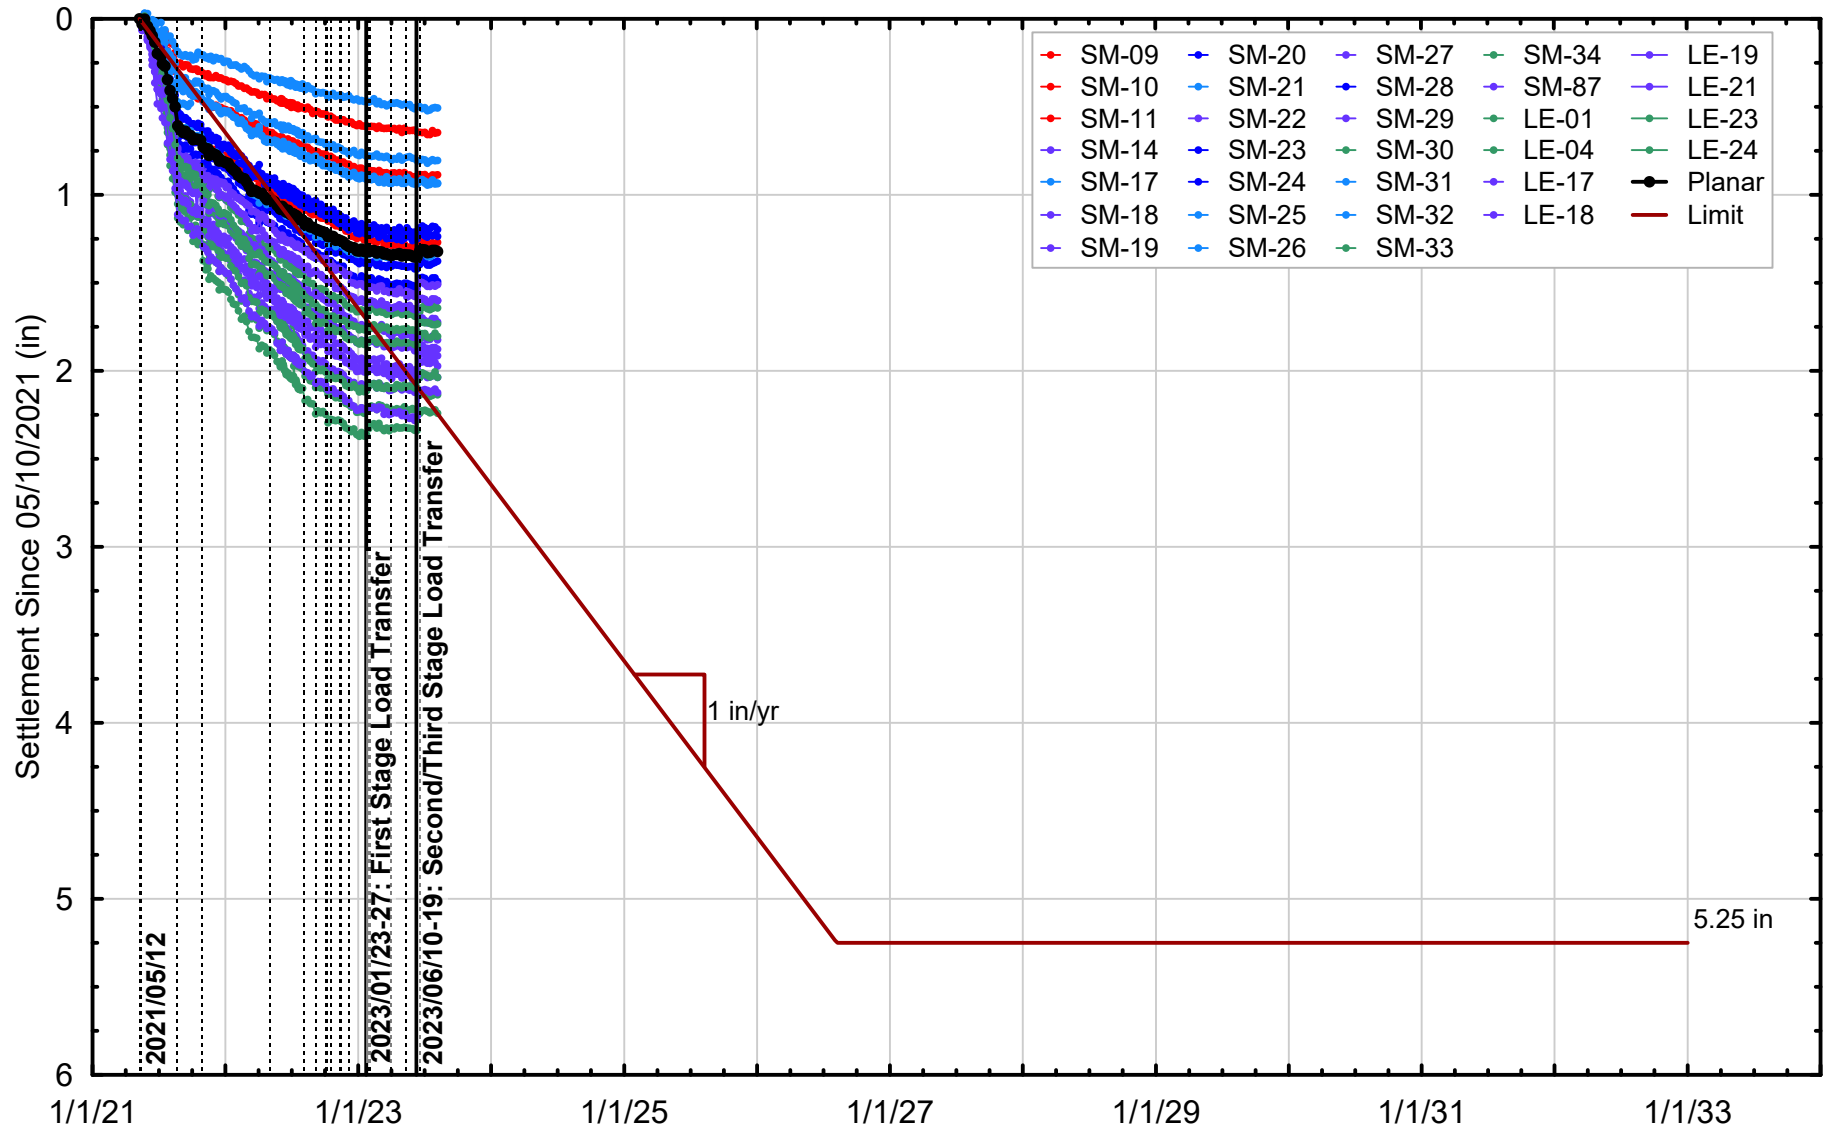
Figure No: **118-03A**

SETTLEMENT MARKER DATA
SINCE 05/10/2021 THROUGH 08/07/2023

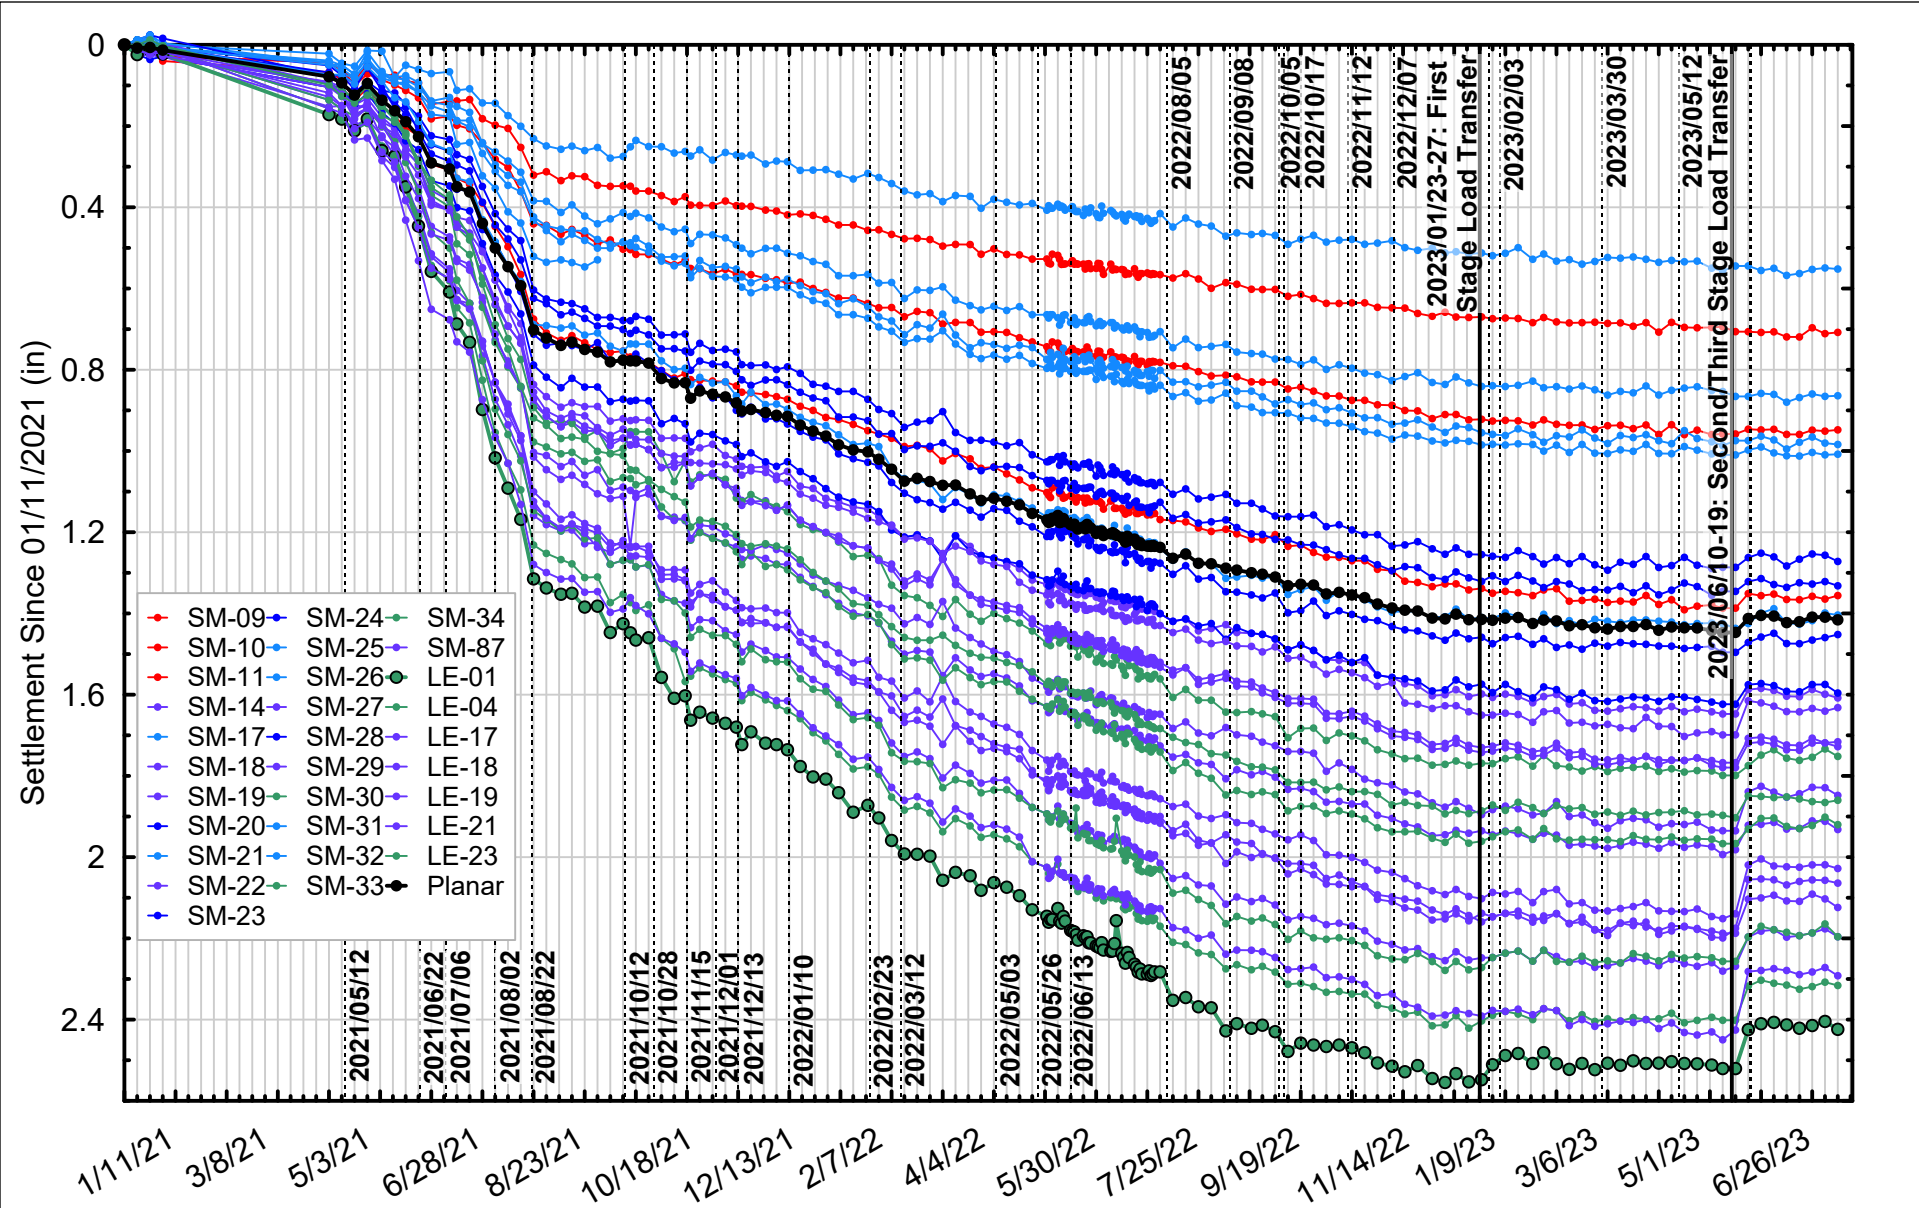
Project No: 19-009.00	Date: 8/8/2023	Created By: NBW	Checked By: DGM	Figure No: 118-03B
-----------------------	----------------	-----------------	-----------------	--------------------

SETTLEMENT MARKER DATA
SINCE 01/11/2021 THROUGH 08/07/2023

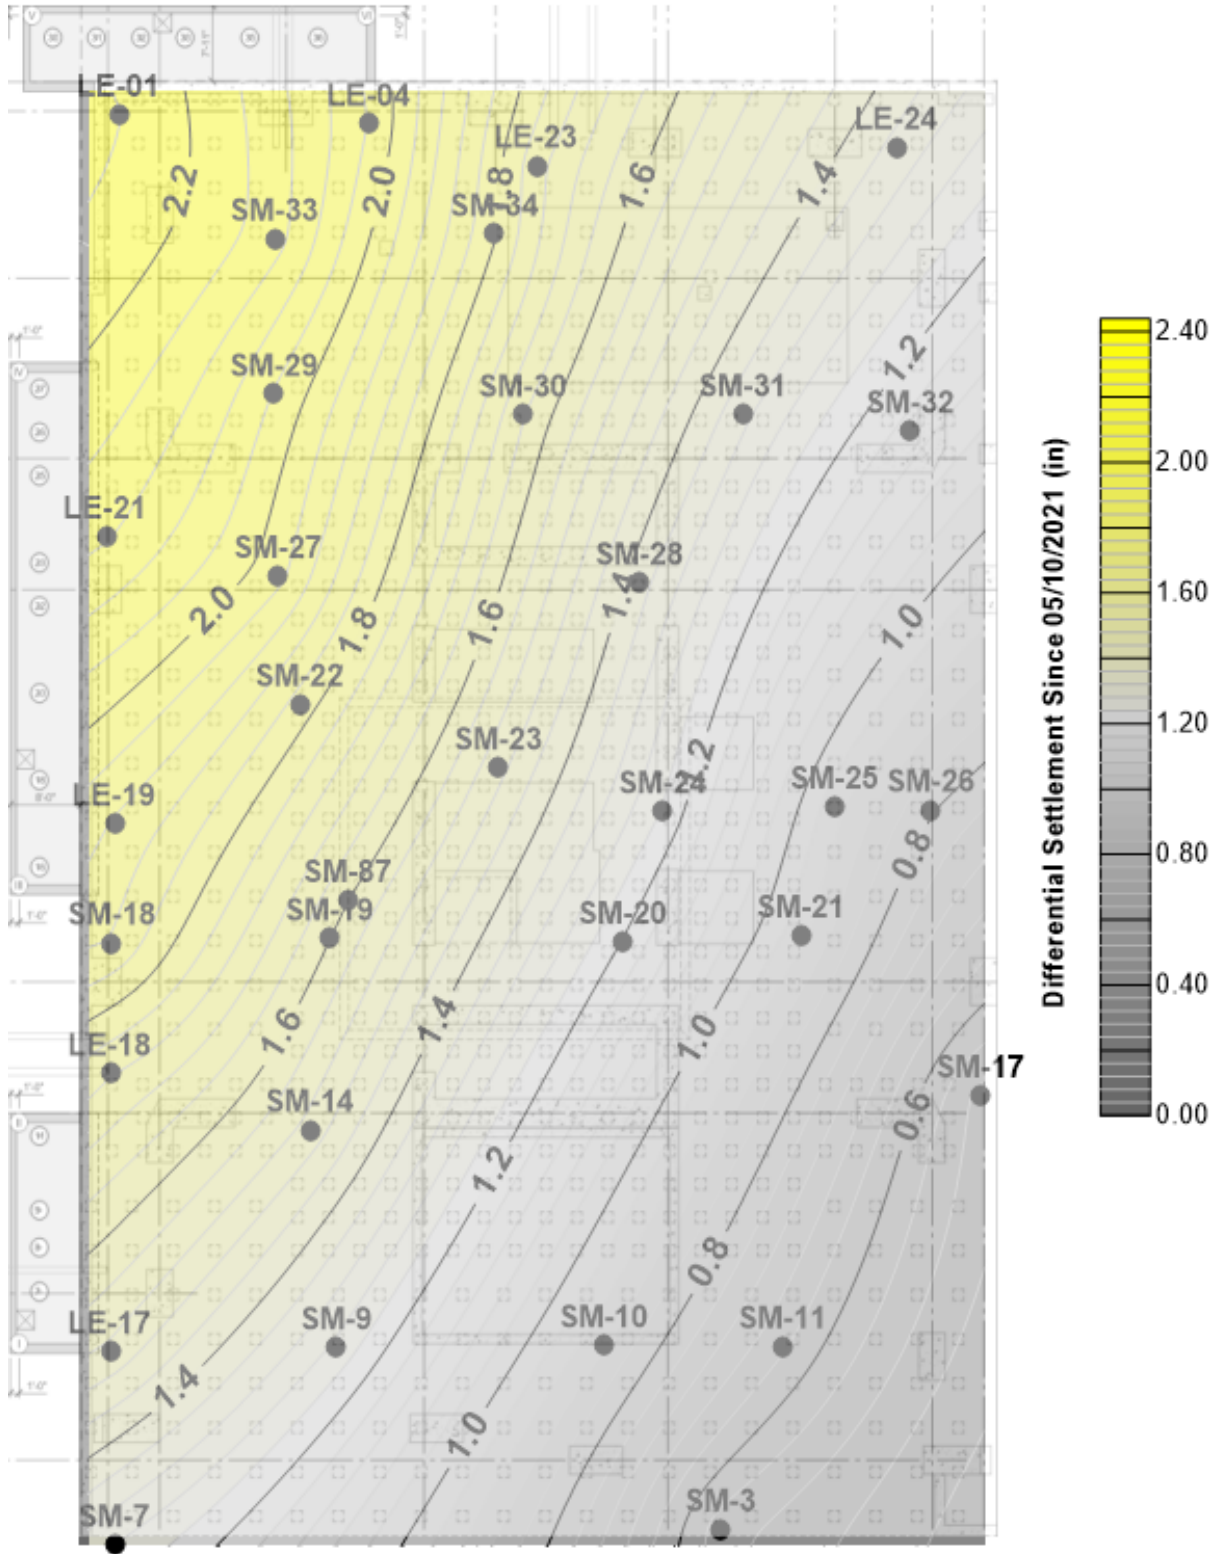
Figure No: **118-04**

**SETTLEMENT CONTOURS
SINCE 05/10/2021 THROUGH 08/07/2023**

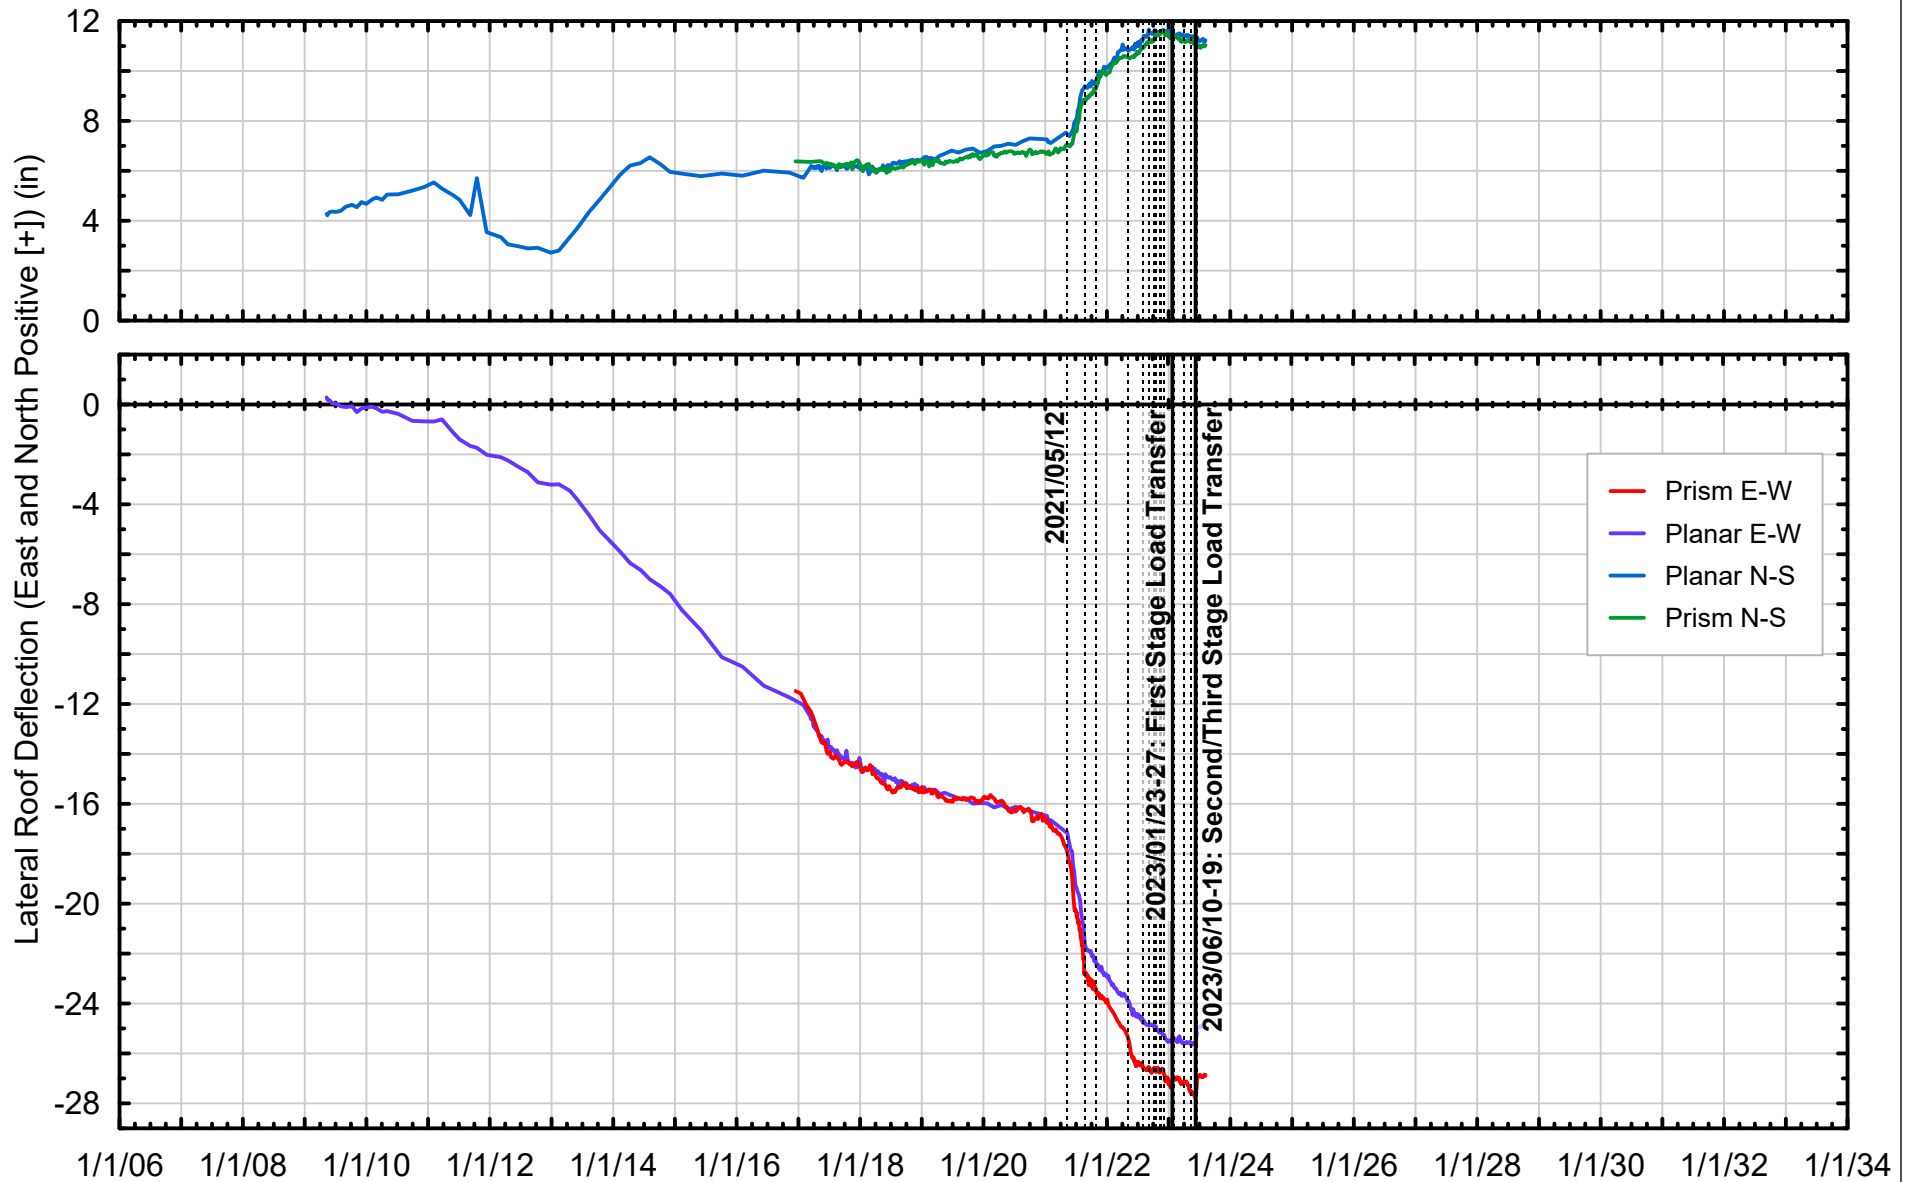
Project No: 19-009.00	Date: 8/8/2023	Created By: NBW	Checked By: DGM	Figure No: 118-05
-----------------------	----------------	-----------------	-----------------	-------------------

HISTORICAL LATERAL ROOF DEFLECTION DATA

Figure 05 presents historical lateral roof deflections in the project north-south and project east-west directions interpreted from survey prisms mounted on the exterior of the Tower, from InSAR data, and from a planar fit of the settlement marker data. In addition, data from surveys performed during the retrofit are included. Figure 06A presents lateral roof deflection data from a planar fit of the settlement marker data and from survey prisms mounted on the exterior of the Tower since the start of production pile installation (May 12, 2021; baseline readings on May 10 and 13, 2021, respectively) through August 7, 2023. Figure 06B presents lateral roof deflection data from a planar fit of the settlement marker data and from survey prisms mounted on the exterior of the Tower since January 11, 2021, through August 7, 2023.

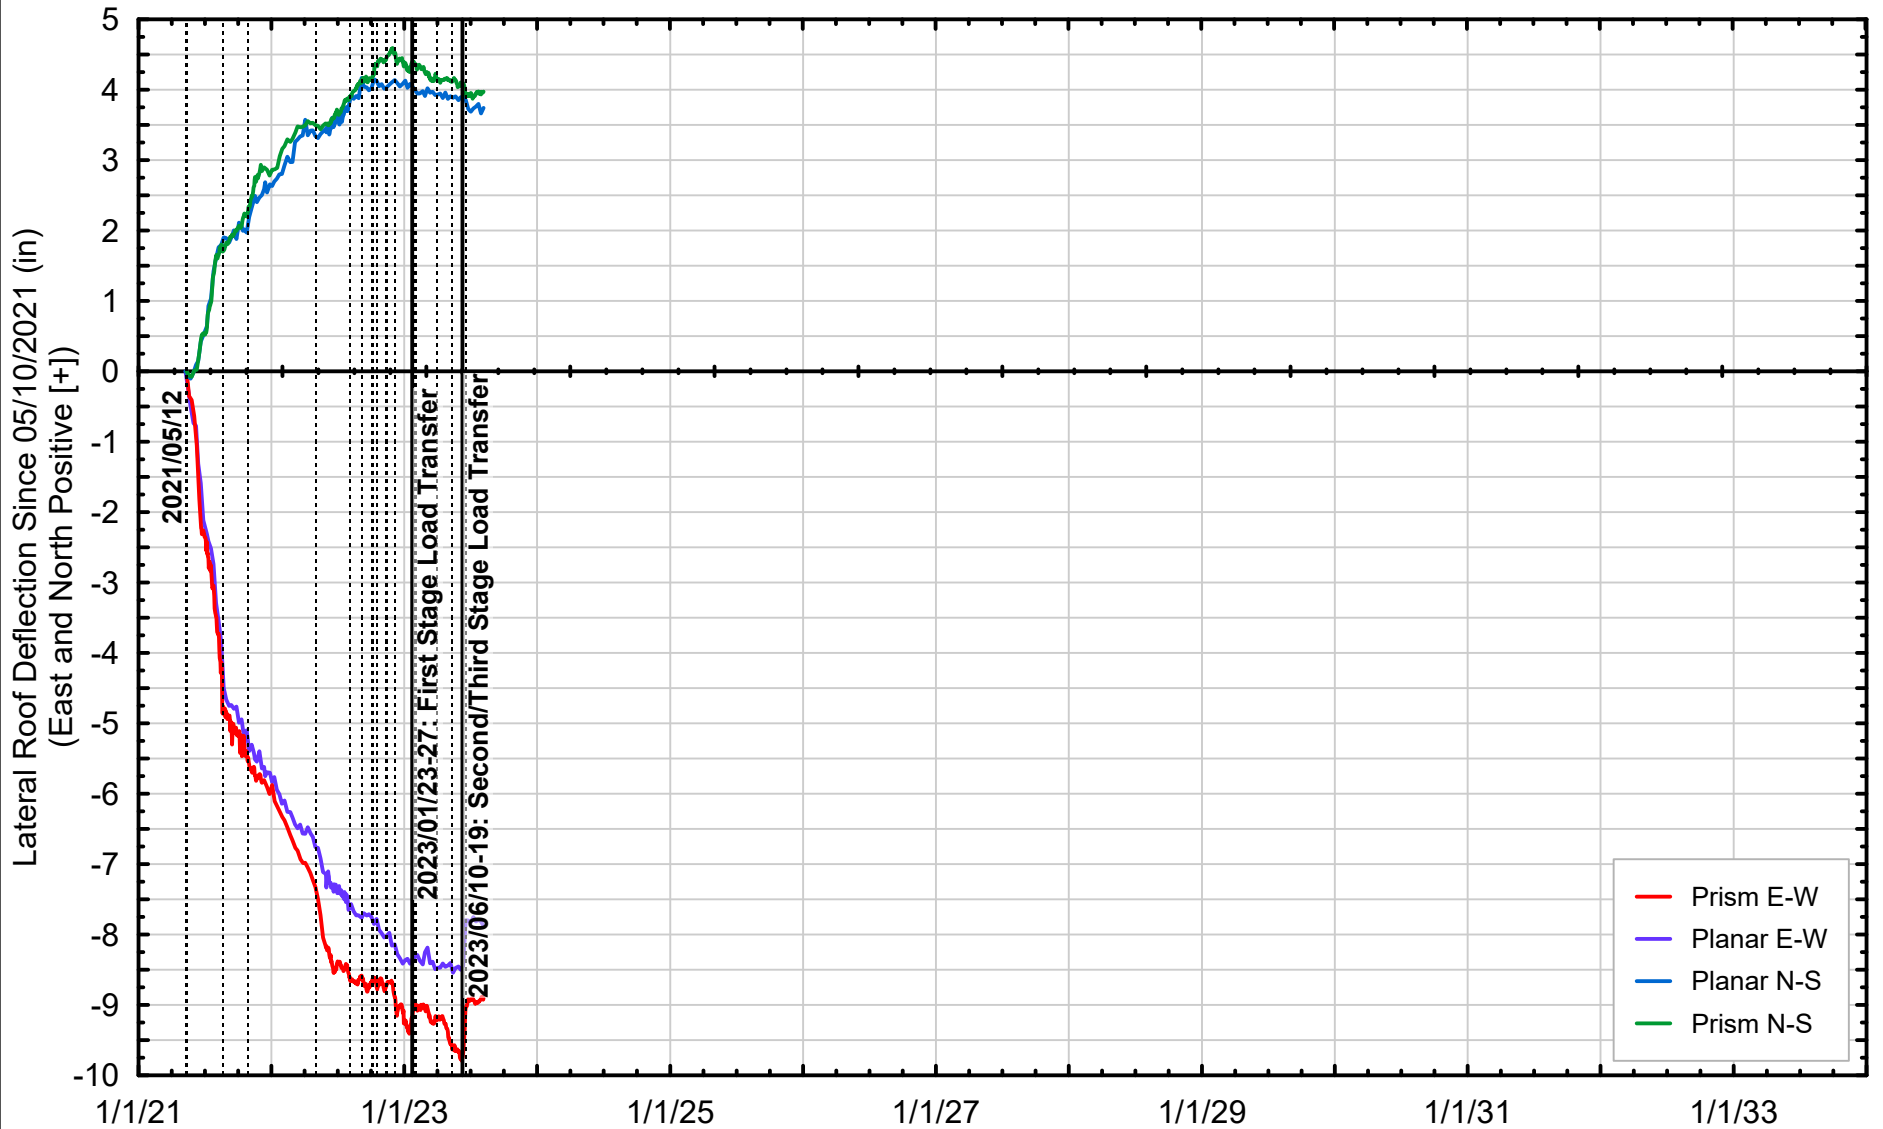
Project No: 19-009.00	Date: 8/8/2023	Created By: NBW	Checked By: DGM	Figure No: 118-06A
-----------------------	----------------	-----------------	-----------------	--------------------

LATERAL ROOF DEFLECTION DATA
SINCE 05/10/2021 THROUGH 08/07/2023

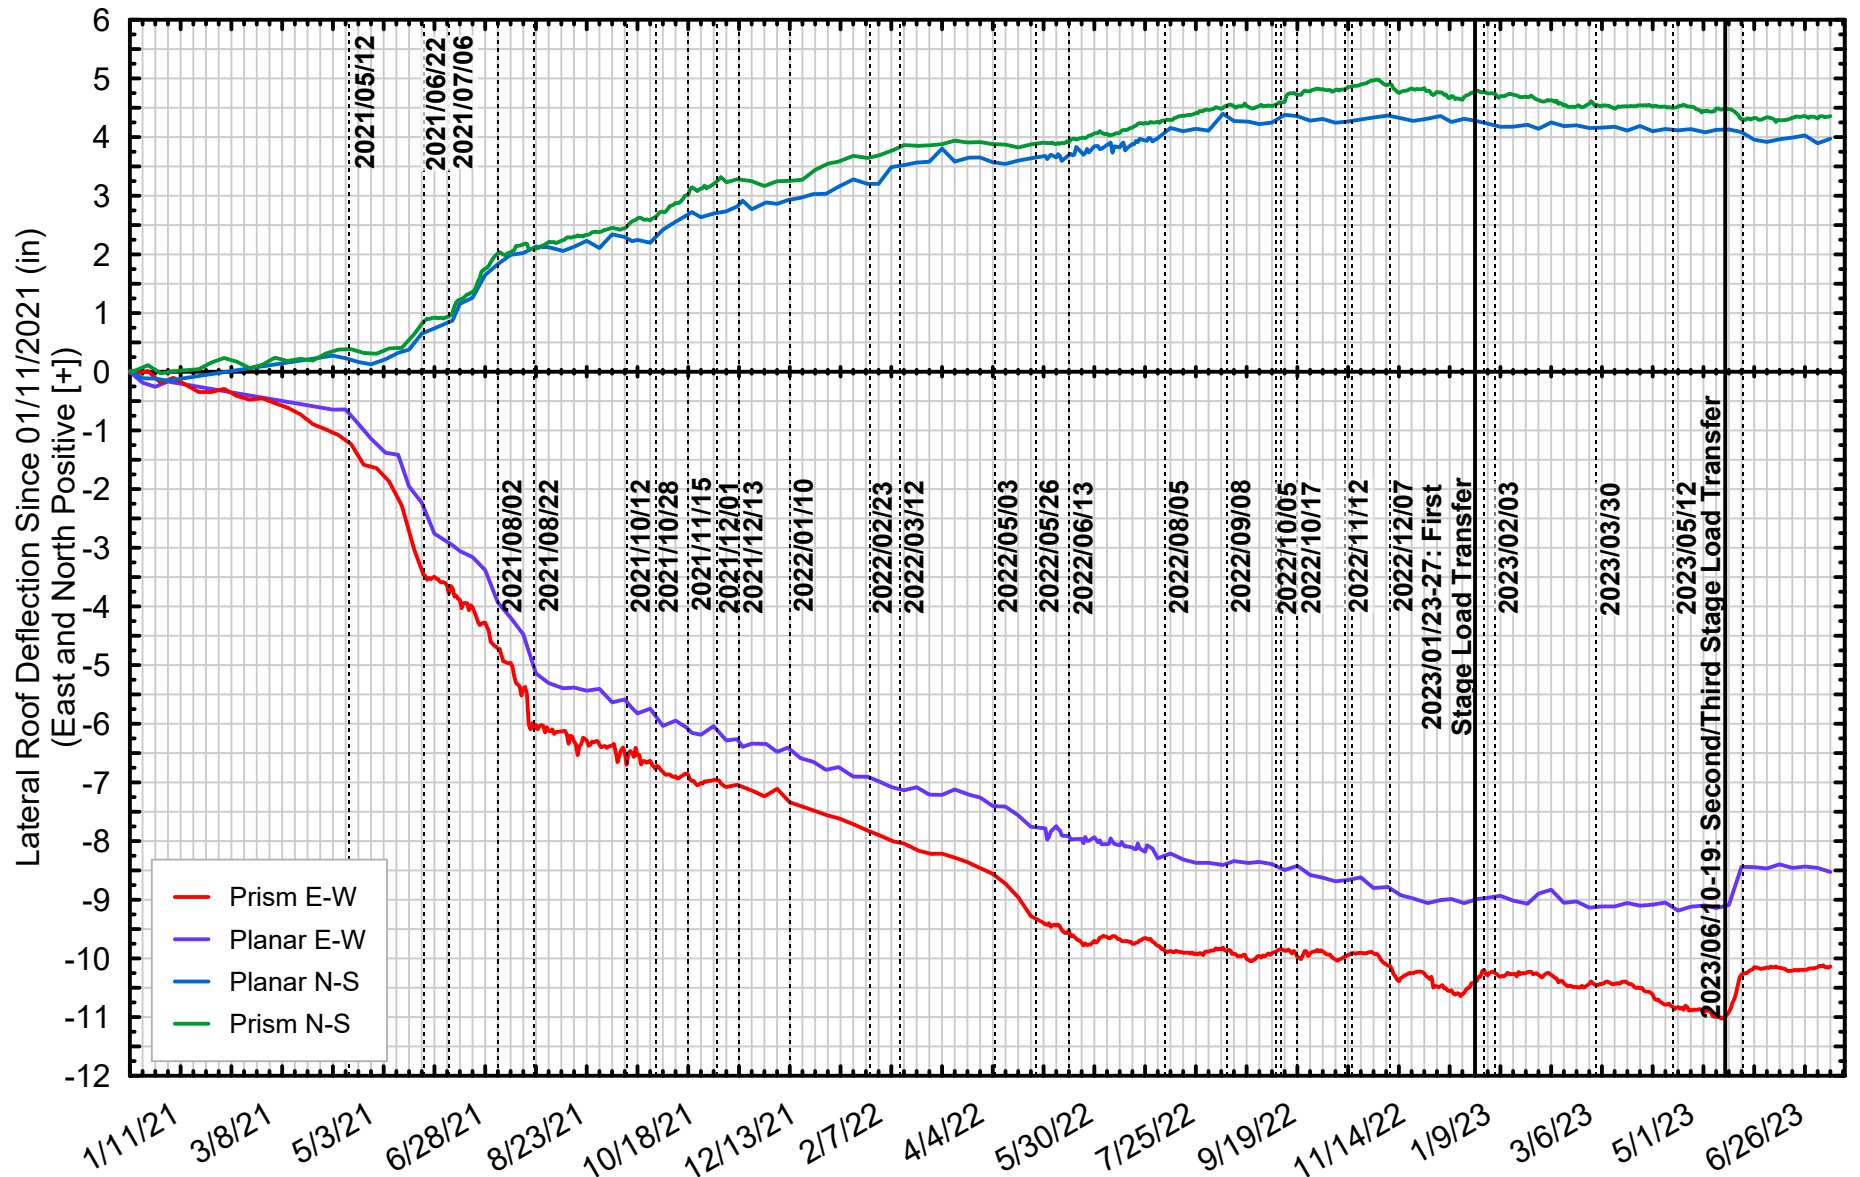
Project No: 19-009.00 Date: 8/8/2023 Created By: NBW Checked By: DGM Figure No: 118-06B

LATERAL ROOF DEFLECTION DATA
SINCE 01/11/2021 THROUGH 08/07/2023

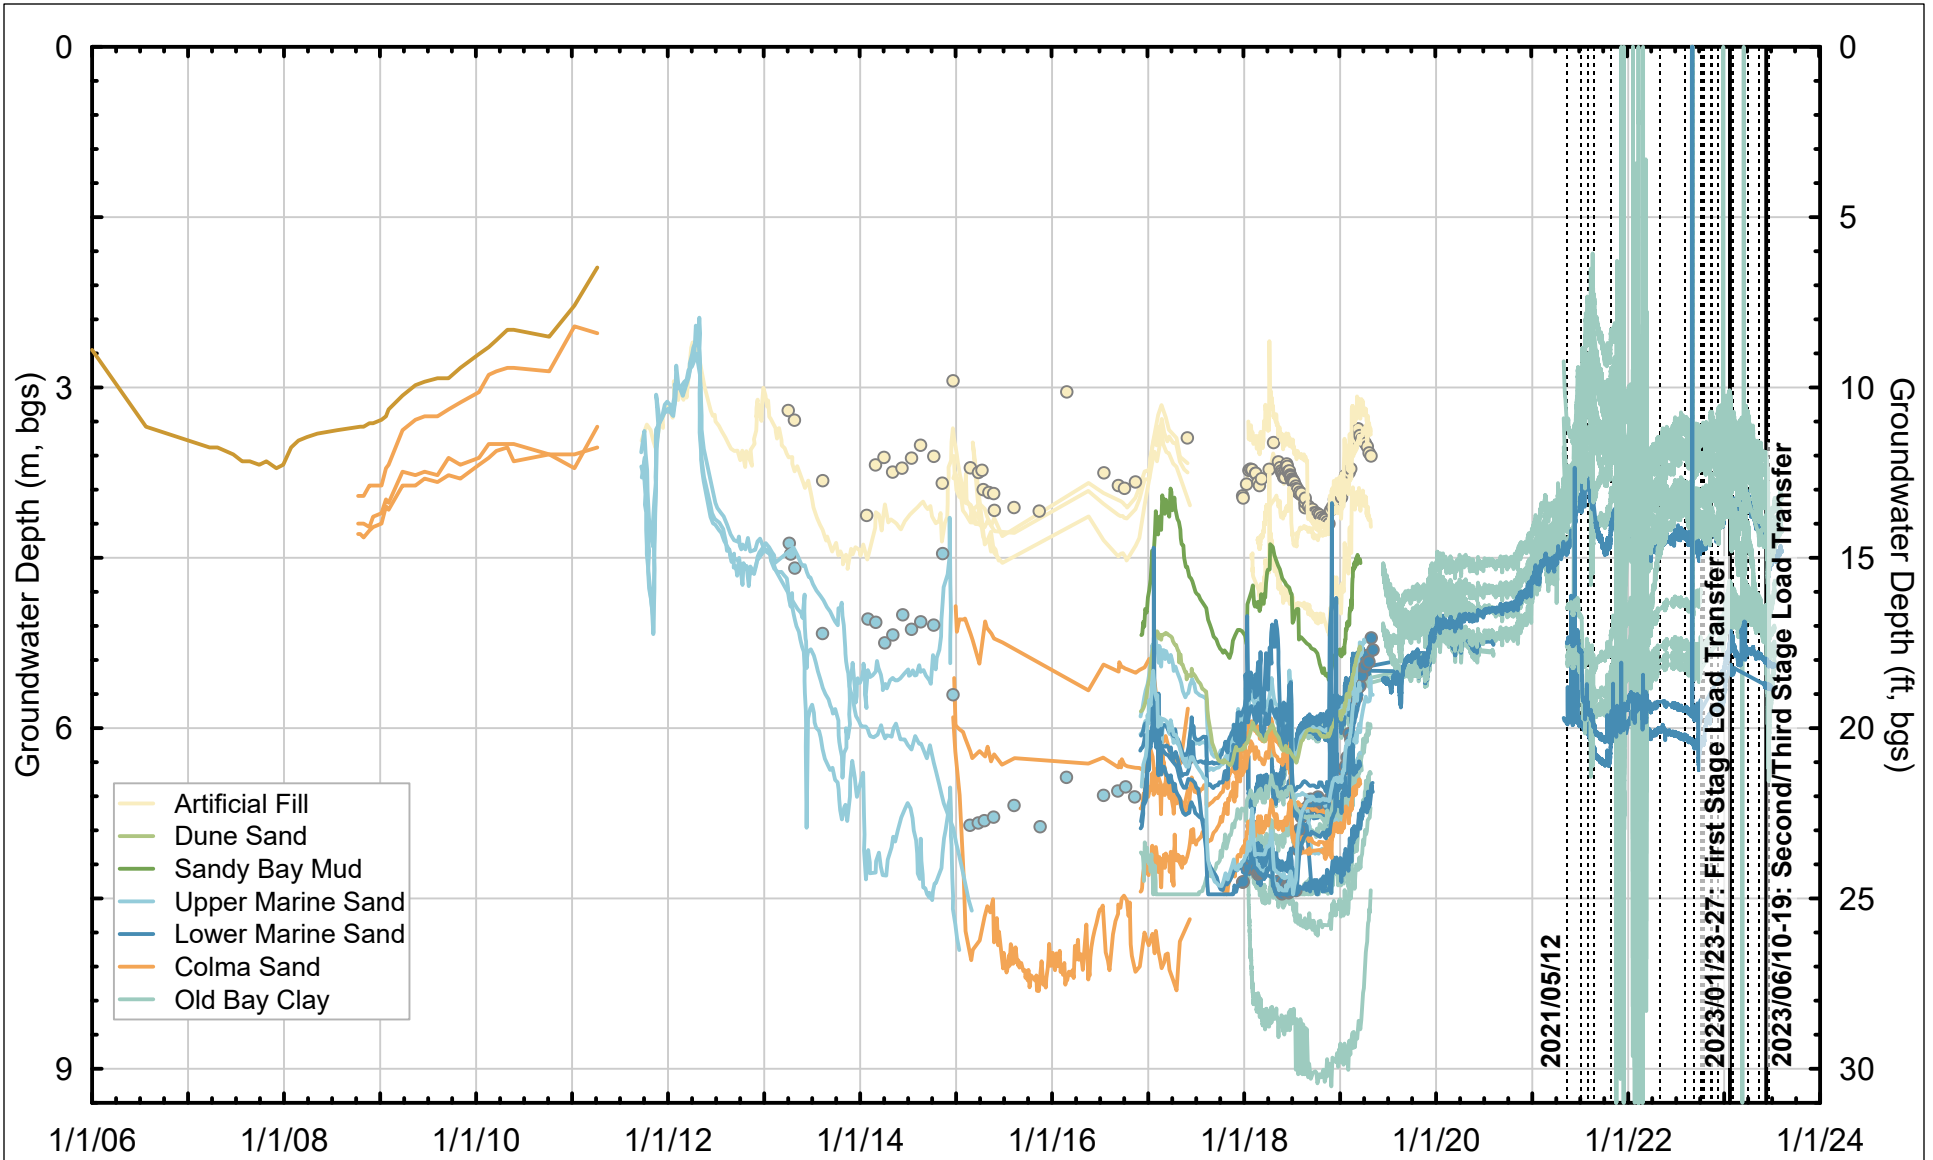
Project No: 19-009.00	Date: 8/8/2023	Created By: NBW	Checked By: DGM	Figure No: 118-07
-----------------------	----------------	-----------------	-----------------	-------------------

HISTORICAL GROUNDWATER ELEVATION MEASUREMENTS
AT LOCATIONS NEAR 301 MISSION

Figure 07 presents the historical groundwater elevation interpreted from piezometer readings at locations near 301 Mission. In addition, data from piezometers installed to monitor groundwater elevation during the retrofit are included. Figures 08 and 09 present groundwater elevation interpreted from piezometer readings in the Marine/Colma Sand and the Old Bay Clay, respectively, for the time period prior to the start of production pile installation (January 1, 2021) through August 7, 2023.

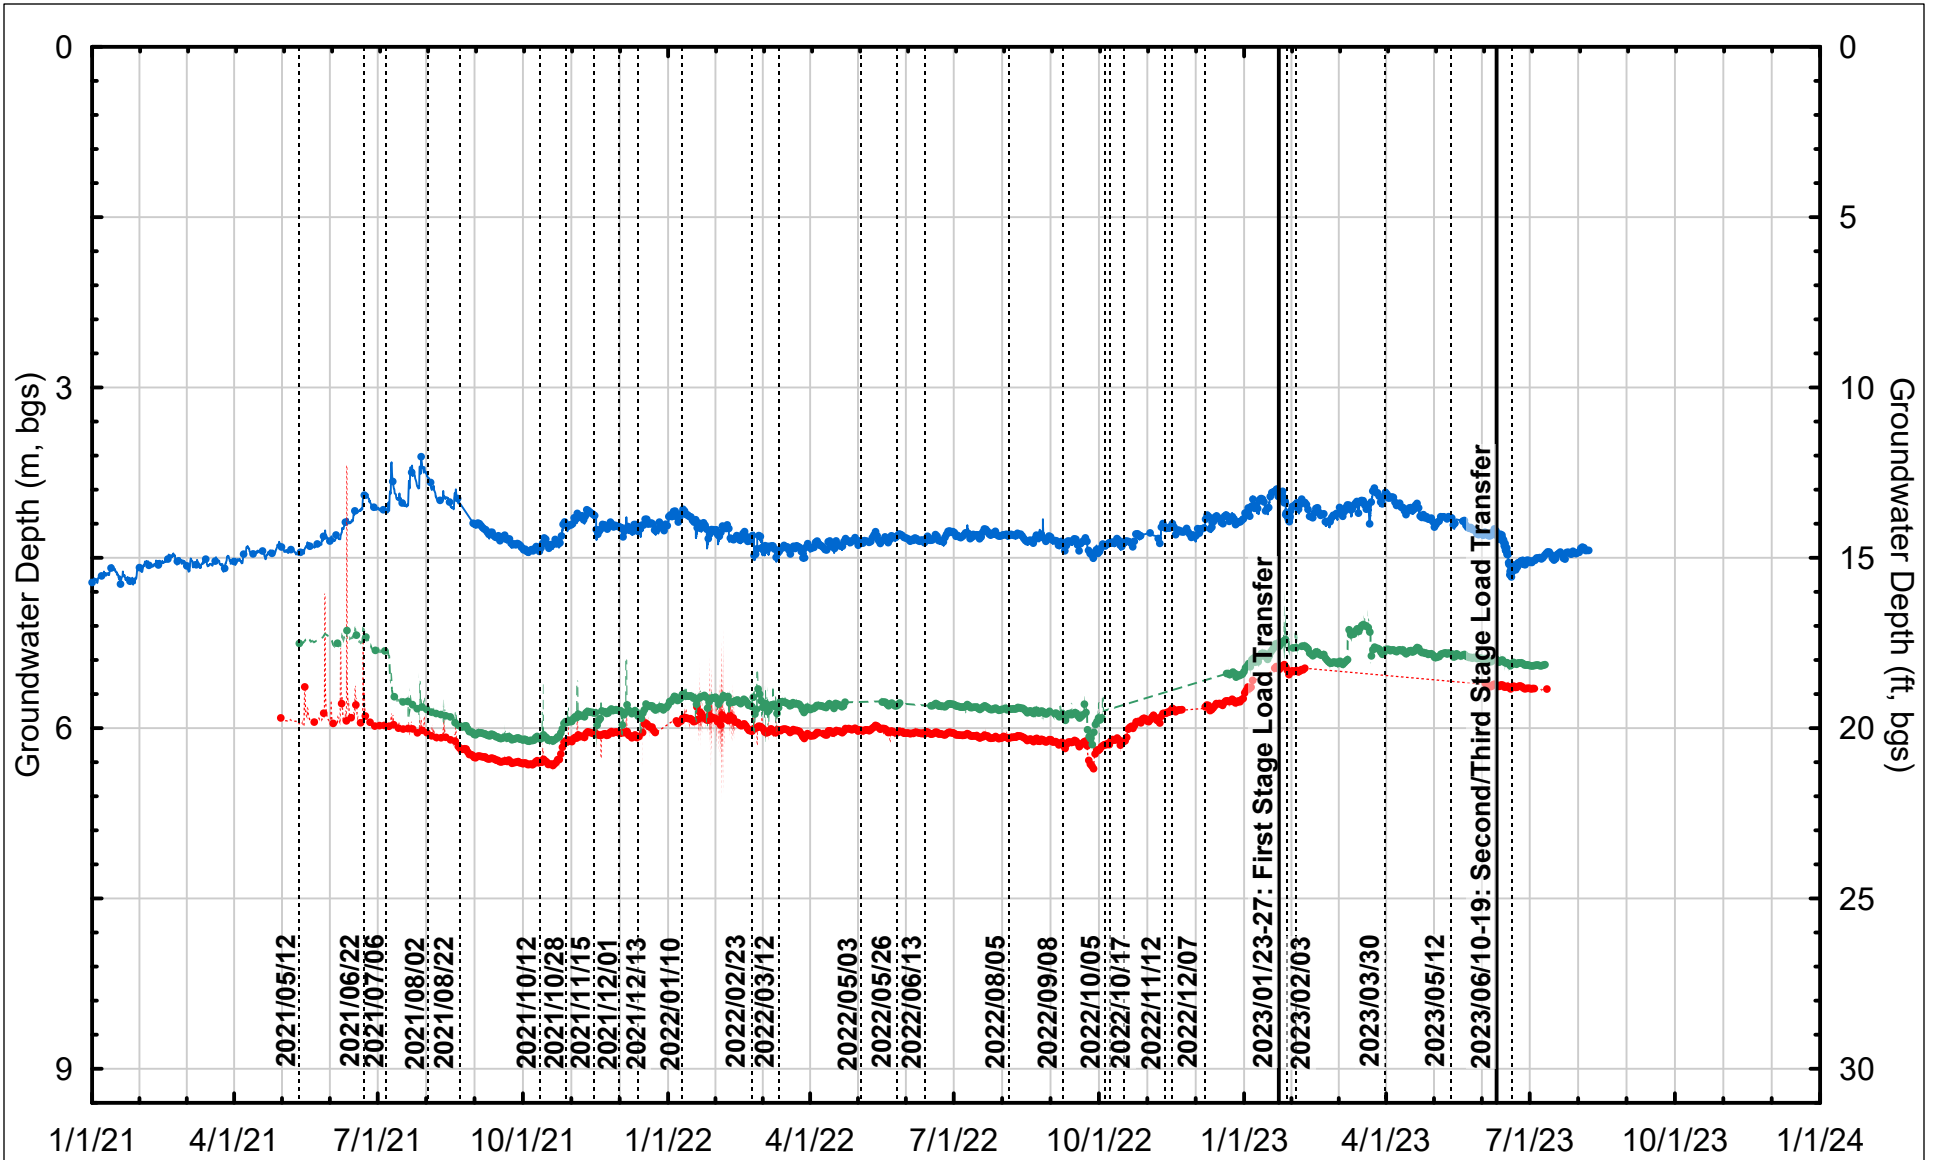
Project No: 19-009.00	Date: 8/8/2023	Created By: NBW	Checked By: DGM	Figure No: 118-08A
-----------------------	----------------	-----------------	-----------------	---------------------------

GROUNDWATER ELEVATION MEASUREMENTS IN MARINE AND COLMA SAND
SINCE 01/01/2021 THROUGH 08/07/2023
