Subject: 301 Mission Retrofit Monitoring Report 118: Results as of August 7, 2023

Millennium Tower Perimeter Pile Upgrade: Instrumentation Monitoring Data
City and County of San Francisco, California

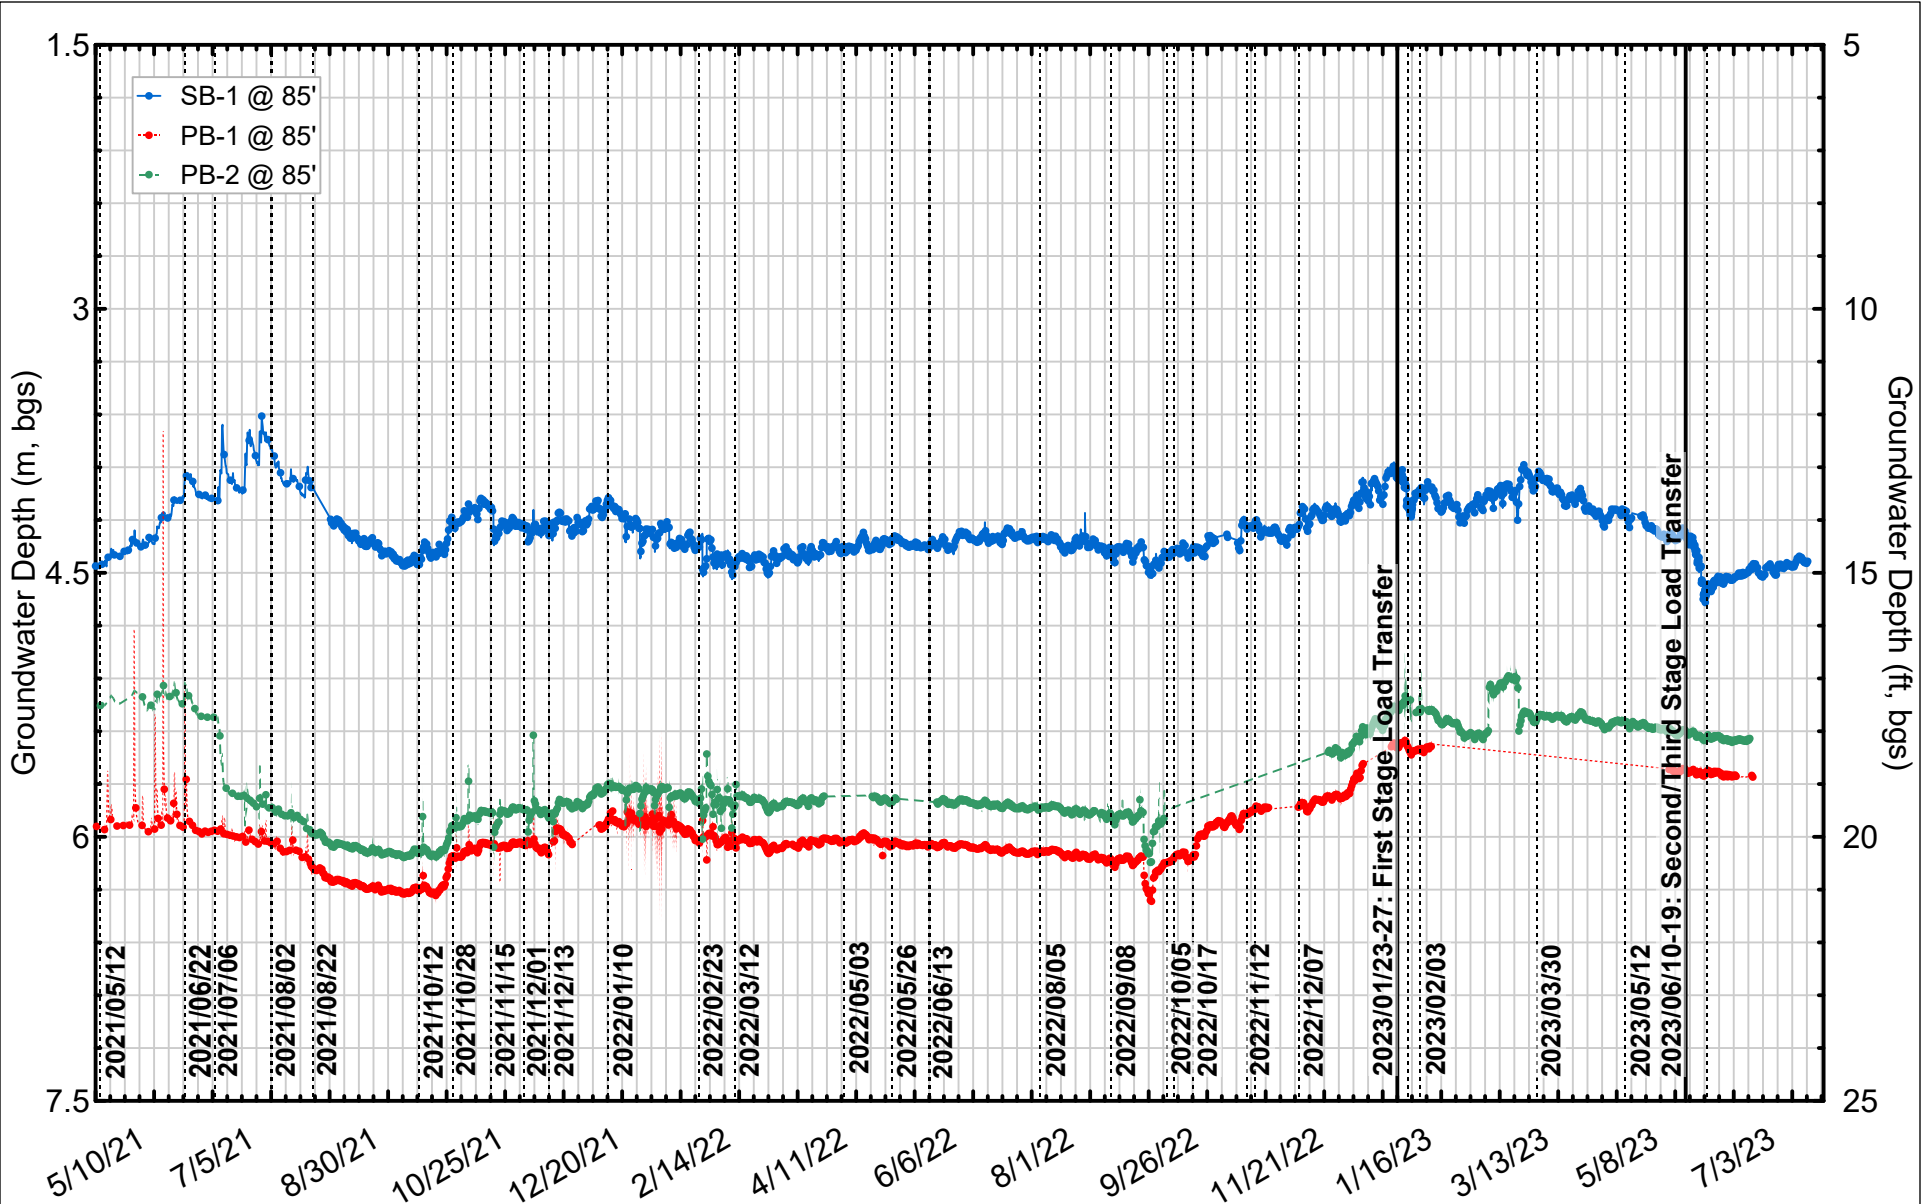
Project No: 19-009.00	Date: 8/8/2023	Created By: NBW	Checked By: DGM	Figure No: 118-08B
-----------------------	----------------	-----------------	-----------------	---------------------------

GROUNDWATER ELEVATION MEASUREMENTS IN MARINE AND COLMA SAND
SINCE 05/10/2021 THROUGH 08/07/2023

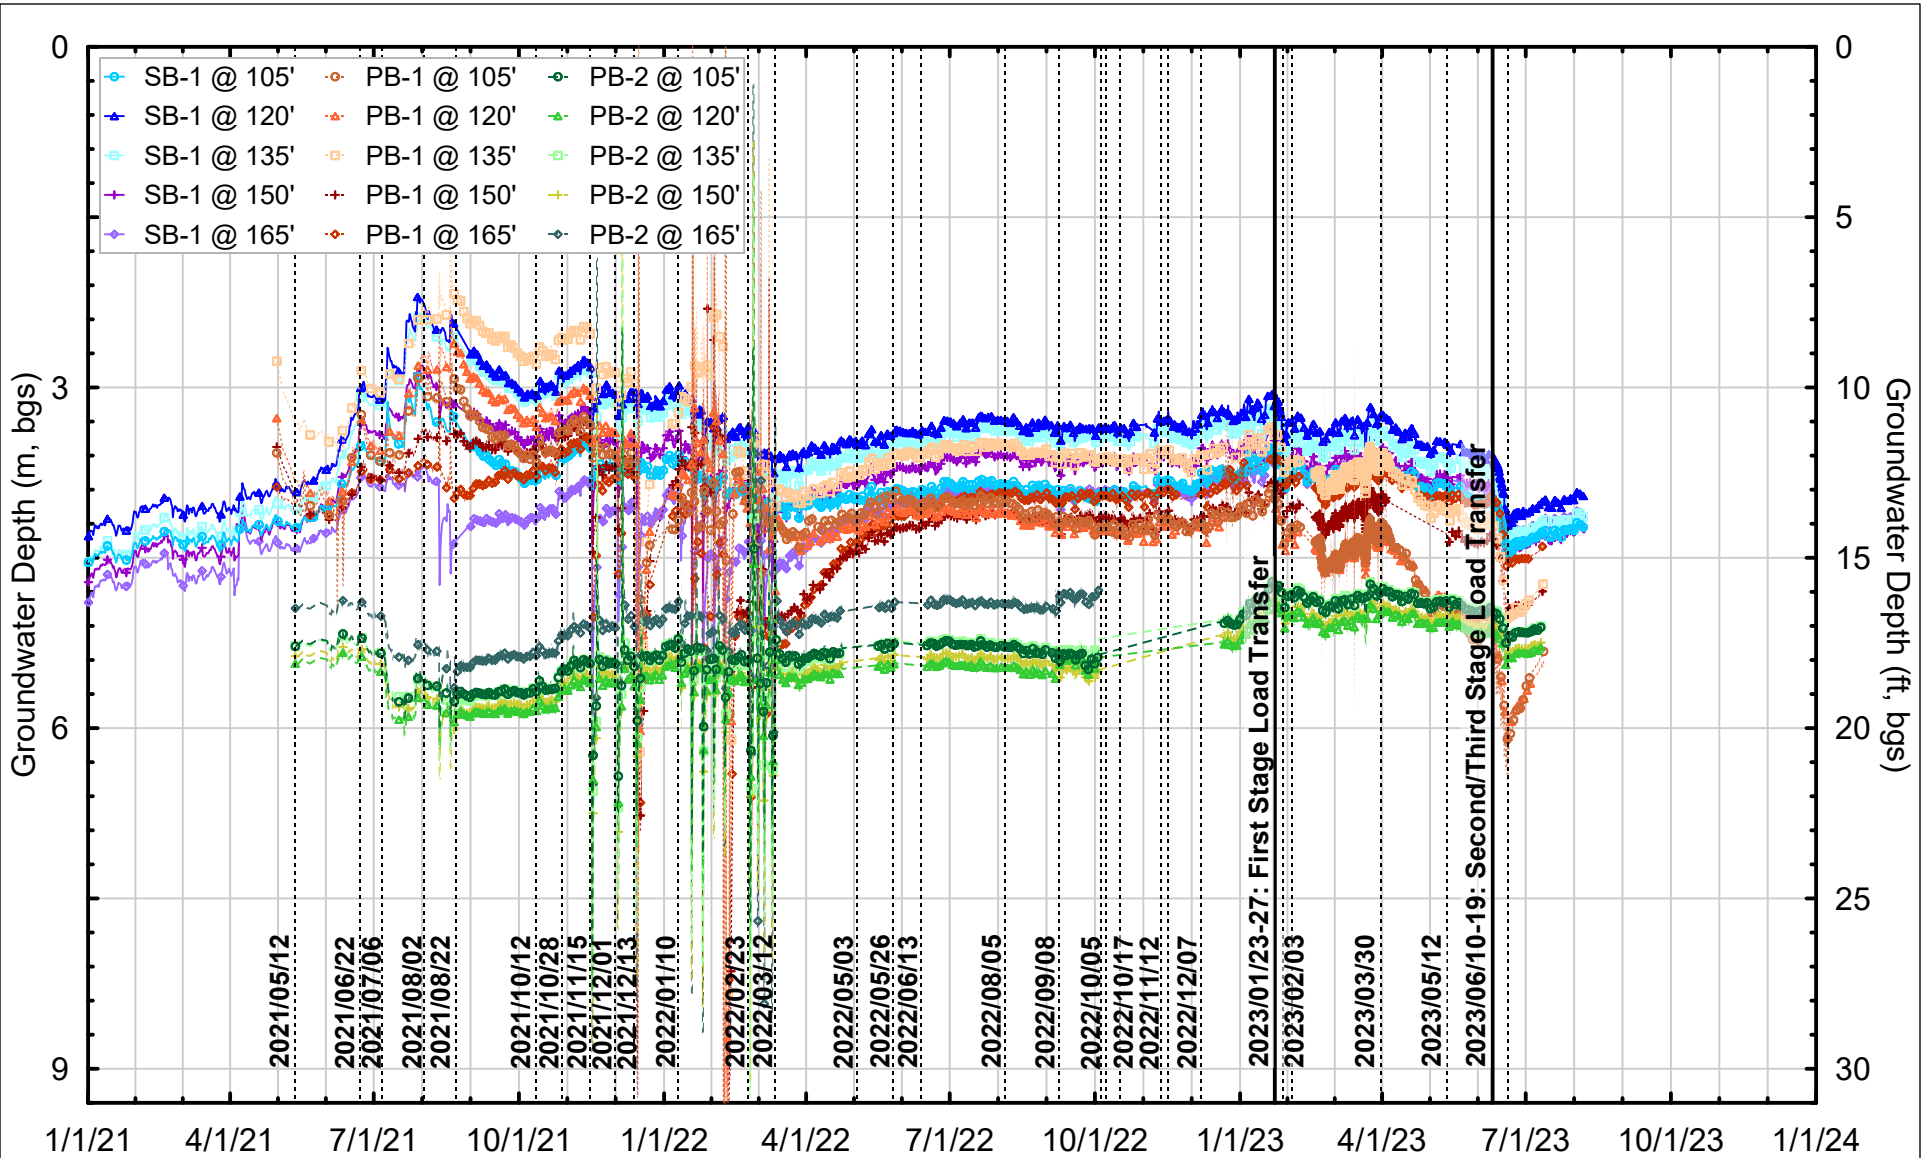
Project No: 19-009.00	Date: 8/8/2023	Created By: NBW	Checked By: DGM	Figure No: 118-09A
-----------------------	----------------	-----------------	-----------------	---------------------------

GROUNDWATER ELEVATION MEASUREMENTS IN OLD BAY CLAY
 SINCE 01/01/2021 THROUGH 08/07/2023

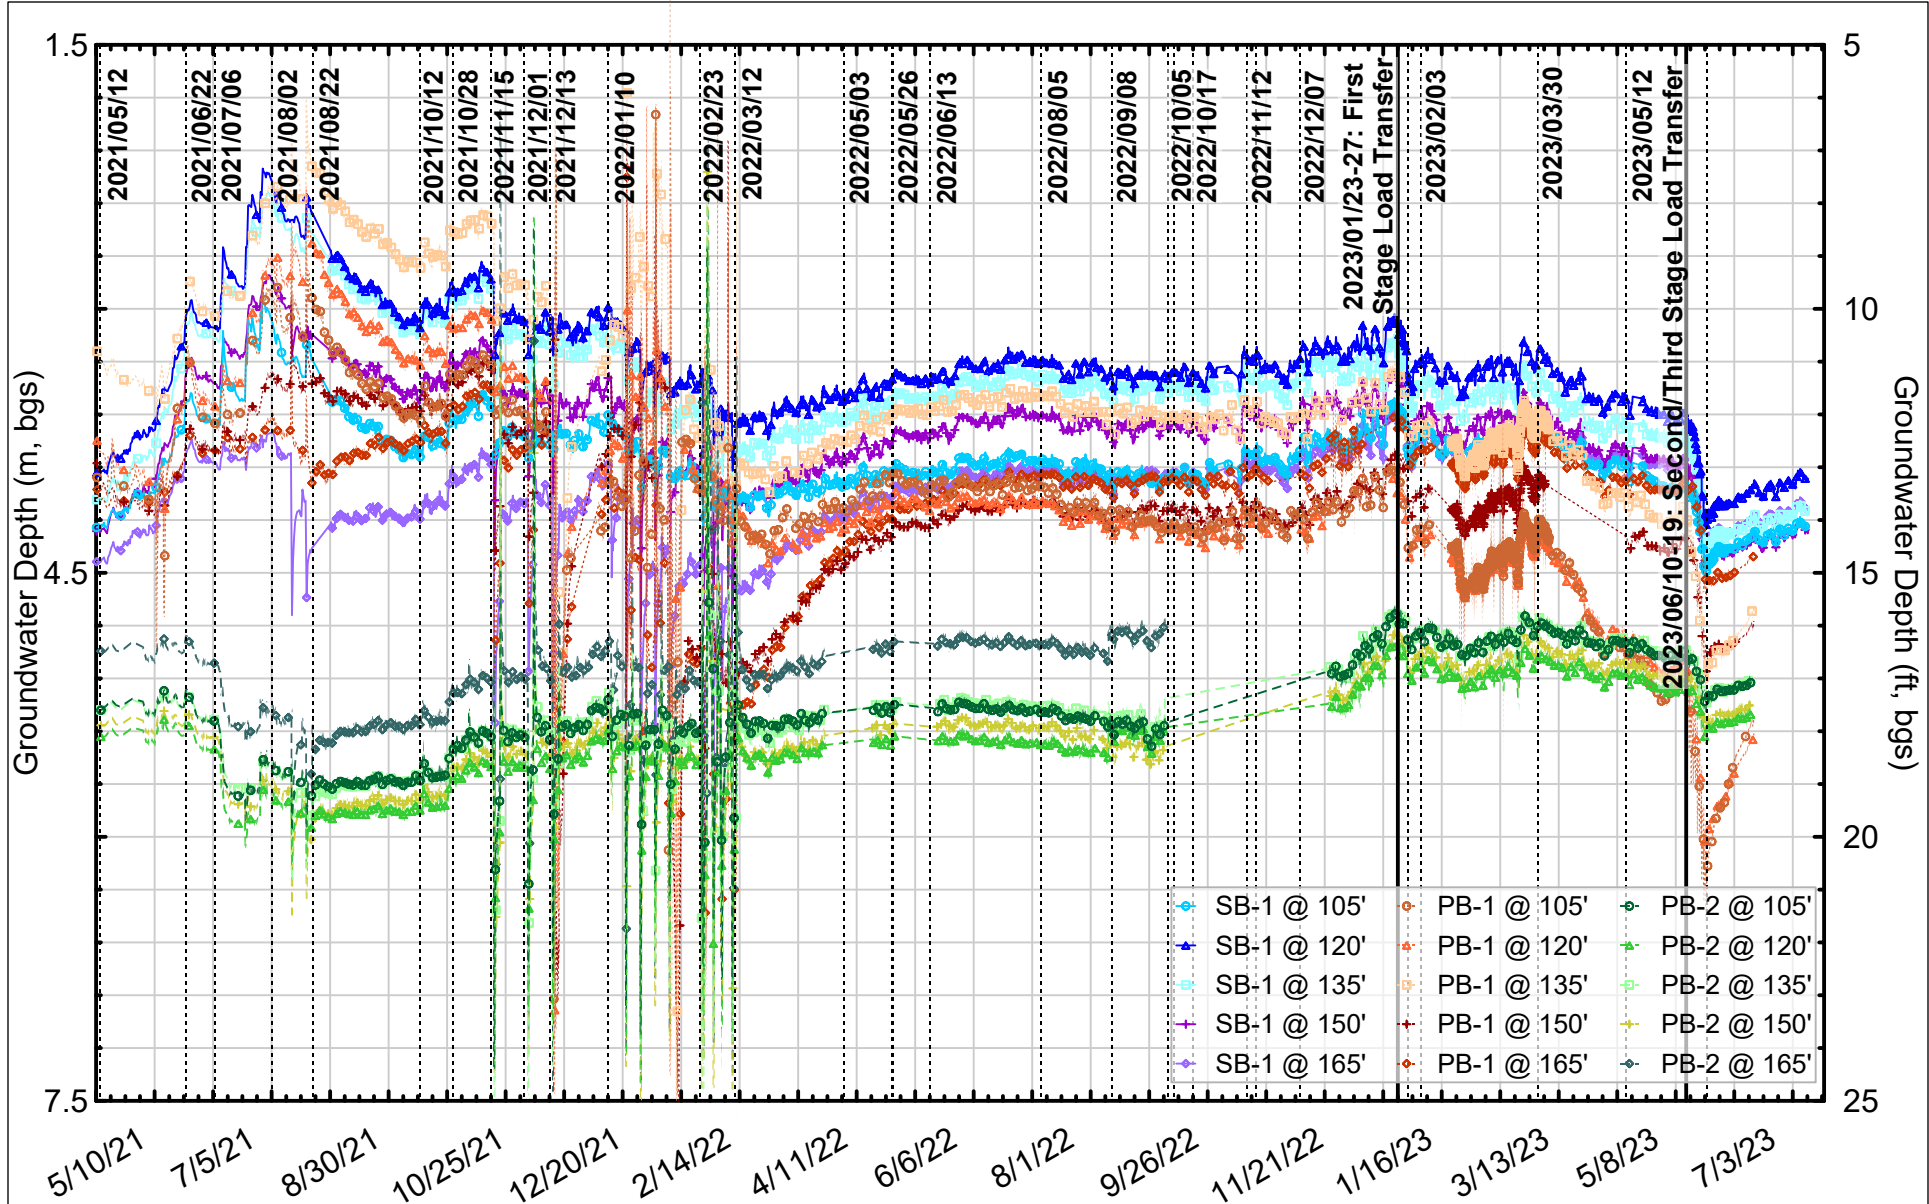
Project No: 19-009.00	Date: 8/8/2023	Created By: NBW	Checked By: DGM	Figure No: 118-09B
-----------------------	----------------	-----------------	-----------------	---------------------------

GROUNDWATER ELEVATION MEASUREMENTS IN OLD BAY CLAY
SINCE 05/10/2021 THROUGH 08/07/2023

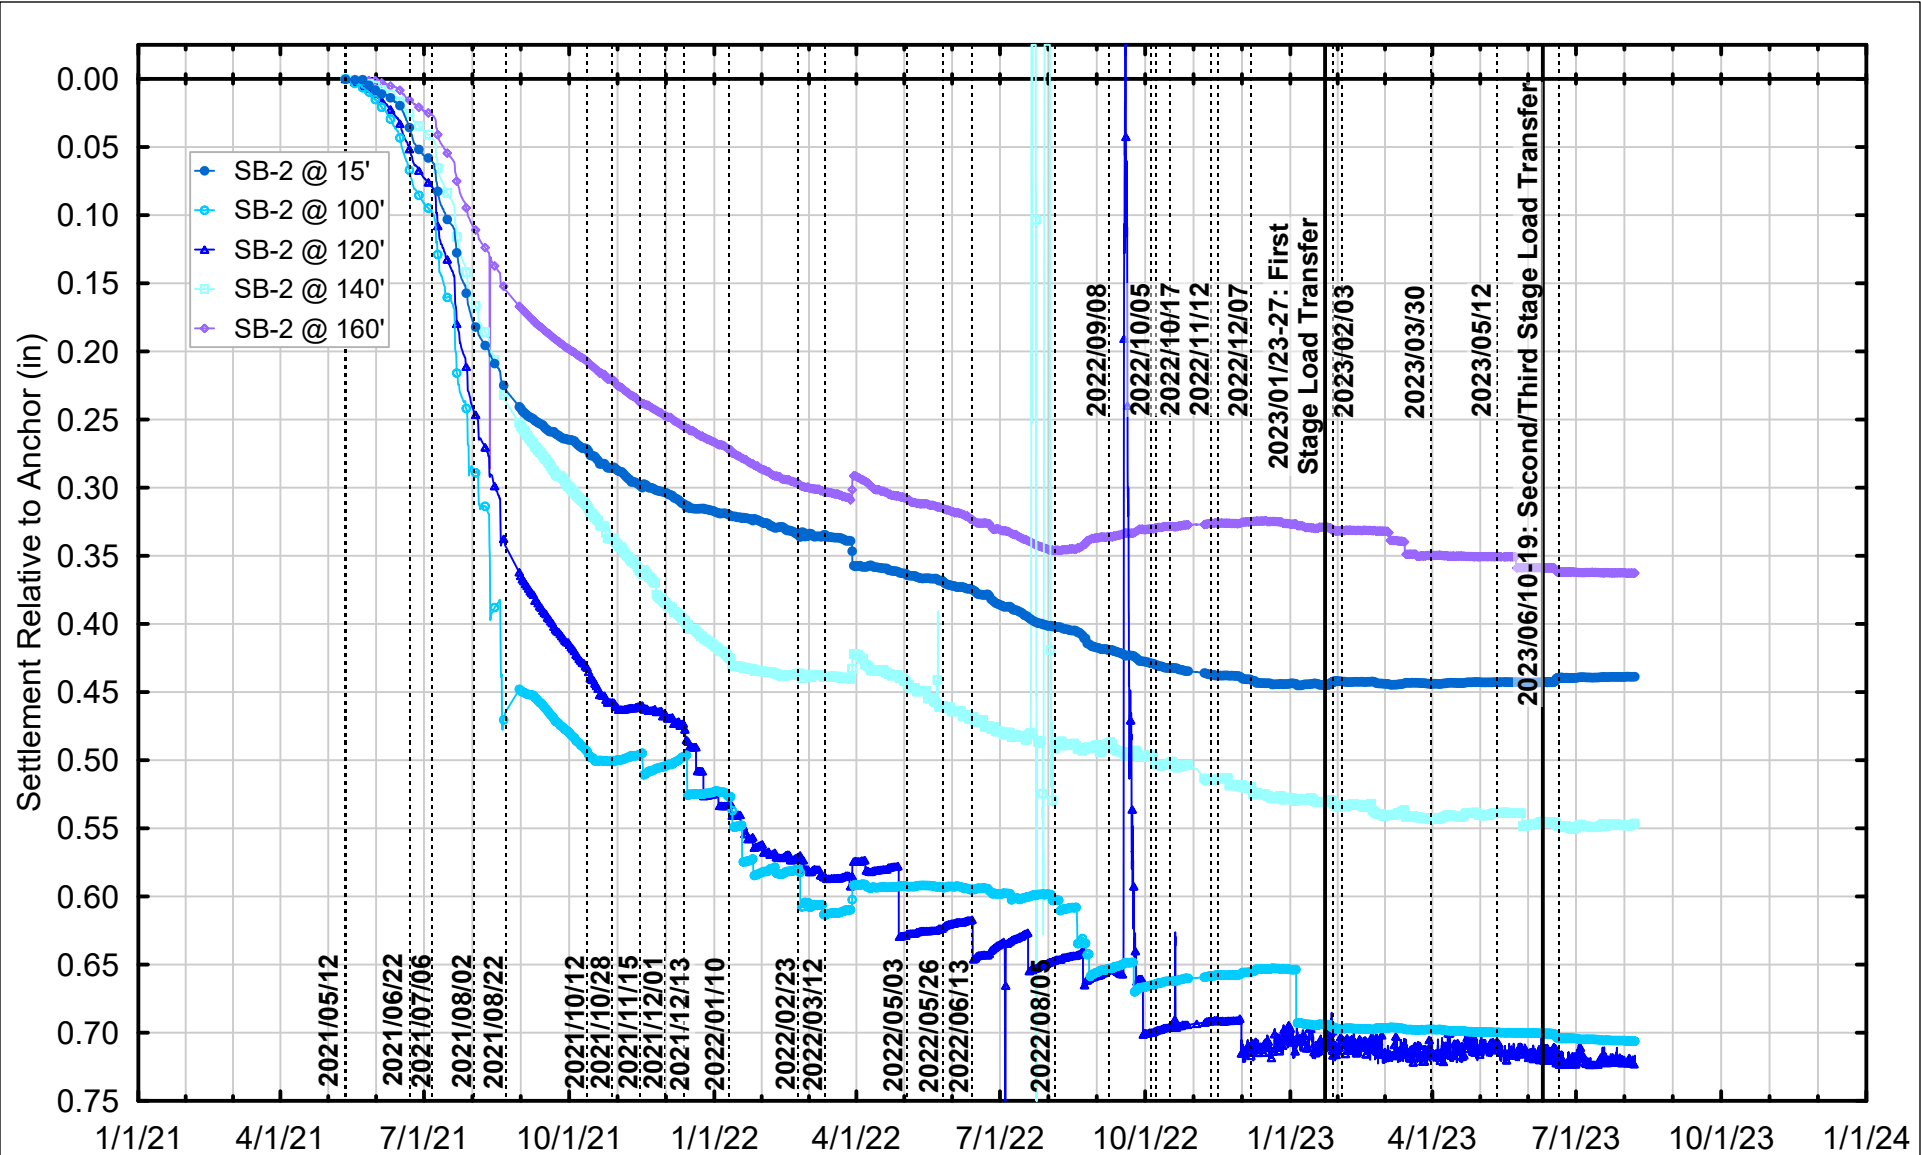
Project No: 19-009.00	Date: 8/8/2023	Created By: NBW	Checked By: DGM	Figure No: 118-10A
-----------------------	----------------	-----------------	-----------------	---------------------------

EXTENSOMETER DATA FROM WITHIN TOWER BASEMENT
SINCE 01/01/2021 THROUGH 08/07/2023

Figure 10 presents extensometer data from within the Tower basement since the start of production pile installation (May 12, 2021) through August 7, 2023. Figure 11 presents extensometer data from Fremont Street since the start of production pile installation (May 12, 2021) through May 16, 2023, and from the restart after fixing the extensometer (May 30, 2023) through July 14, 2023. Figure 12 presents extensometer data from Mission Street since the start of production pile installation (May 12, 2021) through July 10, 2023.

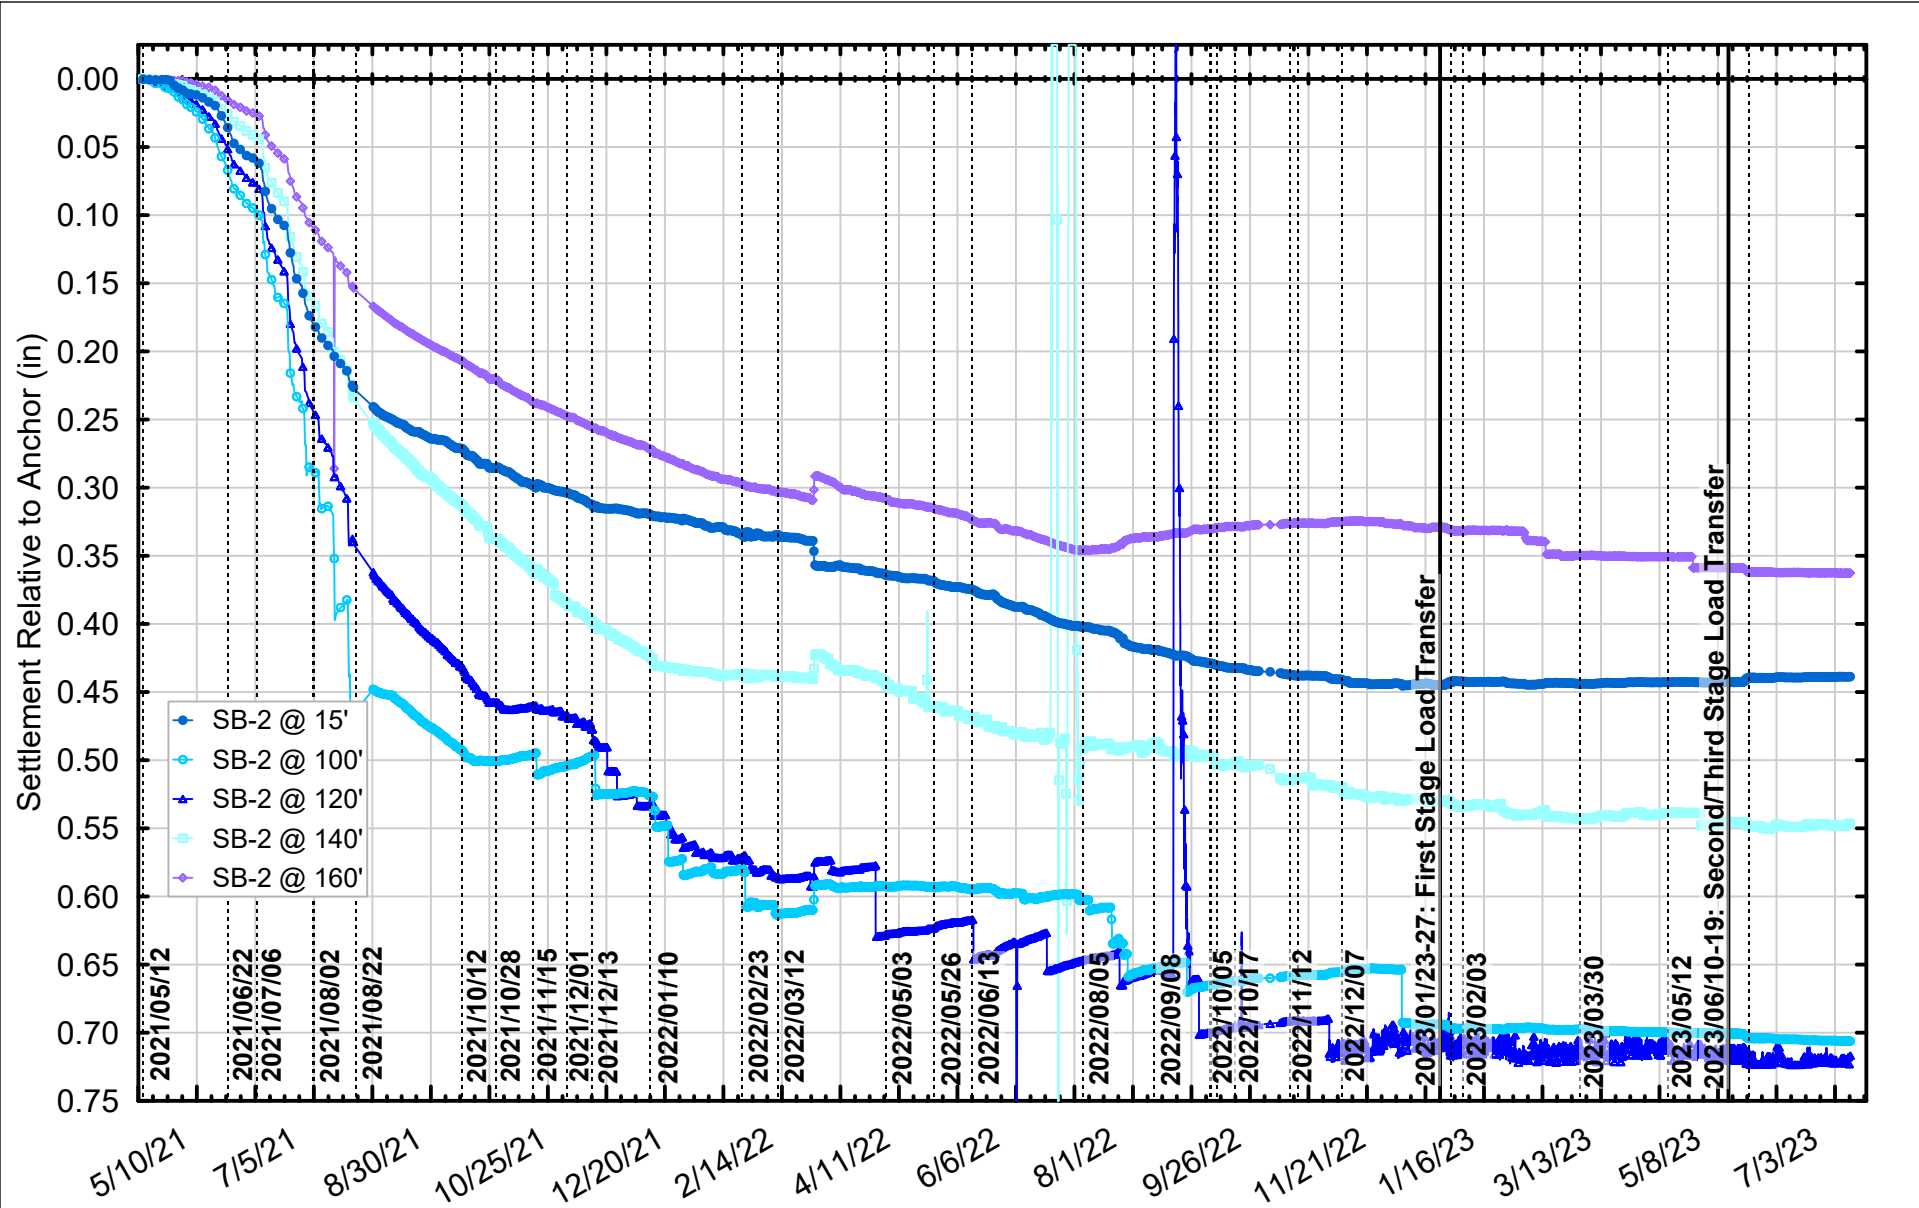
Project No: 19-009.00	Date: 8/8/2023	Created By: NBW	Checked By: DGM	Figure No: 118-10B
-----------------------	----------------	-----------------	-----------------	--------------------

EXTENSOMETER DATA FROM WITHIN TOWER BASEMENT
SINCE 05/10/2021 THROUGH 08/07/2023

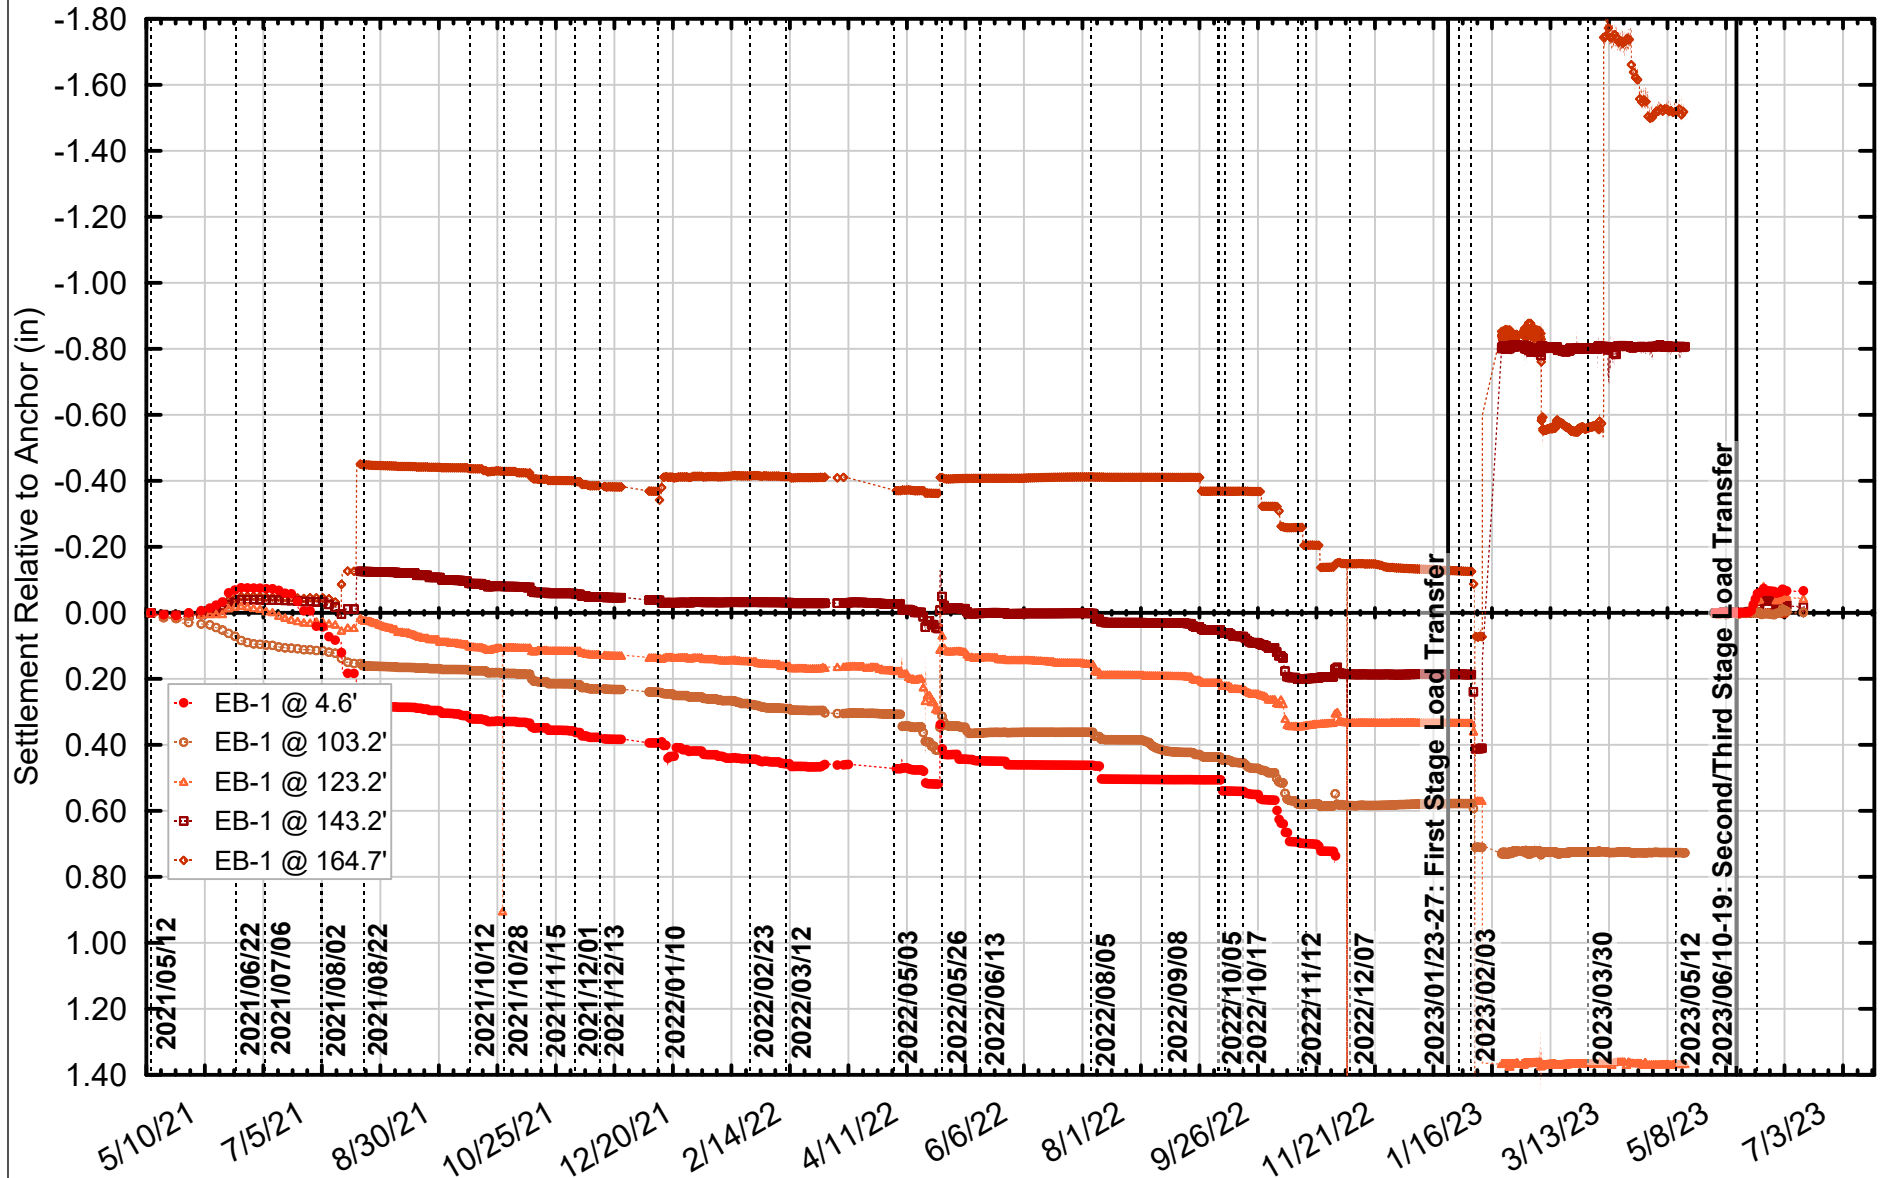
Figure No: 118-11B

Note: EB-1 was repaired and reset on 2023/05/30

EXTENSOMETER DATA FROM FREMONT STREET
 SINCE 05/10/2021 THROUGH 05/16/2023
 SINCE 05/30/2023 THROUGH 07/14/2023
 Millennium Tower Perimeter Pile Upgrade: Instrumentation Monitoring Data
 City and County of San Francisco, California

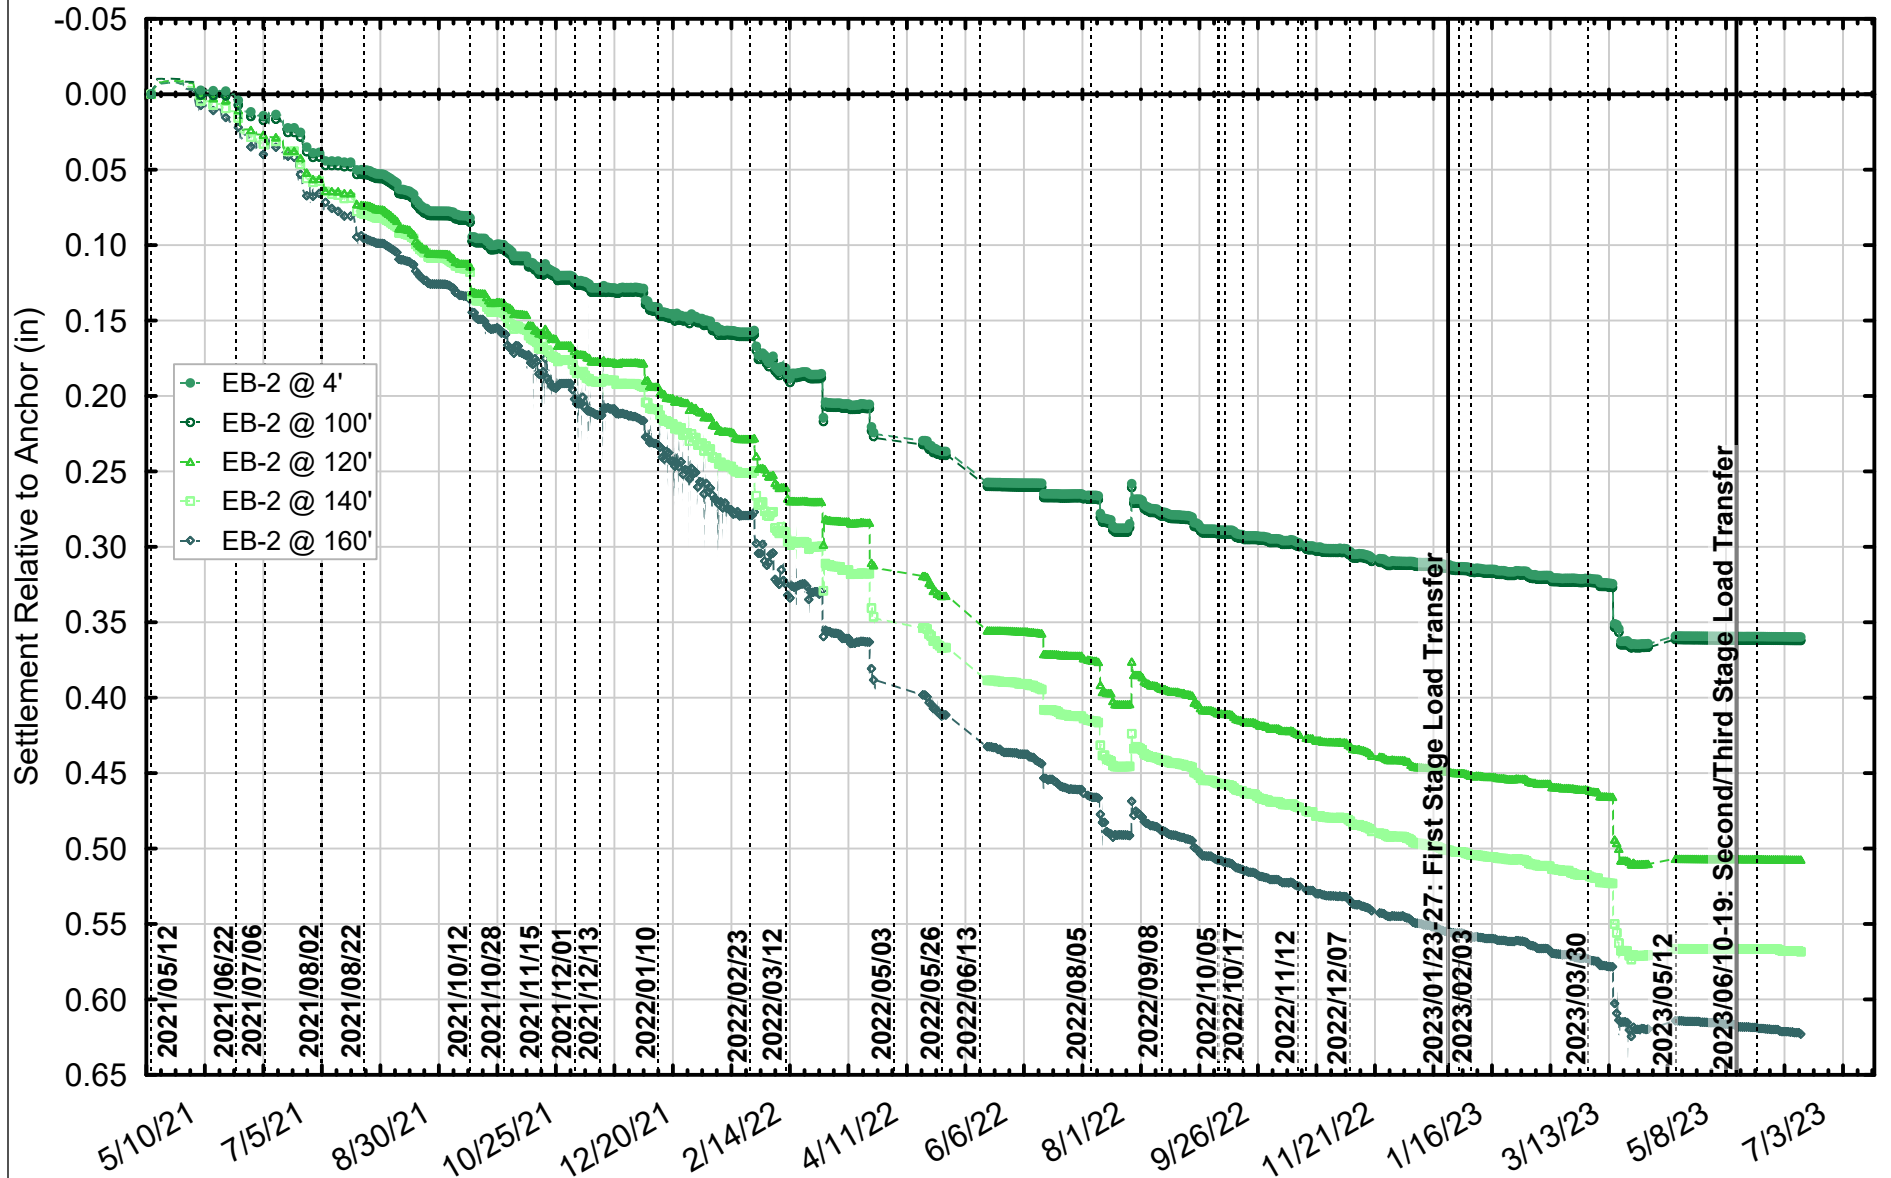
Project No: 19-009.00 Date: 8/8/2023 Created By: NBW Checked By: DGM Figure No: 118-12B

EXTENSOMETER DATA FROM MISSION STREET
SINCE 05/10/2021 THROUGH 07/10/2023

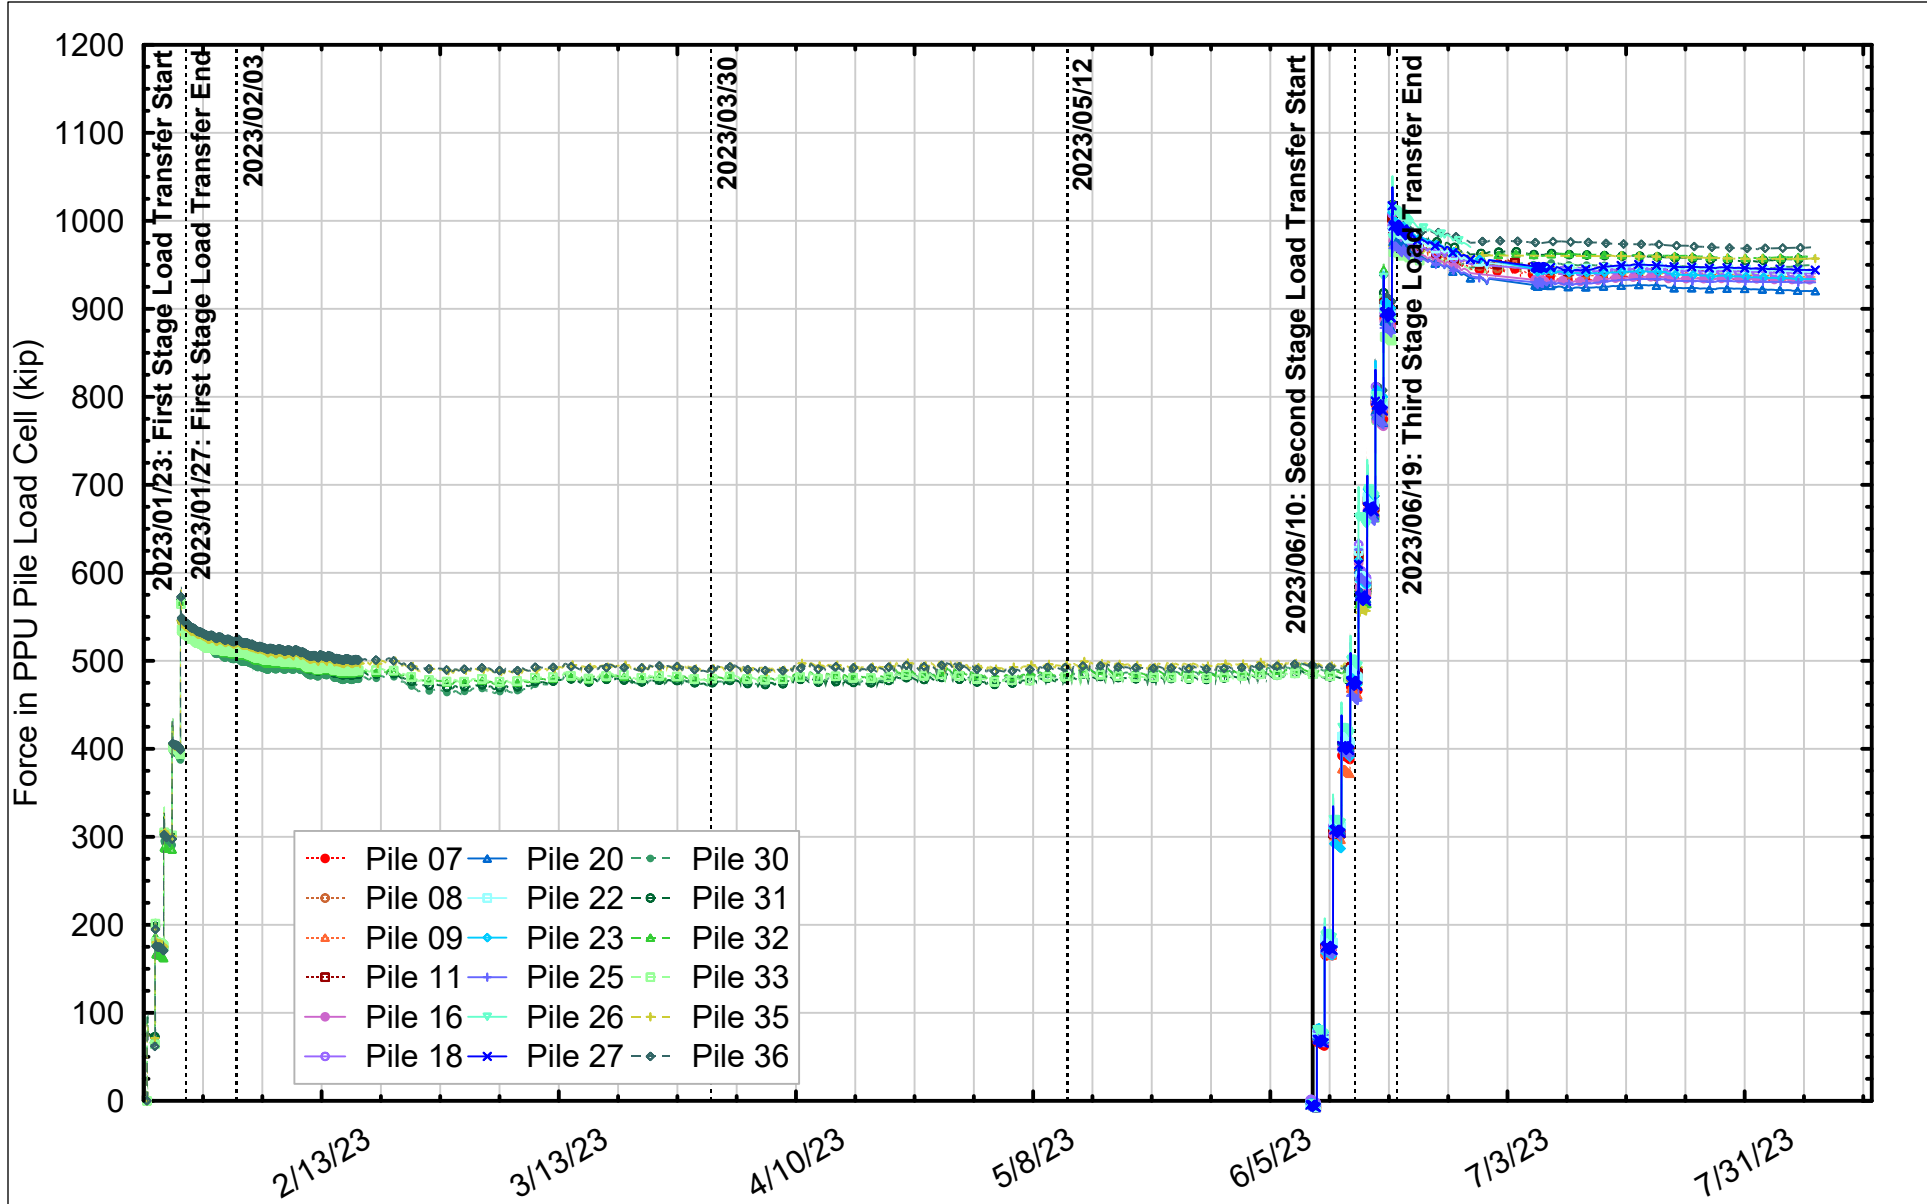
Project No: 19-009.00	Date: 8/8/2023	Created By: NBW	Checked By: DGM	Figure No: 118-13
-----------------------	----------------	-----------------	-----------------	-------------------

PILE LOAD CELL DATA
SINCE 01/23/2023 THROUGH 08/07/2023

Figure 13 presents pile load cell data since the start of the First Stage Load Transfer (January 23, 2023) through August 7, 2023.
