Date: November 29, 2023

Project Number: 23-018-01

Subject: 301 Mission Retrofit Monitoring Report 126: Results as of November 28, 2023

Millennium Tower Perimeter Pile Upgrade: Instrumentation Monitoring Data
 City and County of San Francisco, California

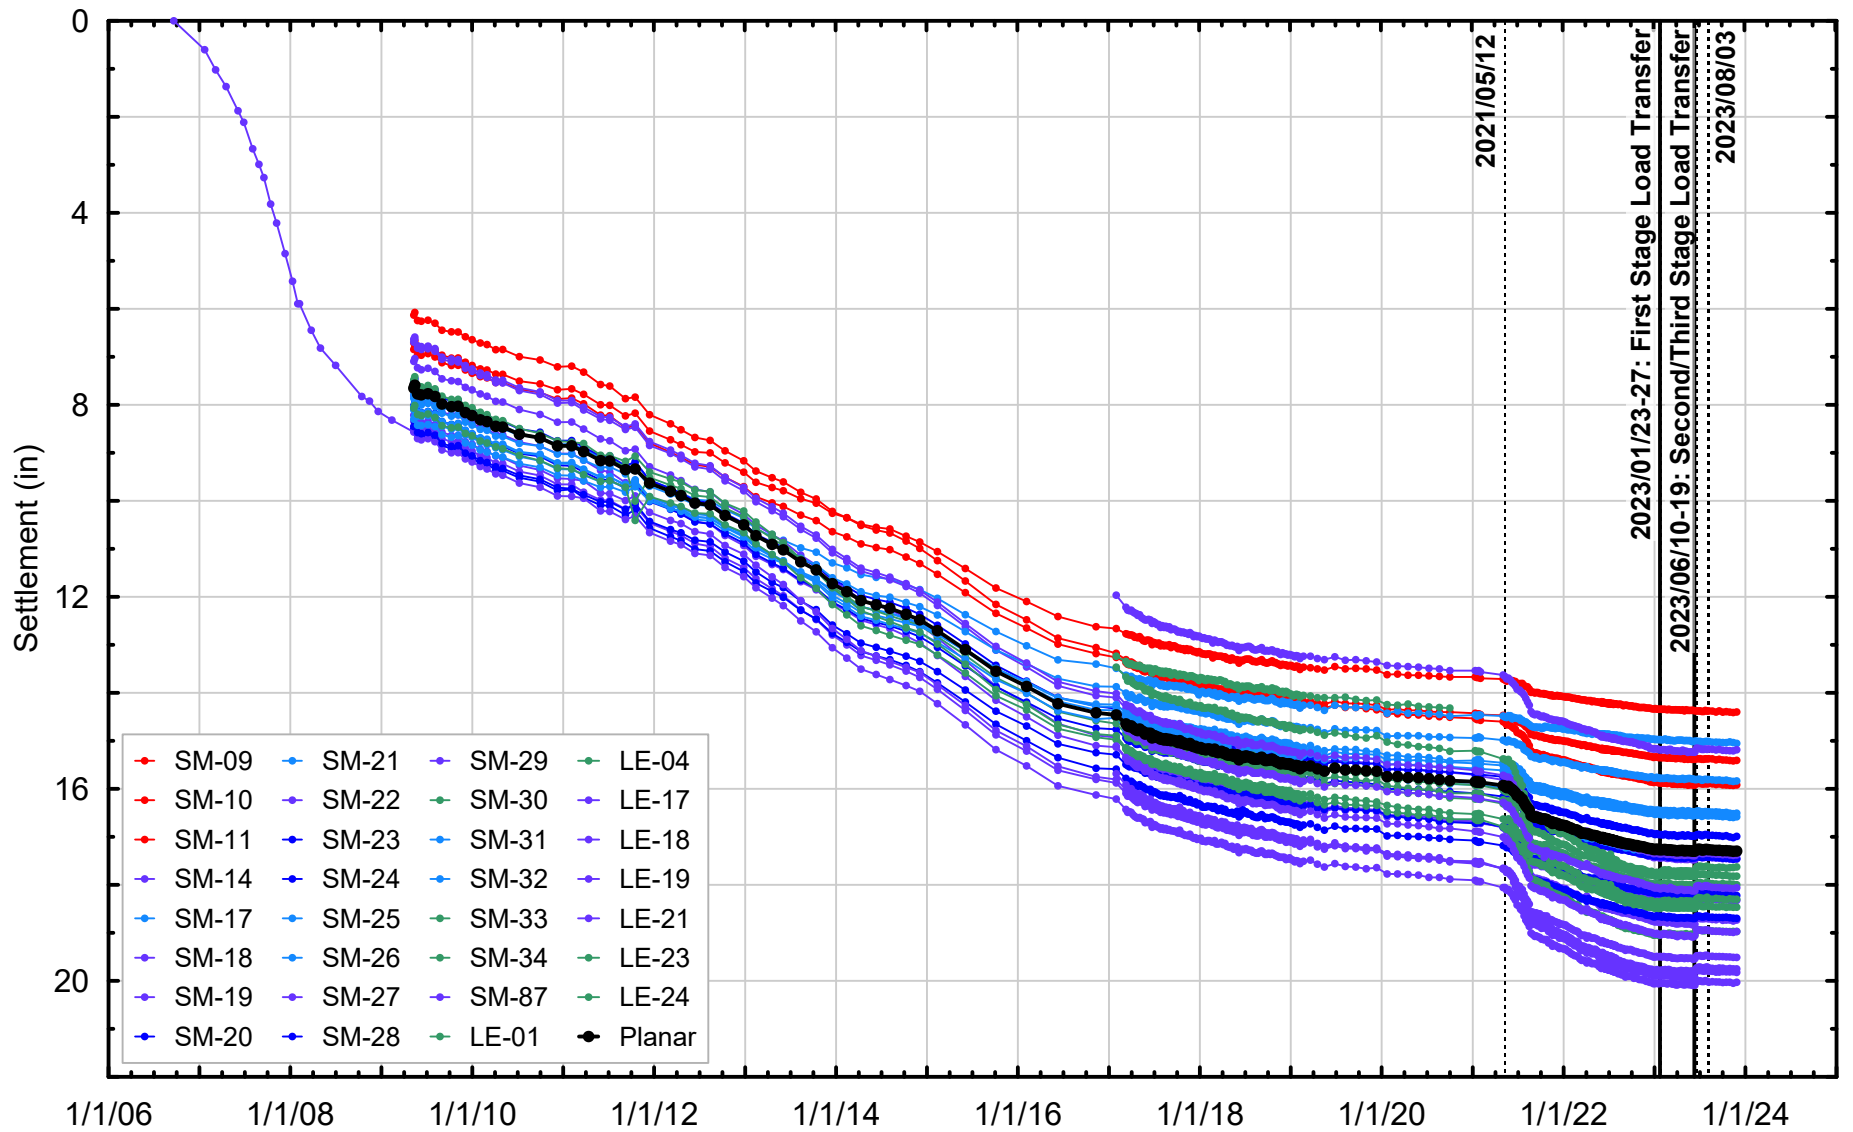
Project No: 23-018-01	Date: 11/29/2023	Created By: TB	Checked By: DGM	Figure No: 126-02

Figure 02 presents the historical settlement data interpreted from settlement markers installed on the B-1 Level of 301 Mission Tower. In addition, data from surveys performed during the retrofit are included. Figure 03 presents settlement data since the start of production pile installation (May 12, 2021; baseline readings on May 10, 2021) through November 27, 2023. Figure 04 presents current settlement contours (in inches) on November 27, 2023.

HISTORICAL SETTLEMENT MARKER DATA		
		Millennium Tower Perimeter Pile Upgrade: Instrumentation Monitoring Data City and County of San Francisco, California

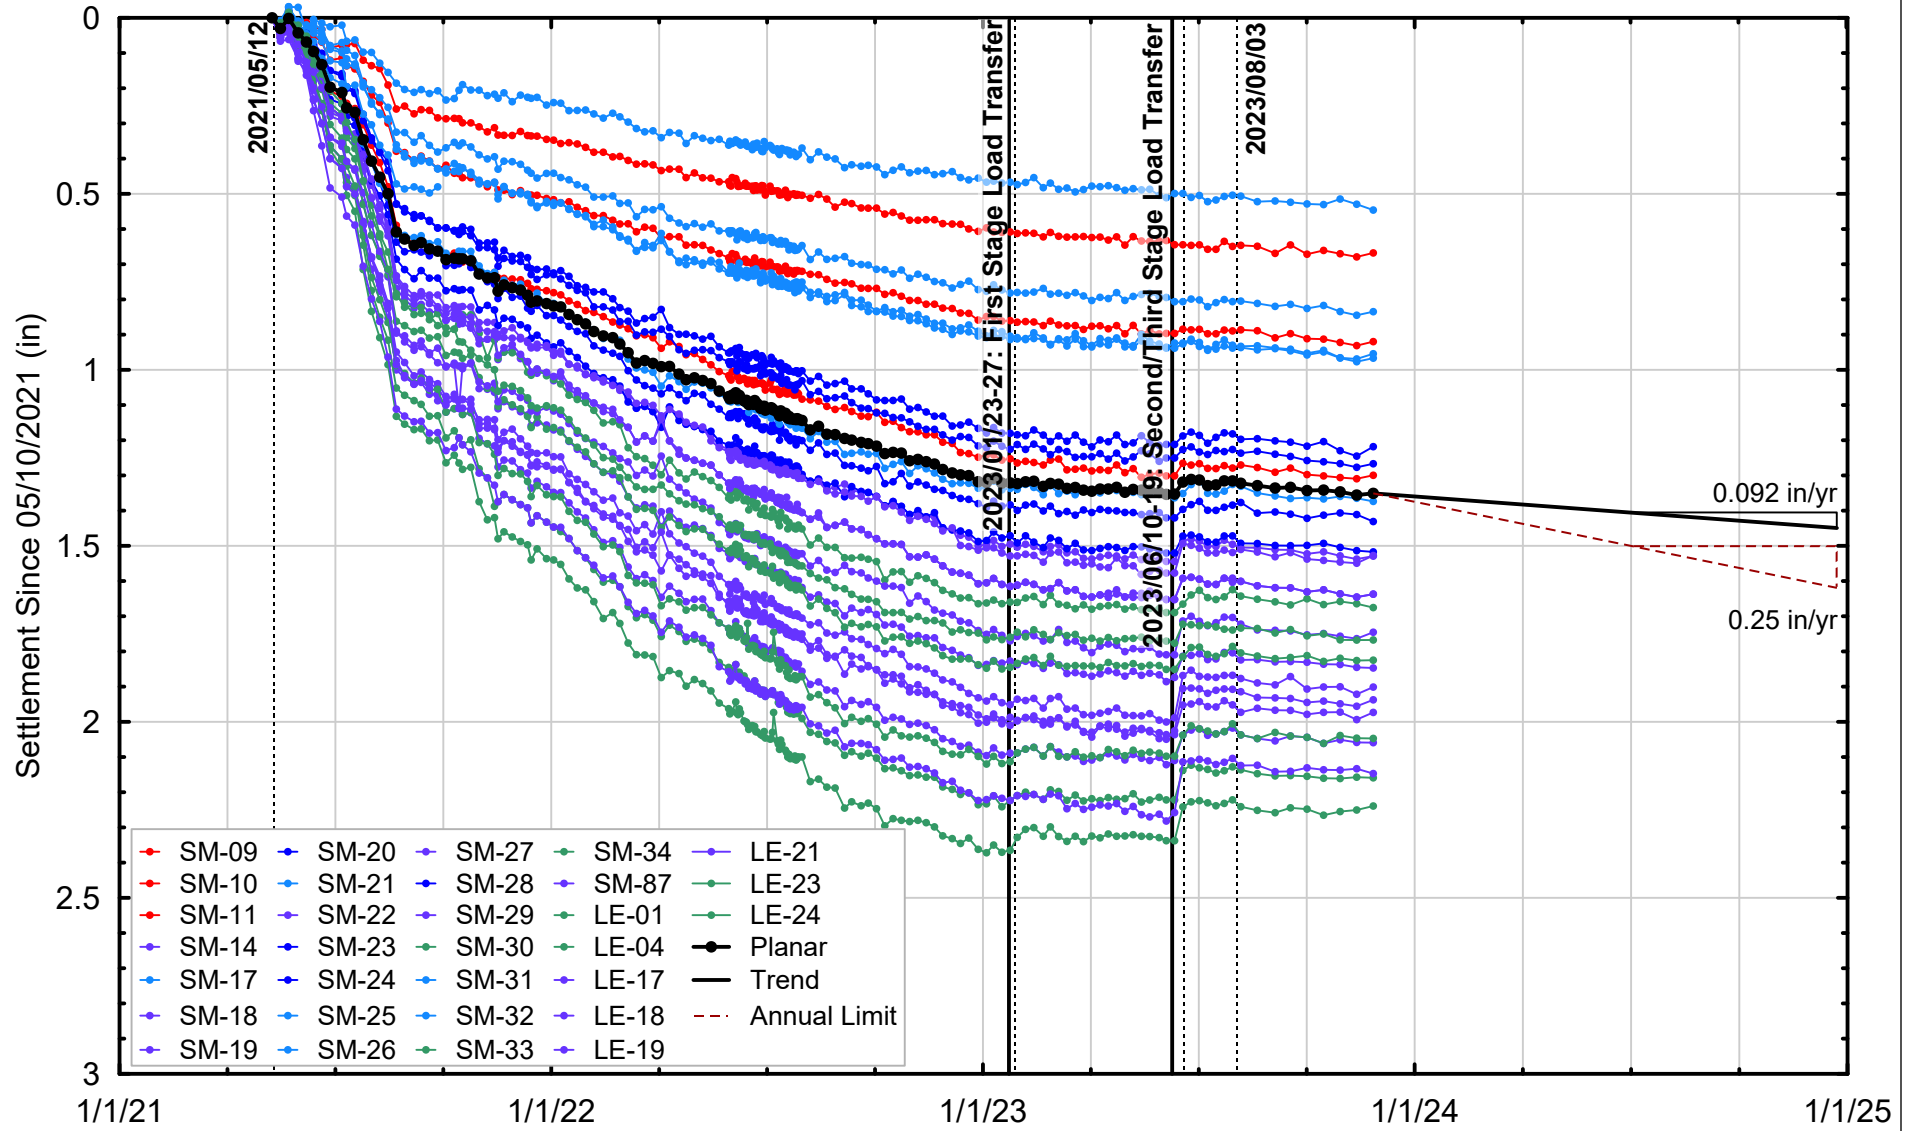
Project No: 23-018-01	Date: 11/29/2023	Created By: TB	Checked By: DGM	Figure No: 126-03

⁵ As plotted on Figure 03. The annual rate is calculated starting on the settlement monitoring date closest to one year prior to the current date or on June 19, 2023 (the settlement monitoring date corresponding to the last day of jacking load application), whichever is later, and ending on the current date.

<p align="center">SETTLEMENT MARKER DATA SINCE 05/10/2021 THROUGH 11/27/2023</p> <p align="center">Millennium Tower Perimeter Pile Upgrade: Instrumentation Monitoring Data City and County of San Francisco, California</p>

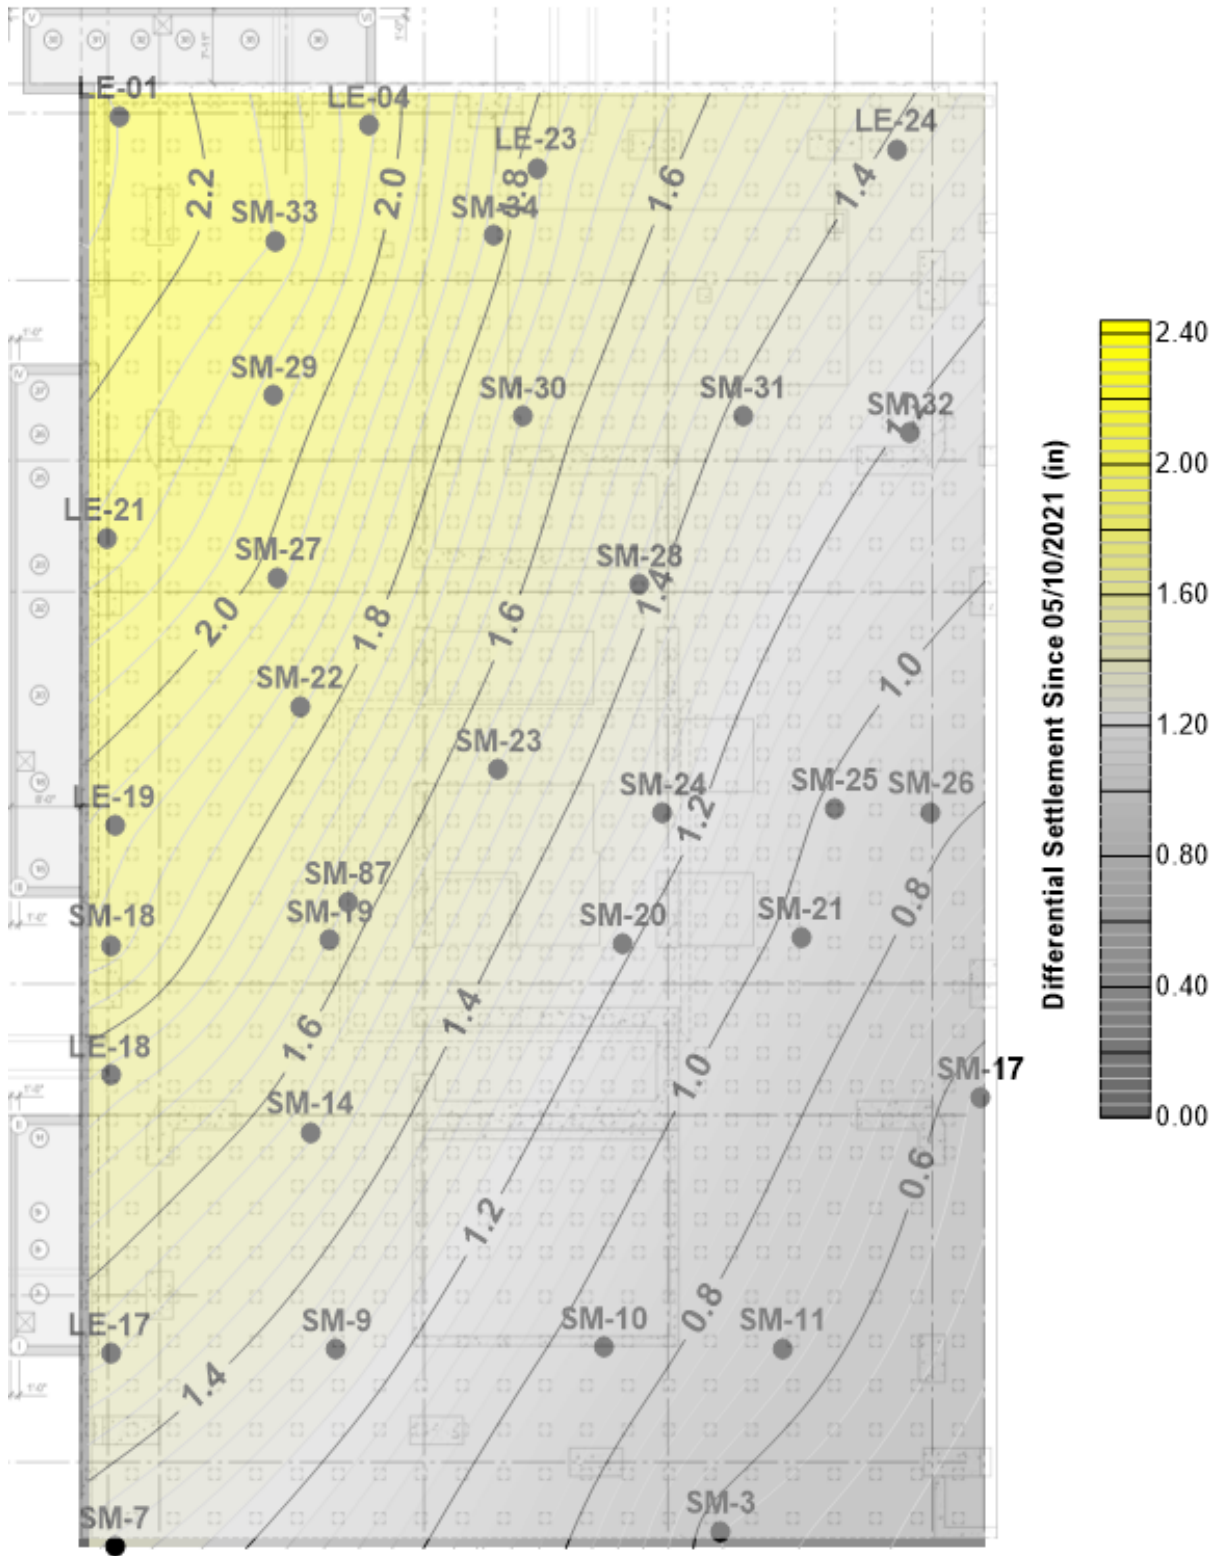
Figure No: 126-04

SETTLEMENT CONTOURS
SINCE 05/10/2021 THROUGH 11/27/2023

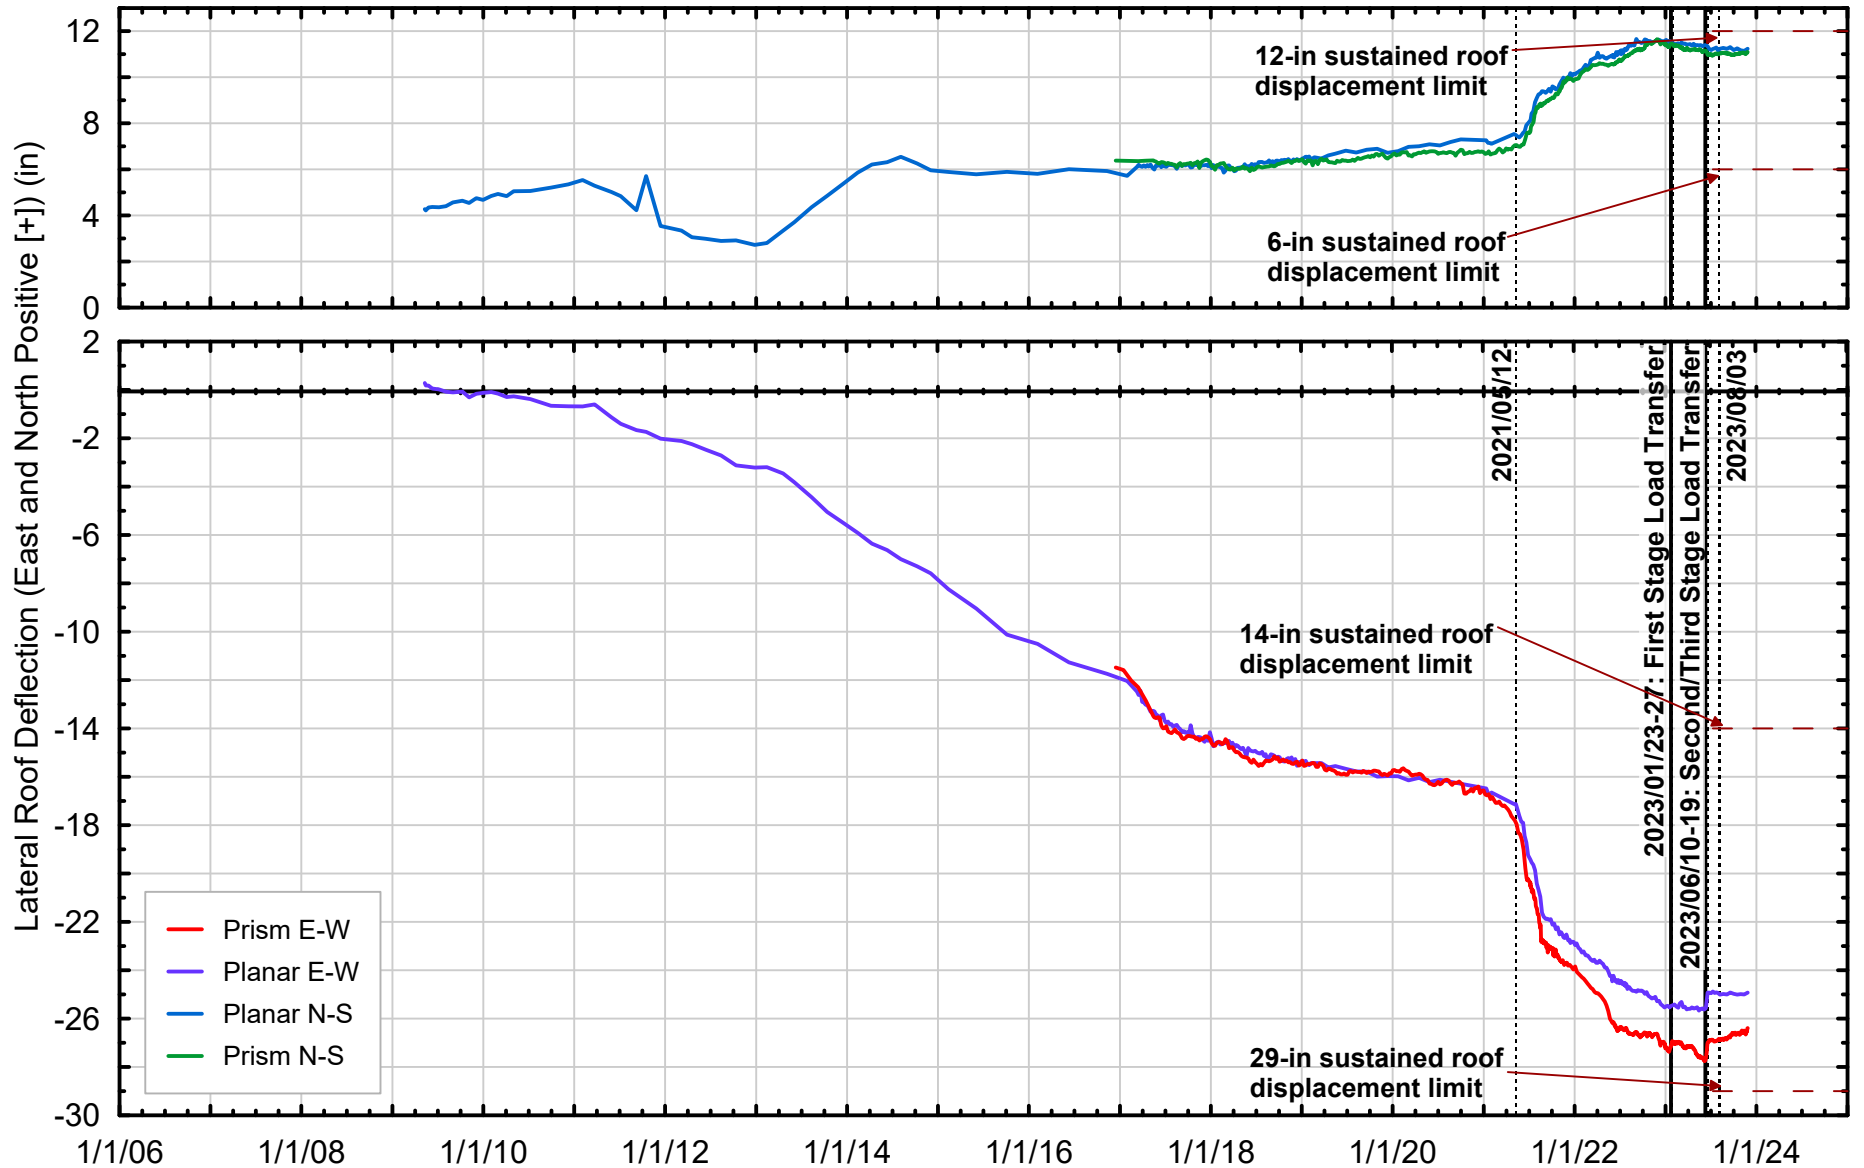
Project No: 23-018-01	Date: 11/29/2023	Created By: TB	Checked By: DGM	Figure No: 126-05
-----------------------	------------------	----------------	-----------------	-------------------

Figure 05 presents historical lateral roof deflections in the project north-south and project east-west directions interpreted from survey prisms mounted on the exterior of the Tower, from InSAR data, and from a planar fit of the settlement marker data. In addition, data from surveys performed during the retrofit are included. Figure 06A presents lateral roof deflection data from a planar fit of the settlement marker data and from survey prisms mounted on the exterior of the Tower since the start of production pile installation (May 12, 2021; baseline readings on May 10 and 13, 2021, respectively) through November 27, 2023.

⁶ As plotted on Figure 05, relative to a plumb condition.

HISTORICAL LATERAL ROOF DEFLECTION DATA

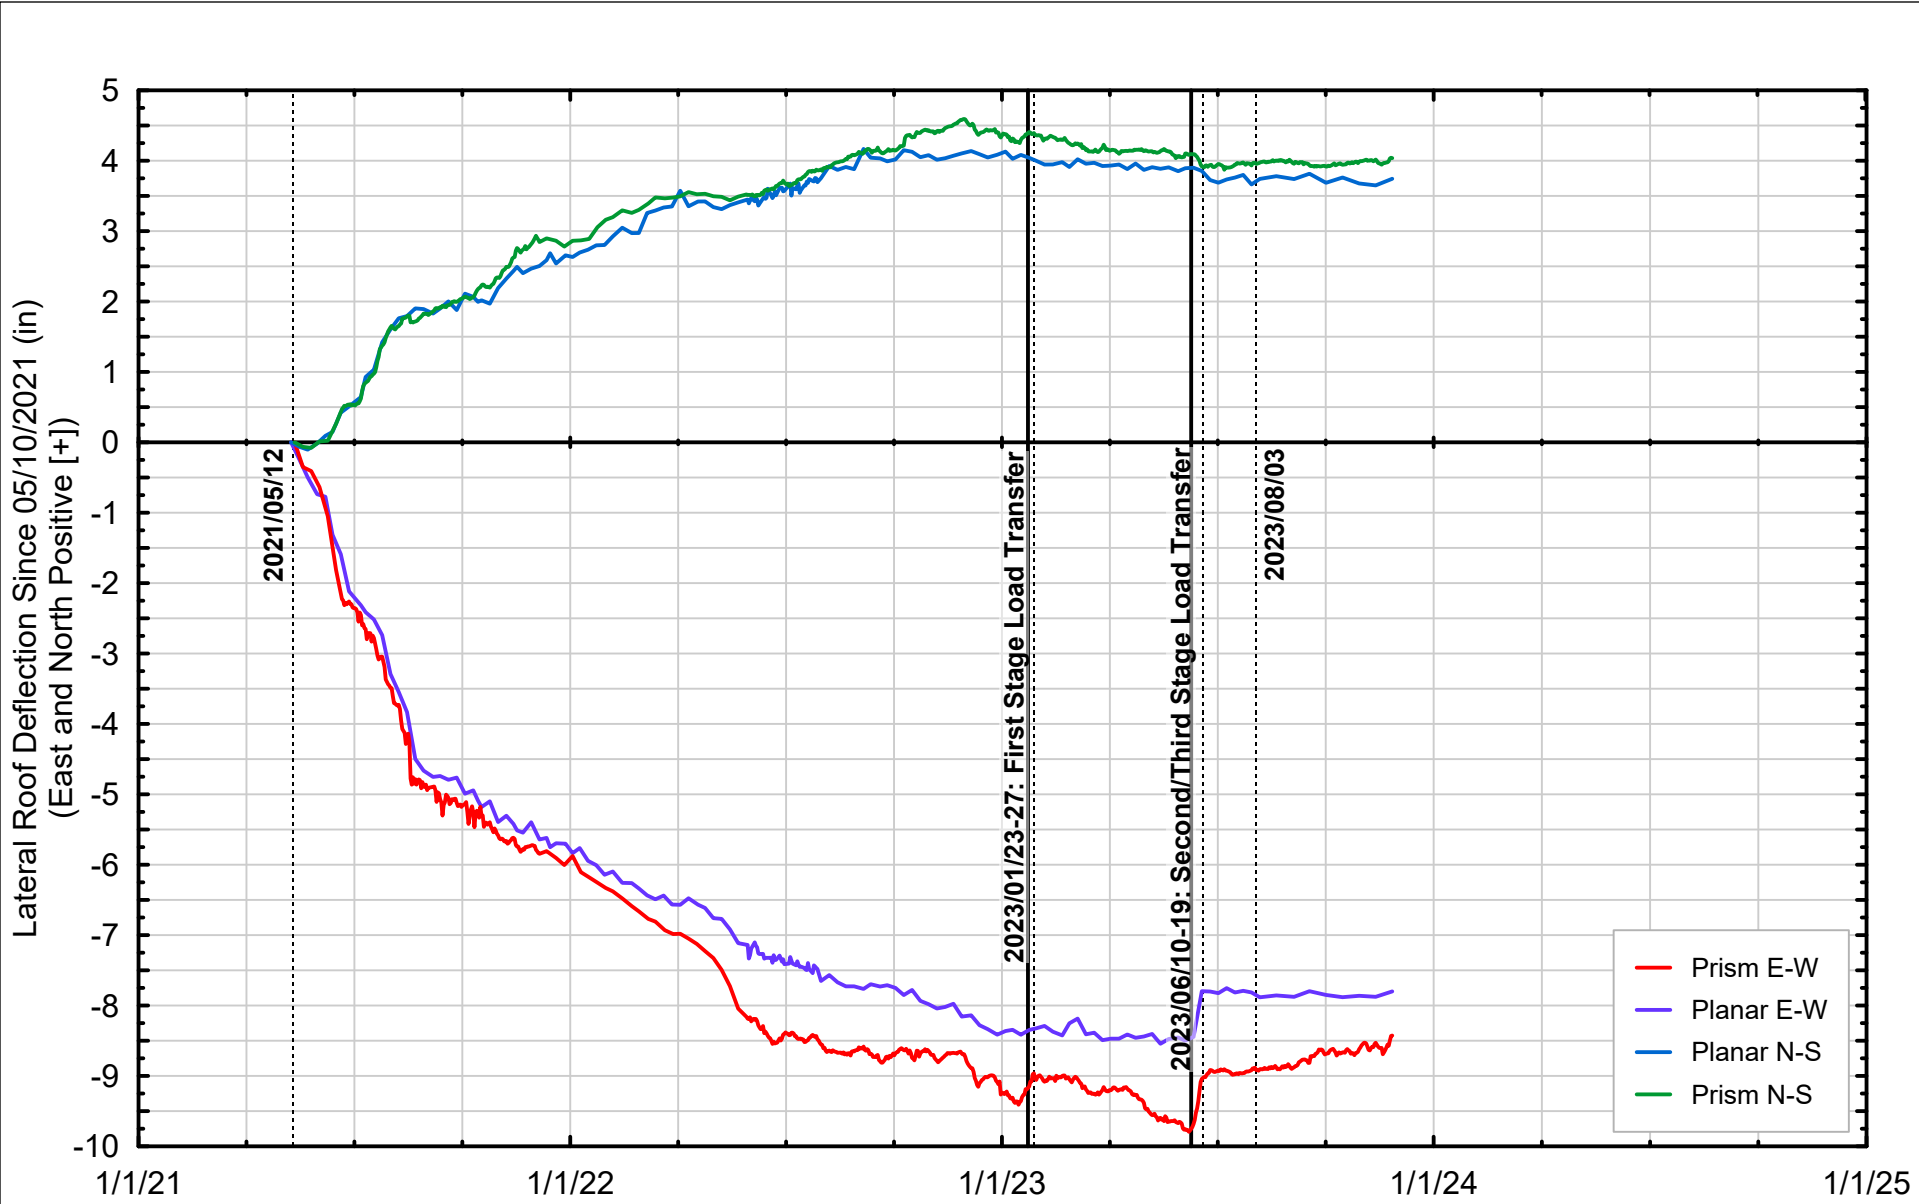
Project No: 23-018-01	Date: 11/29/2023	Created By: TB	Checked By: DGM	Figure No: 126-06
-----------------------	------------------	----------------	-----------------	--------------------------

LATERAL ROOF DEFLECTION DATA
 SINCE 05/10/2021 THROUGH 11/27/2023
 Millennium Tower Perimeter Pile Upgrade: Instrumentation Monitoring Data
 City and County of San Francisco, California

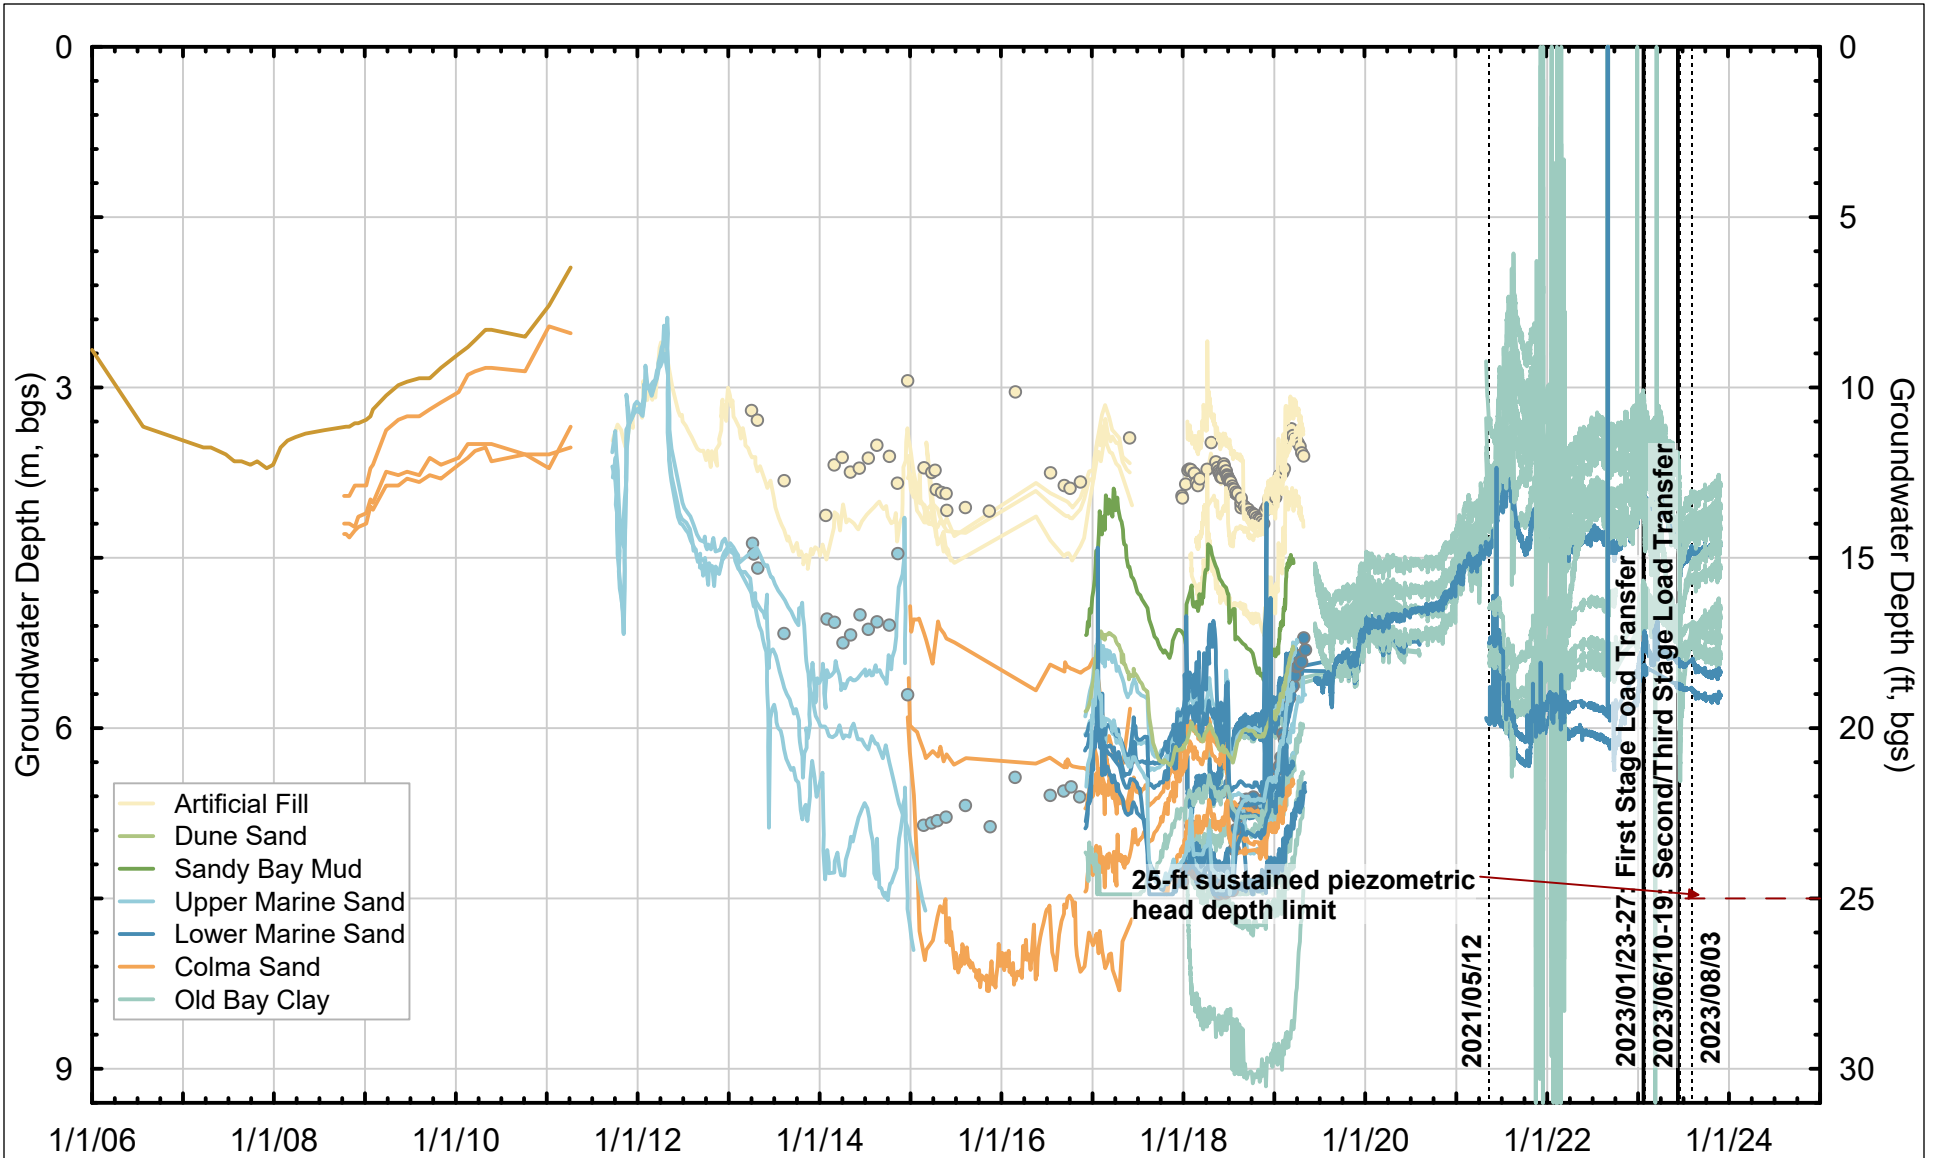
Project No: 23-018-01	Date: 11/29/2023	Created By: TB	Checked By: DGM	Figure No: 126-07
-----------------------	------------------	----------------	-----------------	--------------------------

Figure 07 presents the historical groundwater elevation interpreted from piezometer readings at locations near 301 Mission. In addition, data from piezometers installed to monitor groundwater elevation during the retrofit are included. Figures 08 and 09 present groundwater elevation interpreted from piezometer readings

HISTORICAL GROUNDWATER ELEVATION MEASUREMENTS
AT LOCATIONS NEAR 301 MISSION

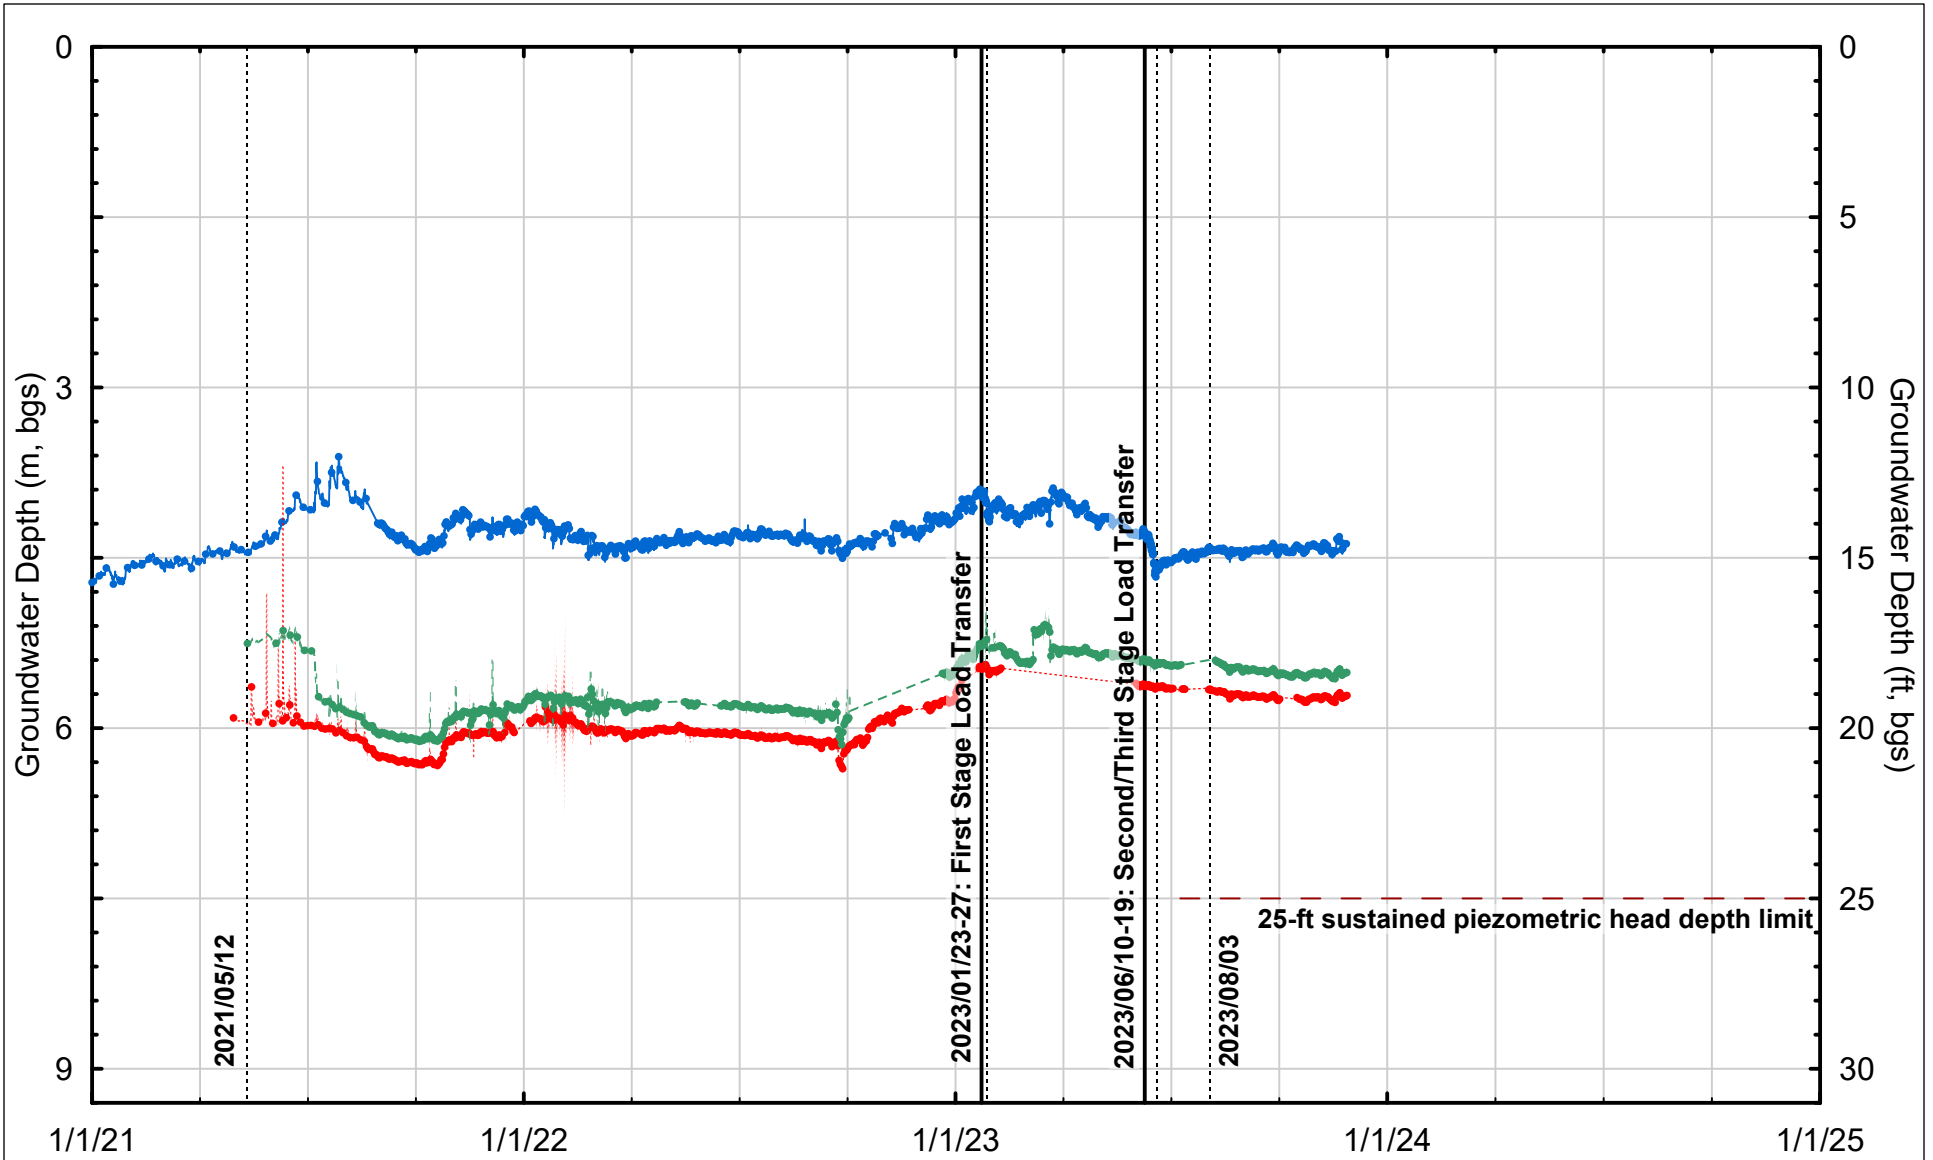
Figure No: **126-08**

in the Marine/Colma Sand and the Old Bay Clay, respectively, for the time period prior to the start of production pile installation (January 1, 2021) through November 28, 2023.

- SB-1 @ 85'
- PB-1 @ 85'
- PB-2 @ 85'

GROUNDWATER ELEVATION MEASUREMENTS IN MARINE AND COLMA SAND
SINCE 01/01/2021 THROUGH 11/28/2023

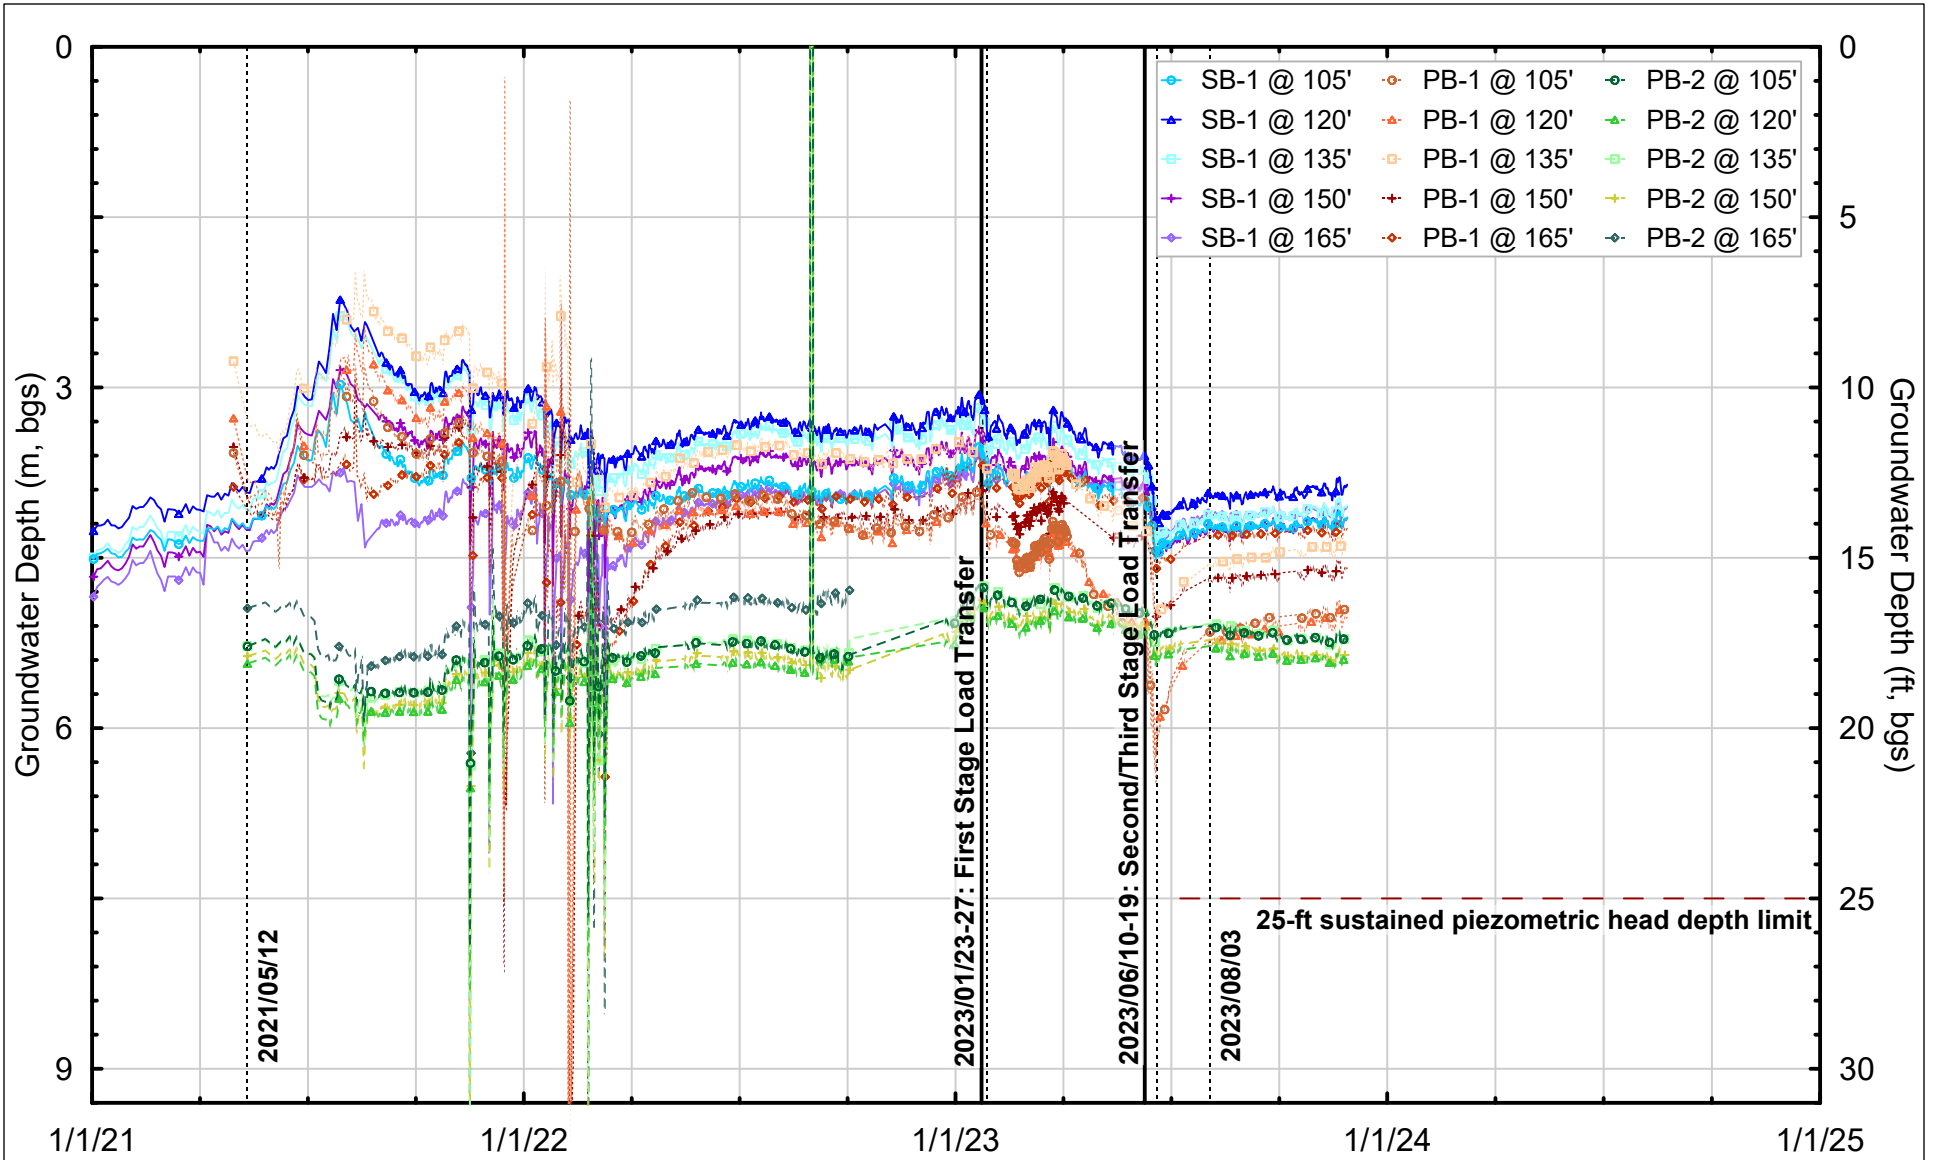
Project No: 23-018-01	Date: 11/29/2023	Created By: TB	Checked By: DGM	Figure No: 126-09
-----------------------	------------------	----------------	-----------------	-------------------

GROUNDWATER ELEVATION MEASUREMENTS IN OLD BAY CLAY
SINCE 01/01/2021 THROUGH 11/28/2023

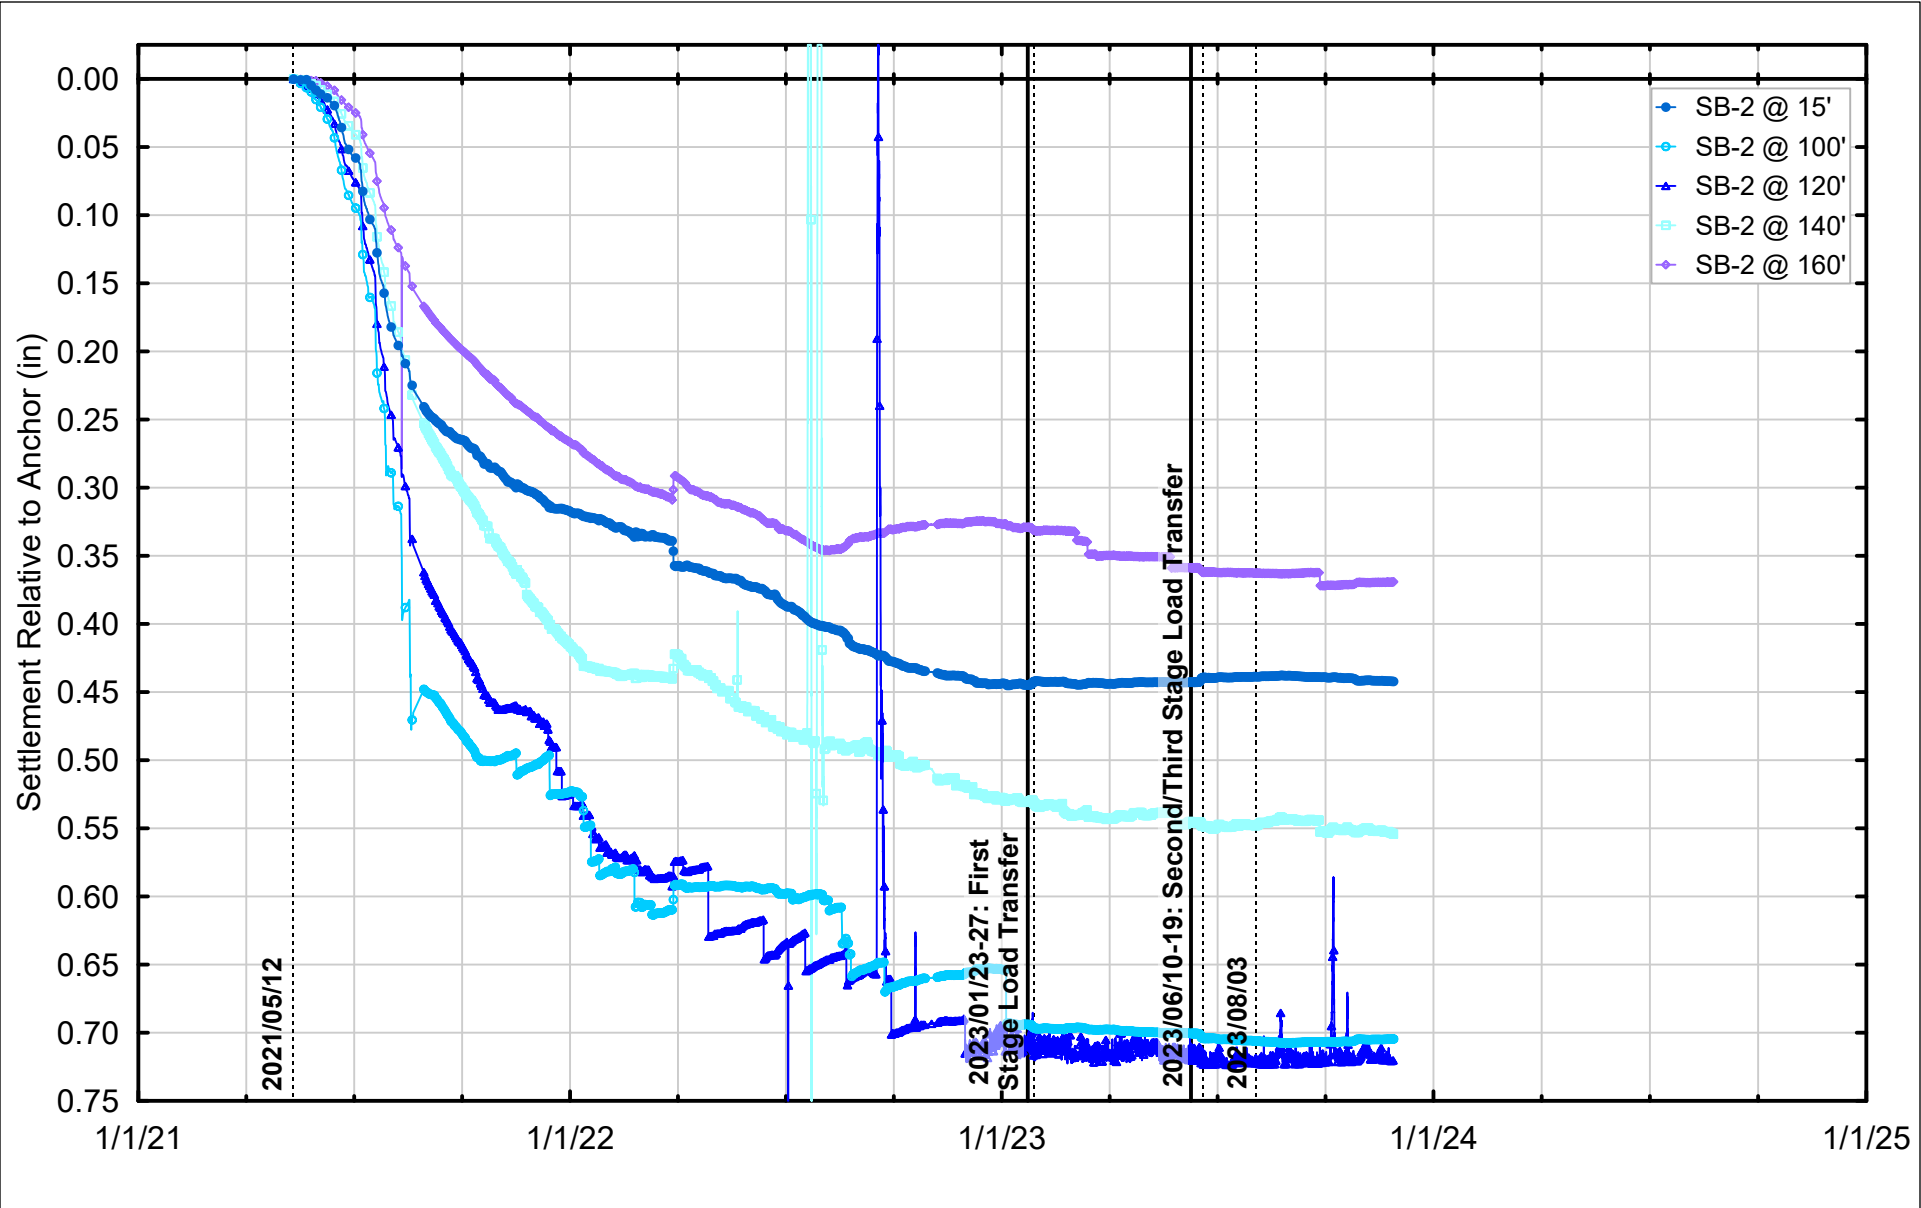
Project No: 23-018-01	Date: 11/29/2023	Created By: TB	Checked By: DGM	Figure No: 126-10

Figure 10 presents extensometer data from within the Tower basement since the start of production pile installation (May 12, 2021) through November 28, 2023. Figure 11 presents extensometer data from Fremont Street since the start of production pile installation (May 12, 2021) through May 16, 2023, and from the restart after fixing the extensometer (May 30, 2023) through November 28, 2023. Figure 12 presents extensometer data from Mission Street since the start of production pile installation (May 12, 2021) through November 28, 2023.

EXTENSOMETER DATA FROM WITHIN TOWER BASEMENT SINCE 01/01/2021 THROUGH 11/28/2023 Millennium Tower Perimeter Pile Upgrade: Instrumentation Monitoring Data City and County of San Francisco, California
