Date: November 29, 2023

Project Number: 23-018-01

Subject: 301 Mission Retrofit Monitoring Report 126: Results as of November 28, 2023

Millennium Tower Perimeter Pile Upgrade: Instrumentation Monitoring Data
 City and County of San Francisco, California

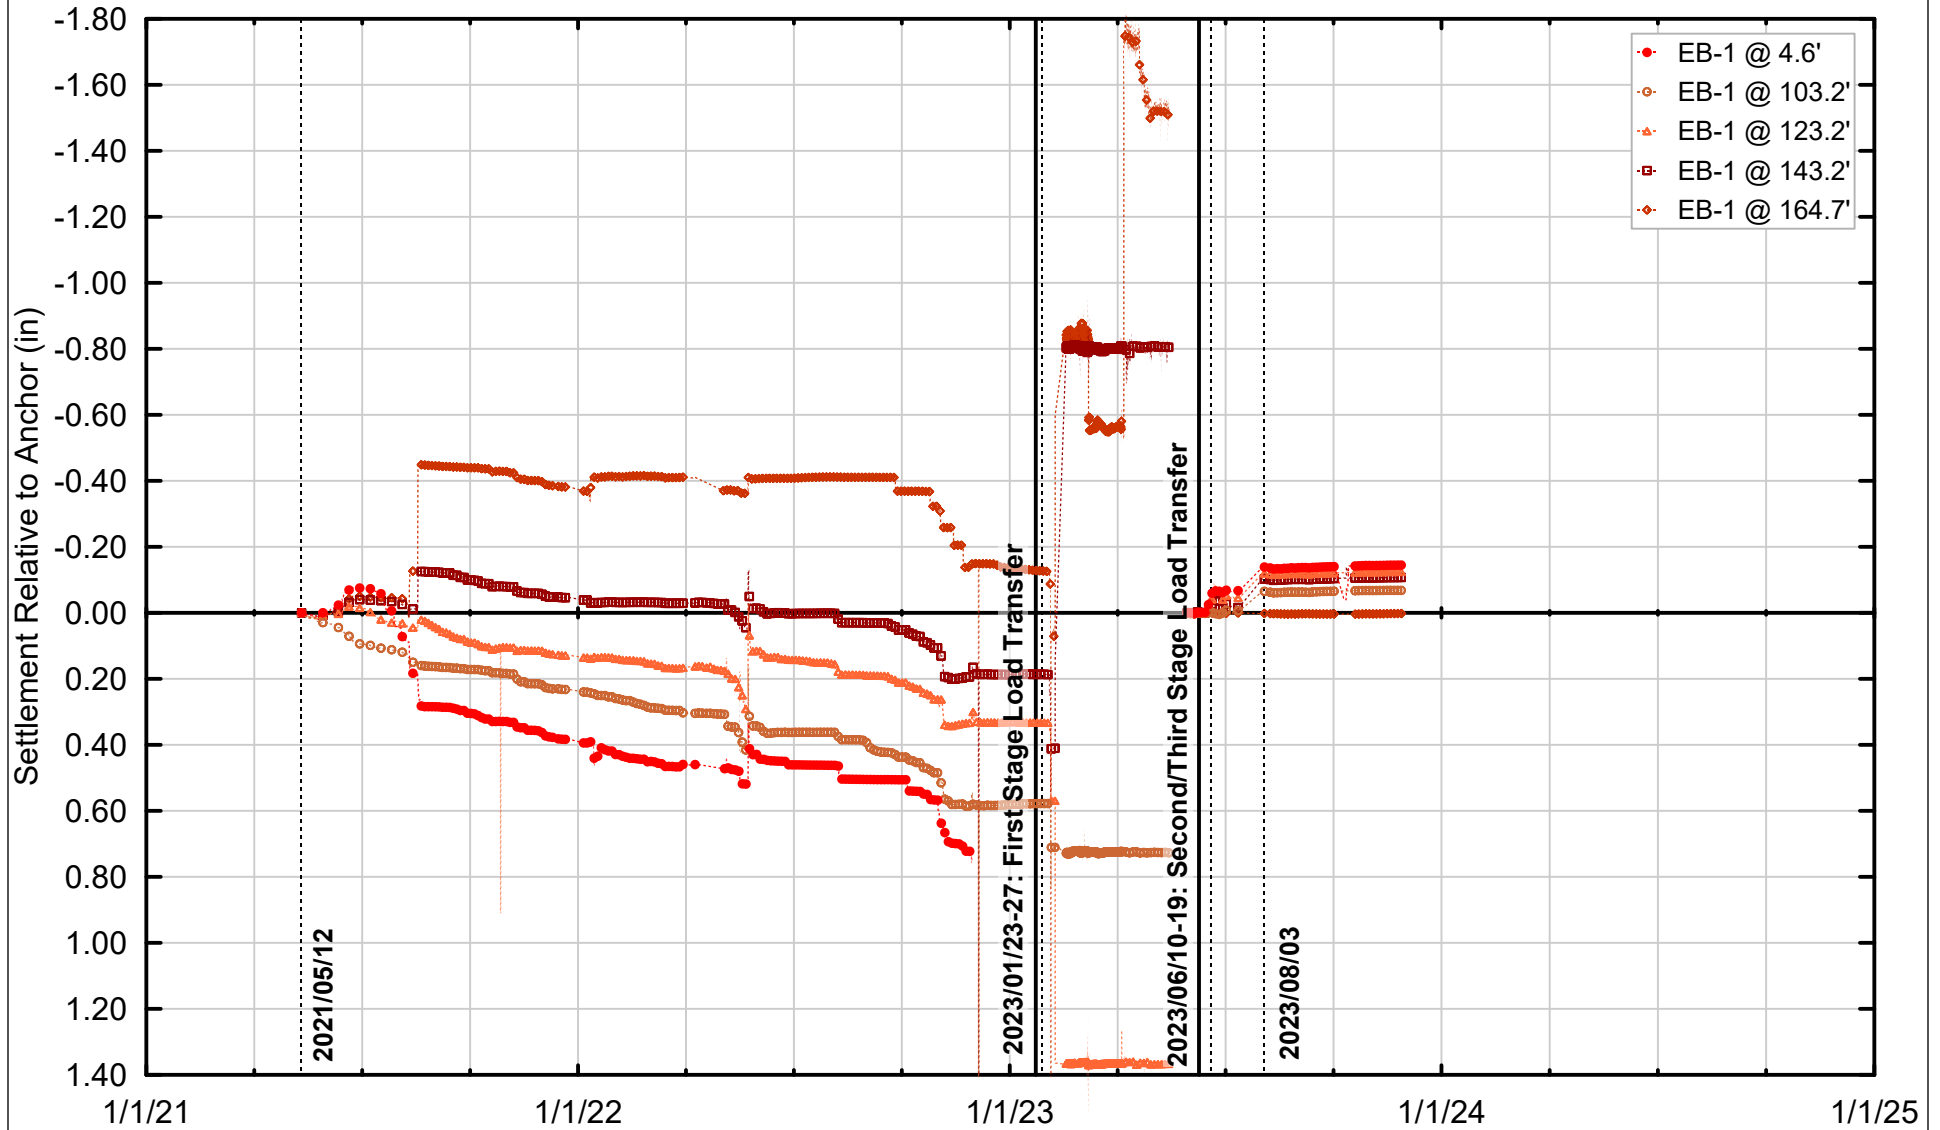
Figure No: 126-11

Note: EB-1 was repaired and reset on 2023/05/30

EXTENSOMETER DATA FROM FREMONT STREET
 SINCE 05/10/2021 THROUGH 05/16/2023
 SINCE 05/30/2023 THROUGH 11/28/2023
 Millennium Tower Perimeter Pile Upgrade: Instrumentation Monitoring Data
 City and County of San Francisco, California

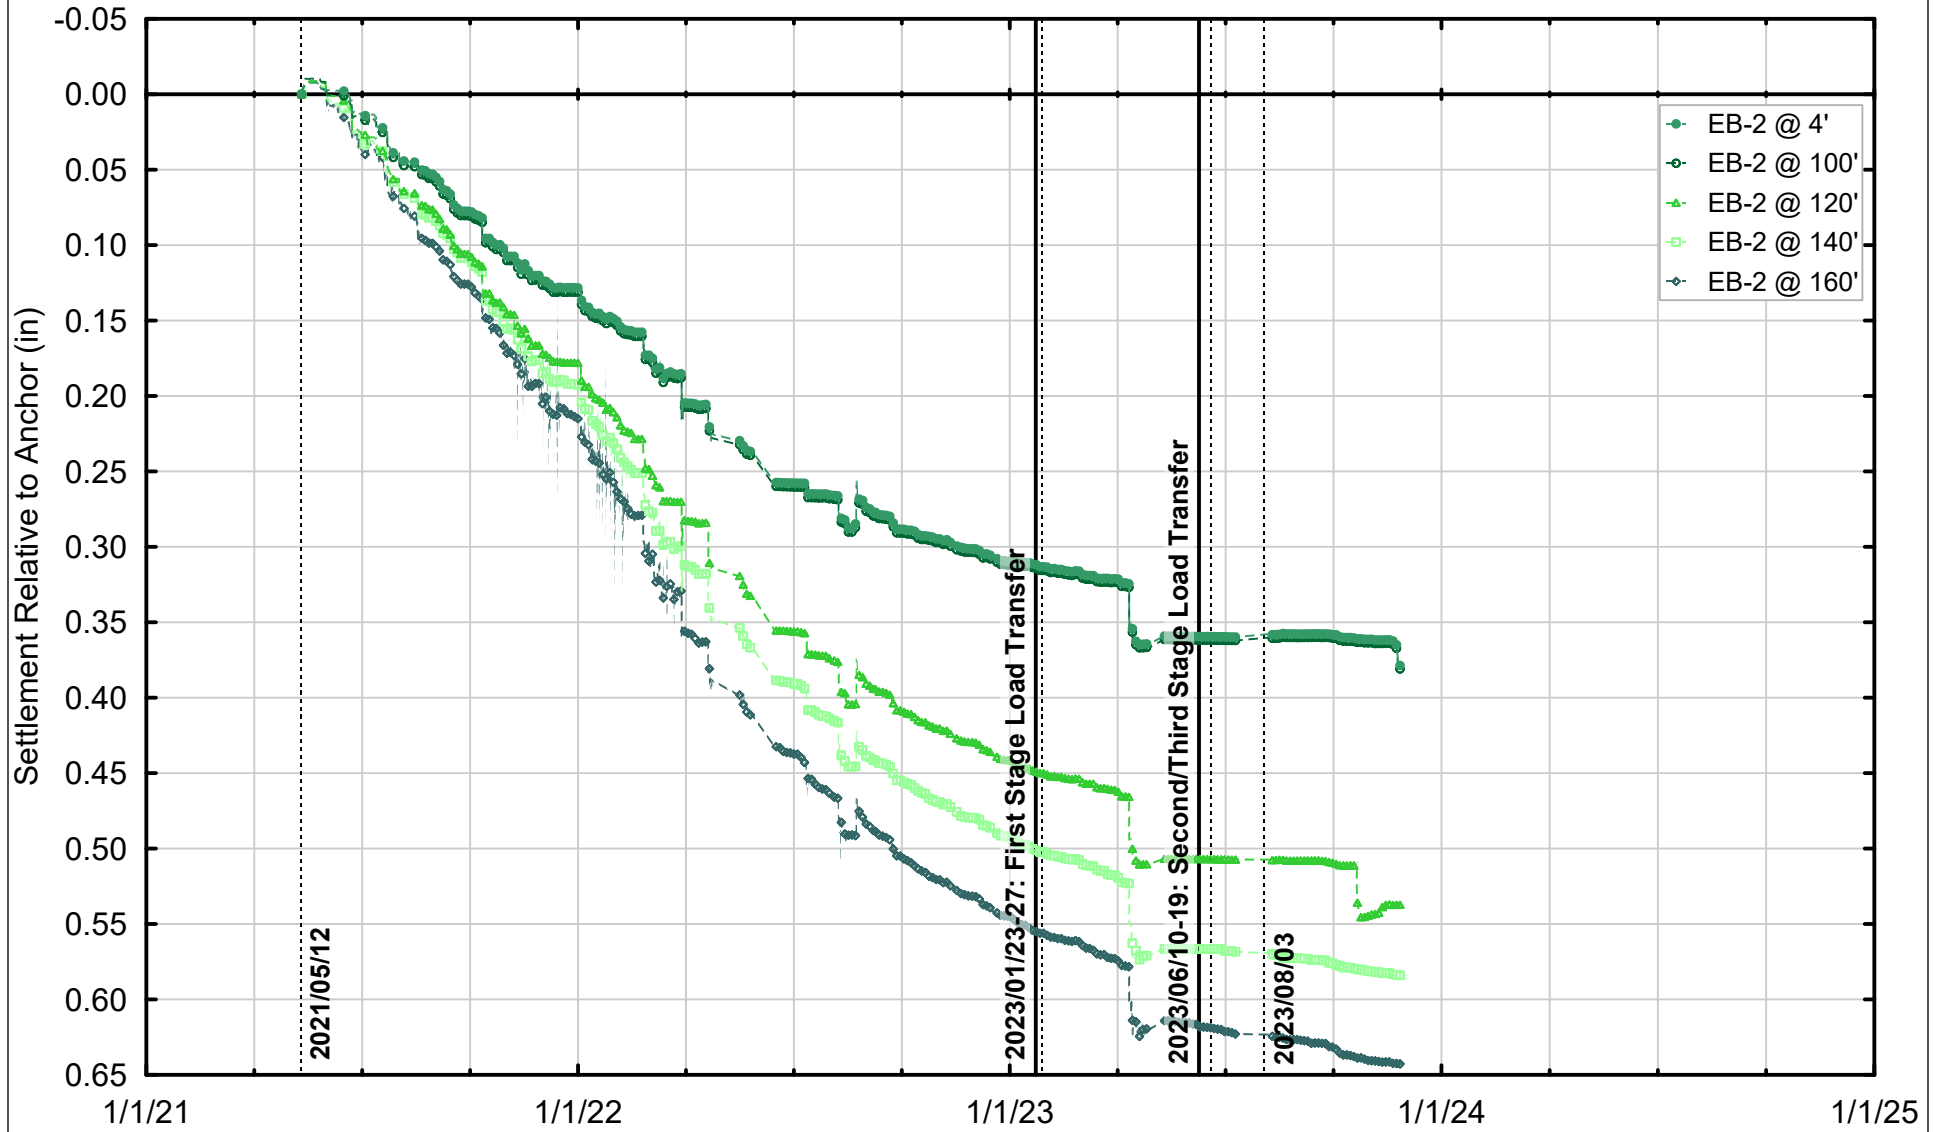
Project No: 23-018-01	Date: 11/29/2023	Created By: TB	Checked By: DGM	Figure No: 126-12
-----------------------	------------------	----------------	-----------------	-------------------

EXTENSOMETER DATA FROM MISSION STREET
SINCE 01/01/2021 THROUGH 11/28/2023

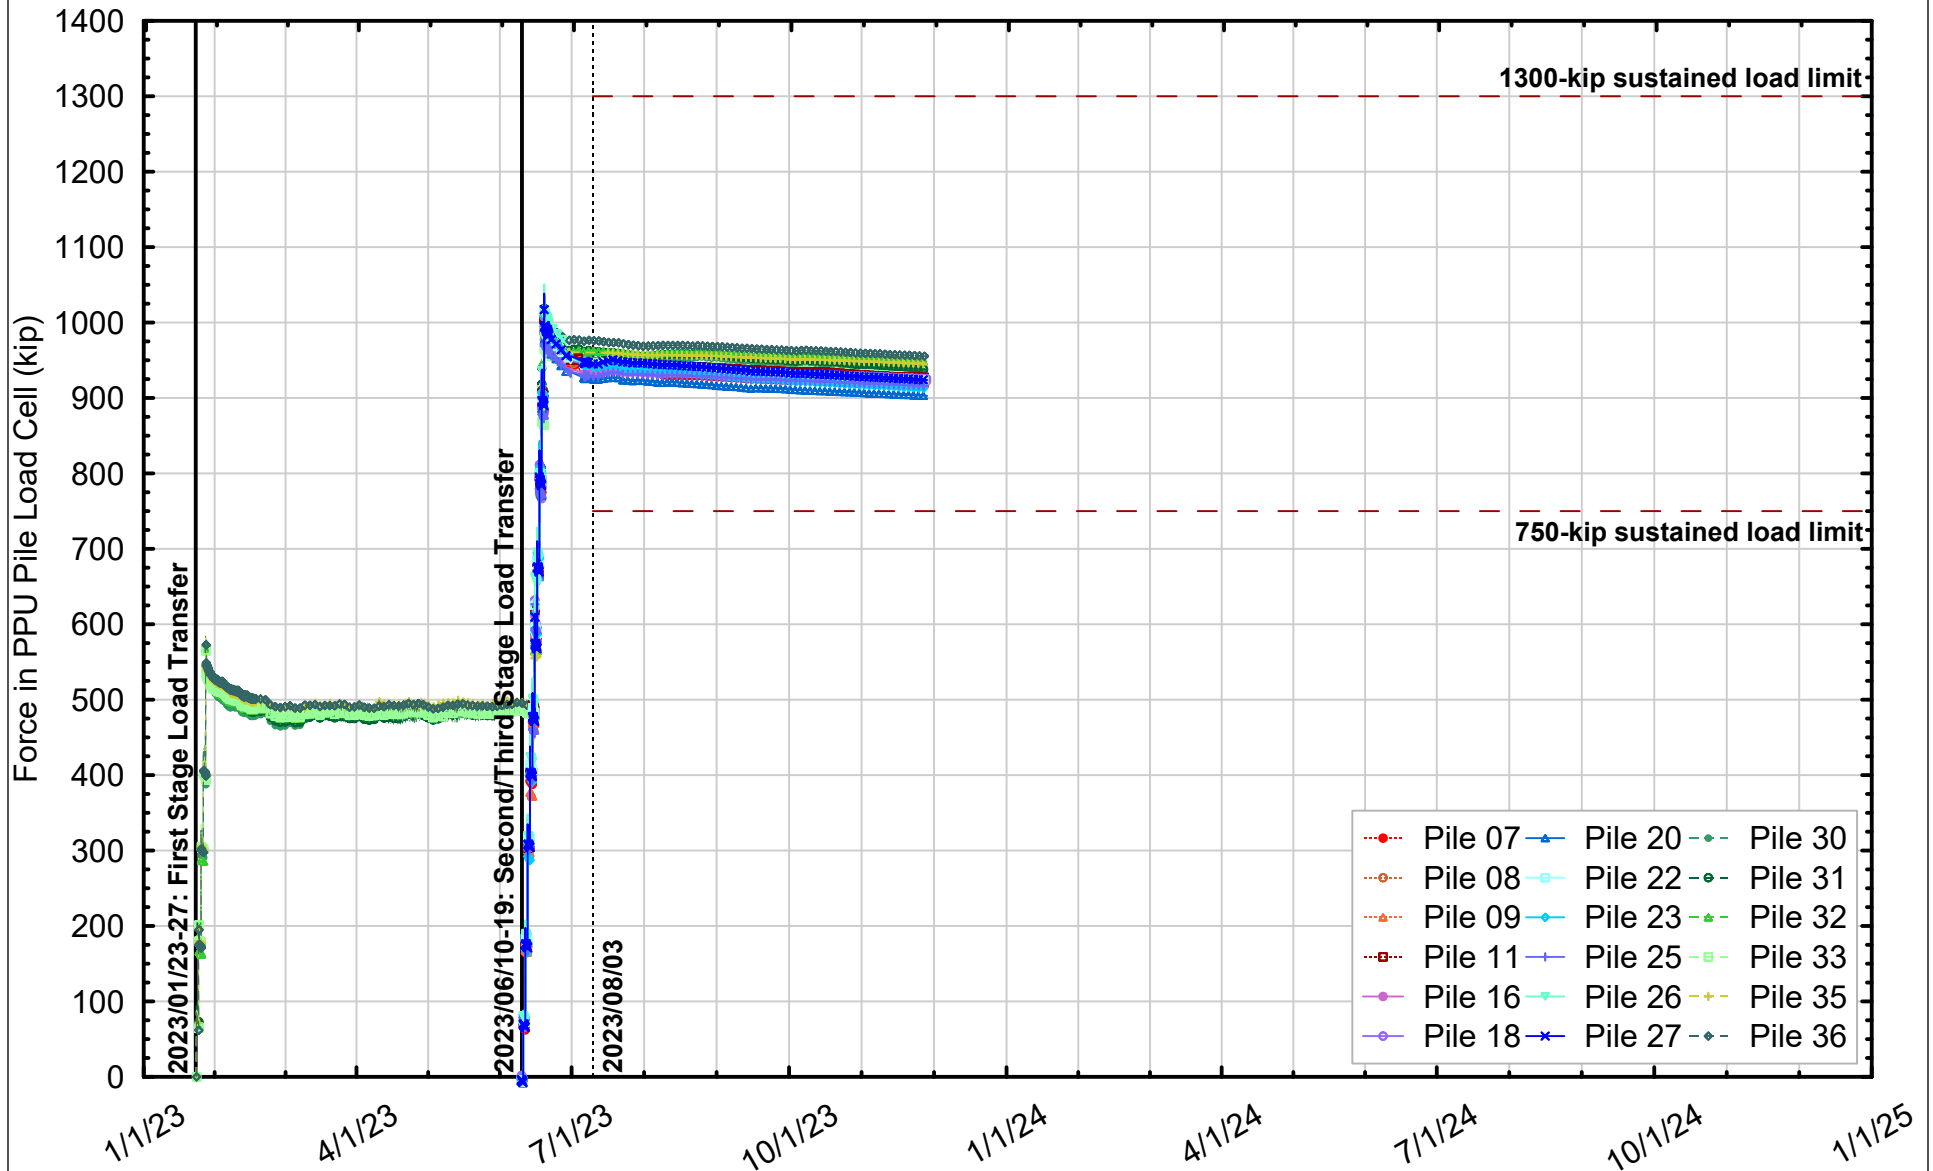
Project No: 23-018-01	Date: 11/29/2023	Created By: TB	Checked By: DGM	Figure No: 126-13A
-----------------------	------------------	----------------	-----------------	--------------------

Figure 13A presents pile load cell data since the start of the First Stage Load Transfer (January 23, 2023) through November 28, 2023. Figure 13B presents the total pile load cell data since July 15, 2023, through November 28, 2023.

⁴ The load transfer rods have a maximum safe loading of 375 kips per rod, or 1,500 kips per pile. The 1,300-kip threshold is set to allow sufficient time to evaluate building behavior, should excessive load develop in one or more piles.

PILE LOAD CELL DATA
SINCE 01/23/2023 THROUGH 11/28/2023

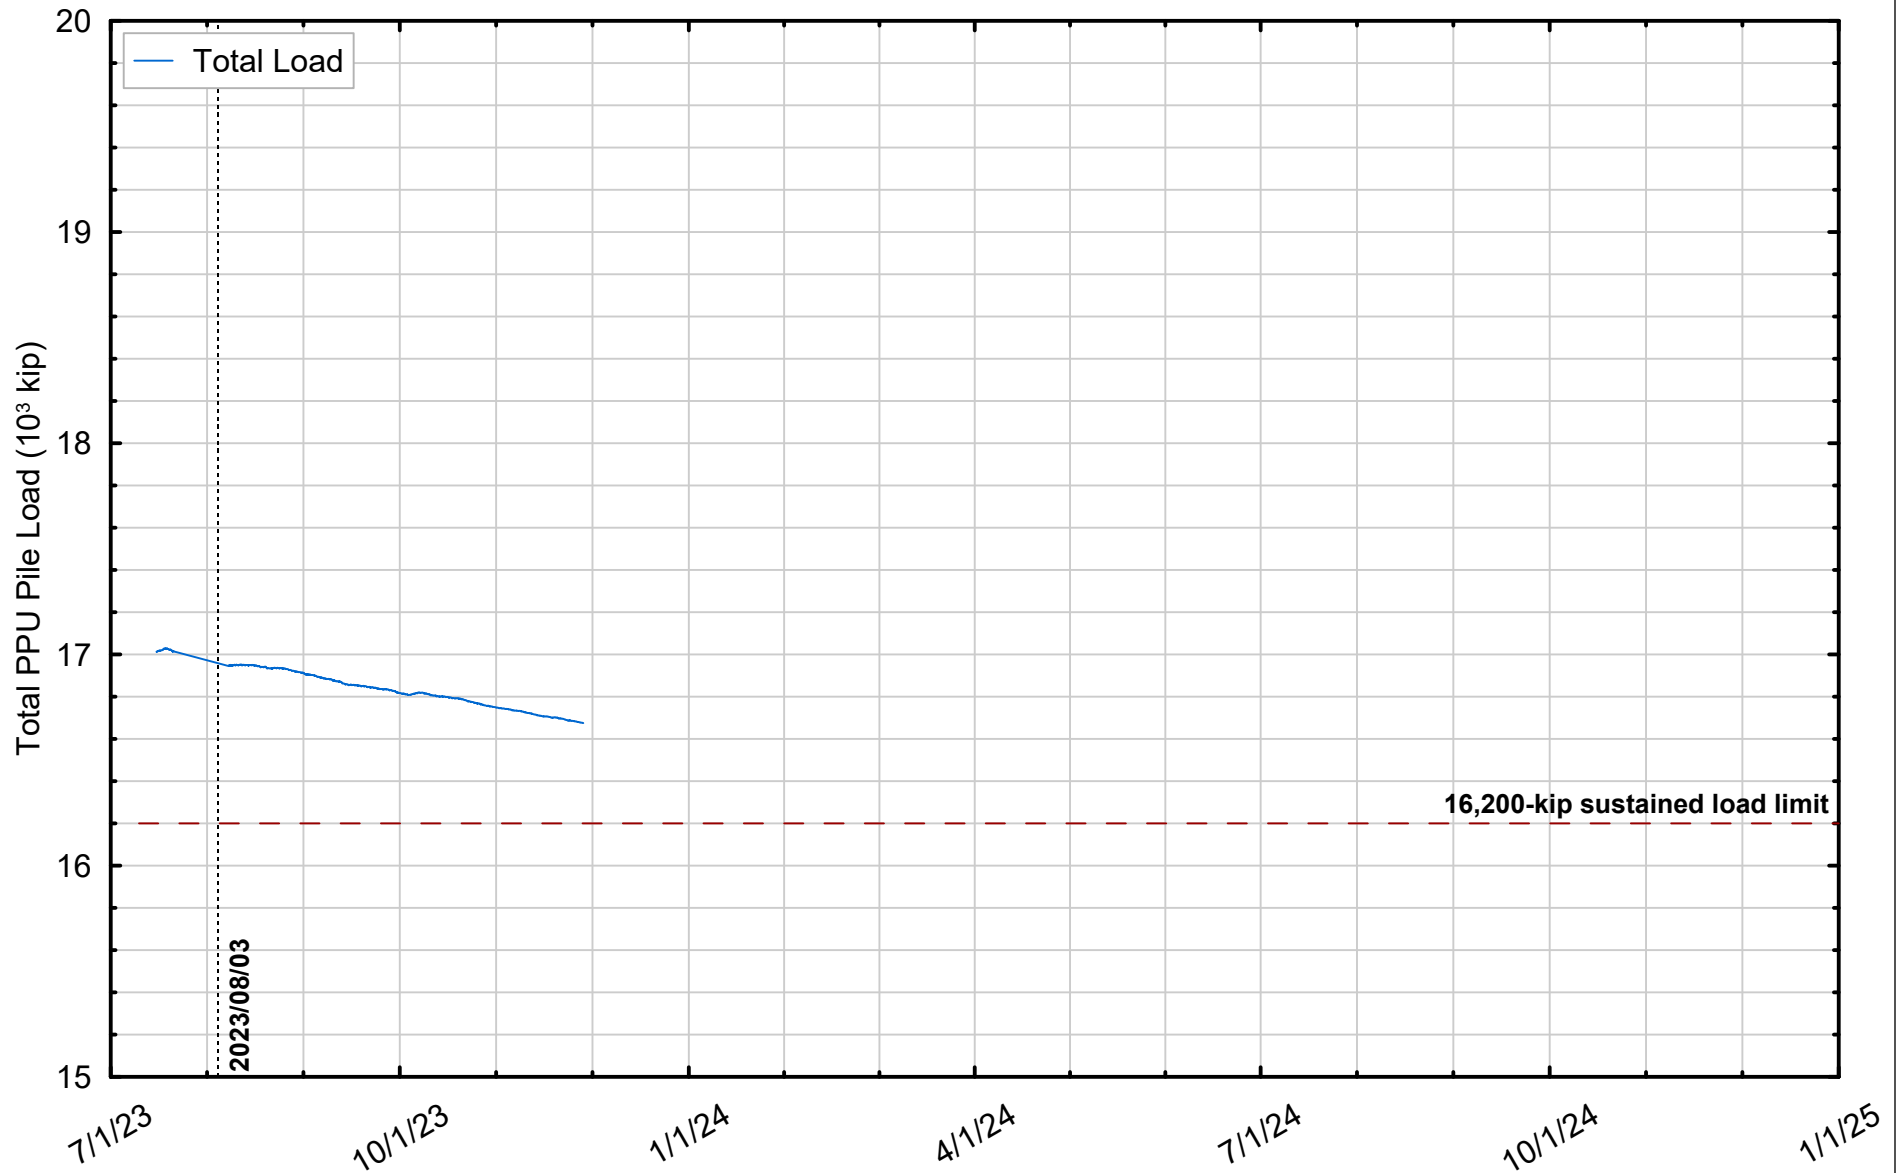
Project No: 23-018-01	Date: 11/29/2023	Created By: TB	Checked By: DGM	Figure No: 126-13B
-----------------------	------------------	----------------	-----------------	--------------------

TOTAL PILE LOAD CELL DATA
 SINCE 07/15/2023 THROUGH 11/28/2023

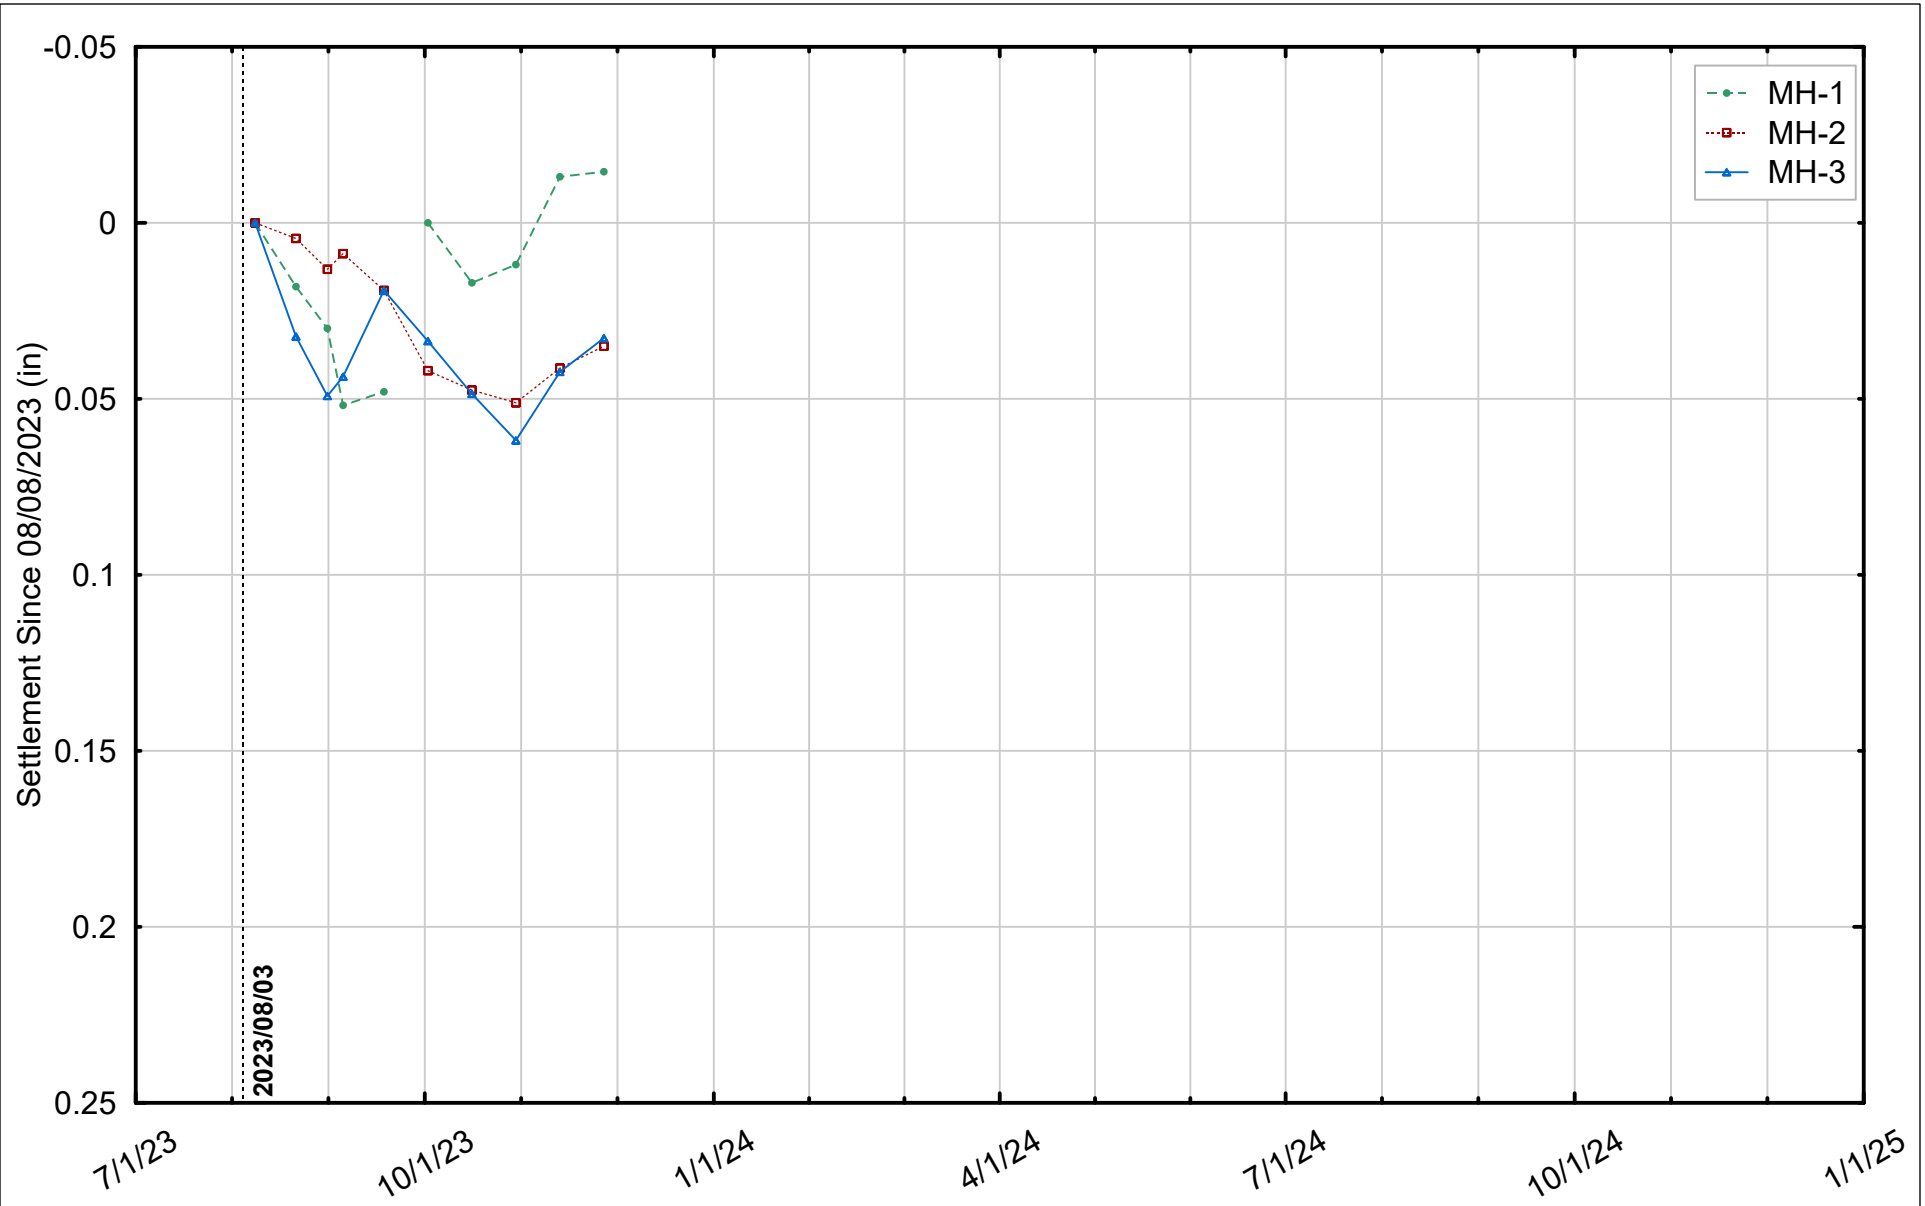
Project No: 23-018-01	Date: 11/29/2023	Created By: TB	Checked By: DGM	Figure No: 126-14
-----------------------	------------------	----------------	-----------------	-------------------

Figure 14 presents settlement data interpreted from survey points located on manholes around the Tower since August 8, 2023, through November 27, 2023.

Note: MH-1 was reset on 10/02/2023

MANHOLE SETTLEMENT DATA
 SINCE 08/08/2023 THROUGH 11/27/2023
 Millennium Tower Perimeter Pile Upgrade: Instrumentation Monitoring Data
 City and County of San Francisco, California
