Project Number: 23-018-01

Subject: 301 Mission Retrofit Monitoring Report 128: Results as of December 22, 2023

Millennium Tower Perimeter Pile Upgrade: Instrumentation Monitoring Data  
City and County of San Francisco, California

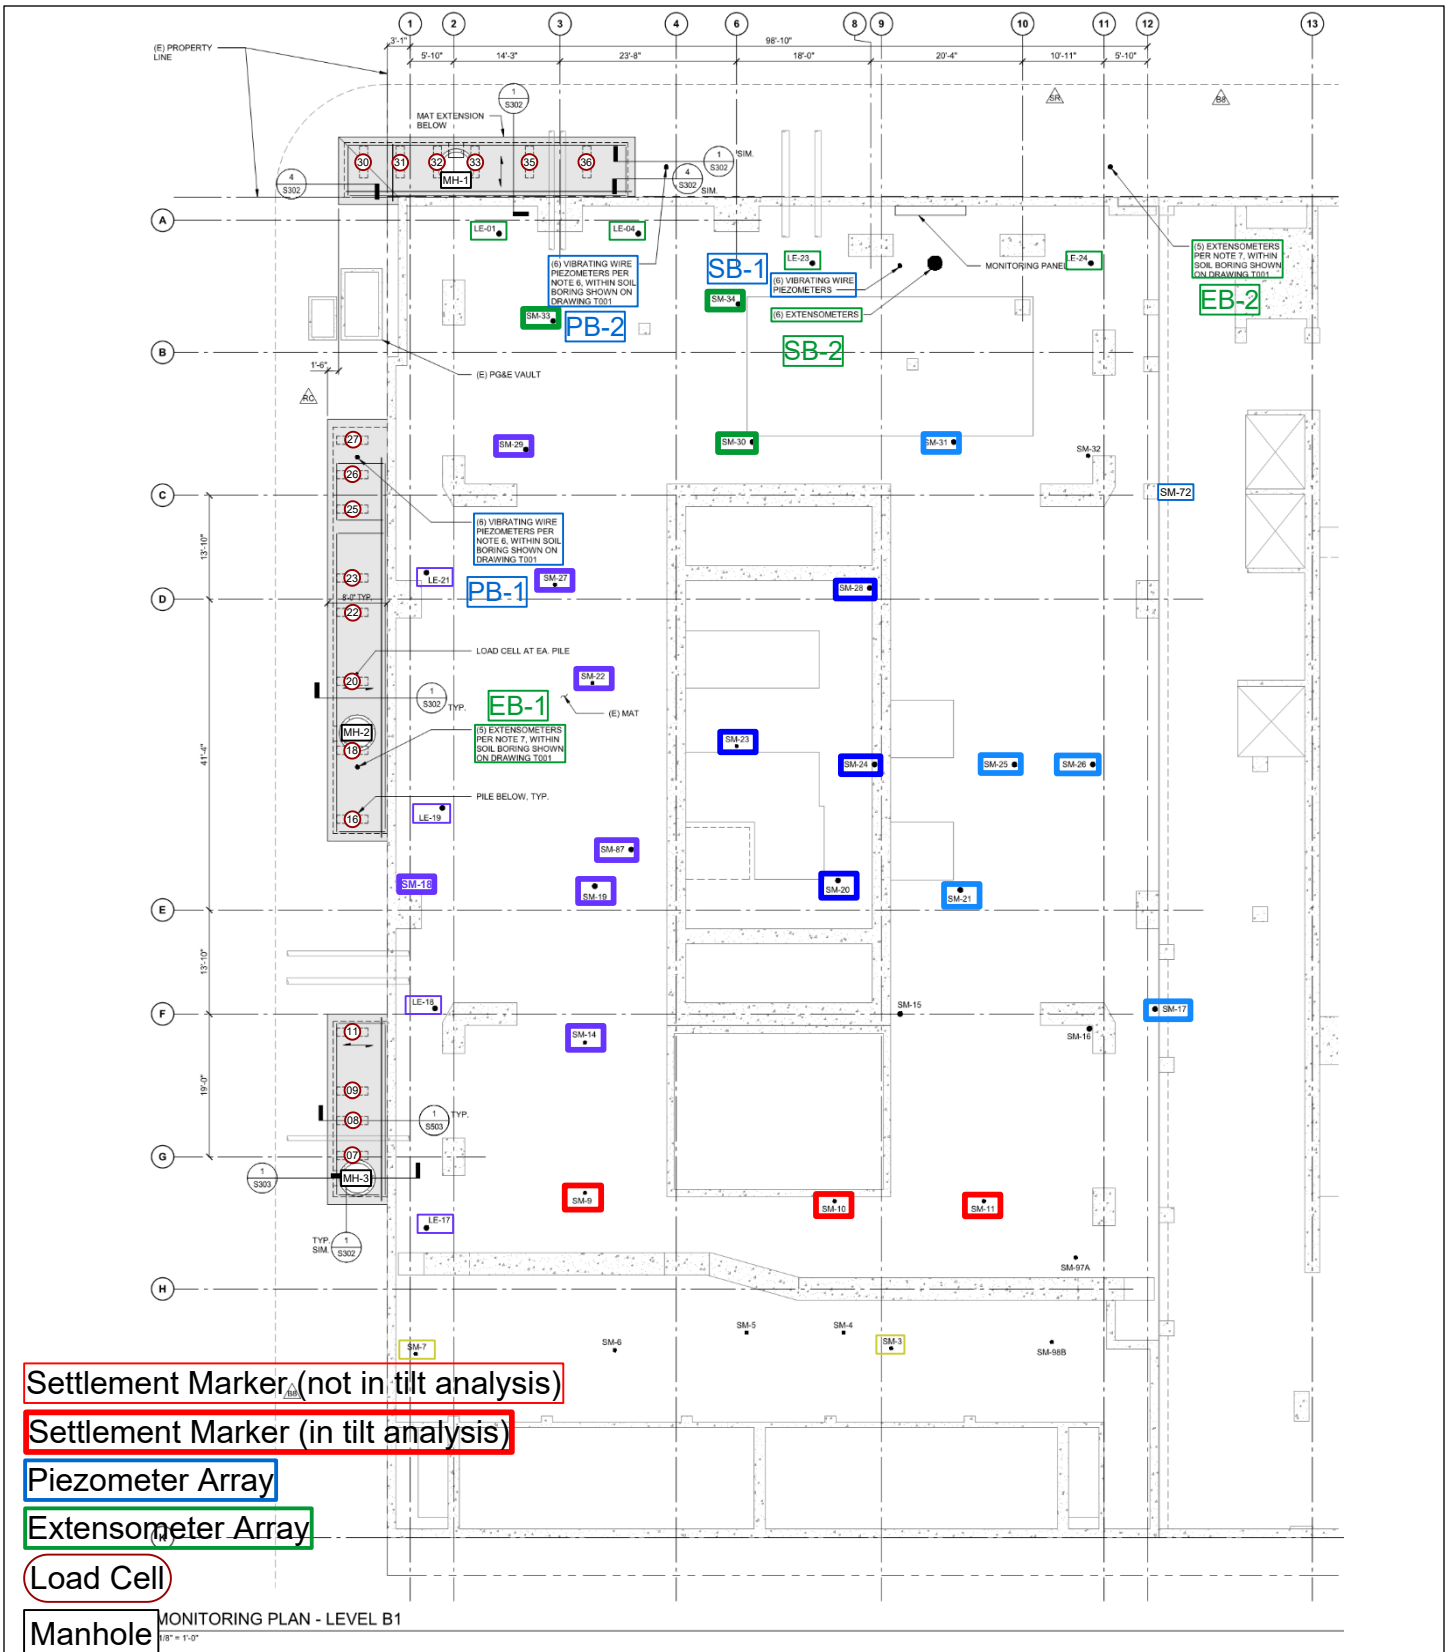
Project No: 23-018-01	Date: 8/22/2023	Created By: NBW	Checked By: DGM	Figure No: <b>128-01A</b>
-----------------------	-----------------	-----------------	-----------------	---------------------------

Figure 01 presents the instrument locations as referenced in later figures.

- SM-1 Settlement Marker (not in tilt analysis)
- SM-2 Settlement Marker (in tilt analysis)
- PB-1 Piezometer Array
- EB-1 Extensometer Array
- EA Load Cell
- MH-1 Manhole

**INSTRUMENT LOCATION MAP  
SETTLEMENT MARKERS, PIEZOMETERS, EXTENSOMETERS, LOAD CELLS**

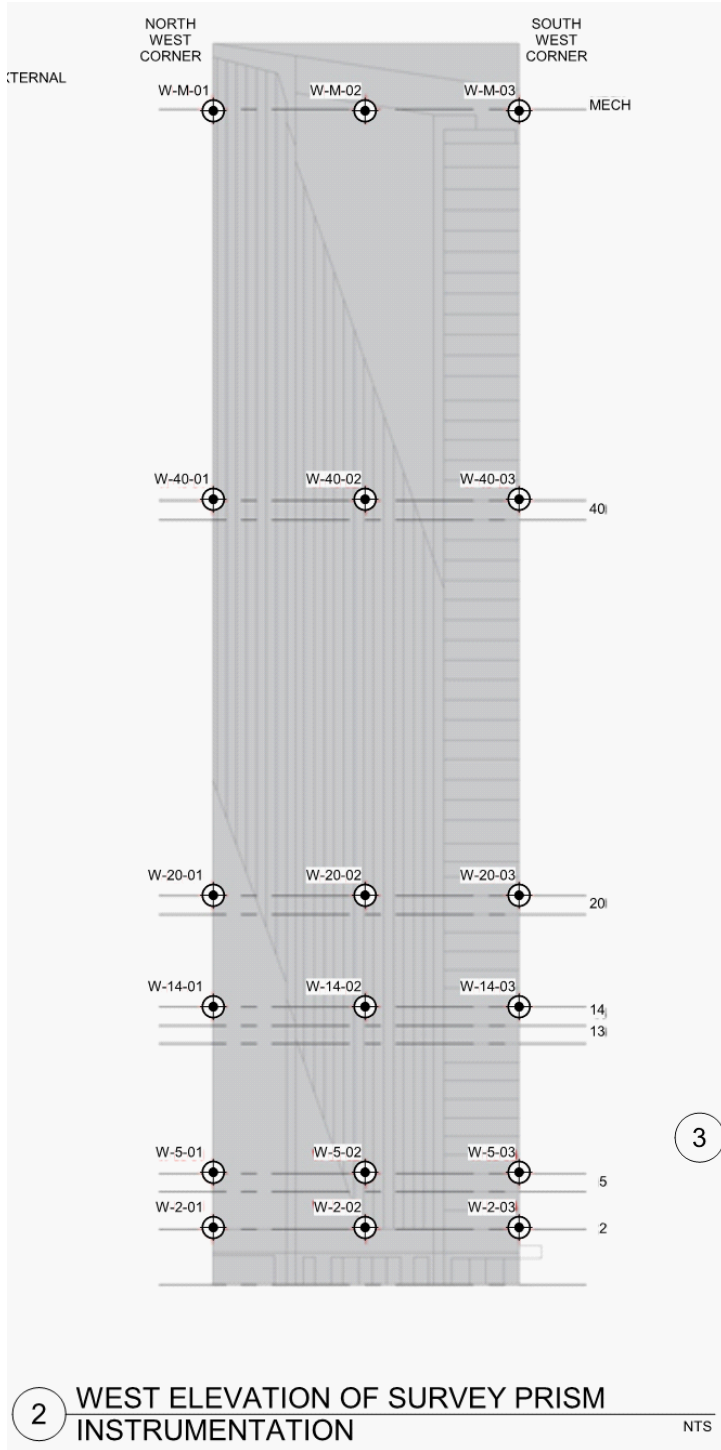
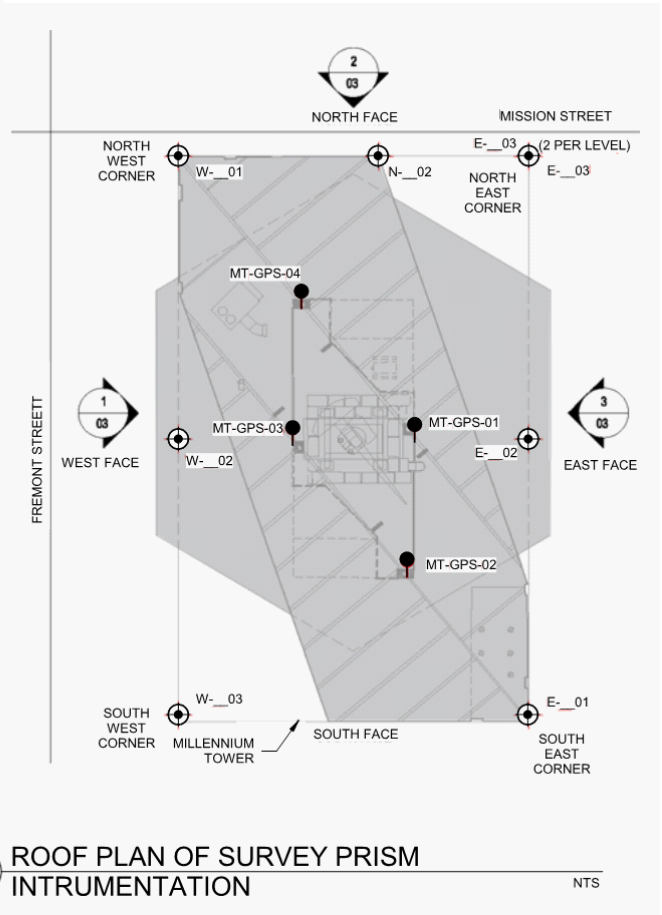
Project No: 23-018-01	Date: 7/26/2021	Created By: NBW	Checked By: DGM	Figure No: <b>128-01B</b>
-----------------------	-----------------	-----------------	-----------------	---------------------------

TOWER SURVEY PRISM LOCATION SCHEMATIC

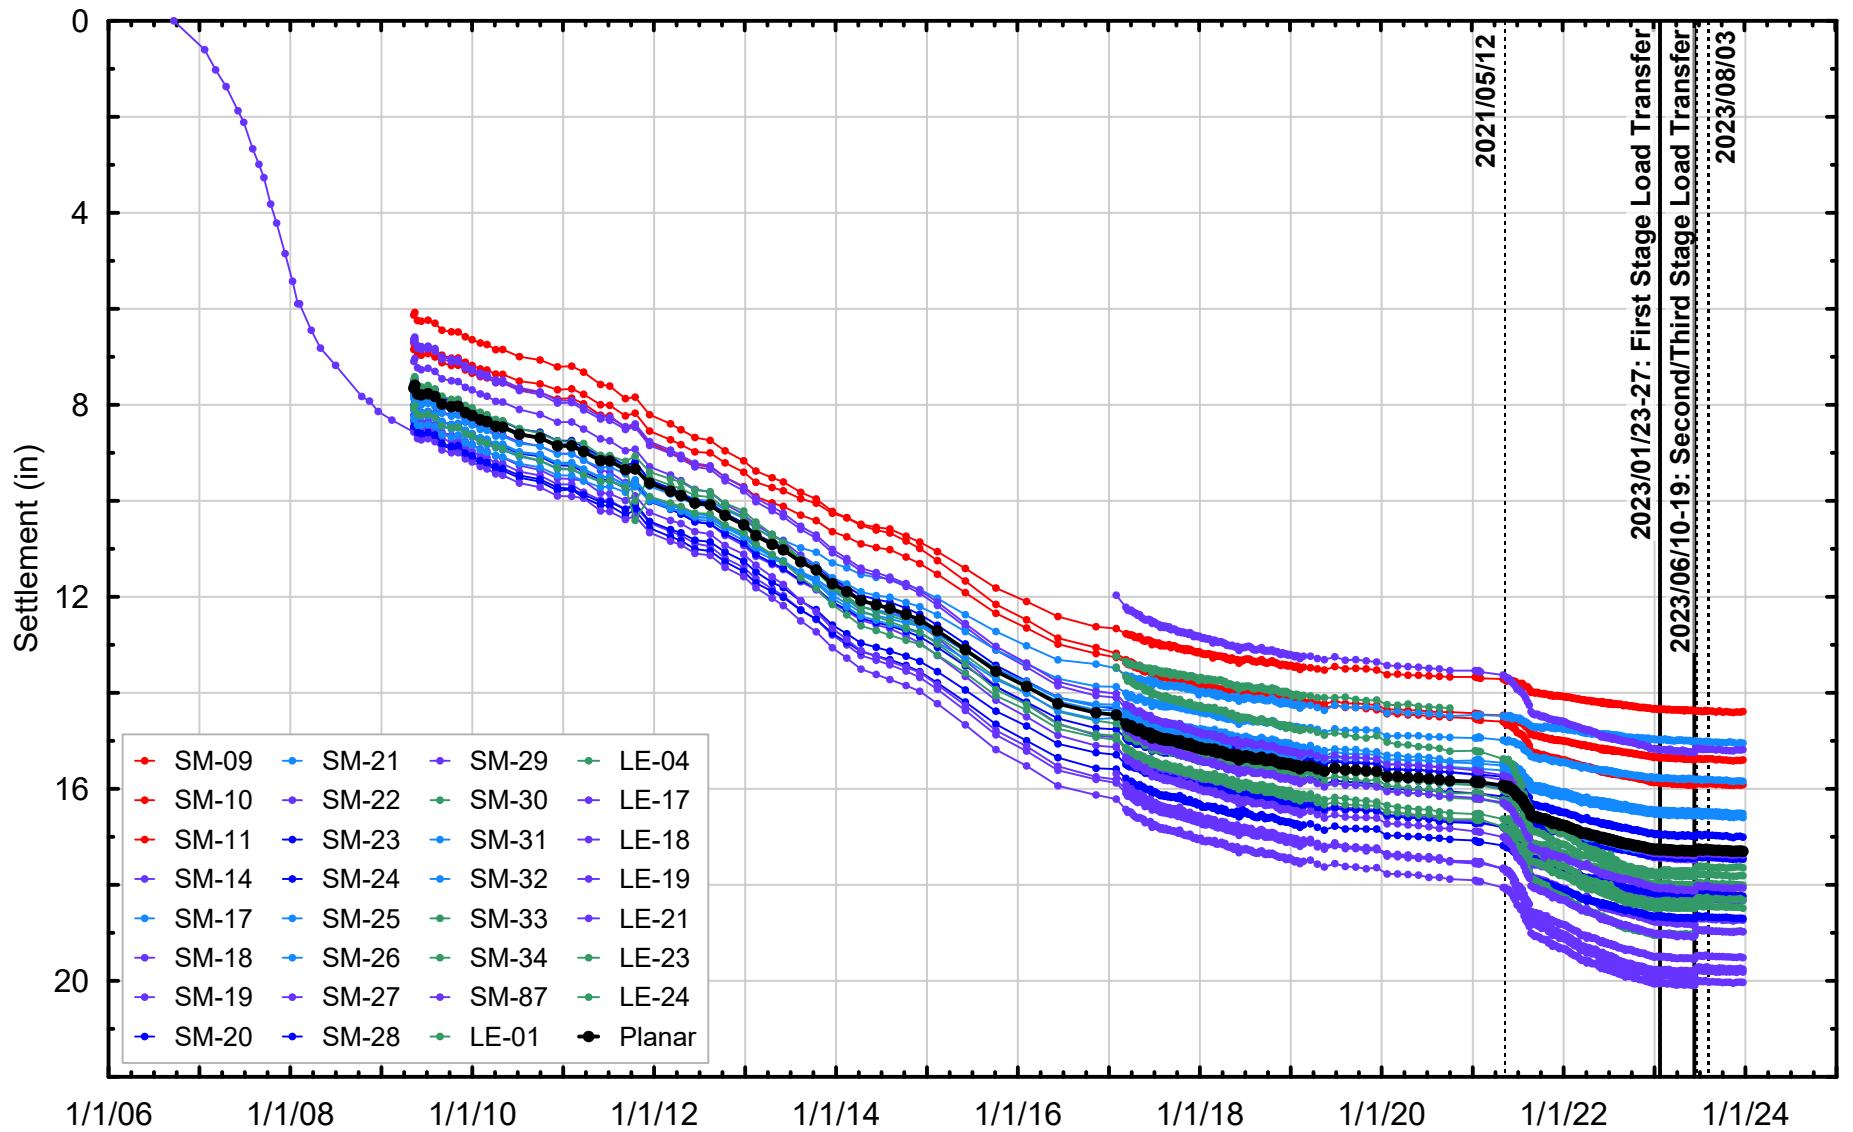
Project No: 23-018-01	Date: 1/3/2024	Created By: TB	Checked By: DGM	Figure No: <b>128-02</b>

Figure 02 presents the historical settlement data interpreted from settlement markers installed on the B-1 Level of 301 Mission Tower. In addition, data from surveys performed during the retrofit are included. Figure 03 presents settlement data since the start of production pile installation (May 12, 2021; baseline readings on May 10, 2021) through December 22, 2023. Figure 04 presents current settlement contours (in inches) on December 22, 2023.

HISTORICAL SETTLEMENT MARKER DATA		
		Millennium Tower Perimeter Pile Upgrade: Instrumentation Monitoring Data City and County of San Francisco, California

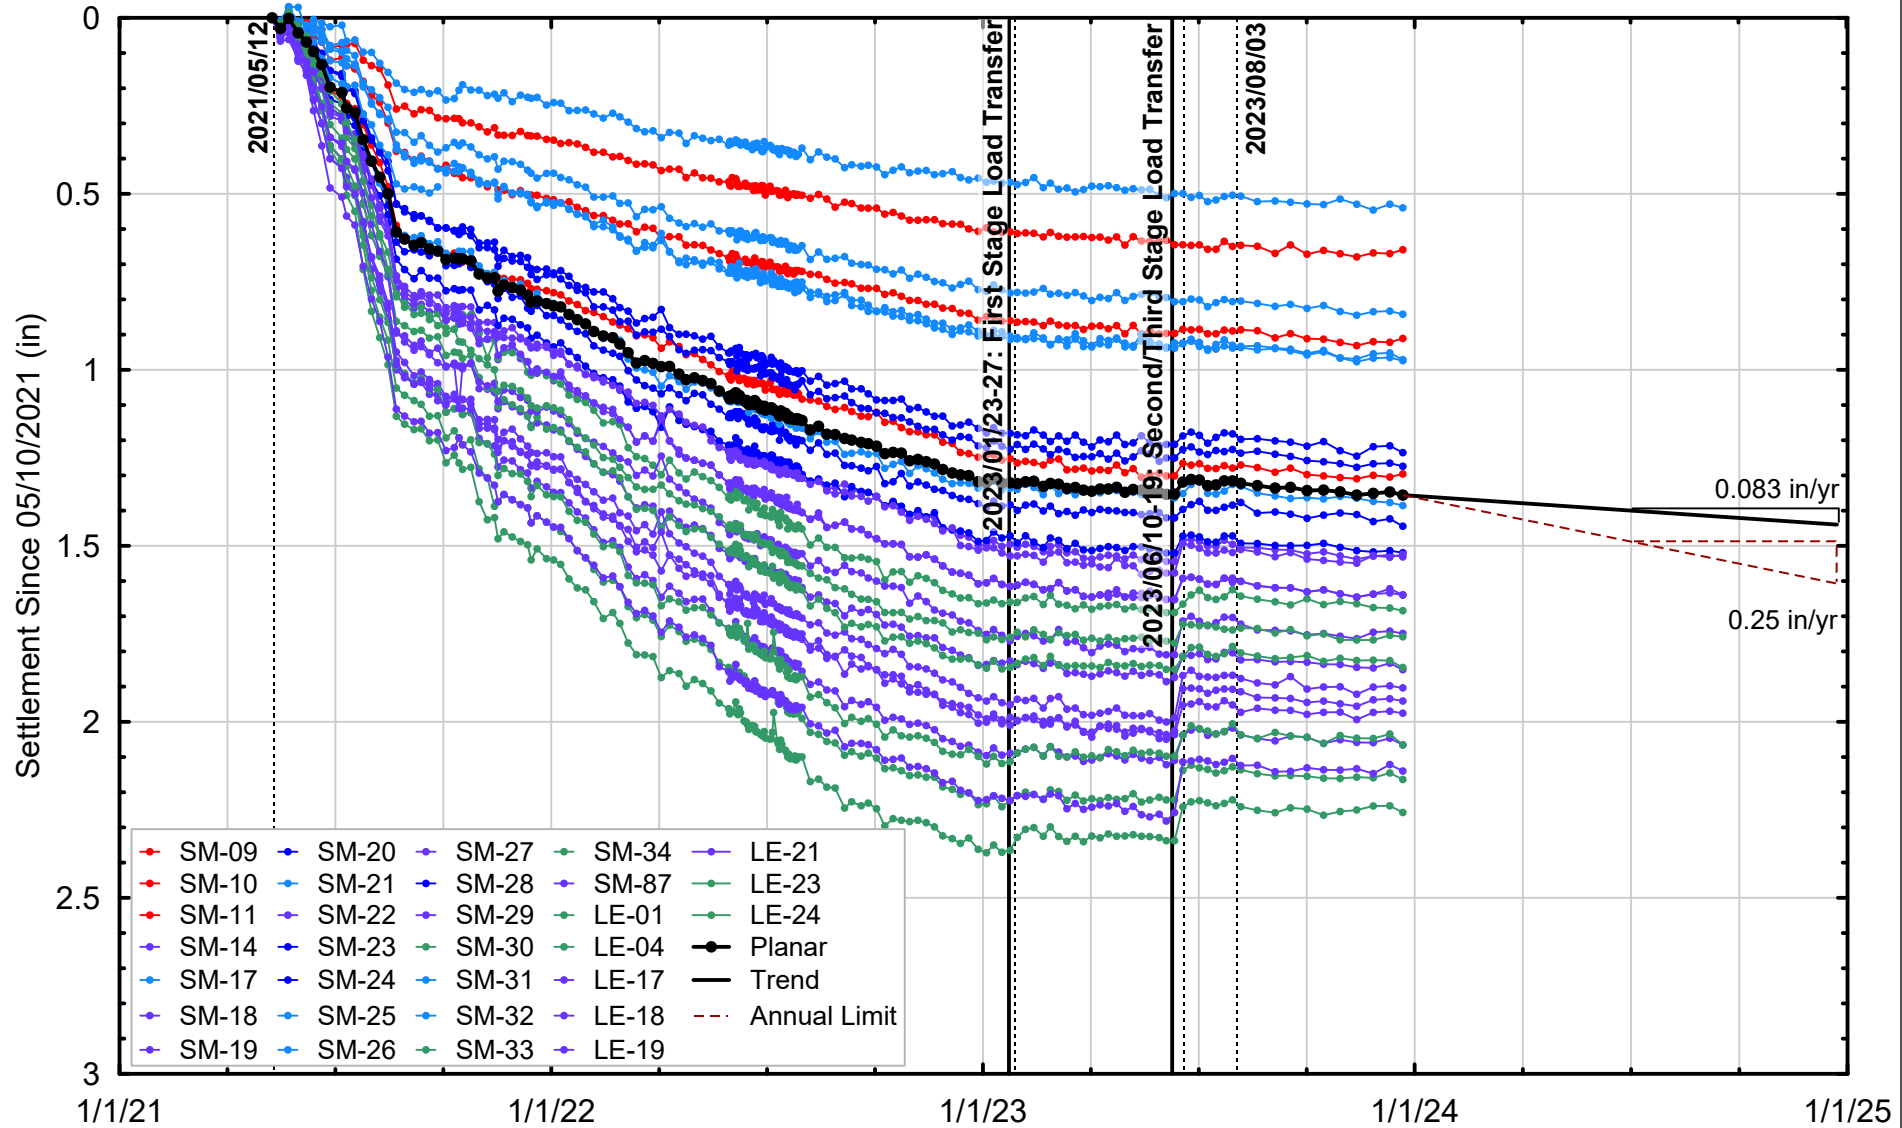
Project No: 23-018-01	Date: 1/3/2024	Created By: TB	Checked By: DGM	Figure No: <b>128-03</b>

<sup>5</sup> As plotted on Figure 03. The annual rate is calculated starting on the settlement monitoring date closest to one year prior to the current date or on June 19, 2023 (the settlement monitoring date corresponding to the last day of jacking load application), whichever is later, and ending on the current date.

<p align="center">SETTLEMENT MARKER DATA SINCE 05/10/2021 THROUGH 12/22/2023</p> <p align="center">Millennium Tower Perimeter Pile Upgrade: Instrumentation Monitoring Data City and County of San Francisco, California</p>

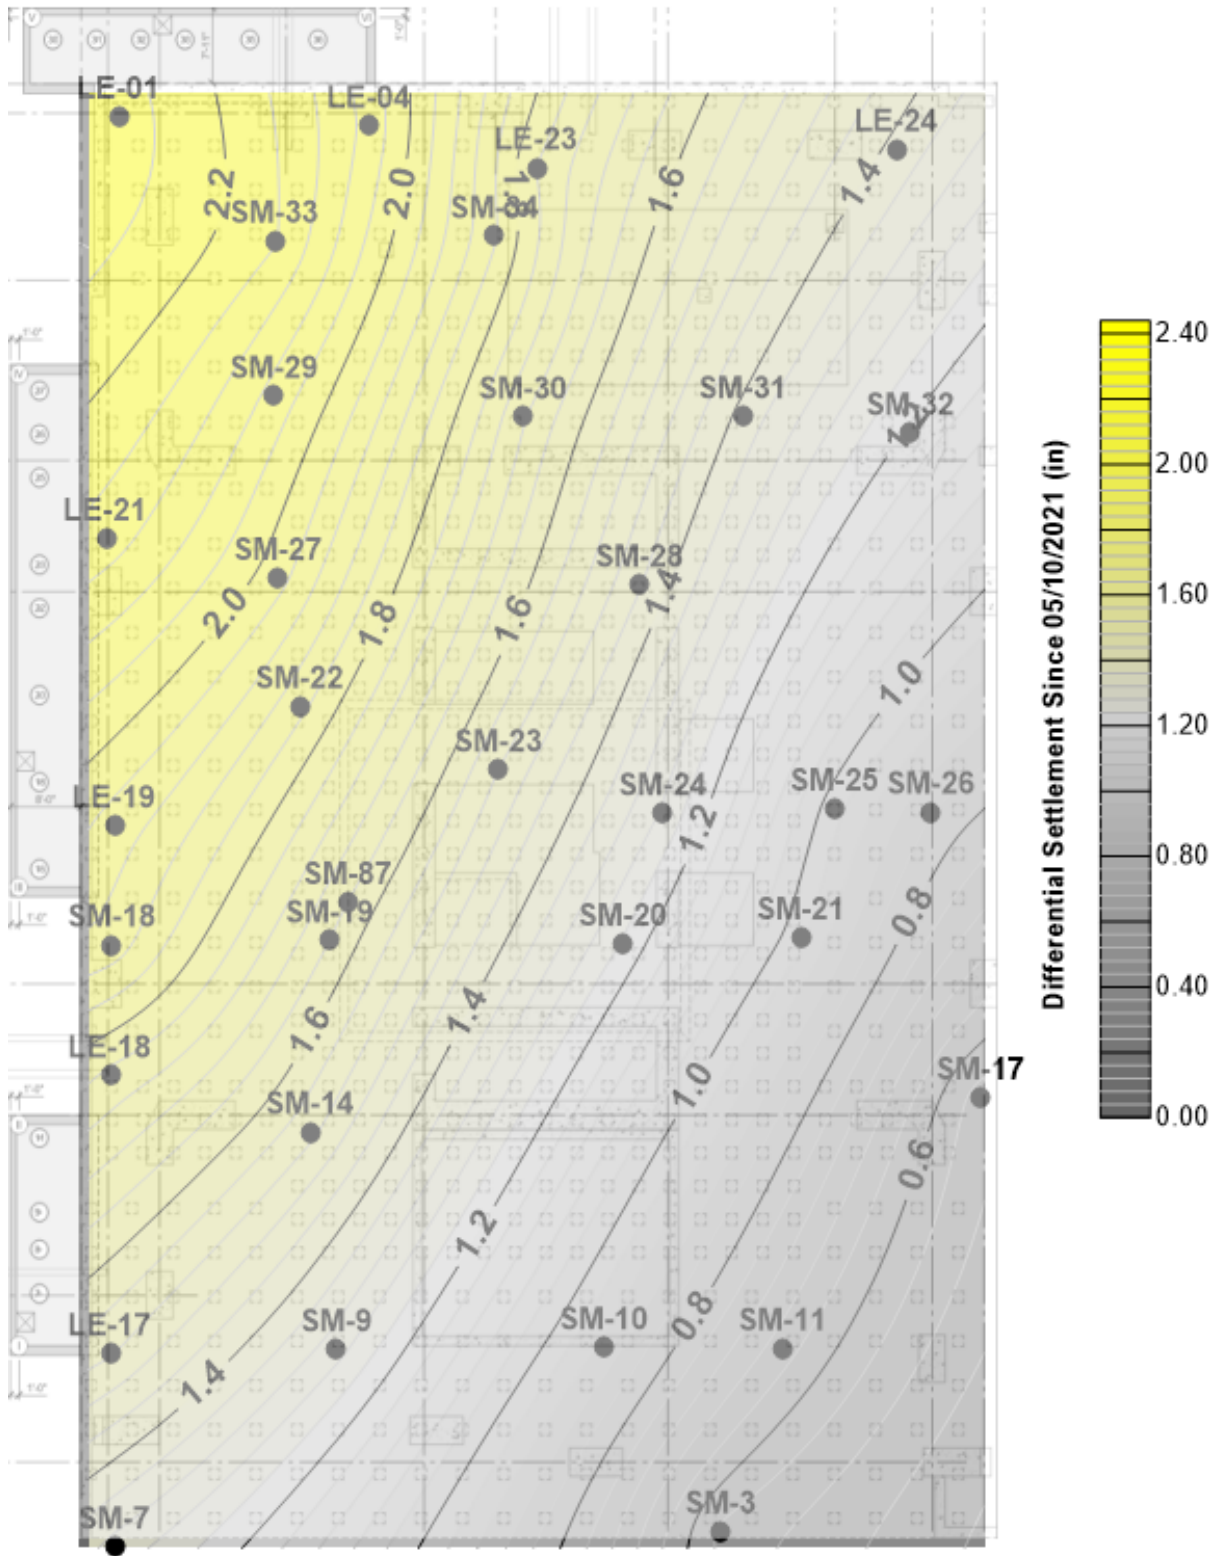
Figure No: **128-04**

SETTLEMENT CONTOURS  
SINCE 05/10/2021 THROUGH 12/22/2023

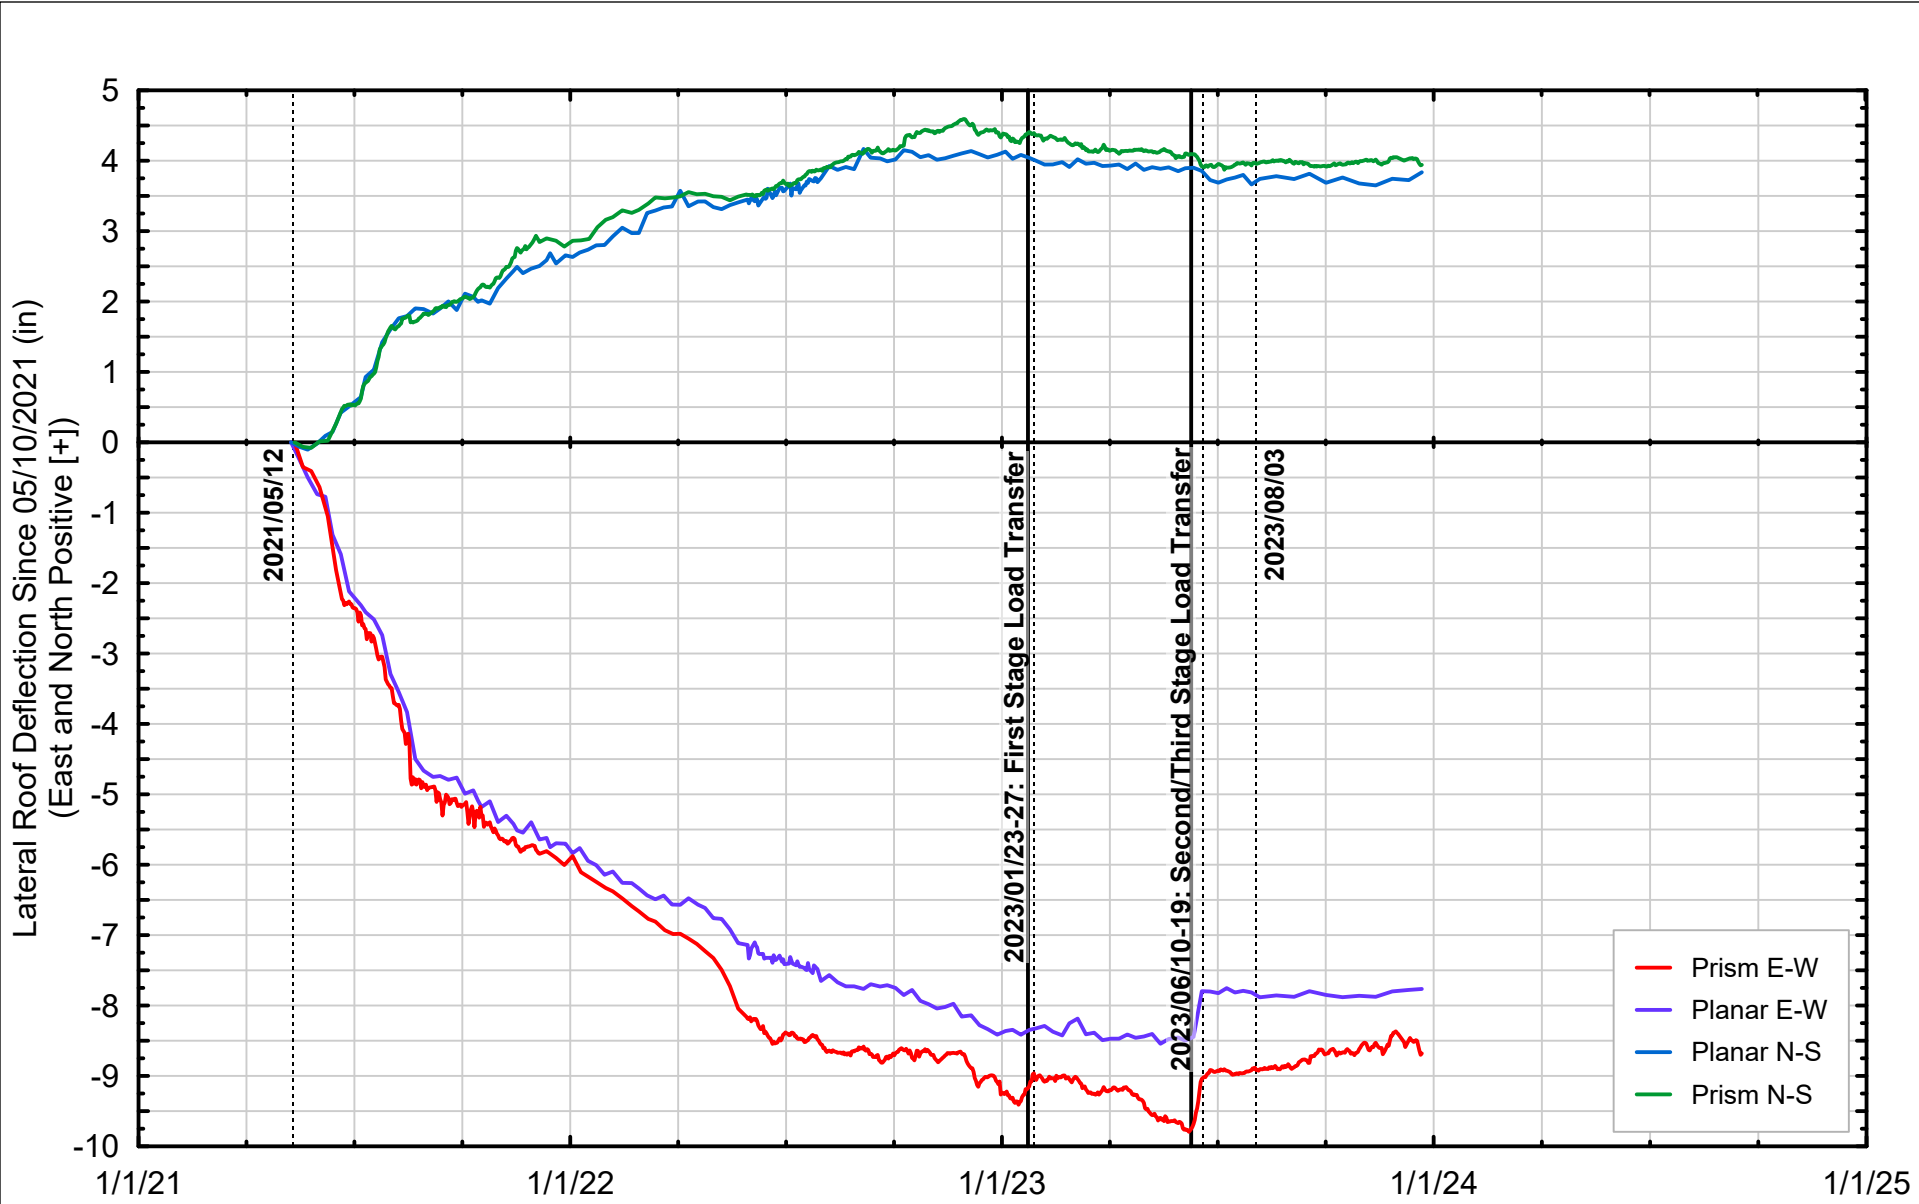
Project No: 23-018-01	Date: 1/3/2024	Created By: TB	Checked By: DGM	Figure No: 128-06
-----------------------	----------------	----------------	-----------------	-------------------

LATERAL ROOF DEFLECTION DATA  
 SINCE 05/10/2021 THROUGH 12/22/2023

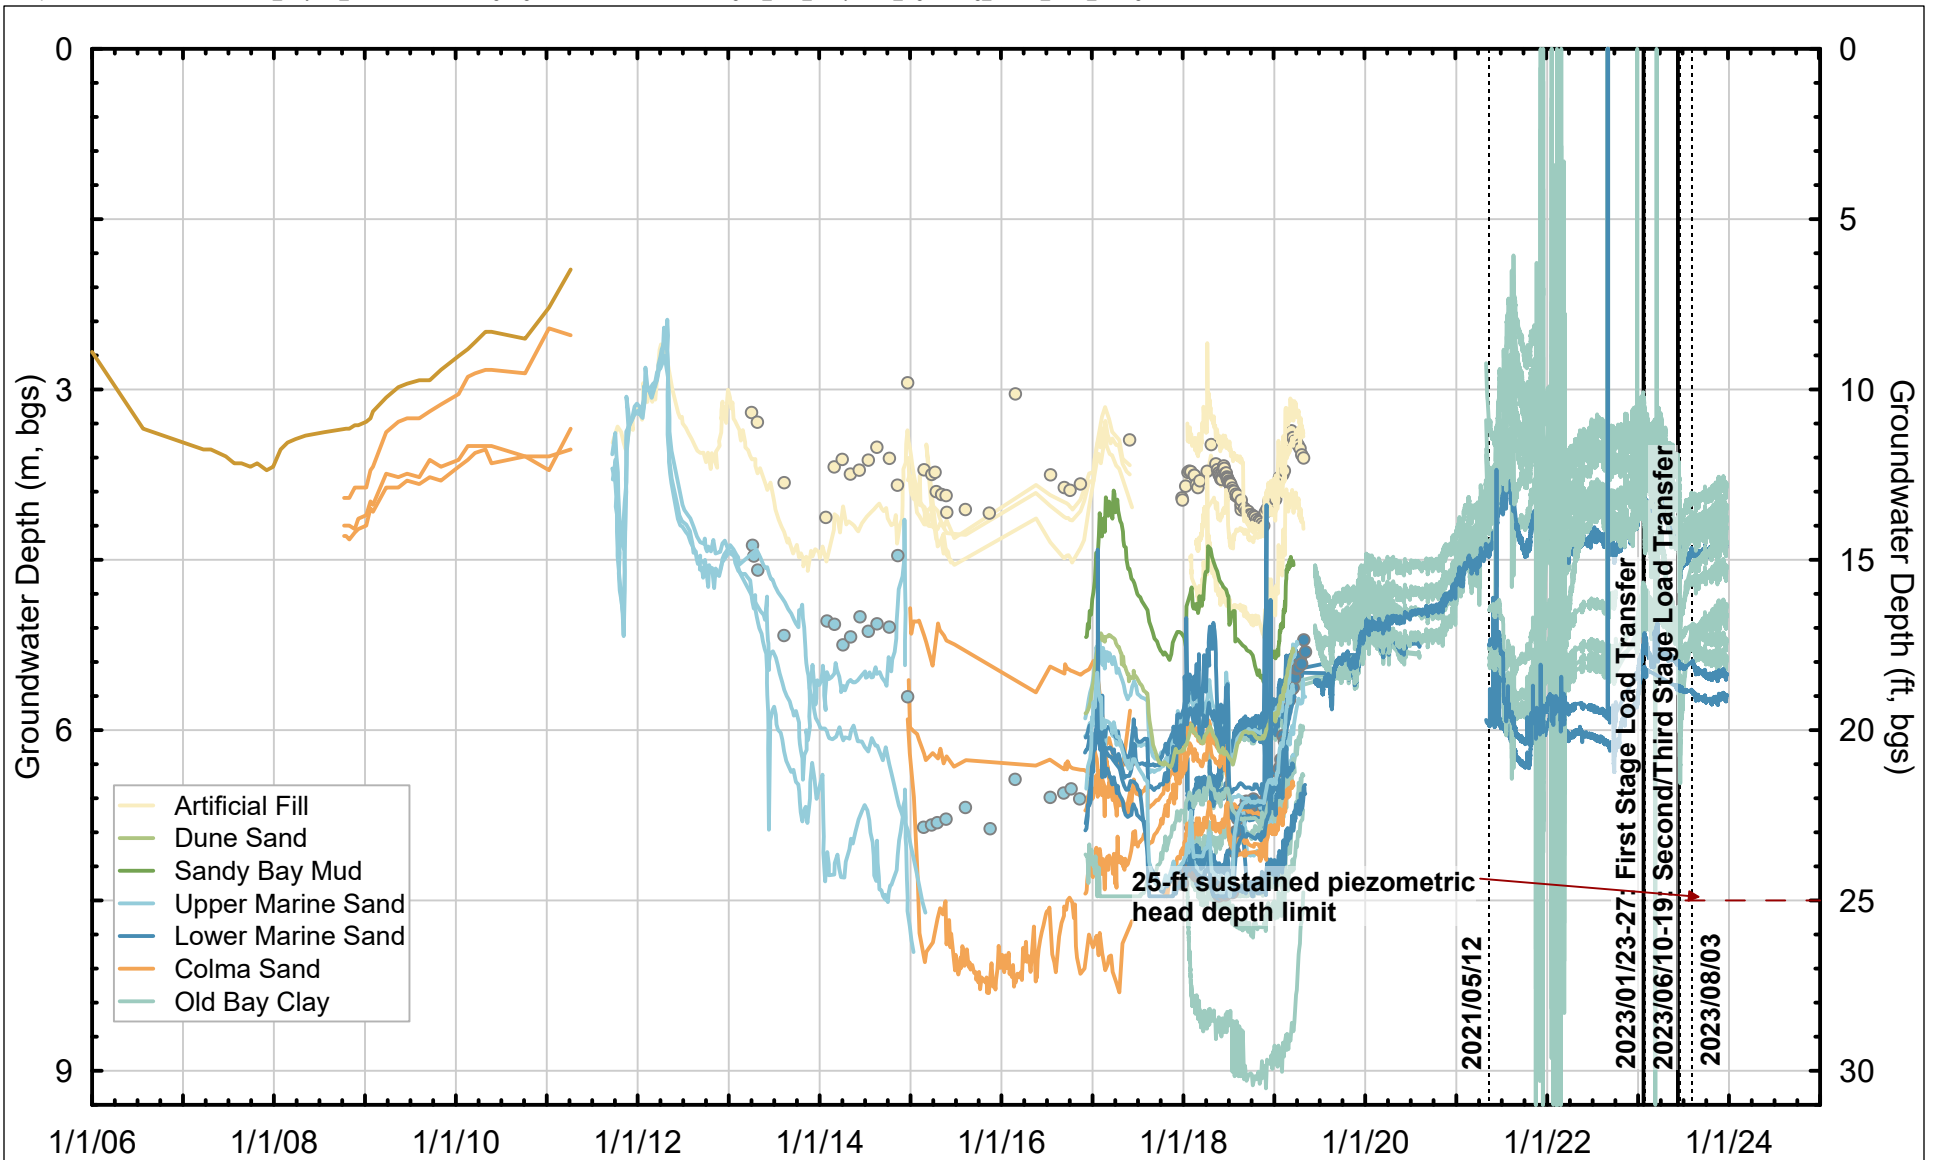
Project No: 23-018-01	Date: 1/3/2024	Created By: TB	Checked By: DGM	Figure No: 128-07
-----------------------	----------------	----------------	-----------------	-------------------

Figure 07 presents the historical groundwater elevation interpreted from piezometer readings at locations near 301 Mission. In addition, data from piezometers installed to monitor groundwater elevation during the retrofit are included. Figures 08 and 09 present groundwater elevation interpreted from piezometer readings

HISTORICAL GROUNDWATER ELEVATION MEASUREMENTS  
AT LOCATIONS NEAR 301 MISSION

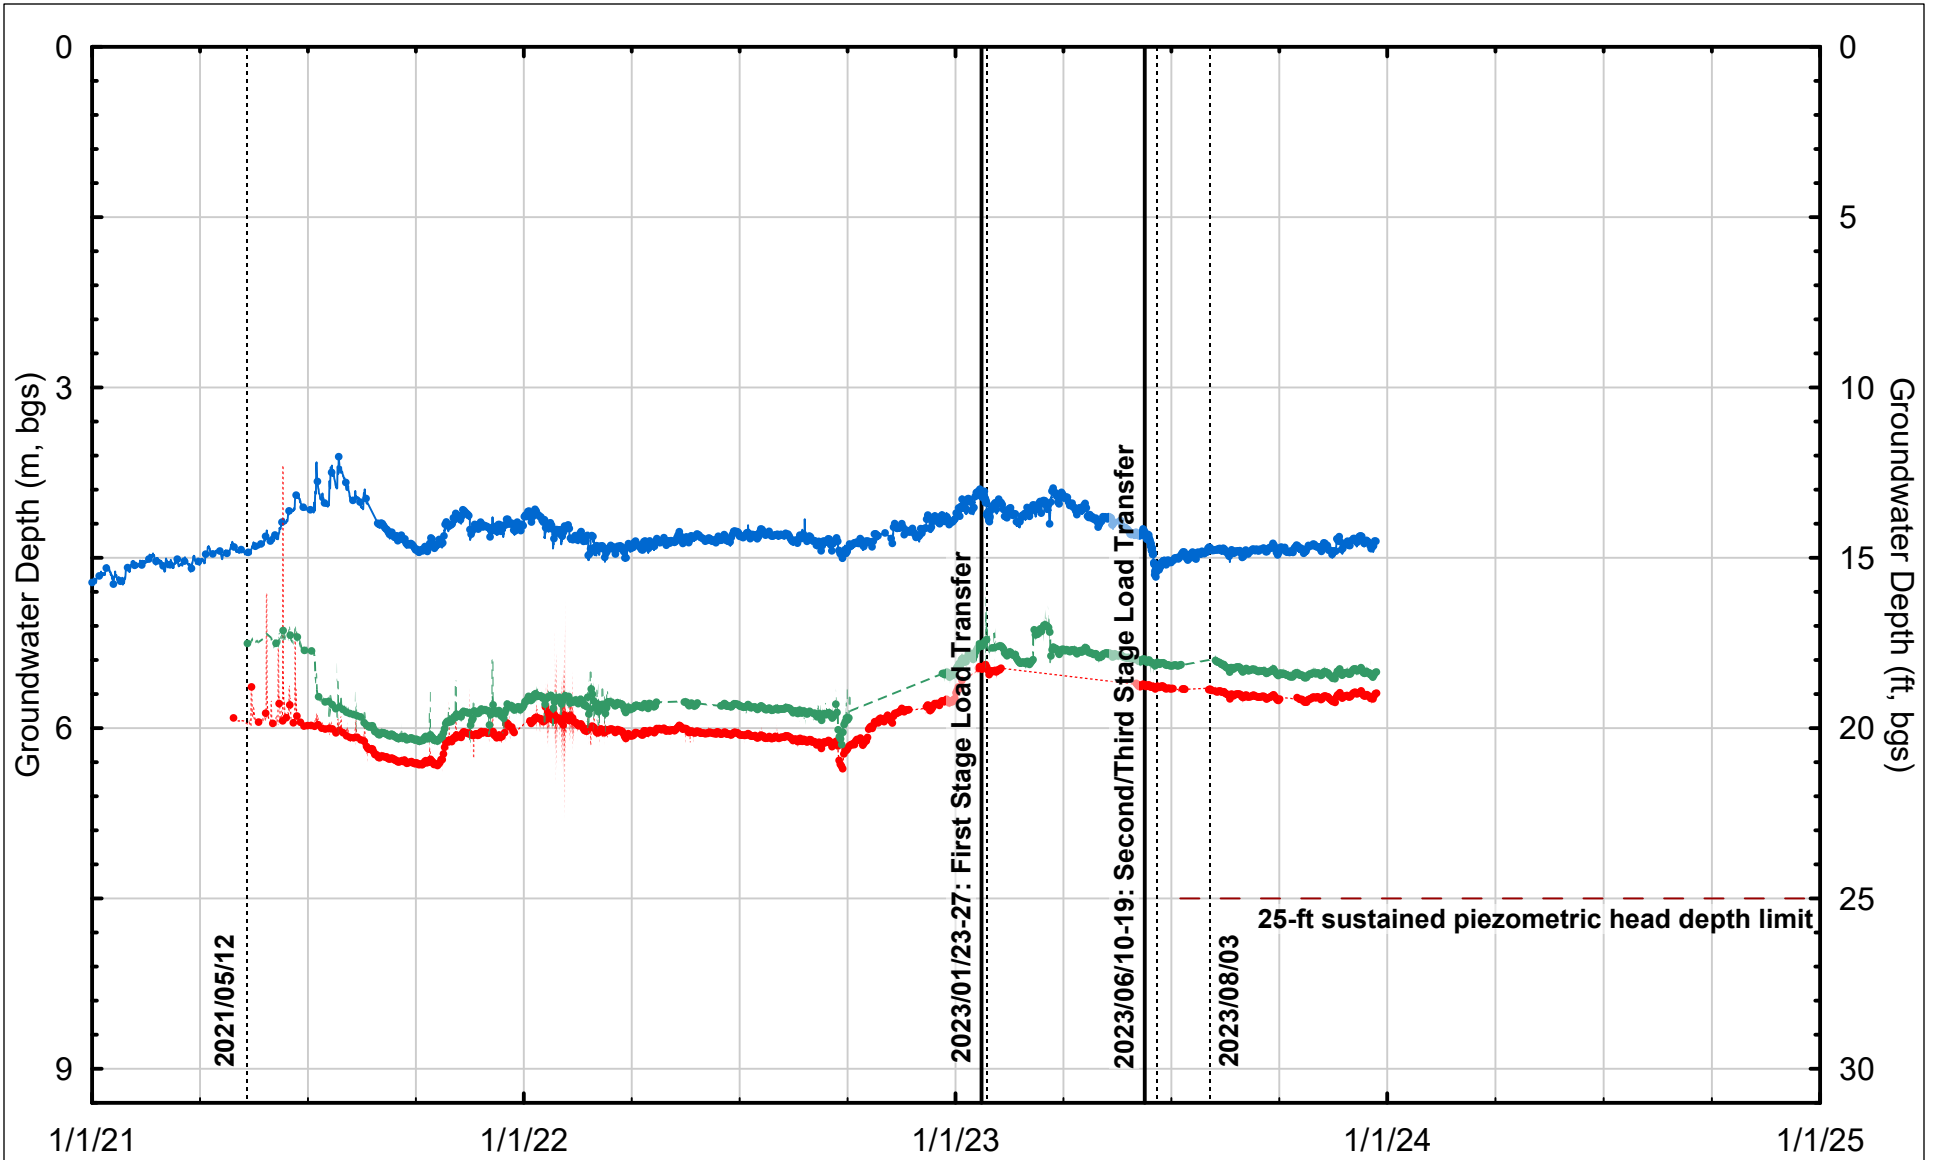
Project No: 23-018-01	Date: 1/3/2024	Created By: TB	Checked By: DGM	Figure No: <b>128-08</b>

in the Marine/Colma Sand and the Old Bay Clay, respectively, for the time period prior to the start of production pile installation (January 1, 2021) through December 22, 2023.

- SB-1 @ 85'
- PB-1 @ 85'
- PB-2 @ 85'

GROUNDWATER ELEVATION MEASUREMENTS IN MARINE AND COLMA SAND SINCE 01/01/2021 THROUGH 12/22/2023		
		Millennium Tower Perimeter Pile Upgrade: Instrumentation Monitoring Data City and County of San Francisco, California

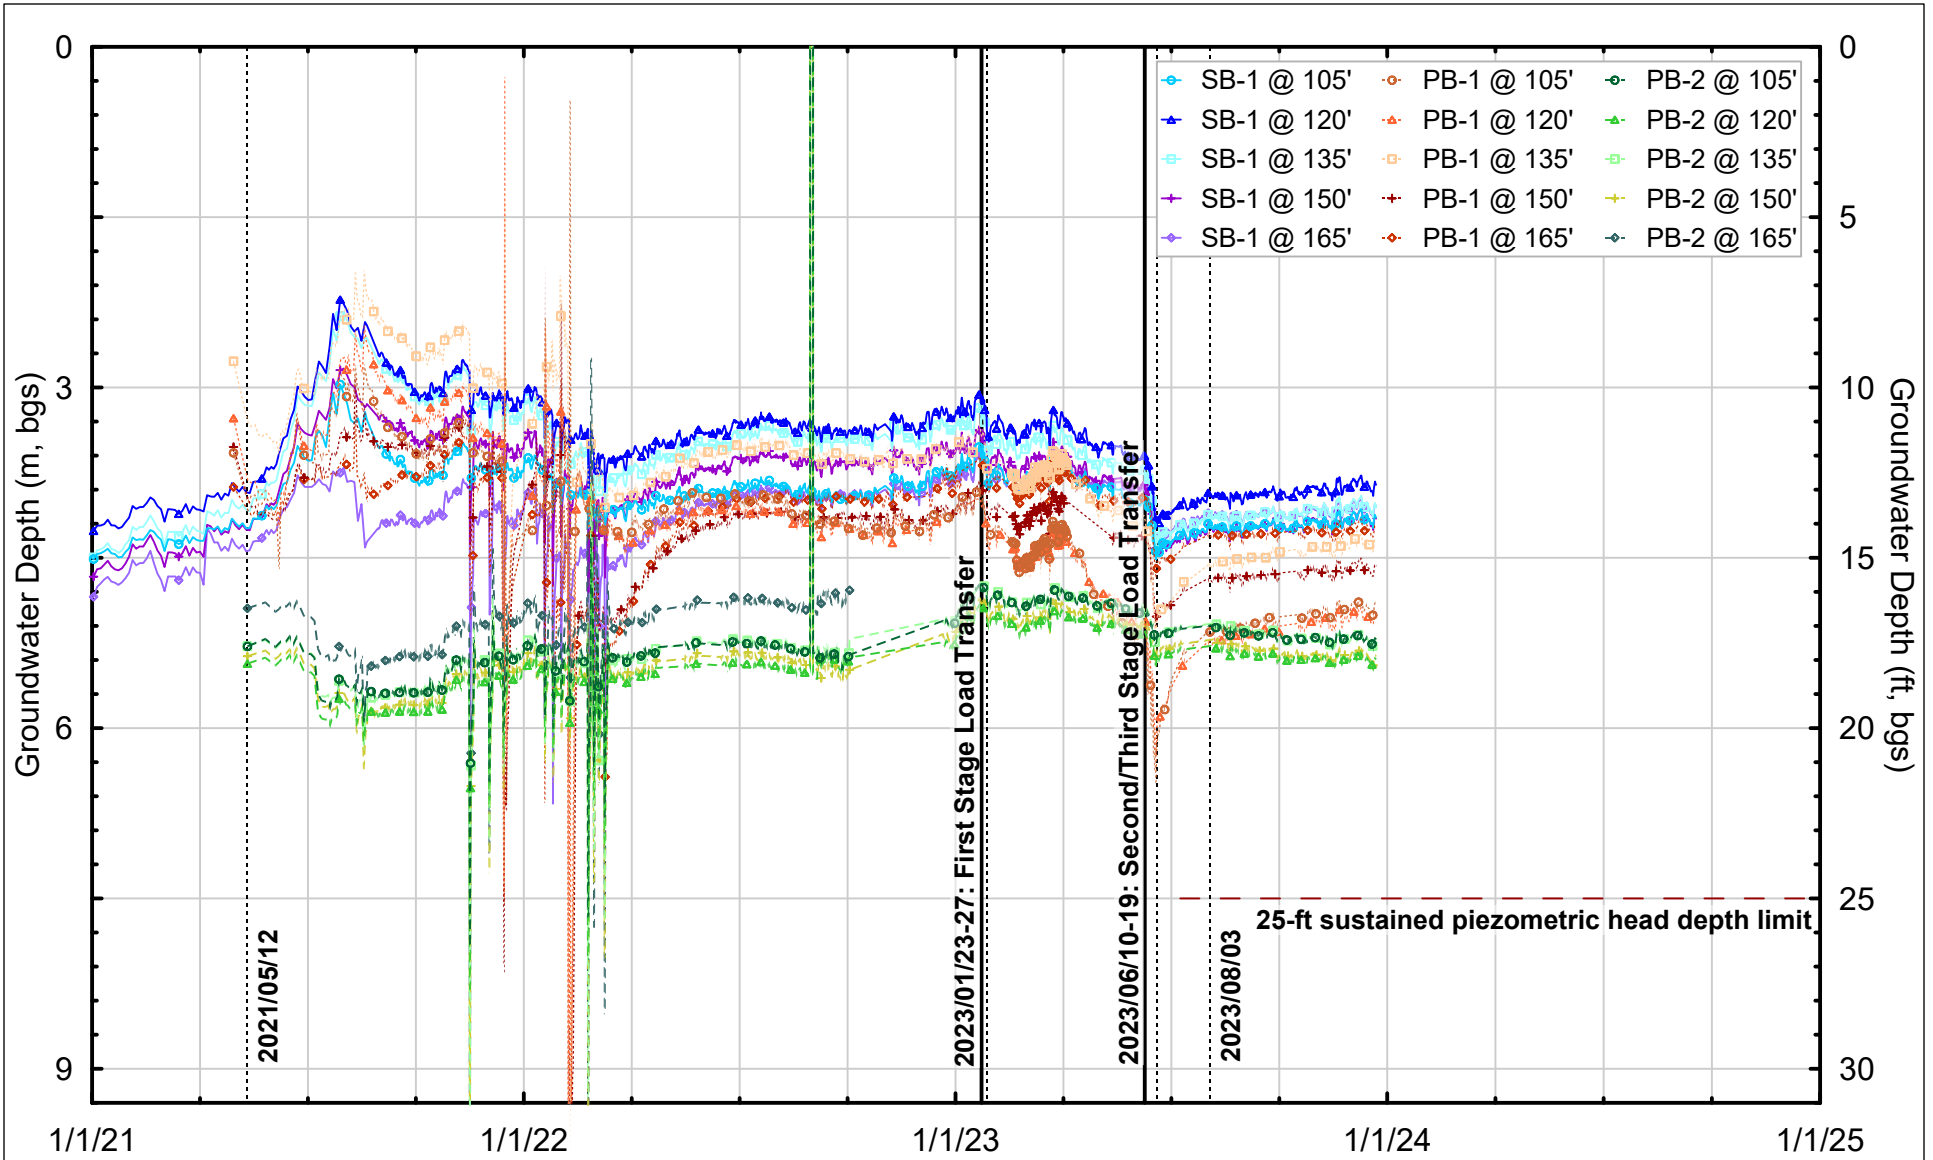
Project No: 23-018-01	Date: 1/3/2024	Created By: TB	Checked By: DGM	Figure No: 128-09
-----------------------	----------------	----------------	-----------------	-------------------

GROUNDWATER ELEVATION MEASUREMENTS IN OLD BAY CLAY  
SINCE 01/01/2021 THROUGH 12/22/2023

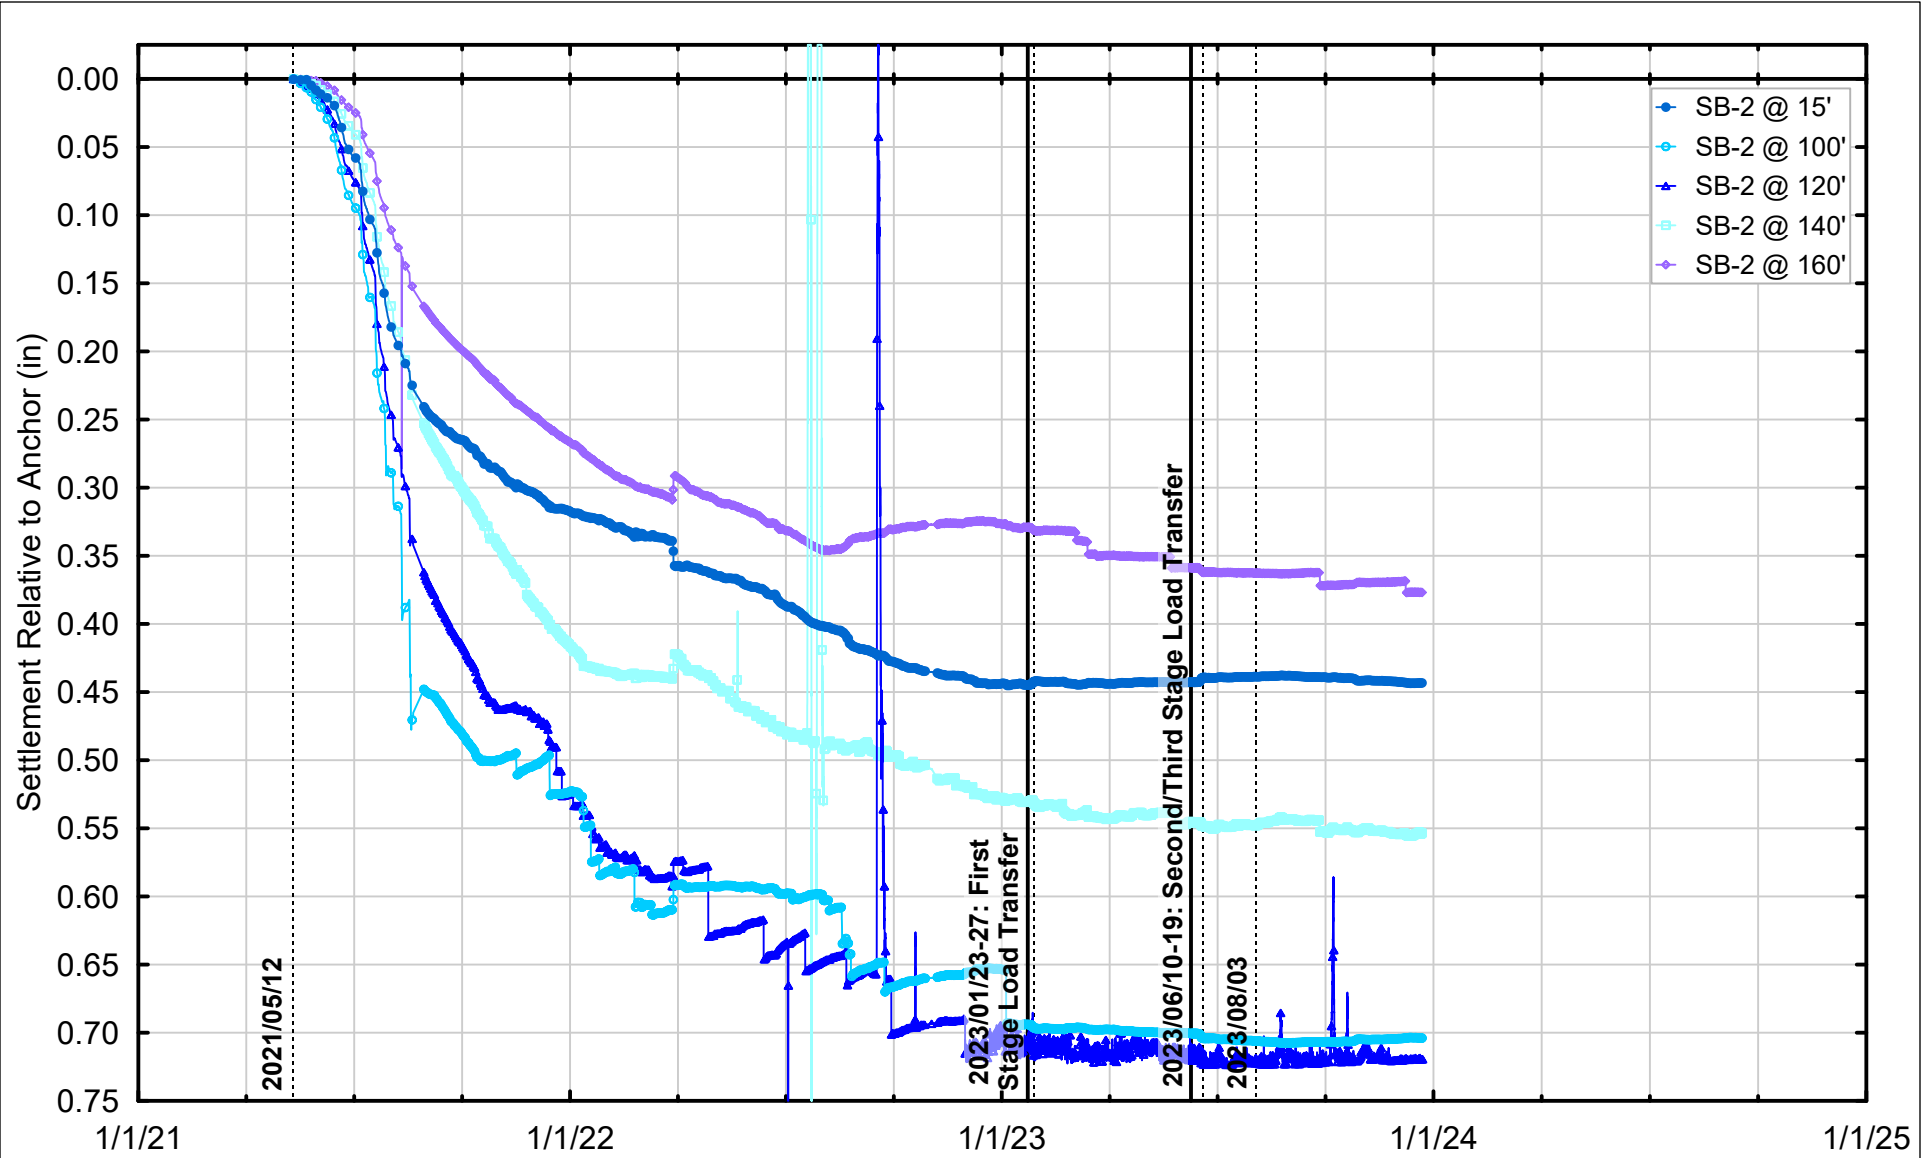
Project No: 23-018-01	Date: 1/3/2024	Created By: TB	Checked By: DGM	Figure No: <b>128-10</b>
-----------------------	----------------	----------------	-----------------	--------------------------

Figure 10 presents extensometer data from within the Tower basement since the start of production pile installation (May 12, 2021) through December 22, 2023. Figure 11 presents extensometer data from Fremont Street since the start of production pile installation (May 12, 2021) through May 16, 2023, and from the restart after fixing the extensometer (May 30, 2023) through December 22, 2023. Figure 12 presents extensometer data from Mission Street since the start of production pile installation (May 12, 2021) through December 22, 2023.

EXTENSOMETER DATA FROM WITHIN TOWER BASEMENT  
SINCE 01/01/2021 THROUGH 12/22/2023
