Project Number: 23-018-01

Subject: 301 Mission Retrofit Monitoring Report 128: Results as of December 22, 2023

Millennium Tower Perimeter Pile Upgrade: Instrumentation Monitoring Data  
City and County of San Francisco, California

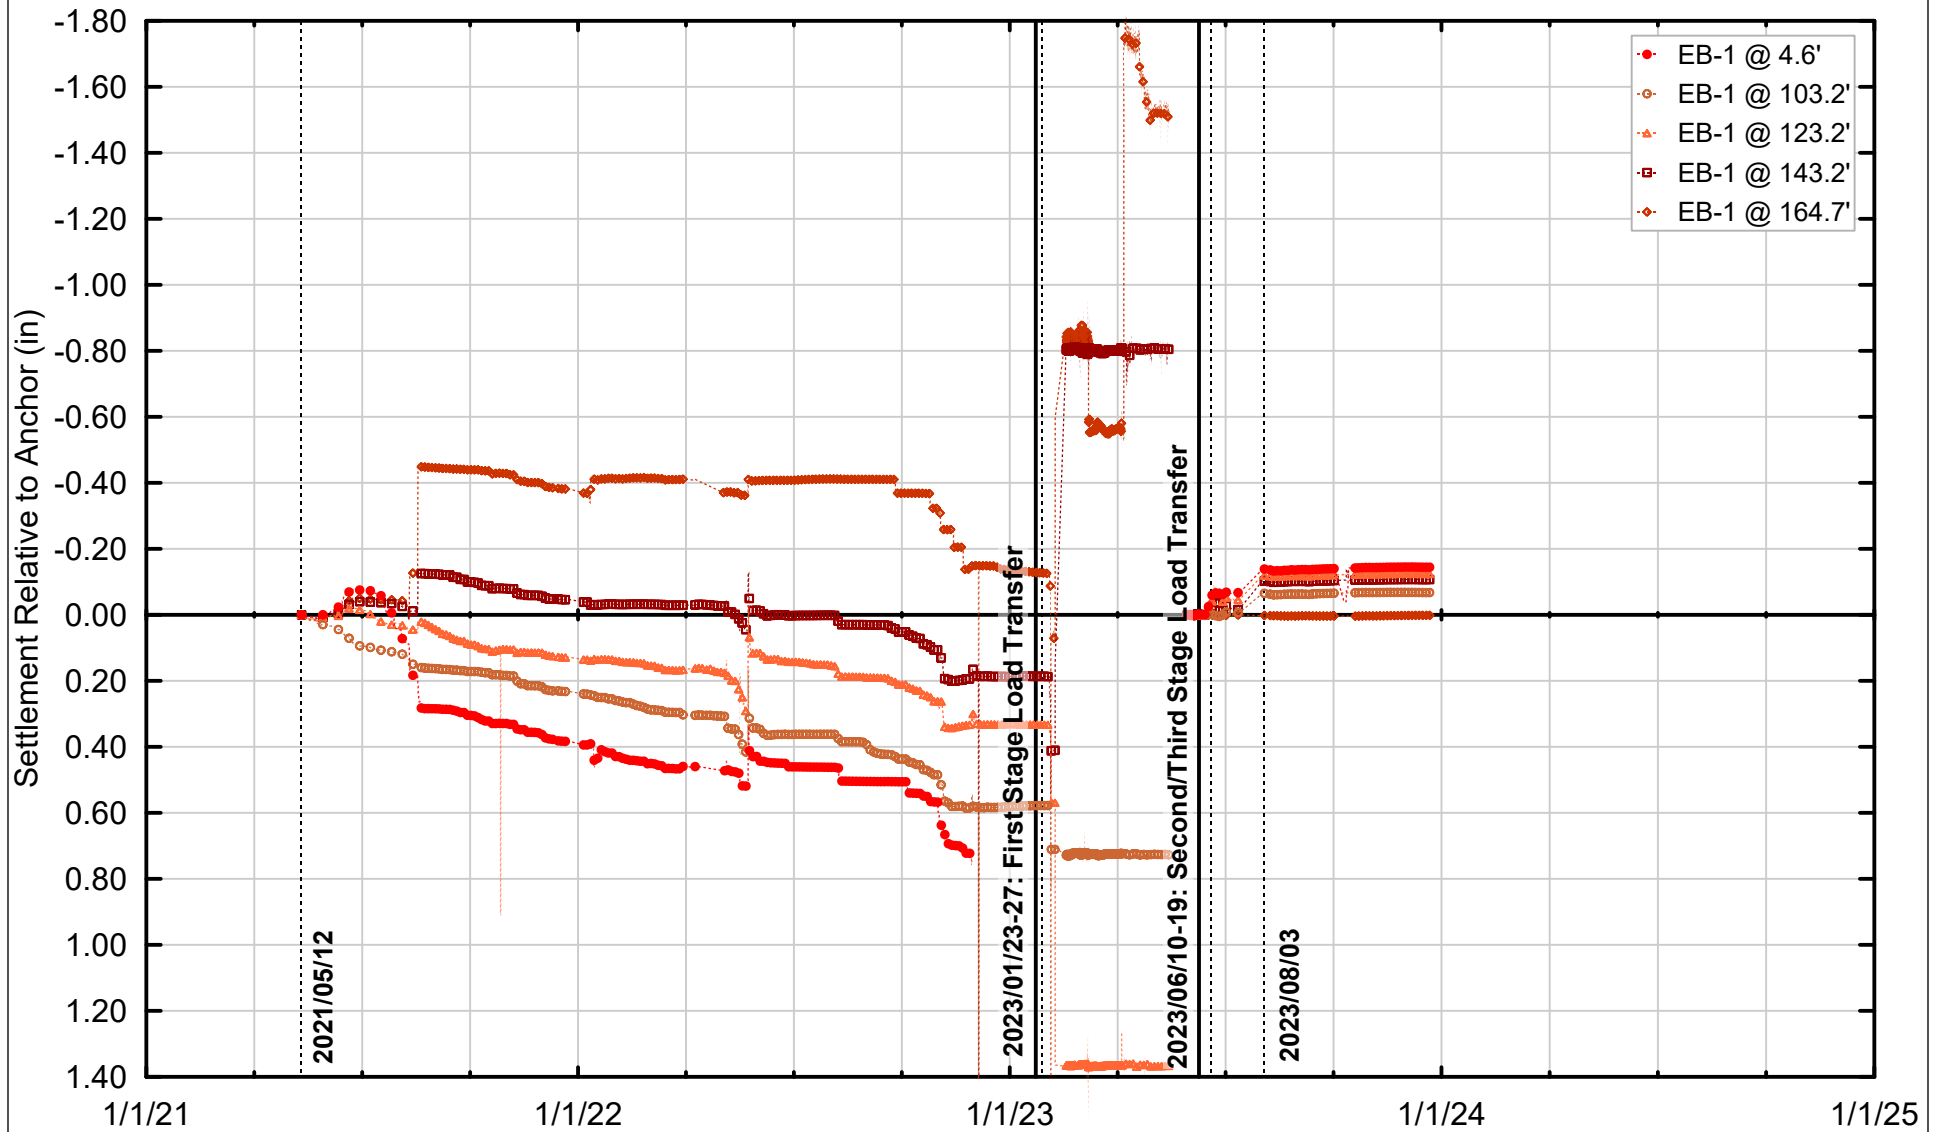
Figure No: 128-11

Note: EB-1 was repaired and reset on 2023/05/30

EXTENSOMETER DATA FROM FREMONT STREET  
 SINCE 05/10/2021 THROUGH 05/16/2023  
 SINCE 05/30/2023 THROUGH 12/22/2023  
 Millennium Tower Perimeter Pile Upgrade: Instrumentation Monitoring Data  
 City and County of San Francisco, California

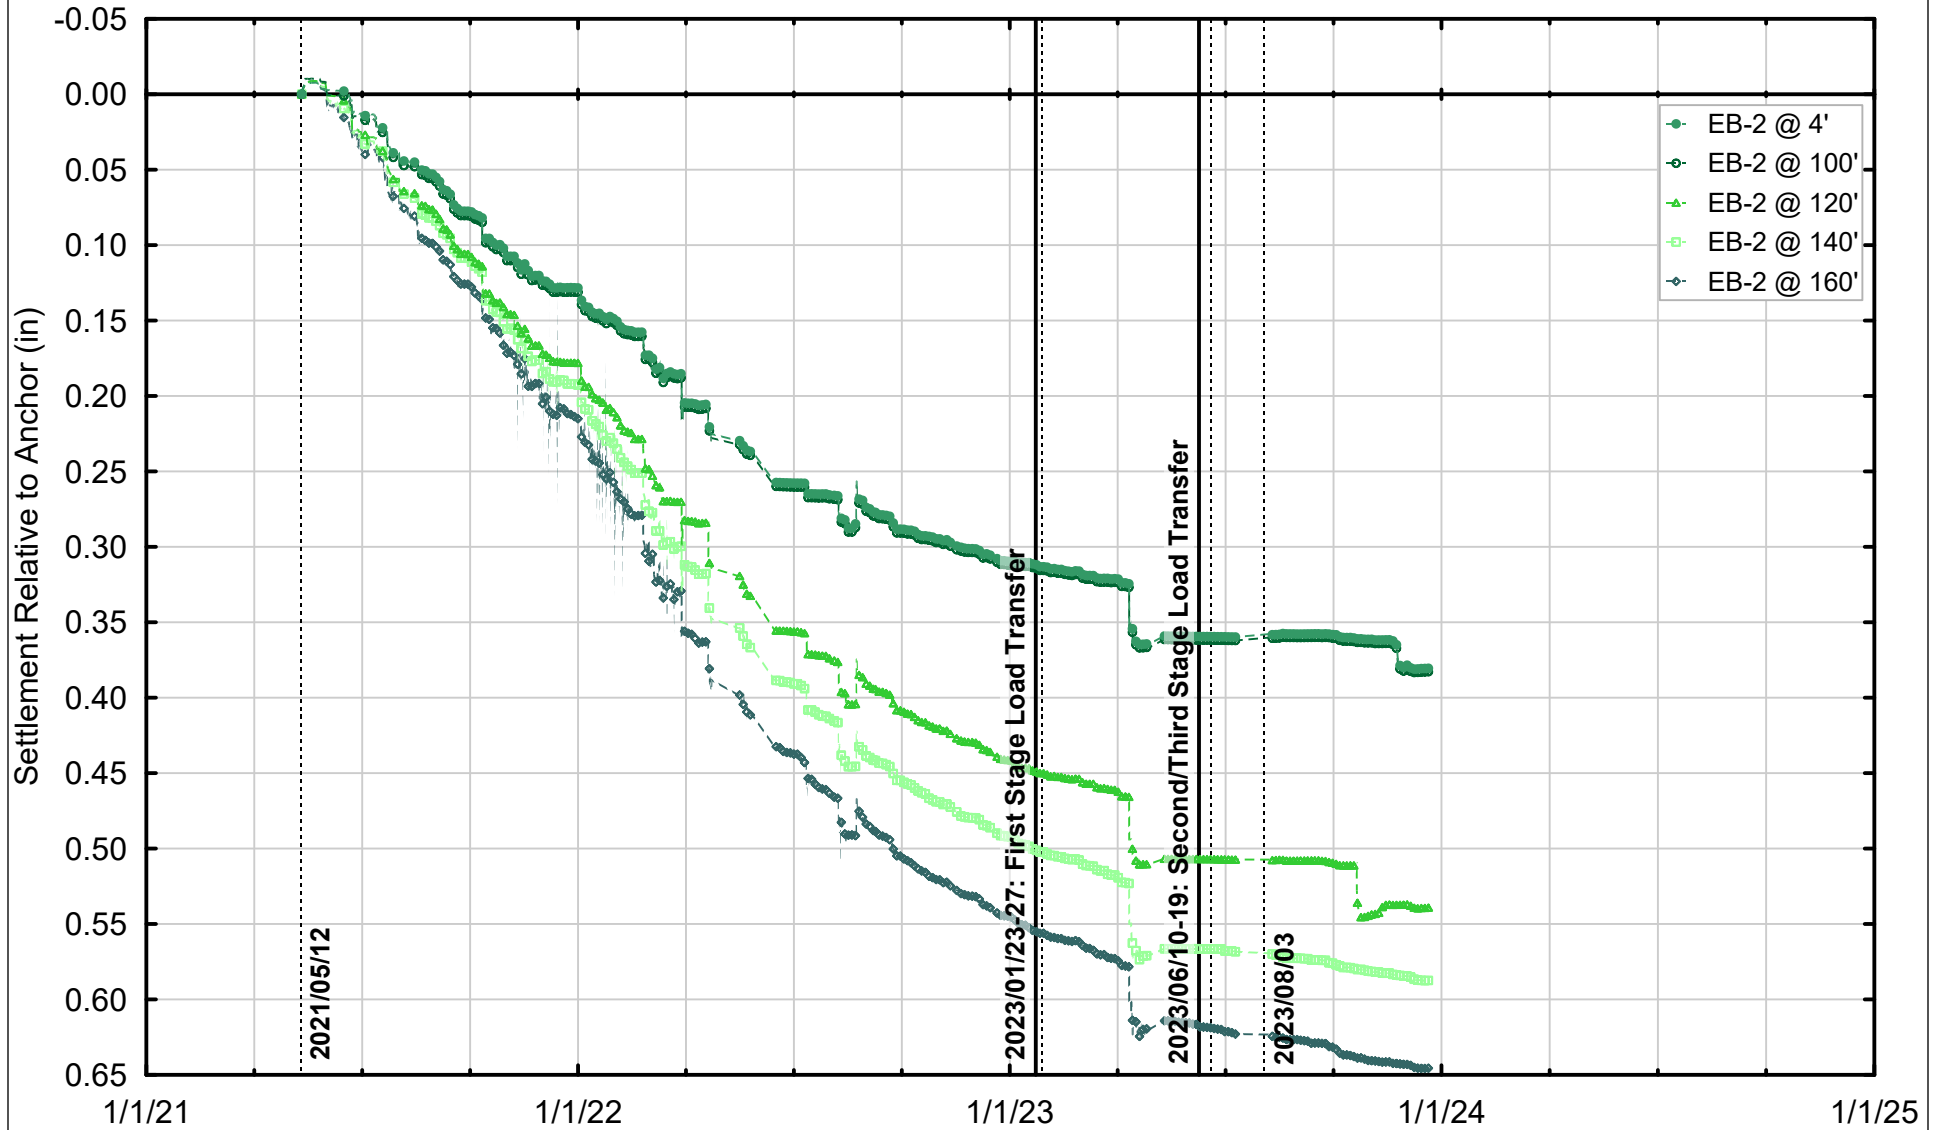
Project No: 23-018-01	Date: 1/3/2024	Created By: TB	Checked By: DGM	Figure No: 128-12
-----------------------	----------------	----------------	-----------------	-------------------

EXTENSOMETER DATA FROM MISSION STREET  
SINCE 01/01/2021 THROUGH 12/22/2023

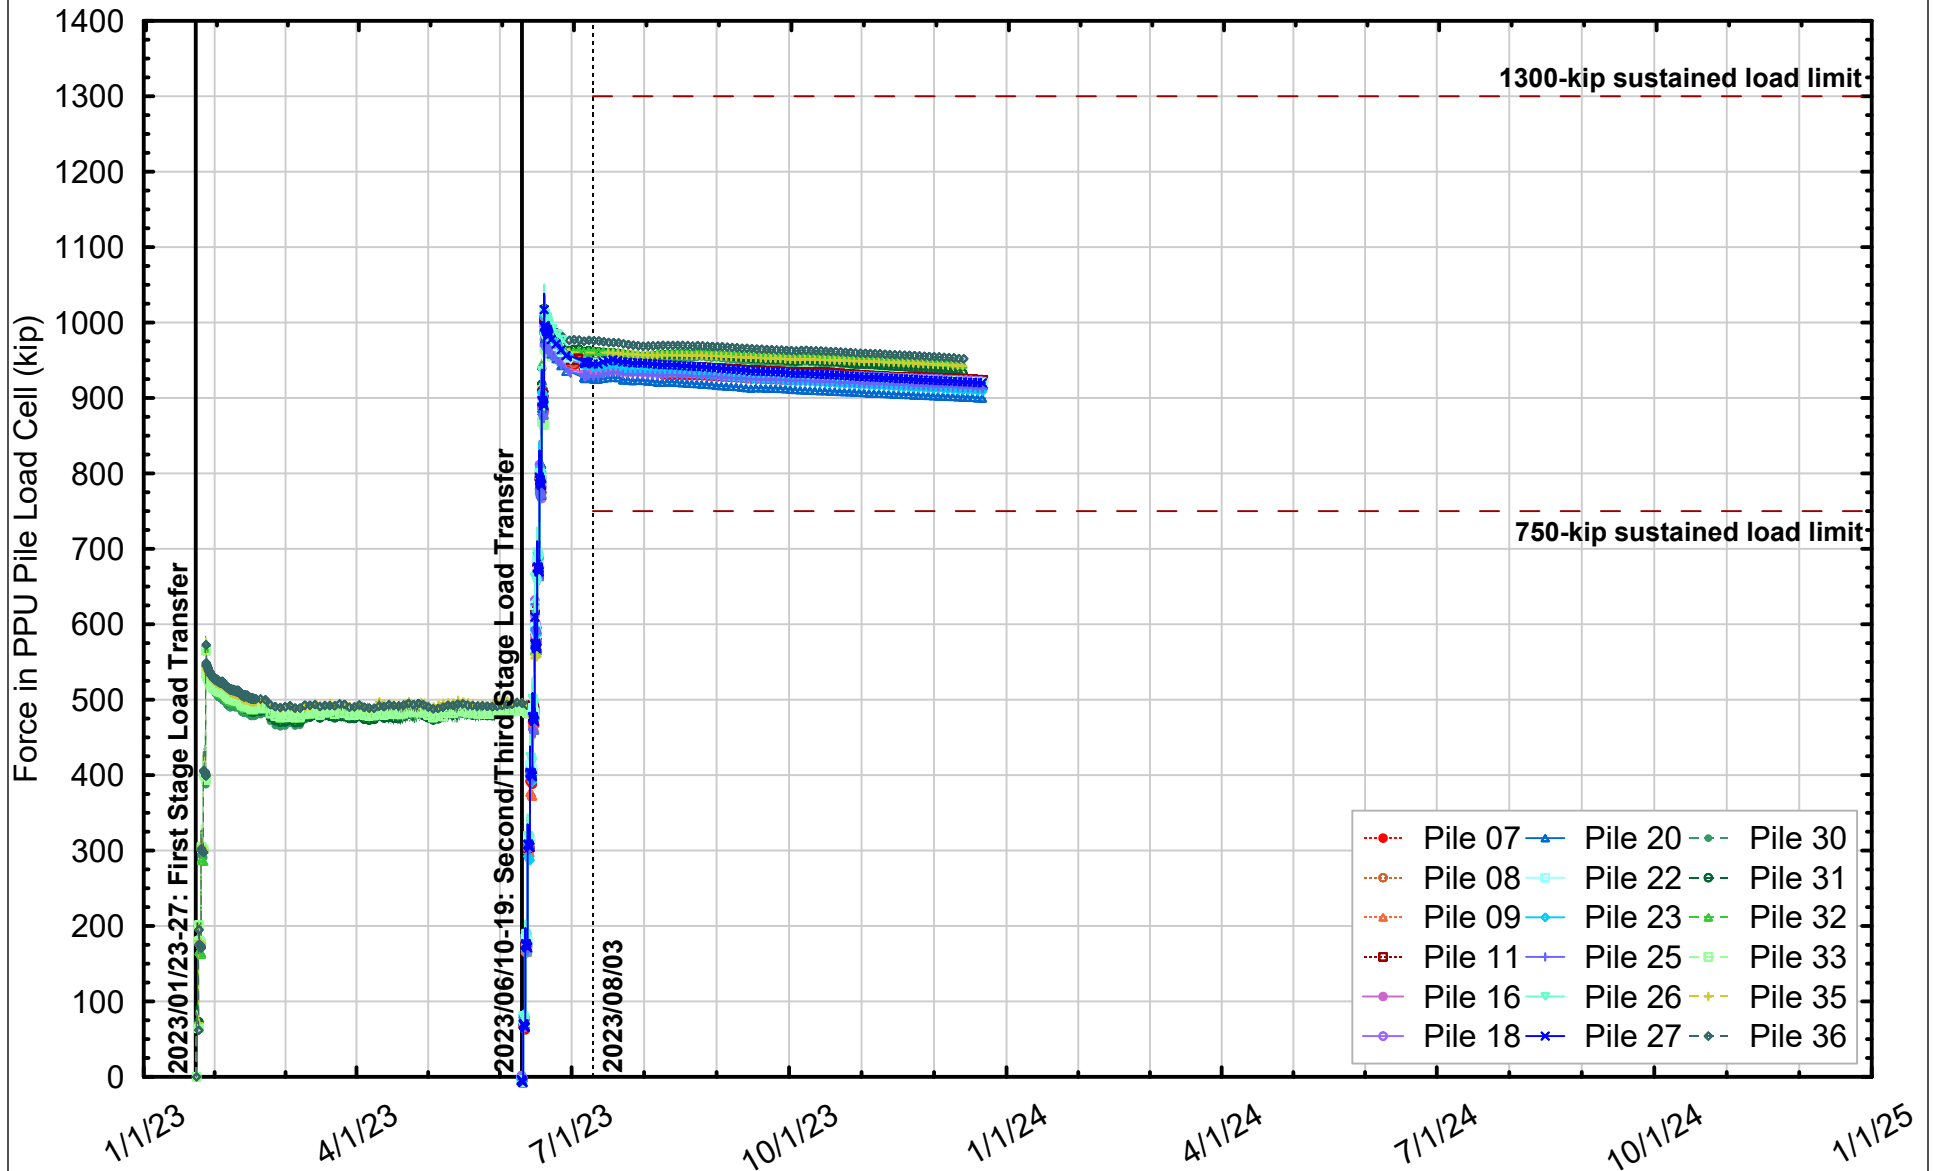
Project No: 23-018-01	Date: 1/3/2024	Created By: TB	Checked By: DGM	Figure No: 128-13A
-----------------------	----------------	----------------	-----------------	--------------------

Mission Street load cell data has not been available since 12/14/2023. Work to correct this is ongoing.

Figure 13A presents pile load cell data since the start of the First Stage Load Transfer (January 23, 2023) through December 22, 2023. Figure 13B presents the total pile load cell data since July 15, 2023, through December 14, 2023.

PILE LOAD CELL DATA  
SINCE 01/23/2023 THROUGH 12/22/2023

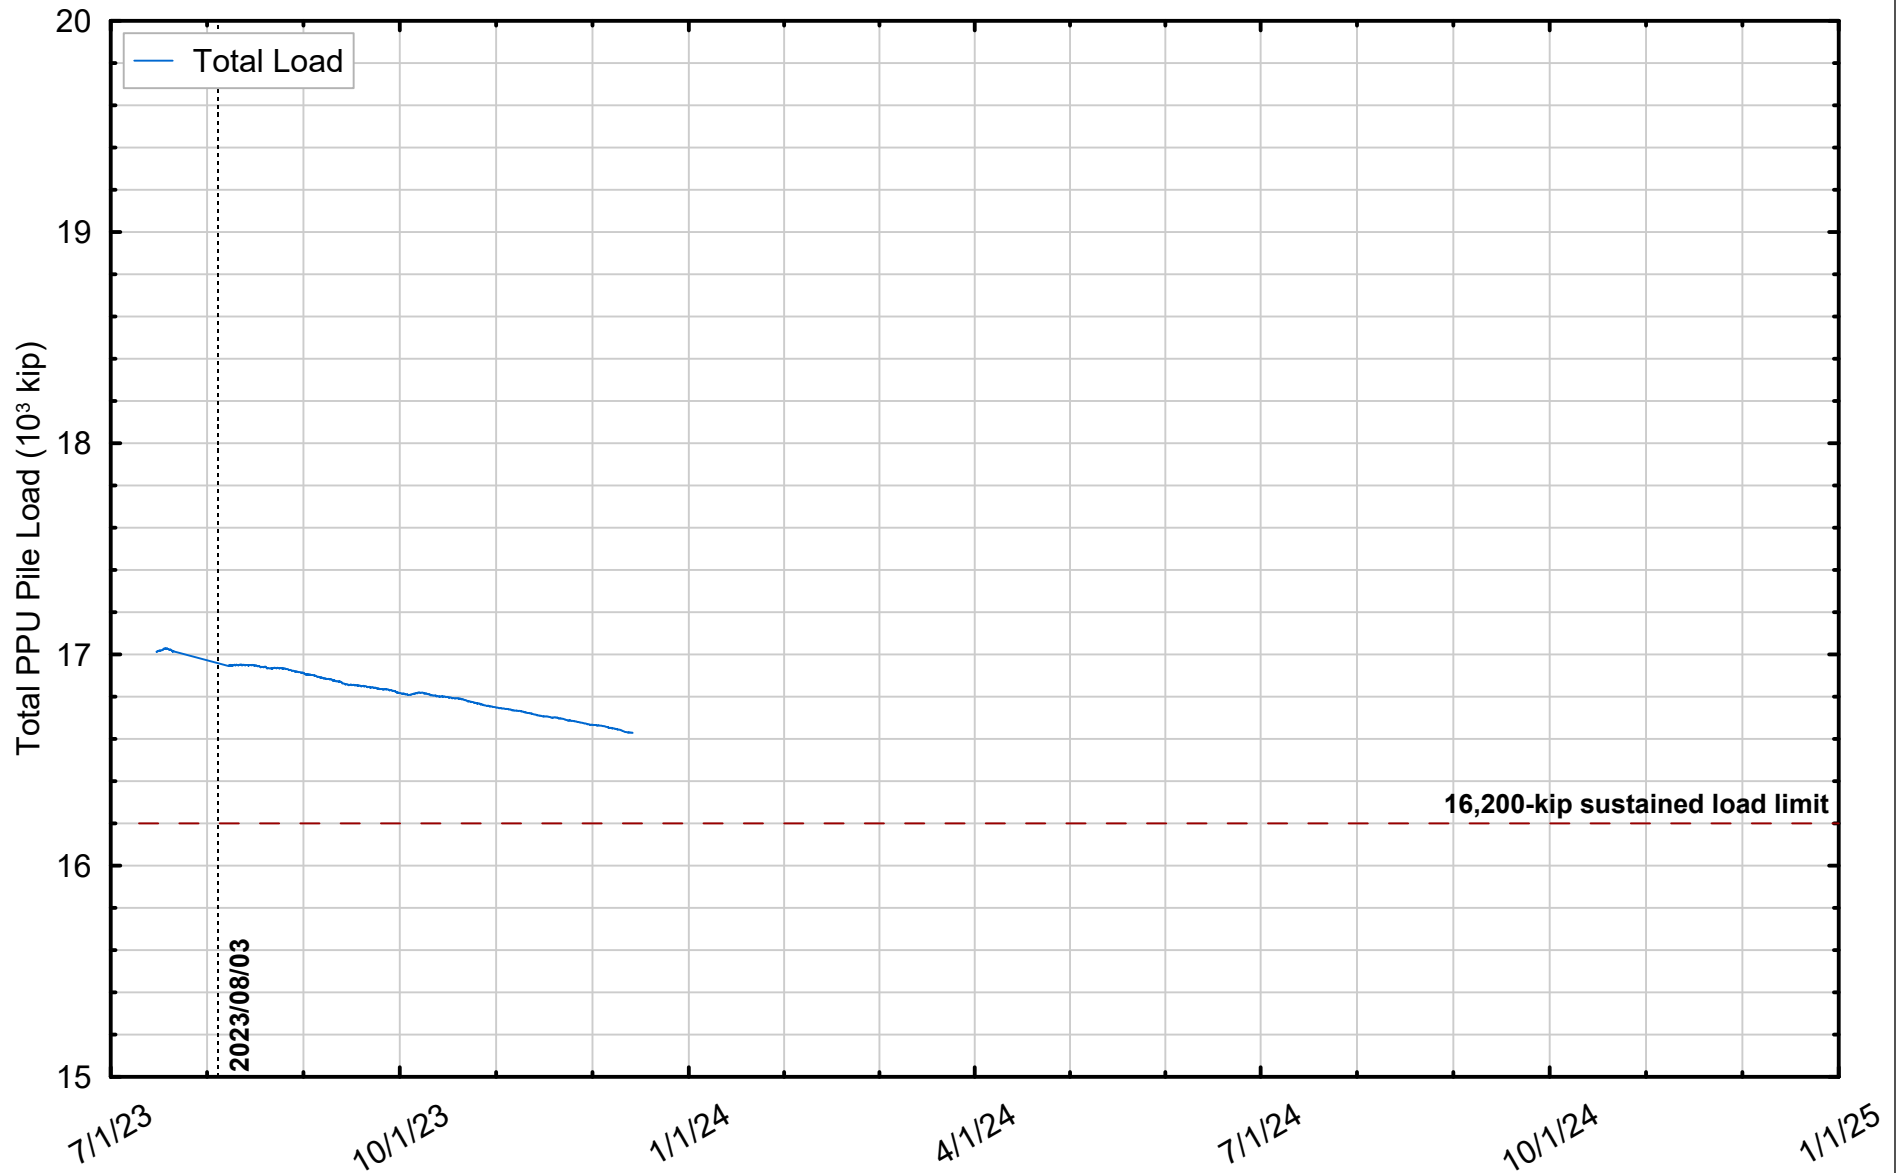
Project No: 23-018-01	Date: 1/3/2024	Created By: TB	Checked By: DGM	Figure No: 128-13B
-----------------------	----------------	----------------	-----------------	--------------------

TOTAL PILE LOAD CELL DATA  
SINCE 07/15/2023 THROUGH 12/14/2023

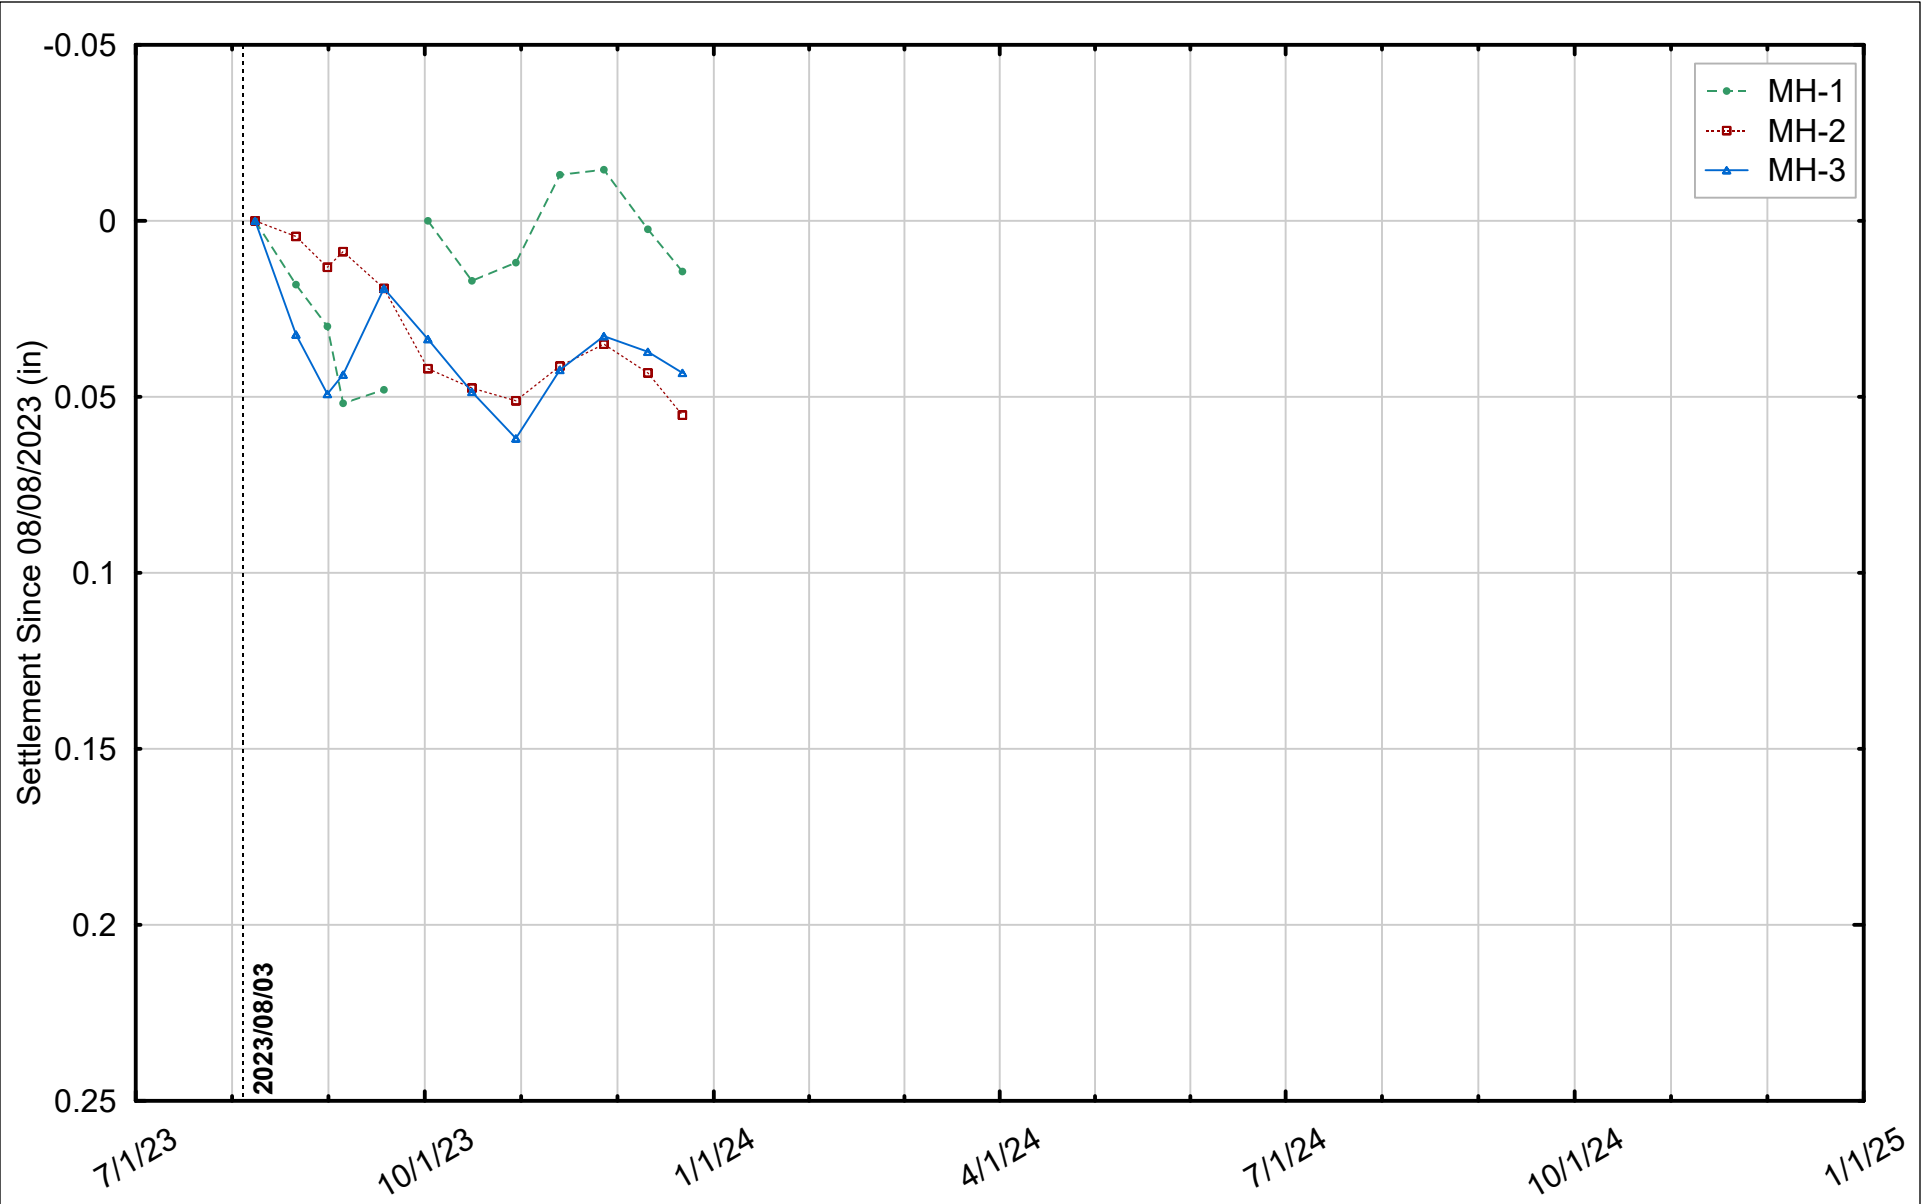
Project No: 23-018-01	Date: 1/3/2024	Created By: TB	Checked By: DGM	Figure No: 128-14
-----------------------	----------------	----------------	-----------------	-------------------

Figure 14 presents settlement data interpreted from survey points located on manholes around the Tower since August 8, 2023, through December 22, 2023.

Note: MH-1 was reset on 10/02/2023

MANHOLE SETTLEMENT DATA  
SINCE 08/08/2023 THROUGH 12/22/2023
