Project Number: 23-018-01

Subject: 301 Mission Retrofit Monitoring Report 135: Results as of July 26, 2024

Millennium Tower Perimeter Pile Upgrade: Instrumentation Monitoring Data
City and County of San Francisco, California

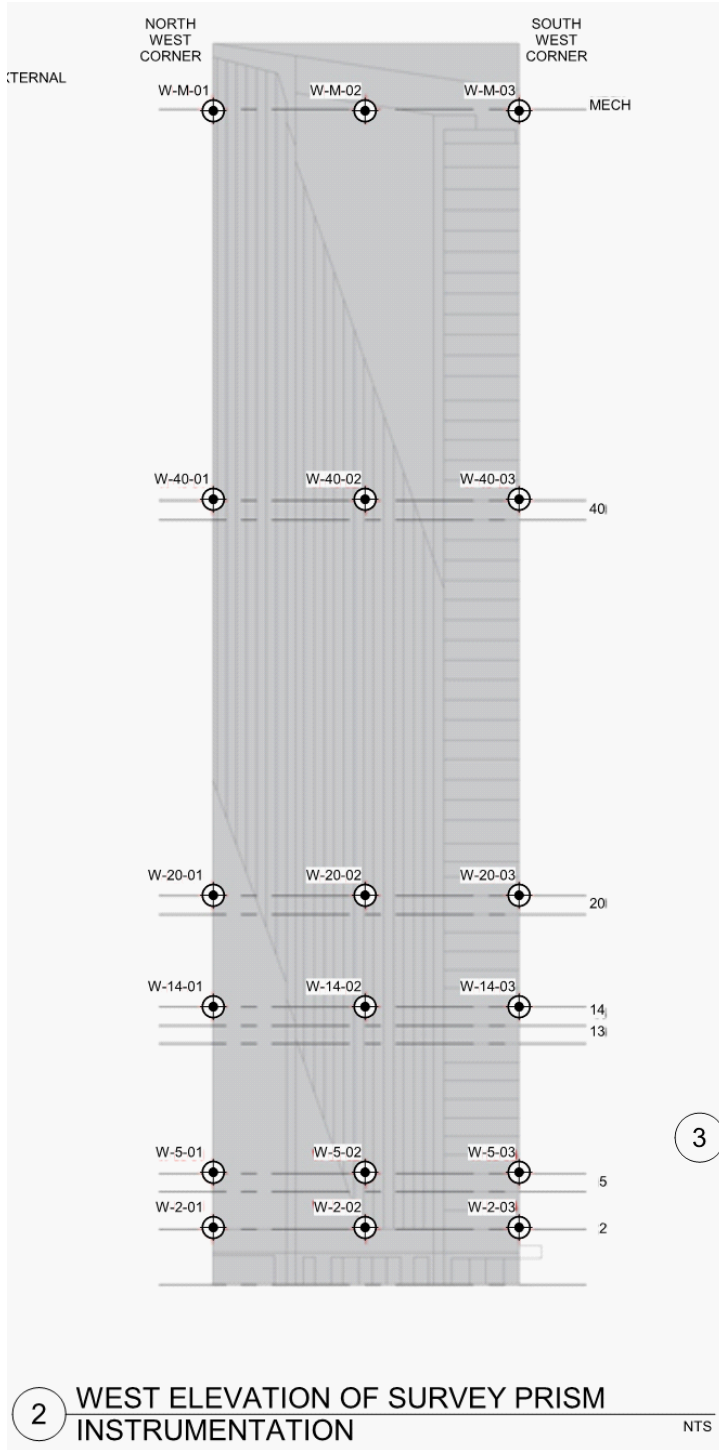
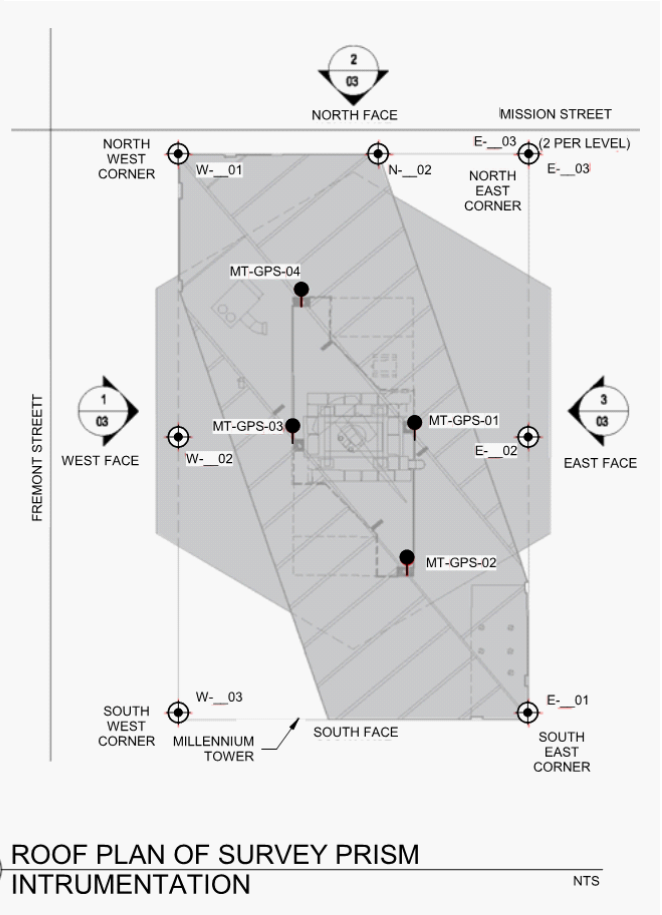
Project No: 23-018-01	Date: 7/26/2021	Created By: NBW	Checked By: DGM	Figure No: 135-01B
-----------------------	-----------------	-----------------	-----------------	---------------------------

TOWER SURVEY PRISM LOCATION SCHEMATIC

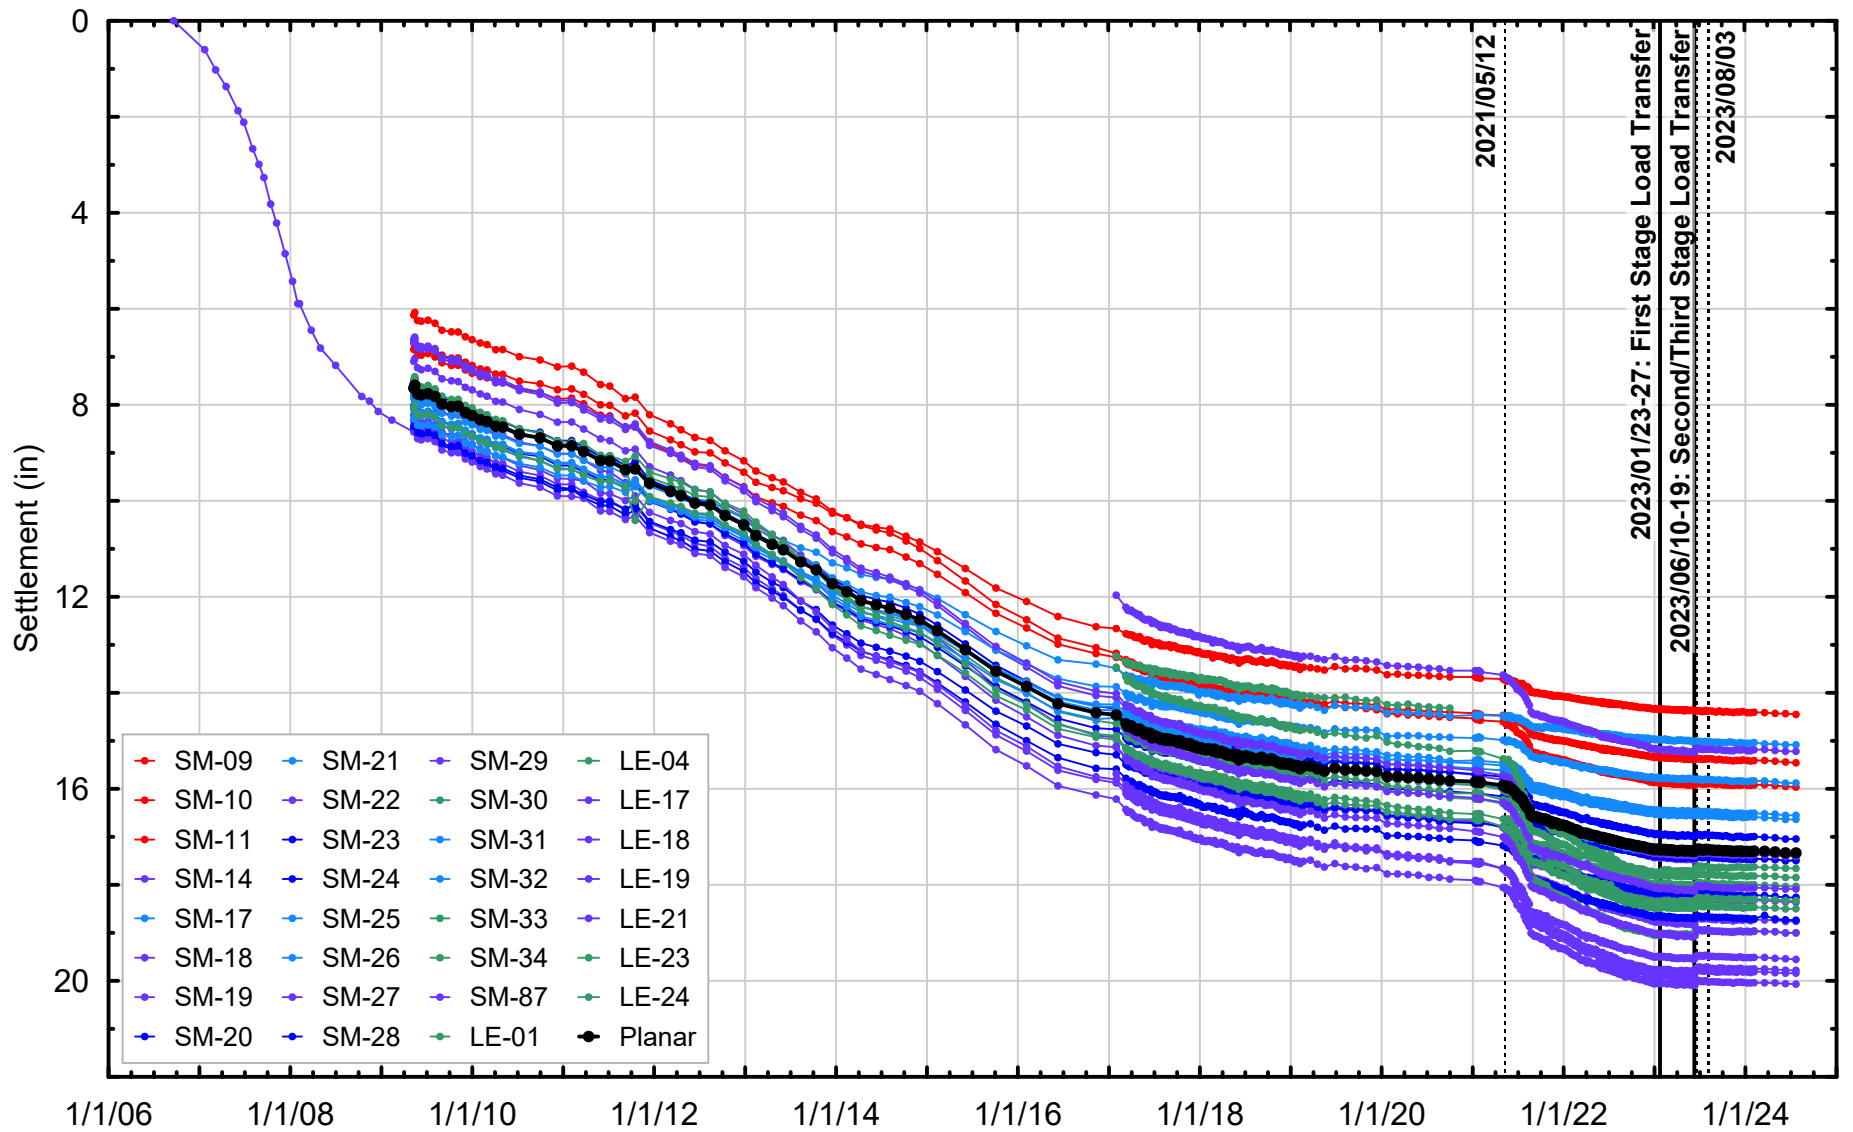
Project No: 23-018-01	Date: 7/29/2024	Created By: TB	Checked By: DGM	Figure No: 135-02

HISTORICAL SETTLEMENT MARKER DATA		
		Millennium Tower Perimeter Pile Upgrade: Instrumentation Monitoring Data City and County of San Francisco, California

Figure 02 presents the historical settlement data interpreted from settlement markers installed on the B-1 Level of 301 Mission Tower. In addition, data from surveys performed during the retrofit are included. Figure 03 presents settlement data since the start of production pile installation (May 12, 2021; baseline readings on May 10, 2021) through July 22, 2024. Figure 04 presents current settlement contours (in inches) on July 22, 2024.

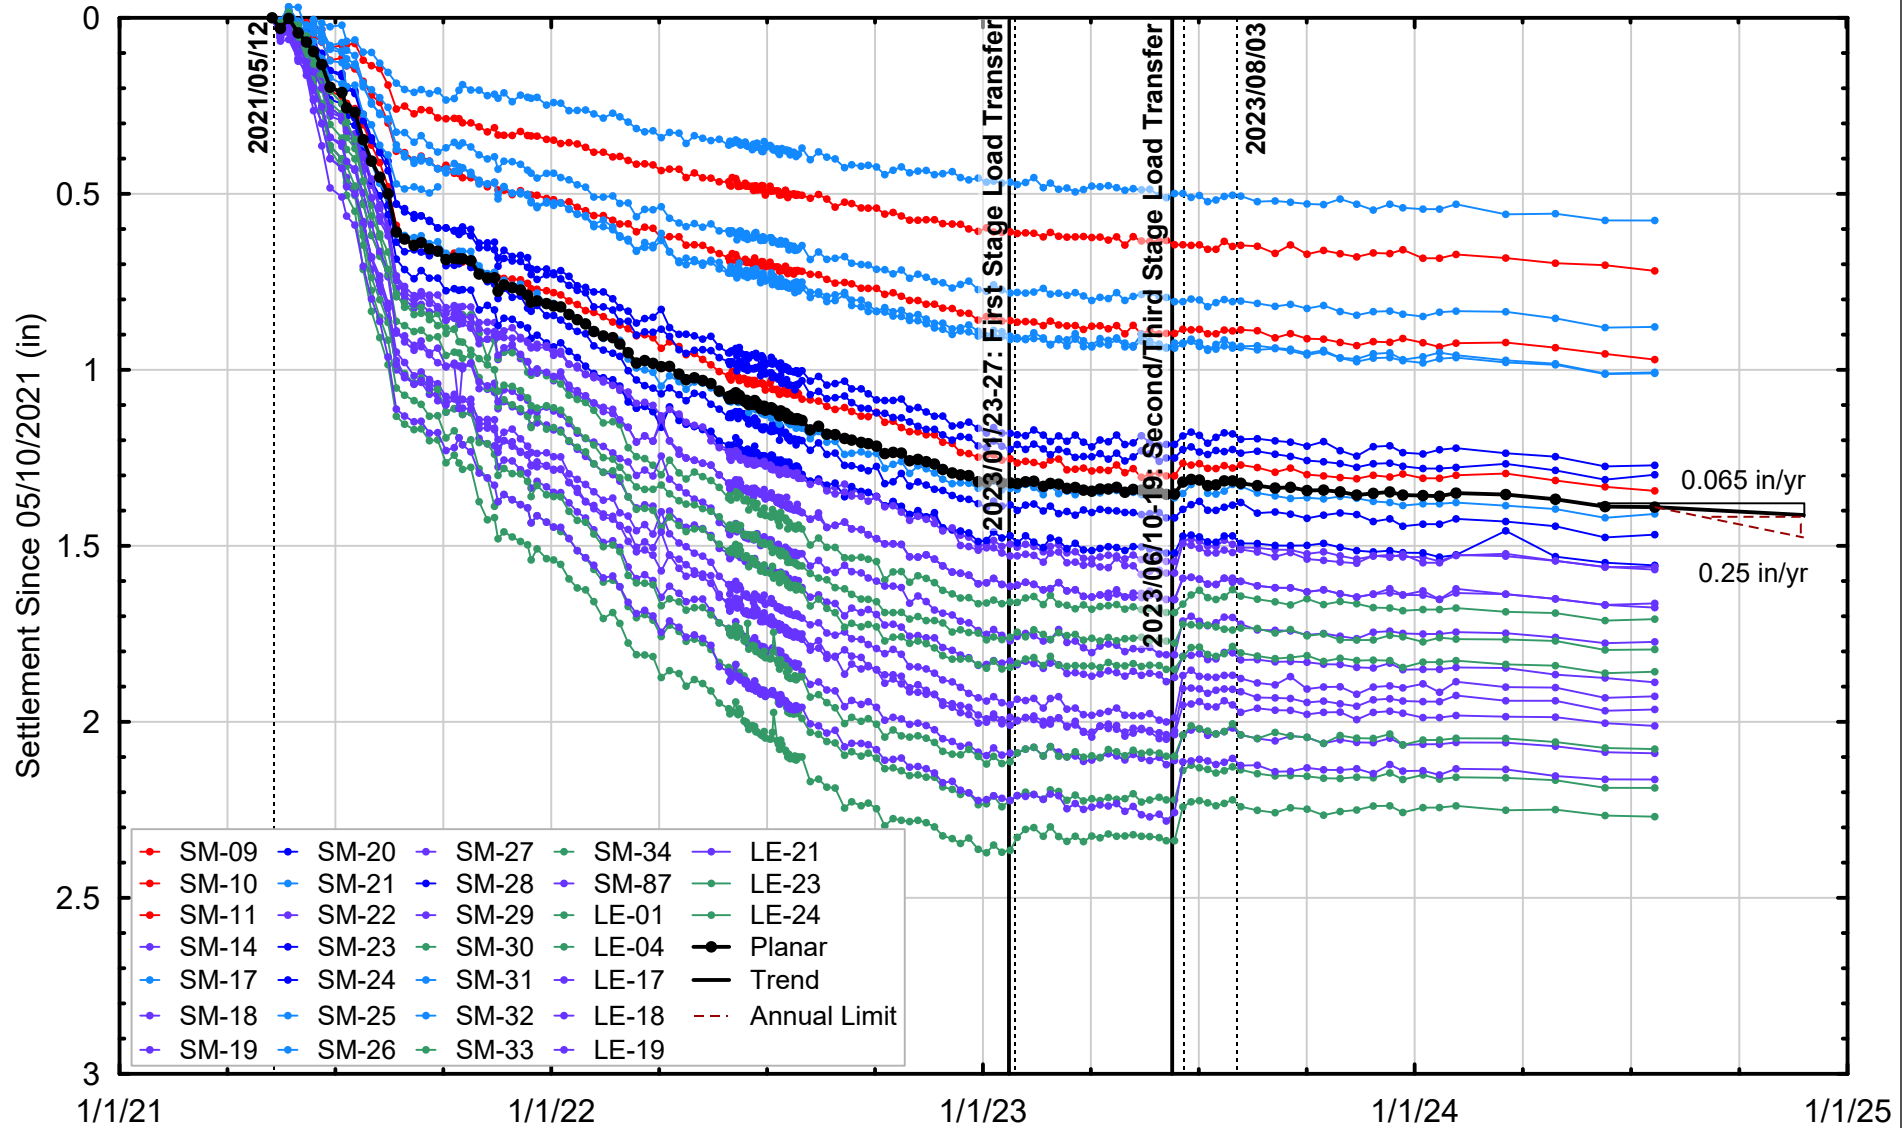
Project No: 23-018-01	Date: 7/29/2024	Created By: TB	Checked By: DGM	Figure No: 135-03

<p align="center">SETTLEMENT MARKER DATA SINCE 05/10/2021 THROUGH 07/22/2024</p> <p align="center">Millennium Tower Perimeter Pile Upgrade: Instrumentation Monitoring Data City and County of San Francisco, California</p>

⁵ As plotted on Figure 03. The annual rate is calculated starting on the settlement monitoring date closest to one year prior to the current date or on June 19, 2023 (the settlement monitoring date corresponding to the last day of jacking load application), whichever is later, and ending on the current date.

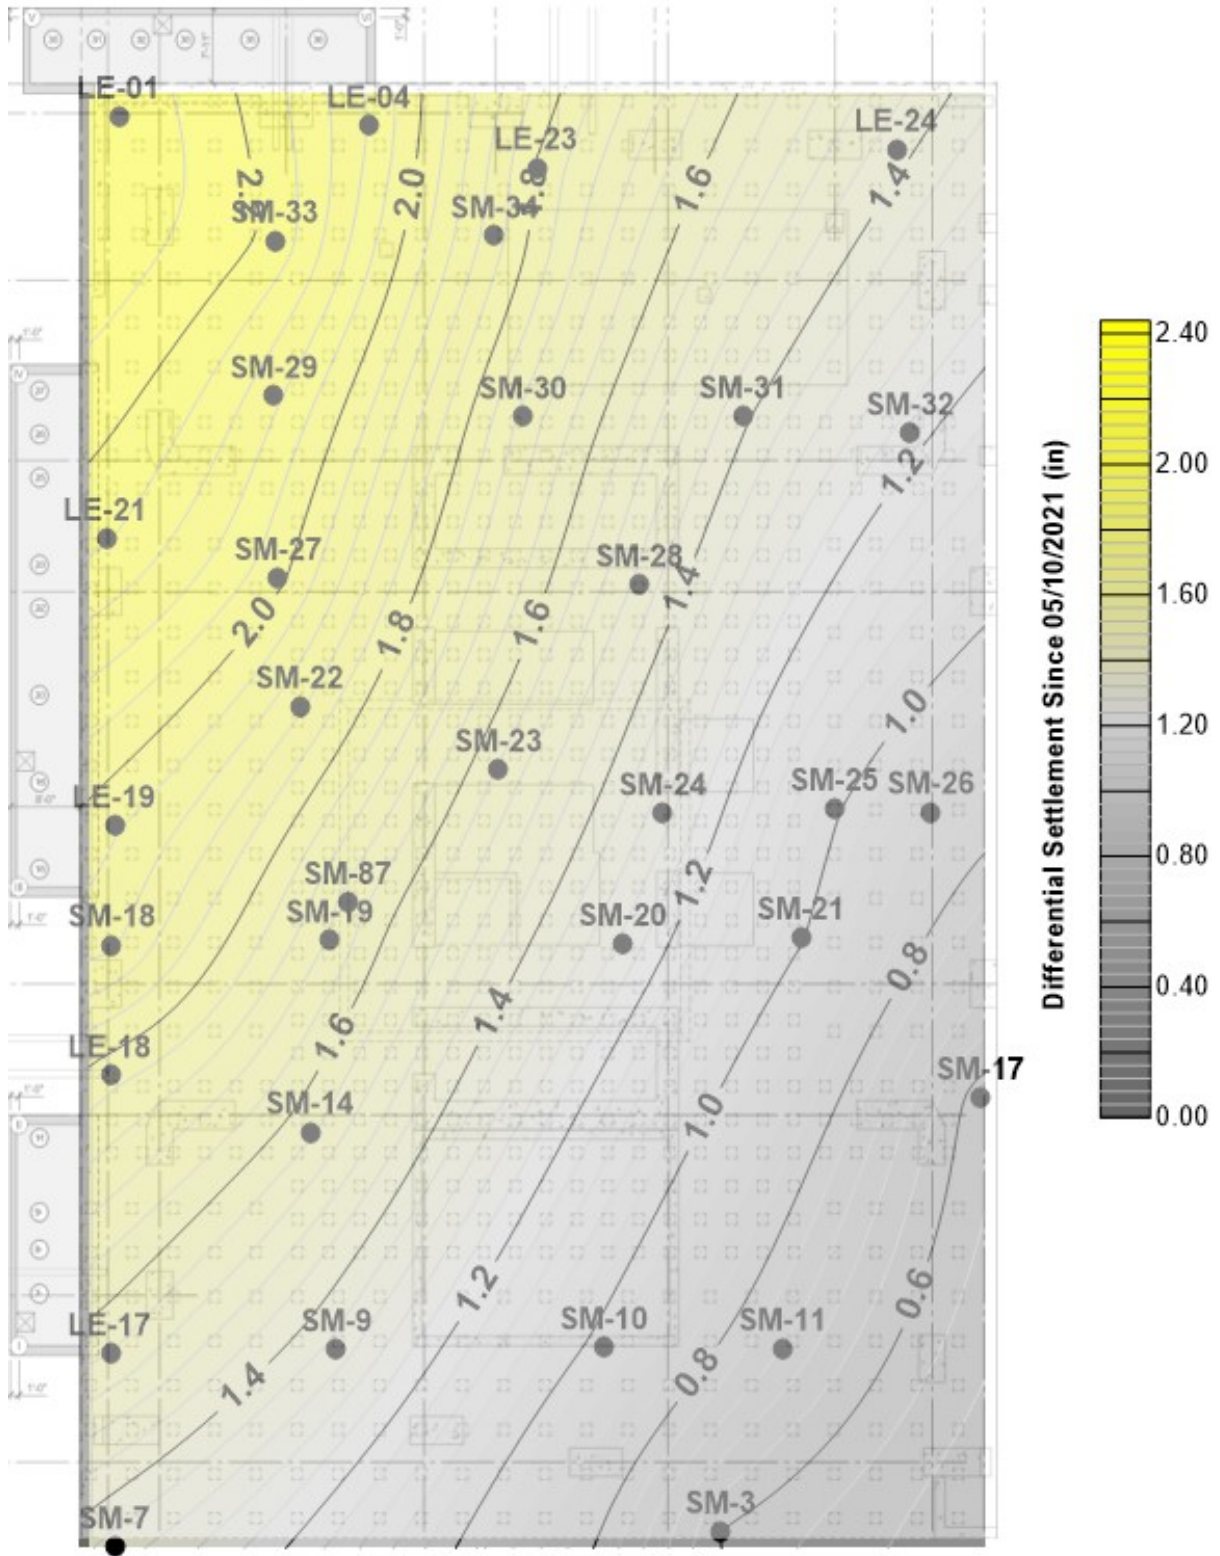
Figure No: **135-04**

SETTLEMENT CONTOURS
SINCE 05/10/2021 THROUGH 07/22/2024

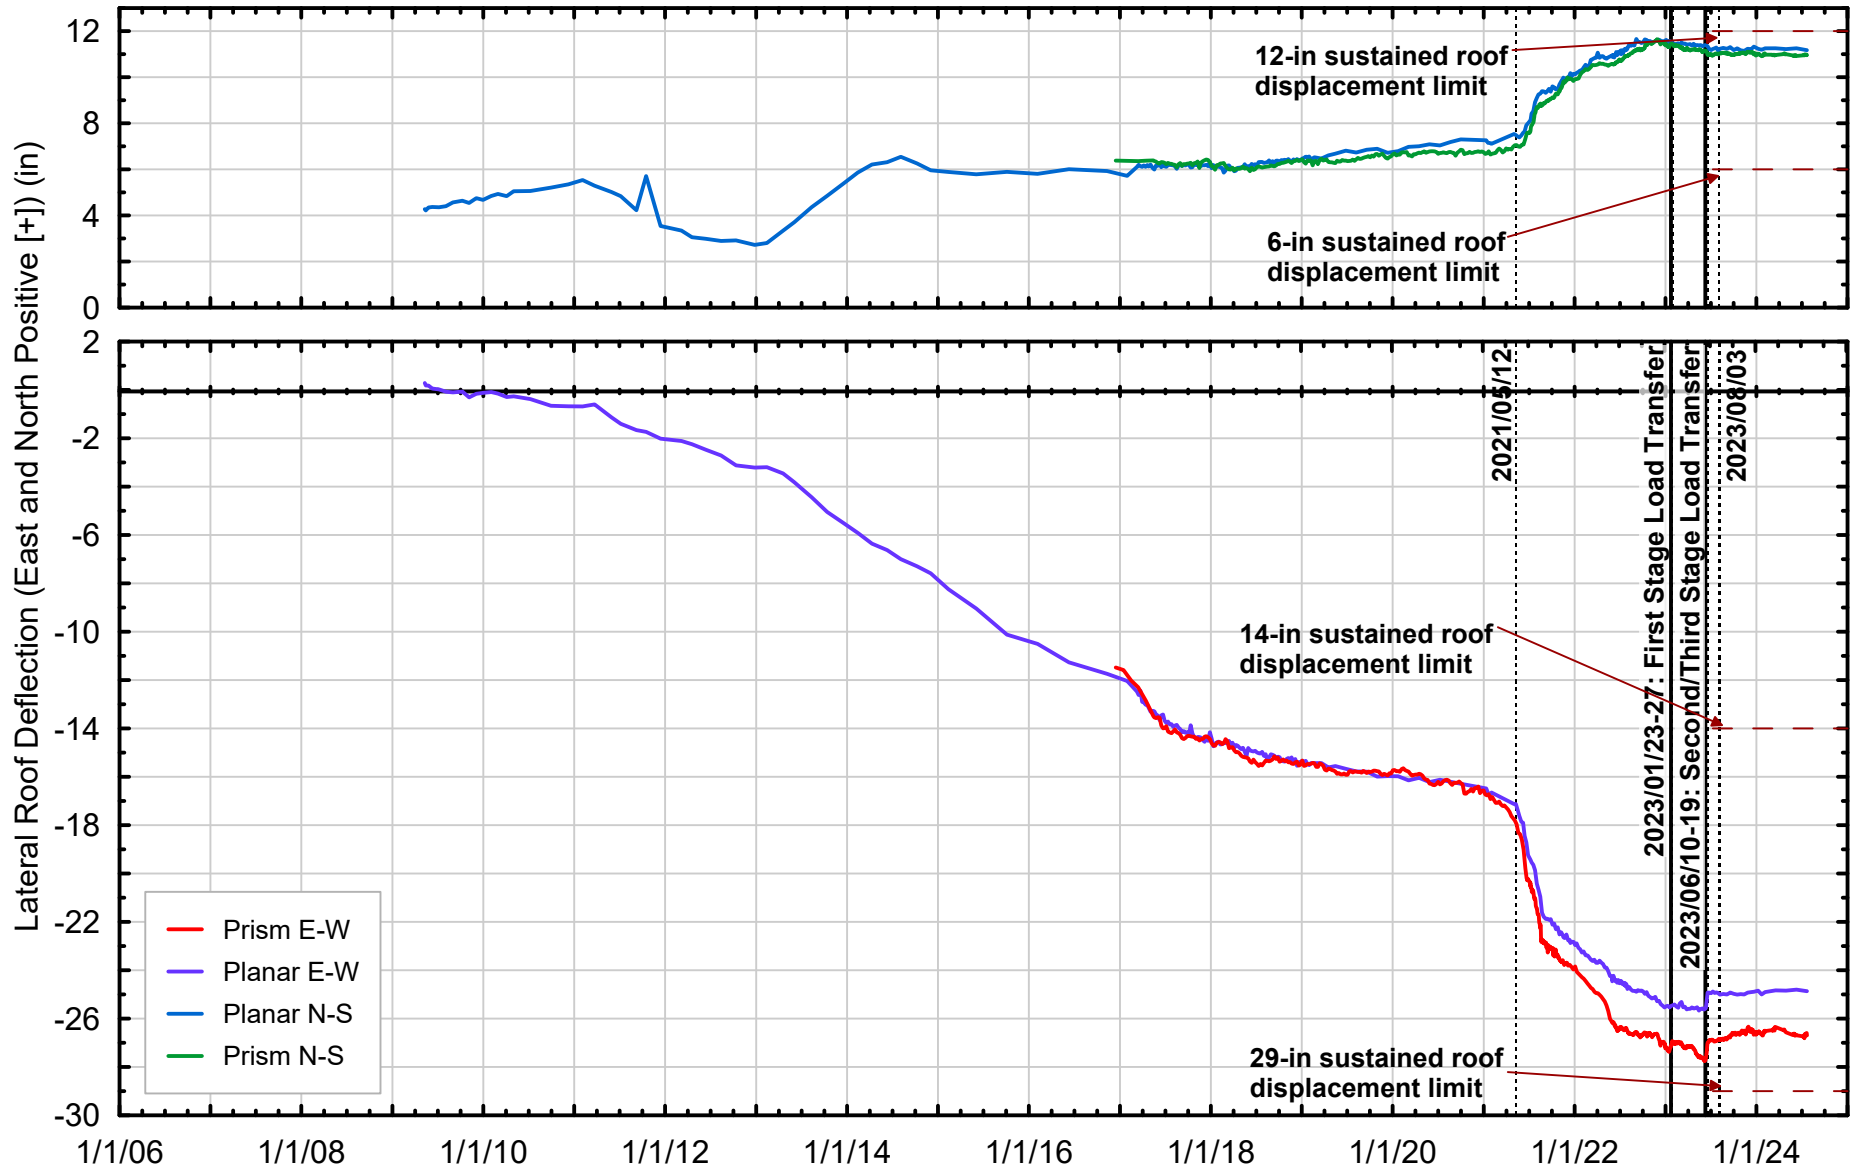
Project No: 23-018-01	Date: 7/29/2024	Created By: TB	Checked By: DGM	Figure No: 135-05
-----------------------	-----------------	----------------	-----------------	-------------------

HISTORICAL LATERAL ROOF DEFLECTION DATA

Figure 05 presents historical lateral roof deflections in the project north-south and project east-west directions interpreted from survey prisms mounted on the exterior of the Tower, from InSAR data, and from a planar fit of the settlement marker data. In addition, data from surveys performed during the retrofit are included. Figure 06A presents lateral roof deflection data from a planar fit of the settlement marker data and from survey prisms mounted on the exterior of the Tower since the start of production pile installation (May 12, 2021; baseline readings on May 10 and 13, 2021, respectively) through July 22, 2024.

⁶ As plotted on Figure 05, relative to a plumb condition.

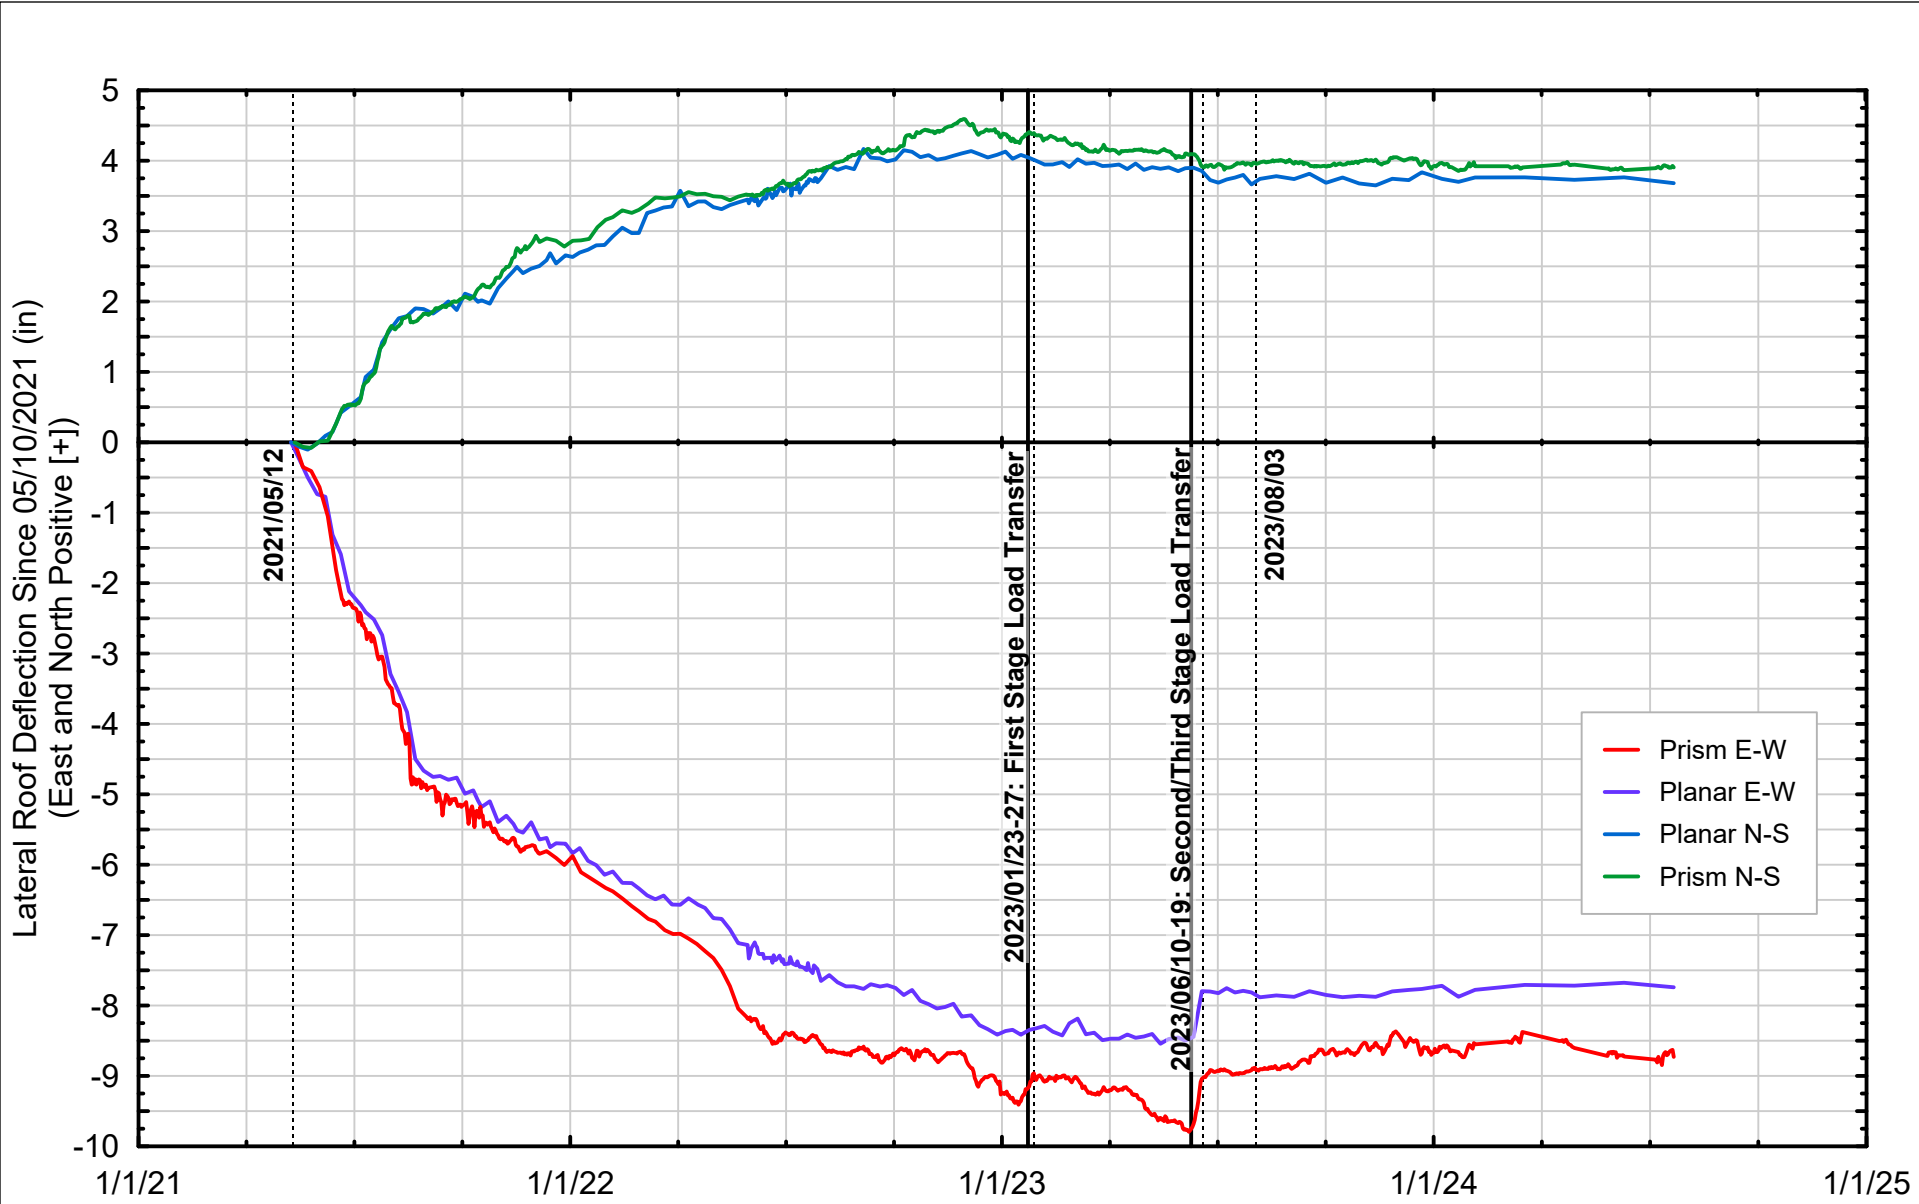
Project No: 23-018-01	Date: 7/29/2024	Created By: TB	Checked By: DGM	Figure No: 135-06
-----------------------	-----------------	----------------	-----------------	-------------------

LATERAL ROOF DEFLECTION DATA
SINCE 05/10/2021 THROUGH 07/22/2024

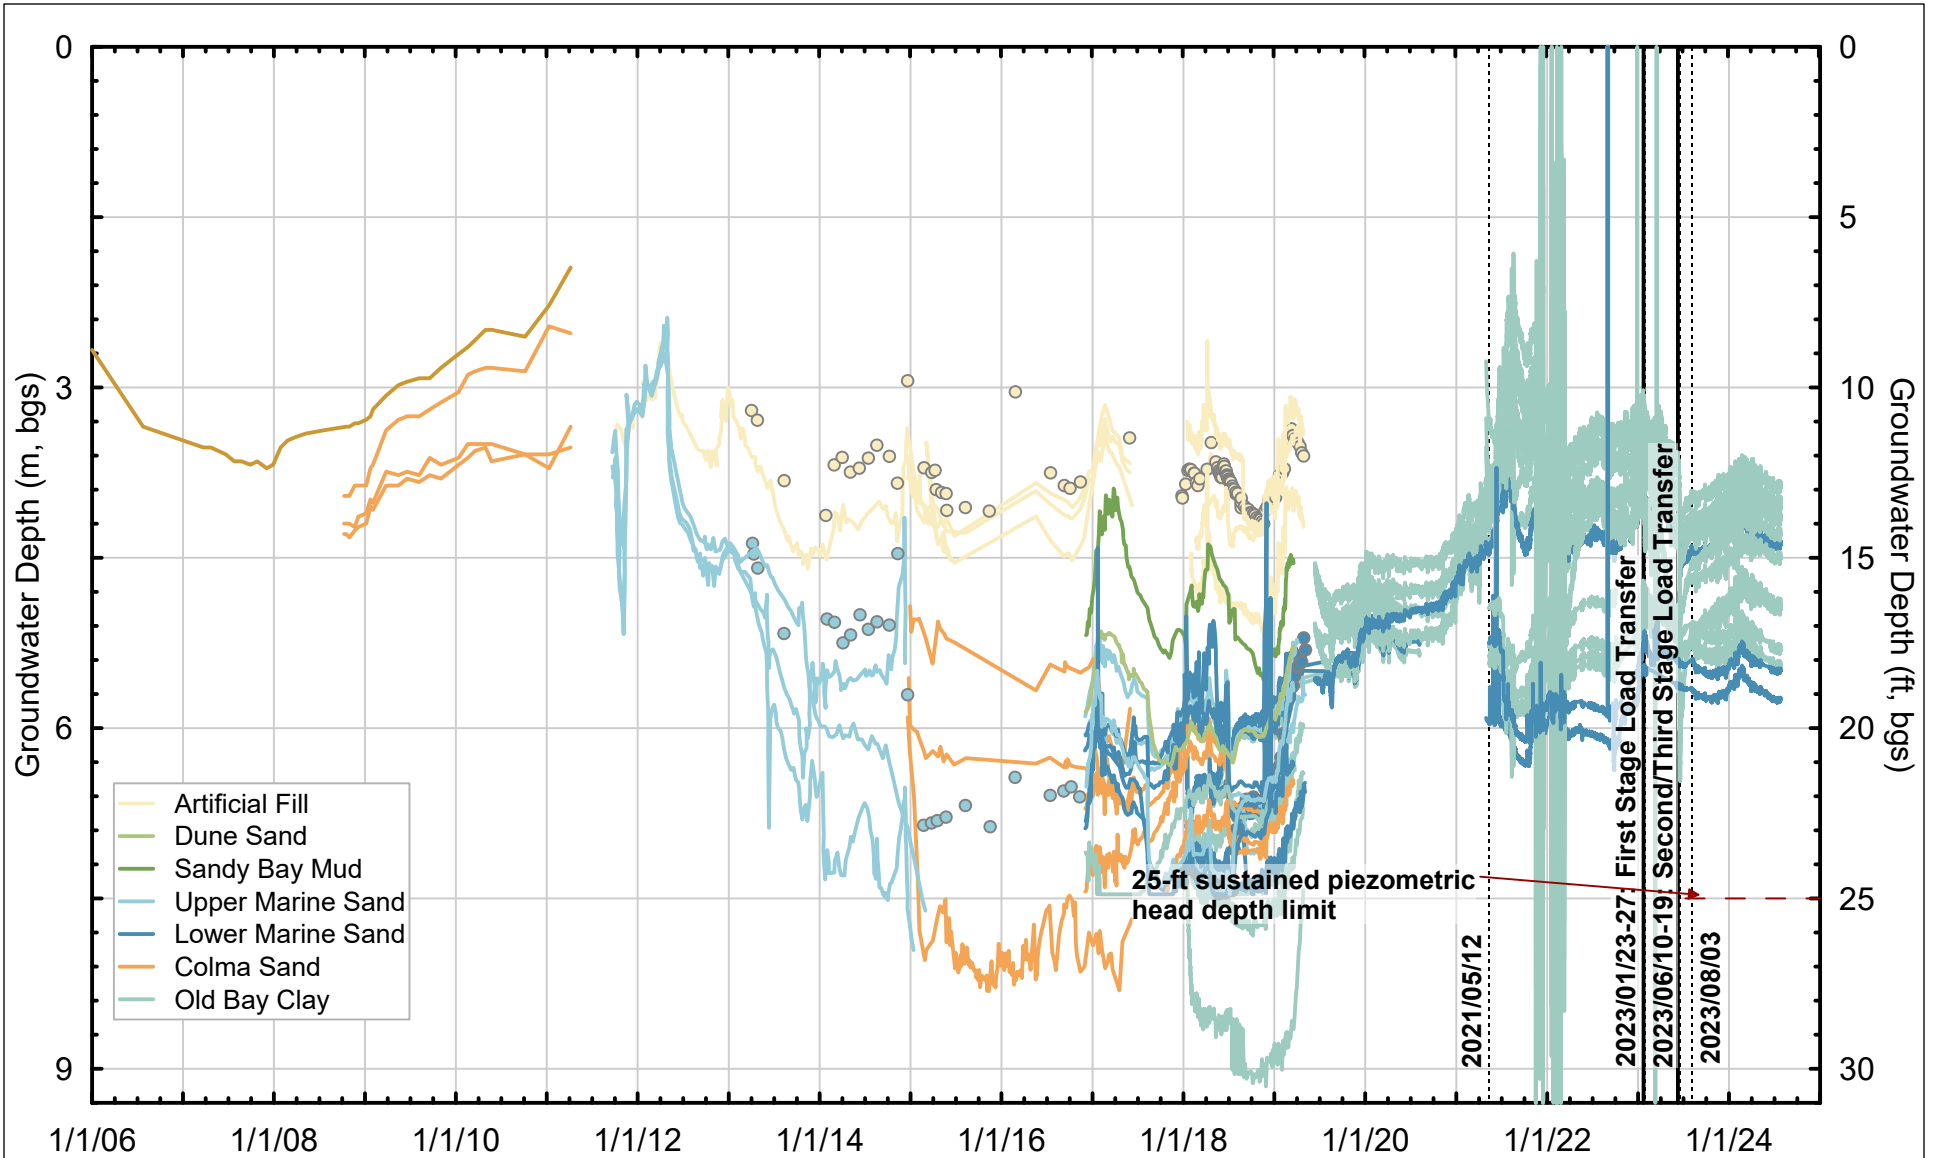
Project No: 23-018-01	Date: 7/29/2024	Created By: TB	Checked By: DGM	Figure No: 135-07
-----------------------	-----------------	----------------	-----------------	--------------------------

HISTORICAL GROUNDWATER ELEVATION MEASUREMENTS
AT LOCATIONS NEAR 301 MISSION

Figure 07 presents the historical groundwater elevation interpreted from piezometer readings at locations near 301 Mission. In addition, data from piezometers installed to monitor groundwater elevation during the retrofit are included. Figures 08 and 09 present groundwater elevation interpreted from piezometer readings

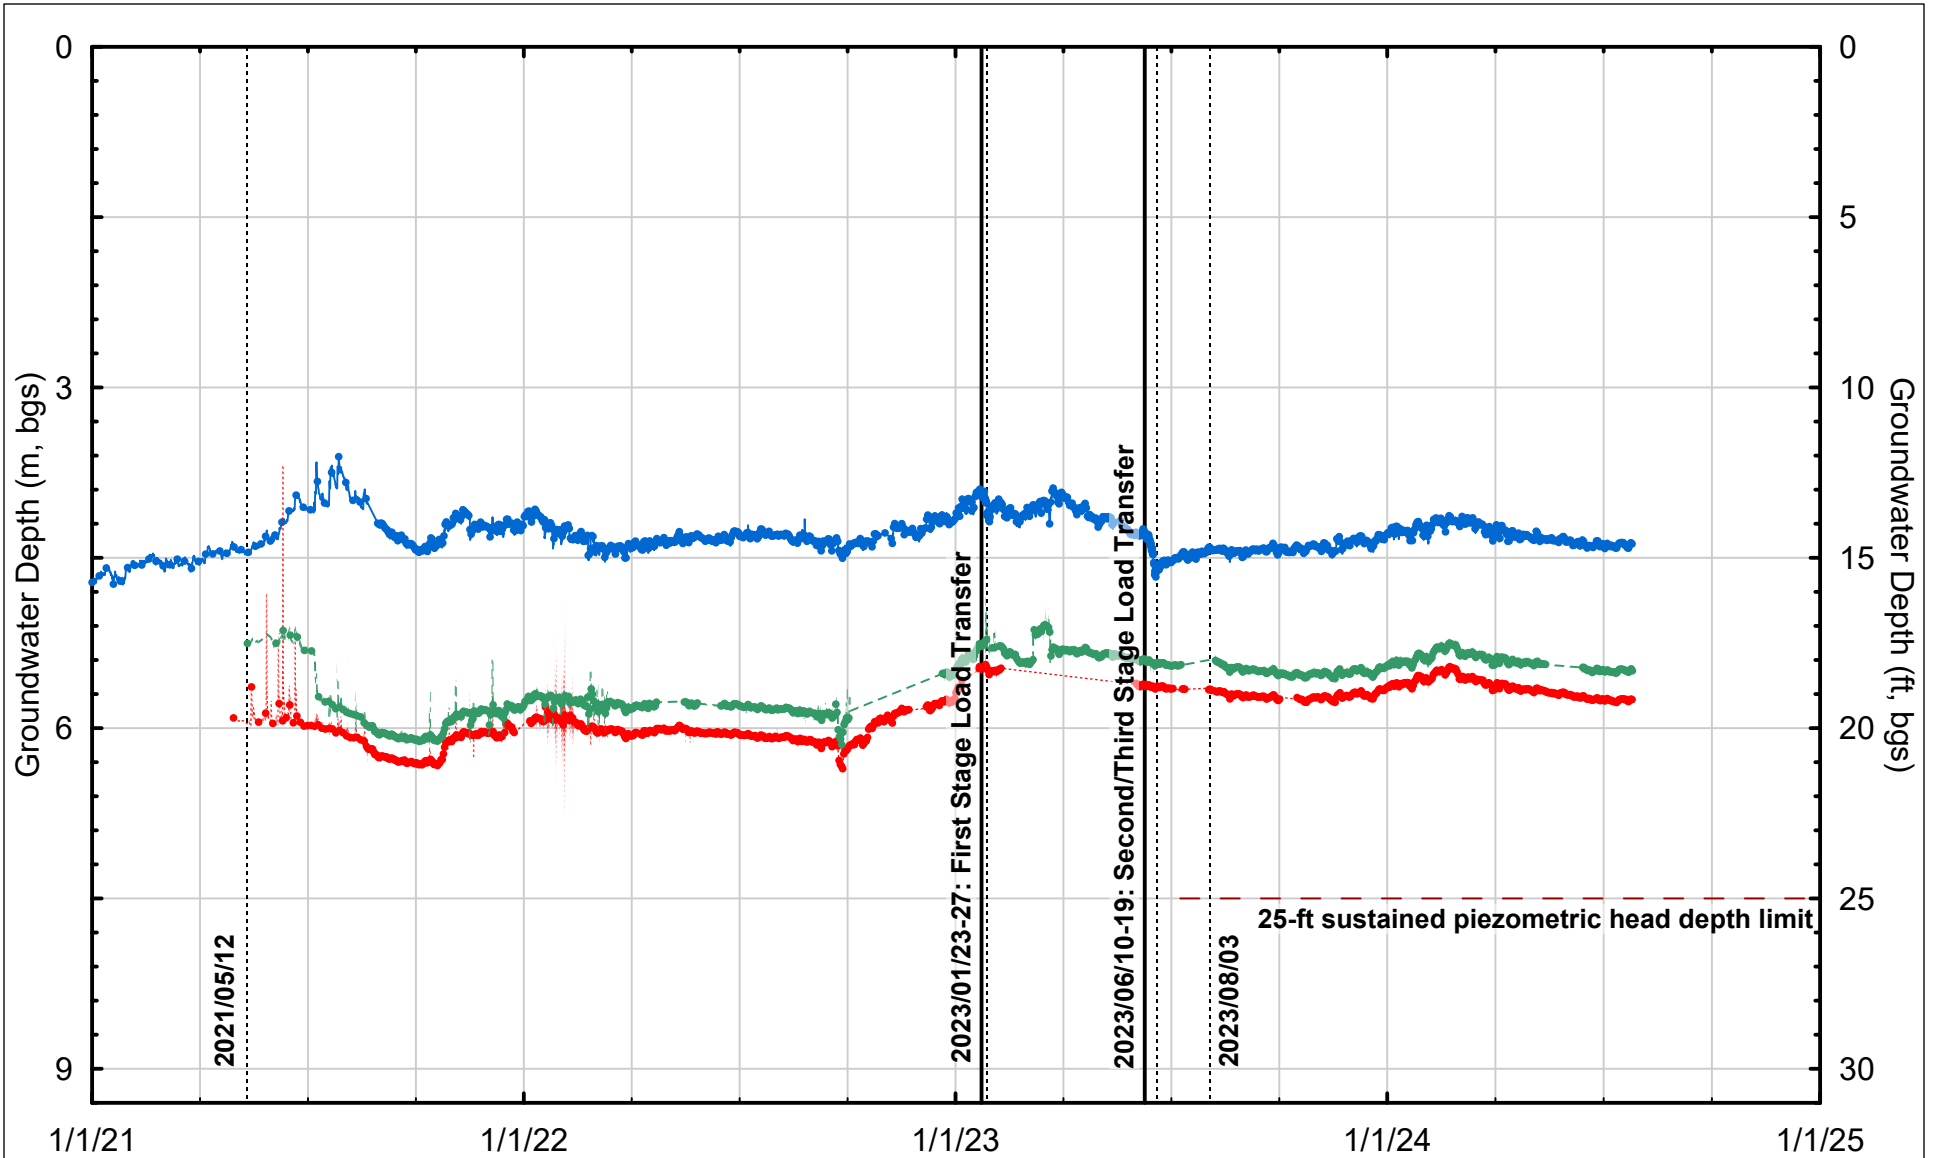
- SB-1 @ 85'
- PB-1 @ 85'
- PB-2 @ 85'

Project No: 23-018-01	Date: 7/29/2024	Created By: TB	Checked By: DGM	Figure No: 135-08
		GROUNDWATER ELEVATION MEASUREMENTS IN MARINE AND COLMA SAND SINCE 01/01/2021 THROUGH 07/26/2024		
		Millennium Tower Perimeter Pile Upgrade: Instrumentation Monitoring Data City and County of San Francisco, California

in the Marine/Colma Sand and the Old Bay Clay, respectively, for the time period prior to the start of production pile installation (January 1, 2021) through July 26, 2024.

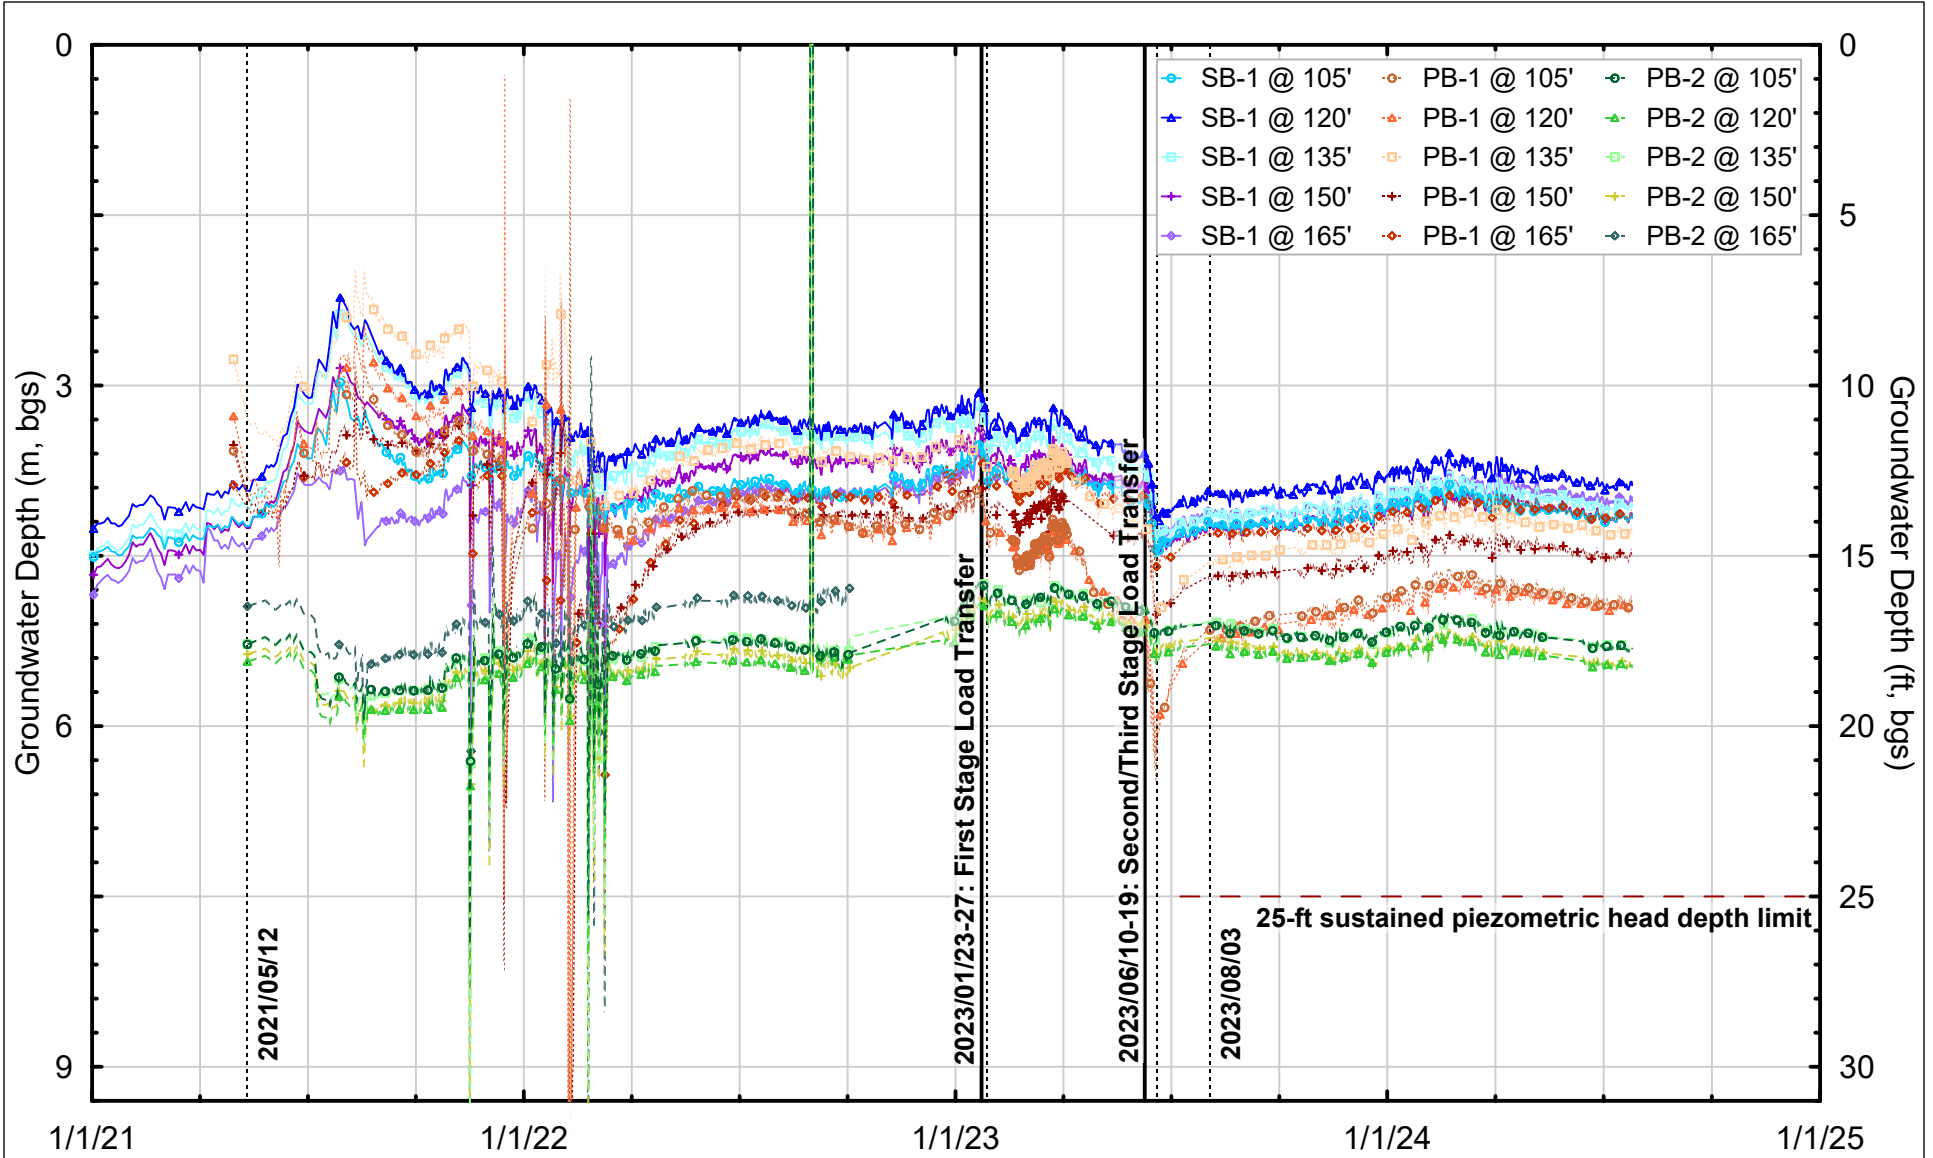
Project No: 23-018-01	Date: 7/29/2024	Created By: TB	Checked By: DGM	Figure No: 135-09
-----------------------	-----------------	----------------	-----------------	--------------------------

GROUNDWATER ELEVATION MEASUREMENTS IN OLD BAY CLAY
SINCE 01/01/2021 THROUGH 07/26/2024

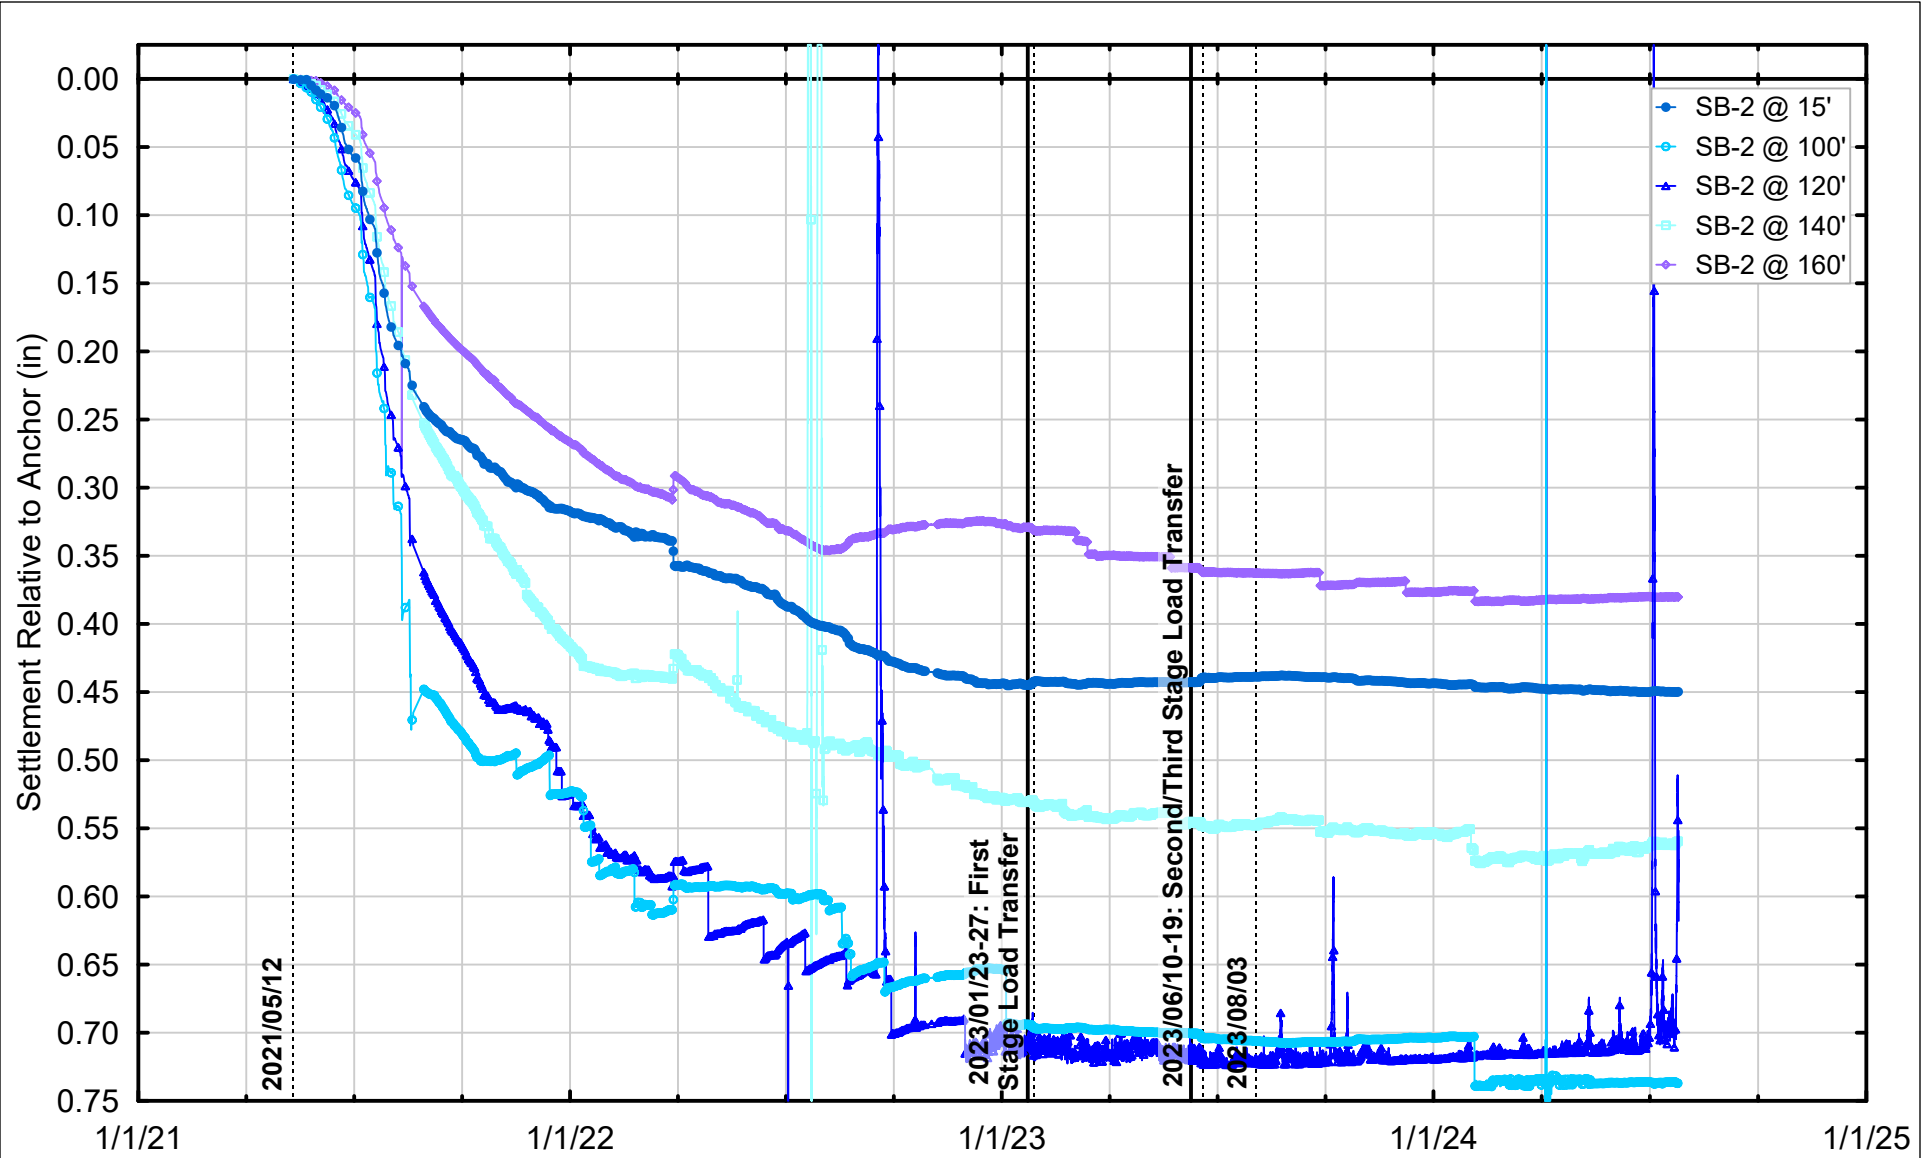
Project No: 23-018-01	Date: 7/29/2024	Created By: TB	Checked By: DGM	Figure No: 135-10
-----------------------	-----------------	----------------	-----------------	--------------------------

EXTENSOMETER DATA FROM WITHIN TOWER BASEMENT
SINCE 01/01/2021 THROUGH 07/26/2024

Figure 10 presents extensometer data from within the Tower basement since the start of production pile installation (May 12, 2021) through July 26, 2024. Figure 11 presents extensometer data from Fremont Street since the start of production pile installation (May 12, 2021) through May 16, 2023, and from the restart after fixing the extensometer (May 30, 2023) through July 26, 2024. Figure 12 presents extensometer data from Mission Street since the start of production pile installation (May 12, 2021) through July 26, 2024.
