Project Number: 23-018-01

Subject: 301 Mission Retrofit Monitoring Report 135: Results as of July 26, 2024

Millennium Tower Perimeter Pile Upgrade: Instrumentation Monitoring Data
City and County of San Francisco, California

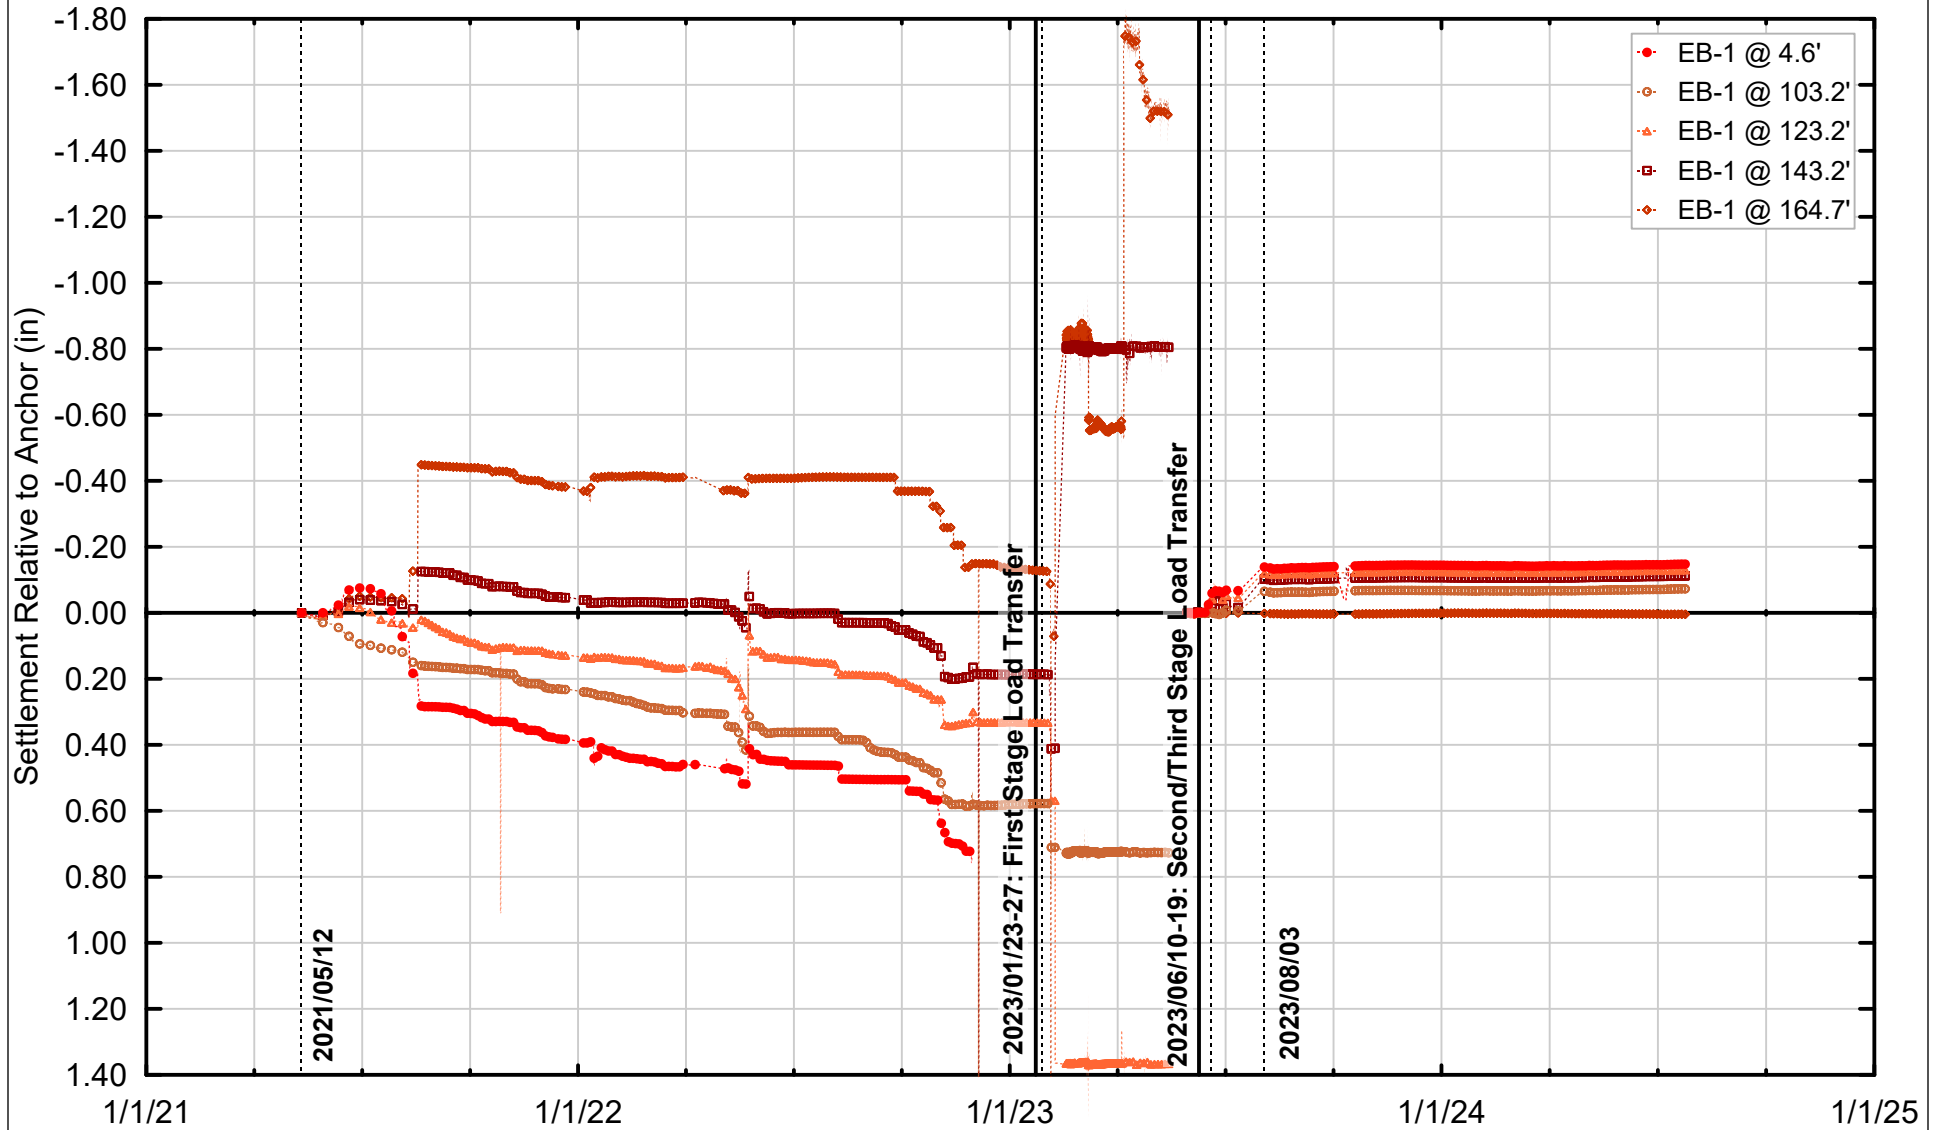
Figure No: 135-11

Note: EB-1 was repaired and reset on 2023/05/30

EXTENSOMETER DATA FROM FREMONT STREET
 SINCE 05/10/2021 THROUGH 05/16/2023
 SINCE 05/30/2023 THROUGH 07/26/2024
 Millennium Tower Perimeter Pile Upgrade: Instrumentation Monitoring Data
 City and County of San Francisco, California

Figure 10 presents extensometer data from within the Tower basement since the start of production pile installation (May 12, 2021) through July 26, 2024. Figure 11 presents extensometer data from Fremont Street since the start of production pile installation (May 12, 2021) through May 16, 2023, and from the restart after fixing the extensometer (May 30, 2023) through July 26, 2024. Figure 12 presents extensometer data from Mission Street since the start of production pile installation (May 12, 2021) through July 26, 2024.

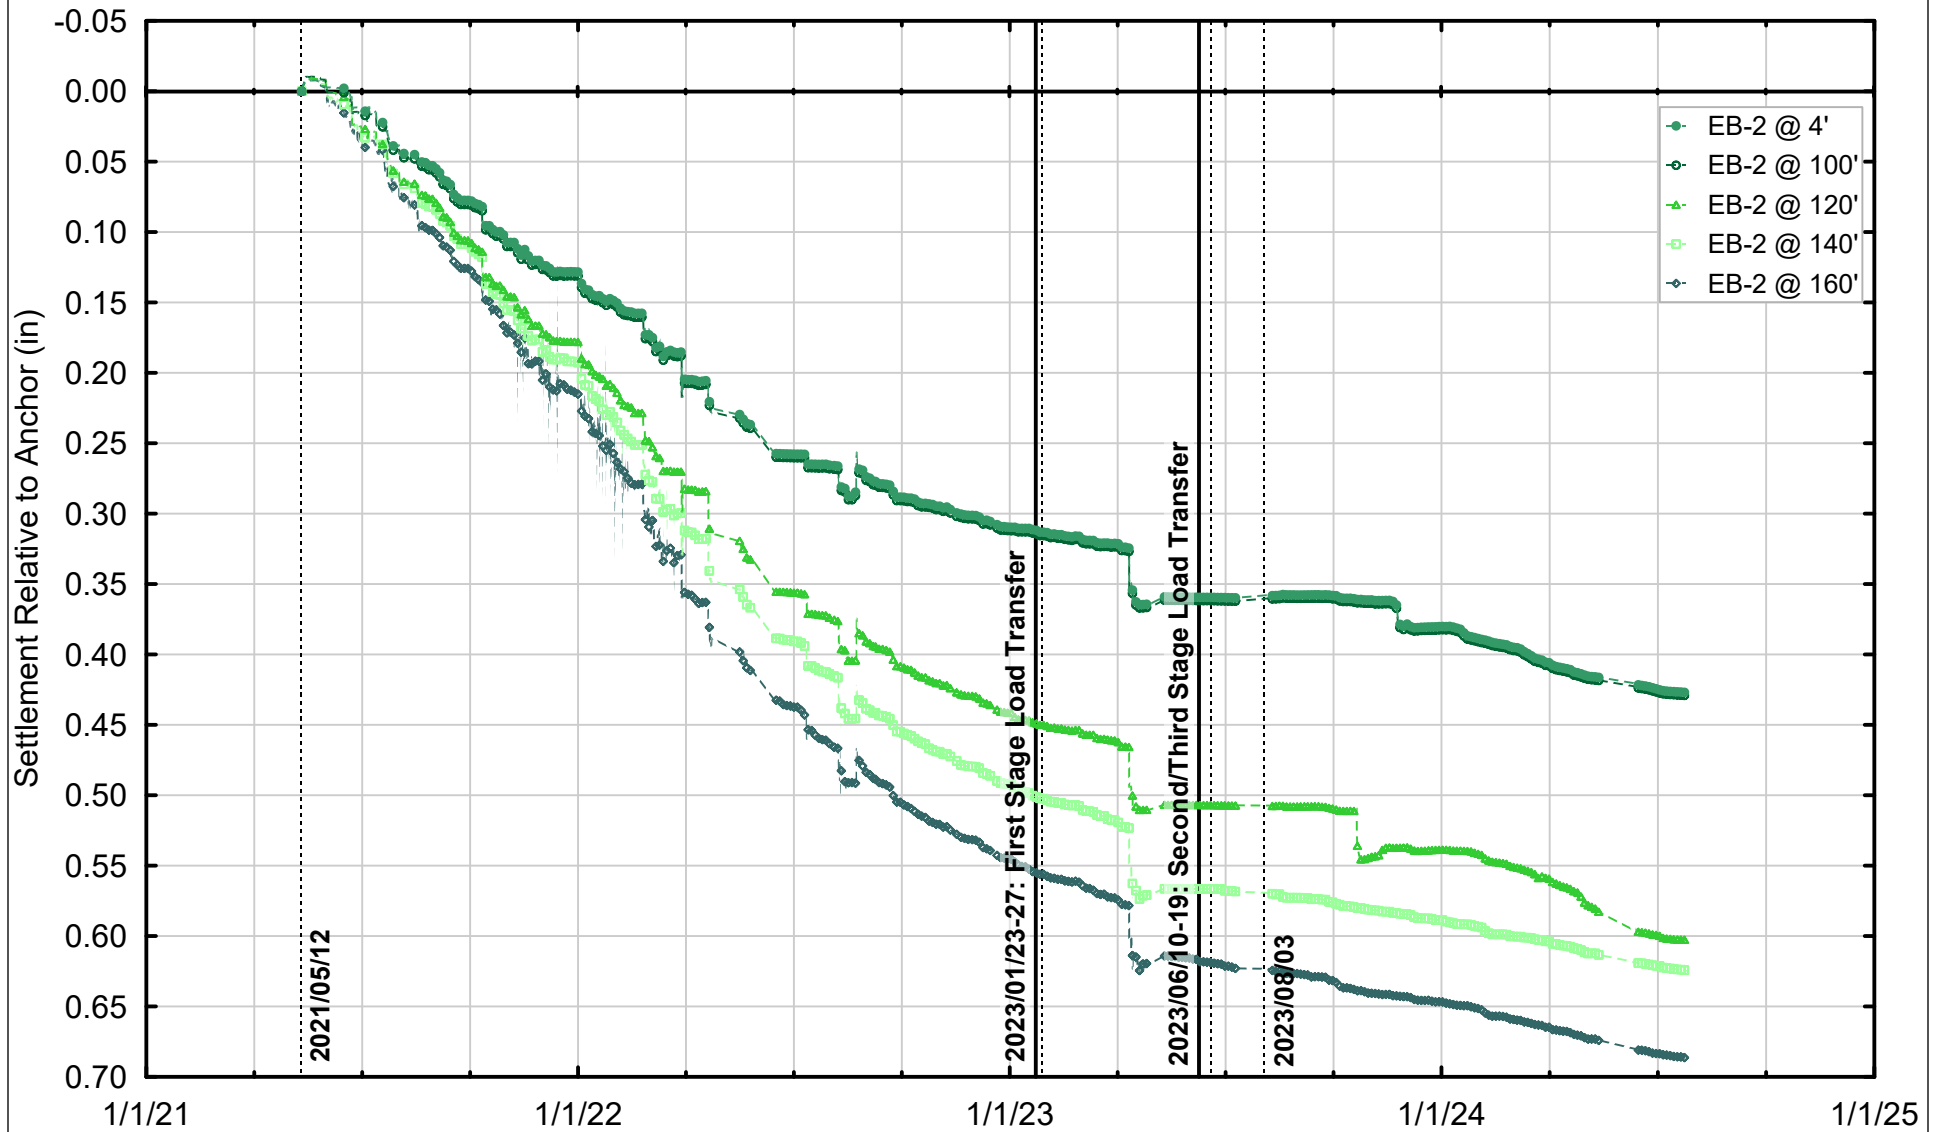
Project No: 23-018-01	Date: 7/29/2024	Created By: TB	Checked By: DGM	Figure No: 135-12
-----------------------	-----------------	----------------	-----------------	-------------------

EXTENSOMETER DATA FROM MISSION STREET
SINCE 01/01/2021 THROUGH 07/26/2024

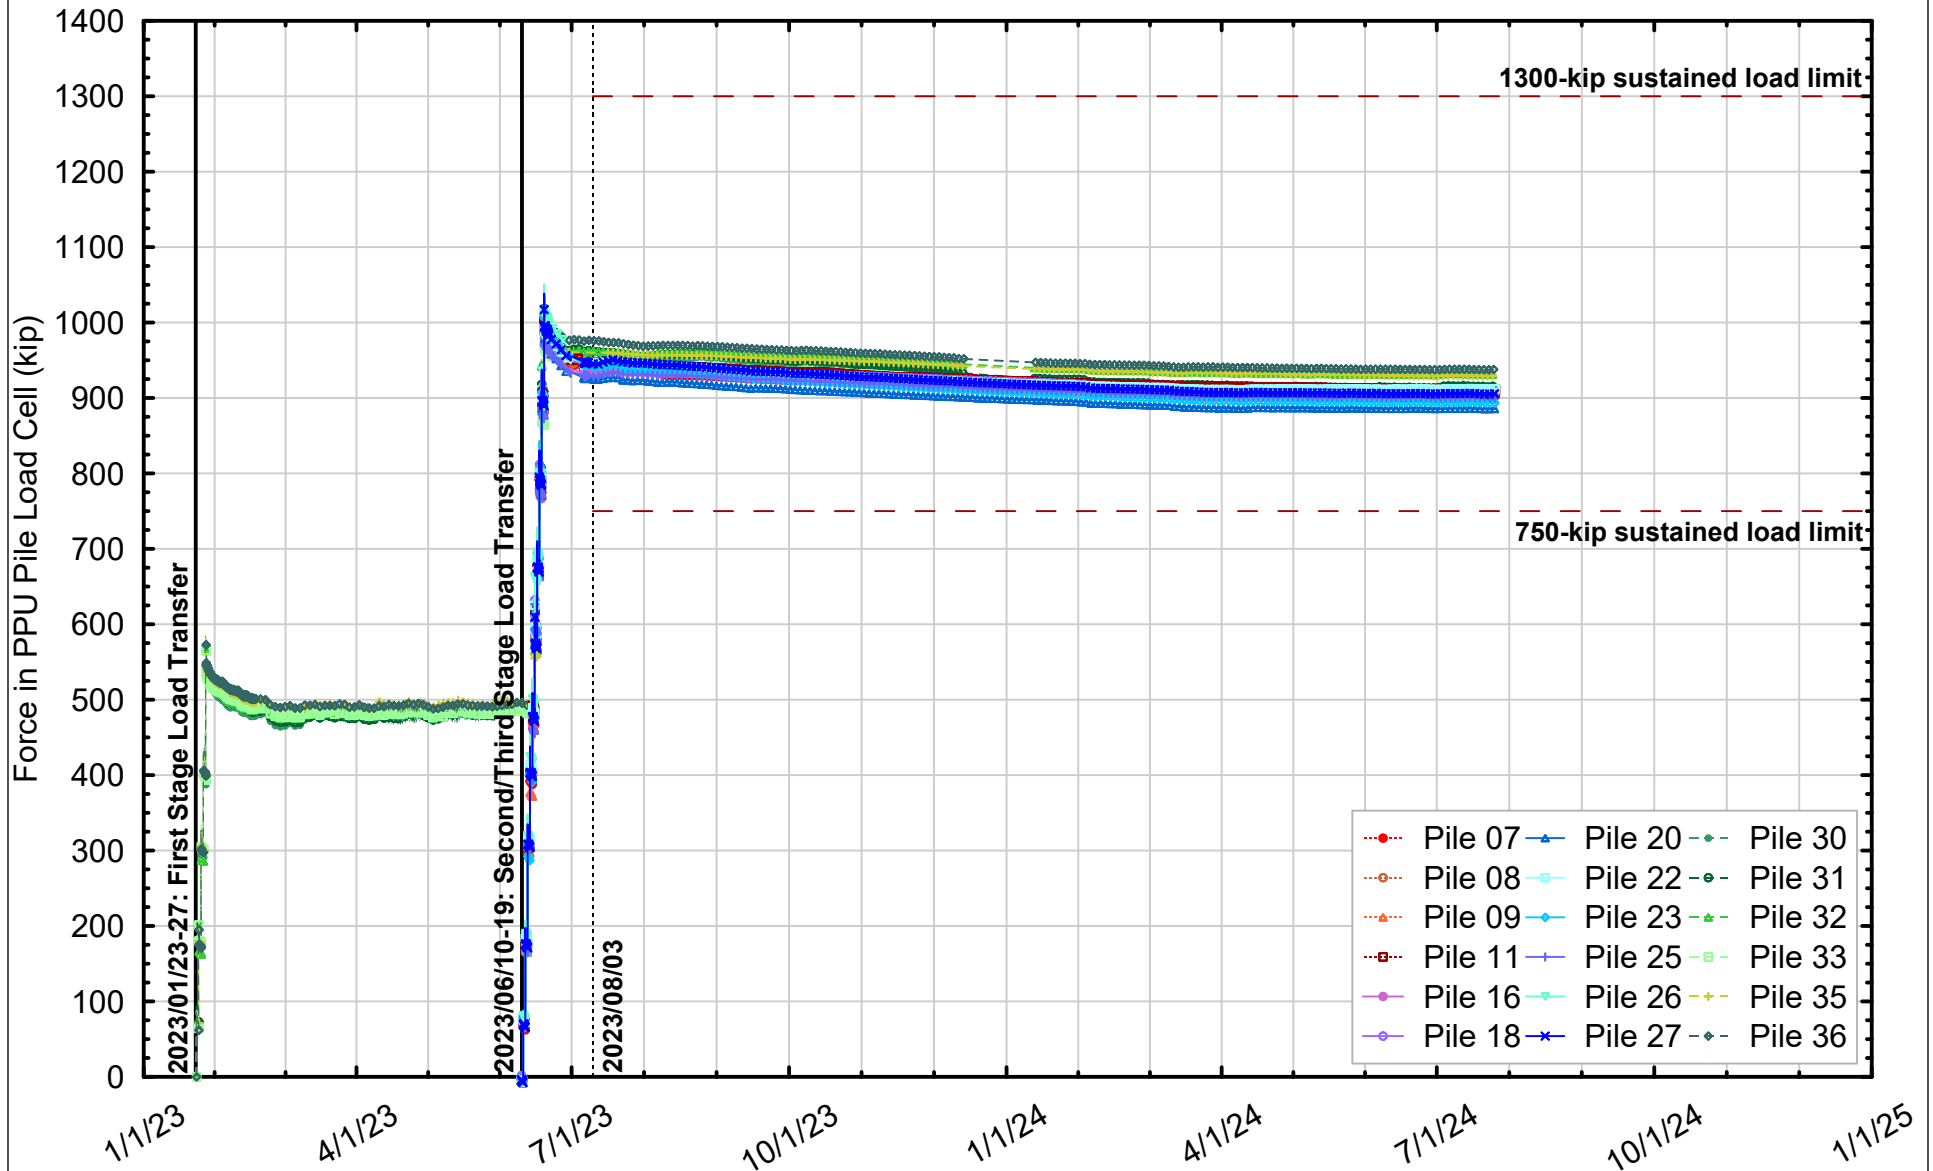
Project No: 23-018-01	Date: 7/29/2024	Created By: TB	Checked By: DGM	Figure No: 135-13A
-----------------------	-----------------	----------------	-----------------	--------------------

PILE LOAD CELL DATA
SINCE 01/23/2023 THROUGH 07/26/2024

Figure 13A presents pile load cell data since the start of the First Stage Load Transfer (January 23, 2023) through July 26, 2024. Figure 13B presents the total pile load cell data since July 15, 2023, through July 26, 2024.

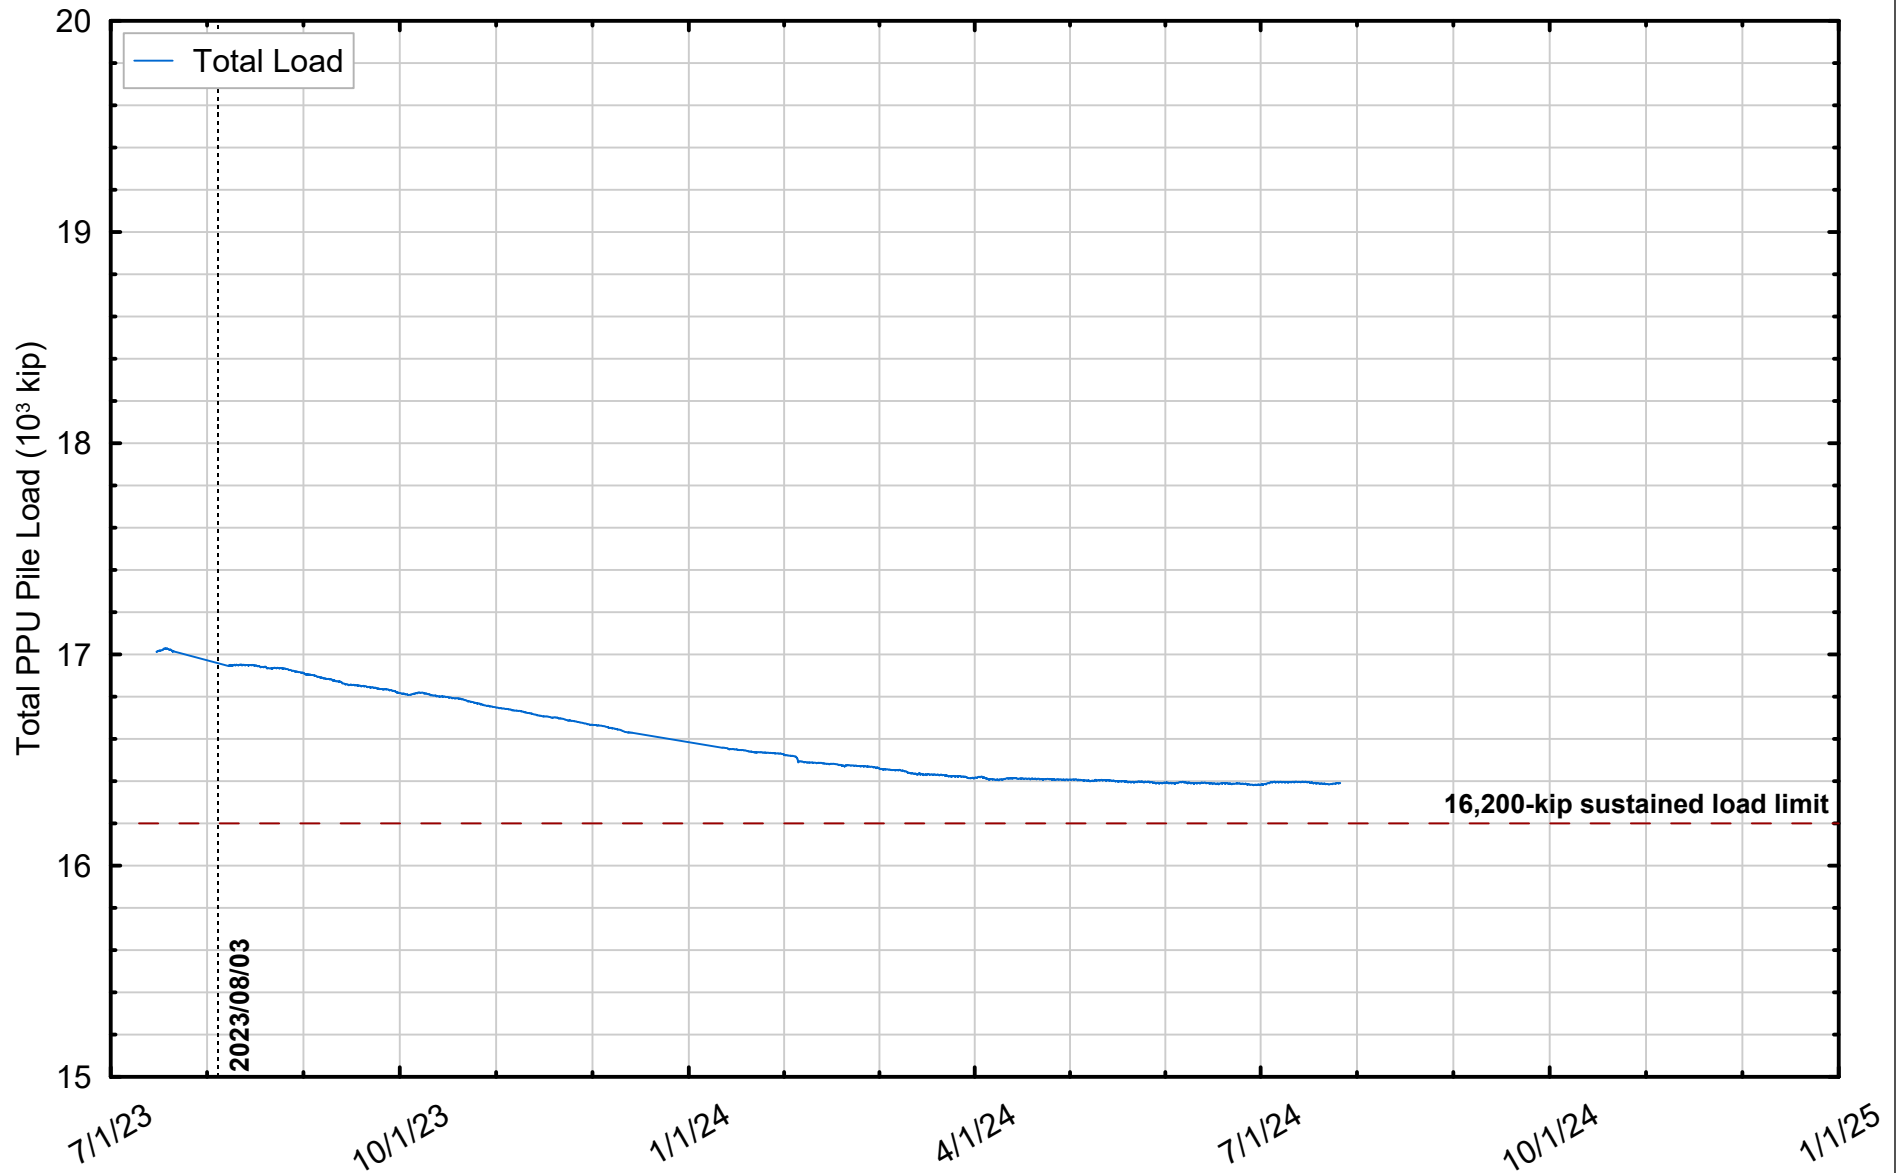
Project No: 23-018-01	Date: 7/29/2024	Created By: TB	Checked By: DGM	Figure No: 135-13B
-----------------------	-----------------	----------------	-----------------	--------------------

TOTAL PILE LOAD CELL DATA
SINCE 07/15/2023 THROUGH 07/26/2024

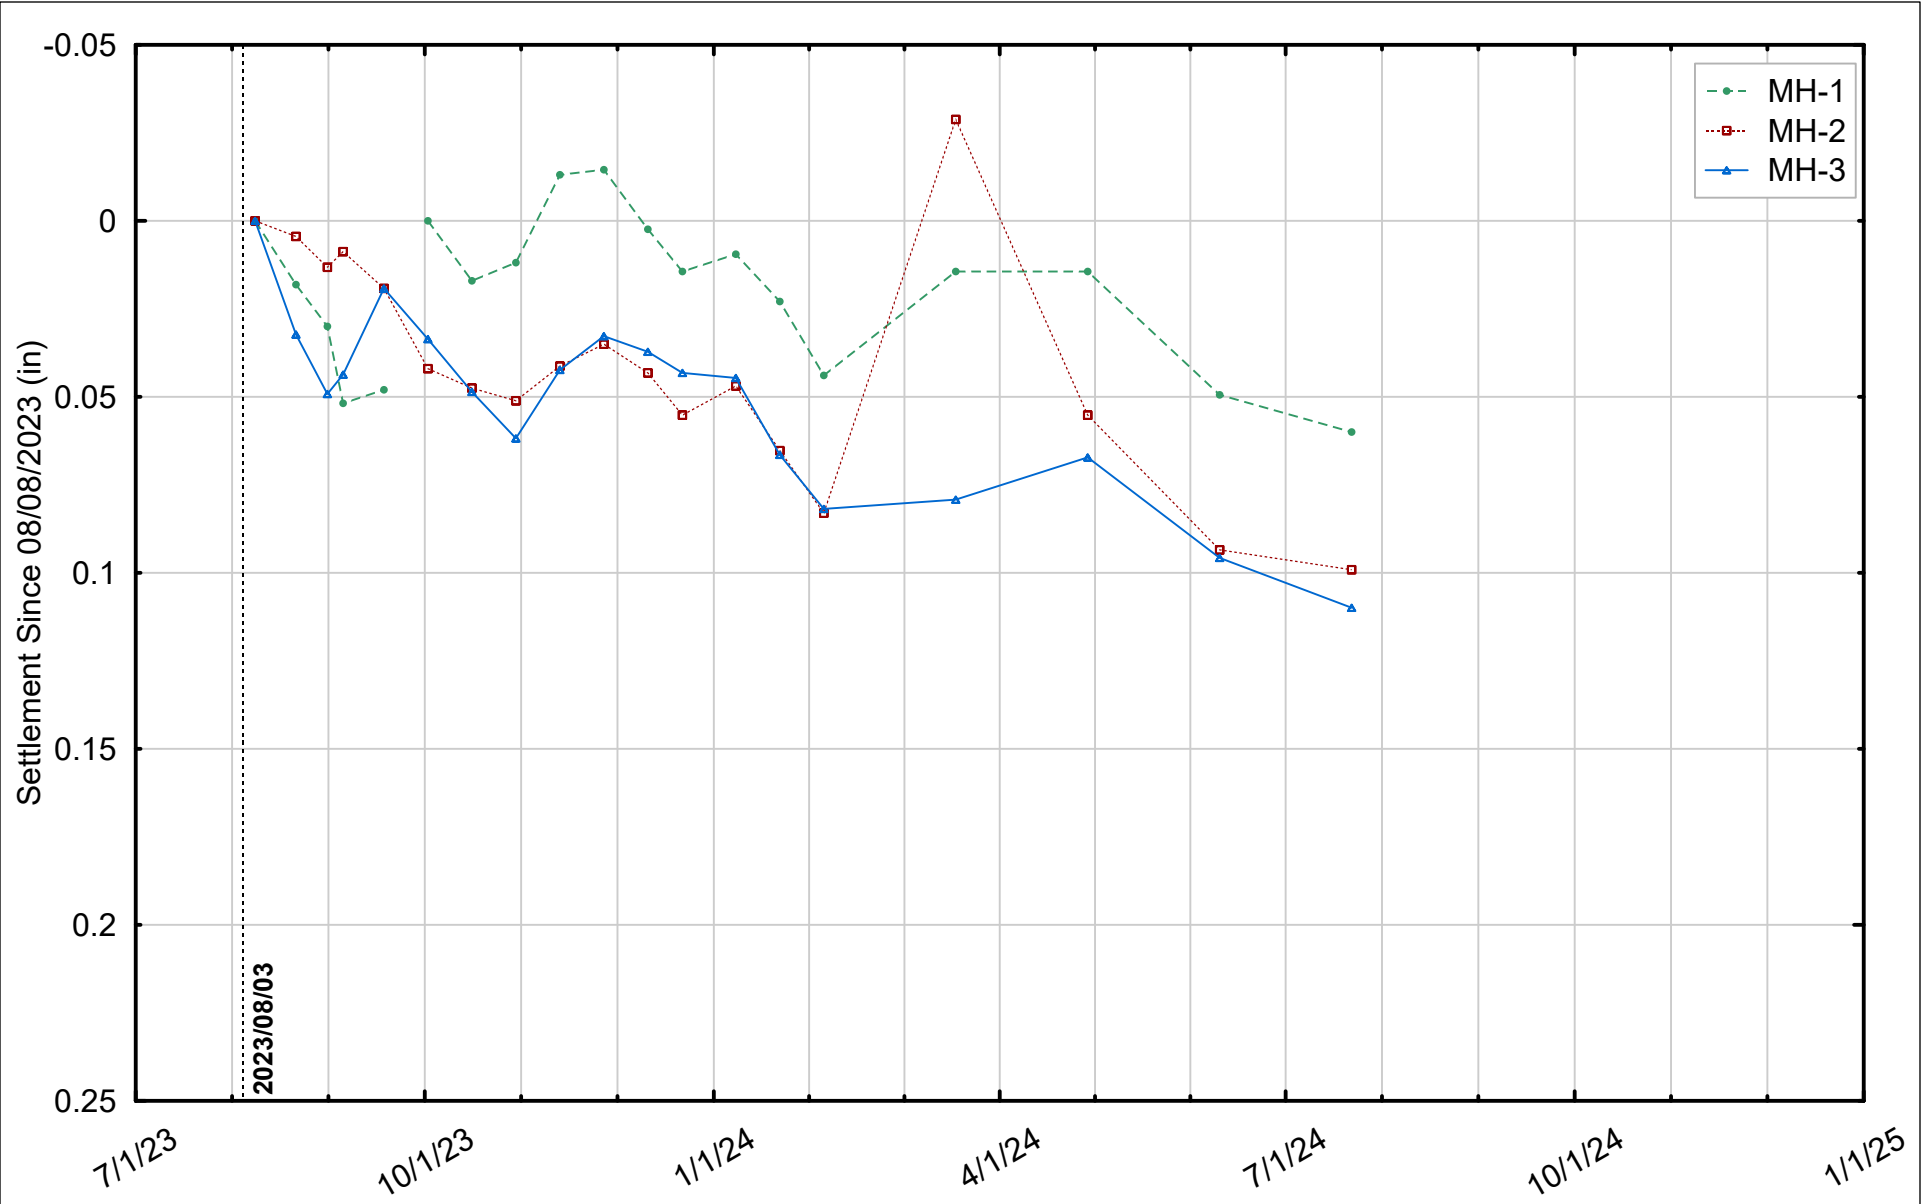
Project No: 23-018-01	Date: 7/29/2024	Created By: TB	Checked By: DGM	Figure No: 135-14
-----------------------	-----------------	----------------	-----------------	-------------------

Note: MH-1 was reset on 10/02/2023

MANHOLE SETTLEMENT DATA
SINCE 08/08/2023 THROUGH 07/22/2024

Figure 14 presents settlement data interpreted from survey points located on manholes around the Tower since August 8, 2023, through July 22, 2024.
