AEI Consultants

PROPERTY CONDITION REPORT - EQUITY

1979 and 1985 Mission Street and 2950, 2960, 2970 and 2978 16th Street
San Francisco, San Francisco County, California 94132

AEI Project No. 425780
Client Reference No.
Client Reference Name:

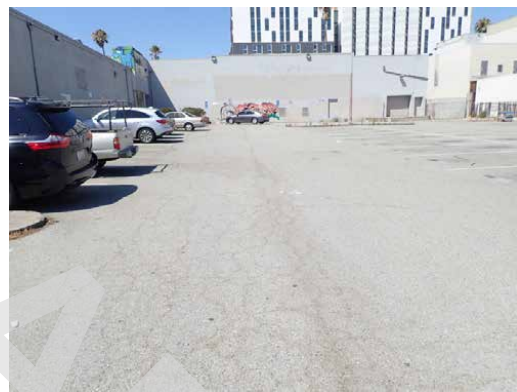
Alligatored asphalt

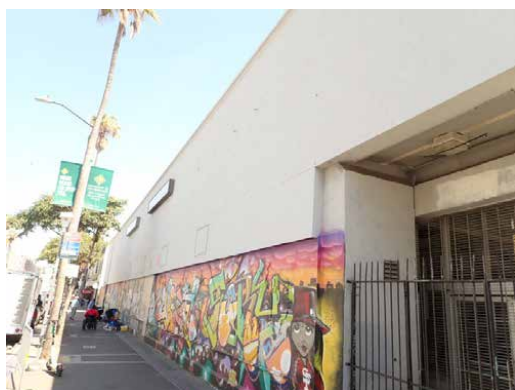
AEI observed damaged stucco cladding areas and graffiti on some areas of the building. Repair of the damage is recommended. An opinion of cost for this work is included in the Tables.

Typical graffiti mural along Mission St

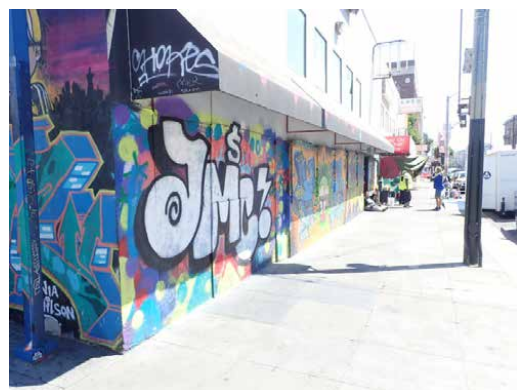
Typical graffiti mural along 16th St.

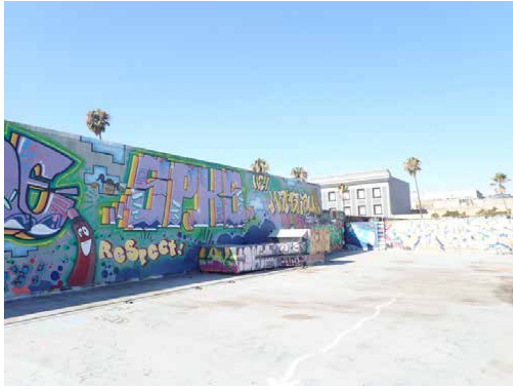
Roof area graffiti mural

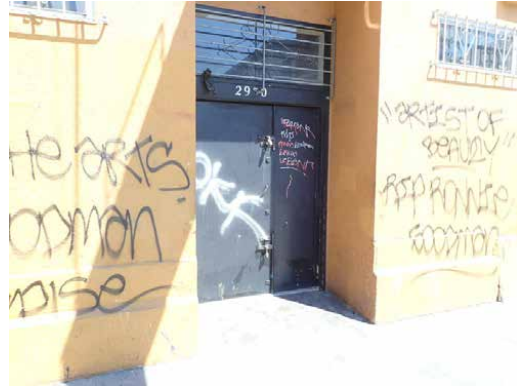
Typical graffiti along 16th St

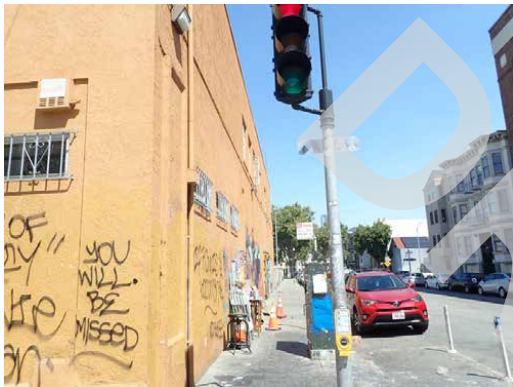
Typical graffiti along Capp St

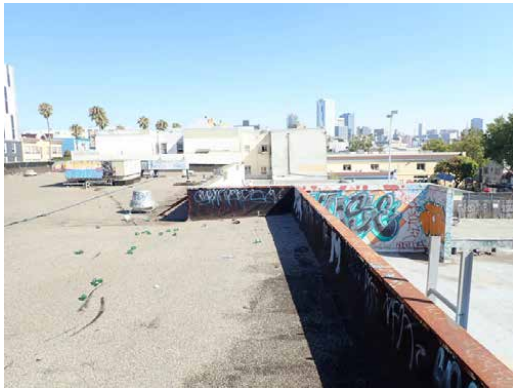
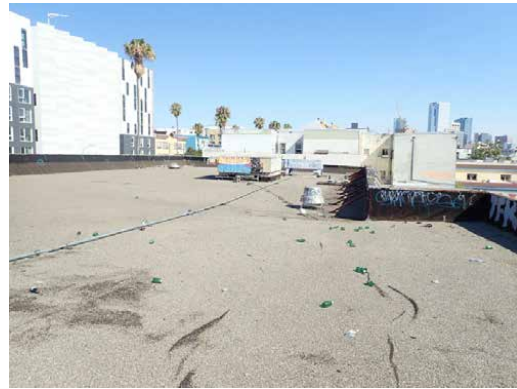
1979 Mission St BUR roof

Based on the condition and estimated RUL of these type of roofing, replacement should be budgeted during the evaluation period. An opinion of cost for this work is included in the Tables.

Cost Recommendation	EUL	EFF AGE	RUL	Year	Cost
1979 Mission St Roof area- Modified Bitumen Roof, Replace	-	-	-	Short Term	\$118,000

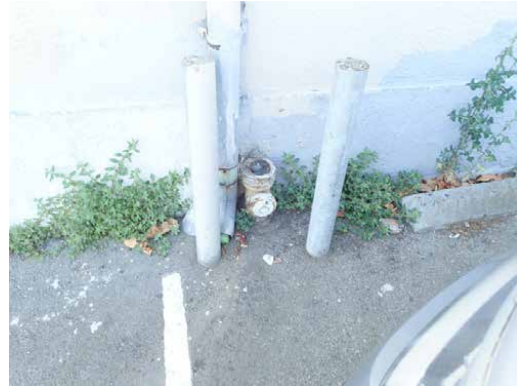
AEI observed that some to the downspout pipe were no longer connected to the leader pipes at ground level. It is recommended that all downspout be reconnect to all leader pipes. An opinion of cost for this work is included in the Tables.

Disconnect drain boot

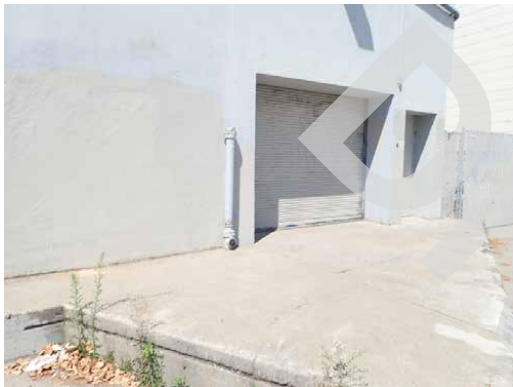
Disconnected downspout

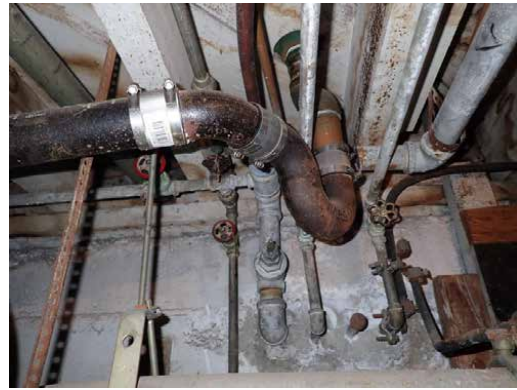
Galvanized piping

Cost Recommendation	EUL	EFF AGE	RUL	Year	Cost
Galvanized Piping, Replace	-	-	-	Short Term	\$15,000
Water heater. Replace (Gas-fired, 75 gallon)	15	10	5	5	\$1,750
				6	\$1,750
				7	\$1,750
				8	\$1,750
				9	\$1,750
				10	\$1,750
Unit 2960 install water heater seismic straps	-	-	0	Immediate	\$200
Total					\$25,700

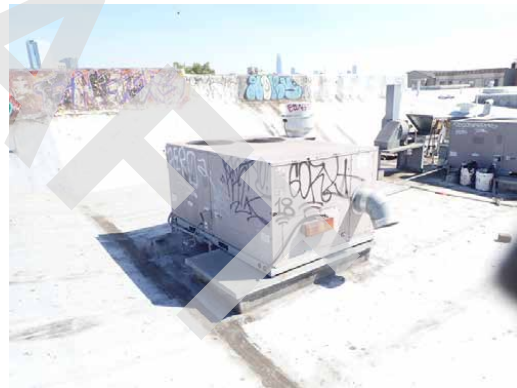
AEI observed that the HVAC units for tenant space 1979 appeared to be no longer operational and should be replaced. All other HVAC units observed have reached their EUL and should be replaced. An opinion of cost for this work is included in the Tables.

2950-2978 16th St- RTY

Cost Recommendation	EUL	EFF AGE	RUL	Year	Cost
Packaged rooftop unit, Replace	15	15	0	Short Term	\$132,000
Air Handling Unit, Replace	30	30	0	Short Term	\$9,000
Total					\$141,000

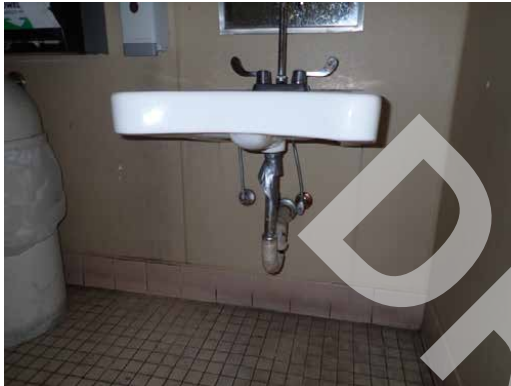
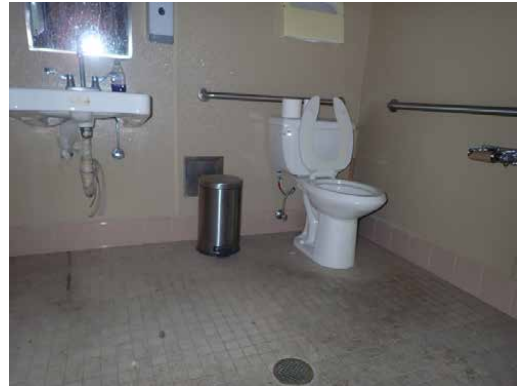
Unit 1979 restroom

All of the tenant restrooms at this site are in fair to poor condition and need to be refurbished. Cost for this work is included in Section 3.4.3. The scope of work should include addressing all achievable ADA deficiencies.

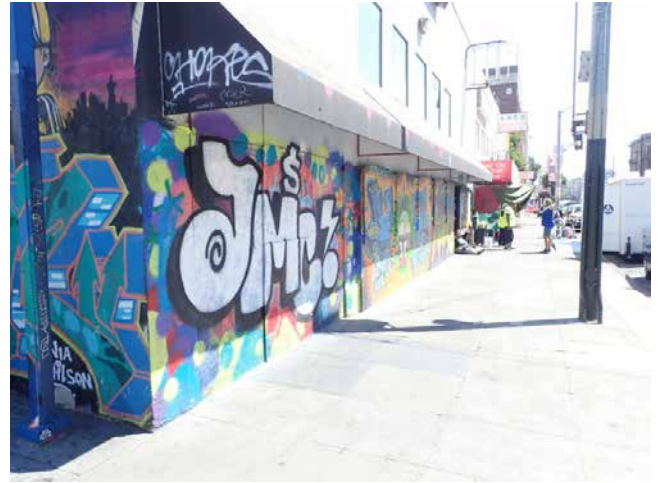
13. Public sidewalk area- east elevation

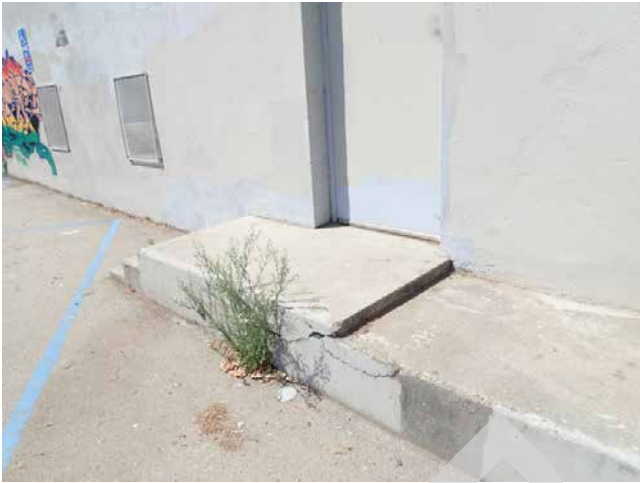
16. Sidewalk area to entrance to 1985 Mission St along Mission St.

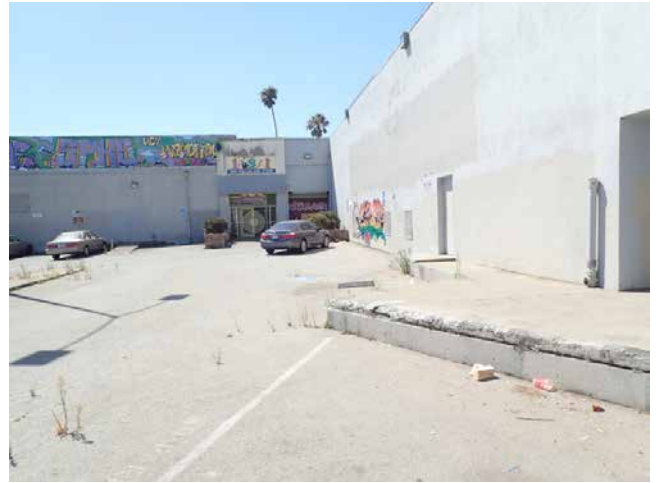
17. Sidewalks

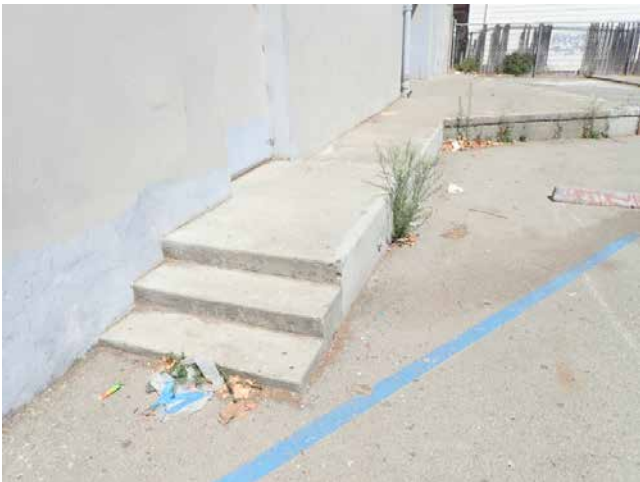
18. Sidewalks

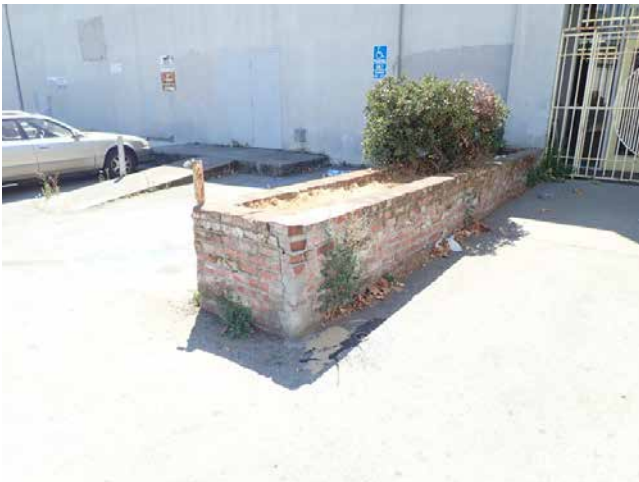
22. Landscape planter

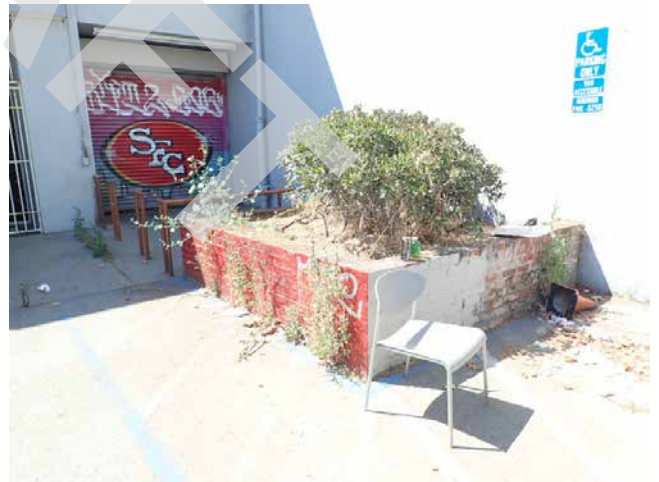
23. Brick planter

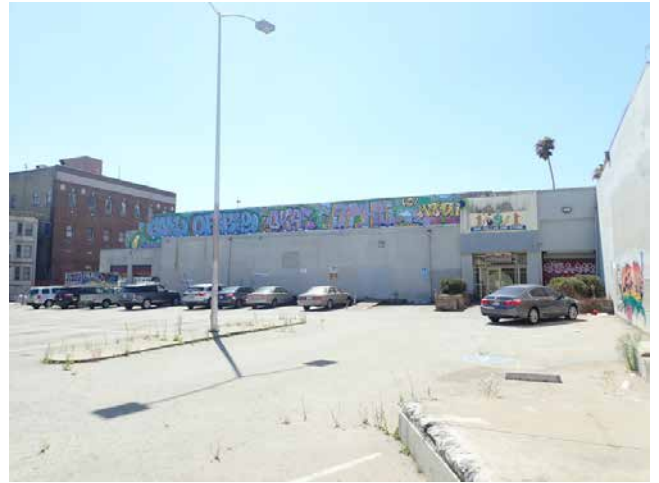
25. Parking lot

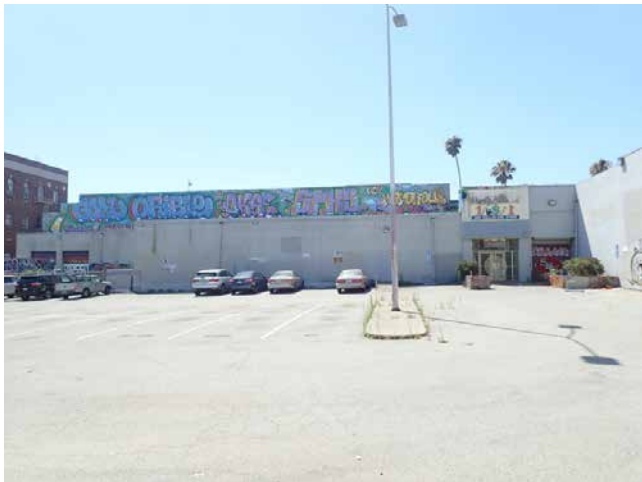
26. Parking lot

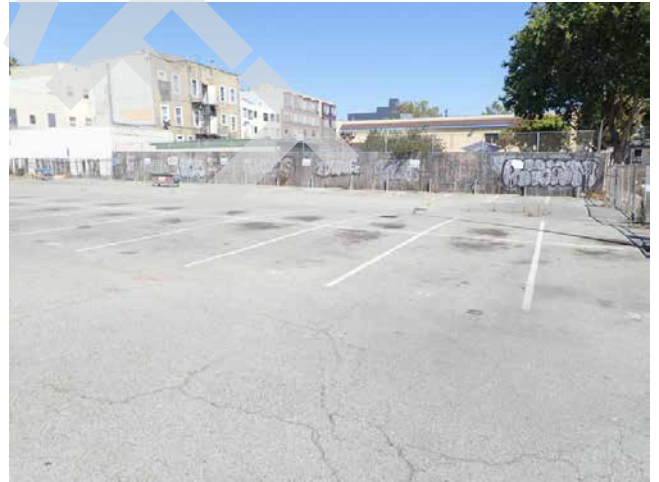
39. Loading dock area- 1979 Mission St

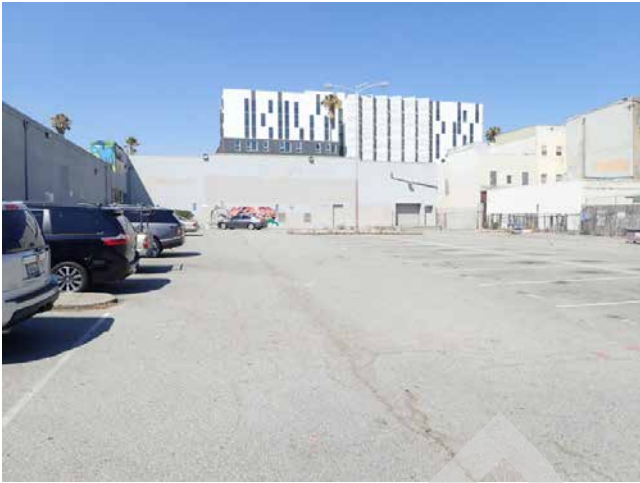
40. Parking lot

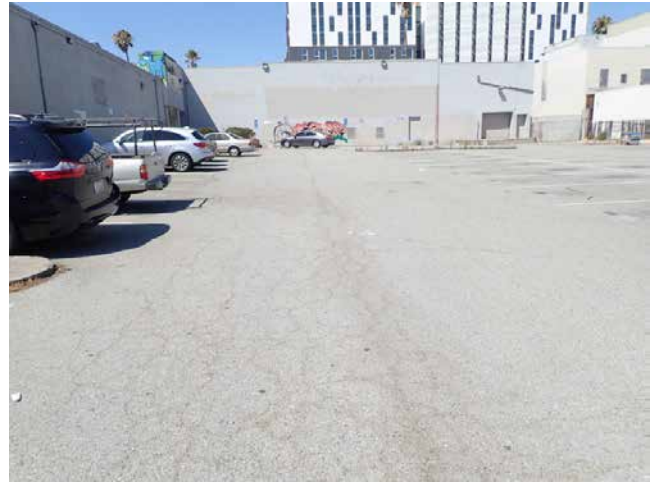
41. Parking lot

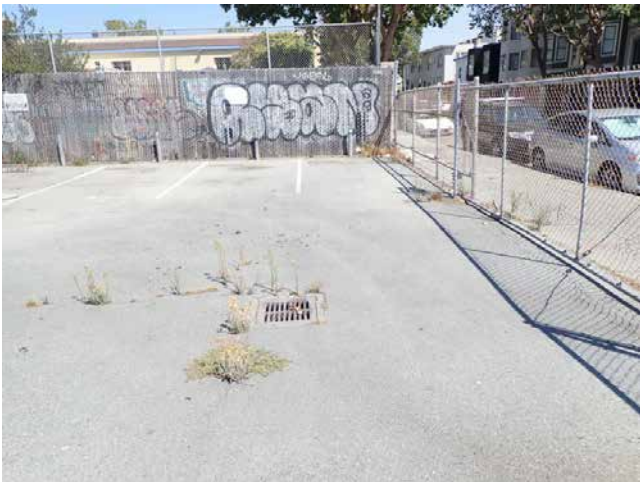
42. Alligatorred asphalt

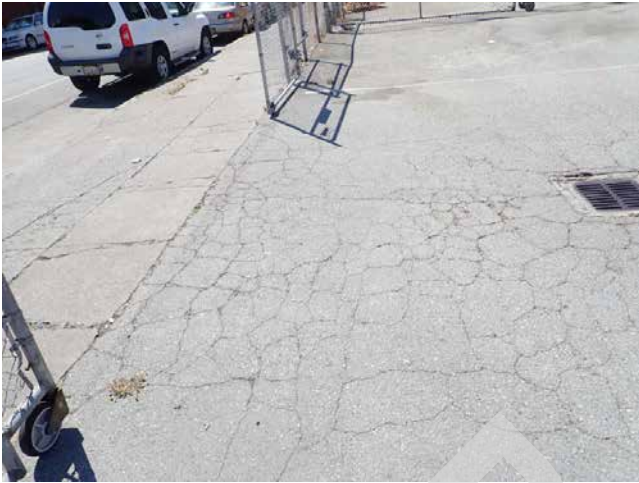
44. Parking lot entrance apron

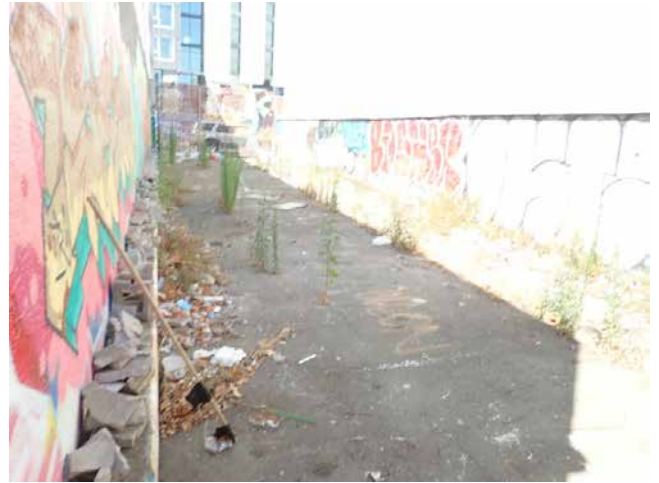
45. Alligatored asphalt

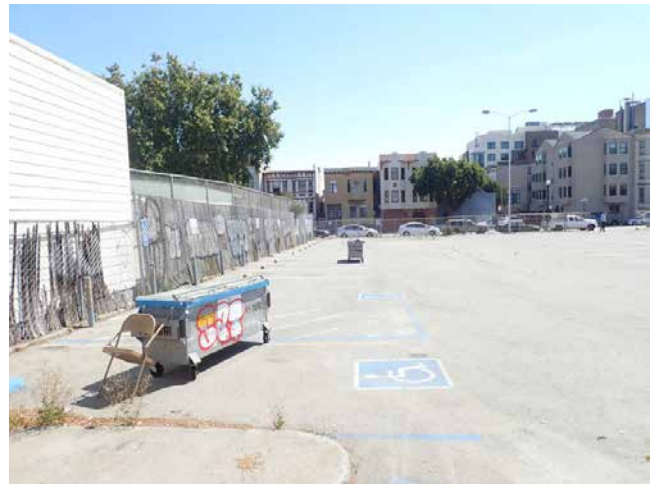
49. Typical handicap parking stall

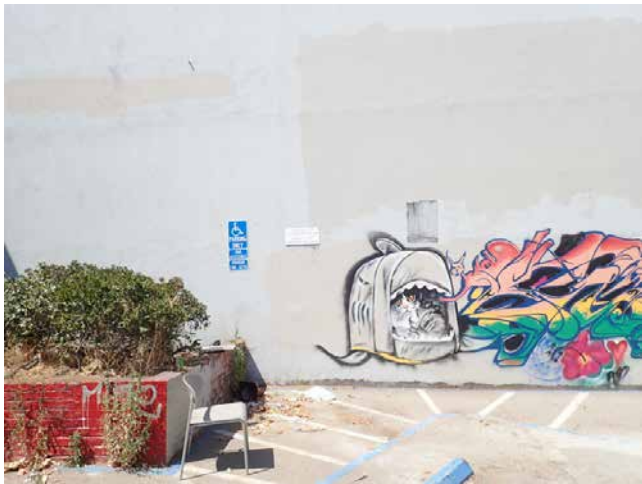
50. Typical handicap parking spaces

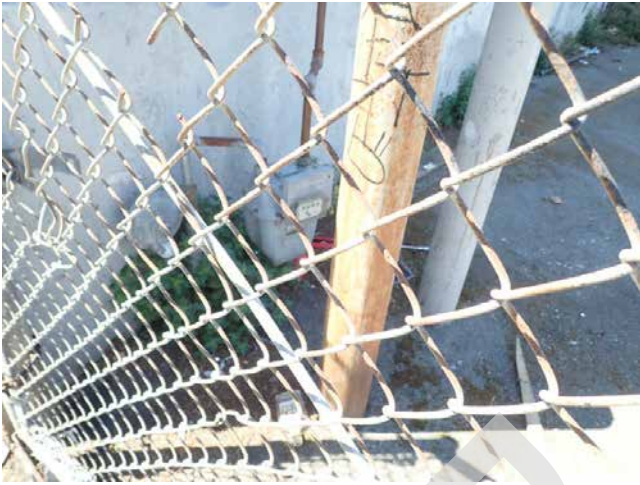
52. Water meter

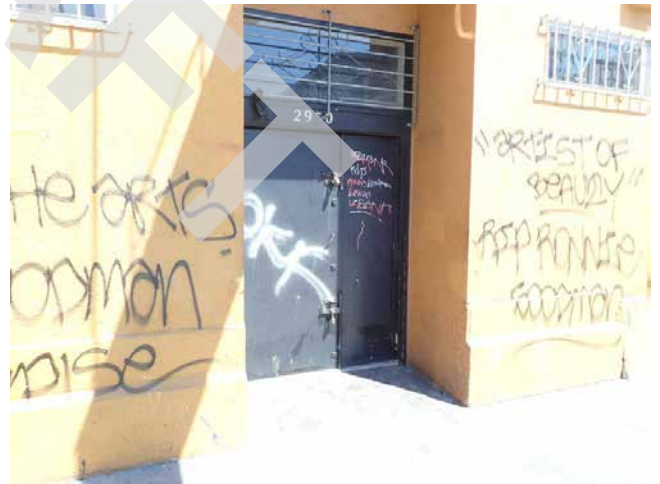
67. Typical store front windows and doors- 2960 16th St.

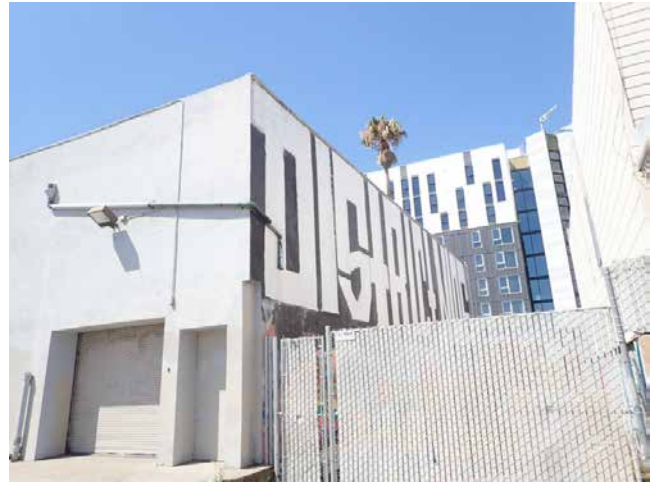
69. Dumpster storage area east side of 1985 Mission St.

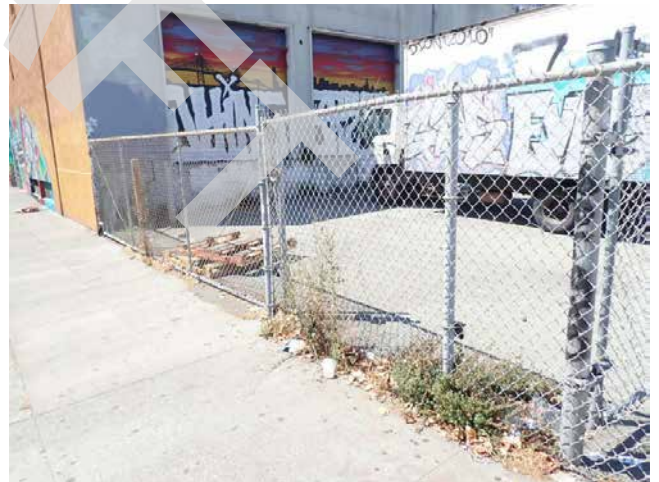
71. Fencing

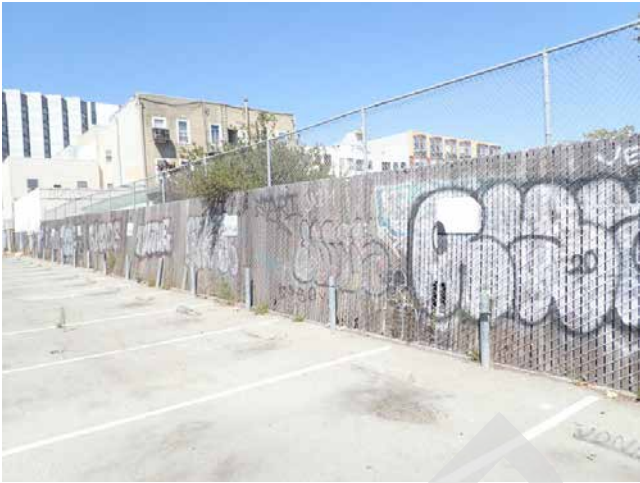
72. Fencing

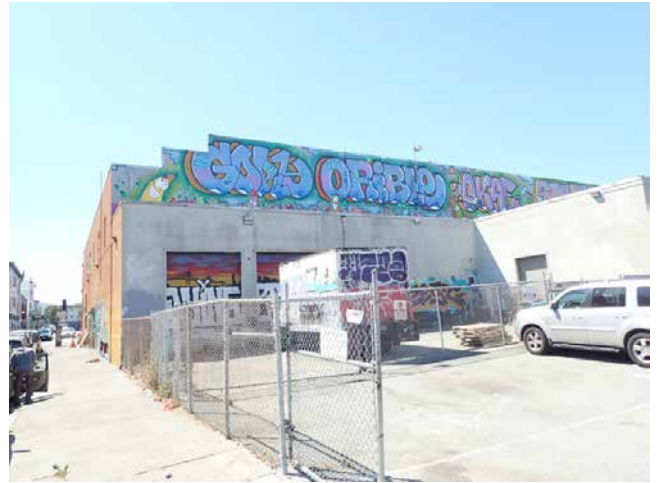
73. Fencing

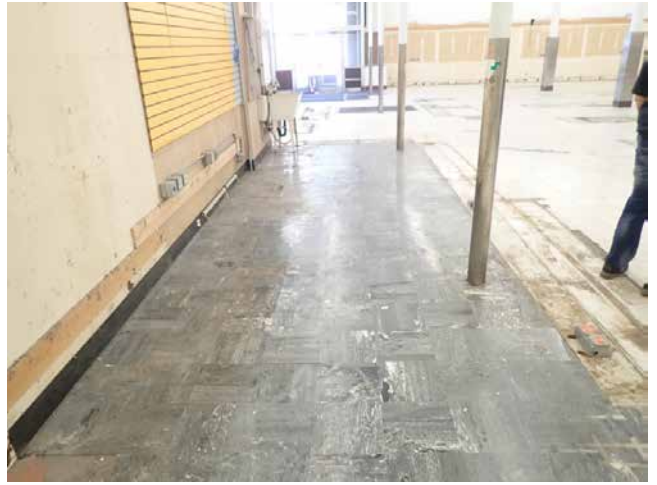
81. 1979 Mission St Framing

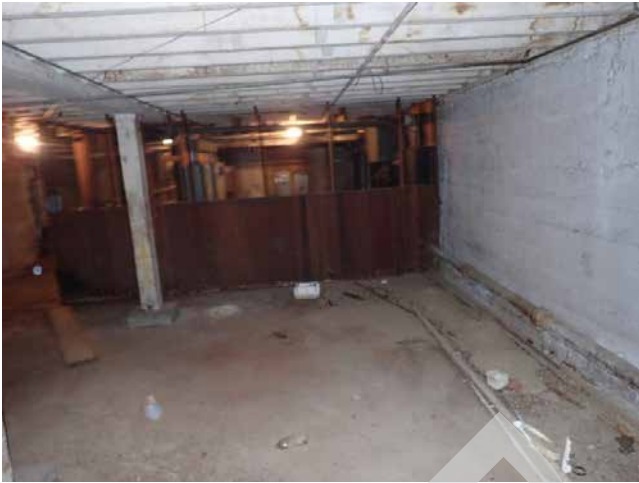
92. 1985 Mission St / 2950-2978 16th St framing

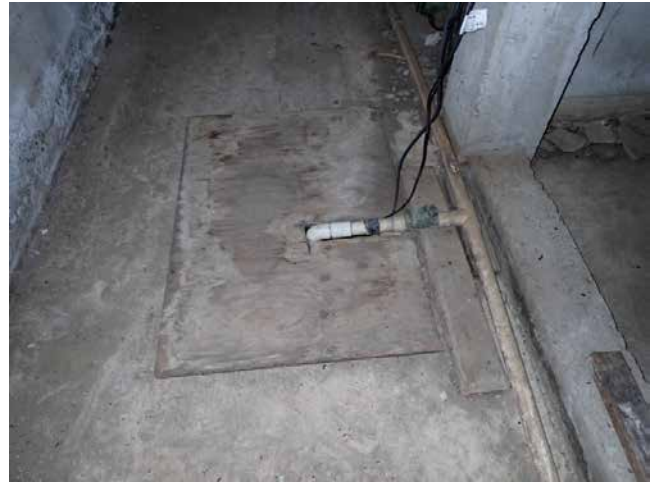
93. 1985 Mission St / 2950-2978 16th St foundation

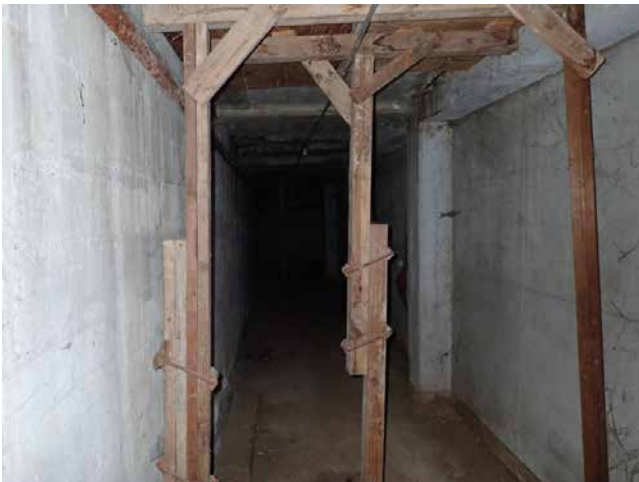
94. 1985 Mission St / 2950-2978 16th St foundation

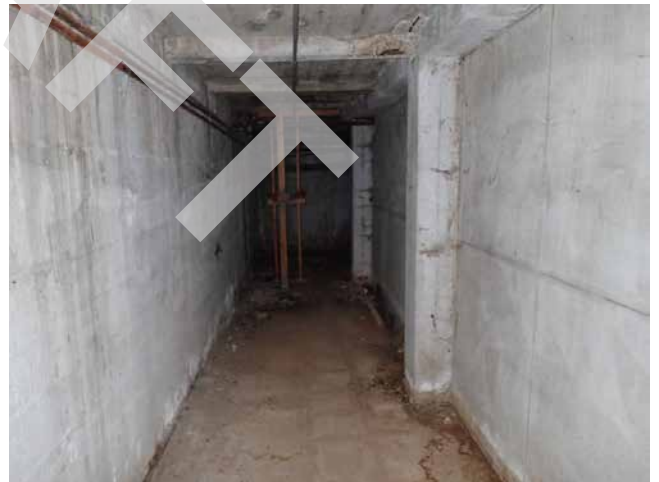
95. 1985 Mission St / 2950-2978 16th St foundation

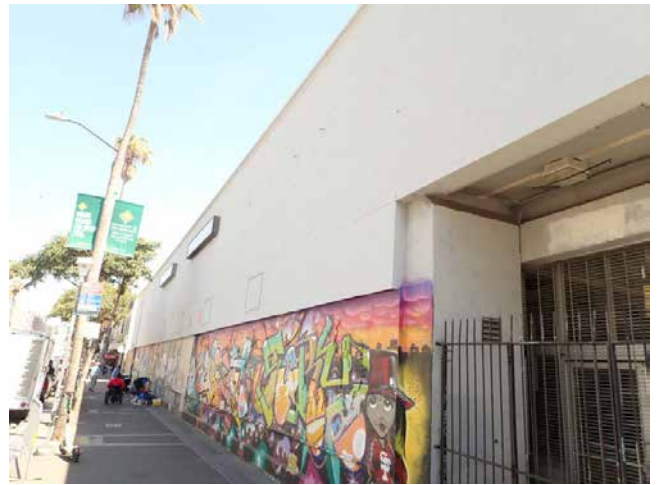
105. Typical graffiti mural

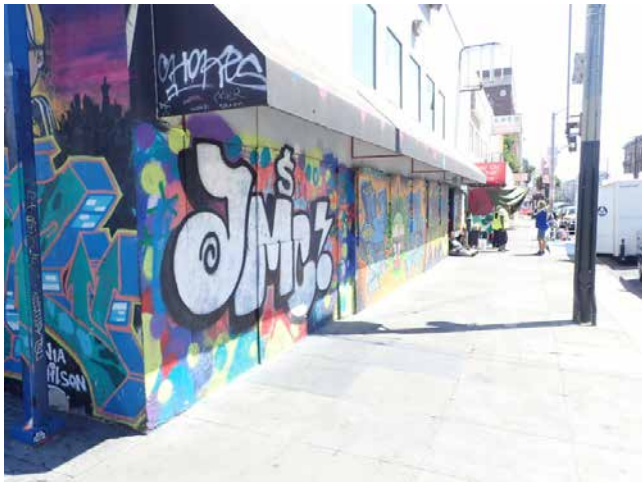
106. Typical graffiti mural

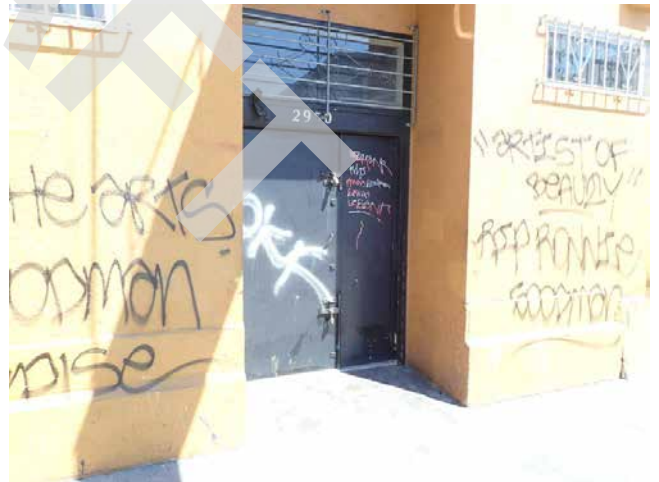
107. Typical graffiti mural

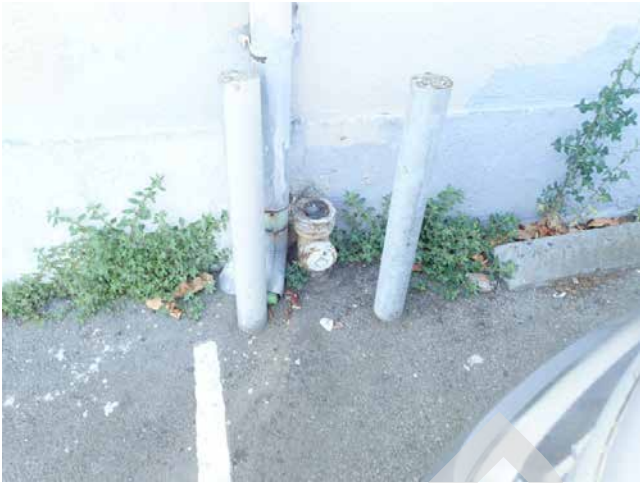
172. Roof downspout modification
